Quality Control Report

ConsultantWahib MedanatConsultant EngineersSite NameJumana Bint Abi Taleb Basic Mixed - MarkaPackagePackage 2ContractorDijlah Est. Construction Co.Tender No.10/2019/USAID/SKEP/3/2			Rep No. Date	QC-23 06 27 /07 / 2021
Descr	iption of Non	Corrective Action	Req	uired by / When
Co	nformance			
 Number of stones have broken edges. Gaps between stones have to be unified. Chesseling pattern has to be unified for all stones as per approved sample. Wooden wedges have to be removed from inside before 		 Broken stones have to be removed. Gaps to be rectified where possible. Stones not complying with sample has to be removed. Wedges to be removed- follow up by SE. Steel ties to be stronger and more fixing points- follow up By SE. 	The Contractor/Immediately

Schools for Knowledge Economy Project SKEP III

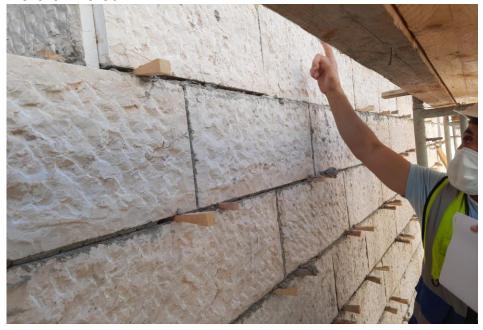
Remarks on the stone work as per report

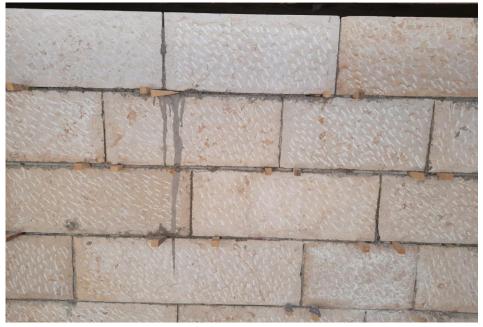
Remarks on the stone work as per the report

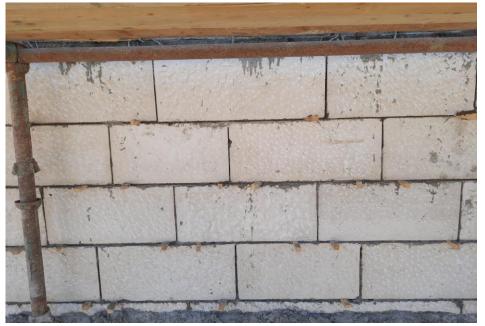
Remarks on the stone work as per the report

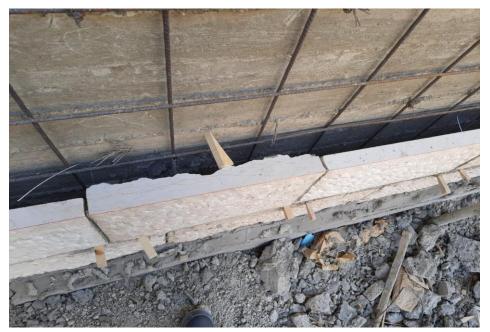
Remarks on the stone work as per the report

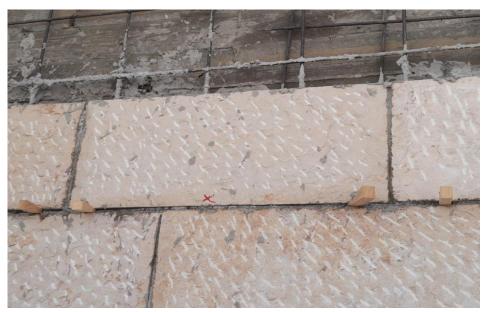
Pointing on the defected stone to be removed

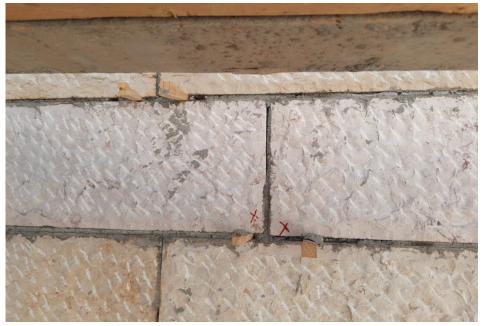
Pointing on the defected stone to be removed
