Quality Control Report

Consultant **Wahib Medanat** Consultant Engineers
Site Name **Jumana Bint Abi Taleb Basic Mixed - Marka**
Package **Package 2**
Contractor **Dijlah Est. Construction Co.**
Tender No. **10/2019/USAID/SKEP/3/2**

Rep No. **QC-23 13**
Date **18 / 12 / 2021**

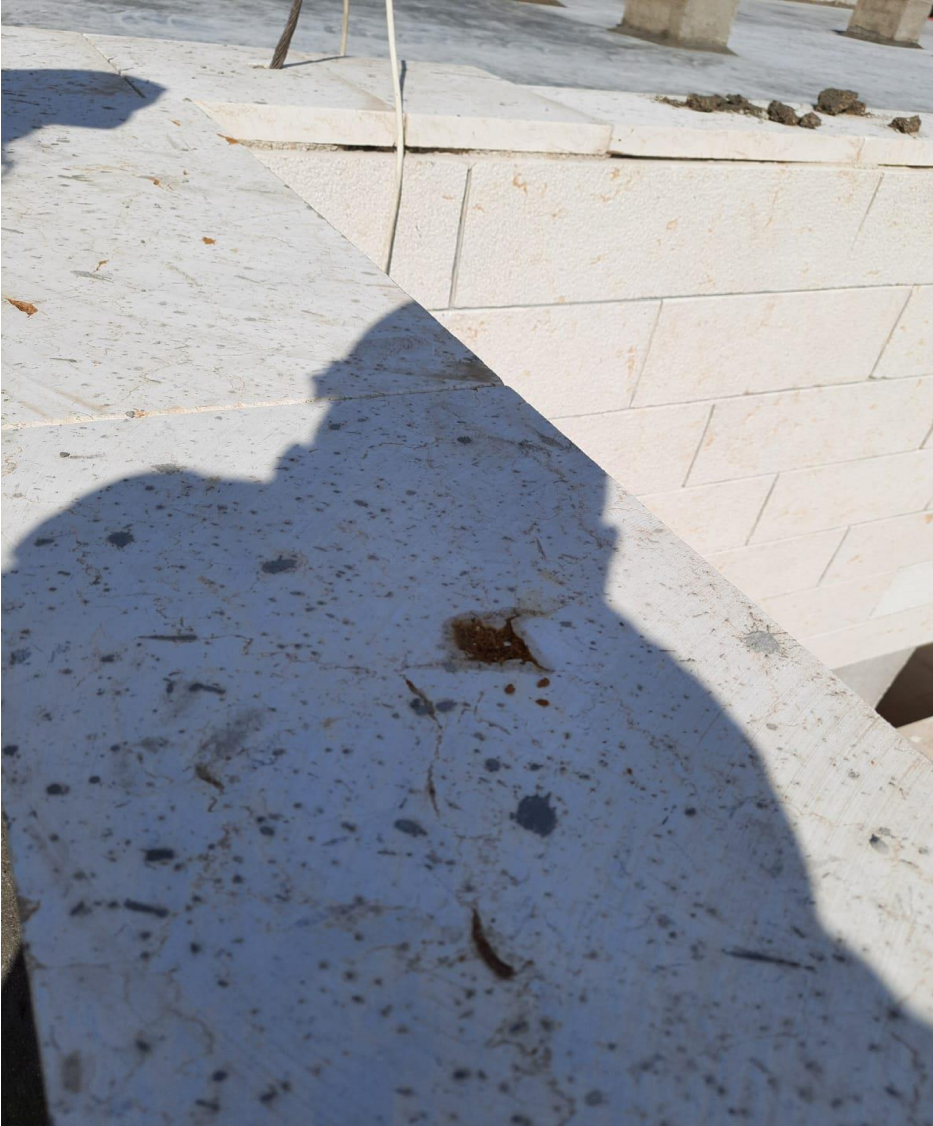
Defected stone coping

| Description of Non Conformance | Corrective Action | Required by / When |
|---|--|---|
| <ol style="list-style-type: none"> 1. Defects in coping. 2. Defects in granite of staircases. 3. Defects in floor tiles. 4. Defects in stone cladding. 5. Finishing work for corners is not done properly. | <ol style="list-style-type: none"> 1. Replace defected coping. 2. Replace defected granite tiles. 3. Undergoing/to be checked. 4. Defected stones to be replaced. 5. Rectify to reach sharp corner. | The Contractor/Immediately |

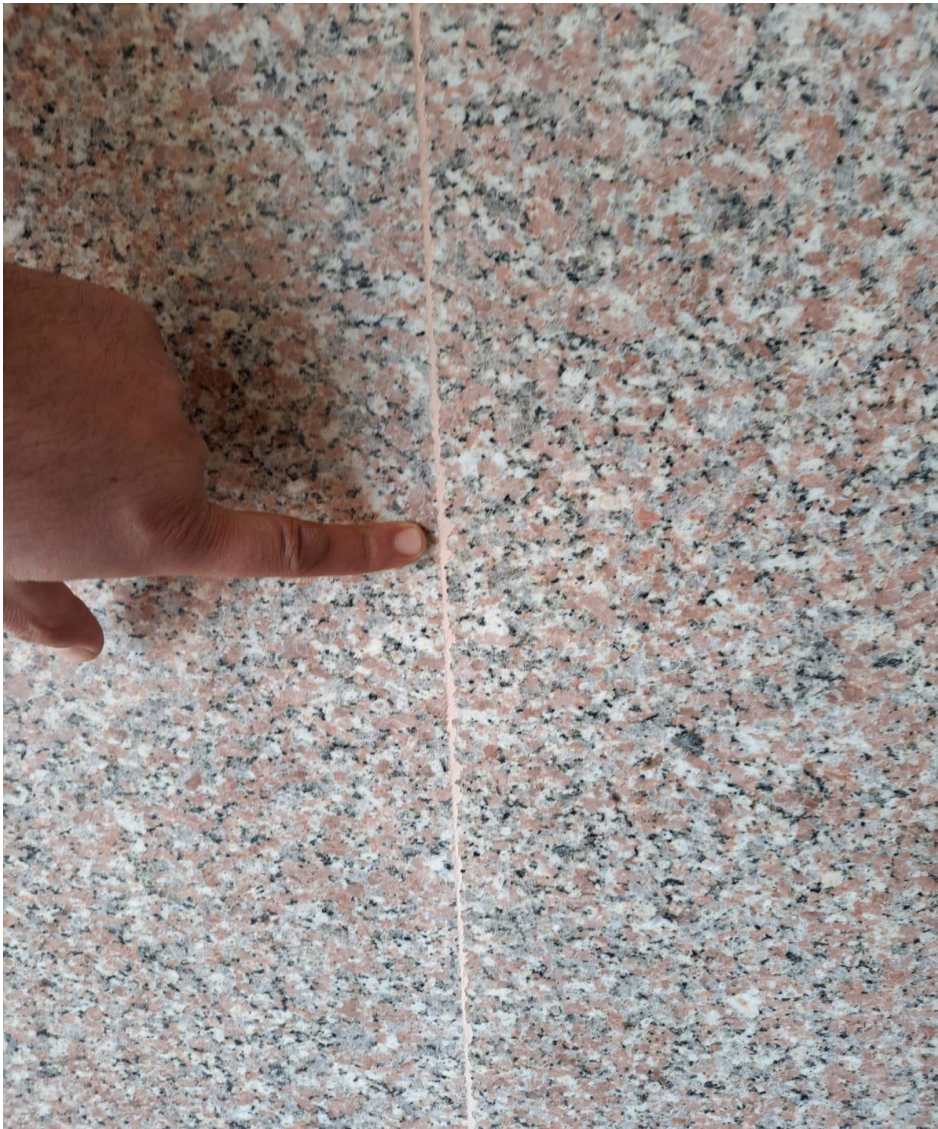
Defected granite tiling

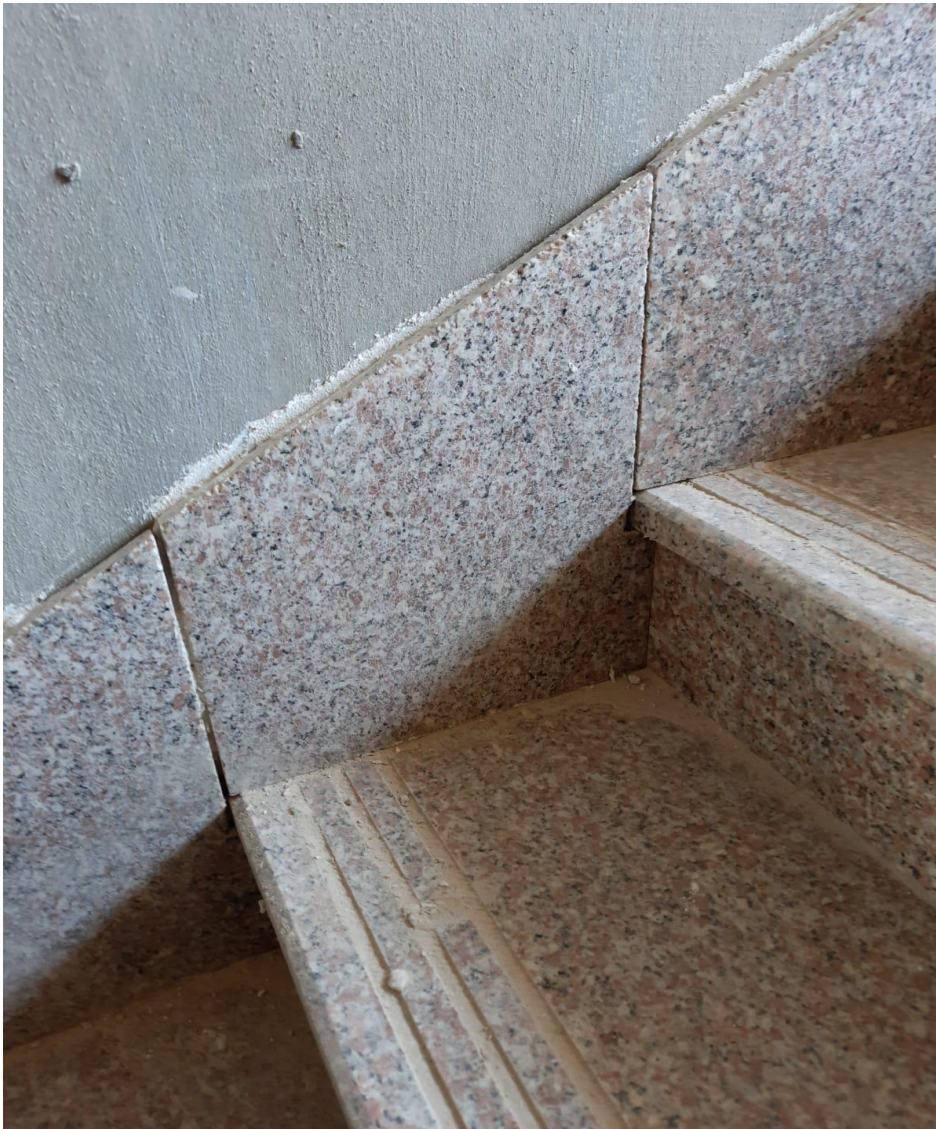
Defected granite tiling

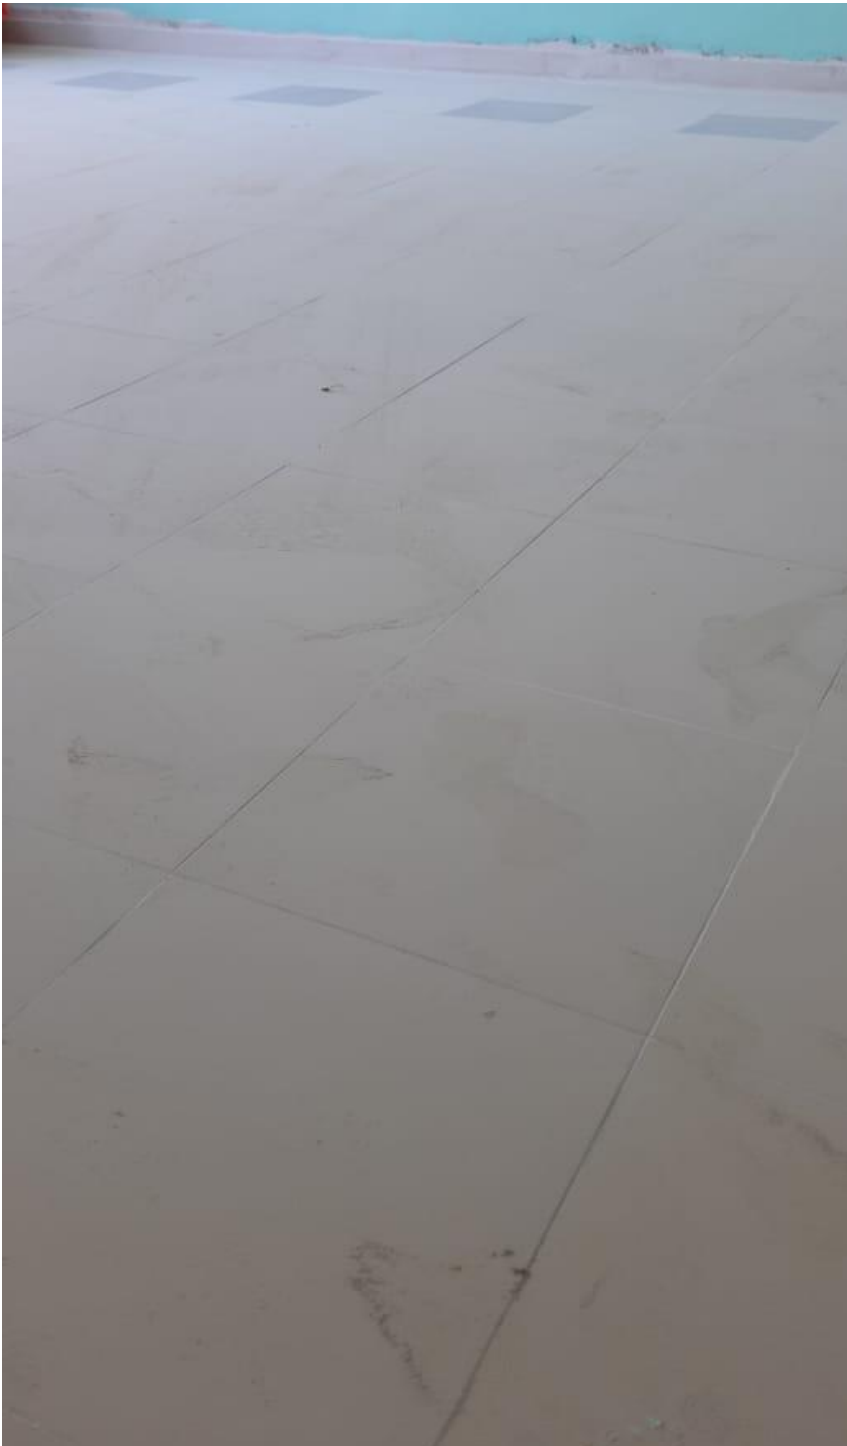
Defected porcelain floor tiles

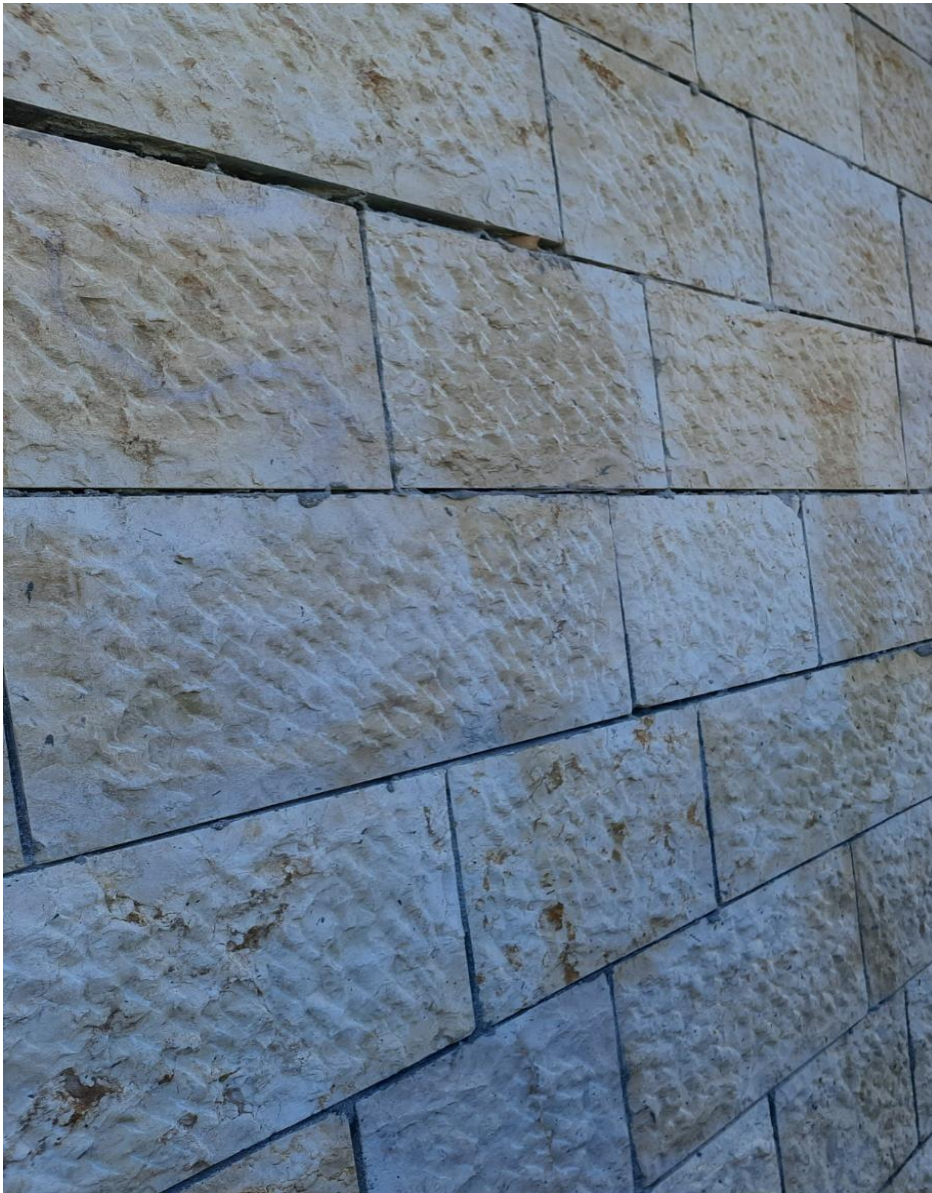
Defected stone

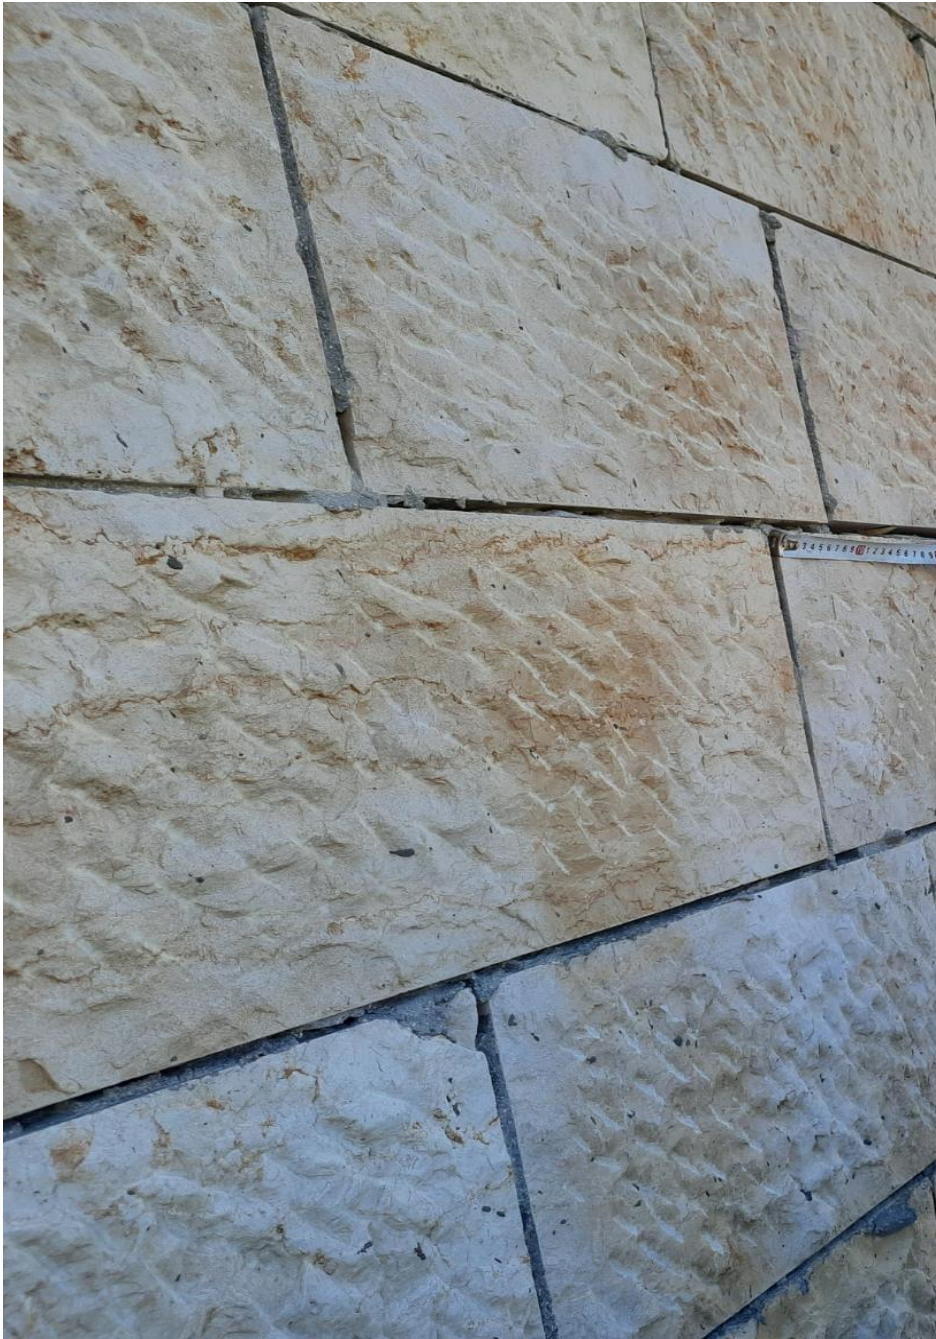
Defected stone

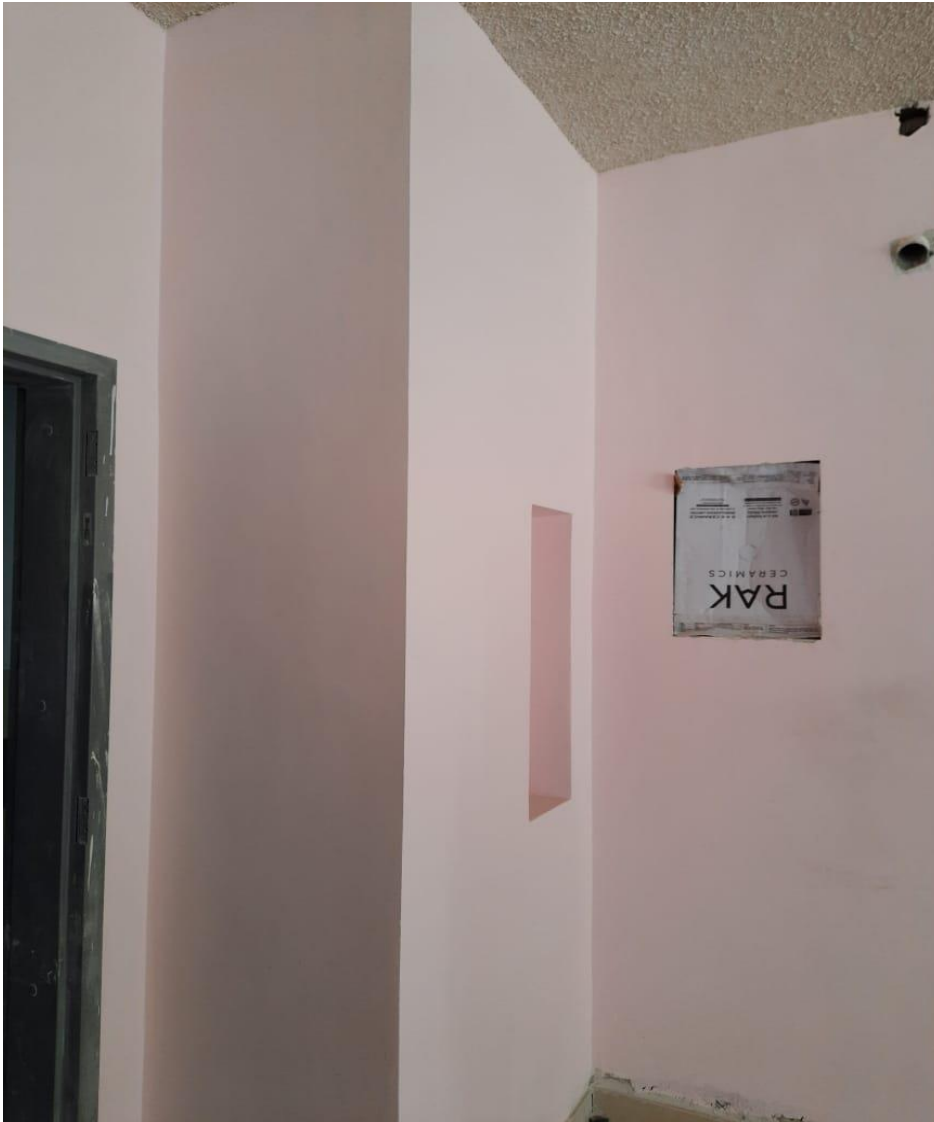
Corners not done properly
