Site Visit Report Form

Program (JSEP or SKEP):	SKEP PHASE: III PACKAGE: 2
School Name:	Thahr Al Sarow Basic Boys School
Supervisory Engineer (SE) Name:	Medanat
Construction Contractor (CC) Name:	Dijlah Contracting Co.
Date and Time of Field Trip:	June 21,2021
Date of Report:	June 24,2021
Weather During Visit	Sunny, 32 Degrees
Prepared By:	Mohammad Sami Ali-Ahmad CMTO/Trigon
Submitted By:	Osama Obeid CMTO/Trigon

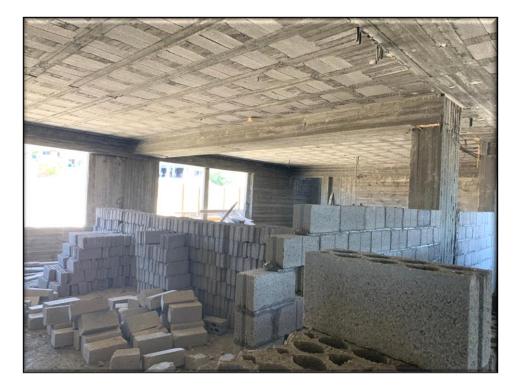
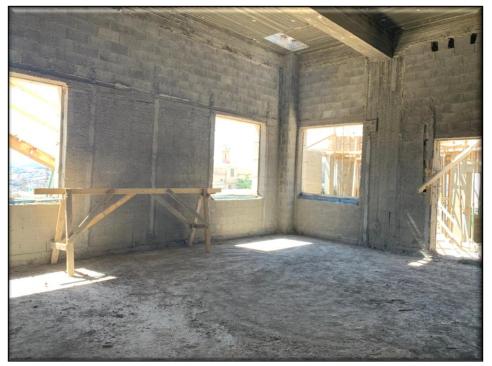
FIGURE #04&05:

Installation of cement block walls is ongoing

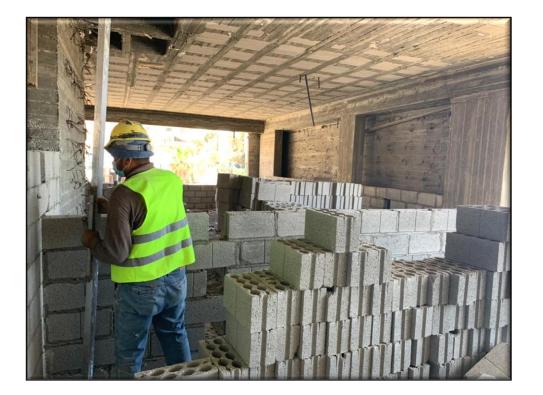
FIGURE #06:

Installation of cement block walls is ongoing

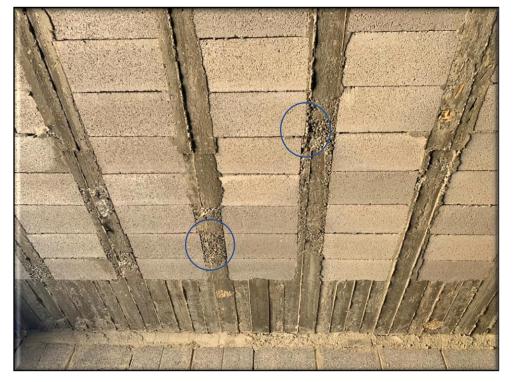
FIGURE #07:

Minor roughness and segregation were noticed

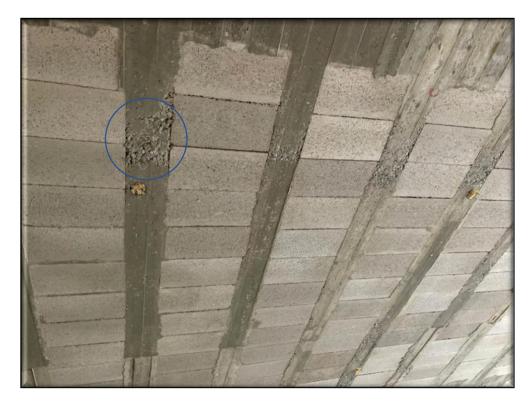
Minor roughness and segregation were noticed

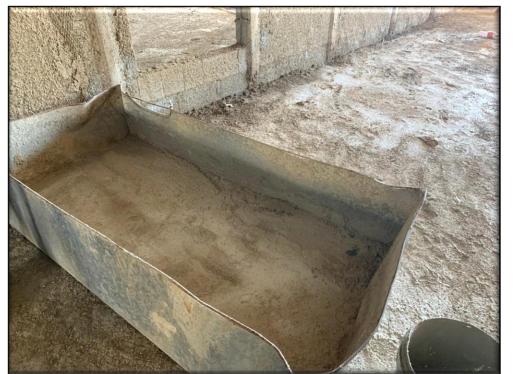
The CC is using a steel container to ensure W/C ratio

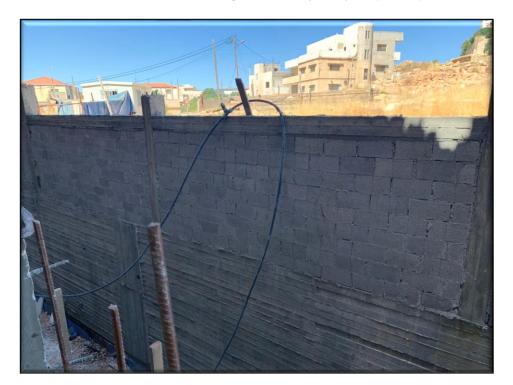
FIGURE #10:

Construction works of boundary wall

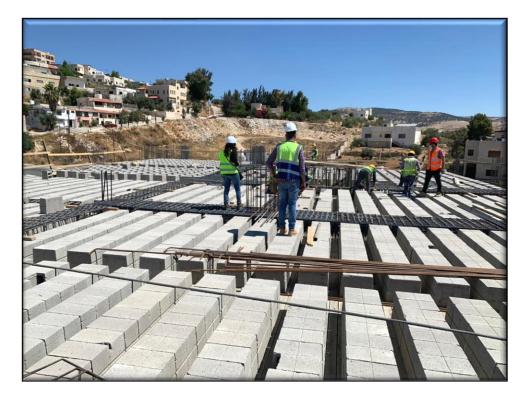
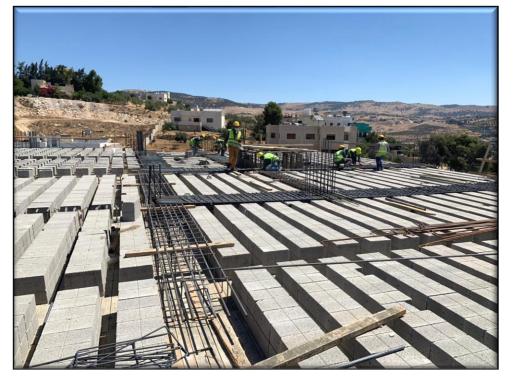
FIGURE #12&13:

- Site is well secured and a proper gate has been installed to secure the construction area in addition to steel fence
- COVID-19 precautions taken at entrance
- Visitors' log at entrance
- Not all workers had full PPE gear on
- Falling hazard at the 2nd part of slab work area, the work area must be protected to avoid safety incidents

Preparation for placing the 2nd part of final slab is ongoing, also, the CC must protect the working area to ensure the safety of workers

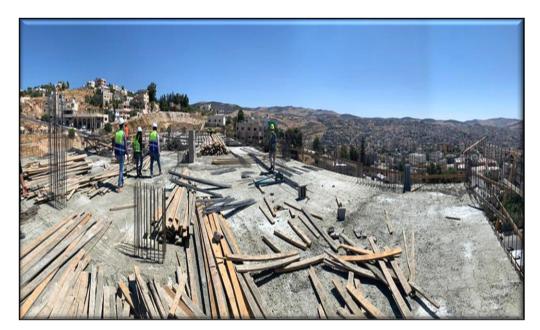
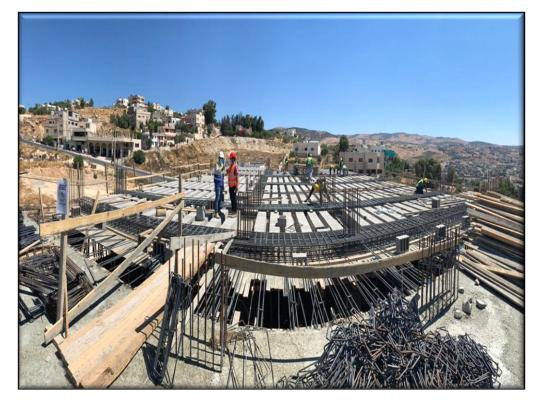
FIGURE #14&15:

1st and 2nd part of final slab, placing the 1st part is completed

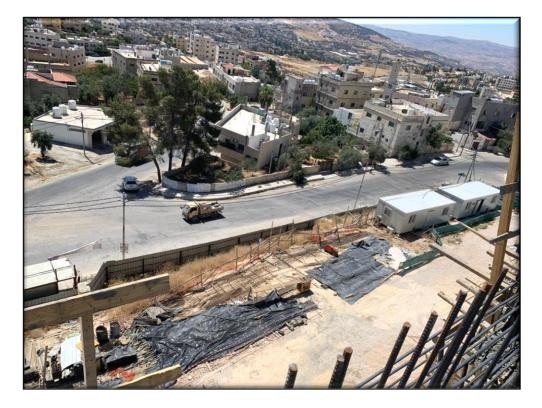
FIGURE #16:

The site obstacle is not solved officially yet and still causing progress delays

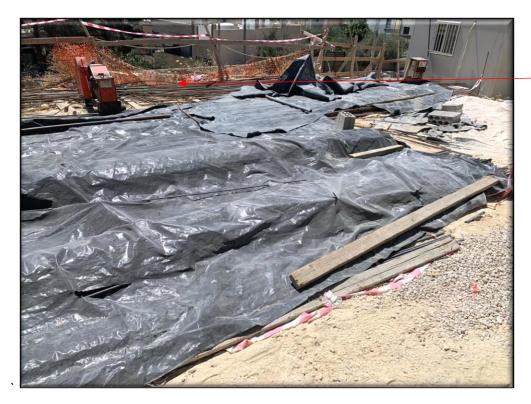
FIGURE #18:

Needs more attention on covering construction materials

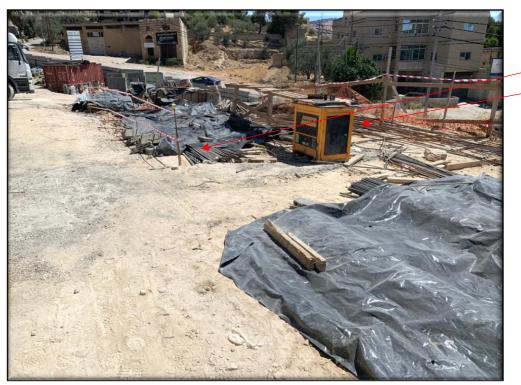
FIGURE #19:

Needs more attention on covering construction materials

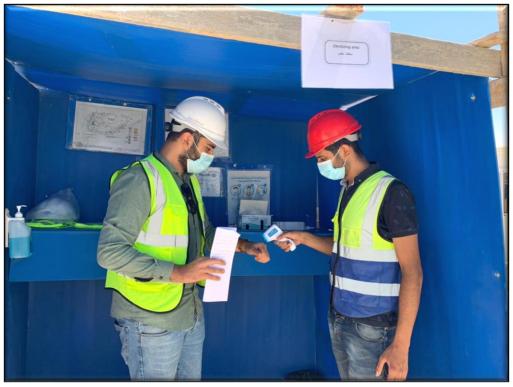
FIGURE #21:

COVID-19 precautions at entrance

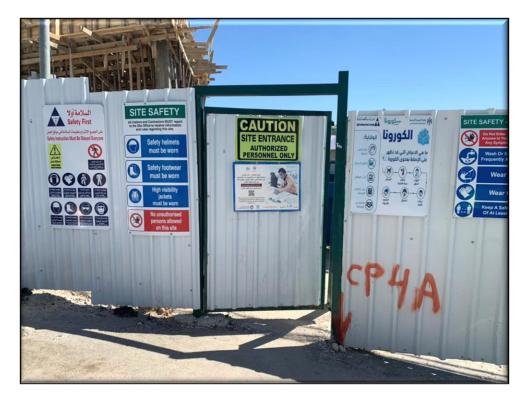
FIGURE #22:

Site gate and warning signs
