Quality Control Report

Consultant **Wahib Medanat** Consultant Engineers
Site Name **Um Al Dananir Basic Mixed - Balqa**
Package **Package 1**
Contractor **Derar Saraireh & Sons for Engineering & Contracting**
Tender No. **1/2020/USAID/SKEP/3/1**

Rep No. **QC-11 10**
Date **11 / 08 / 2021**

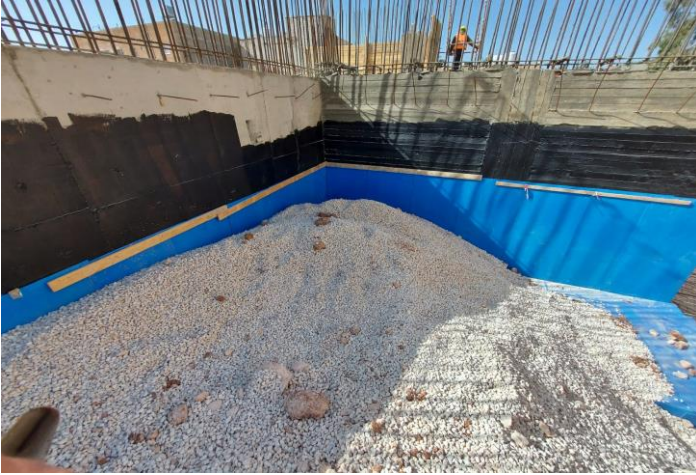
Conducting back-filling work without doing the appropriate insulation work

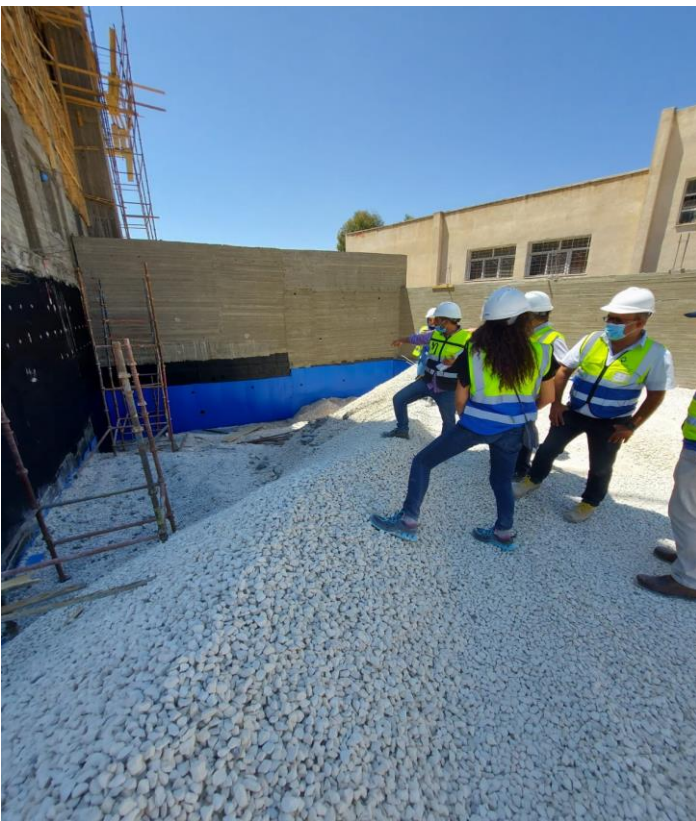
Starting remedy work in the presence of Engineer representatives

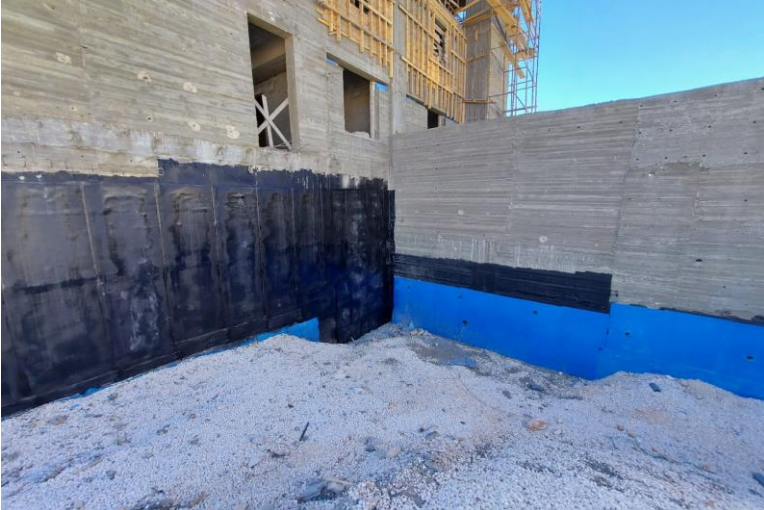
Remedy work has been finished (removing back-filling and applying waterproofing membrane as per specification)

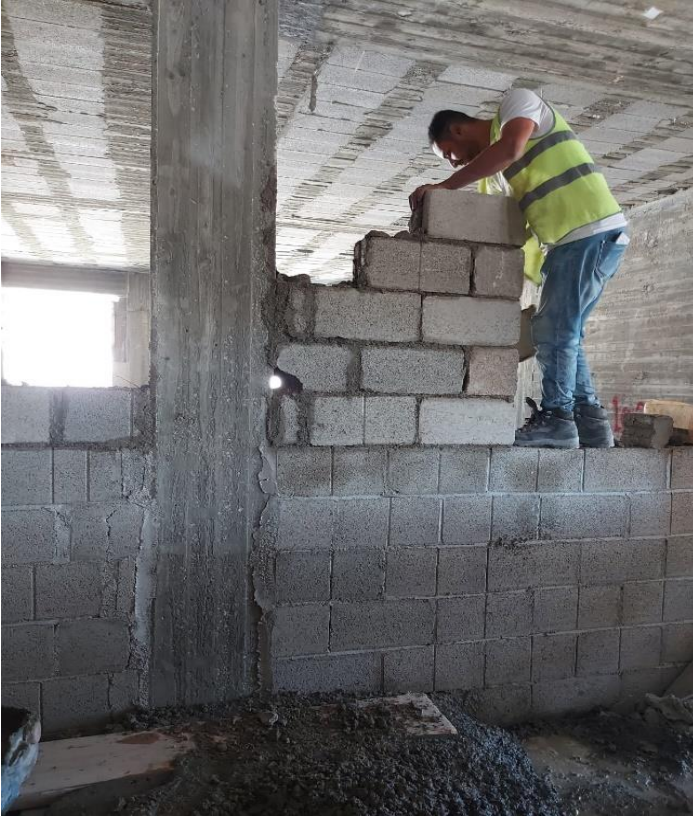
removal of un-complied blockwork

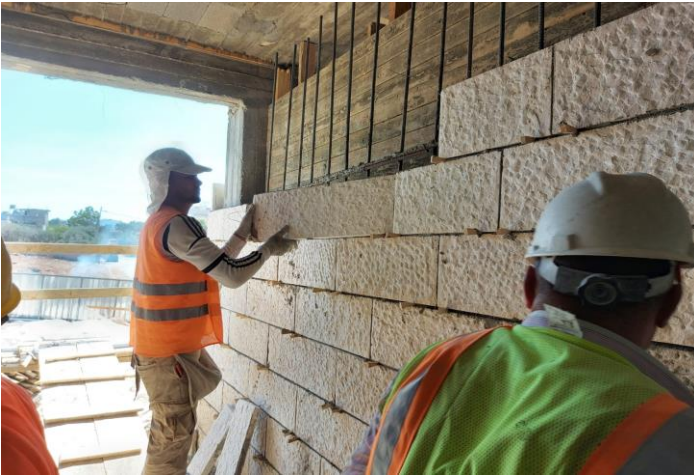
removal of un-complied Stone
