Site Visit Report Form

FTR # QR 394

Program (JSEP or SKEP): SKEP PHASE: ||| PACKAGE: 2

School Name: Jumana Bint Abi Taleb Basic Mixed School

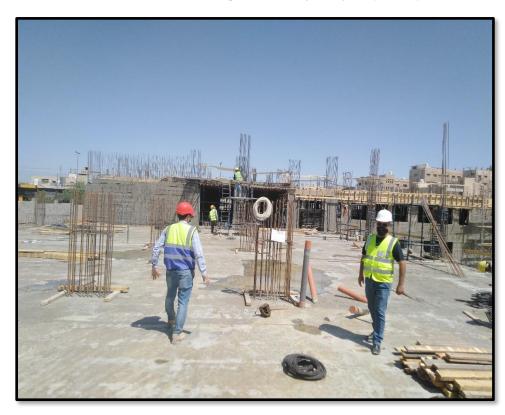
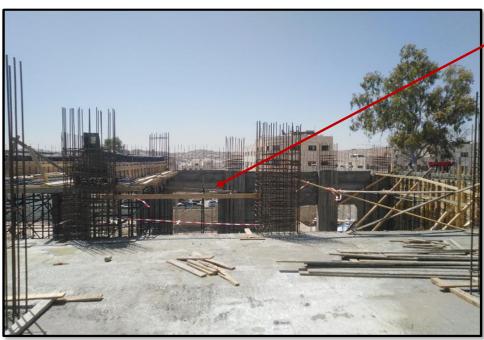
FIGURE #04&05:

Preparation works for placing concrete for the Columns of first floor

Multipurpose building under construction

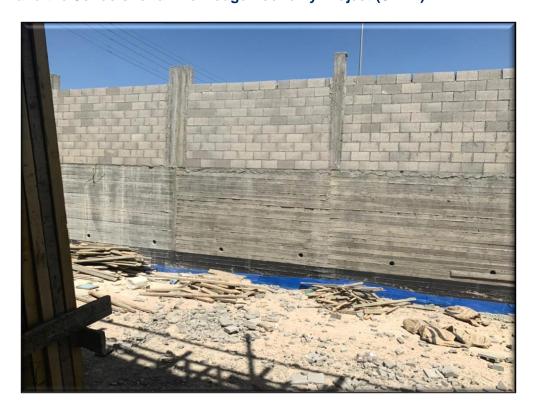
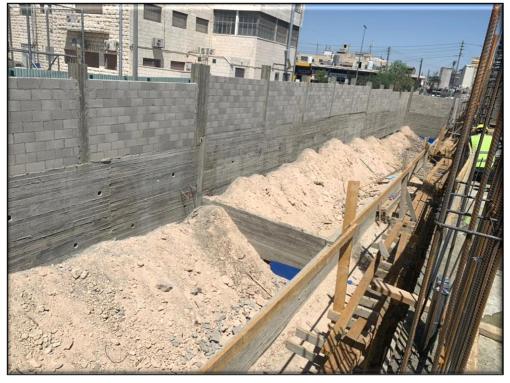
FIGURE #06&07:

Construction works for boundary wall has been completed adjacent to Mabrrat UM Hussein boundary Walls

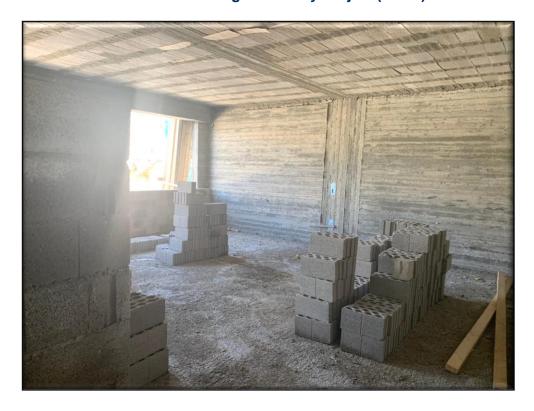
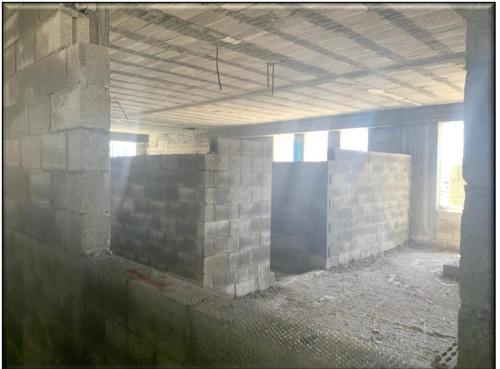
FIGURE #08&09:

Installing cement block walls for ground floor is ongoing

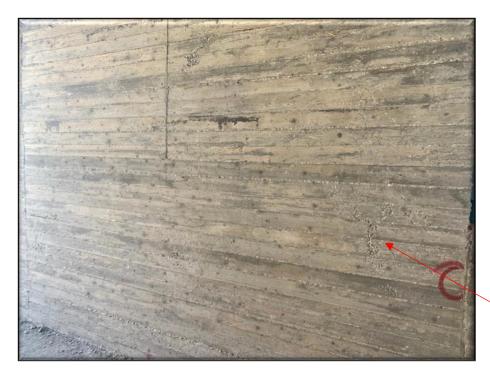
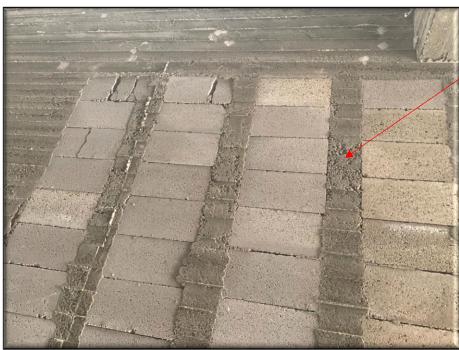
FIGURE #10 & 11:

- Casting the first-floor slab is **completed**, the CC must give more **attention** to curing works
- Installing cement block walls for ground floor is ongoing
- Construction works for boundary walls adjacent to Mabarrat Um Al Hssein boundary walls has been completed
- Concrete segregation and roughness were noticed, but **minimal in comparison** with the area of the proposed school
- Construction steel bars were uncovered during the site visit, CMTO recommends that the steel bars must be covered to avoid being damaged by rust
- The CC is not using a Steel Container to mix concrete, CMTO recommends that the CC must mix the concrete in a Steel Container to maintain the W/C as required in contract specifications

Roughness and segregation were noticed, but minimal

D. SuperStructural, Concrete, Masonry works				
1 Columns				
2 Beams				
3 Slabs		Y	Casting is completed	Curing must be done in compliance with specifications
4 Roof	District	Y	Roughness and segregation was noticed	Must be repaired with special materials
	oncrete Block (internal) oncrete Block (external)	Y	Installing block walls is ongoing	must be done in compliacne with specifications
6 Hollow Co	oncrete block (external)			
	latural Stones			
9 Flectrical	conuits/ sleeves			
10 Mechnica	I pipes/sleeves

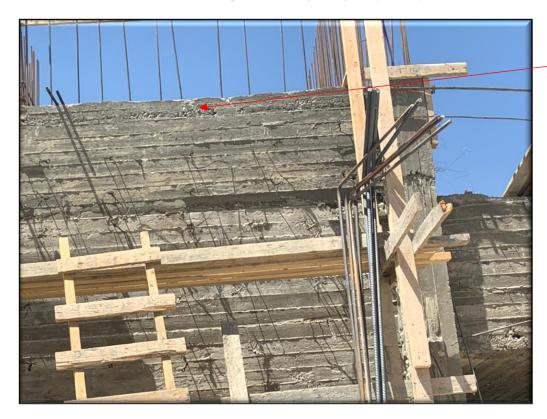
FIGURE #12:

Roughness and segregation were noticed, but minimal

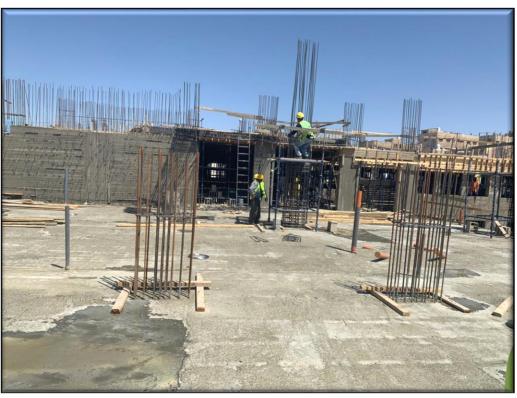
FIGURE #13:

Casting the 1st floor slab has been completed

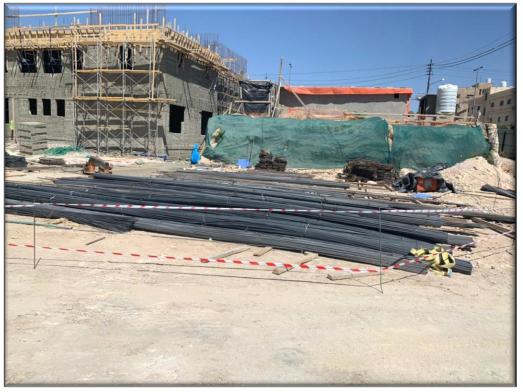
FIGURE #15:

Uncovered steel bars, must be covered to avoid being damaged by rust

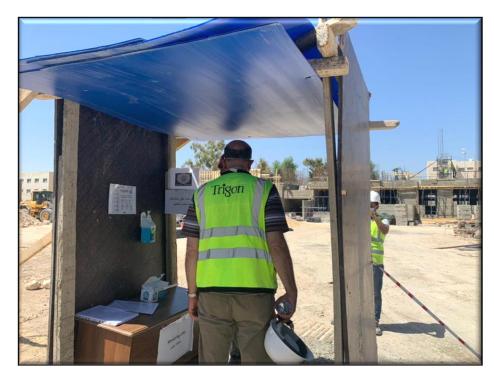
FIGURE #16:

COVID-19 precautions at entrance

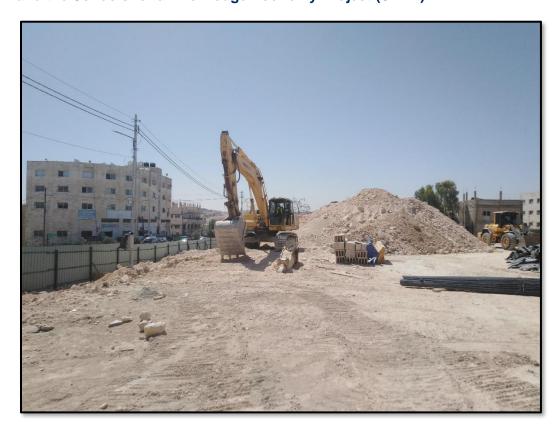
FIGURE #18:

Excavation works for the Boundary Walla
