Consultant	Wahib Medanat Consultant Engineer	Rep No.	21-21092021
Contractor	Dijlah Establishment Constr. Contracting	Tender No.	(11/2019/USAID/SKEP/3/S) Schools for a Knowledge Economy Project (SKEP) - Phase (3) Package (1, 2)
Site Name	Hay Al Iskan Basic Mixed School- Jerash	Day/ Date	Tue. 21/09/2021
Duration of Project	450 Calendar Days	Total Project Budget	8,314,983.735 JD

Visit Notes

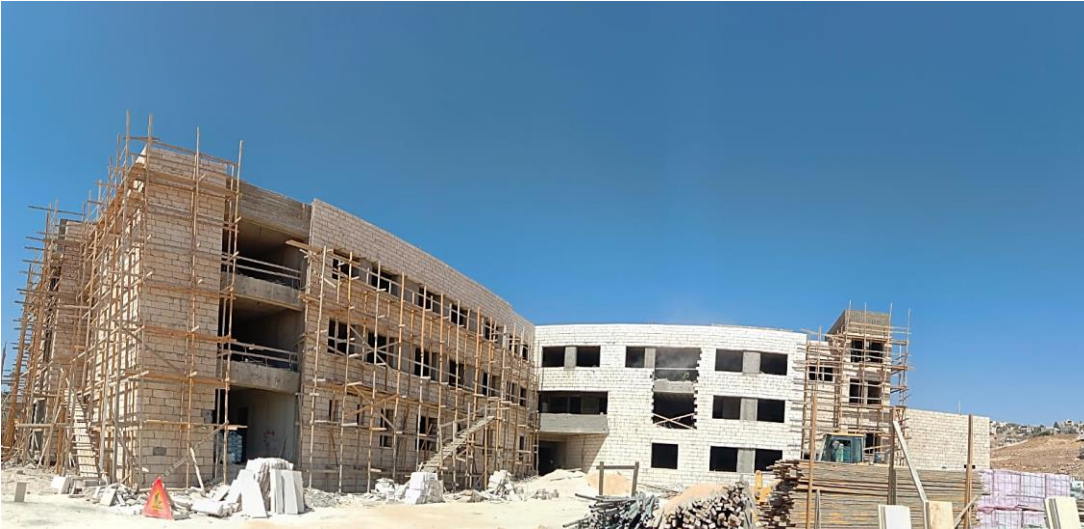
(Figure: 01)

General view of the completed second floor casting (the last slab)

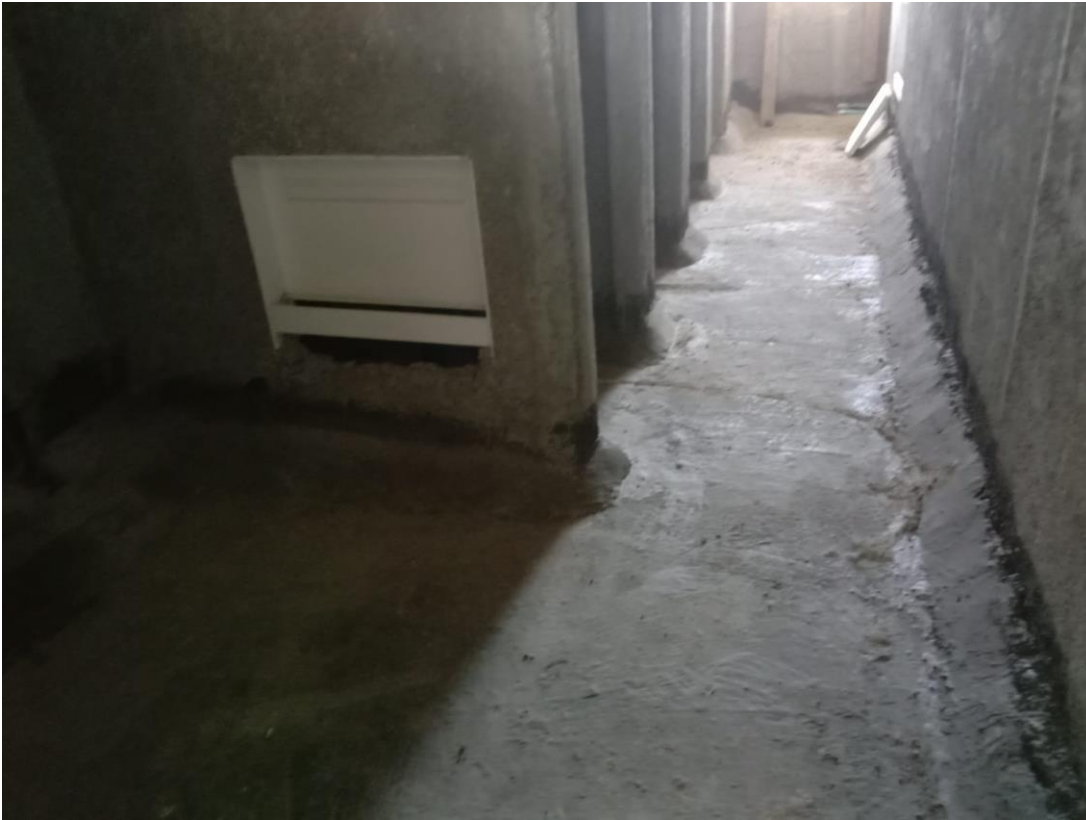
(Figure: 03)

It was observed that the Contractor is progressing in the waterproofing work for the wet areas floors. The Contractor was instructed to conduct water penetration test to those floors before next activities

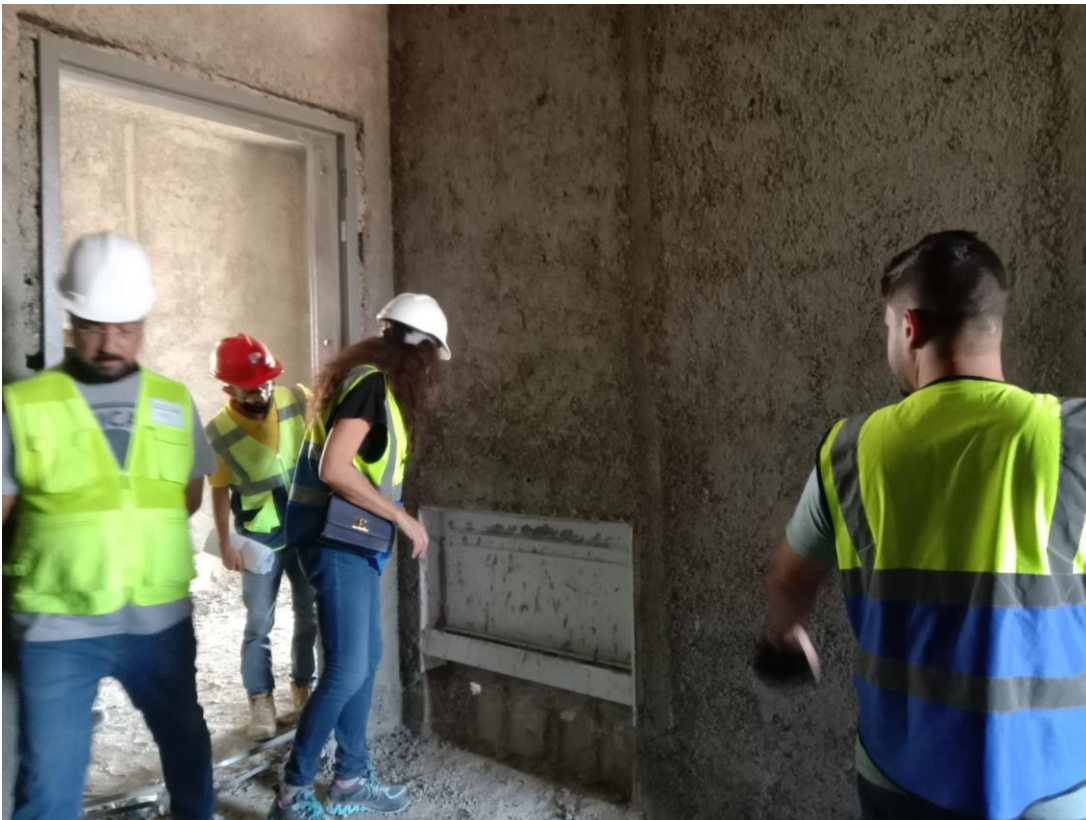
(Figure: 04)

A number of mechanical cabinets in the sanitary units are close to the door frames in compliance with the shop drawings.

The Contractor was requested to remove those cabinets to allow for tiling around in an appropriate way

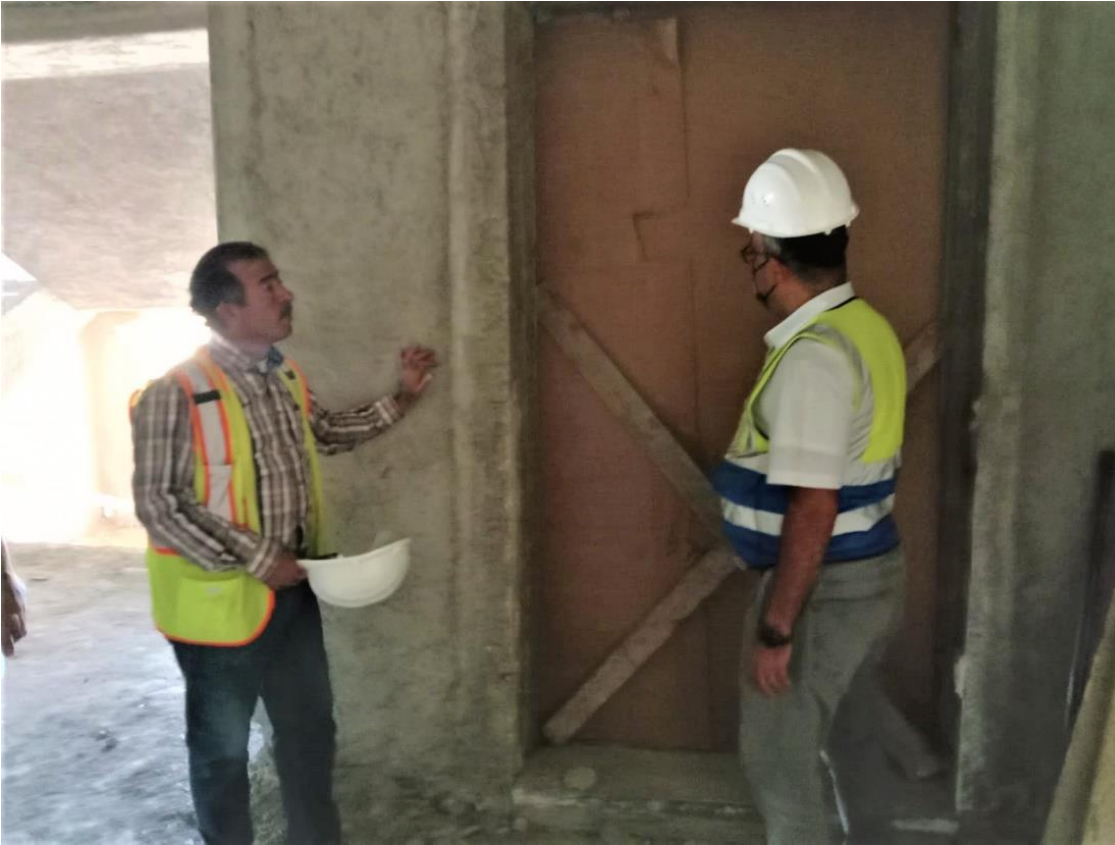
(Figure: 07)

It was observed that the Contractor has initially completed the installation of elevators

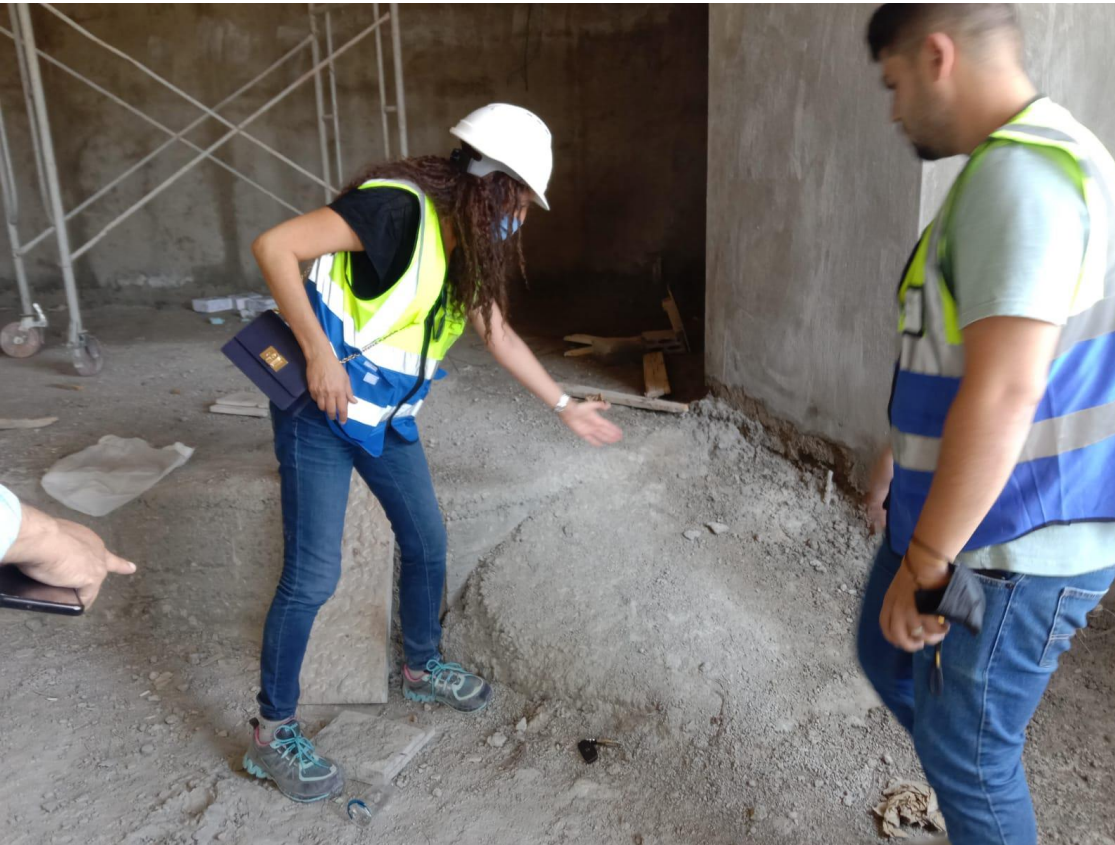
(Figure: 08)

It was observed that the Contractor is progressing in the waterproofing work for the wet areas floors. The Contractor was instructed to conduct water penetration test to those floors before next activities

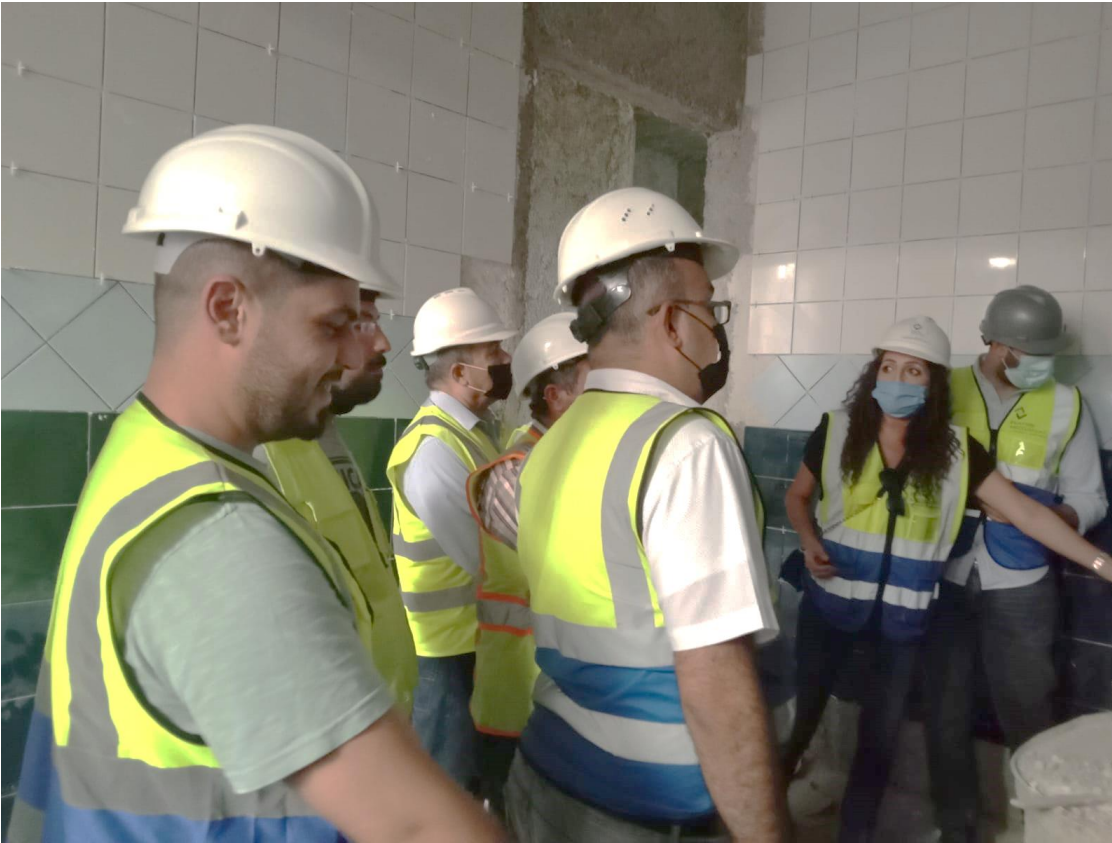
(Figure: 09)

Inspecting Tiling work at the wet area/ground floor

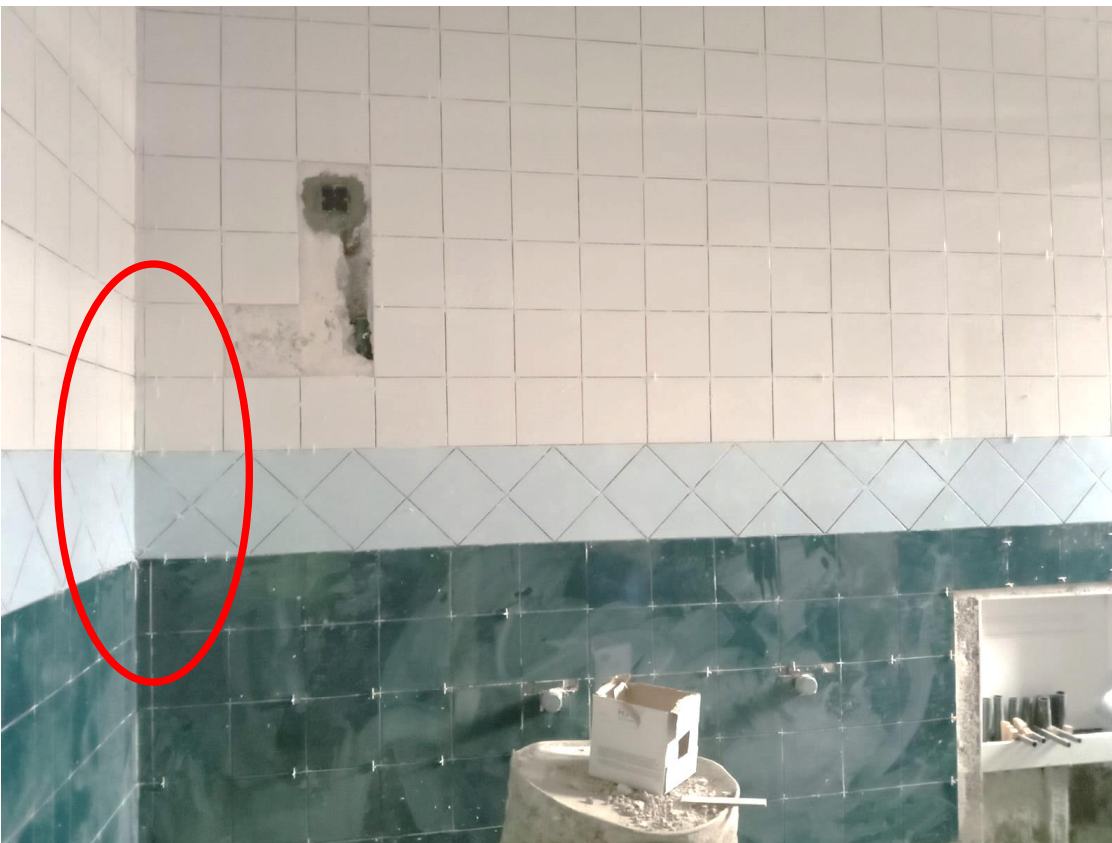
(Figure: 10)

The supervision team observed that the tiling work at one wall does not comply with the shop drawings due to defect in the starting points of tiling

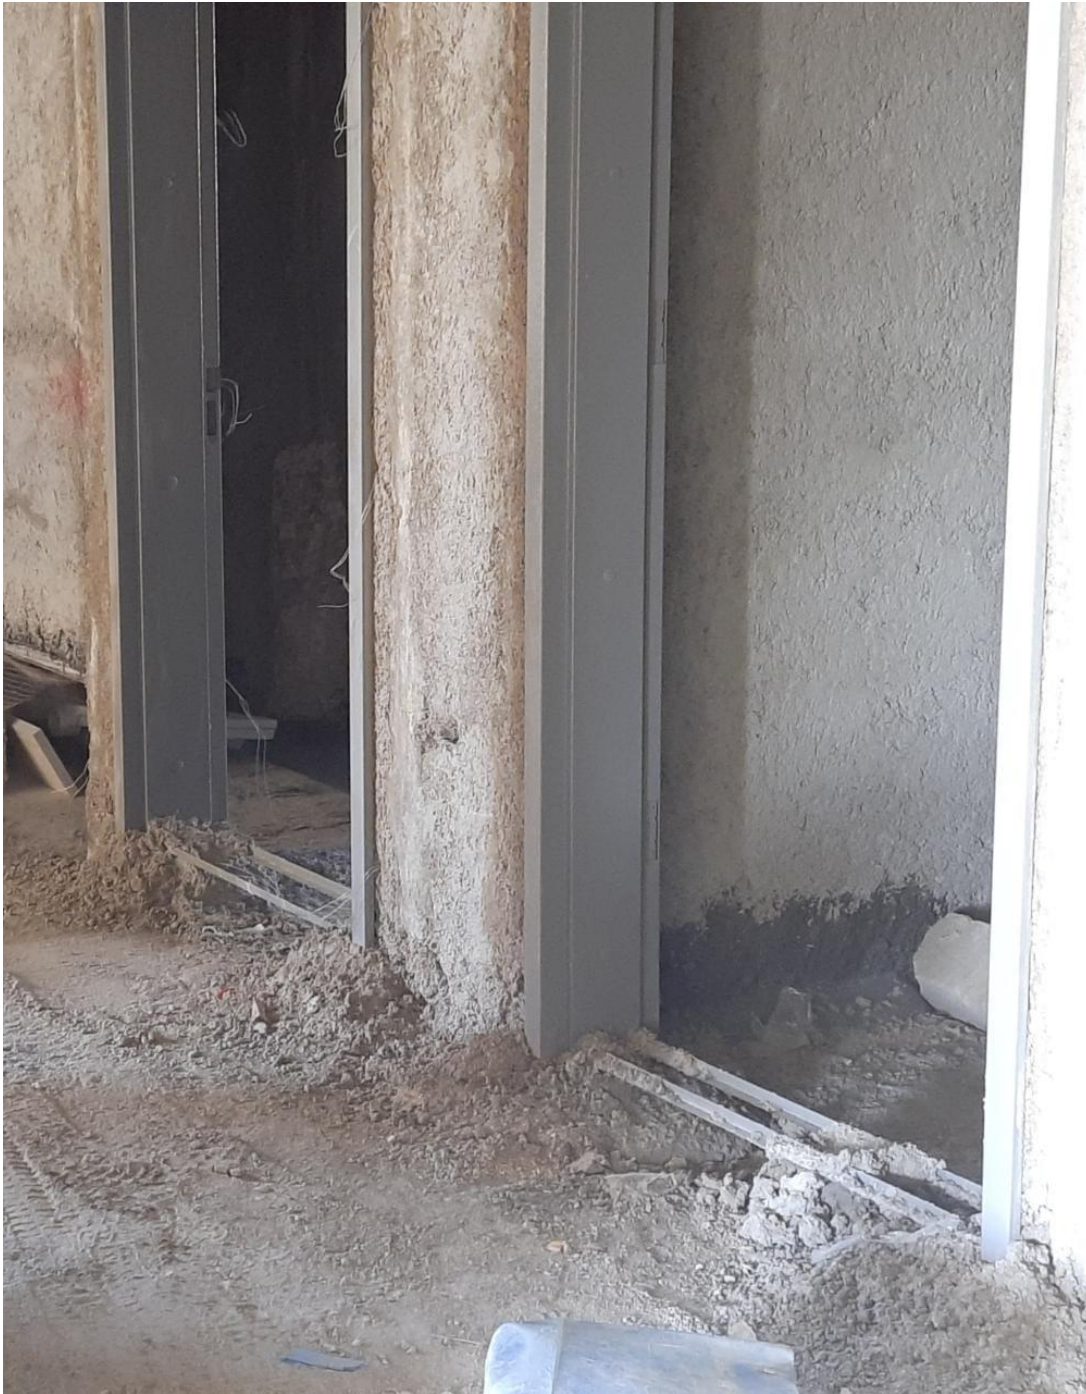
(Figure: 12)

The door frames of the sanitary units at the recess should be supported by mass concrete with convenient dimensions. Also dismantling of the bracing at the door frames before starting with floor tiling to avoid defects in the frame during the tiling work

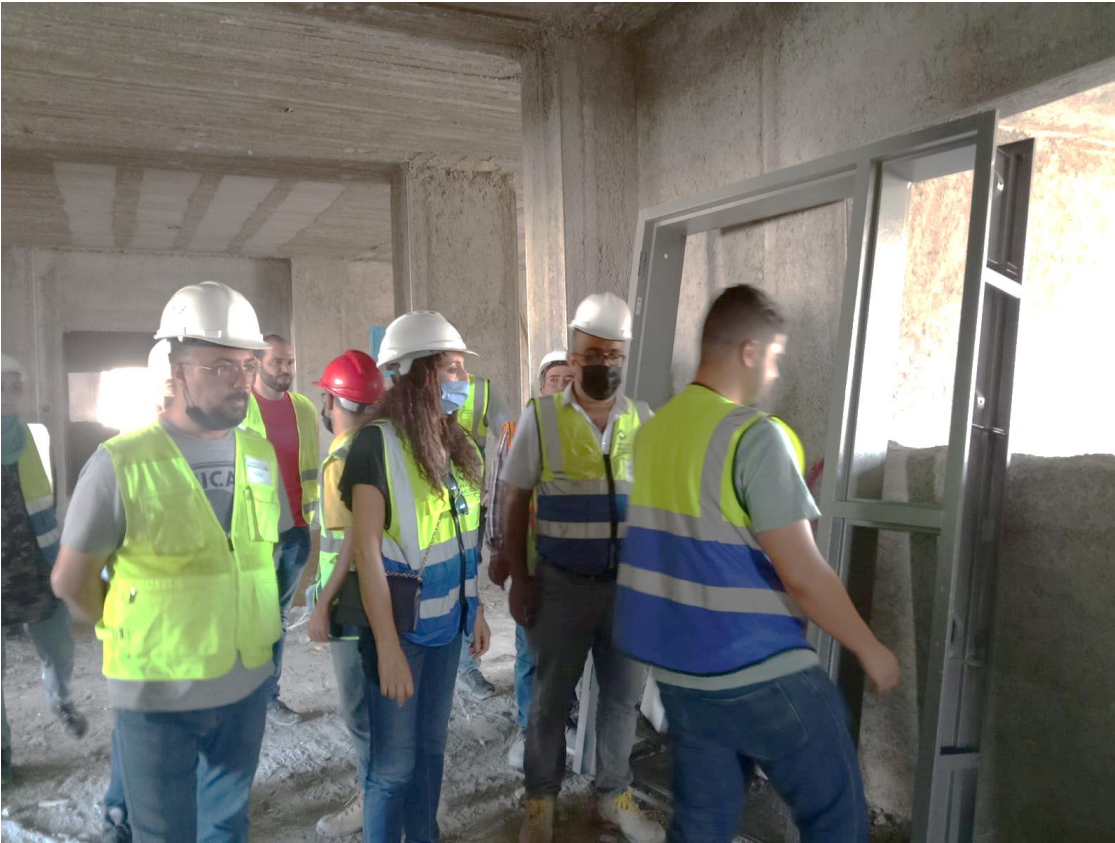
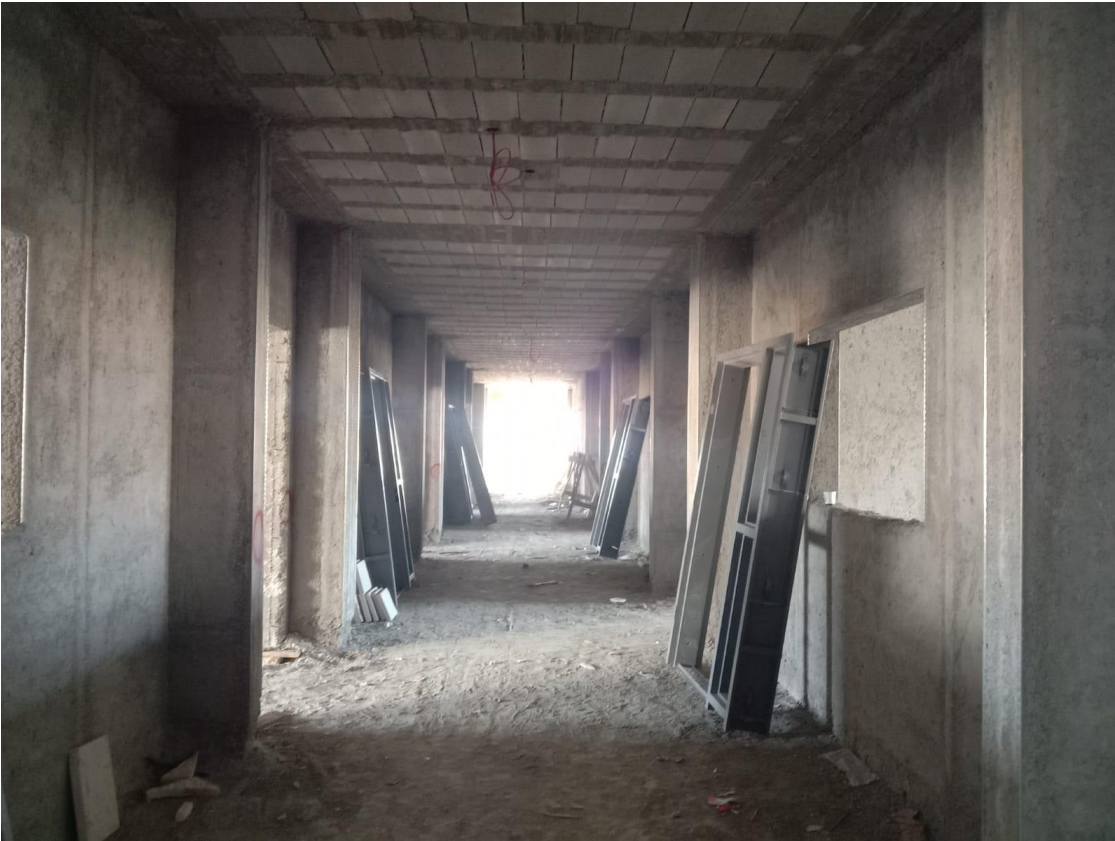
(Figure: 13 & 14)

It was observed that a number of delivered door frames to the site have manufacturing defects. The Contractor was requested to replace those frames or repair where possible

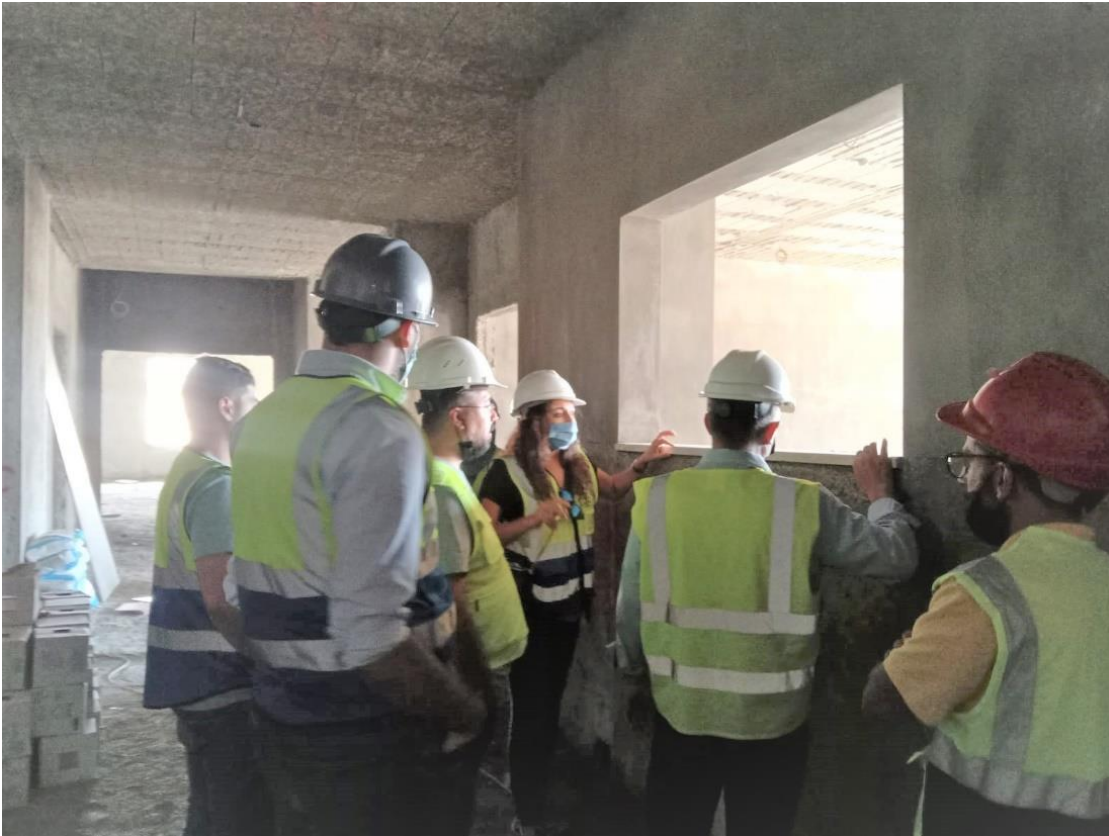
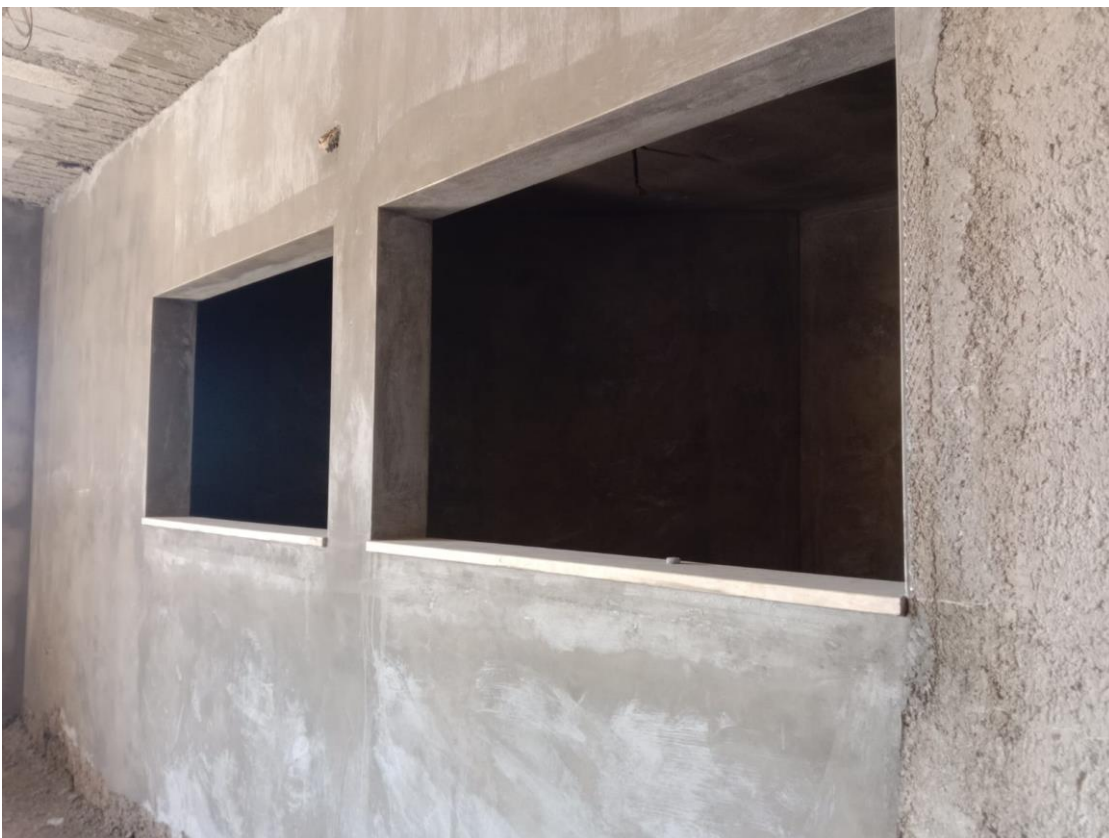
(Figure: 15 & 16)

Inspection was carried out on the sills installed at the internal windows and the supervision team stressed on the compliance with the design drawings in regarding the relation between the window sills and internal walls

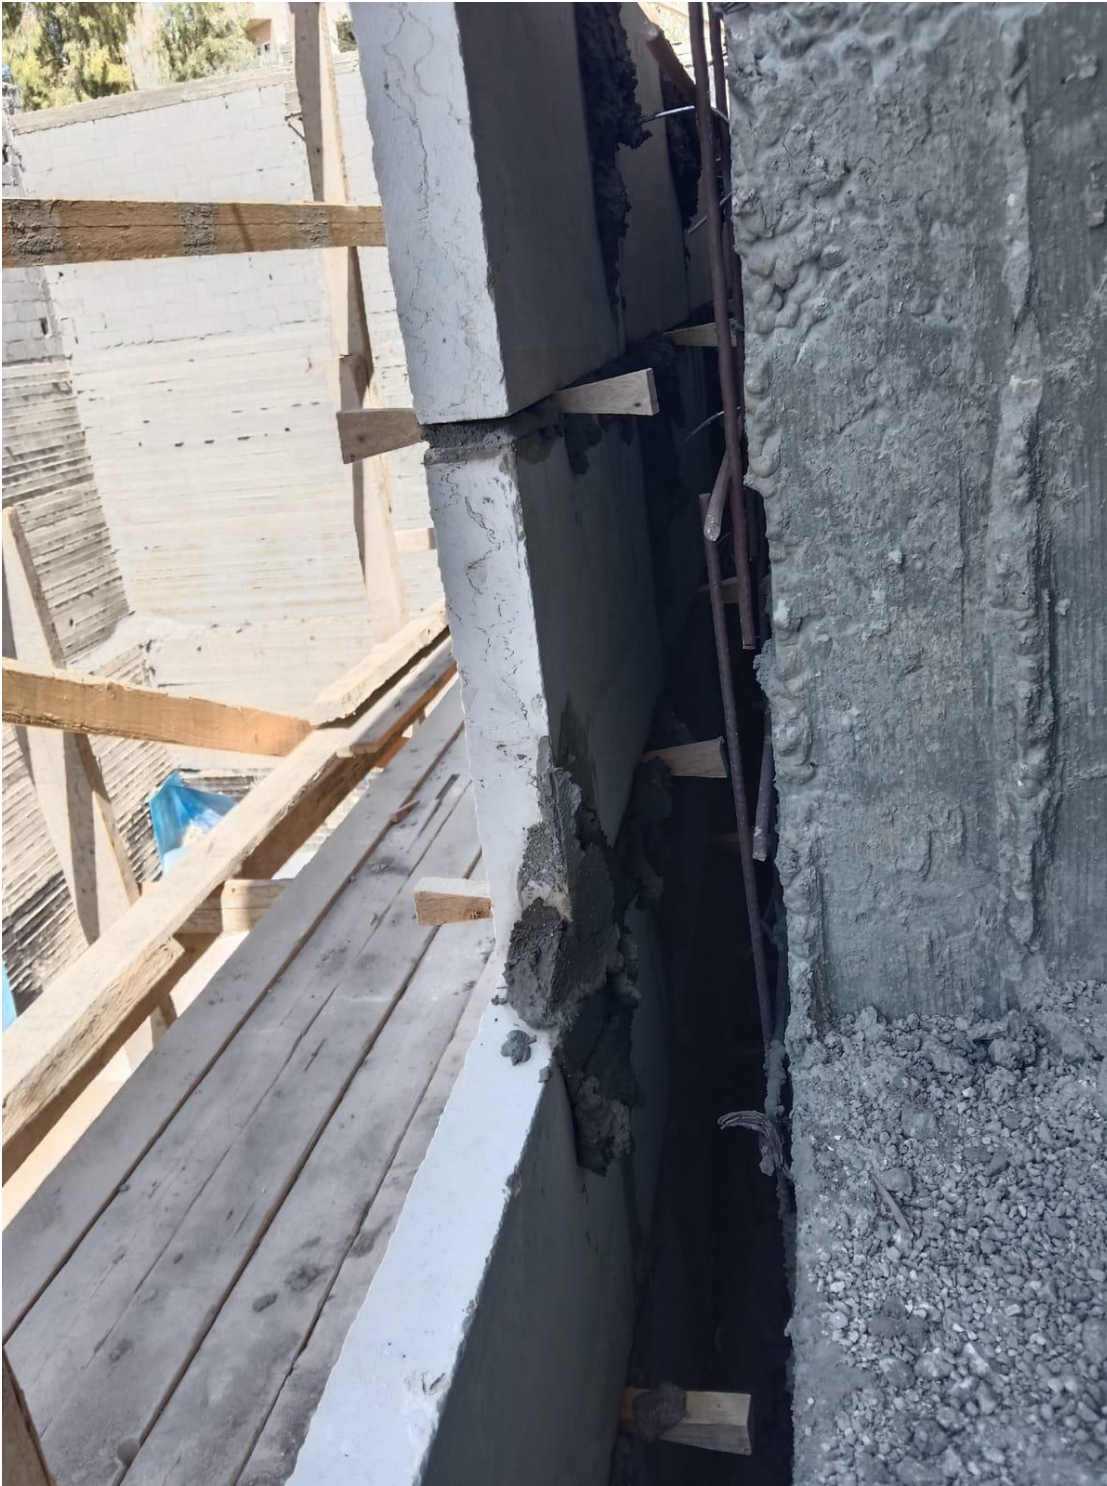
(Figure: 17)

Wooden wedges were observed within the backing concrete space behind stone layers. The Contractor was requested to remove those wedges before pouring concrete behind stone layers
