Quality Control Report

Consultant	Wahib Medanat Consultant Engineers	Rep No.	QC-11 11
Site Name	Um Al Dananir Basic Mixed - Balqa	Date	7 / 09 / 2021
Package	Package 1		
Contractor	Derar Saraireh & Sons for Engineering & Contracting		
Tender No.	1/2020/USAID/SKEP/3/1

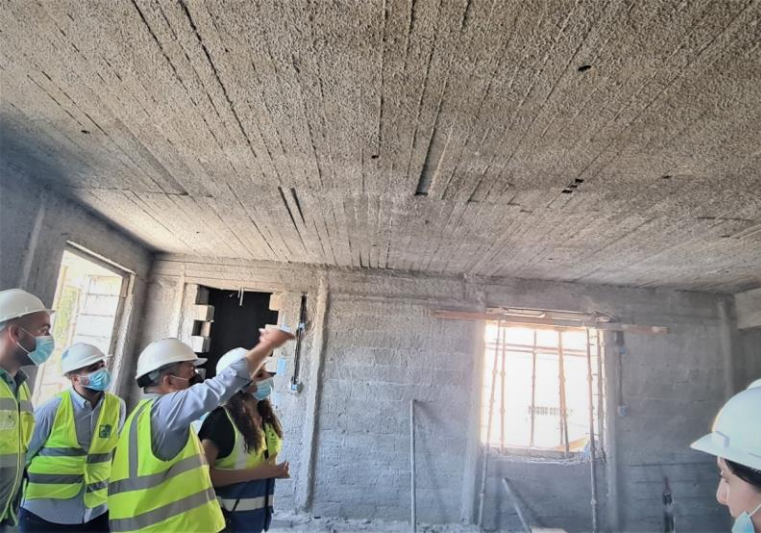
Irregularity in the formwork of the slab

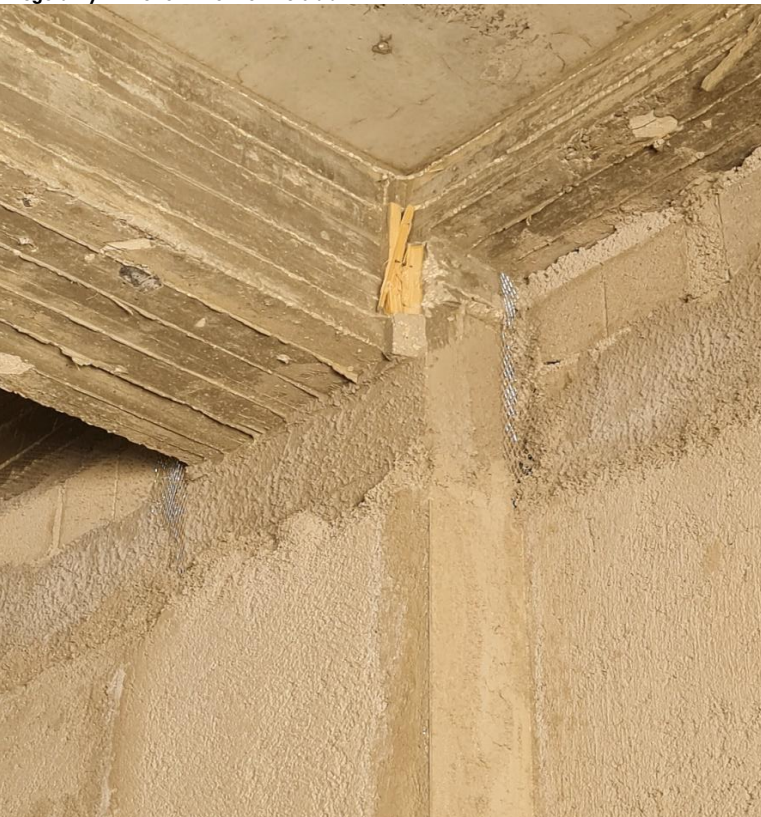
Remaining wooden pieces in the slab

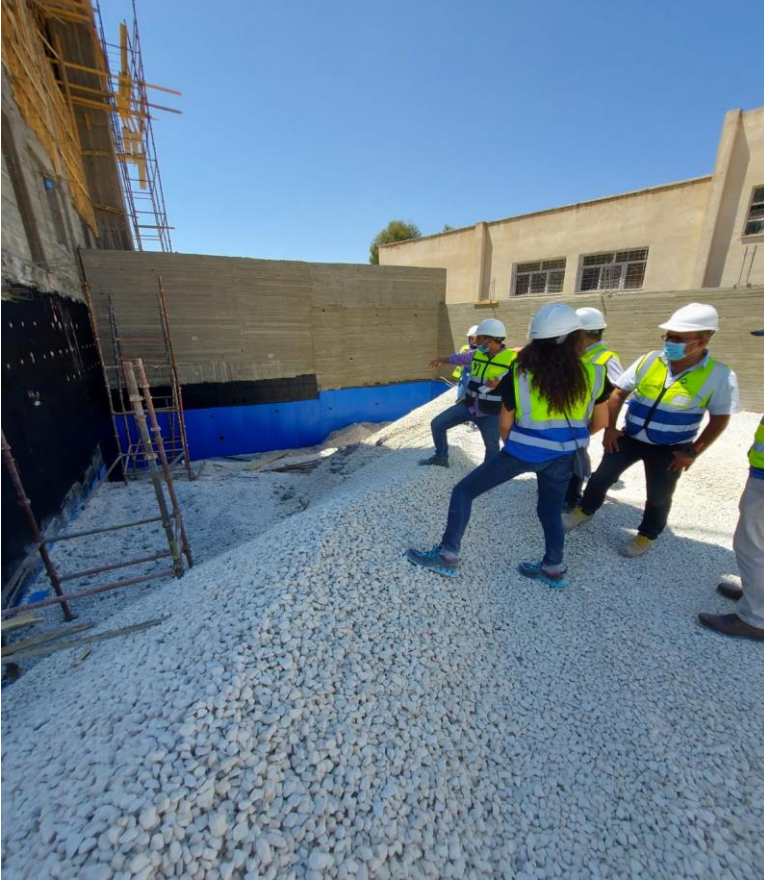
Backfilling work before completing the waterproofing layers
