Consultant	Wahib Medanat Consultant Engineer	Rep No.	13-20122021
Contractor	Derar Saraireh & Sons for Engineering & Contracting	Tender No.	(11/2019/USAID/SKEP/3/S) Schools for a Knowledge Economy Project (SKEP) - Phase (3) Package (1, 2)
Site Name	Khadija Bint Khwailed Basic Mixed School- Shouna Janoubia	Day/ Date	Mon. 20/12/2021
Duration of Project	450 Calendar Days	Total Project Budget	9,789,417.840 JD

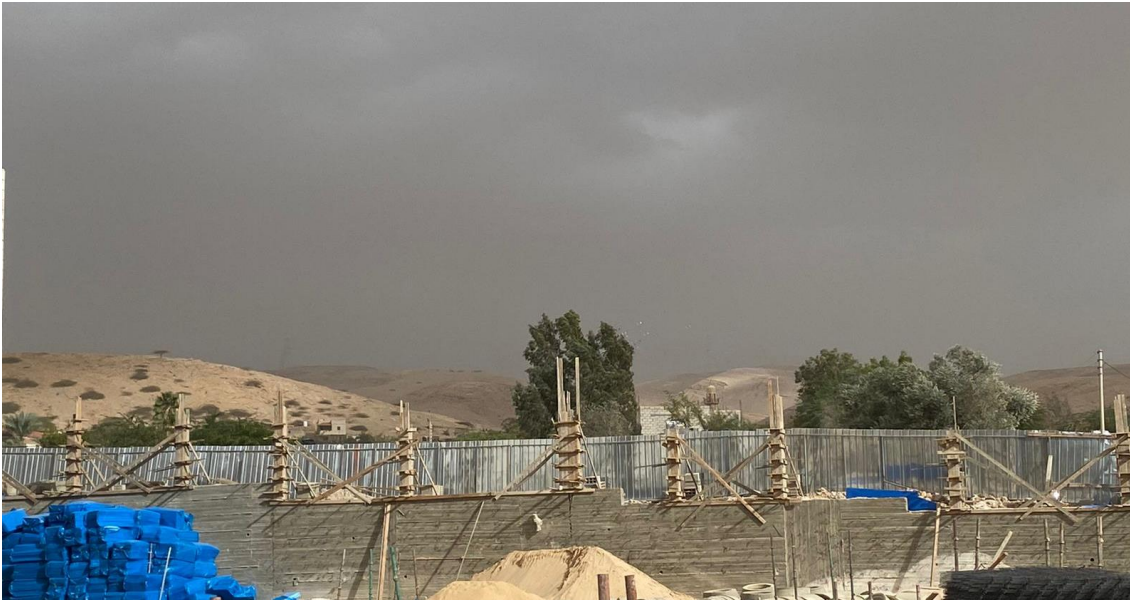
(Figure: 06)

It was observed that the Contractor is preparing the shuttering work for stiffener columns of the boundary walls

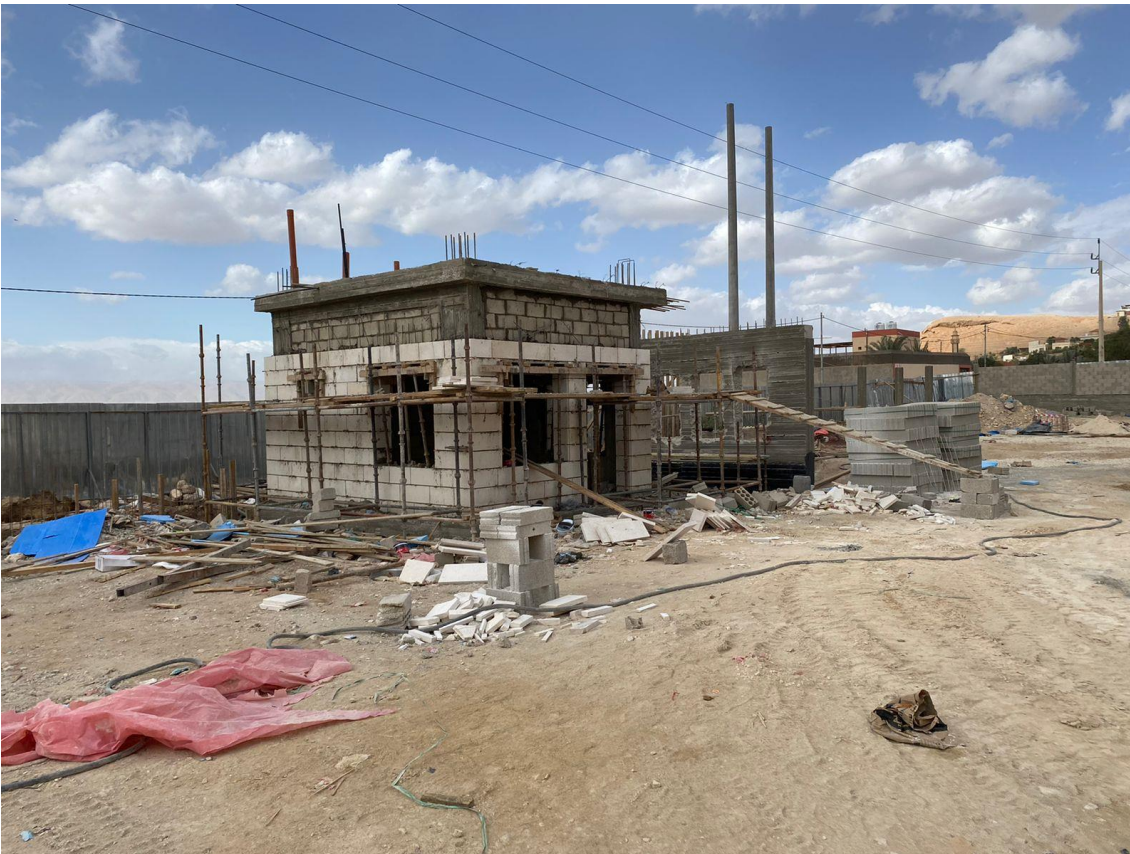
(Figure: 07)

The supervision team inspected the stone work for the guard room and the main gate

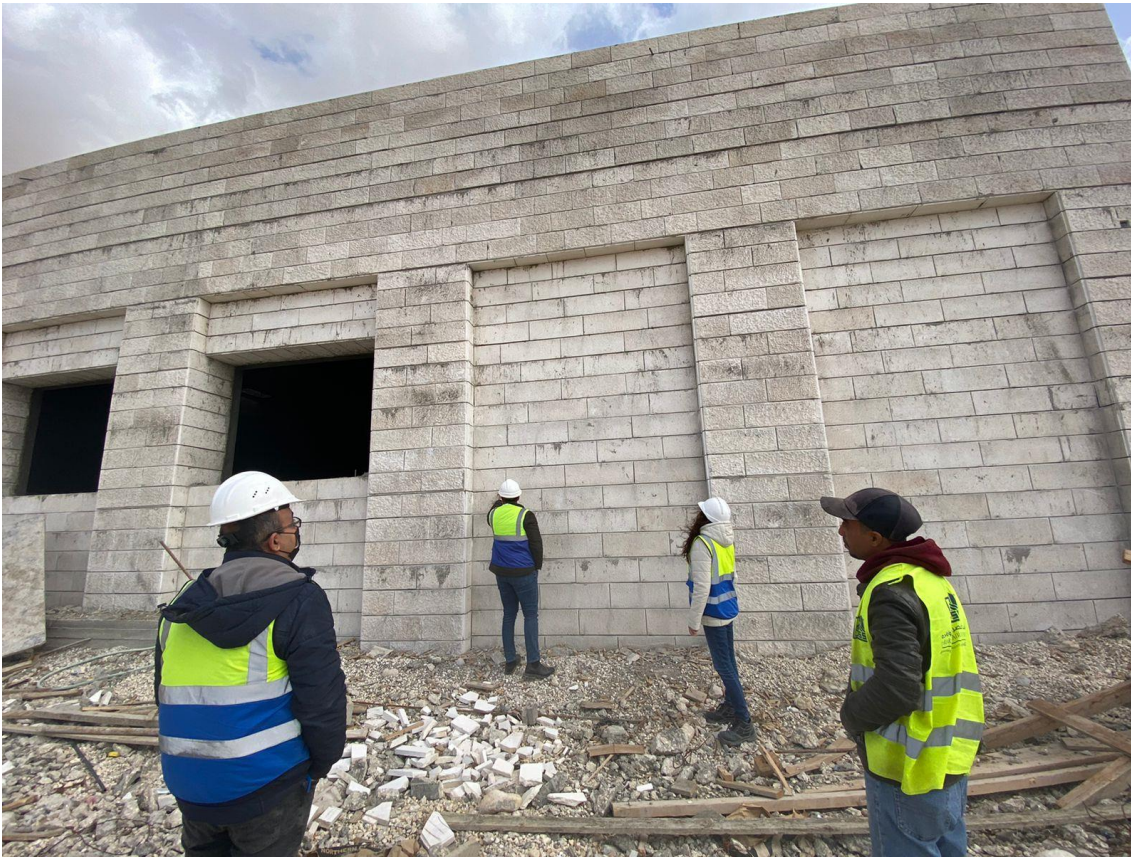
(Figure: 08)

The supervision team inspected the stone facades and comments were given to the Contractor

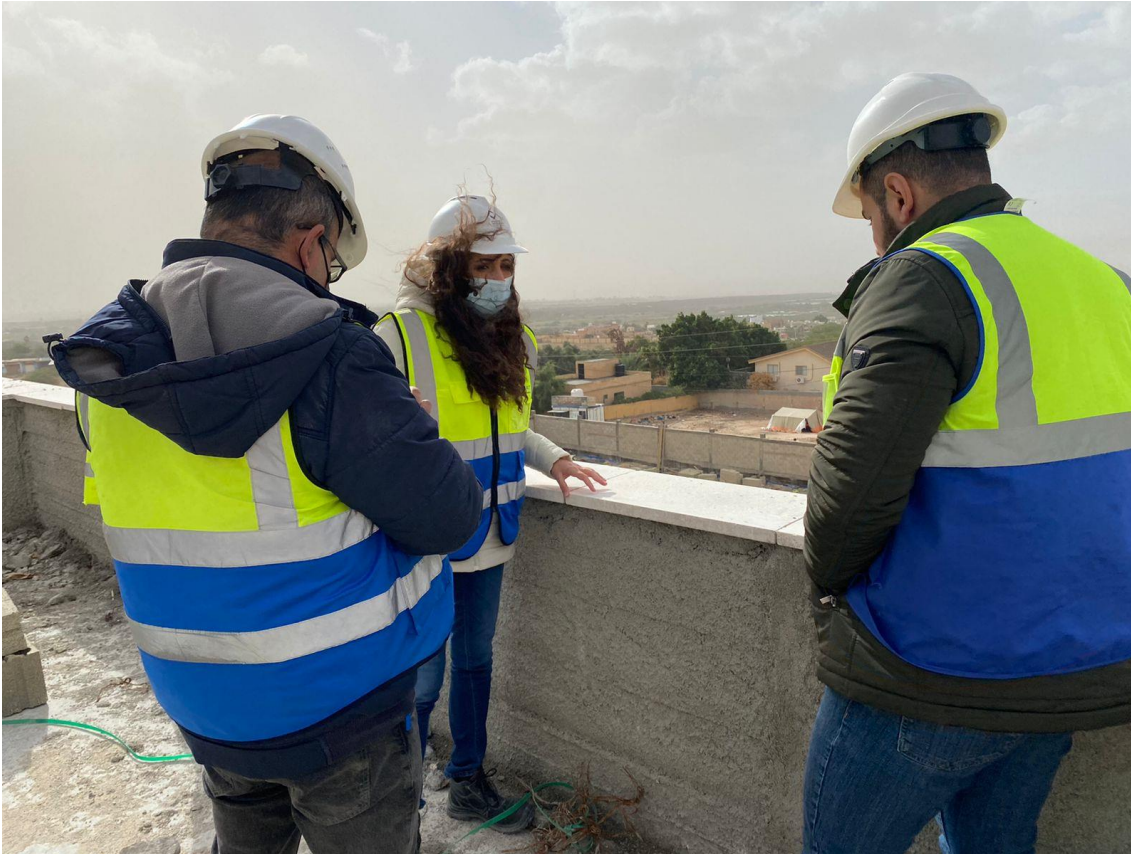
(Figure: 10)

The supervision team inspected the stone coping for parapets and observed the defects in the edges of those coping

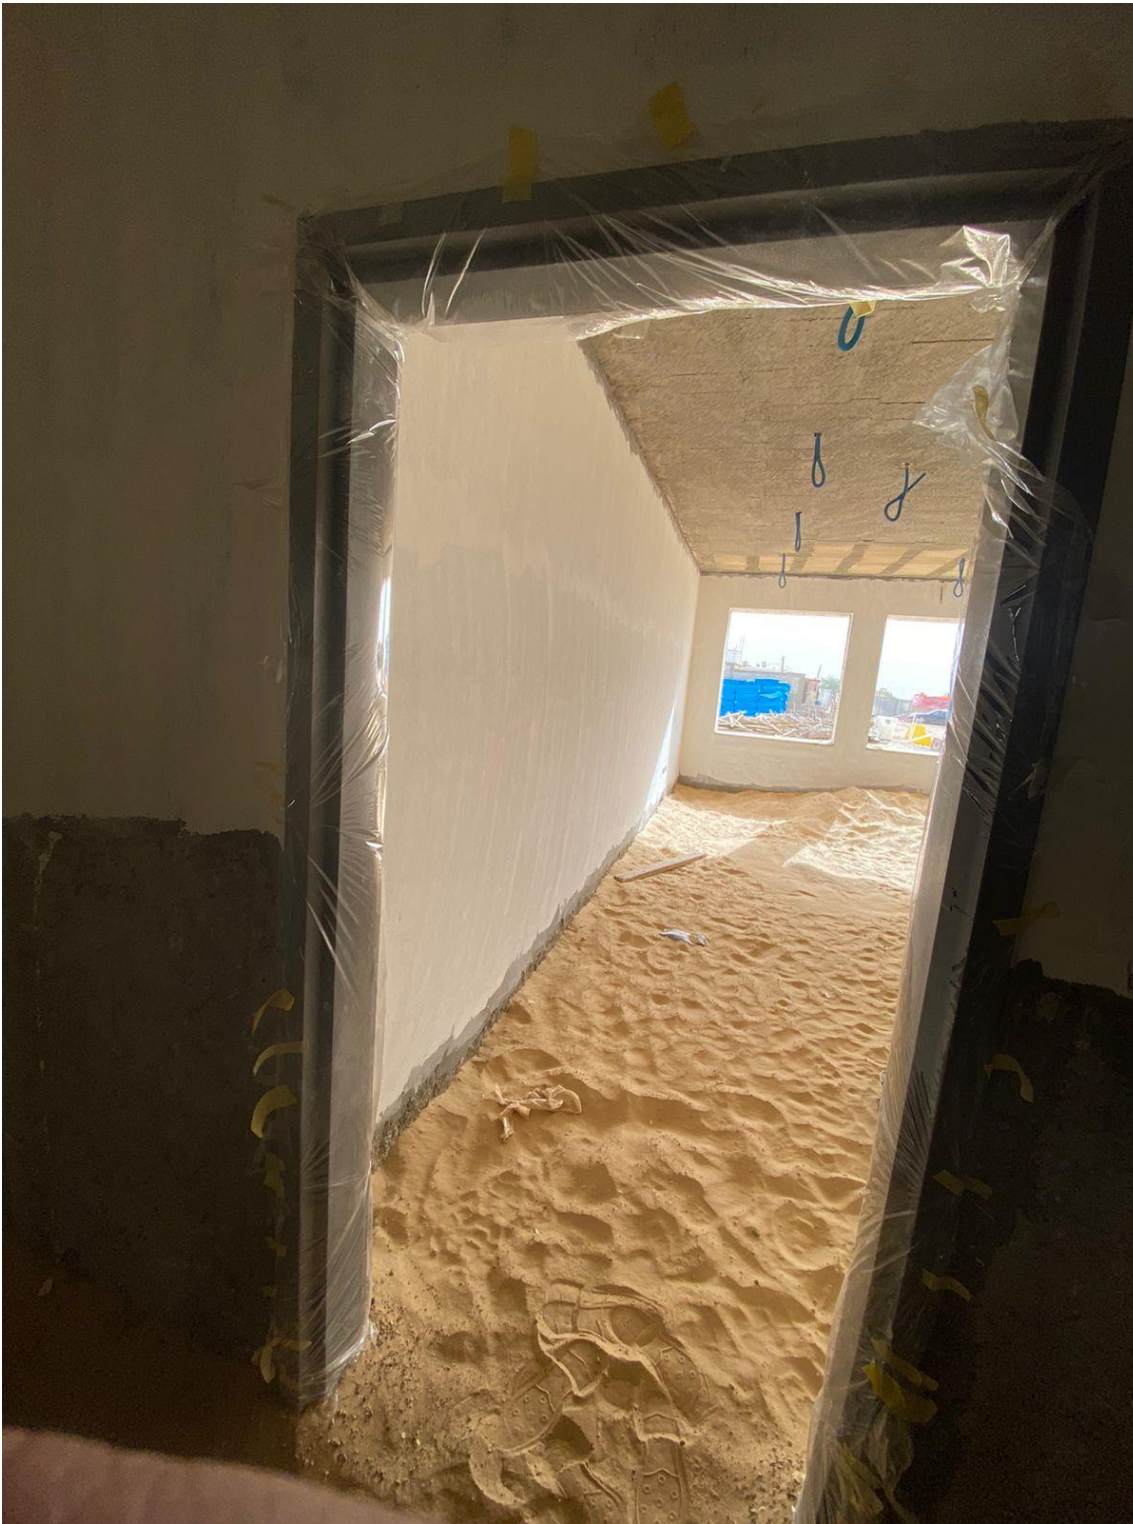
(Figure: 12)

The Contractor has responded positively to the previous supervision instruction to wrap the installed steel door frames as necessary for protection purposes

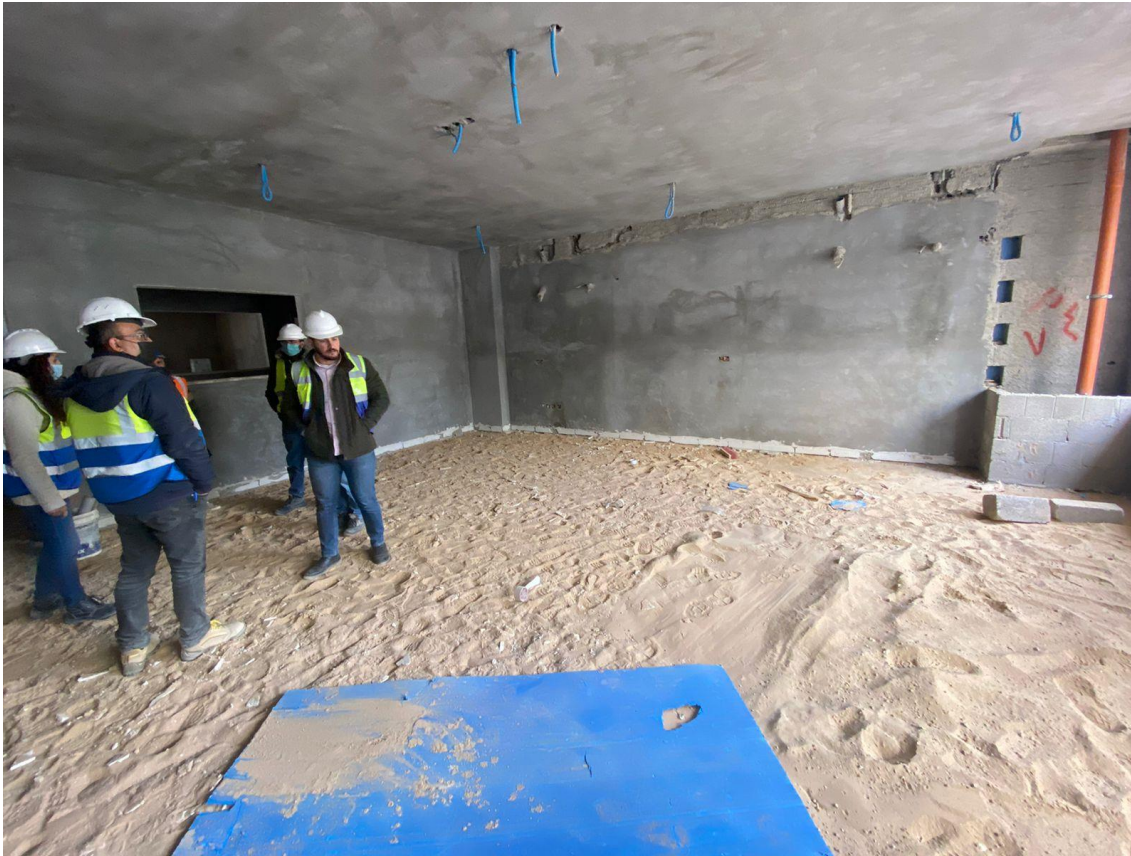
(Figure: 13)

It was observed that the Contractor removed the tiled porcelain and skirting already executed in the building and removed out of the site

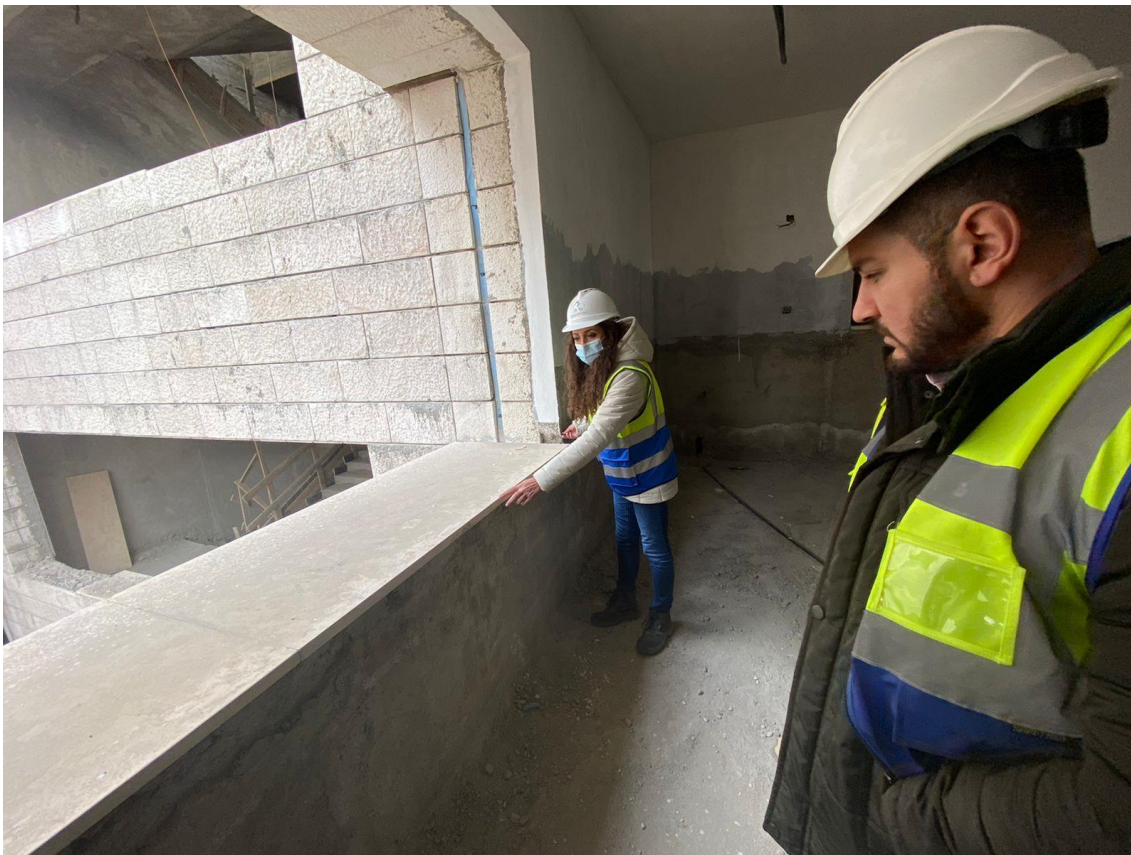
(Figure: 14)

Inspecting the installed window sills

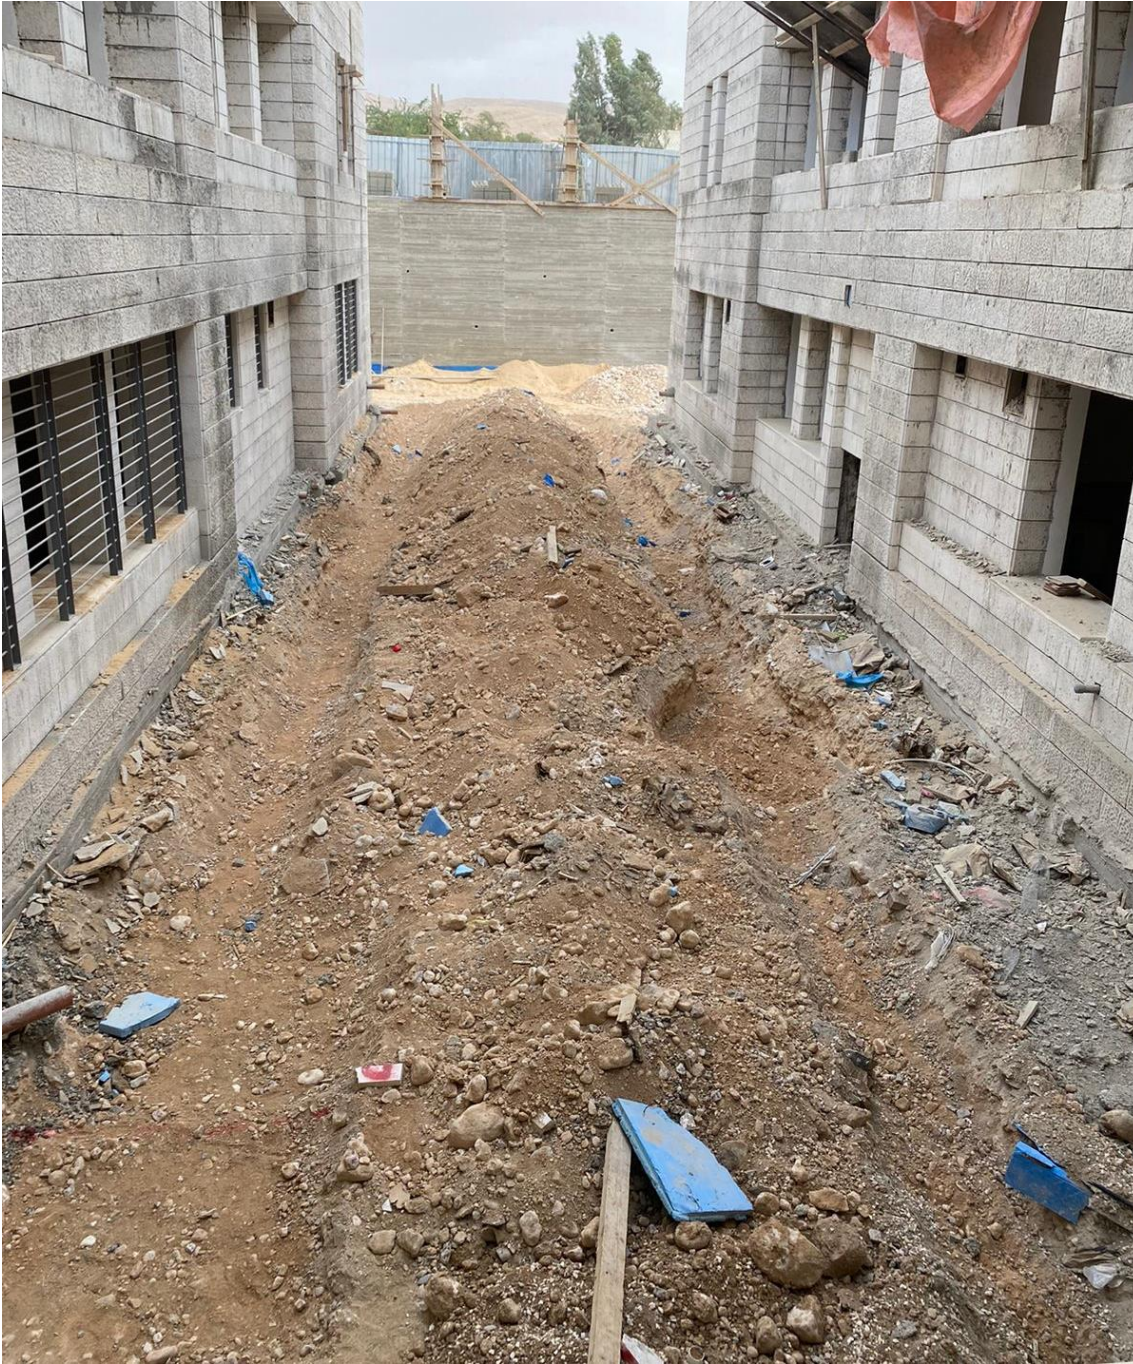
(Figure: 15)

It was observed that the Contractor started with the excavation work for external sewage network

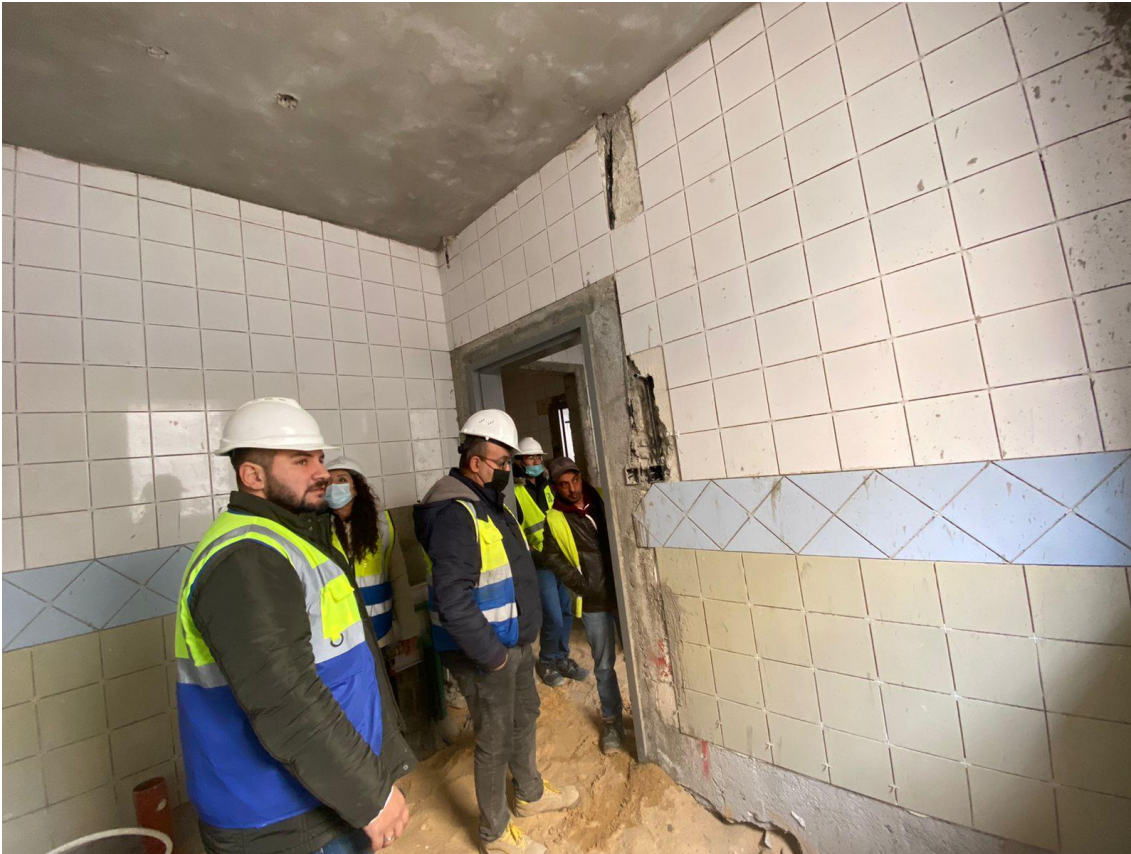
(Figure: 16)

The supervision team inspected the tiling work for the wet areas walls and found the process satisfying

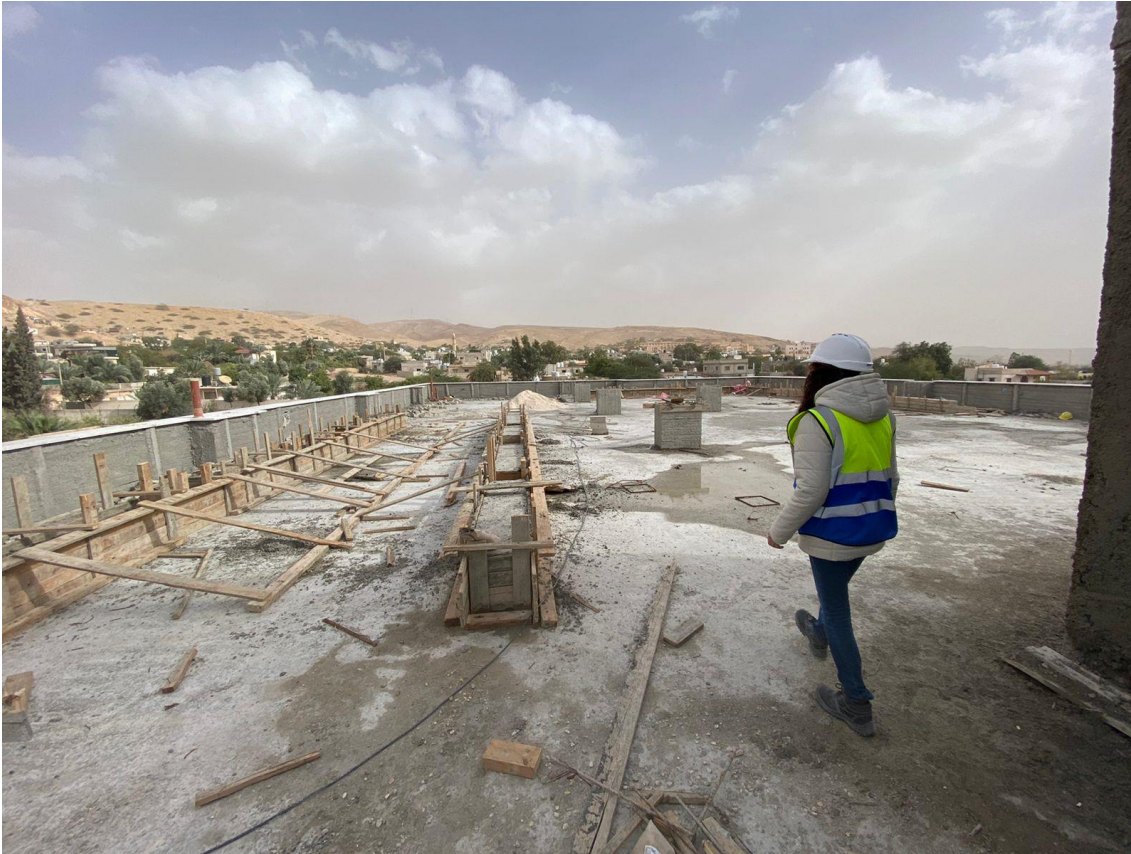
(Figure: 18)

The concrete bases of the mechanical equipment at the roof are under construction

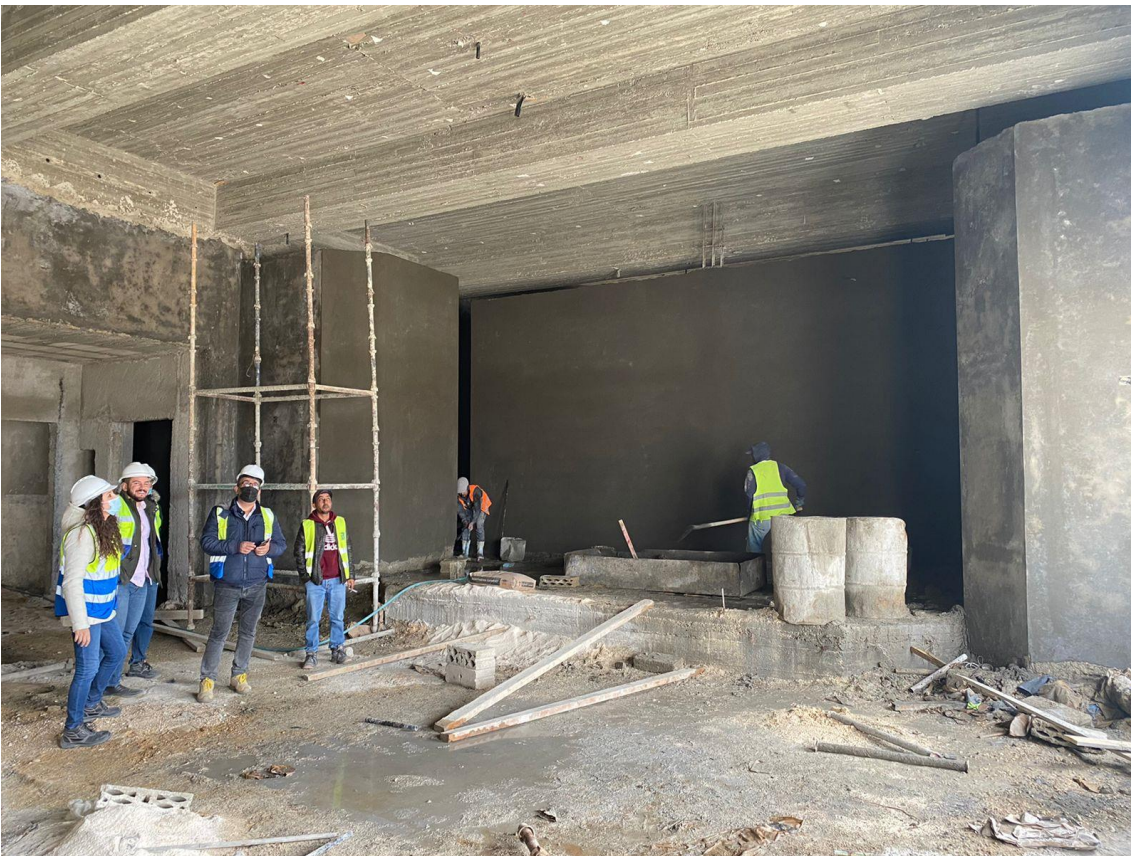
(Figure: 19)

The team inspected the plastering work going on in the multi-purpose hall

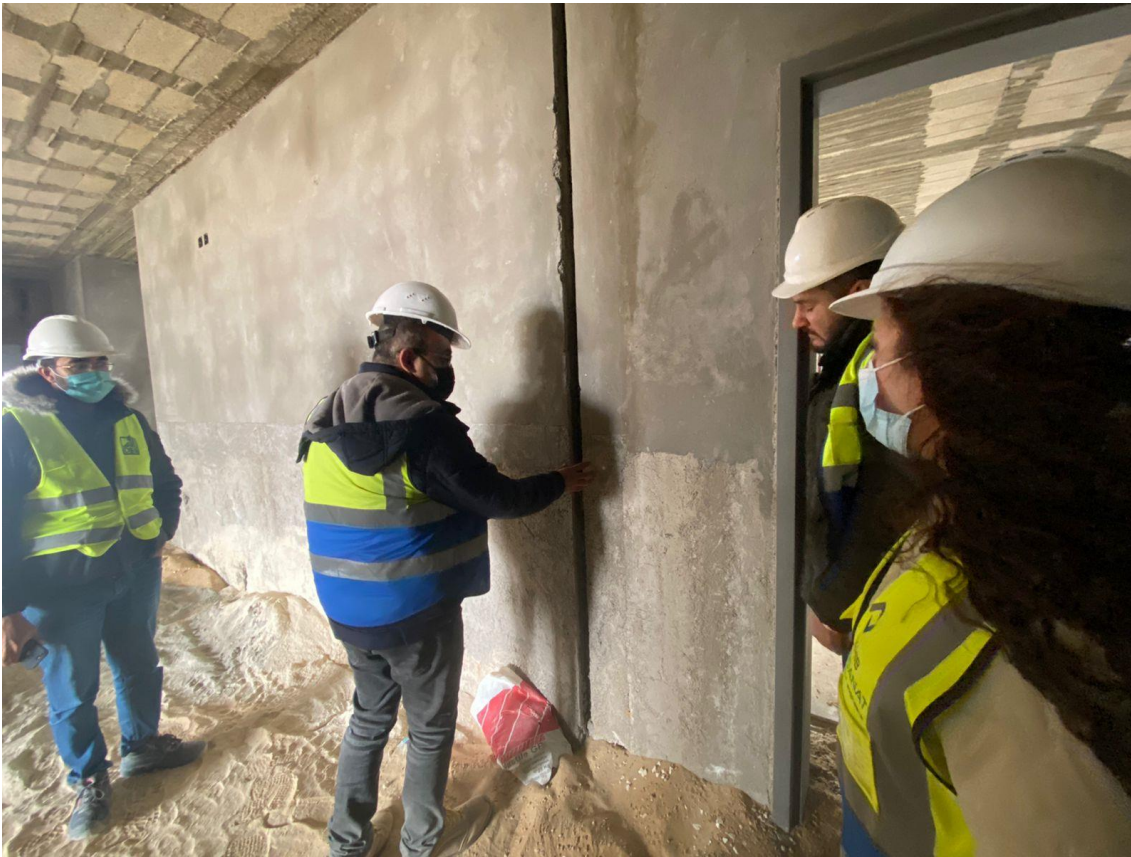
(Figure: 20)

The supervision team observed different alignment in one wall due to different wall thickness. And due to the existing expansion joints, it was agreed with the Contractor to unify the thickness of the wall and replacing one door frames with wider jamb
