Consultant	Wahib Medanat Consultant Engineer	Rep No.	12-17102021
Contractor	Derar Saraireh & Sons for Engineering & Contracting	Tender No.	(11/2019/USAID/SKEP/3/S) Schools for a Knowledge Economy Project (SKEP) - Phase (3) Package (1, 2)
Site Name	Al Khansa' Basic Mixed School- Al Balqa	Day/ Date	Sun. 17/10/2021
Duration of Project	450 Calendar Days	Total Project Budget	9,789,417.840 JD

Visit Notes

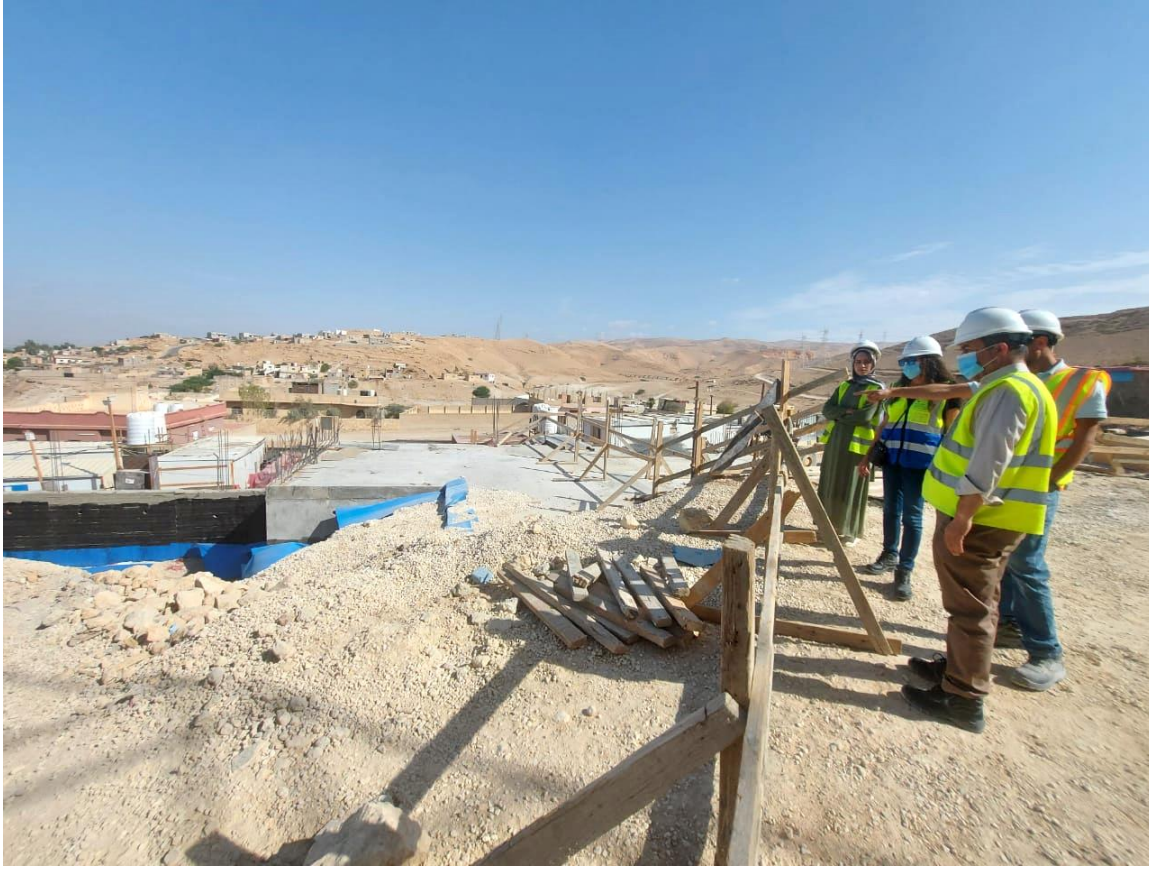
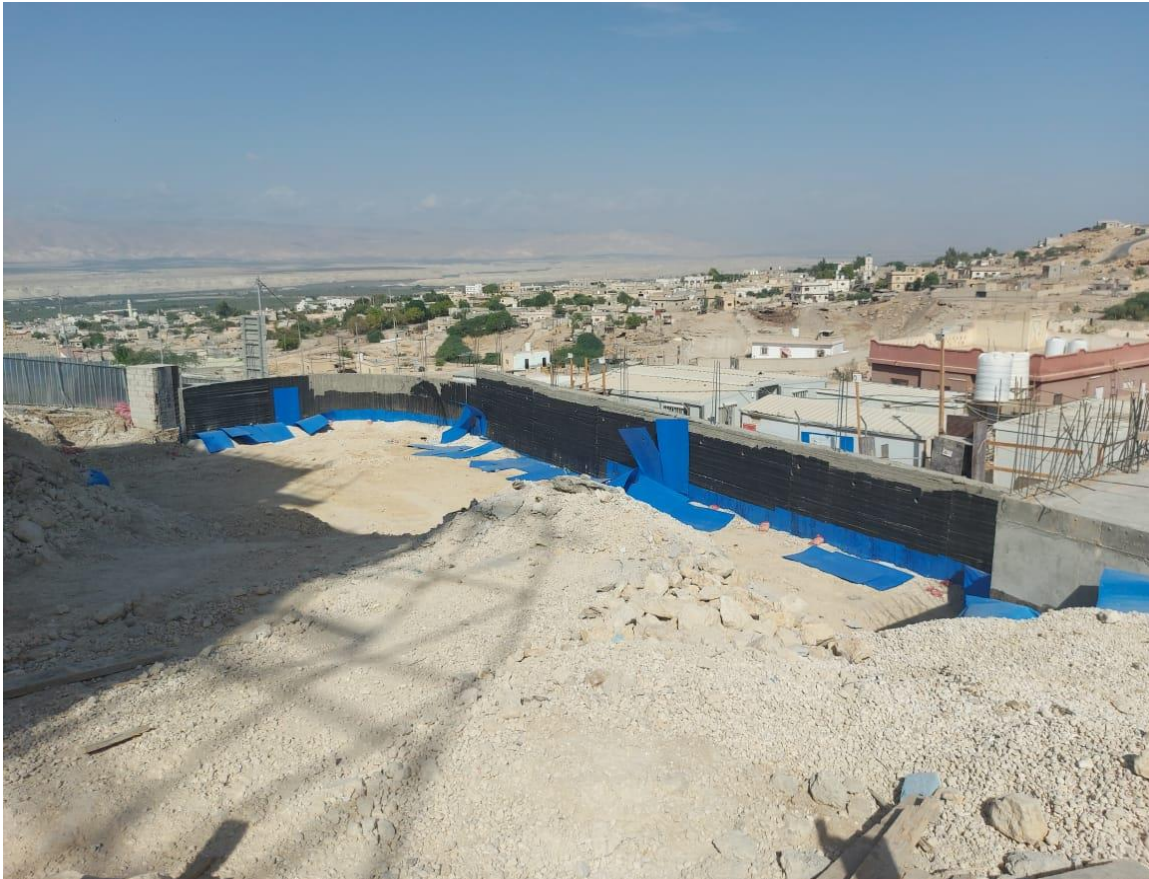
(Figures: 05 & 06)

The supervision team inspecting the Insulation and backfilling works

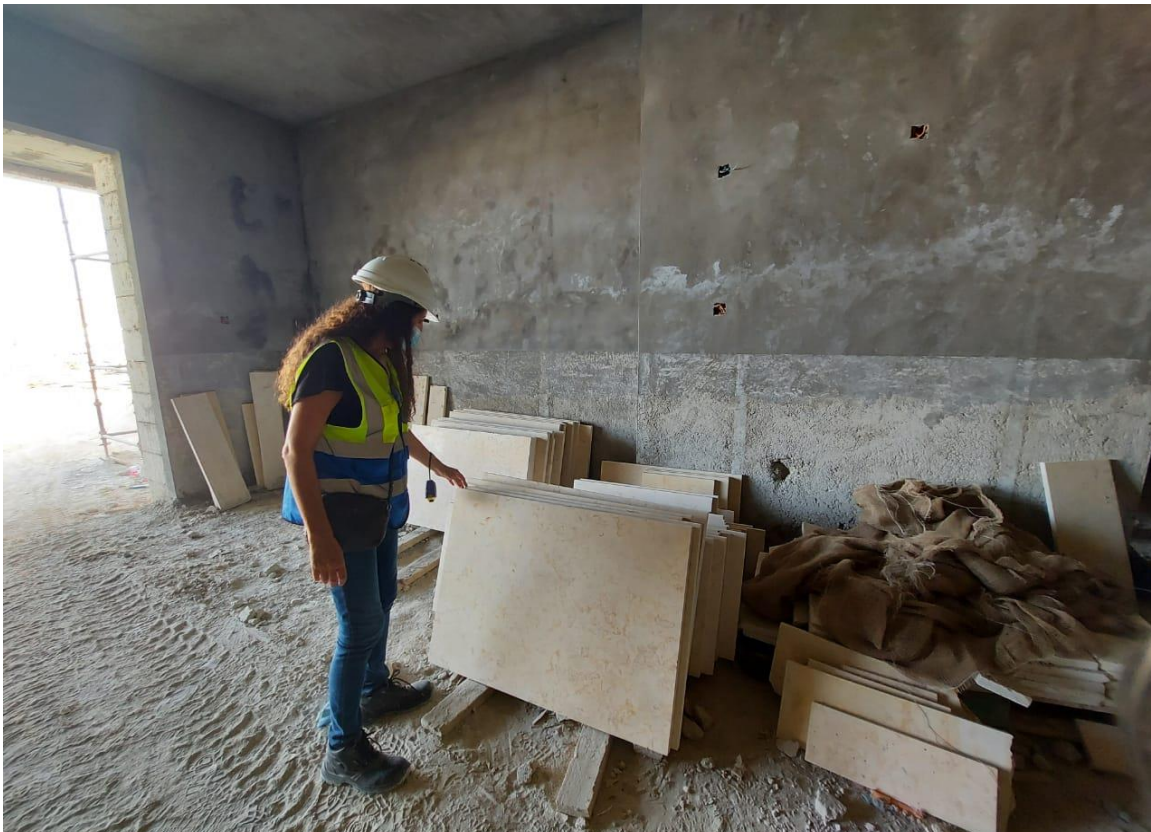
(Figure: 07)

The Supervision team inspected the imported marble window sills and provided the Contractor with general remarks

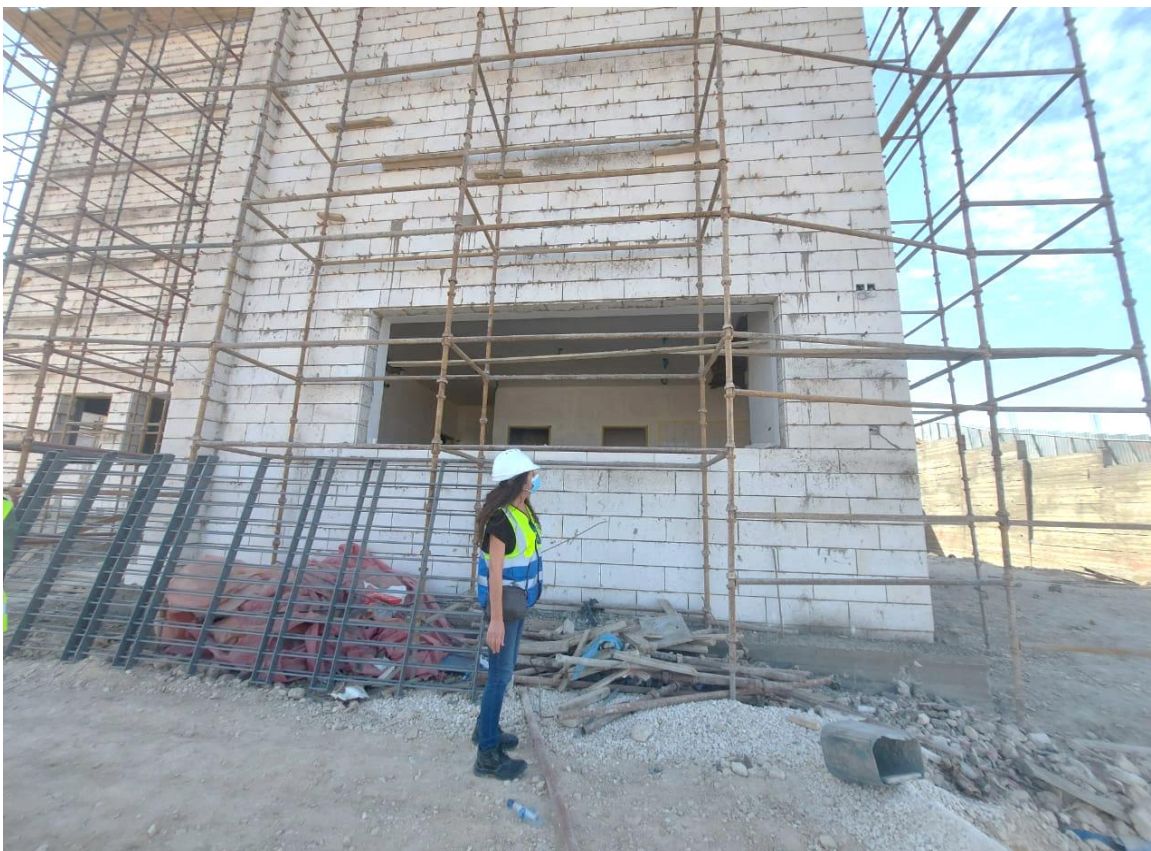
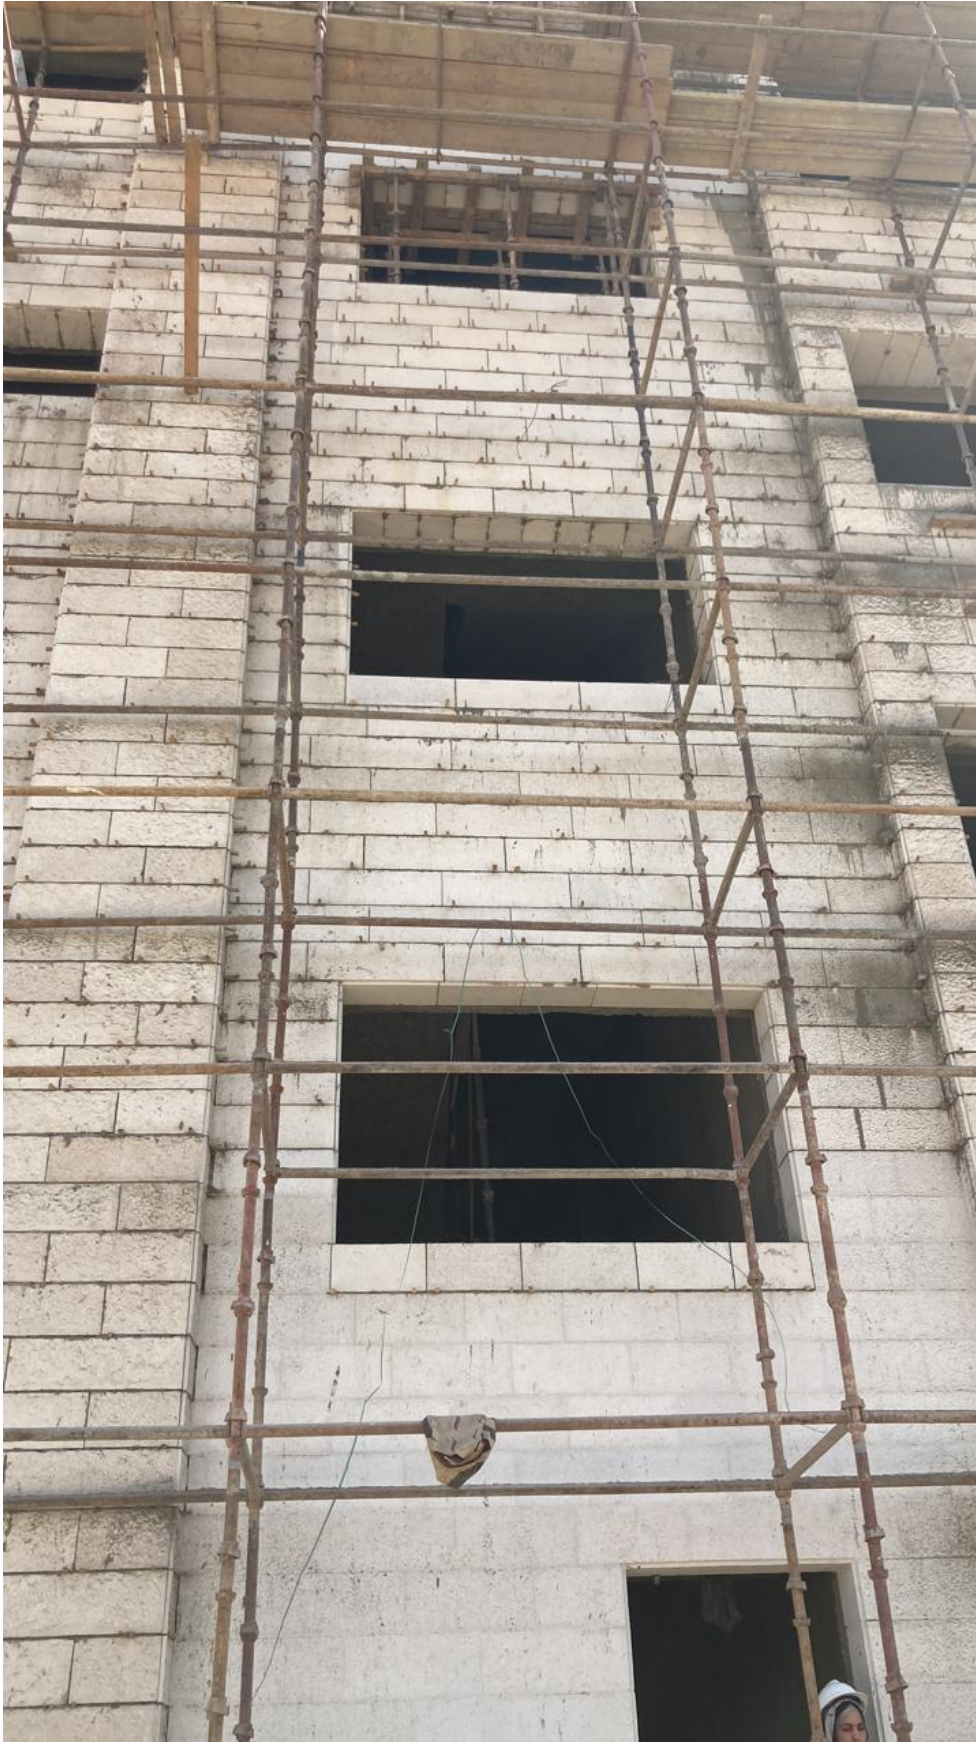
(Figures: 08 & 09)

General inspection was conducted on the stone building for facades

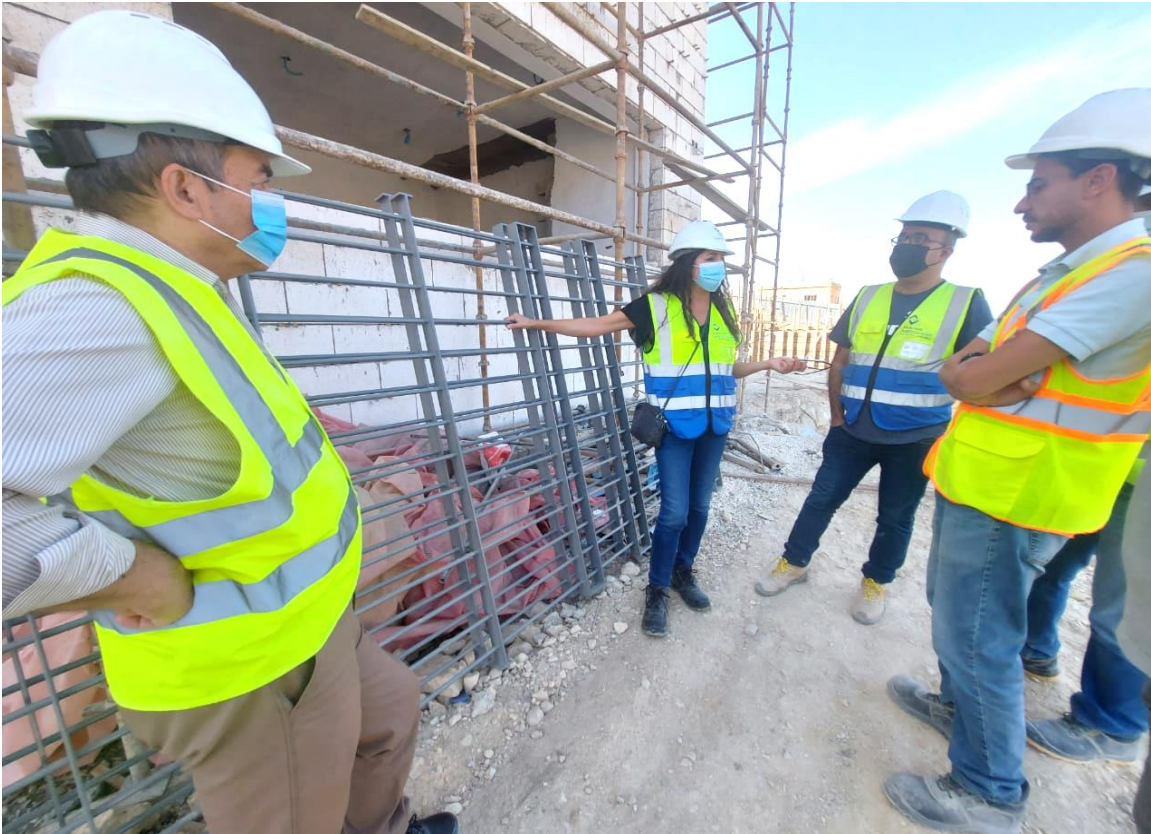
(Figure: 10)

The Contractor imported the steel grill protection and the supervision team inspected before installation

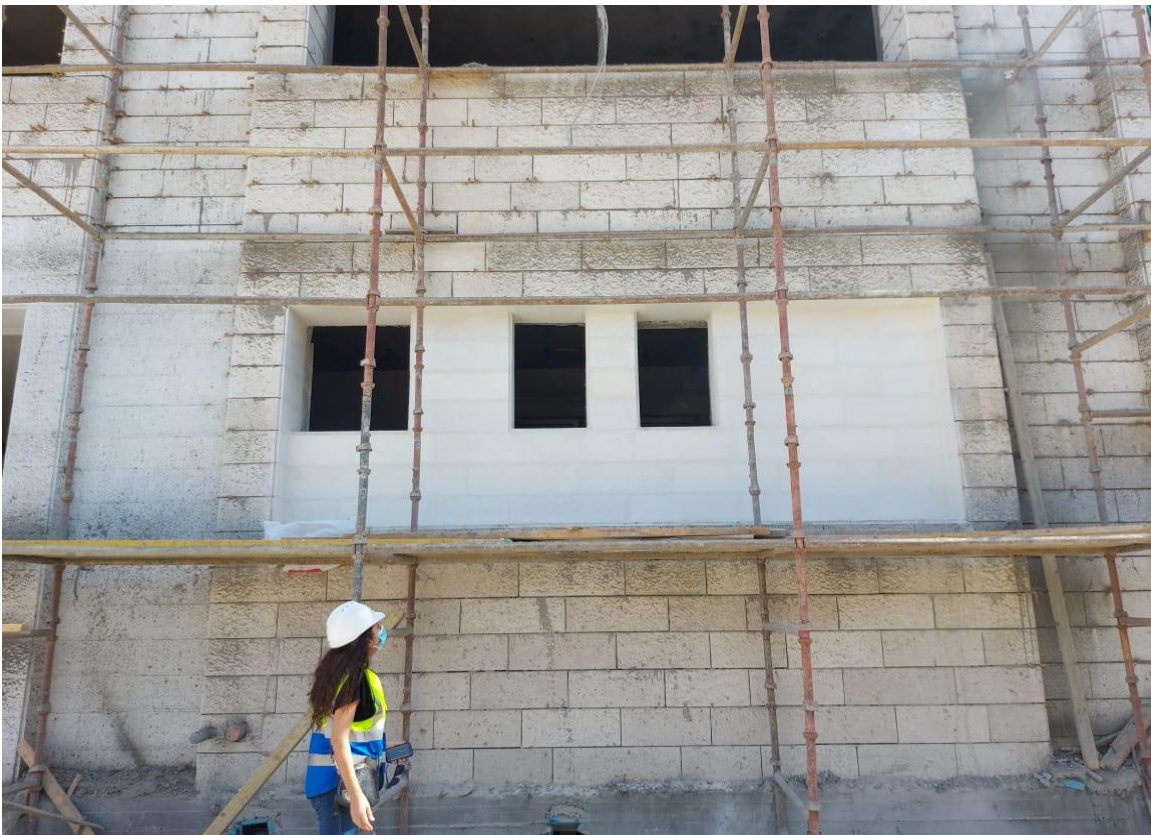
(Figure: 11)

Inspecting stone pointing sample

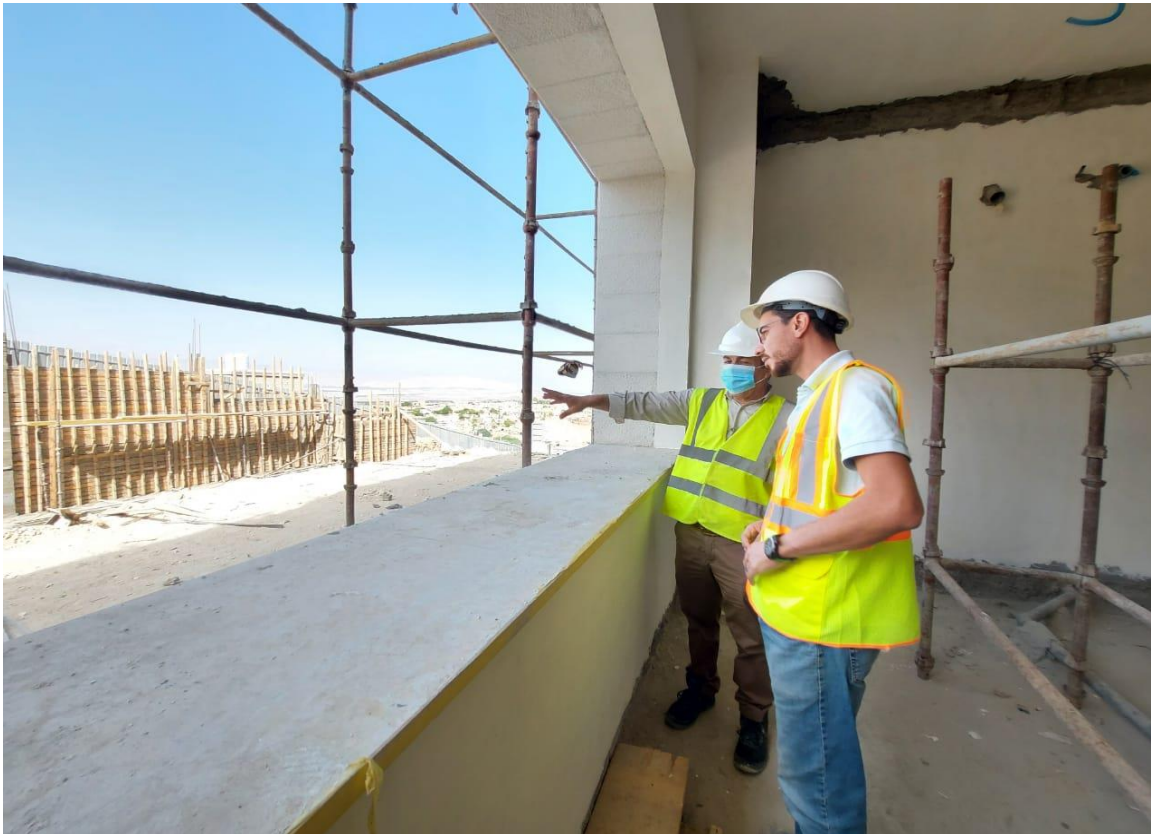
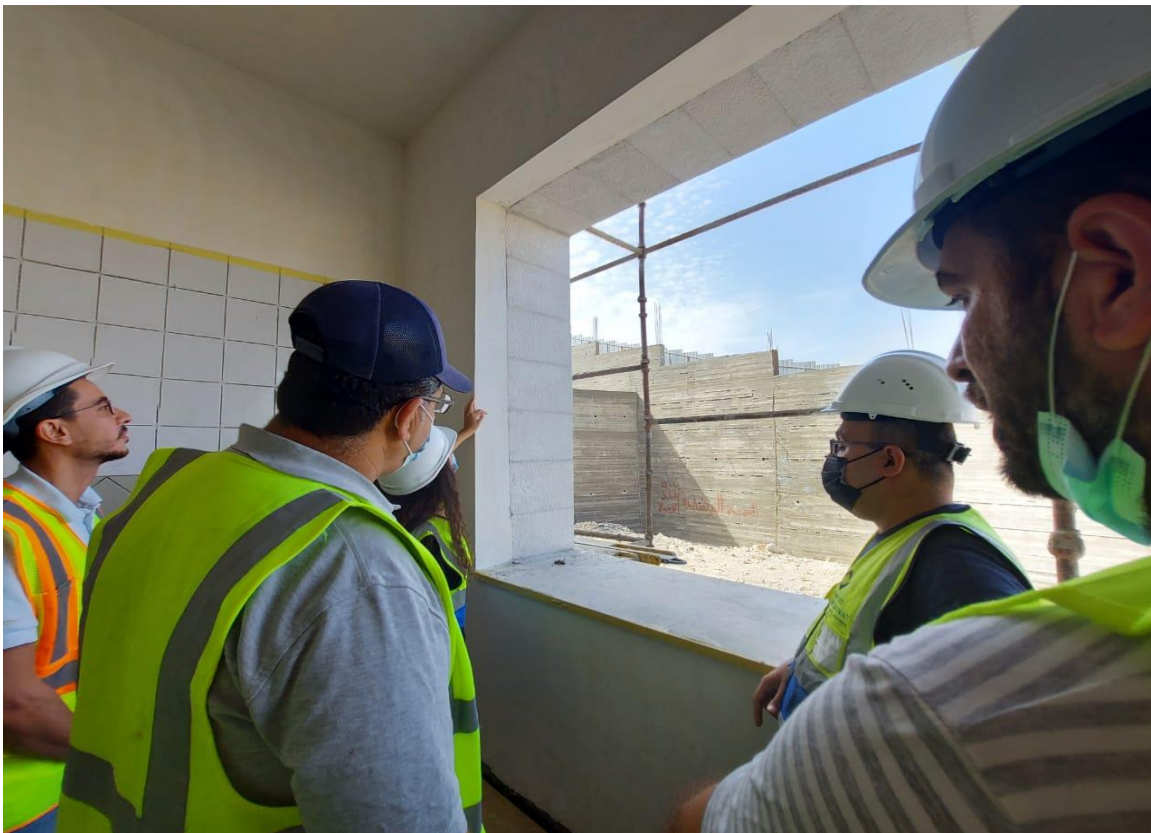
(Figures: 12 & 13)

Inspecting the window opening, i.e., window jambs and the window sill and the slight slope to direct the rain water outside in the mock-up Room

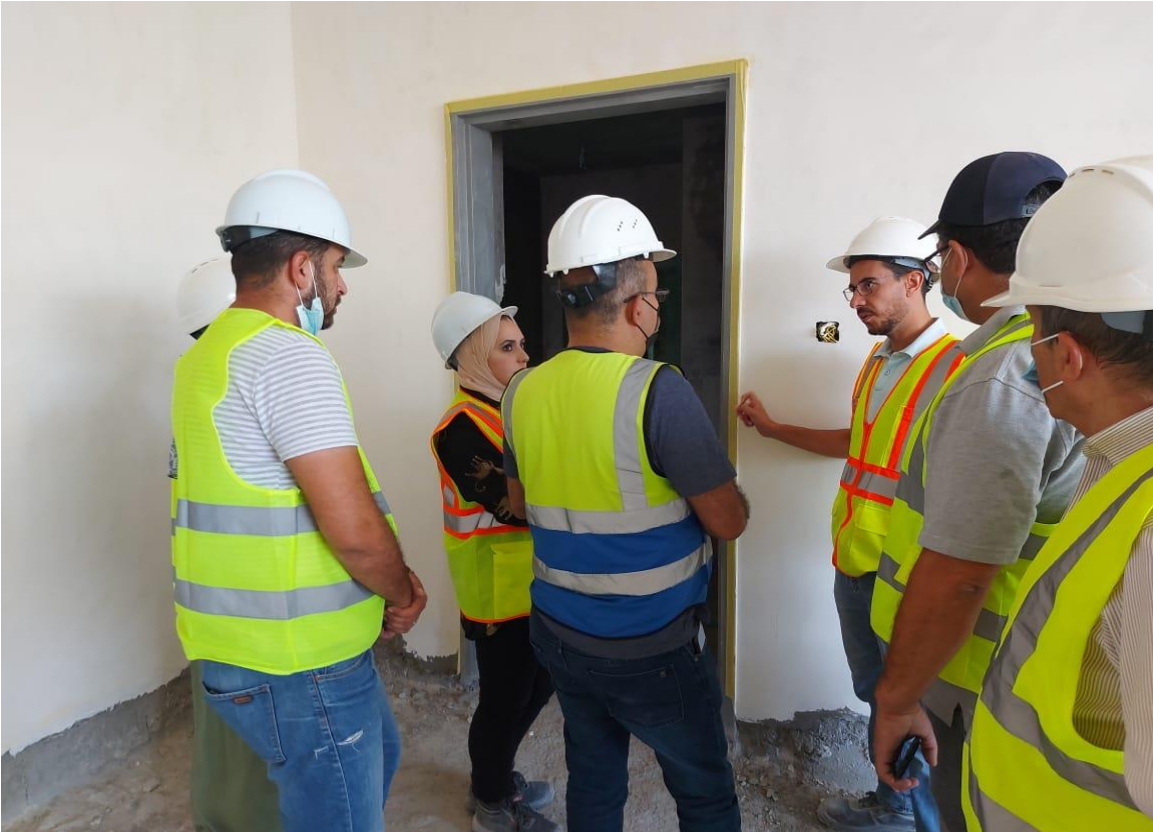
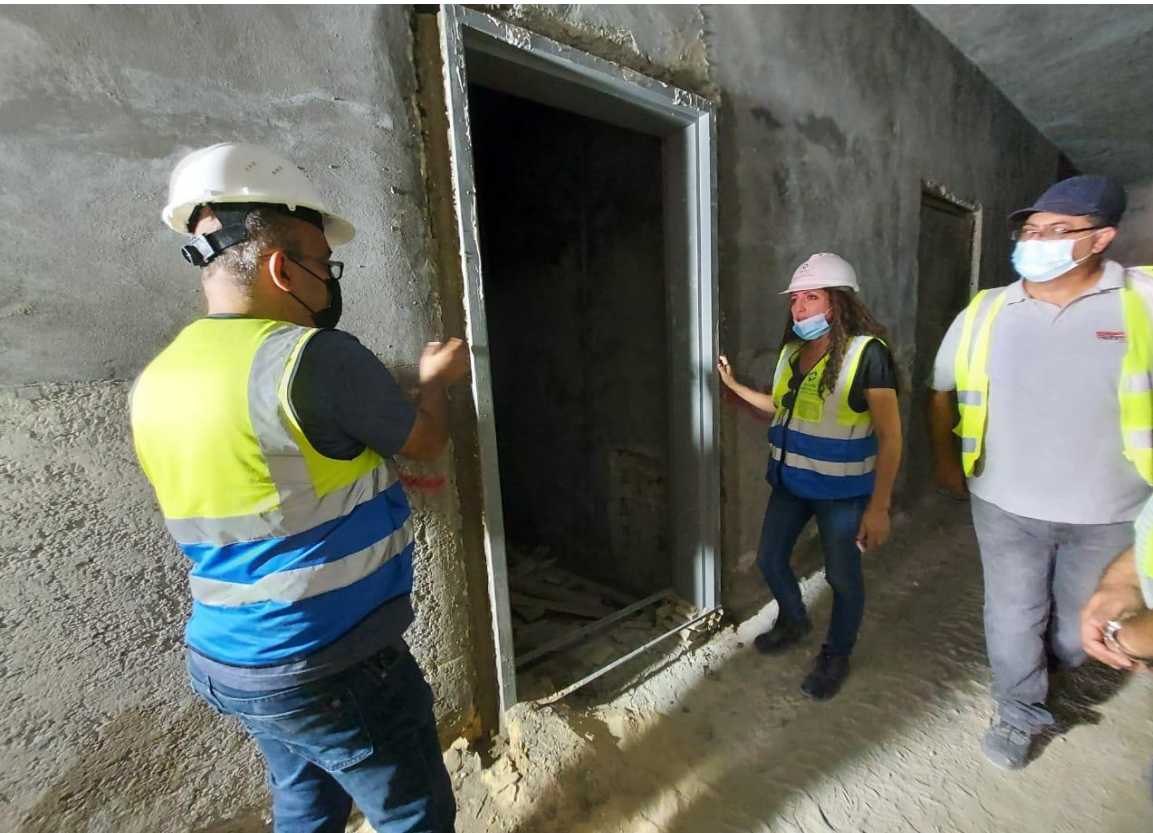
(Figures: 14 % 15)

3	<p>General inspection was conducted on the steel door frames and remarks were given to the Contractor to rectify.</p> <p>3.1. The removal of frames which do not comply regarding the dimensions. 3.1. Casting concrete under the frames at the recess areas to lighten the loads on the bolts those frames are installed in.</p>
4	<p>The installation of mechanical cabinets in the toilet area was inspected to insure the compatibility with tiling and proper cut-off tile pieces. The Contractor was requested to rectify the location of cabinets slightly to avoid small cut-off tile pieces.</p>
5	<p>The Supervision team inspected the imported marble window sills and provided the Contractor with general remarks.</p>
6	<p>The supervision team inspected the executed tiles in the toilets and provided the Contractor with general remarks and the process of tiling.</p>
7	<p>It was observed that the Contractor removed the formwork of the roof slab of the multi-purpose hall.</p>

General inspection was conducted on the steel door frames and remarks were given to the Contractor to rectify

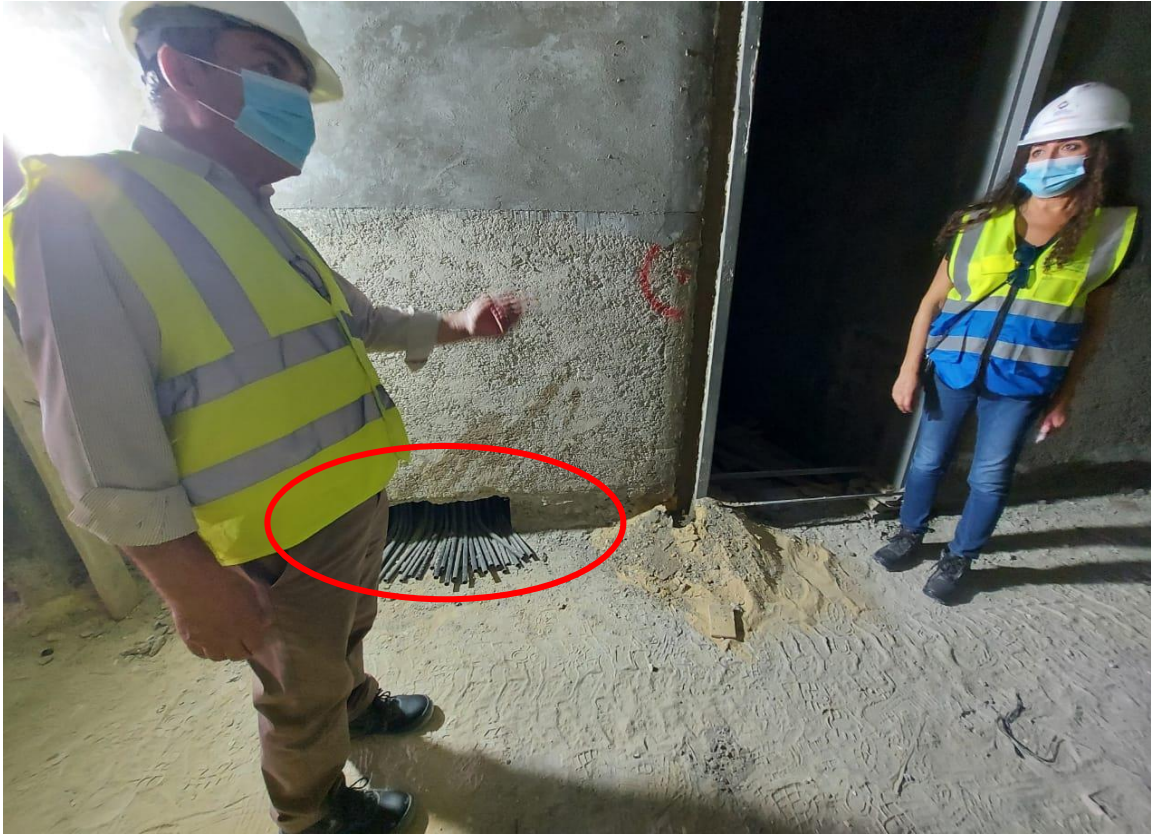
(Figure: 16)

The supervision team instructed the Contractor to temporarily close the ends of installed electrical pipes to avoid entering dirt or debris to those pipes which may cause obstruction to electrical wiring

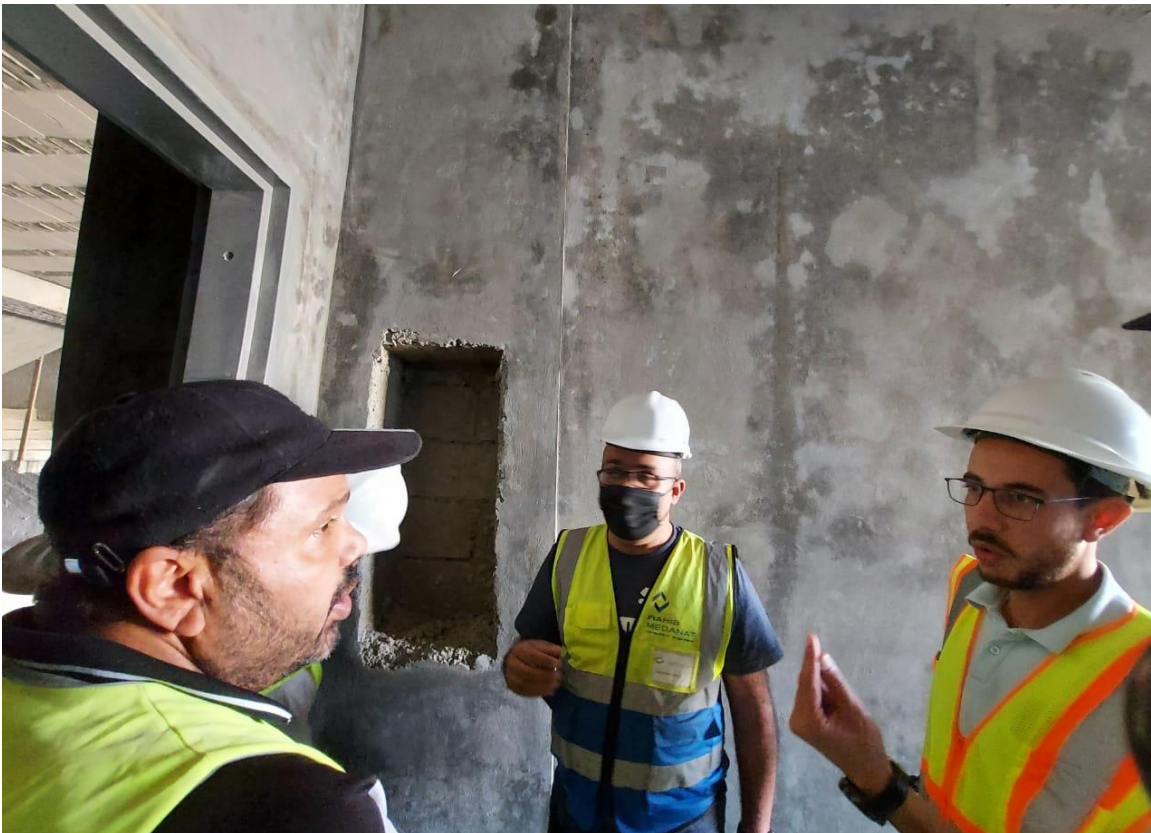
(Figure: 17)

It was noticed that the fire extinguisher place needs to be plastered and well-finished. The Contractor was requested to act accordingly.

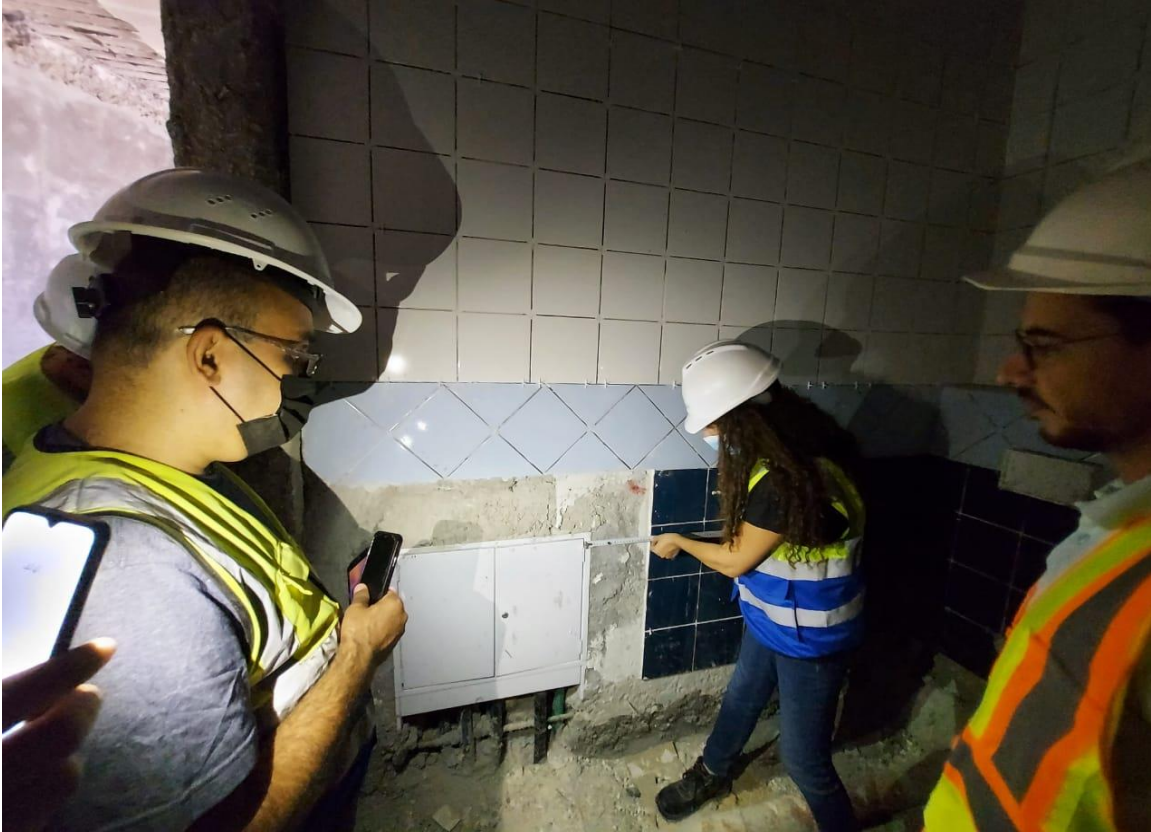
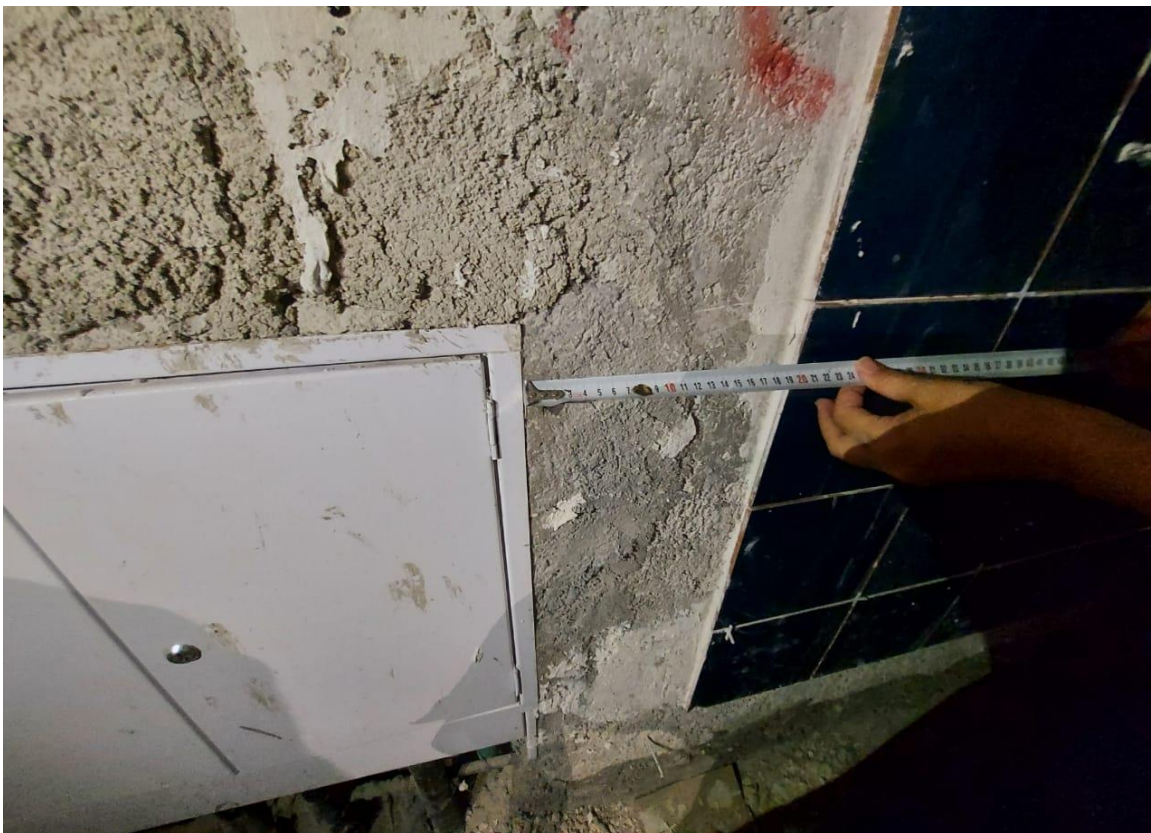
(Figures: 18 & 19)

The installation of mechanical cabinets in the toilet area was inspected to insure the compatibility with tiling and proper cut-off tile pieces.

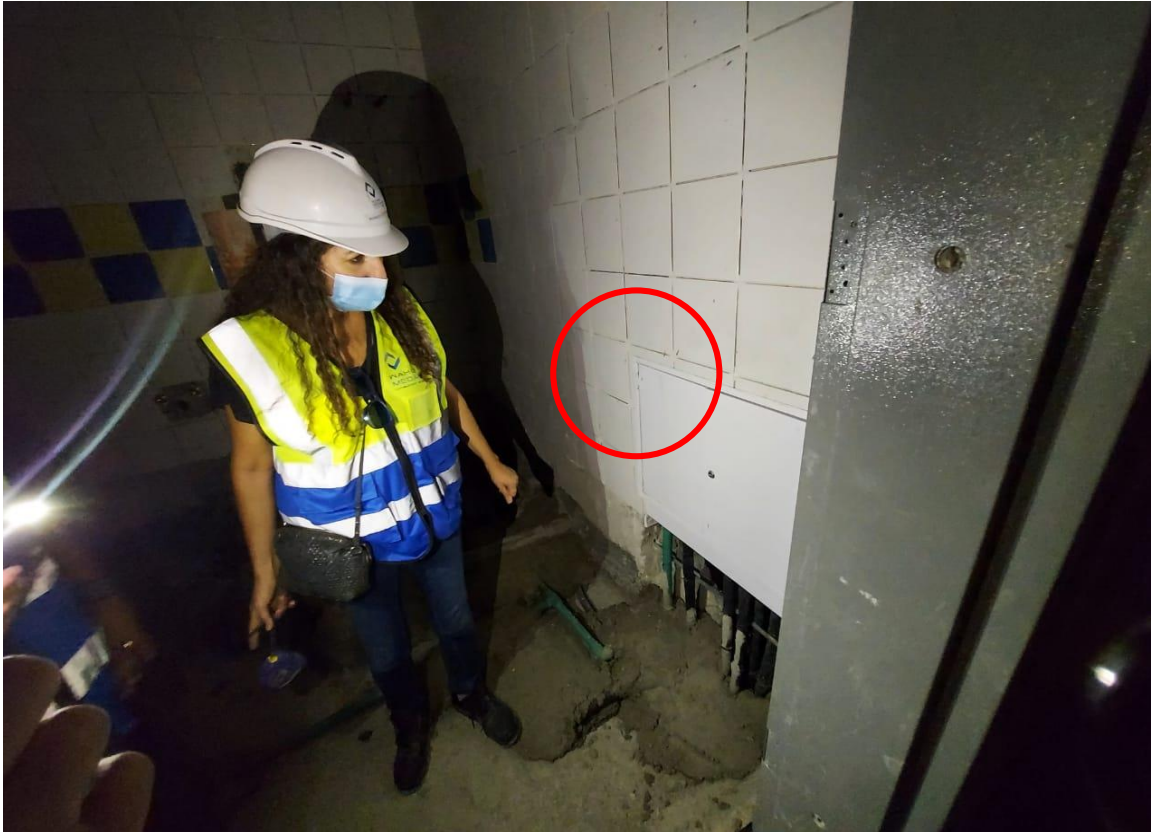
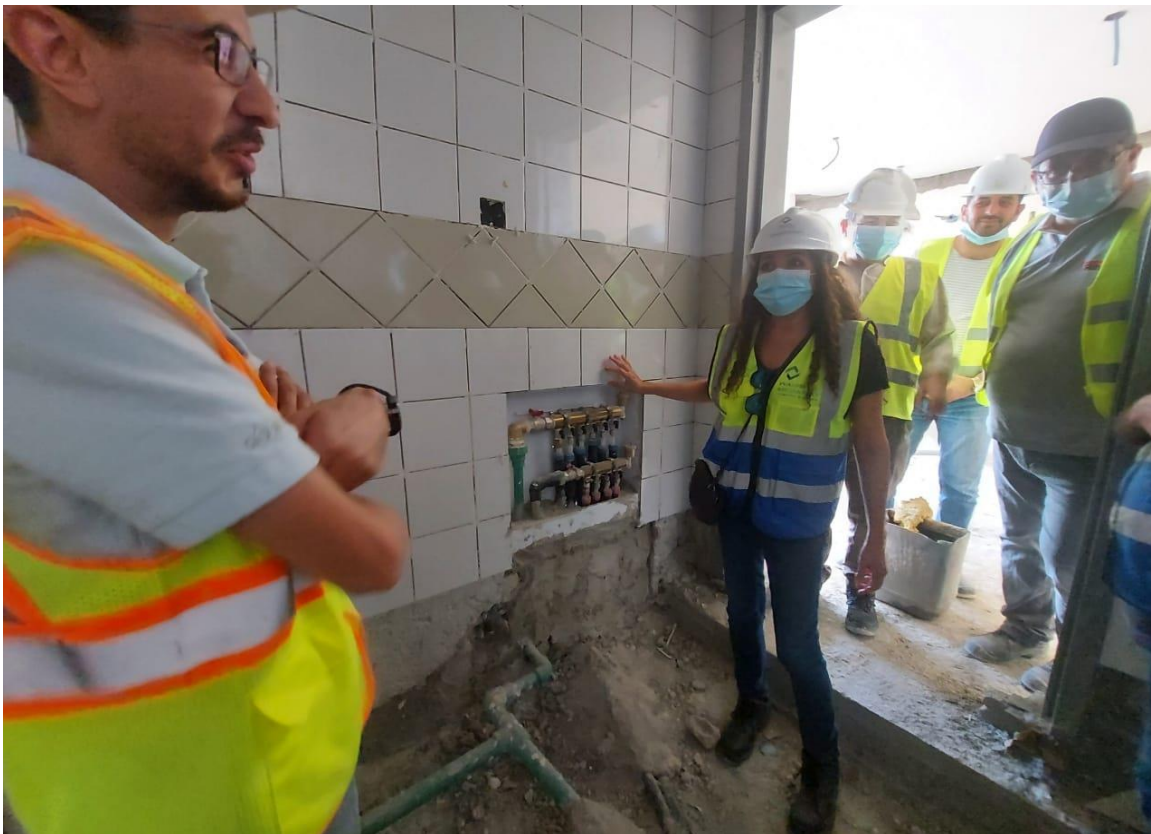
(Figure: 20 & 21)

The Contractor was requested to rectify the location of cabinets slightly to avoid small cut-off tile pieces

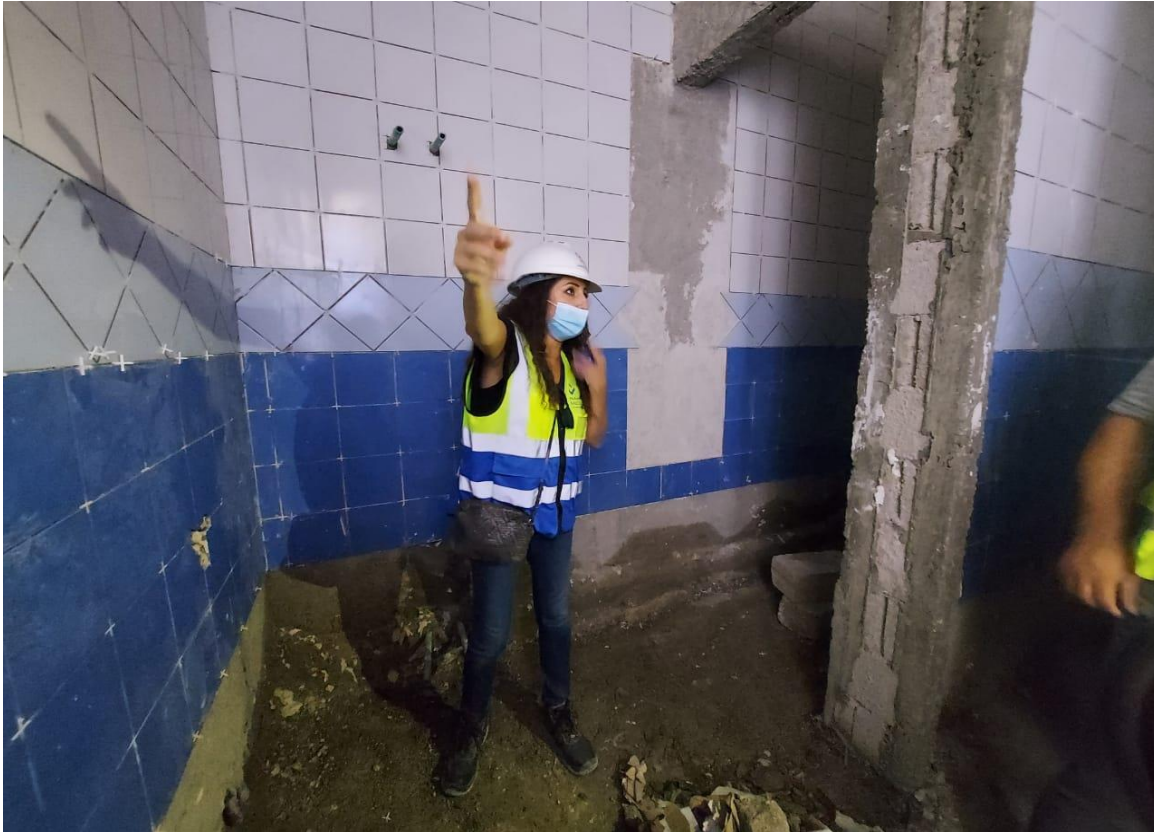
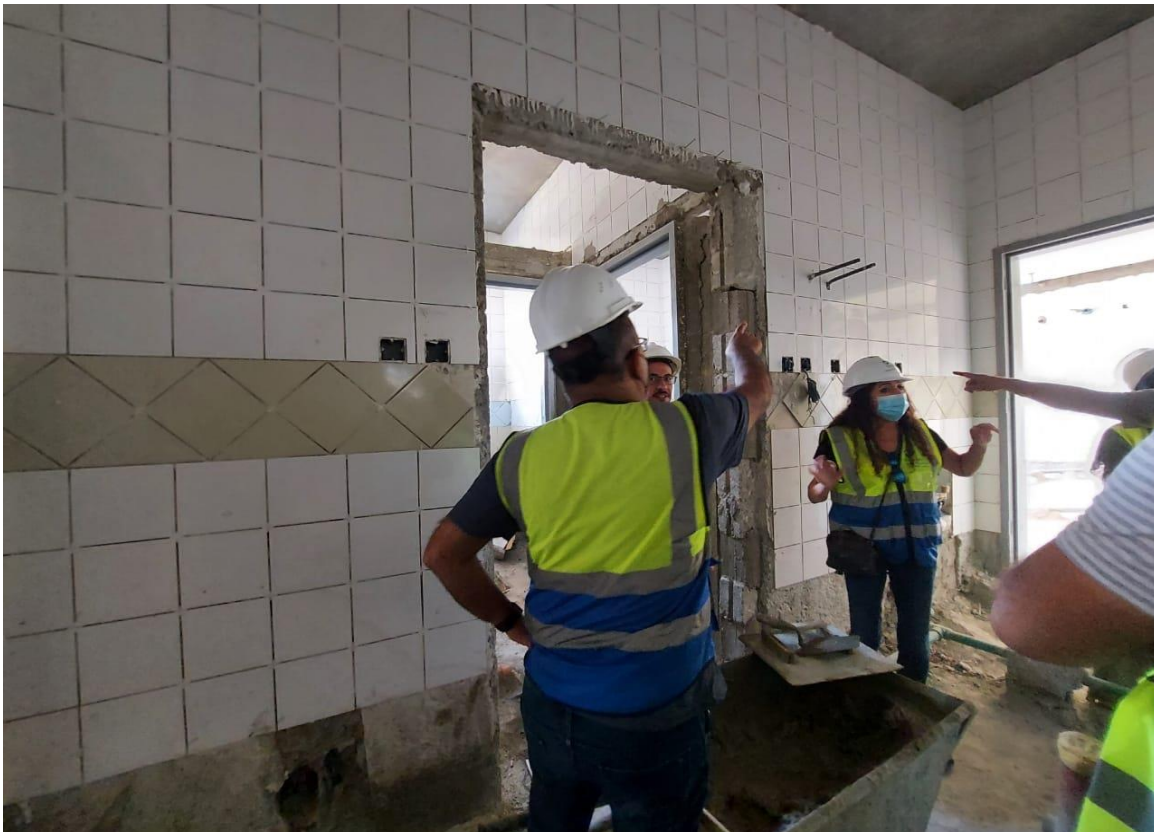
(Figures: 22 & 23)

The supervision team inspected the executed tiles in the toilets and provided the Contractor with general remarks and the process of tiling

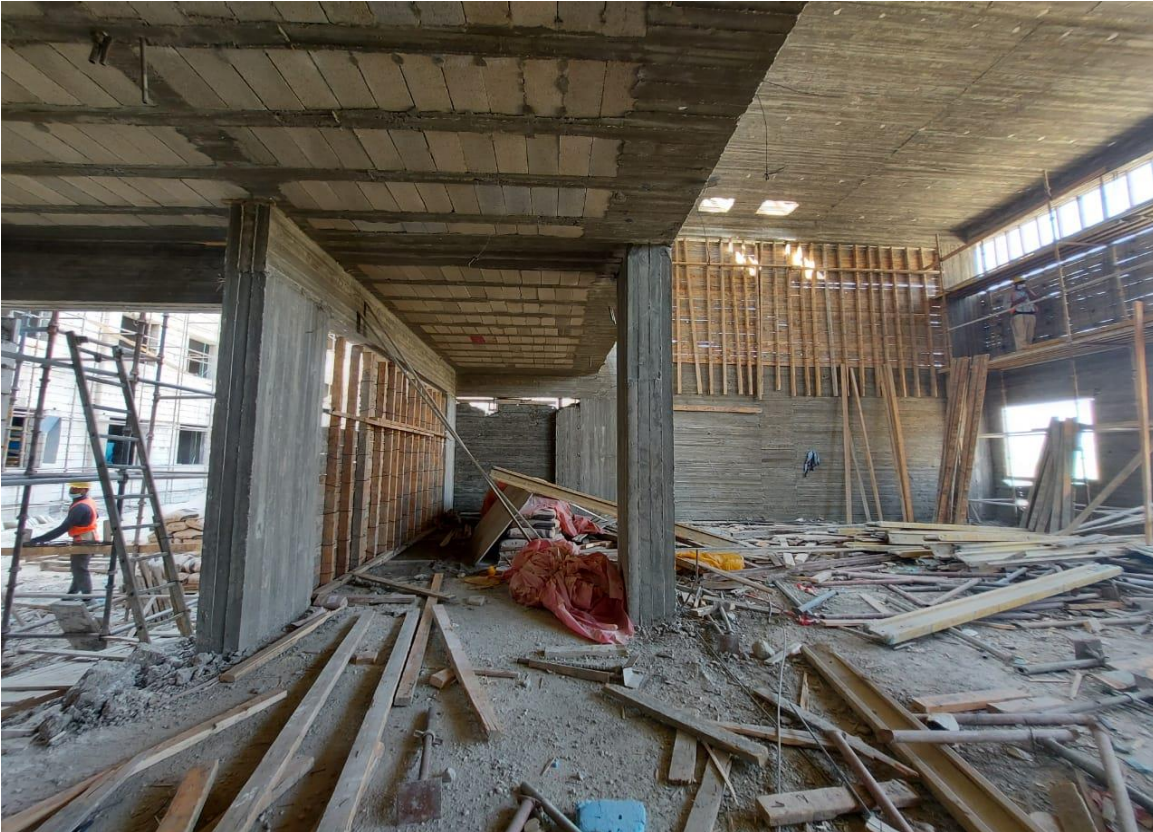
(Figure: 24)

It was observed that the Contractor is working in the execution of the external walls of the multi-purpose hall. Casting of part of those walls was observed

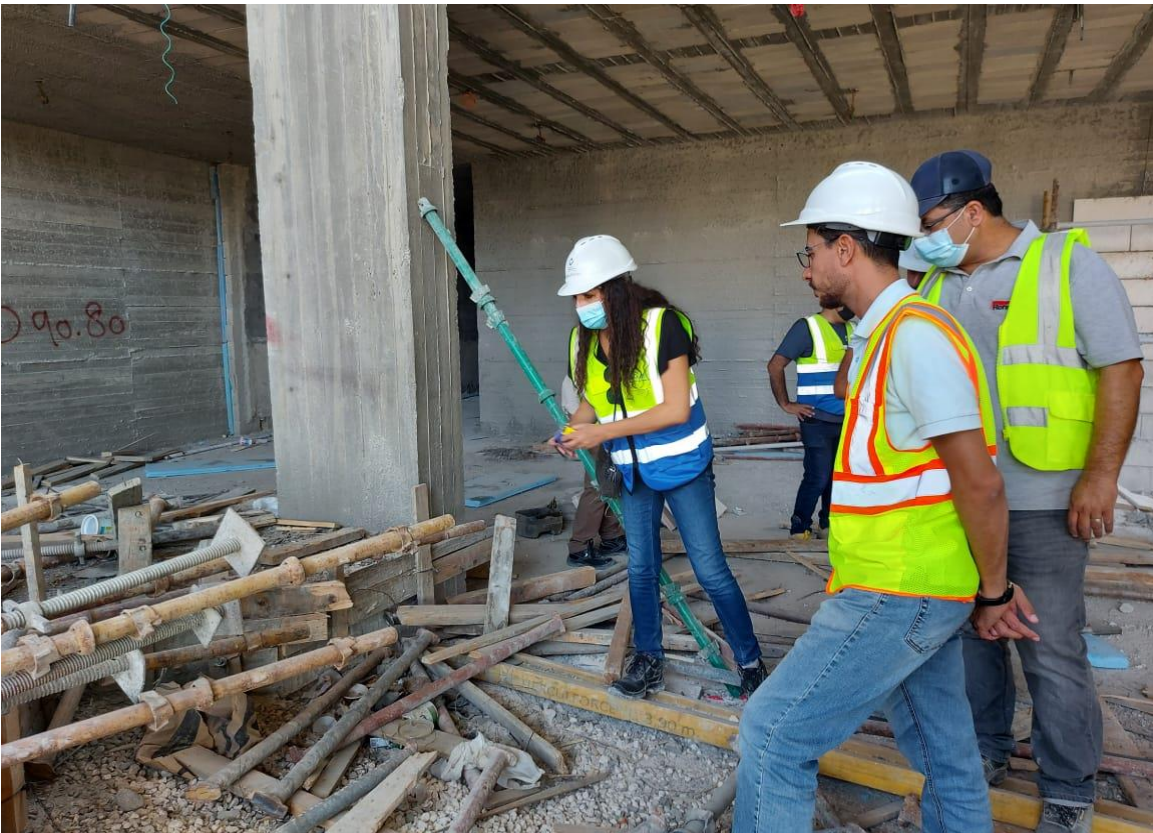
(Figure: 25)

Instructions was given to Contractor regarding the execution of stairs inside the multi-purpose hall

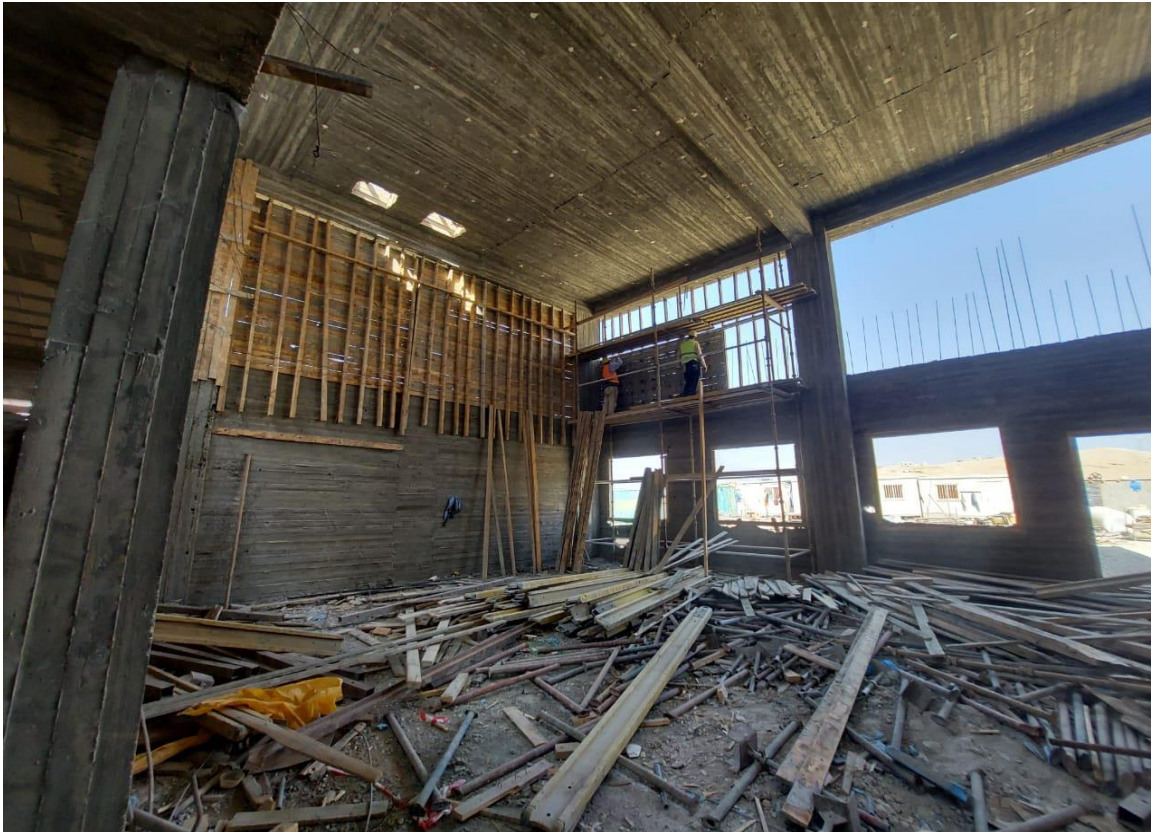
(Figure: 25)

It was observed that the Contractor removed the formwork of the roof slab of the multi-purpose hall
