Quality Control Report

Consultant **Wahib Medanat** Consultant Engineers
Site Name **Um Al Dananir Basic Mixed - Balqa**
Package **Package 1**
Contractor **Derar Saraireh & Sons for Engineering & Contracting**
Tender No. **1/2020/USAID/SKEP/3/1**

Rep No. **QC-11 08**
Date **27 / 07 / 2021**

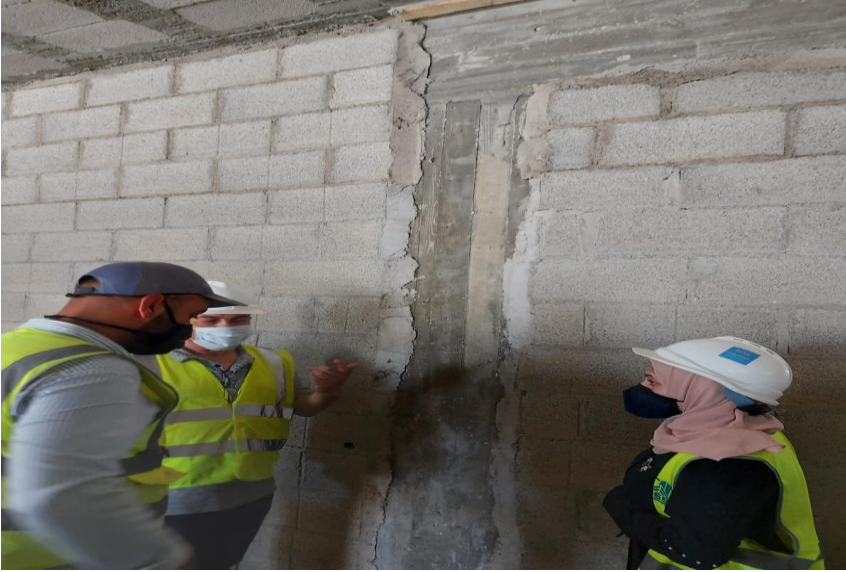
The blockwork is not in line with columns

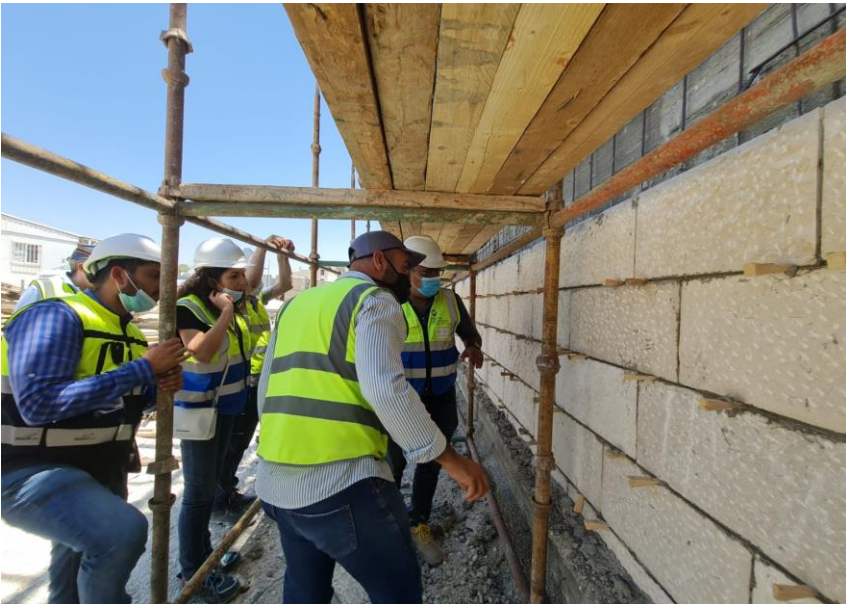
Description of Non Conformance	Corrective Action	Required by / When
<p>Stone:</p> <ol style="list-style-type: none"> Number of stones have broken edges. Gaps between stones have to be unified. Chesseling pattern has to be unified for all stones as per approved sample. Wooden wedges have to be removed from inside before casting backing concrete. Steel ties used for fixing stone have to be increased. <p>Blockwork:</p> <ol style="list-style-type: none"> In some areas, it was observed that block walls are not in line with columns. 	<ol style="list-style-type: none"> Broken stones have to be removed. Gaps to be rectified where possible. Stones not complying with sample has to be removed. Wedges to be removed- follow up by SE. Steel ties to be stronger and more fixing points- follow up By SE. In plasteing work, there should be special case by applying layers with meshes to cover the gaping allignment. 	<p>The Contractor/Immediately</p>

Remarks on the stone, broken edges, gaps not unified, chiseling pattern not unified, ...
