### **Quality Control Report**

Consultant	Wahib Medanat Consultant Engineers
Site Name	Um Al Dananir Basic Mixed - Balqa
Package	Package 1
Contractor	Derar Saraireh & Sons for Engineering & Contracting
Tender No.	1/2020/USAID/SKEP/3/1

Rep No.	QC-11 1	3	
Date	22	/ 11 /	2021

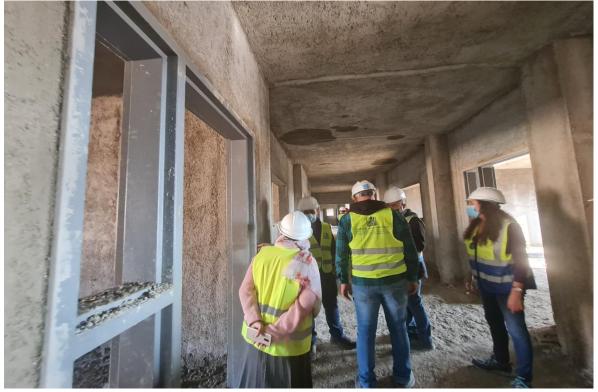
Dirt and cement mortar residues on door frames

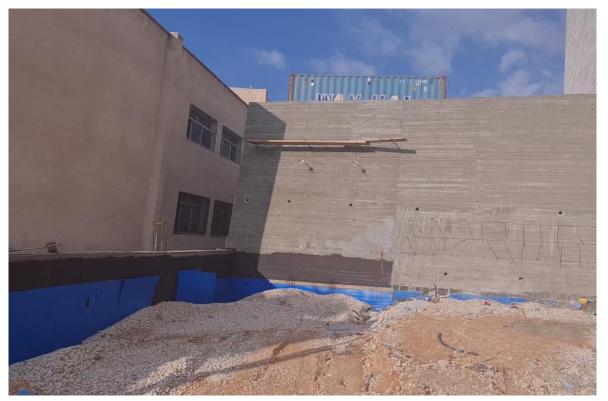
Cartonal sheets protecting the insulation of boundary walls not completed

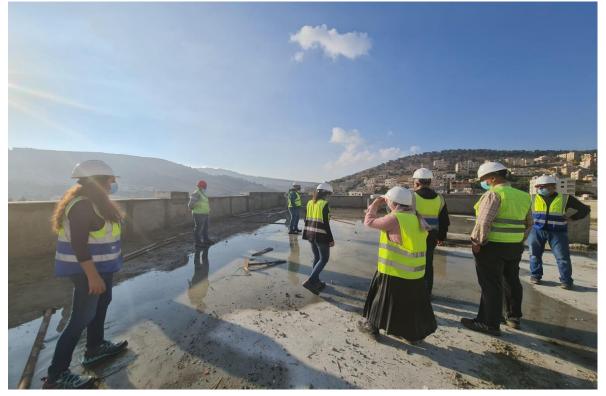
Rain water gathering at the roof

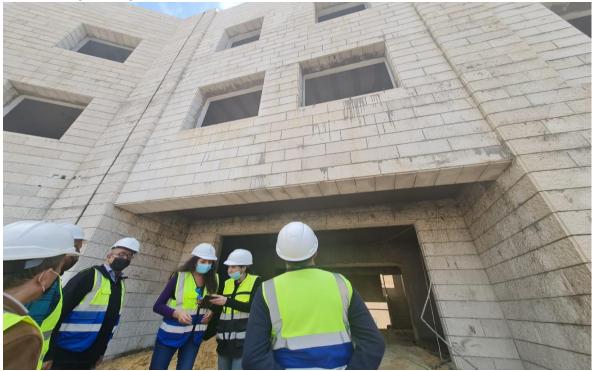
Penetration of rain water through the walls

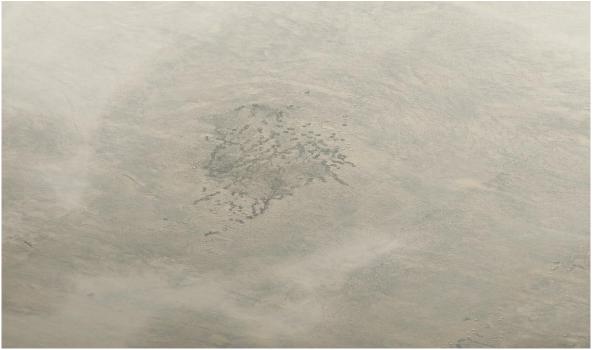
Penetration of water at the ceilings

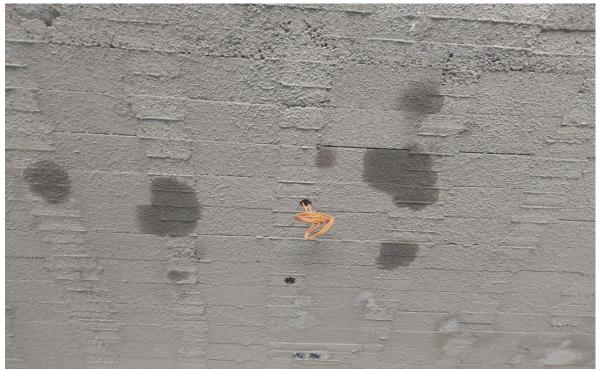
Penetration of water at the ceilings

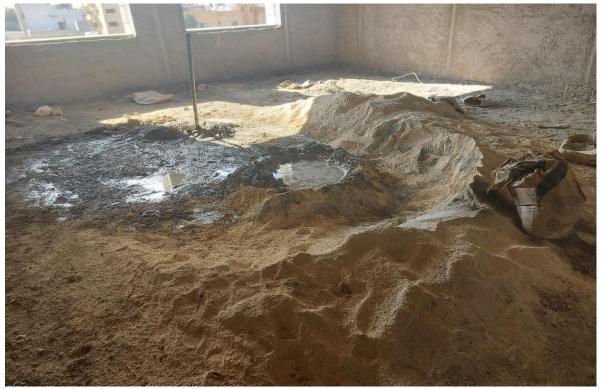
Mixing mortar without container

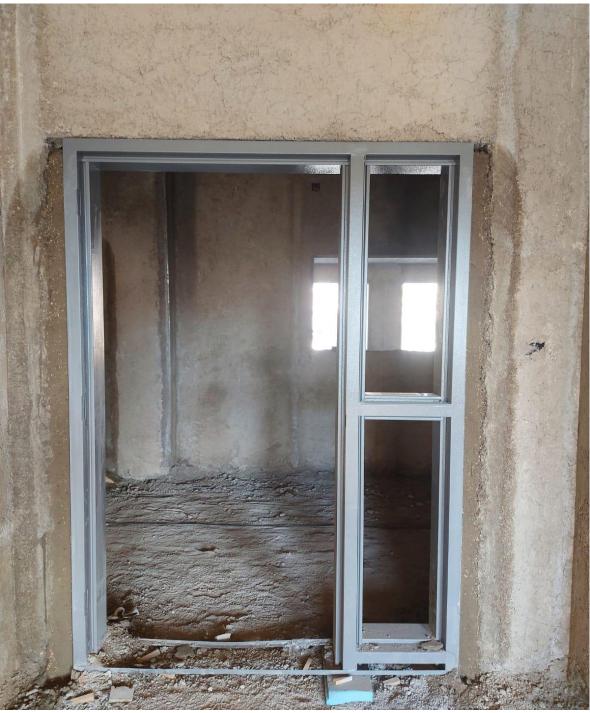
Replaced door frames with the correct dimensions
