SKEP III Home Office Support Site Visit Report

Consultant	Wahib Medanat Consultant Engineer	Rep No.	23-18122021
Contractor	Dijlah Establishment Constr. Contracting	Tender No.	(11/2019/USAID/SKEP/3/S) Schools for a Knowledge Economy Project (SKEP) - Phase (3) Package (1, 2)
Site Name	Jumana Bint Abit Taleb Basic Mixed School - Jerash	Day/ Date	Sat. 18/12/2021
Duration of Project	450 Calendar Days	Total Project Budget	8,314,983.735 JD

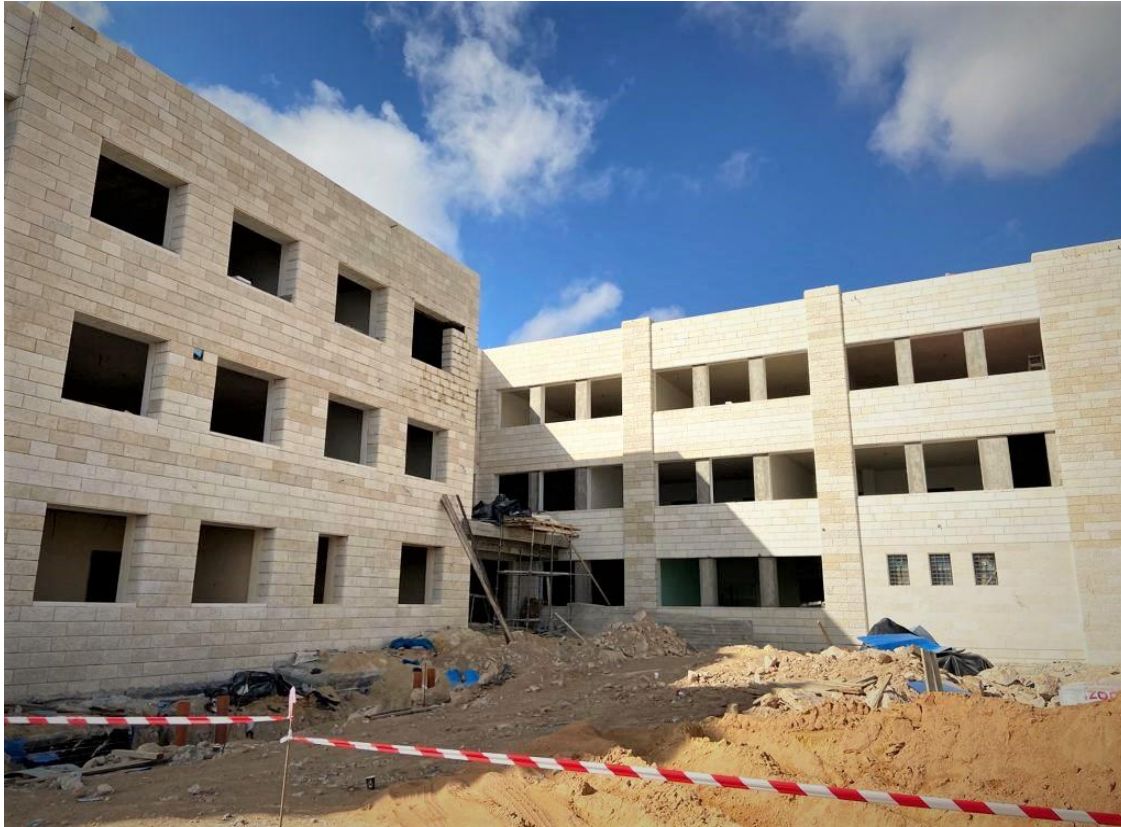
(Figure: 01)

The supervision team inspected the stone facades and comments were given to the Contractor

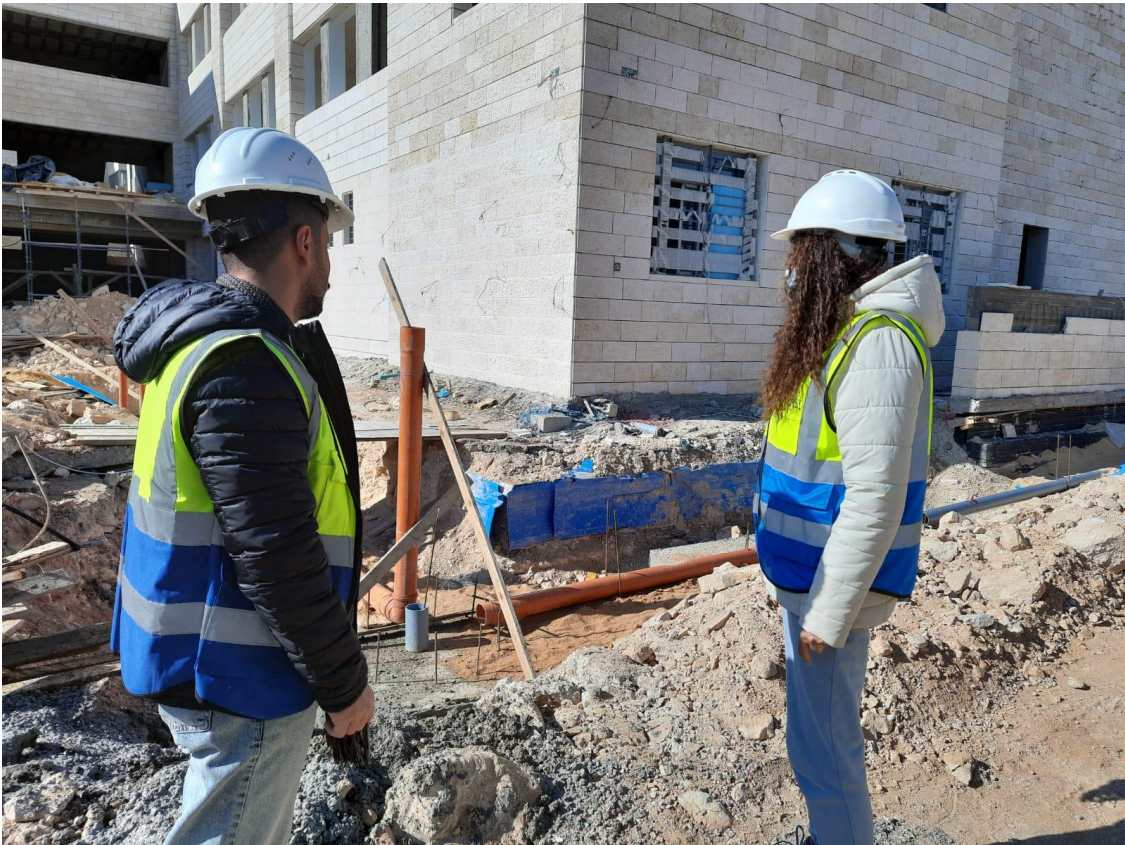
(Figure: 04)

Inspecting the
installation of
sewer pipes

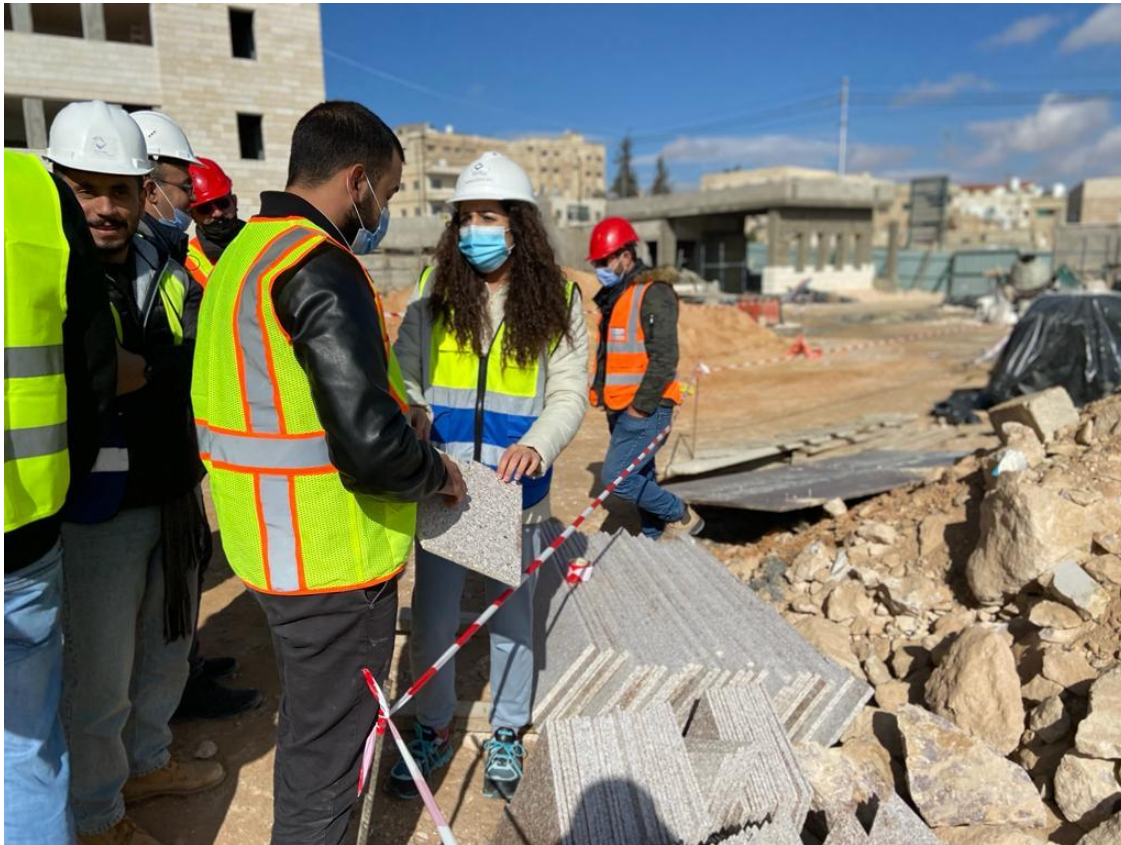
(Figure: 05)

The delivered granite quantities in the site have the same defect and the Contractor was instructed to remove them outside the site

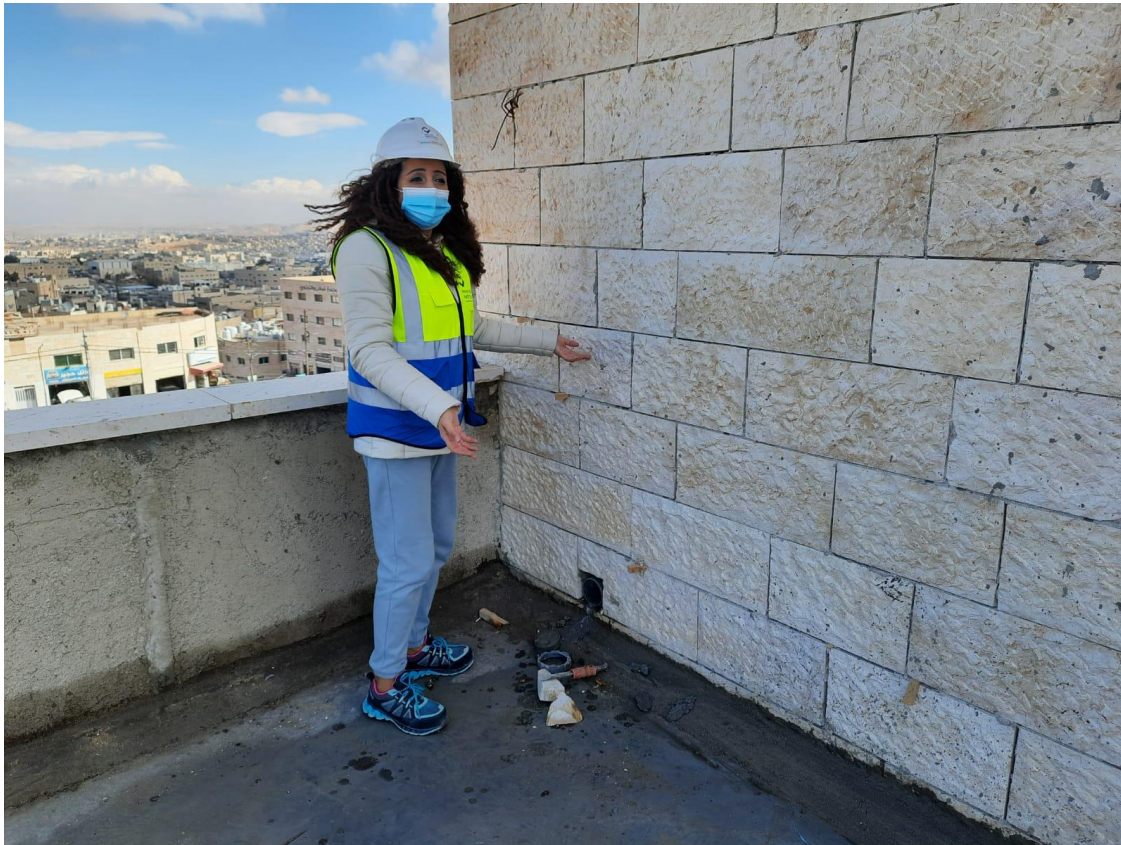
(Figure: 07)

The supervision team inspected the stone facades for the staircases and the team observed the following defects:

- Considerable defects in the used stones, the stone pieces are full of voids and various defects
- The overlapping distance for some parts is less than specified
- A number of stones has lengths less than the minimum allowed length, others have more than maximum allowed length

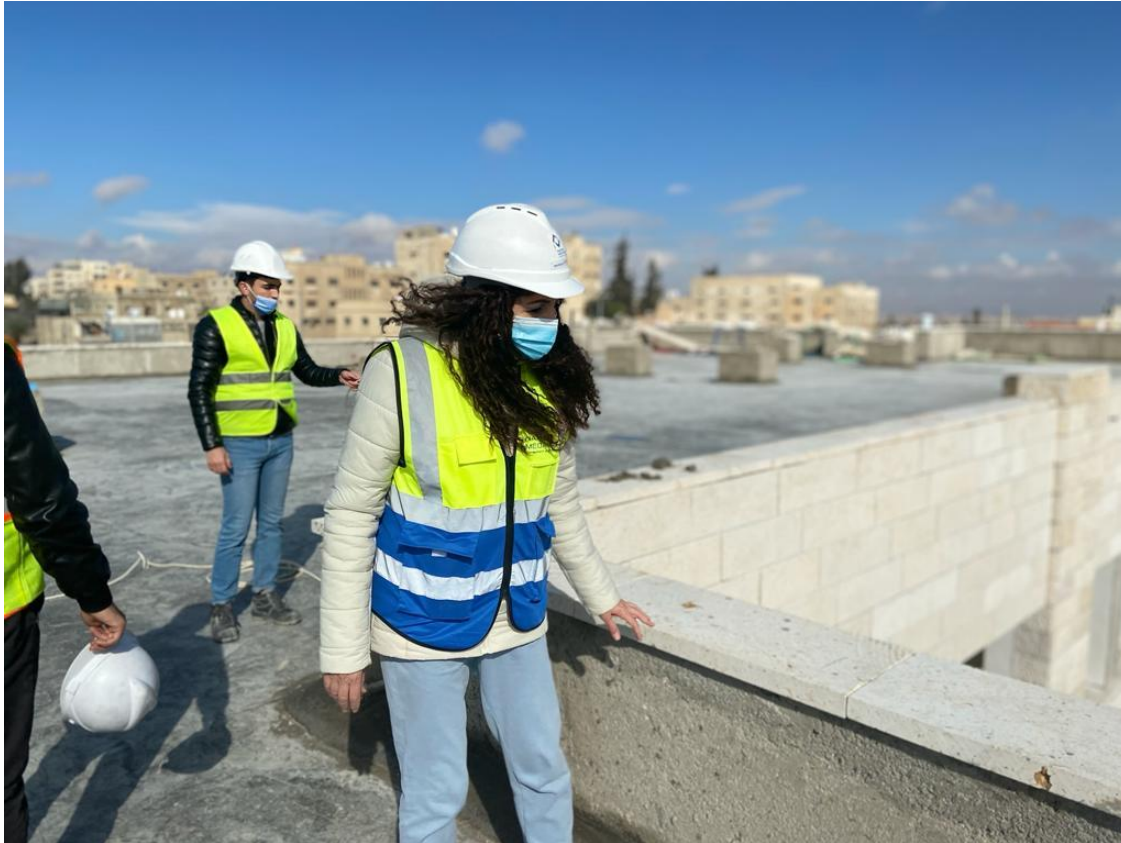
(Figure: 09)

Inspecting the stone coping at the roof parapet:
The face of the coping is full of defects and voids

No.	Description
1	The supervision team observed the following defects in the stone coping at the roof parapet and requested the Contractor to rectify or replace: <ul style="list-style-type: none"> - The face of the coping is full of defects and voids. - The thickness of the coping is not unified for all pieces. - The level of executed coping pieces is not consistent. - Rain water groove is not done as a protection to avoid effects of rain water.
2	The team observed that the granite pieces for staircases (wall granite and skirting) has a major defect since the cutting off to the required size is not done properly. The way of cutting should be factory made result in sharp edge without any teething. The other quantities in the site have the same defect and the Contractor was instructed to remove them outside the site.

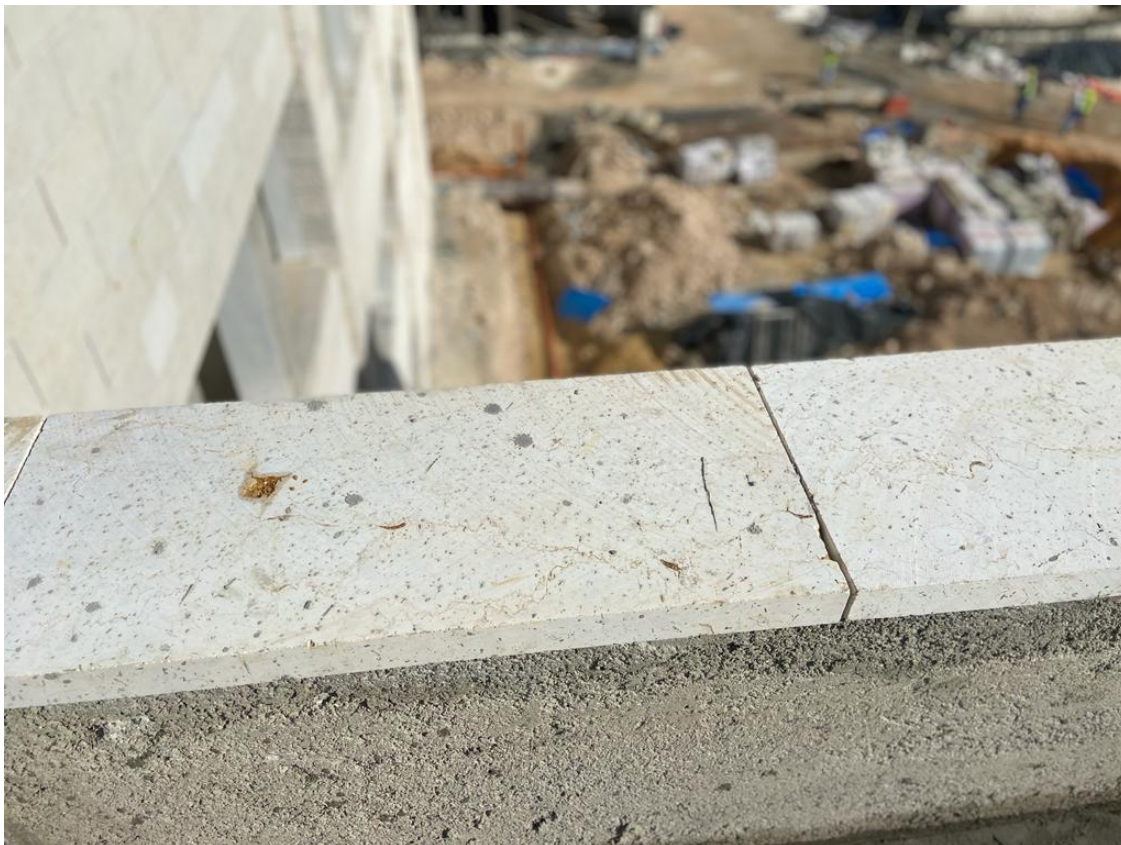
(Figure: 10)

The level of executed coping pieces is not consistent
The thickness of the coping is not unified for all pieces

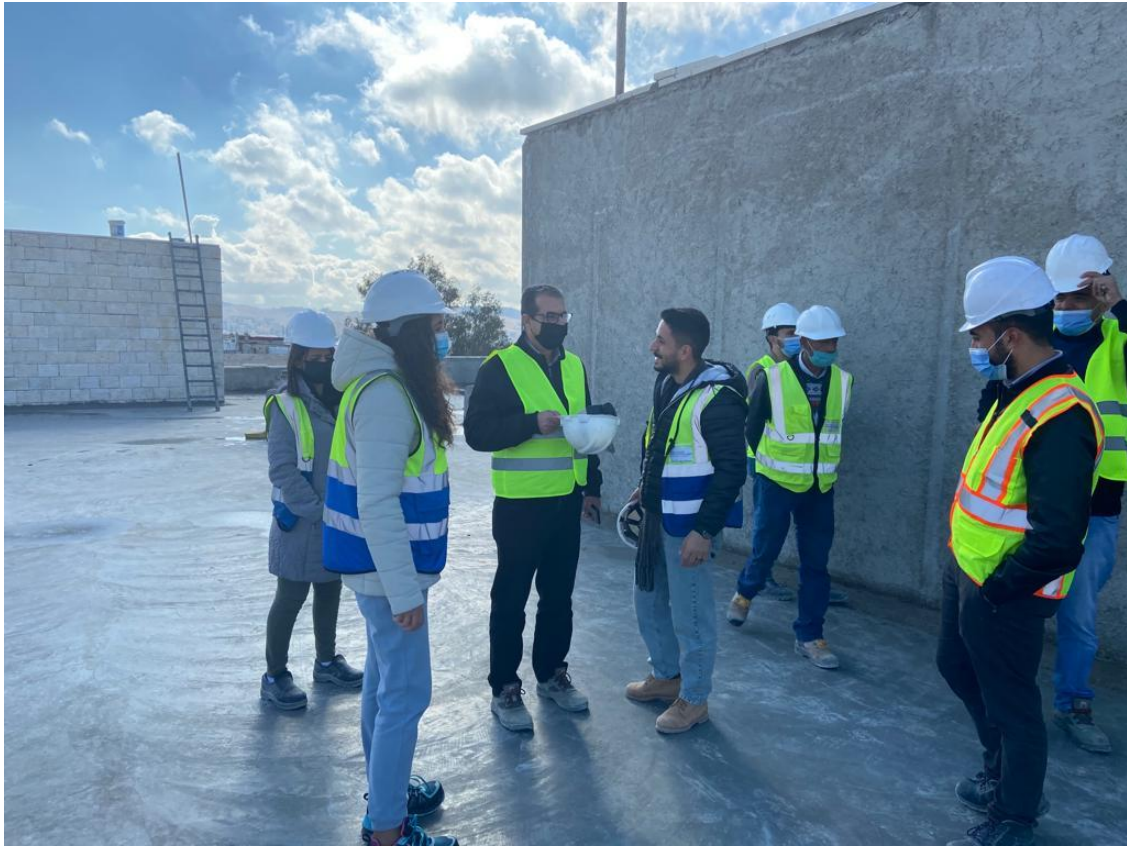
(Figure: 11)

The supervision team inspected the works at the roof:

Screed layer execution and concrete bases for mechanical equipment. The Contactor was instructed to raise the level of water tanks' bases since the current level is low as a result of executing the layers of insulation for the roof

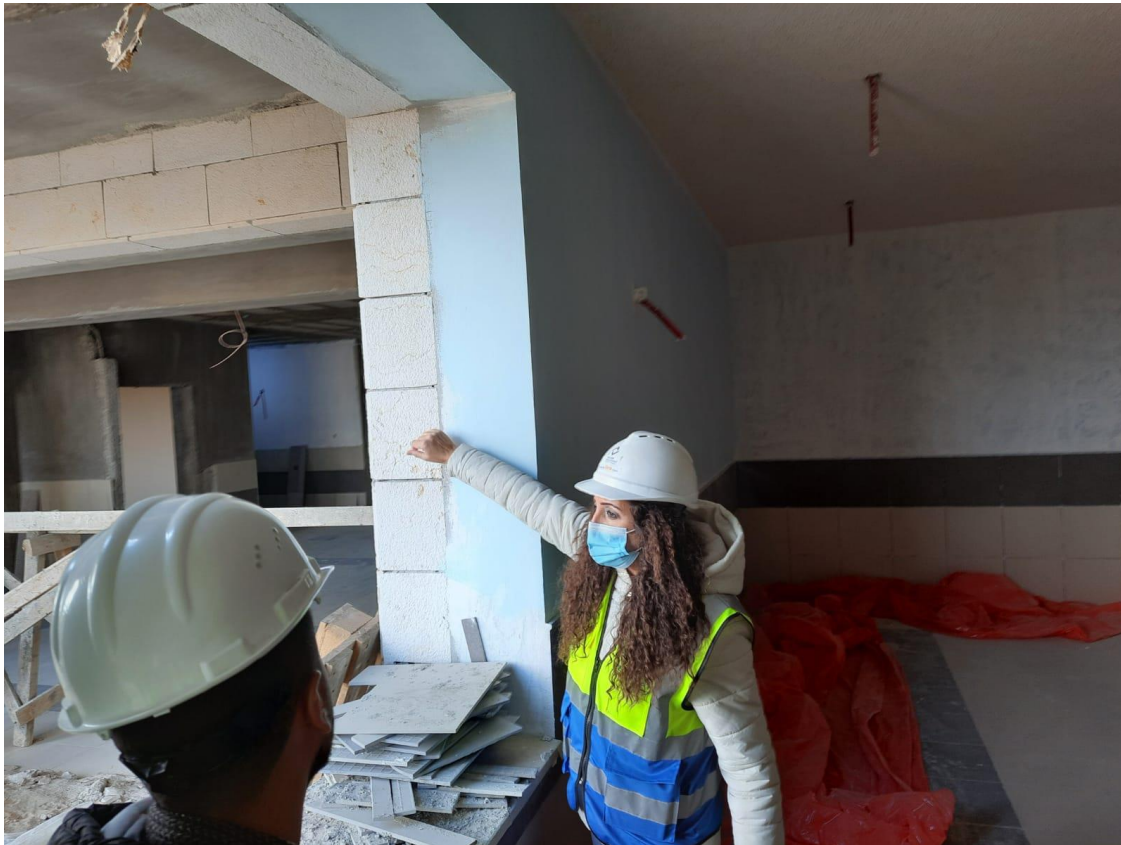
(Figure: 13)

The teams pointed out that the window jambs are rejected since they have defects and voids

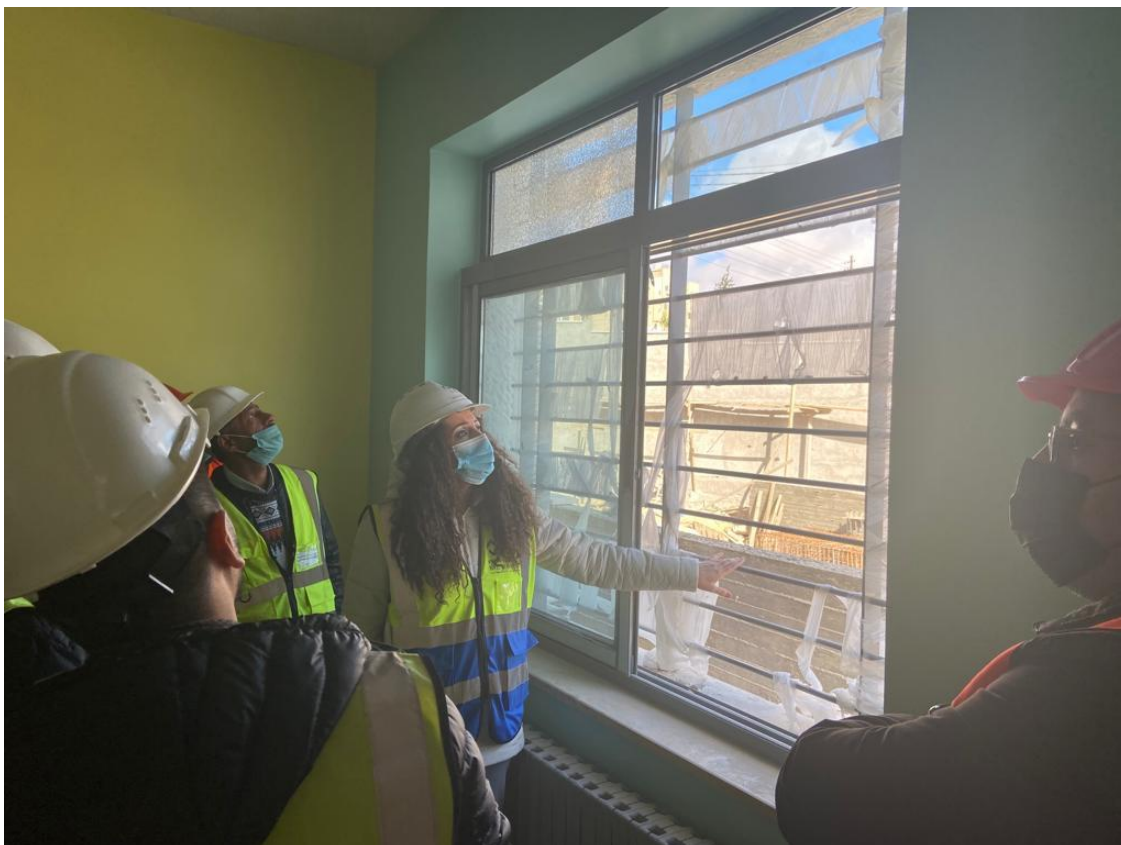
(Figure: 14)

The team inspected the installed aluminum window and steel protection screen at the mock-up room

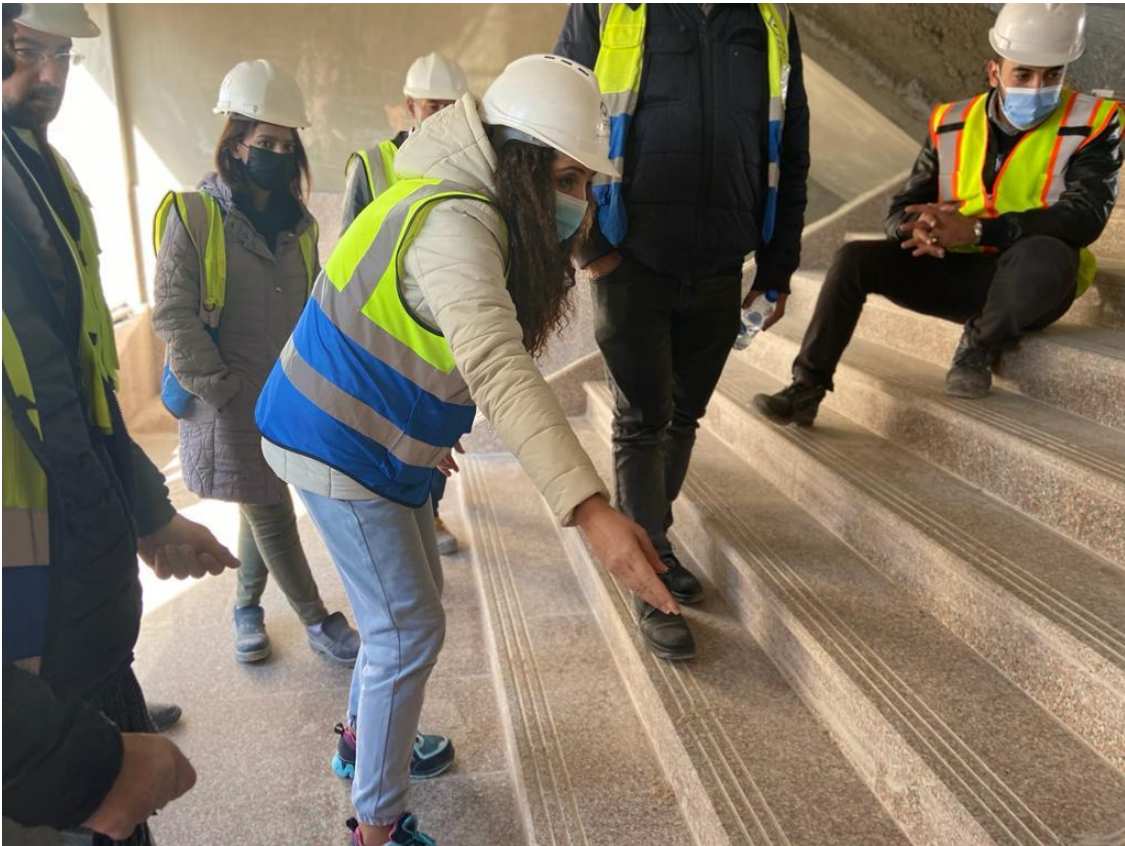
(Figure: 15)

The team observed that the granite pieces for staircases (wall granite and skirting) has a major defect since the cutting off to the required size is not done properly. The way of cutting should be factory made result in sharp edge without any teething

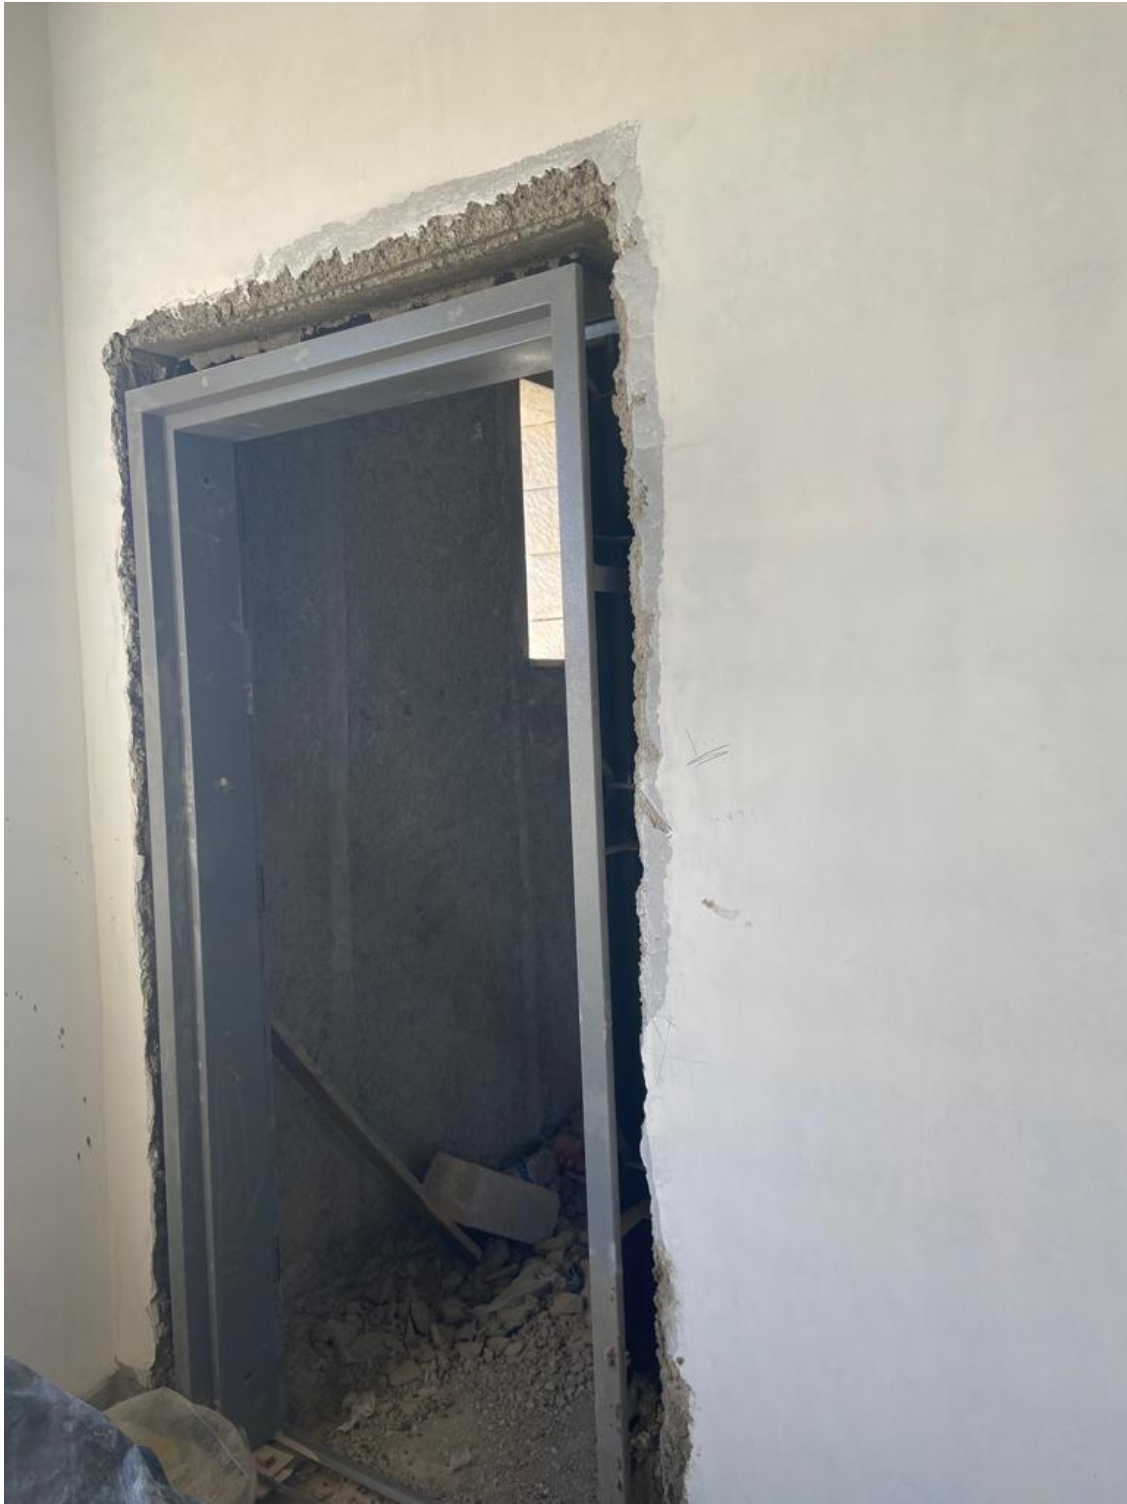
(Figure: 19)

The team observed that the Contractor delivered the remaining door frames completely

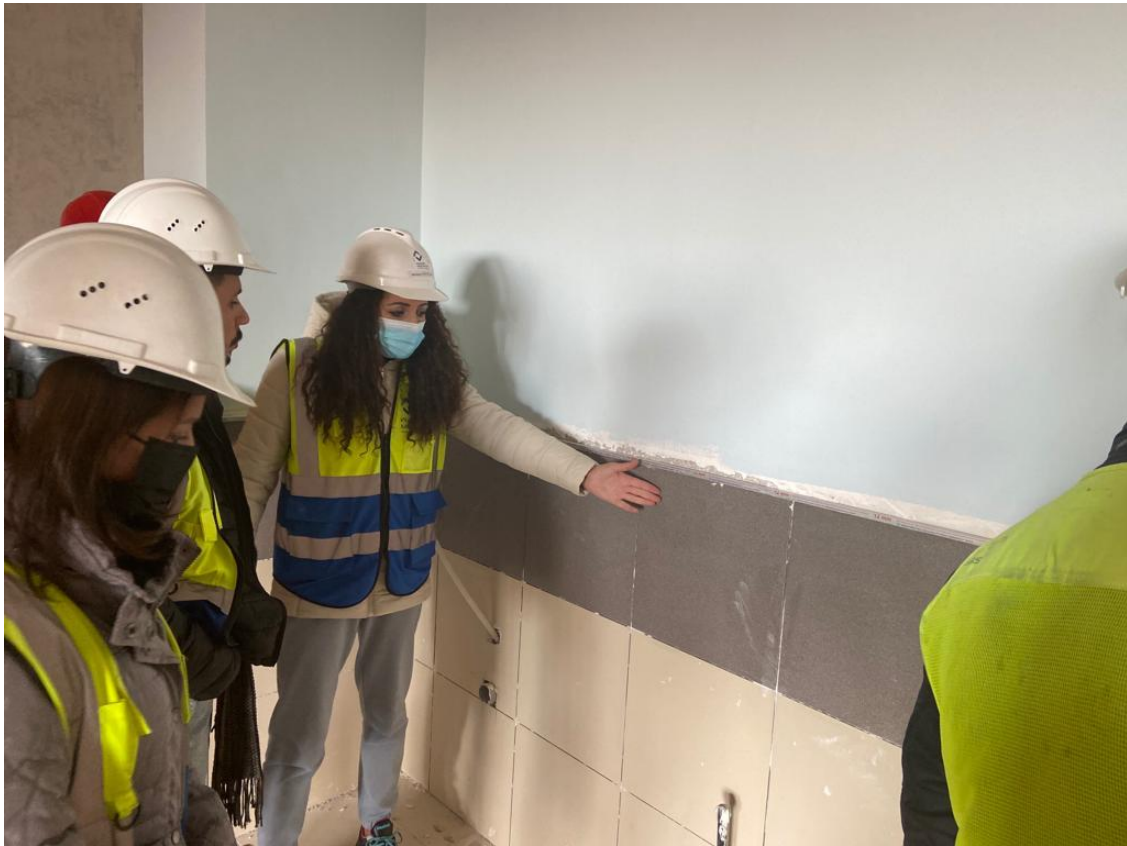
(Figure: 20)

The team inspected all the installed beads at the ends of tiled walls

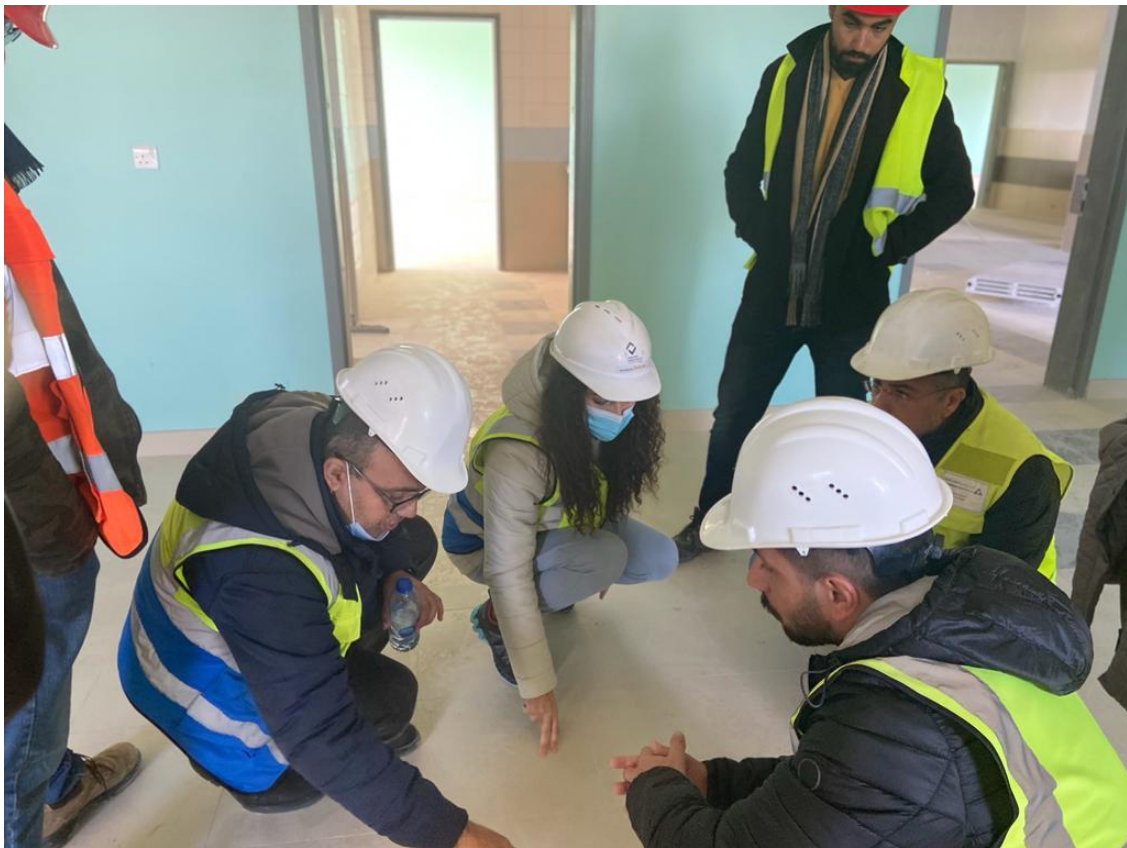
(Figure: 21)

The supervision team inspected the floor tiles at the mock-up room after the Contractor conducted rectification work by replacing number of defected tiles. The team observed that the defects (teething and uneven face) in general still remain
