FTR # QR 410

Construction Management of the Jordan School Expansion Project (JSEP) and the Schools for a Knowledge Economy Project (SKEP)

Site Visit Report Form

School Name: Supervisory Engineer (SE) Name: Construction Contractor (CC) Name: Date and Time of Field Trip: Date of Report: Weather During Visit: Prepared By: Submitted By: SKEP PHASE: III PACKAGE: I Um Al Dananir Basic Mixed School Wahib Medanat Consultant Engineers Derar Al Saraireh & Sons for Engineering & Contracting June 15, 2021 9:30 AM June 17, 2021 Sunny 24 ° Talid Hamdan CMTO/Trigon Osama Obeid CMTO/Trigon

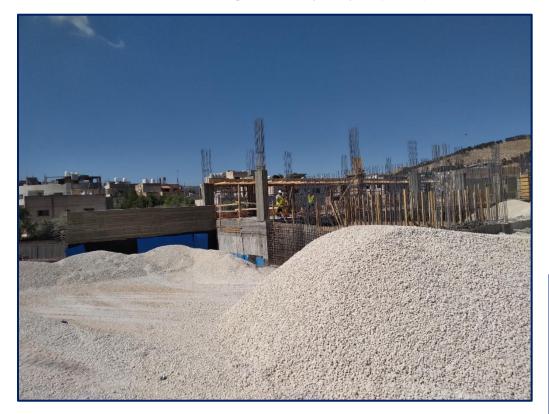
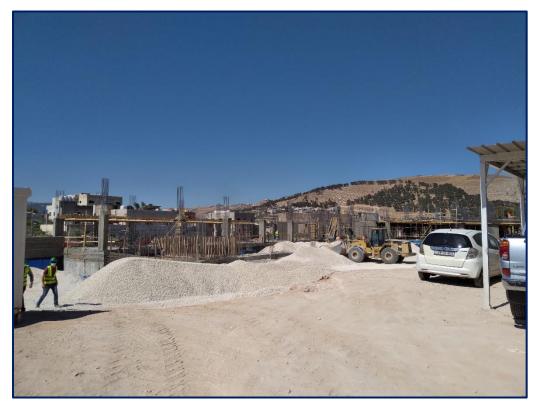
FIGURE #02& 03:

The project consists of five floors building, with a total approximate area of 5420 sq.m, in addition to site works. The project will contain a KG on the ground floor, a playground, an exercise area and a basketball court.

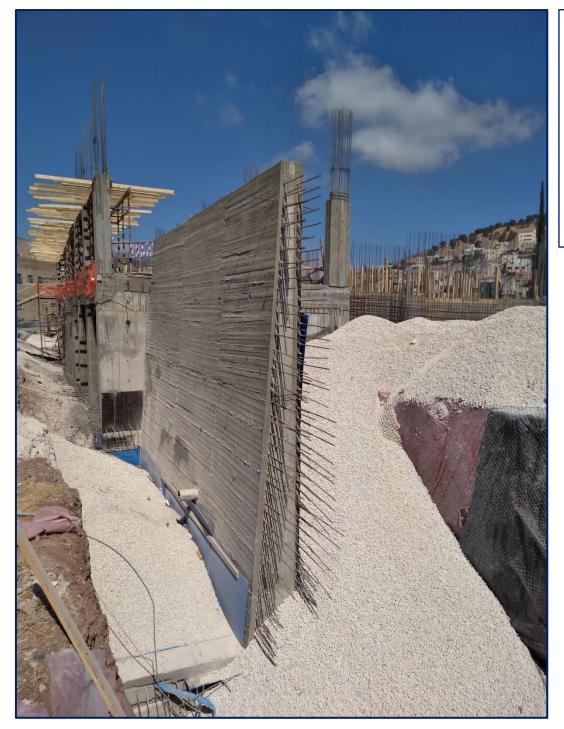
FIGURE #04:

Reinforcement works for the boundary wall are ongoing. The concrete used for the boundary wall is as per specification. Backfilling (single size) works are ongoing.

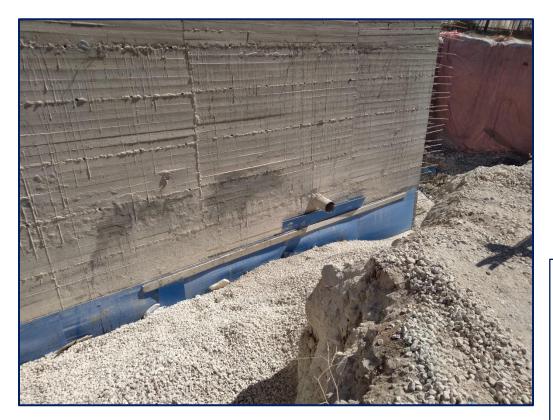
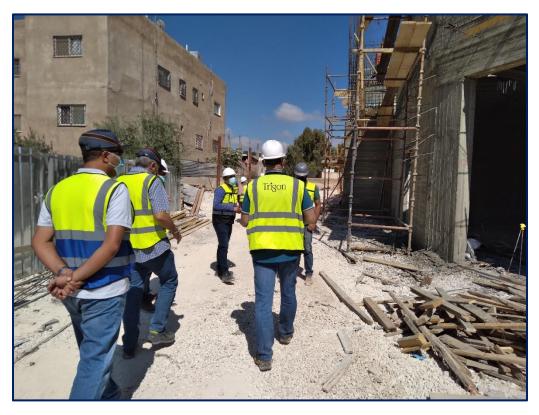
FIGURE #05& 06:

- The quality of the casted concrete is as per specification. Only a small spot of segregation has been noticed. It is recommended to treat that spot.
- The cartonal sheets are fixed using small pieces of wood. It is recommended to properly fixate the sheets.

The cartonal sheets are fixed using small pieces of wood. It is recommended to properly fixate the Cartonal sheets.

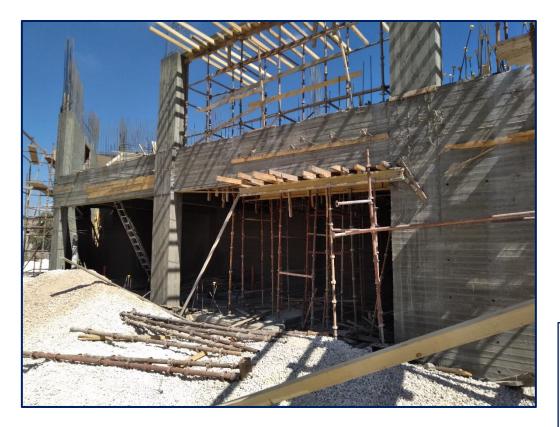
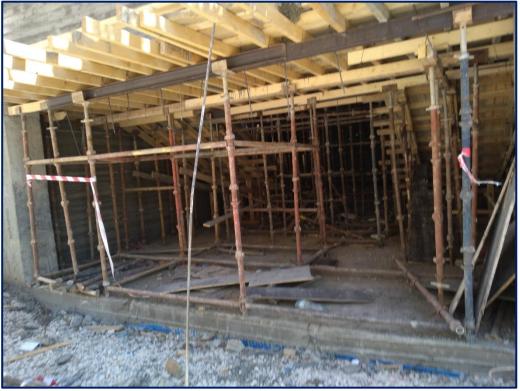
FIGURE #07& 08:

The erected formwork is done as per specification. It is perpendicular to the slab and inflexibly built without undue deflection.

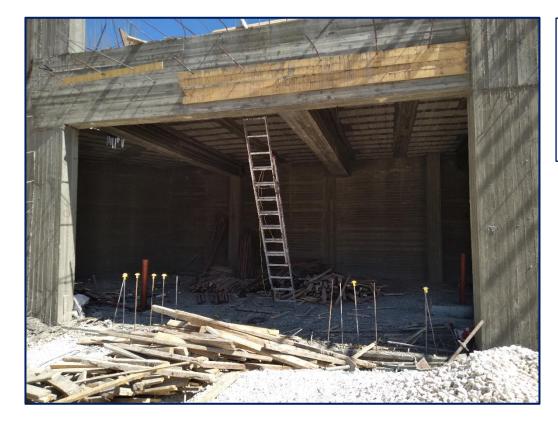
FIGURE #09:

De-shuttering works are ongoing.

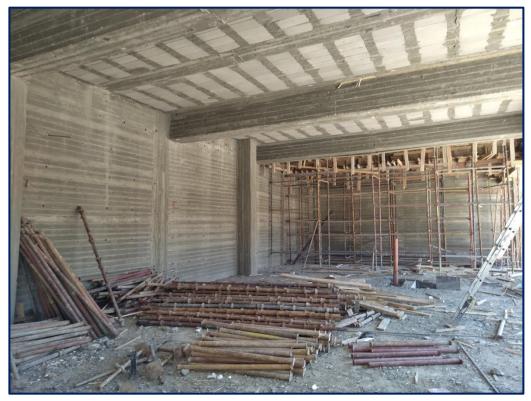
FIGURE #10:

It is recommended to use polystyrene while working with conduits to avoid chipping in concrete that would damage the work.

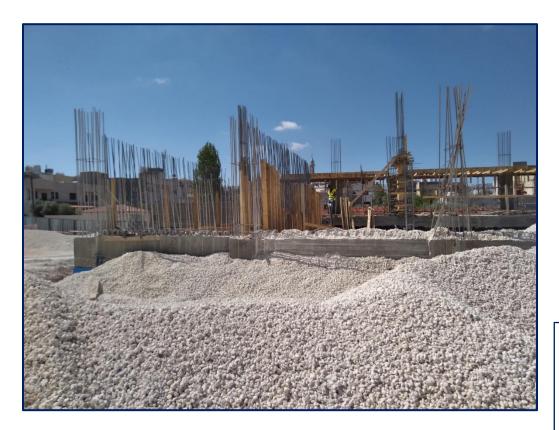
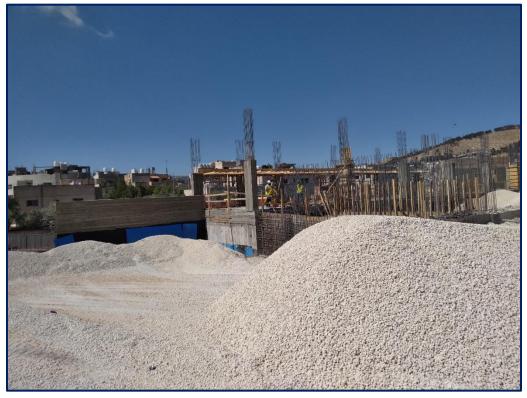
FIGURE #11& 12:

Reinforcement works for GF slab in zone A.

Backfilling works are ongoing.

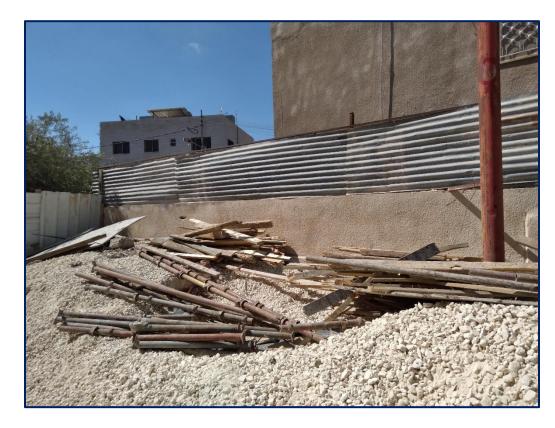
FIGURE #13:

- I. <u>Water Supply</u>: Not connected yet
- 2. Wastewater: Not connected yet
- 3. <u>Electricity</u>: Not connected yet
- 4. Other Issue: Neighbor wall encroachment towards the school boundary plot. Existing street encroachment towards the school land and this will affect the construction of the eastern boundary wall, guard room, R/F concrete water tank, transformer's room and parking lot). According to Municipality organizational site plan, there is an existing street. There is contradiction between the municipality site plan and project site plan must be resolved, the MoE and the MPWH will agree on the best solutions for the issues and send them to USAID for their approval.

Neighboring wall issue is still ongoing, the MoE and the MPWH will agree on the best solution for the issue and send it to USAID for their approval.

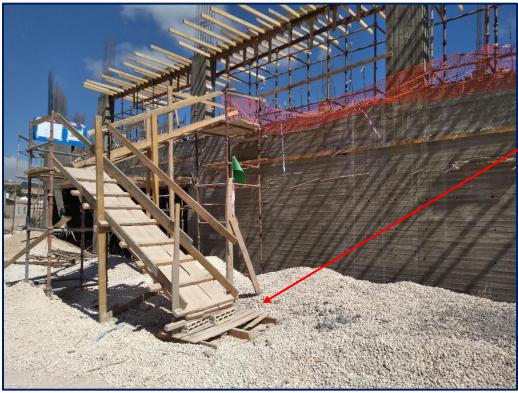
FIGURE #14:

- Site gate is well secured.
- Proper scaffolding. However, the lower part should be rebuilt in accordance with safety standards.
- Poor housekeeping at site, a NCR has been sent regarding the matter. construction materials are exposed to external factors and leftover materials should be properly disposed of.
- Health and safety signs were used at site.

The lower part of Scaffolding must be rebuilt in accordance with safety standards.

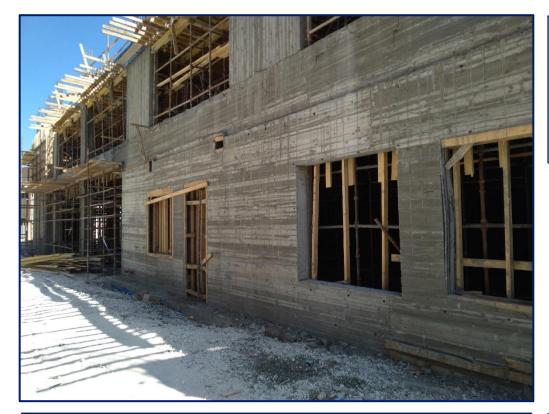
FIGURE #15:

Concrete quality is done as per specification.

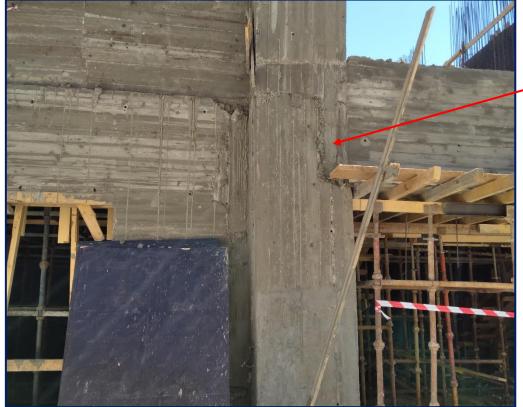
FIGURE #16:

Only a small spot of segregation was noticed during the site tour. It is recommended to treat the segregation before further works.

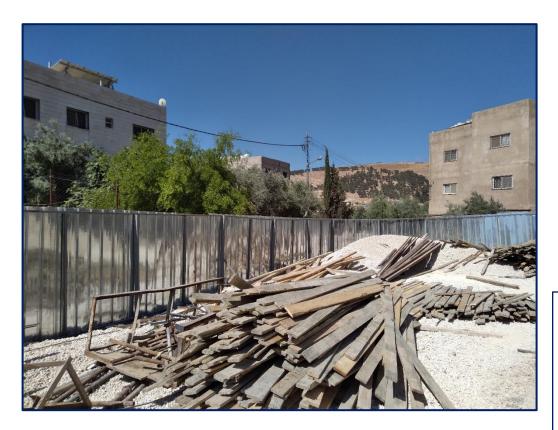
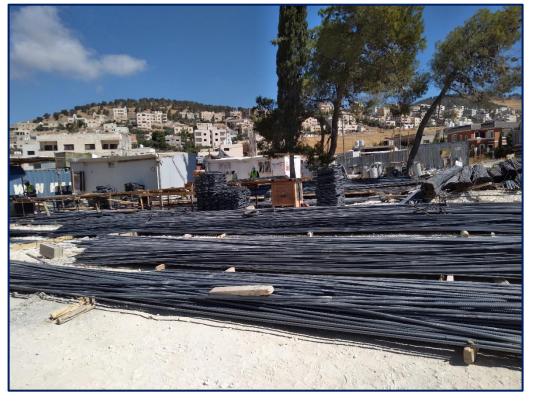
FIGURE #17& 18:

Poor housekeeping at site, a NCR has been sent regarding the matter. construction materials are exposed to external factors and leftover materials should be properly disposed of.
