SKEP III Home Office Support Site Visit Report

Consultant	Wahib Medanat Consultant Engineer	Rep No.	23-210872021
Contractor	Dijlah Establishment Constr. Contracting	Tender No.	(11/2019/USAID/SKEP/3/S) Schools for a Knowledge Economy Project (SKEP) - Phase (3) Package (1, 2)
Site Name	Jumana Bint Abit Taleb Basic Mixed School - Jerash	Day/ Date	Sat. 21/08/2021
Duration of Project	450 Calendar Days	Total Project Budget	8,314,983.735 JD

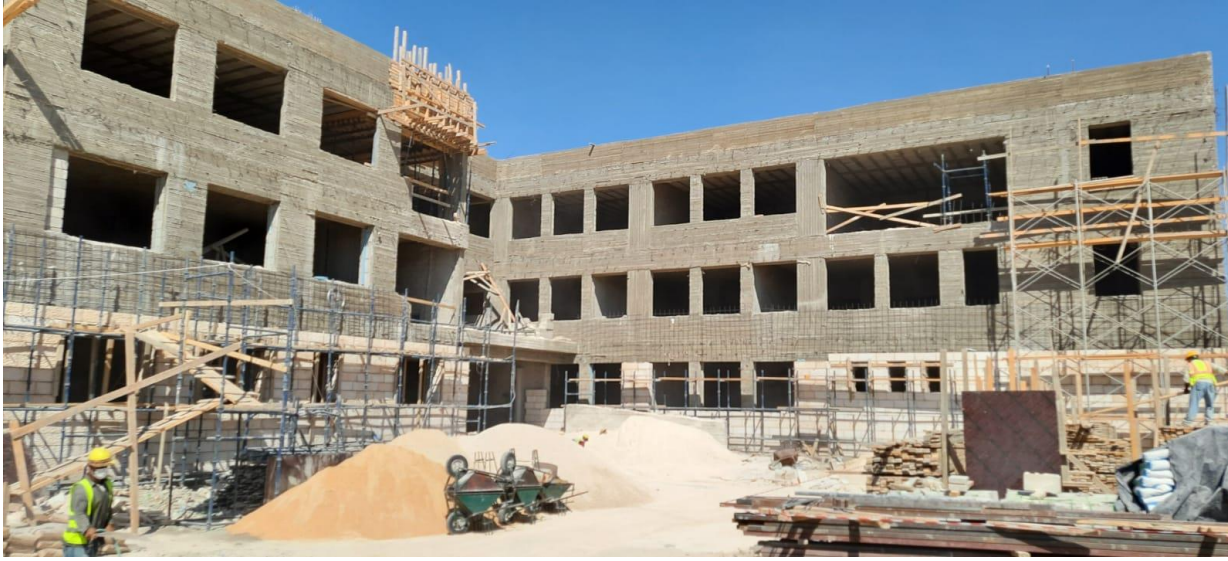
(Figure: 01)

General view of the completed roof floor casting (the last slab)

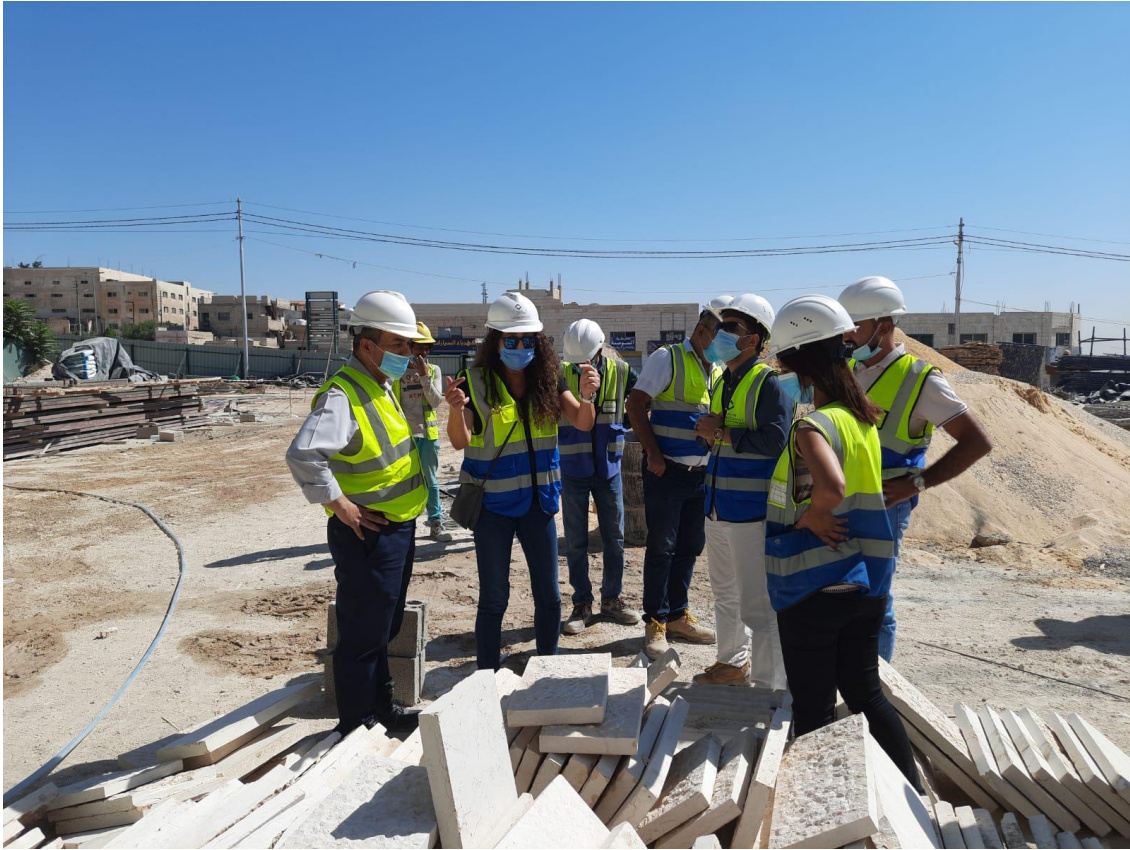
(Figure: 03)

The delivered stones to the site and the built stones as well were checked and the Consultant stressed on the compliance of stones to the approved samples

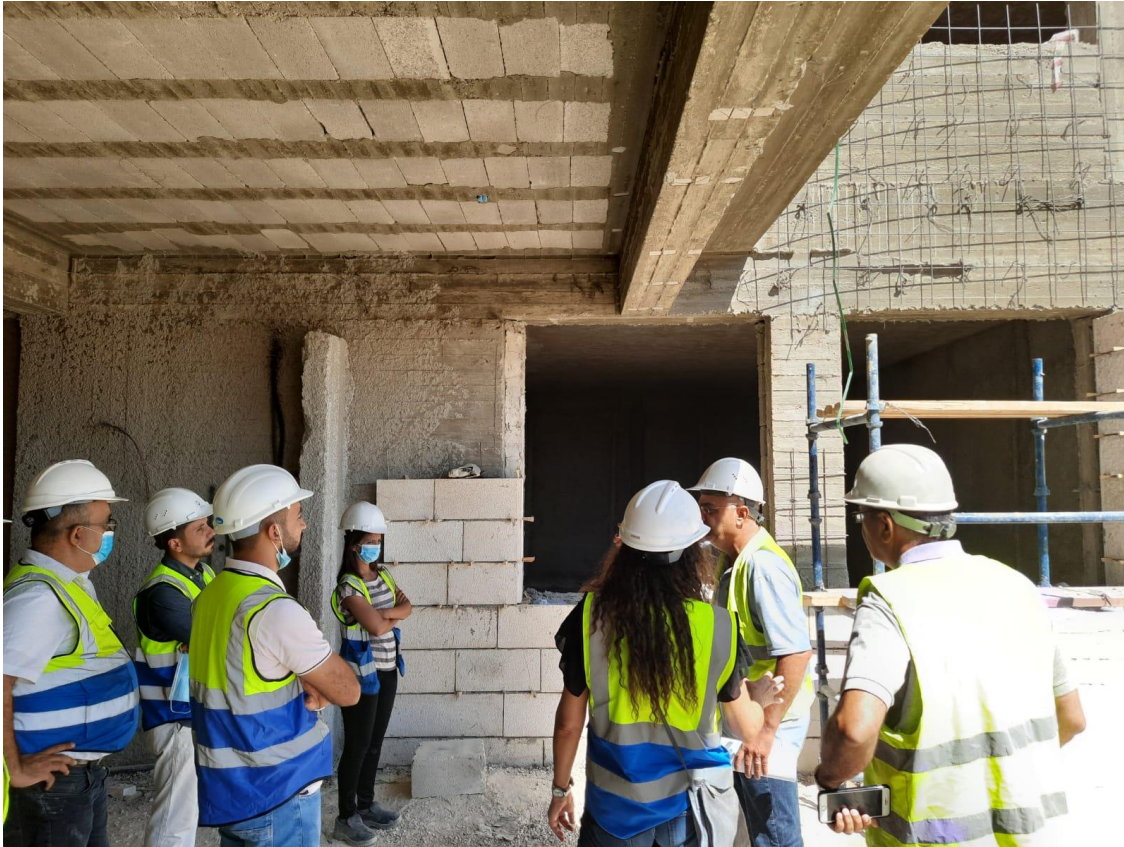
(Figure: 05)

Number of stones were observed at the main entrance to be not complying and the Contractor was requested to replace them in the presence of the stone supplier

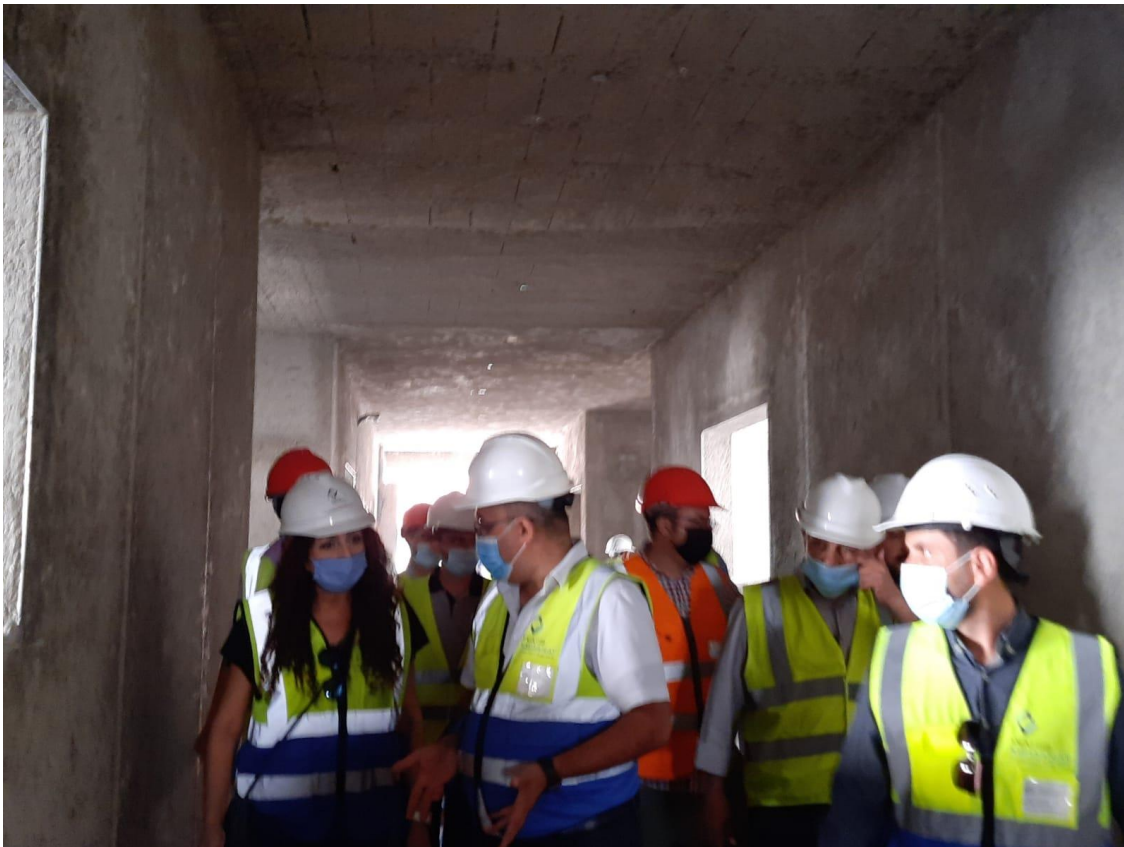
(Figure: 06)

The quality of concrete work, block work and plastering is acceptable in general

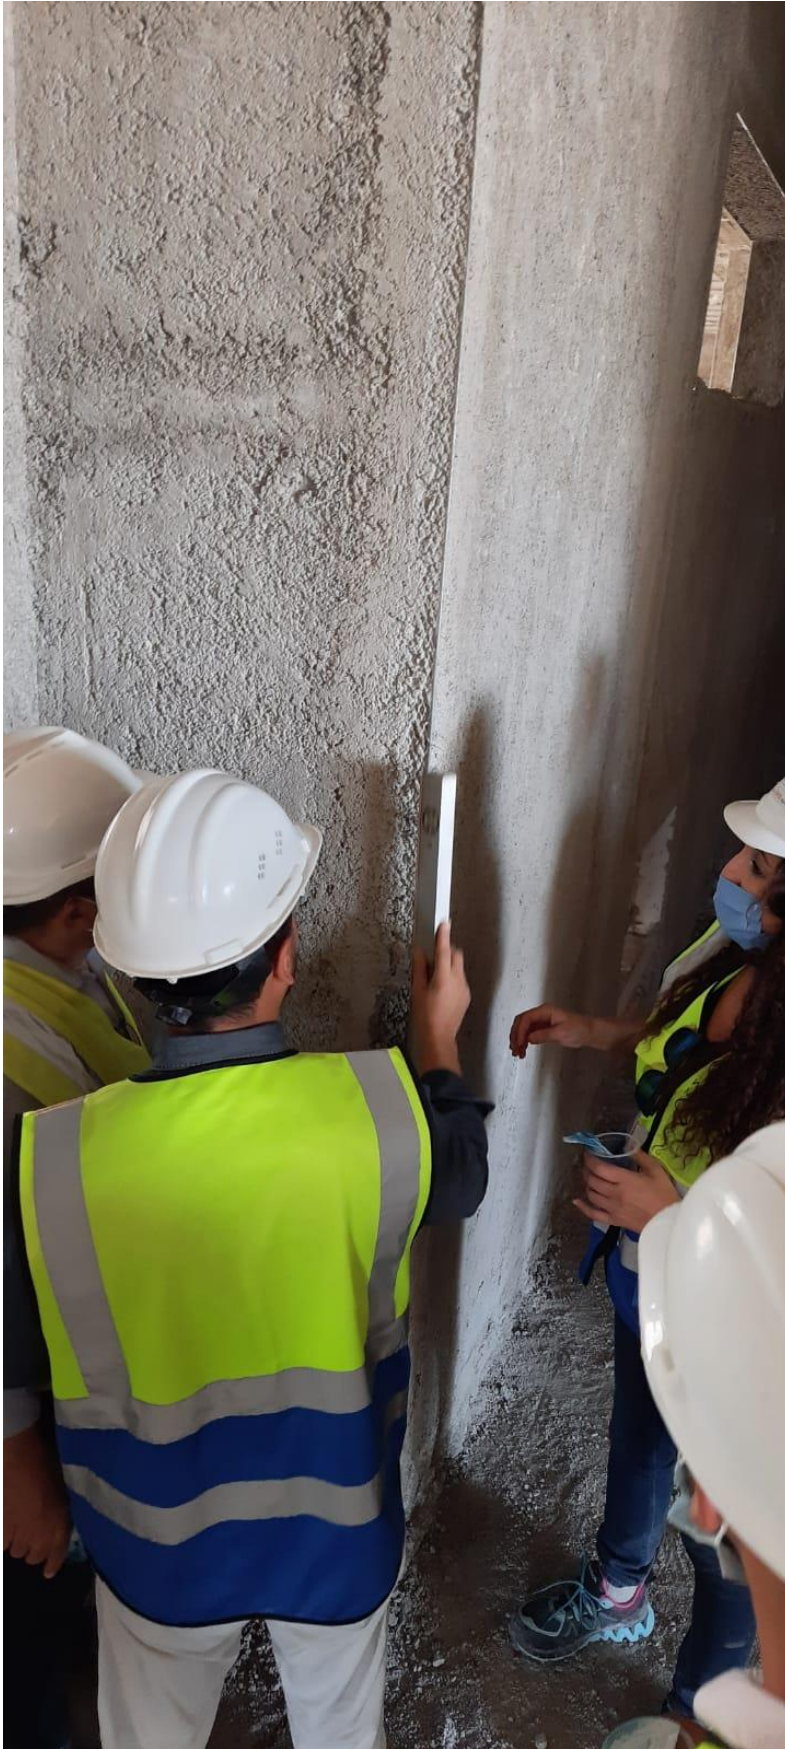
(Figure: 07)

Checking the verticality of the plaster Bead

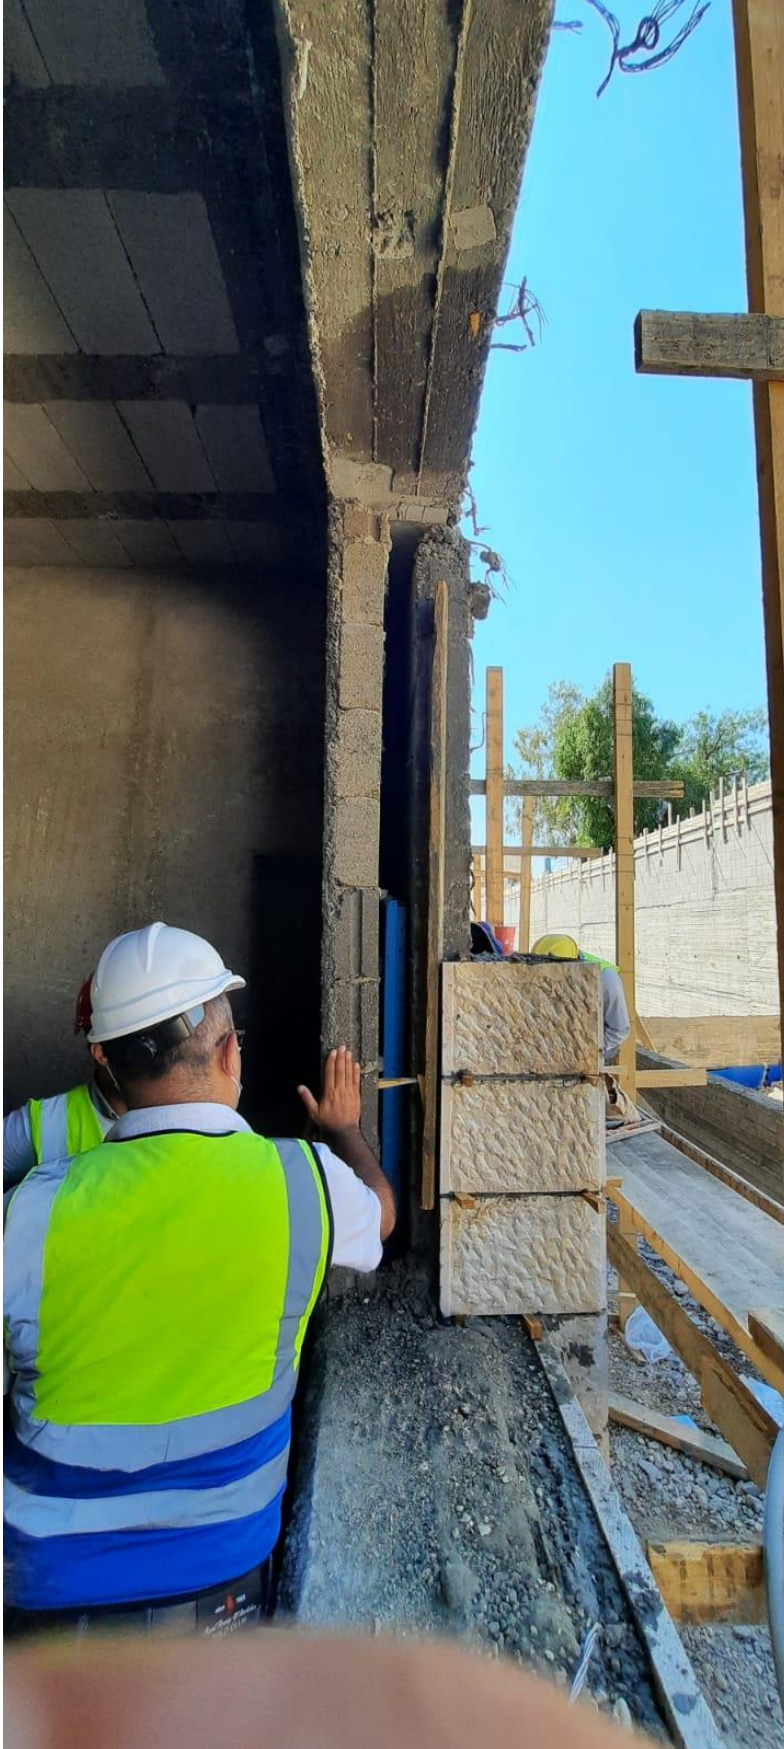
(Figure: 08)

Eng Natheer explaining the correct way to execute window jambs formwork

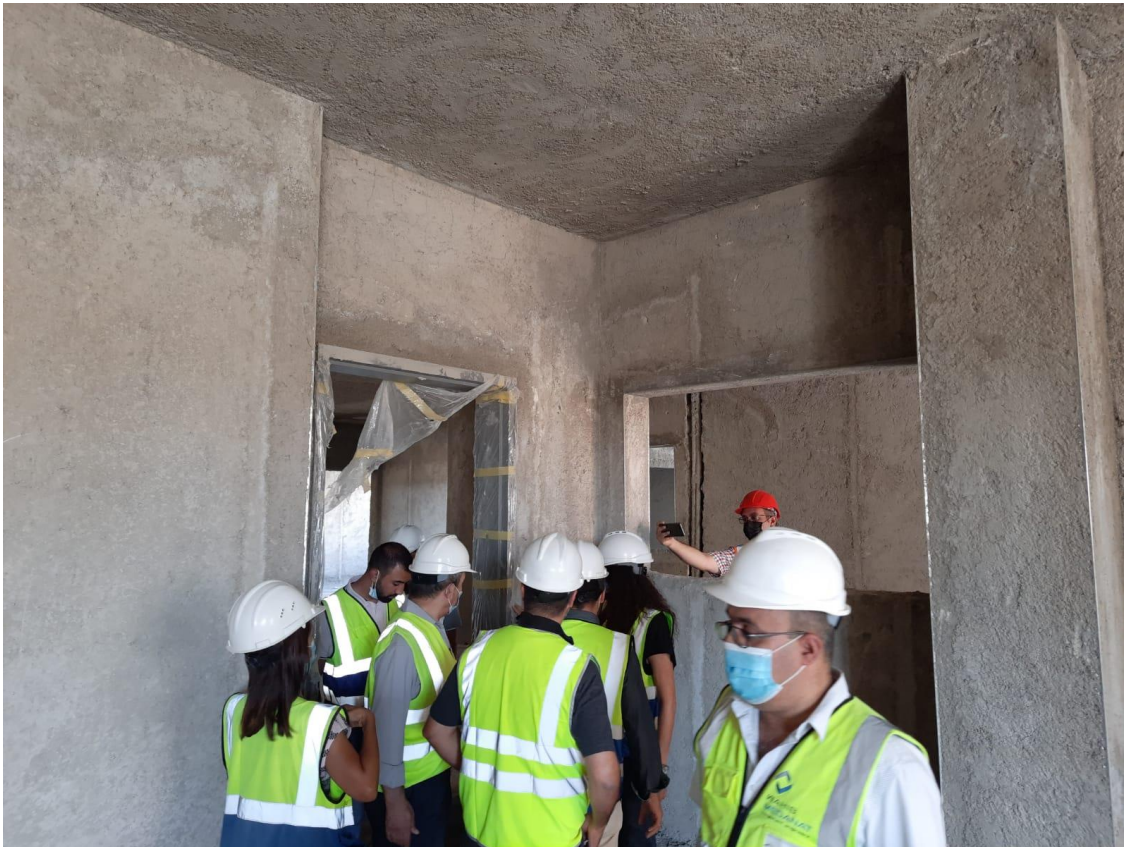
(Figure: 09)

work in the mock-up rooms was inspected including door frames, radiators first fix and cisterns

Eng. Natheer advised the Contractor on the right method of installation and stressed on following the architectural workshop drawing

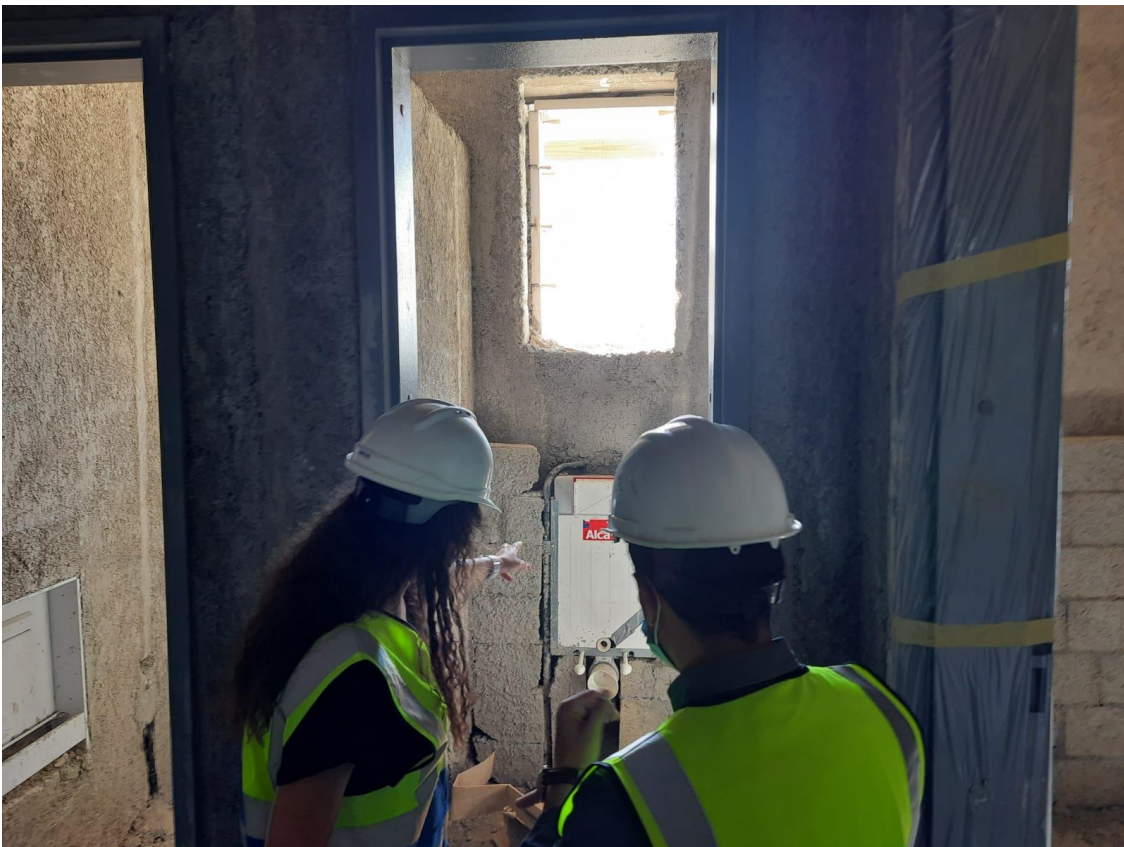
(Figure: 10)

Installation of Concealed Cistern

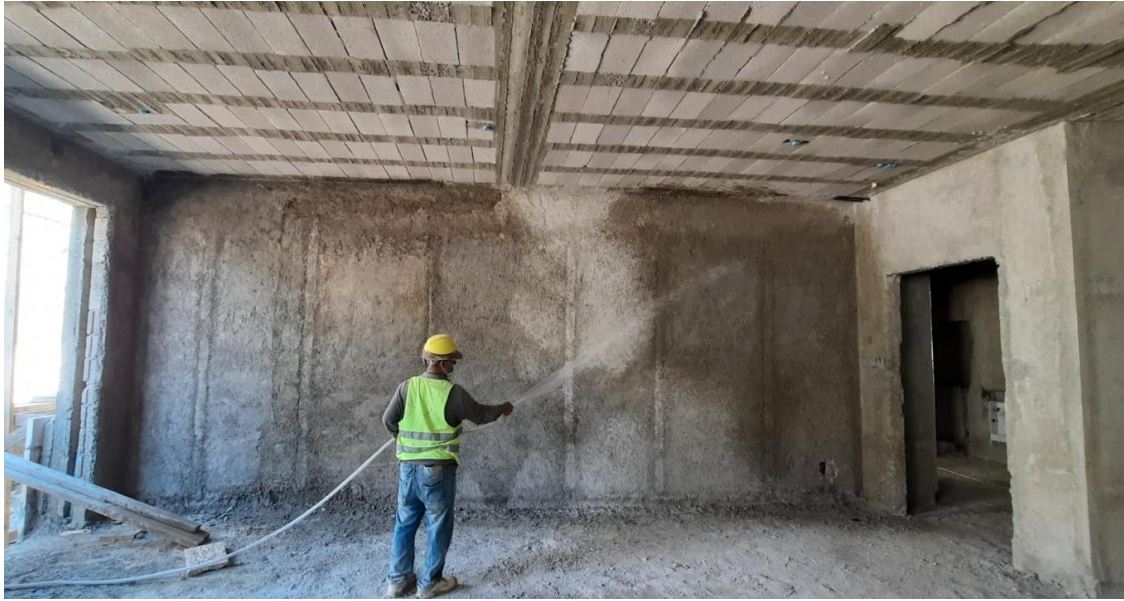
(Figure: 11)

Plastering
work
curing

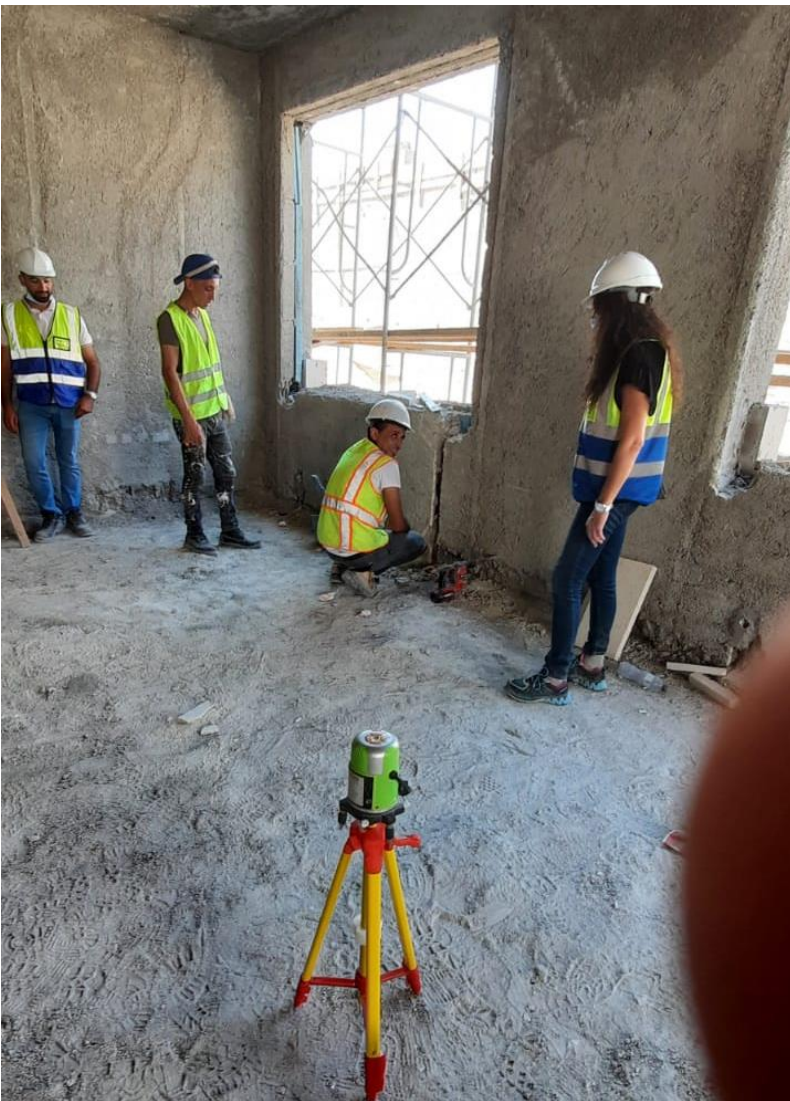
(Figure: 12)

First fix works
for radiators
(bottom-
bottom)

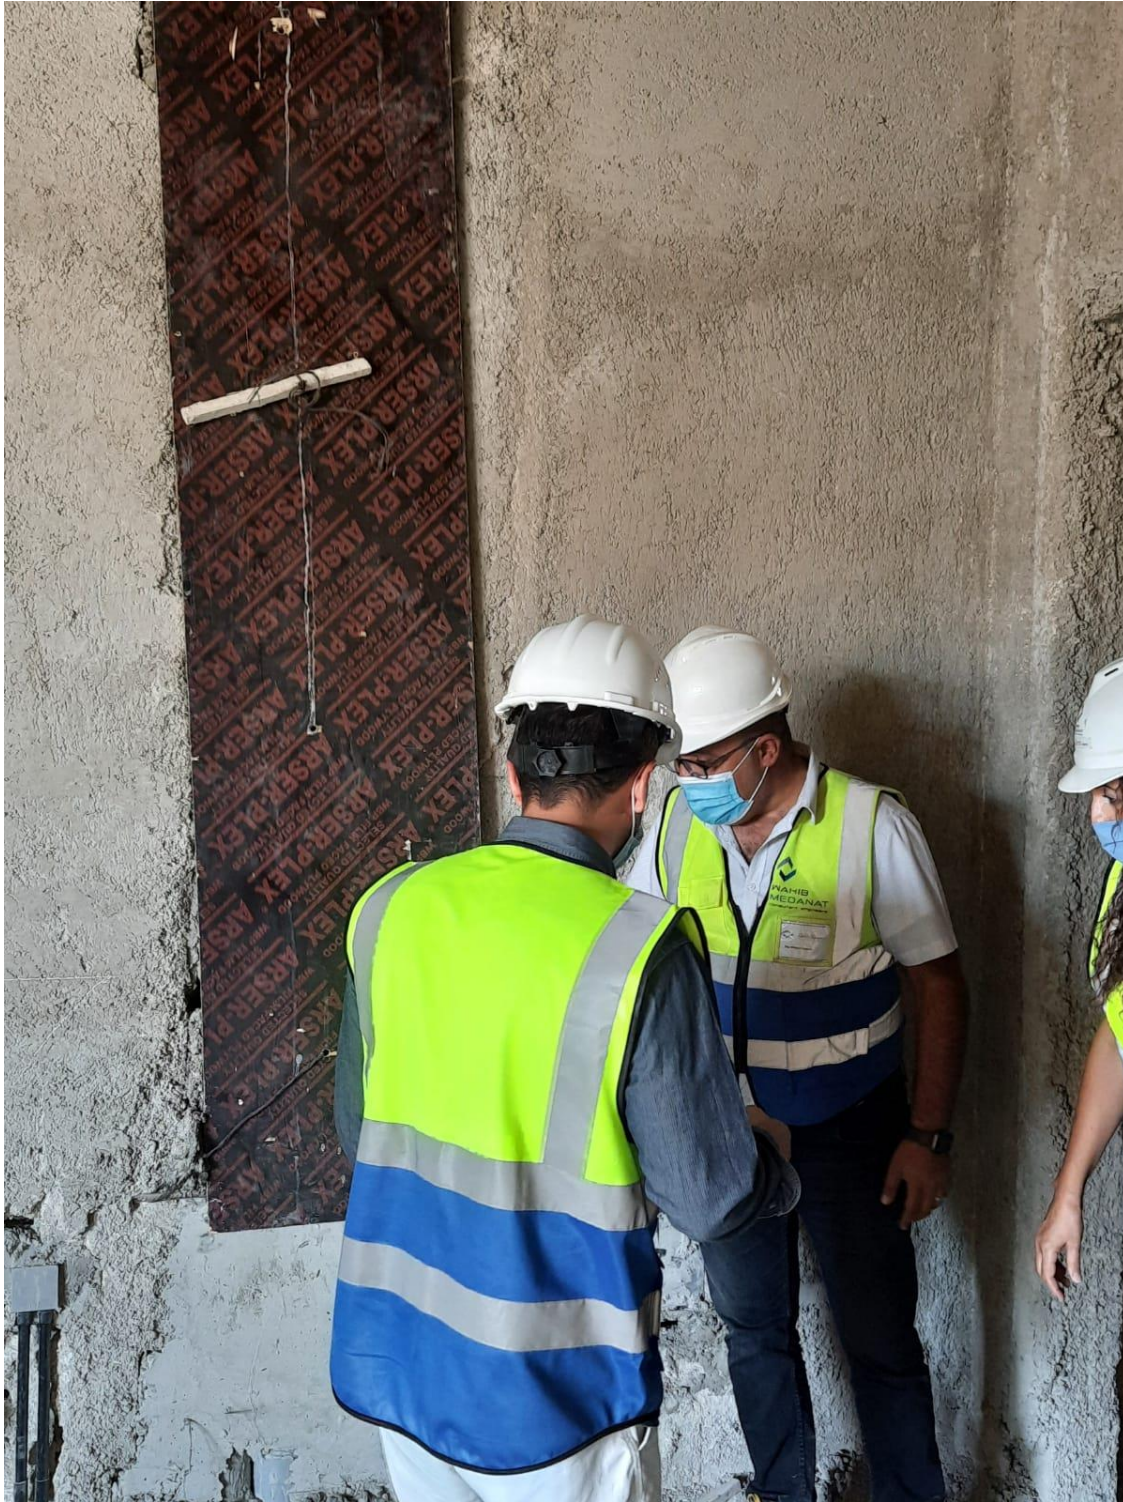
(Figure: 13)

No.	Description
3	At the ground floor, a group of electrical pipes were observed at one wall and fair face casted. This concrete should be chipped, installing a plaster mesh and continue work.
4	The relationship between stone and blockwork at window jambs and the Consultant stressed on that both items should be at the same end.
5	After the site tour, a meeting was held at the site offices to discuss number of issued such as monthly payments, stone work and mock-up rooms. The Consultant stressed that he is concerned that the Contractor increased his progress and submit his invoices with enough amount to enable him to continue his work and avoiding stoppages.

At the ground floor, a group of electrical pipes were observed at one wall and fair face casted. This concrete should be chipped, installing a plaster mesh and continue work
