SKEP III Home Office Support Site Visit Report

Consultant	Wahib Medanat Consultant Engineer	Rep No.	22-15112021
Contractor	Dijlah Establishment Constr. Contracting	Tender No.	(11/2019/USAID/SKEP/3/S) Schools for a Knowledge Economy Project (SKEP) - Phase (3) Package (1, 2)
Site Name	Thahr Al Sarow Basic School for Boys- Jerash	Day/ Date	Mon. 15/11/2021
Duration of Project	450 Calendar Days	Total Project Budget	8,314,983.735 JD

Visit Notes

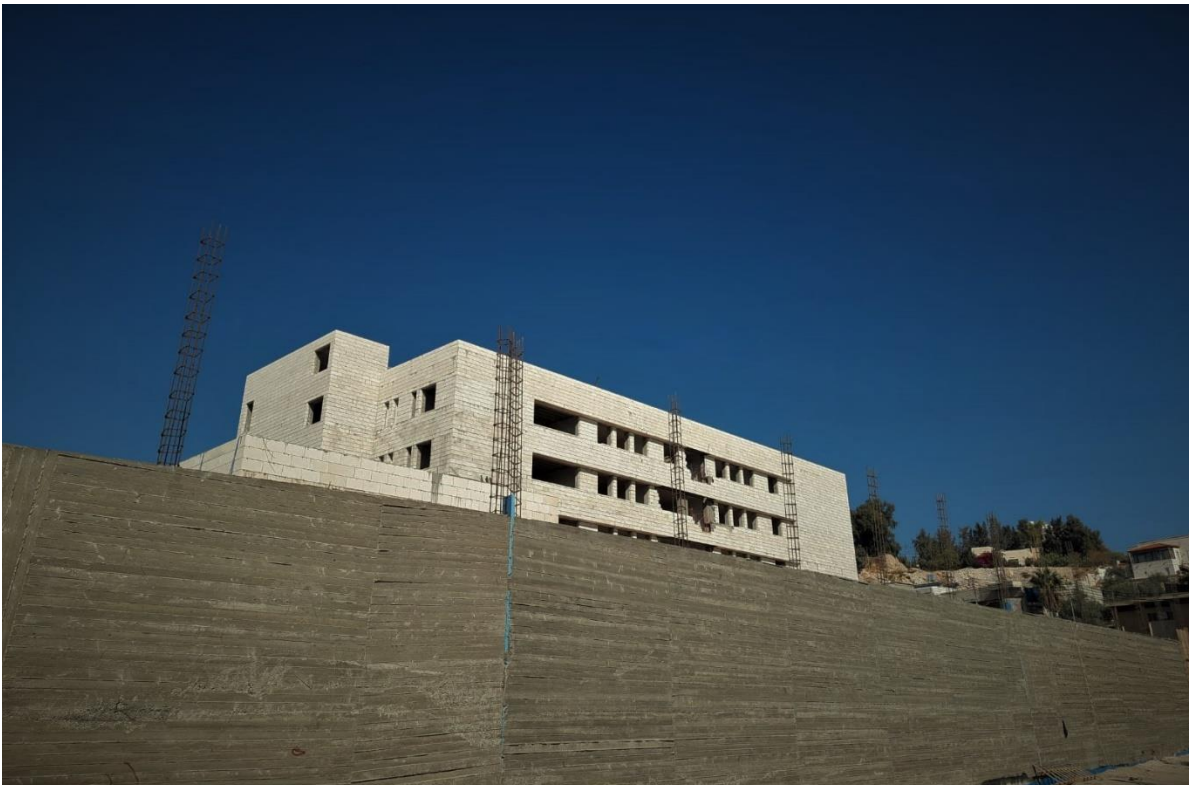
(Figure: 02)

After removing the electrical poles (previous obstacle) on 03/10/2021, the external works continued as shown

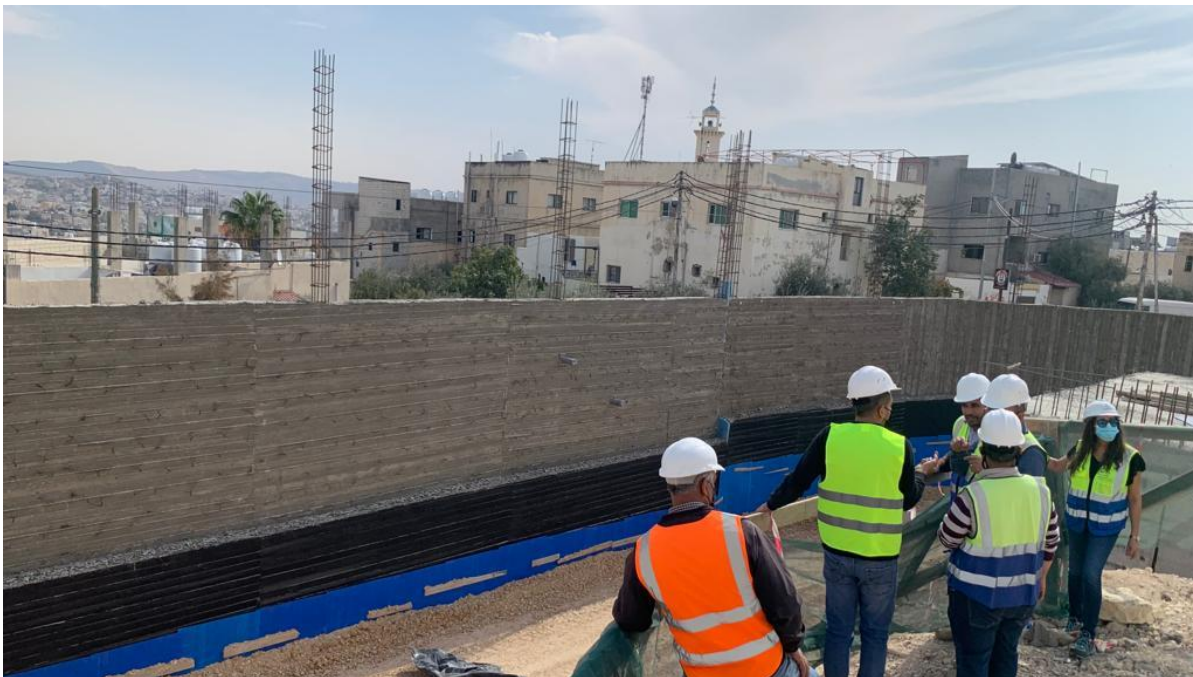
(Figure: 04)

The failure of concrete samples taken from one foot of the boundary walls has been discussed and confirmed a core test will be conducted by the "Royal Scientific Society"

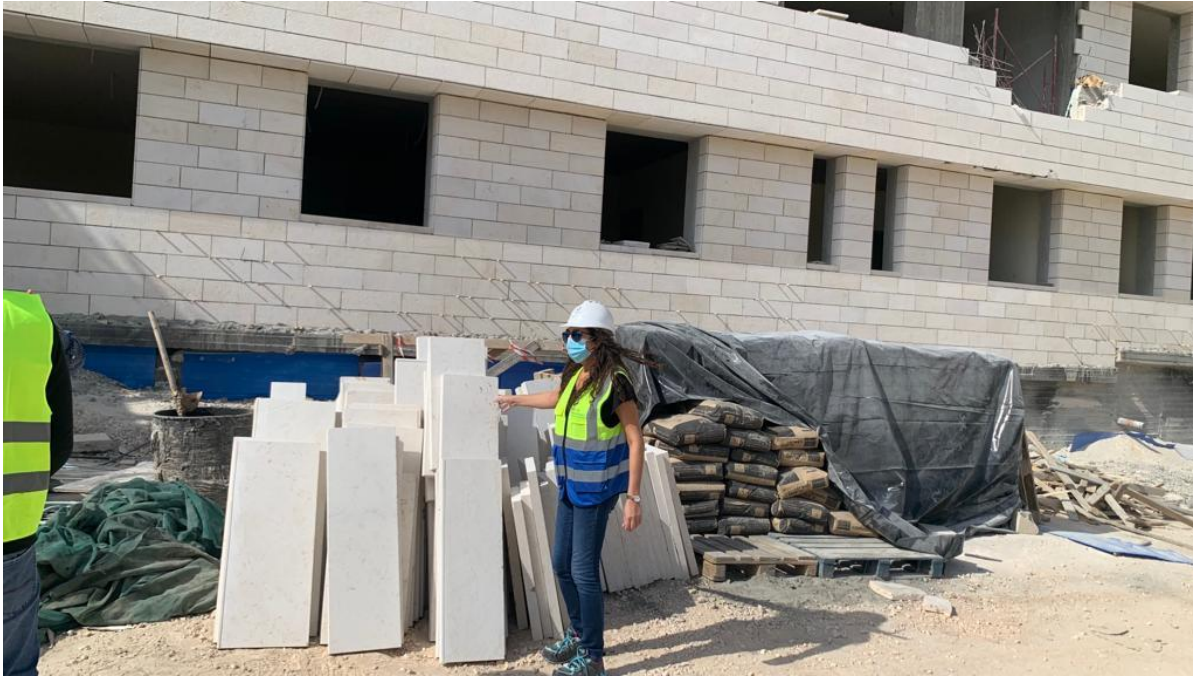
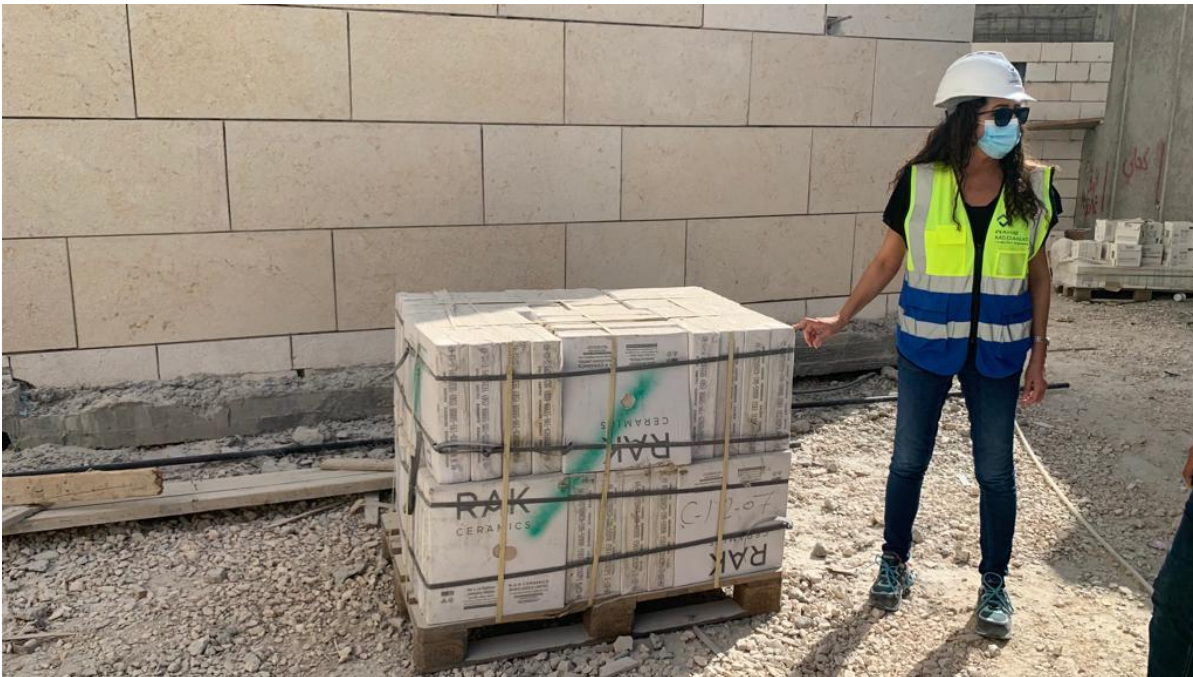
(Figure: 05 & 06)

Visual inspection has been conducted on the delivered quantities of floor tiles and Musaman stone

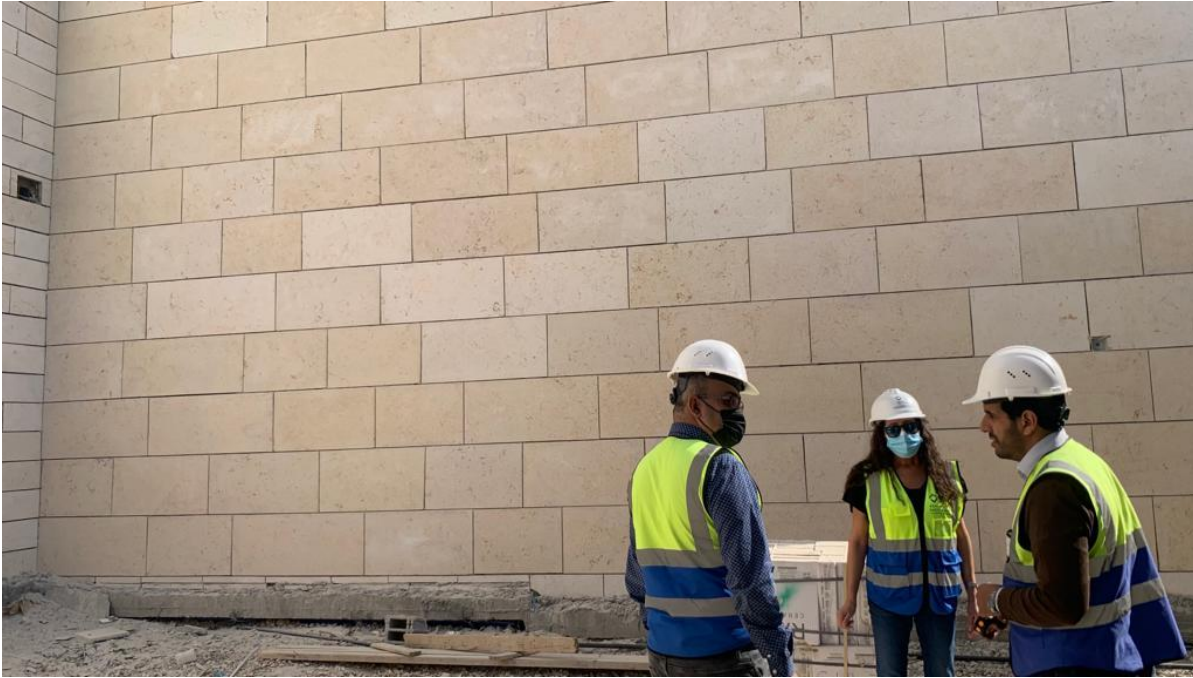
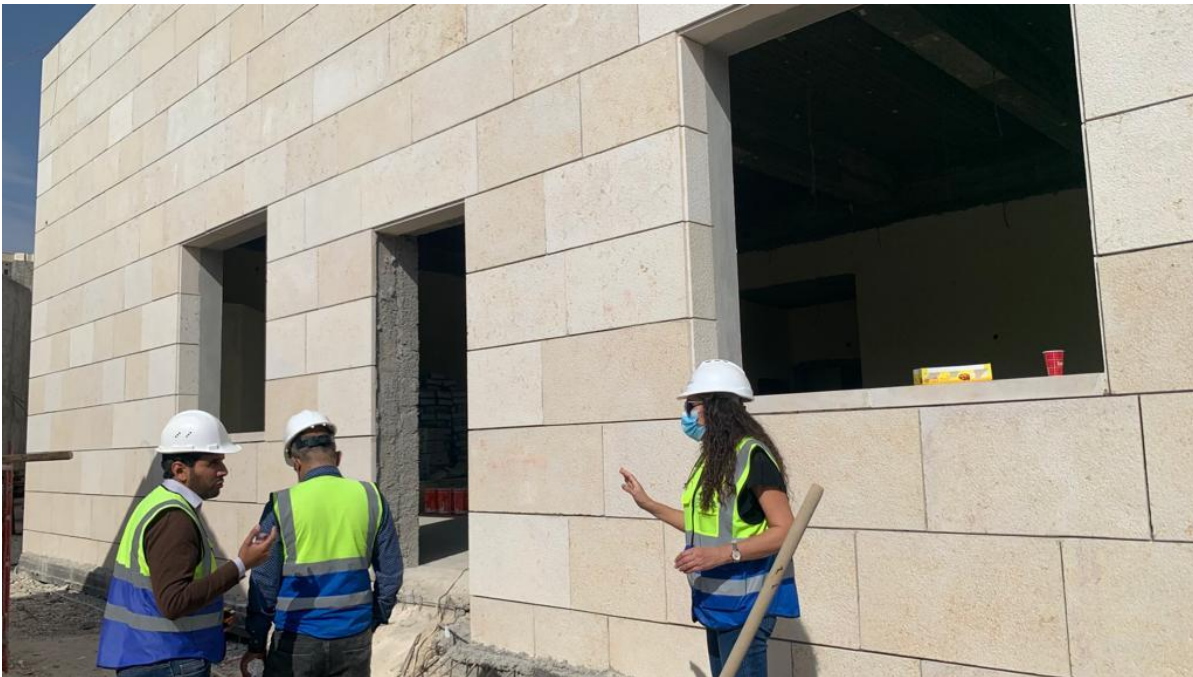
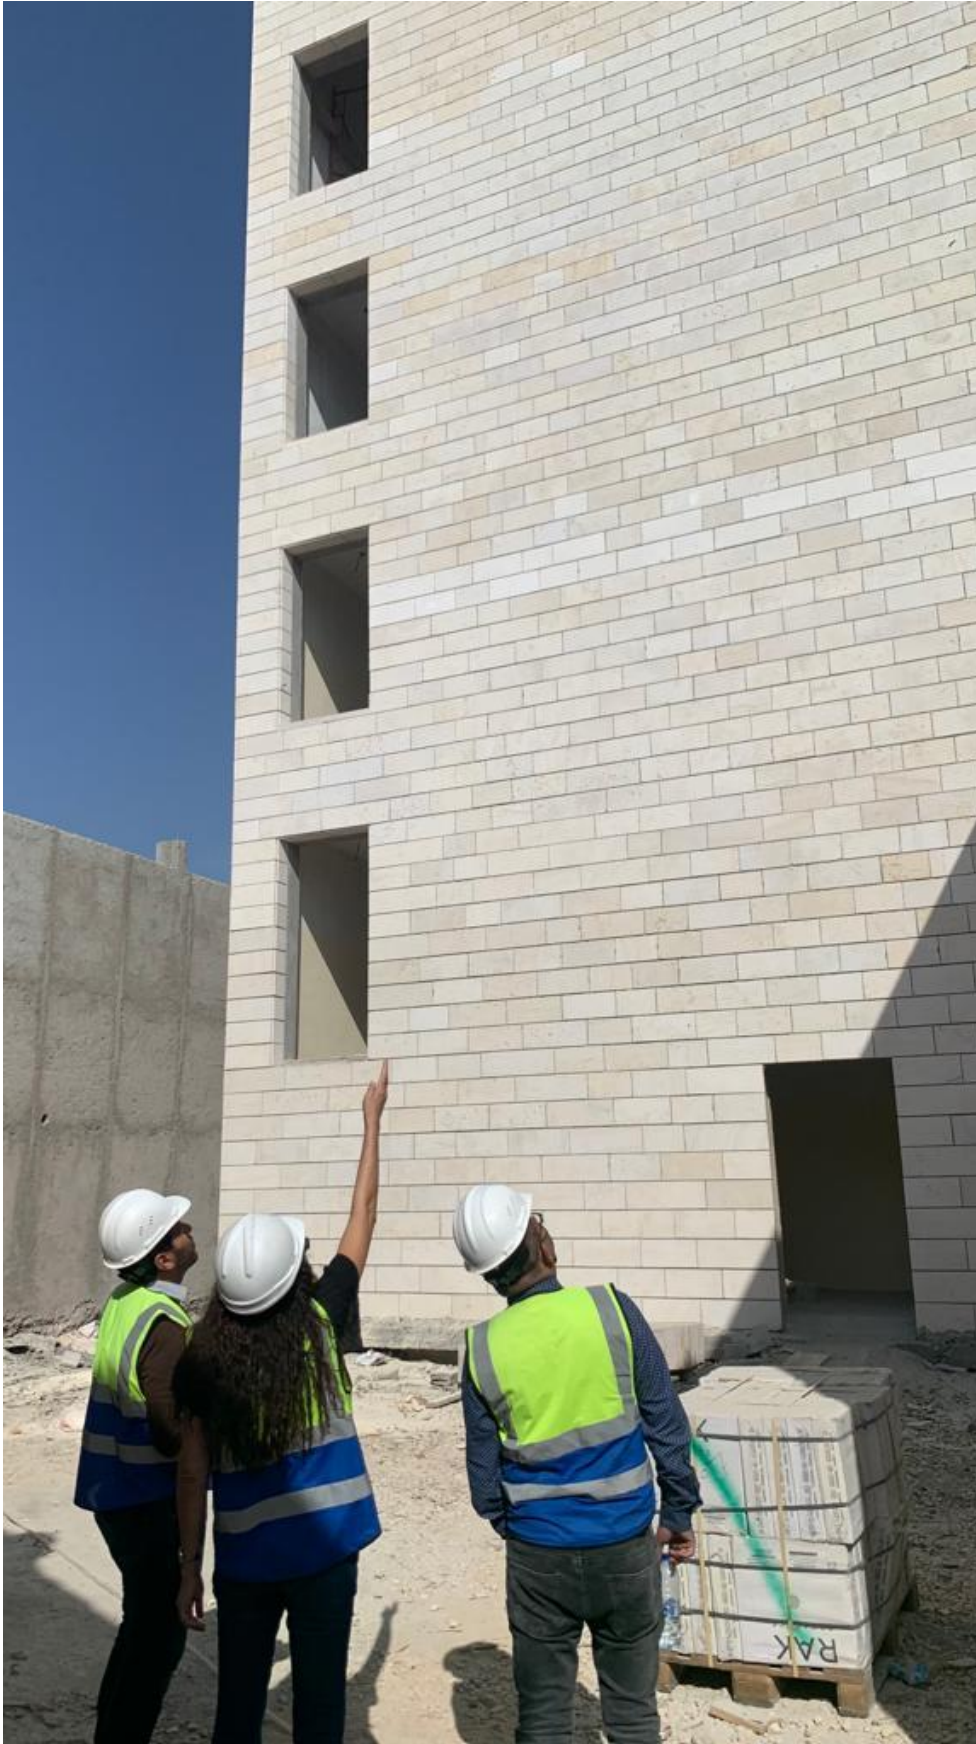
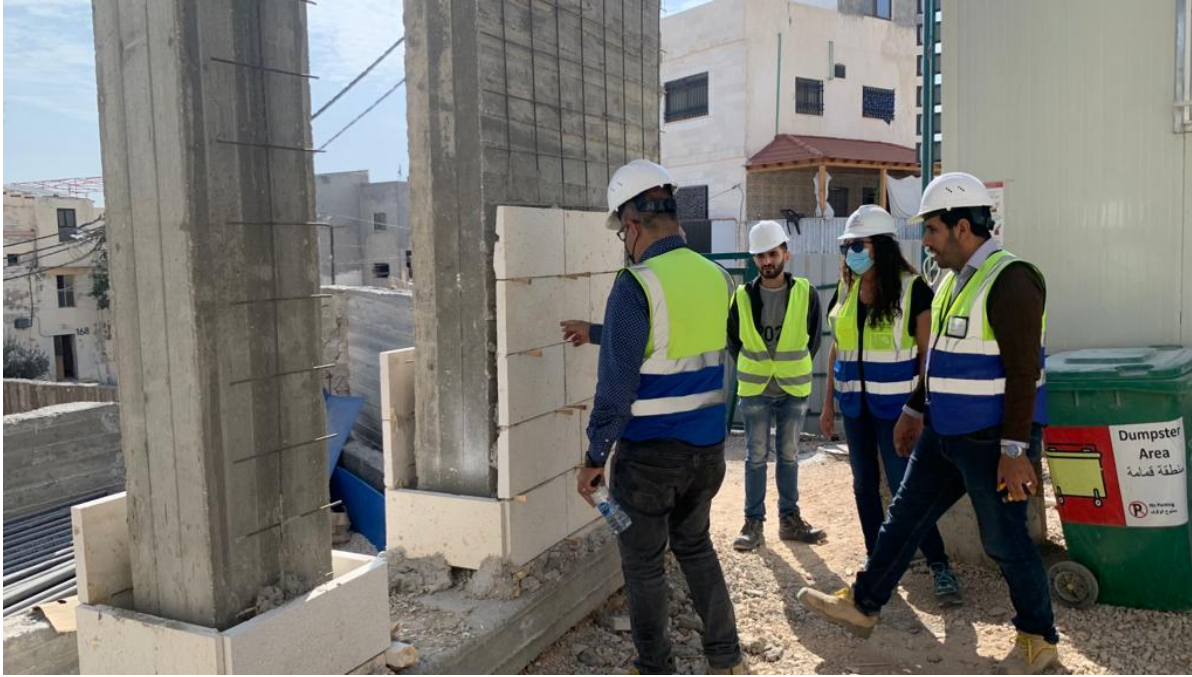
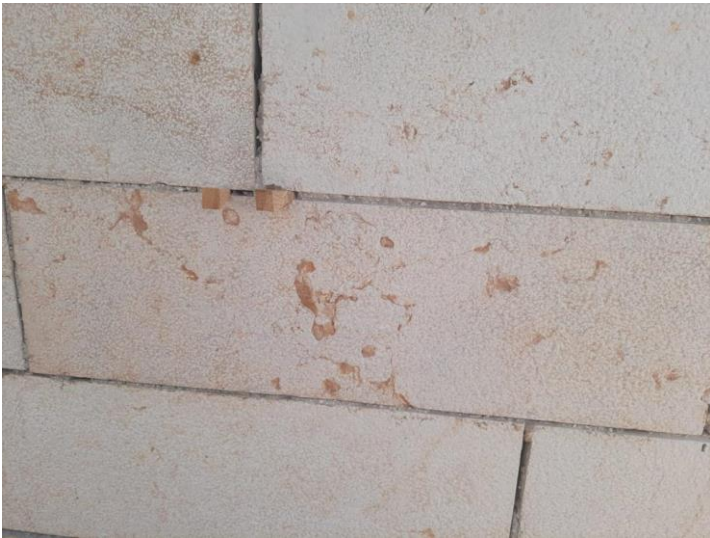
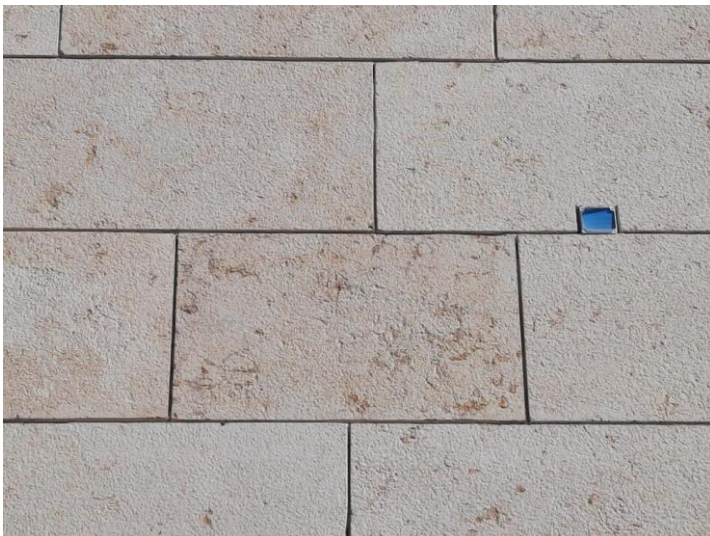
(Figure: 07, 08, 09, 10, 11 & 12)

The stone work at the facades was inspected and the Contractor was requested to replace the defected and broken stones

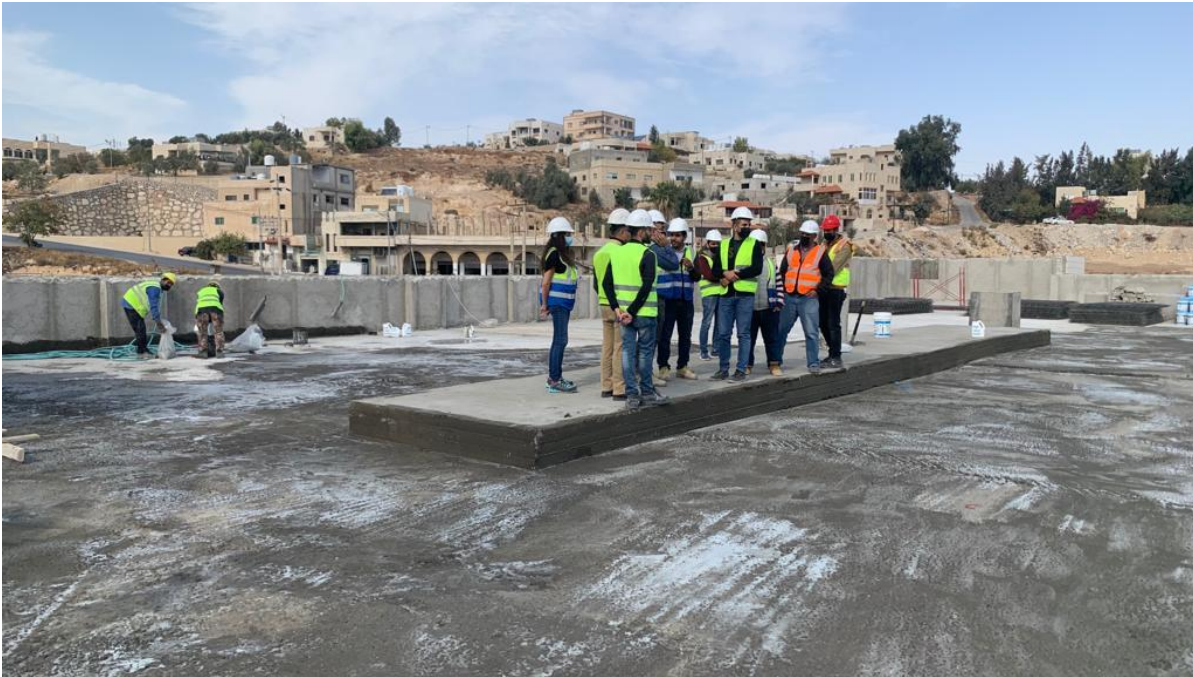
(Figure: 13)

It was observed that the Contractor started with the waterproofing insulation at the roof of the building. General inspection was conducted

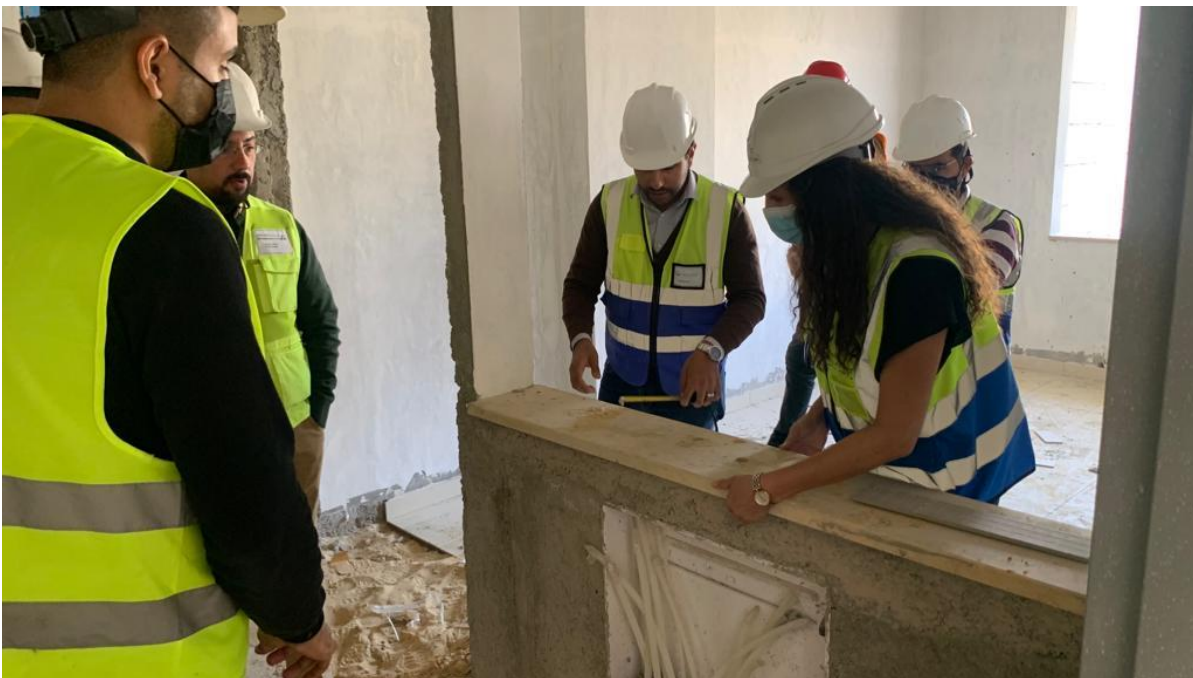
(Figure: 14)

The dimensions of installed window sills have been checked to insure compliance as per requirements

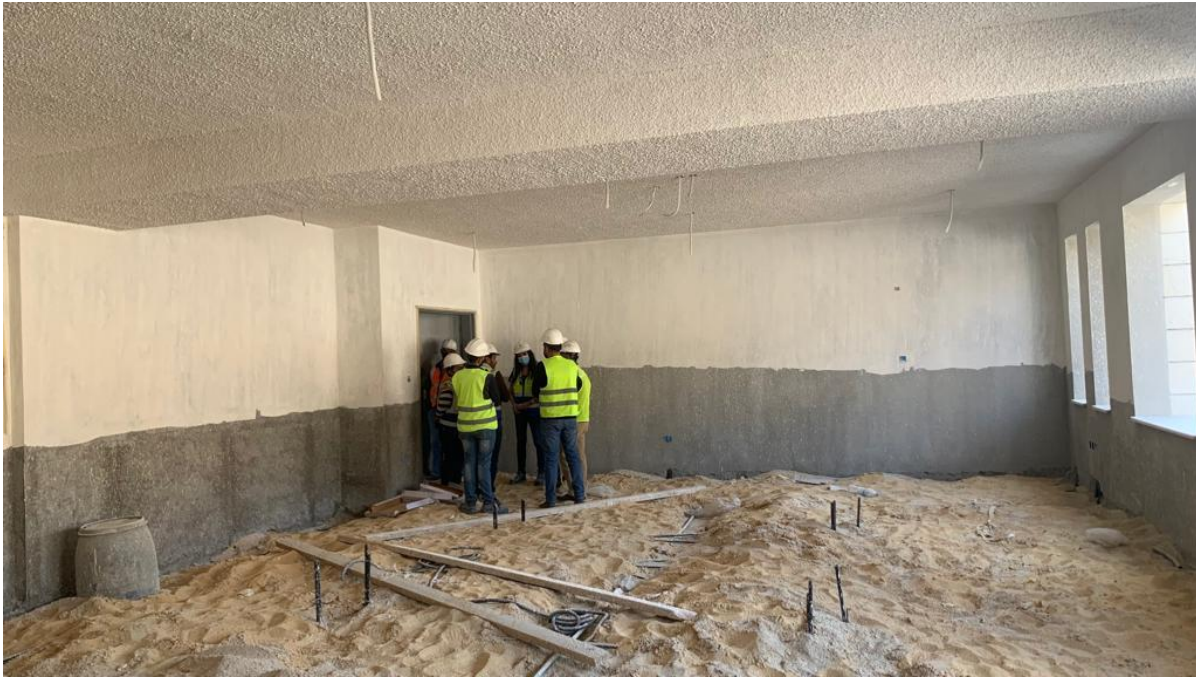
(Figure: 15)

It was observed that the Contractor completed the electro-mechanical installation at the “Art Room”

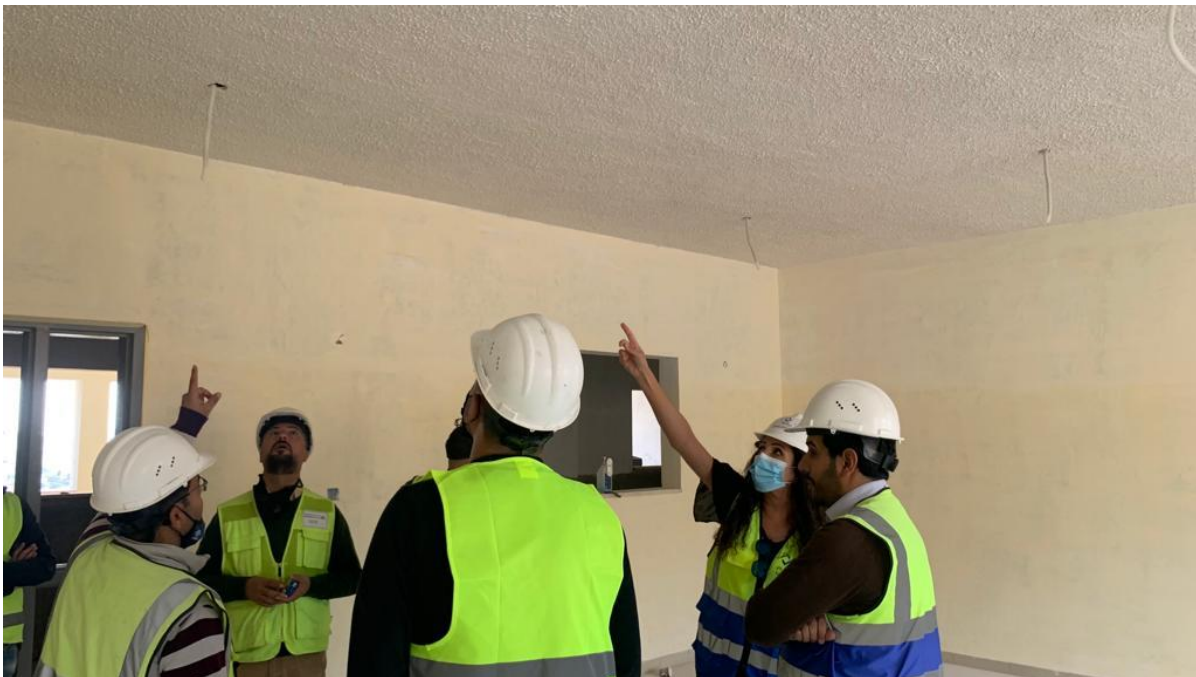
(Figure: 16)

The executed acoustical plastering for ceilings has been checked and remarks have been given to the Contractor to rectify some areas

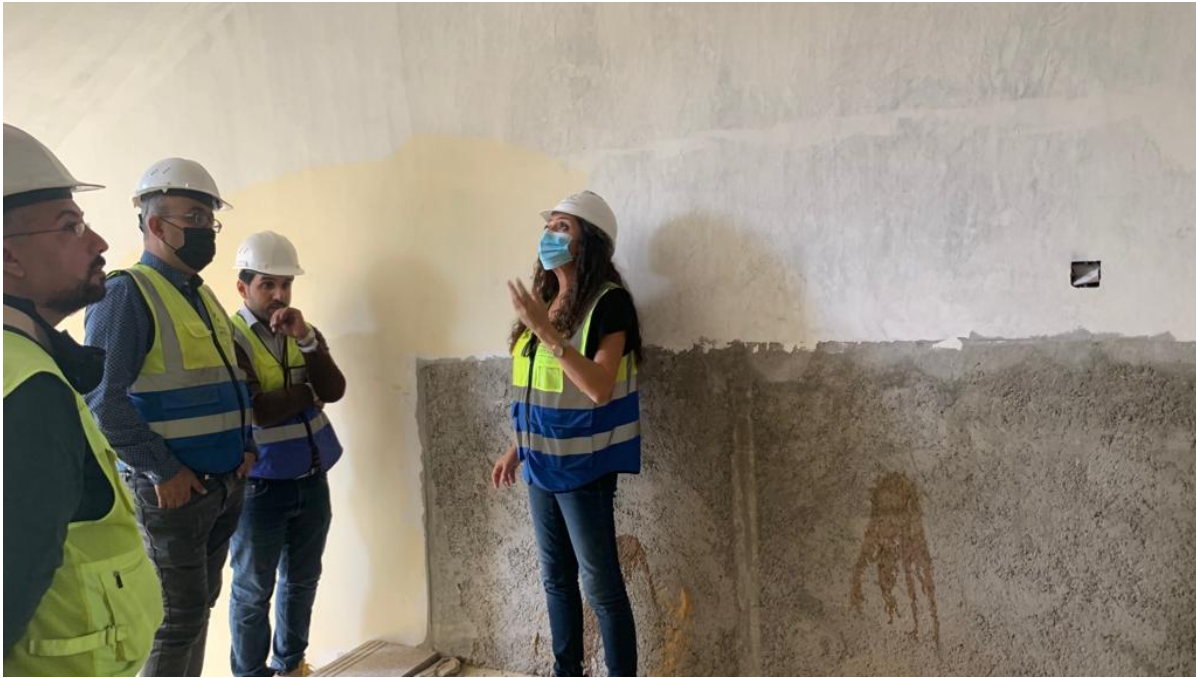
(Figure: 17)

The limits between the porcelain tiles for corridors and the porcelain skirting for staircases have been discussed

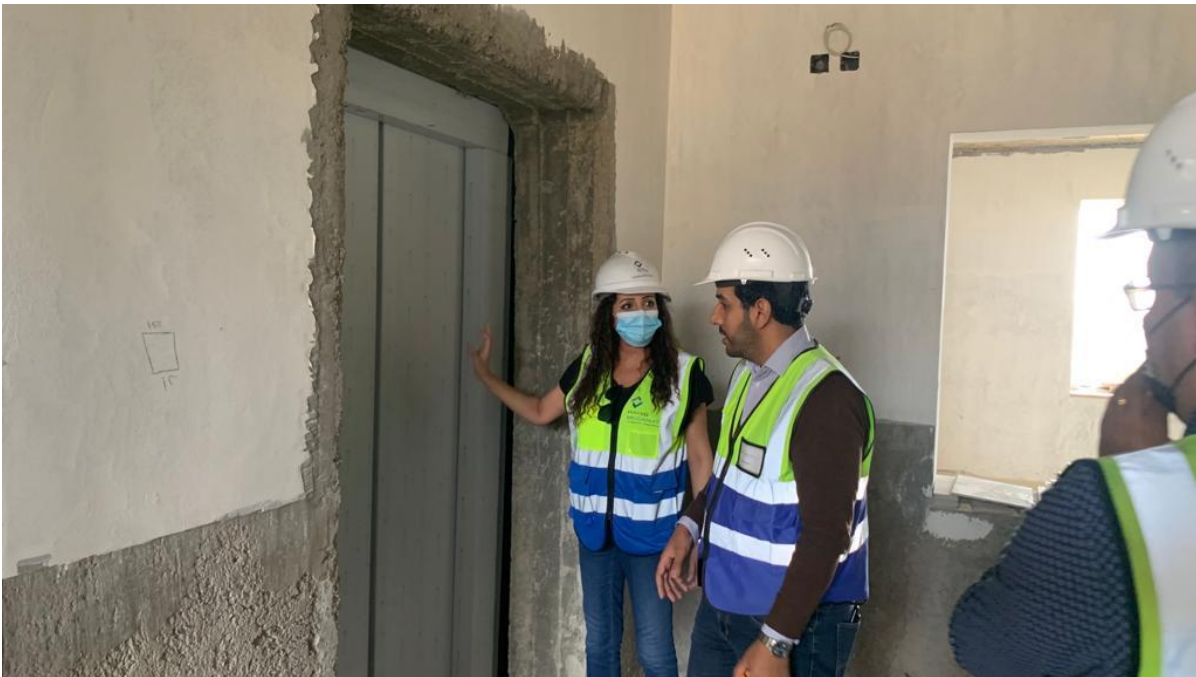
(Figure: 18)

The elevator had been installed

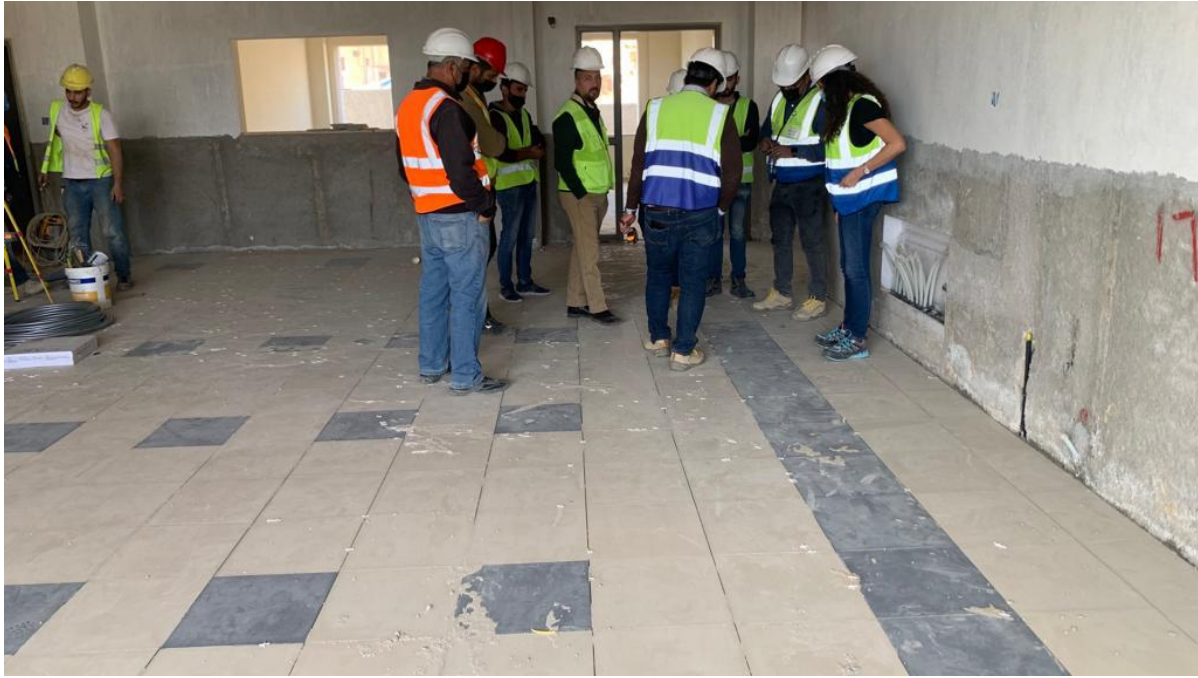
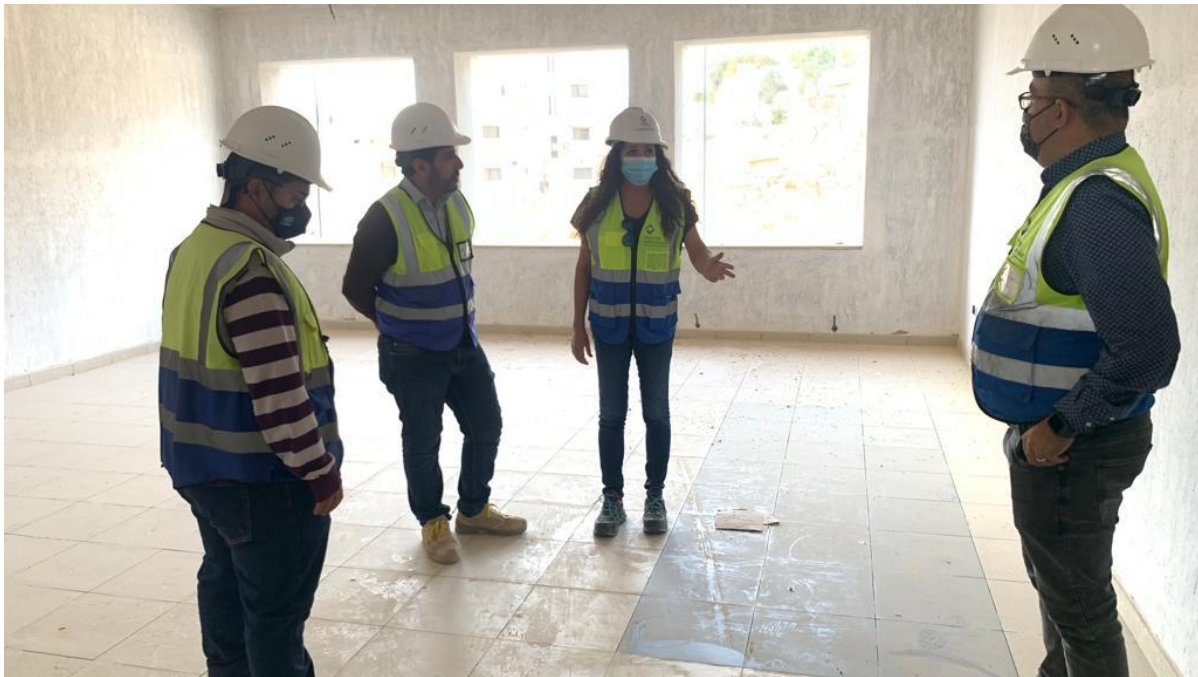
(Figure: 19 & 20)

The color of grout for tiles has been discussed with the Contractor for the areas which have more than one tile color. The Contractor will prepare samples of grout at the three schools subject to the approval of supervision

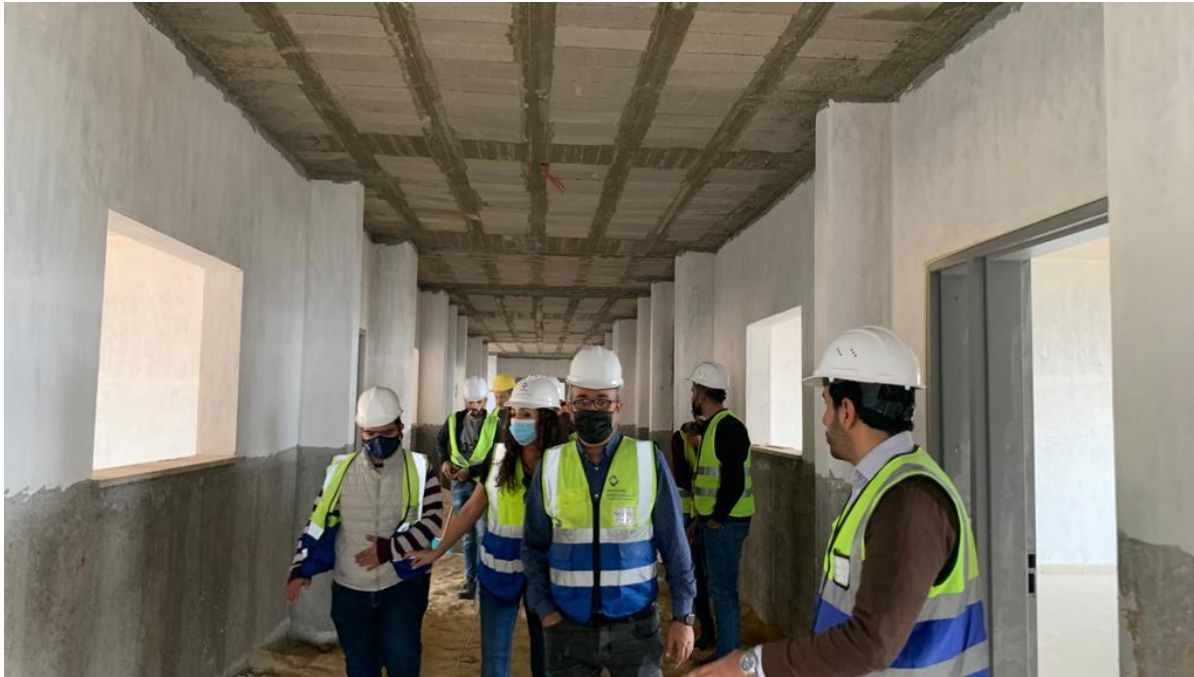
(Figure: 21)

General inspection to the first layers of painting and its relation with the porcelain cladding in the corridors has been conducted

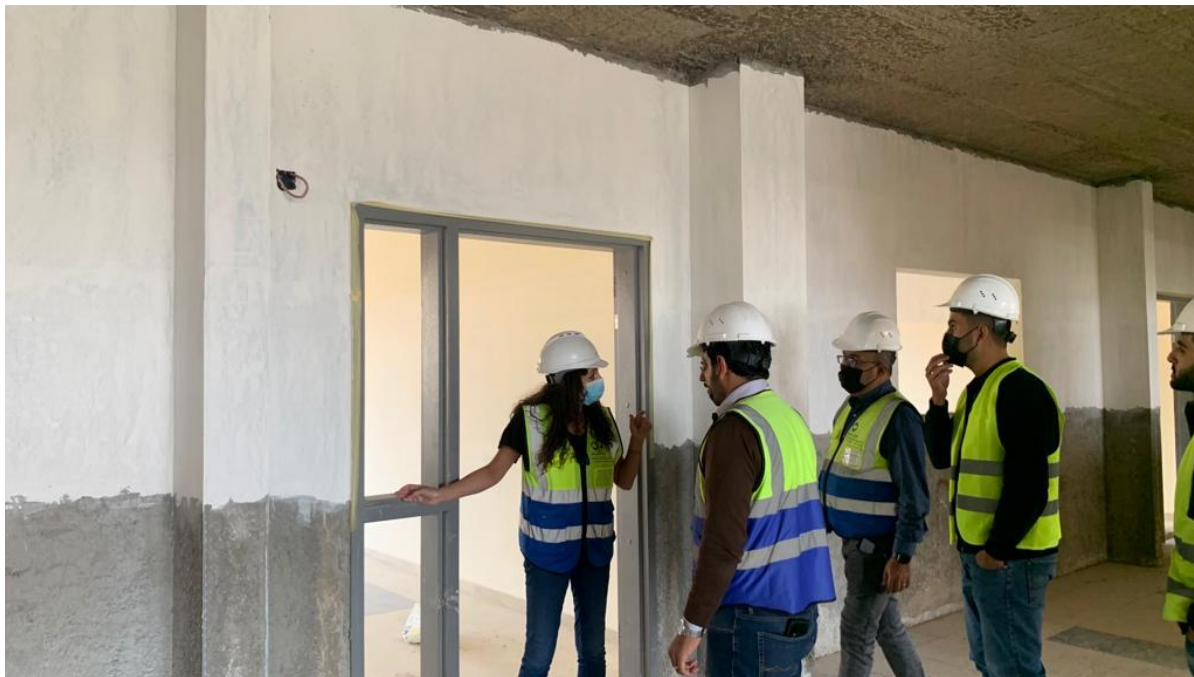
(Figure: 22)

General check has been conducted on the installed door frames and remarks have been given to the Contractor stating that not all the required frames have been delivered to date

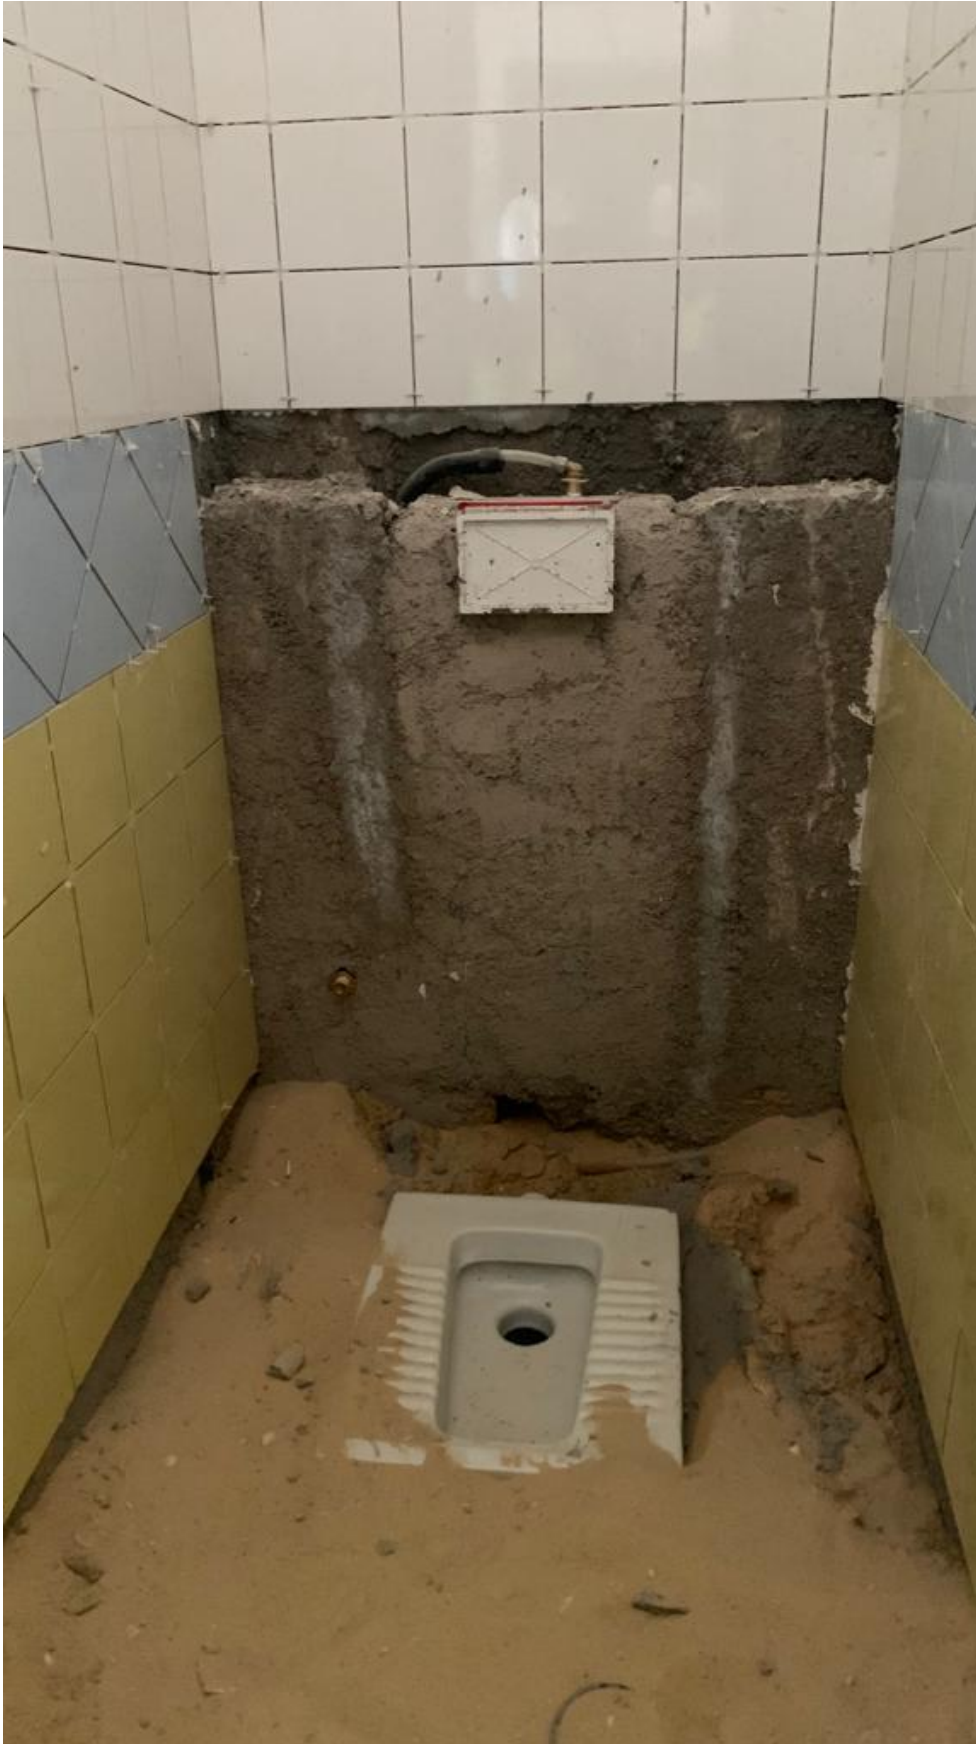
(Figure: 23)

The Contractor was requested to protect the installed toilet fixtures

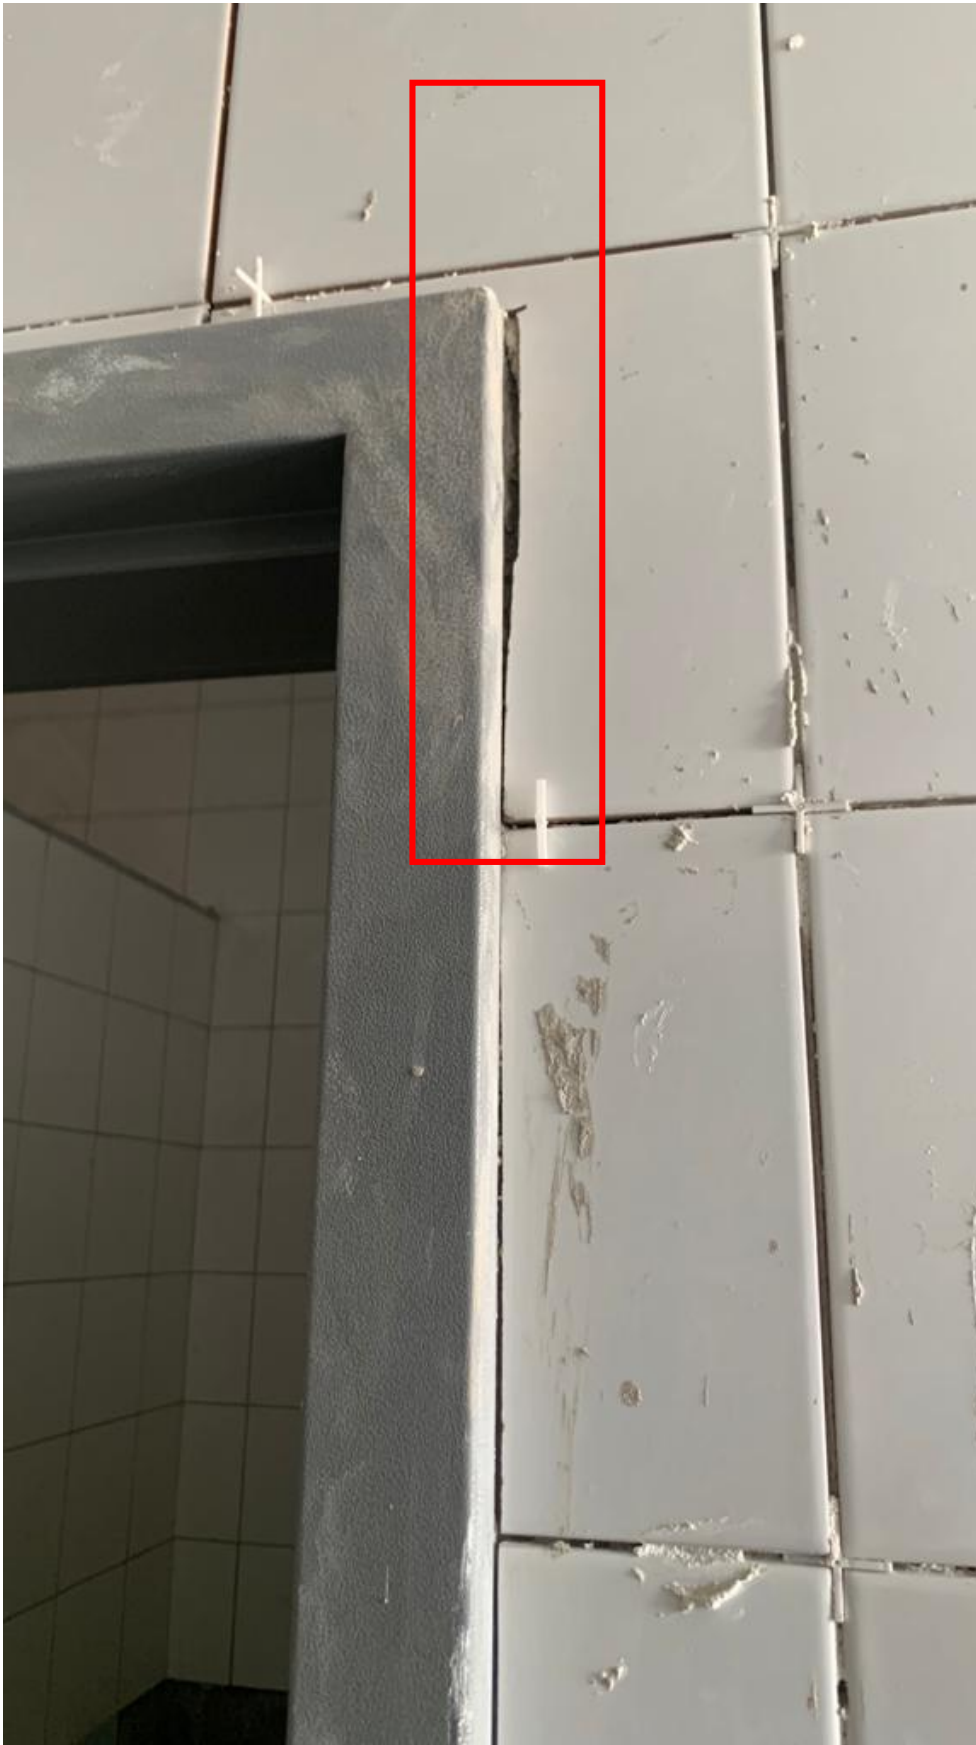
(Figure: 24)

The finishing at the limit lines of the wall tiling with the door frames is not acceptable in some areas. The Contractor was requested to replace some tiles in order to insure good finish

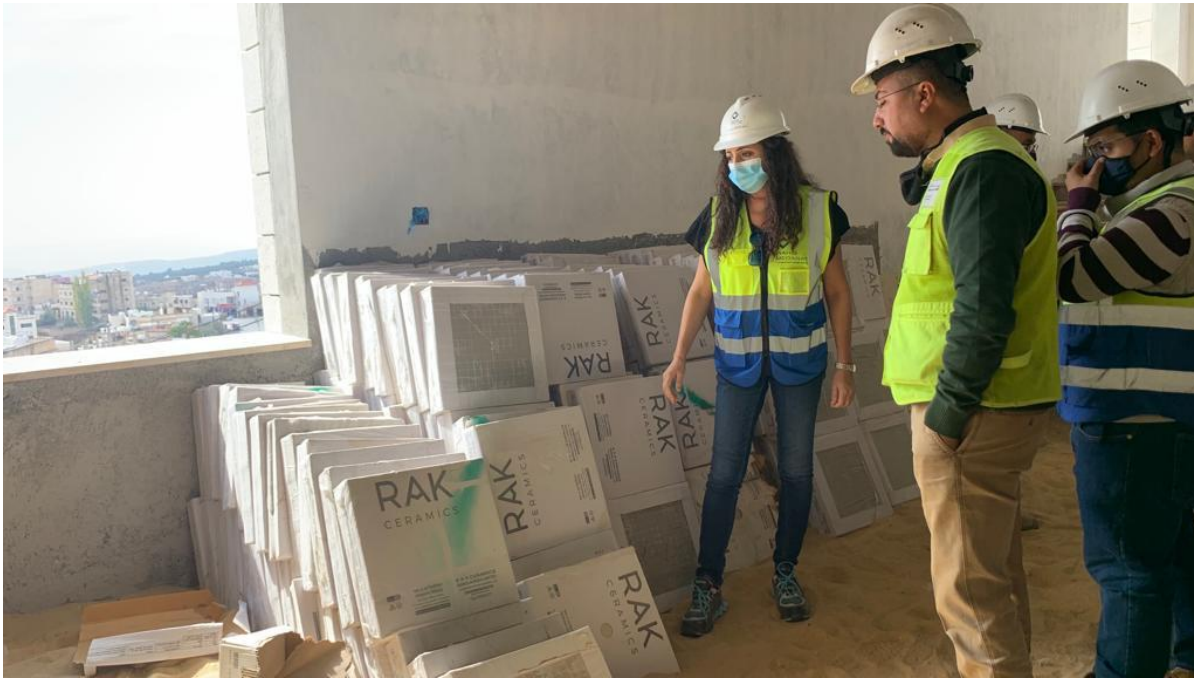
(Figure: 25)

Visual inspection has been conducted on the delivered quantities of floor tiles

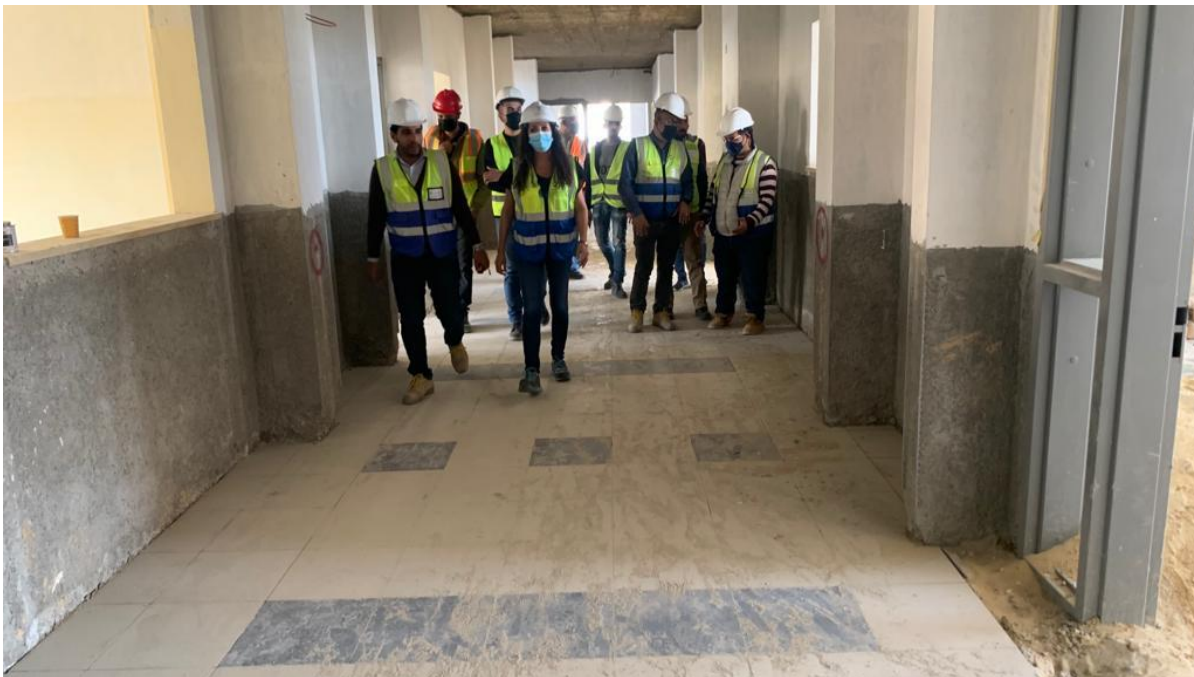
(Figure: 26)

The Contractor was instructed to execute first bottom layer of porcelain at the corridors for the sides for the review and approval of the supervision to enable him to continue his work correctly
