SKEP III Home Office Support Site Visit Report

Consultant	Wahib Medanat Consultant Engineer	Rep No.	22-15112021
Contractor	Dijlah Establishment Constr. Contracting	Tender No.	(11/2019/USAID/SKEP/3/S) Schools for a Knowledge Economy Project (SKEP) - Phase (3) Package (1, 2)
Site Name	Thahr Al Sarow Basic School for Boys- Jerash	Day/ Date	Mon. 15/11/2021
Duration of Project	450 Calendar Days	Total Project Budget	8,314,983.735 JD

Visit Notes

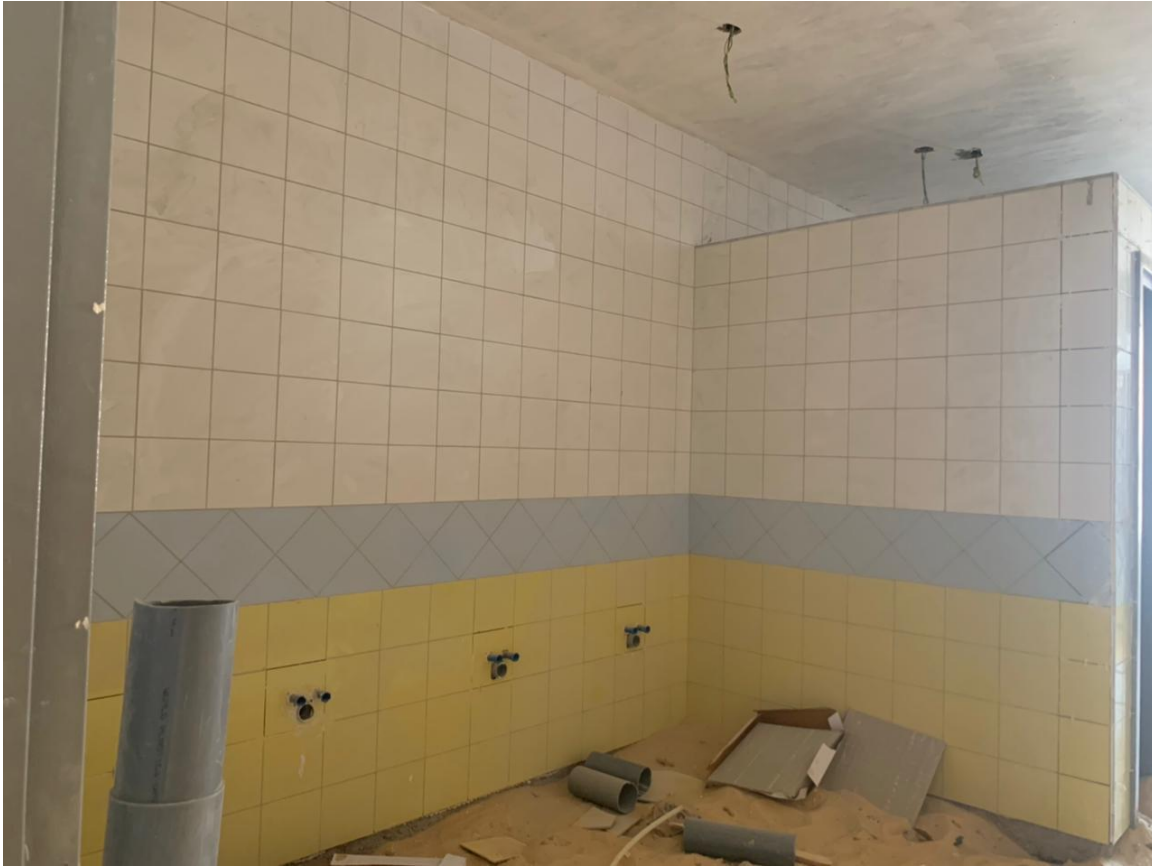
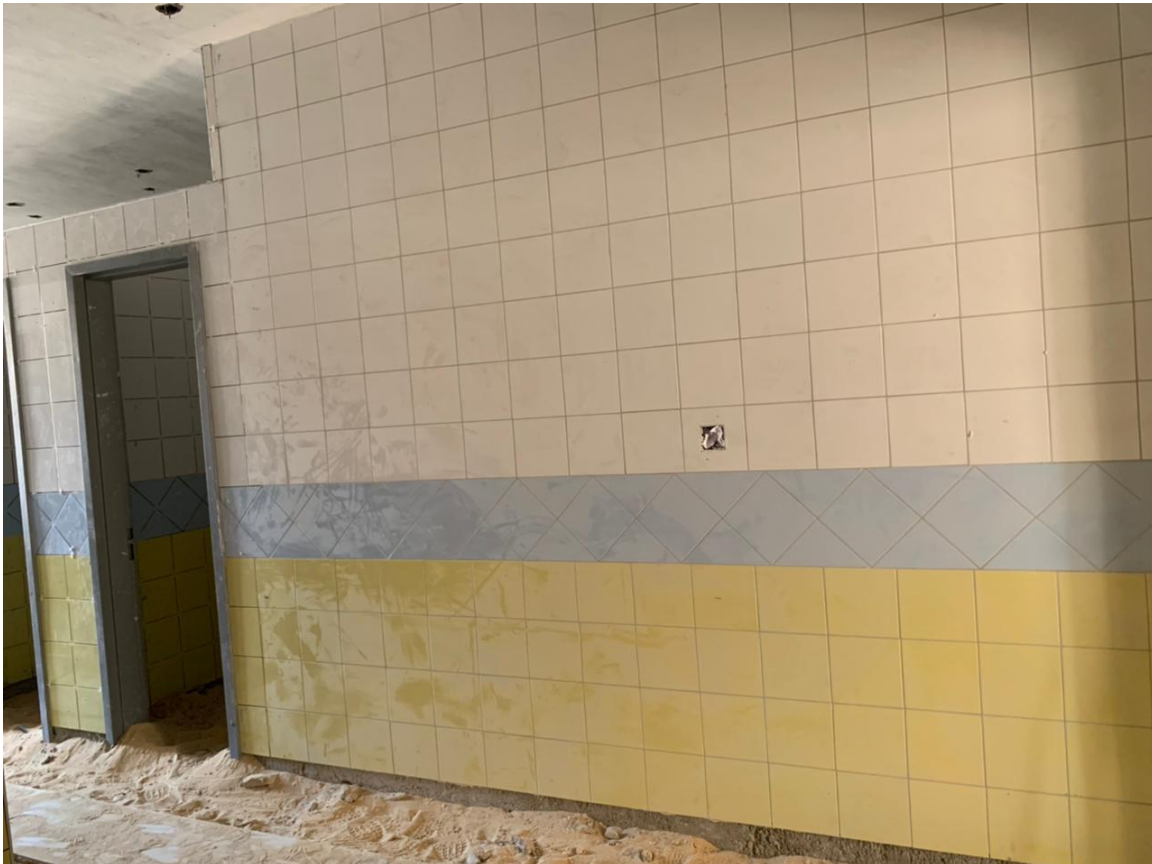
(Figure: 27 & 28)

Wet area wall
tiling work

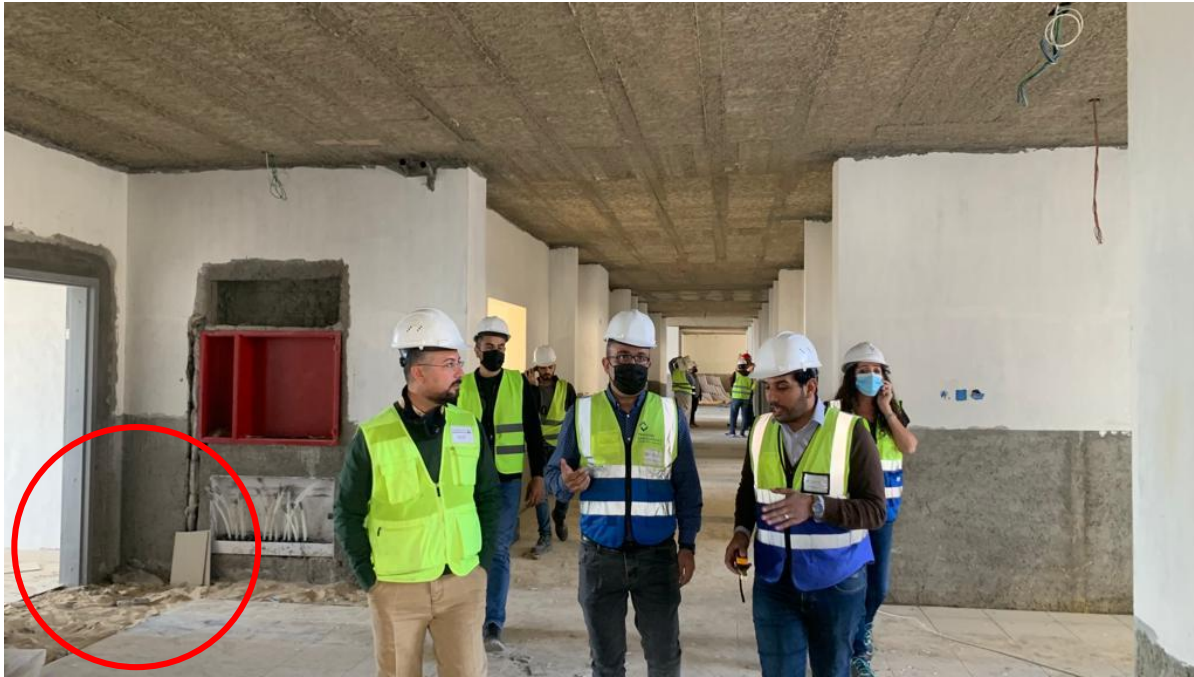
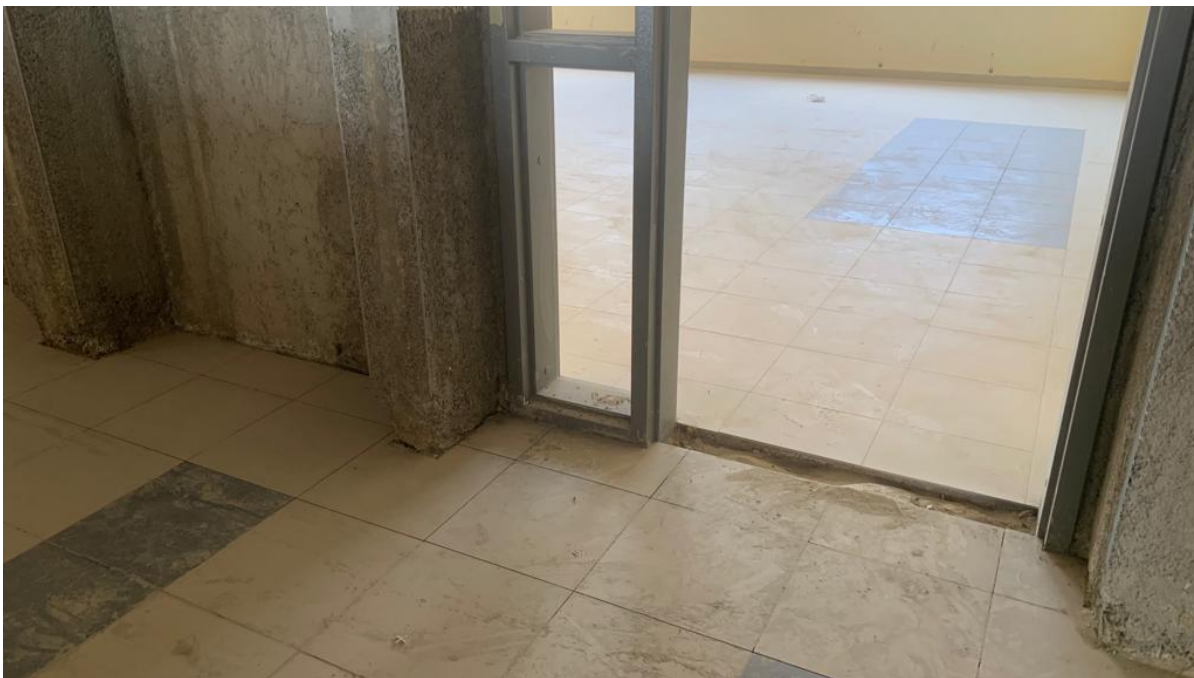
(Figure: 29 & 30)

The width of the thresholds at the doors between the rooms and corridors was discussed with the Contractor
