Quality Control Report

Consultant **Wahib Medanat** Consultant Engineers
Site Name **Thahr Al Sarow Basic Boys - Jerash**
Package **Package 2**
Contractor **Dijlah Est. Construction Co.**
Tender No. **10/2019/USAID/SKEP/3/2**

Rep No. **QC-22 09**
Date **18 / 10 / 2021**

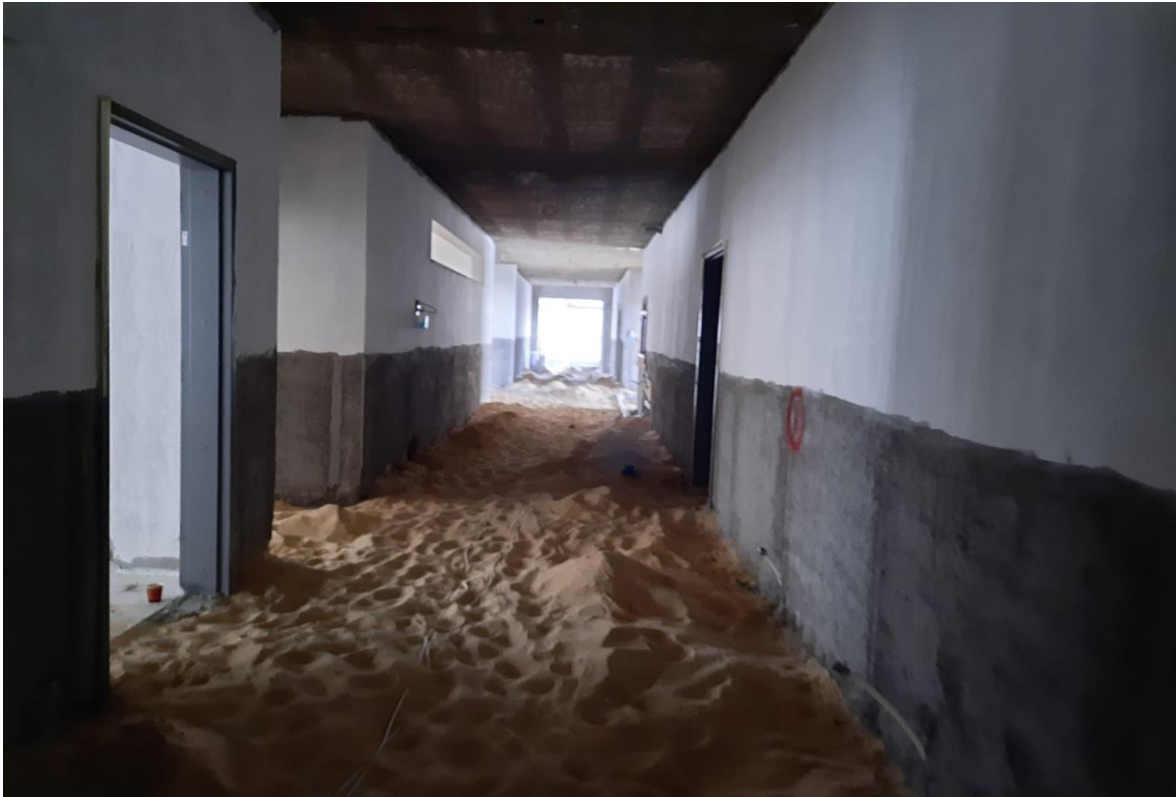
Filling materials under corridor tiles

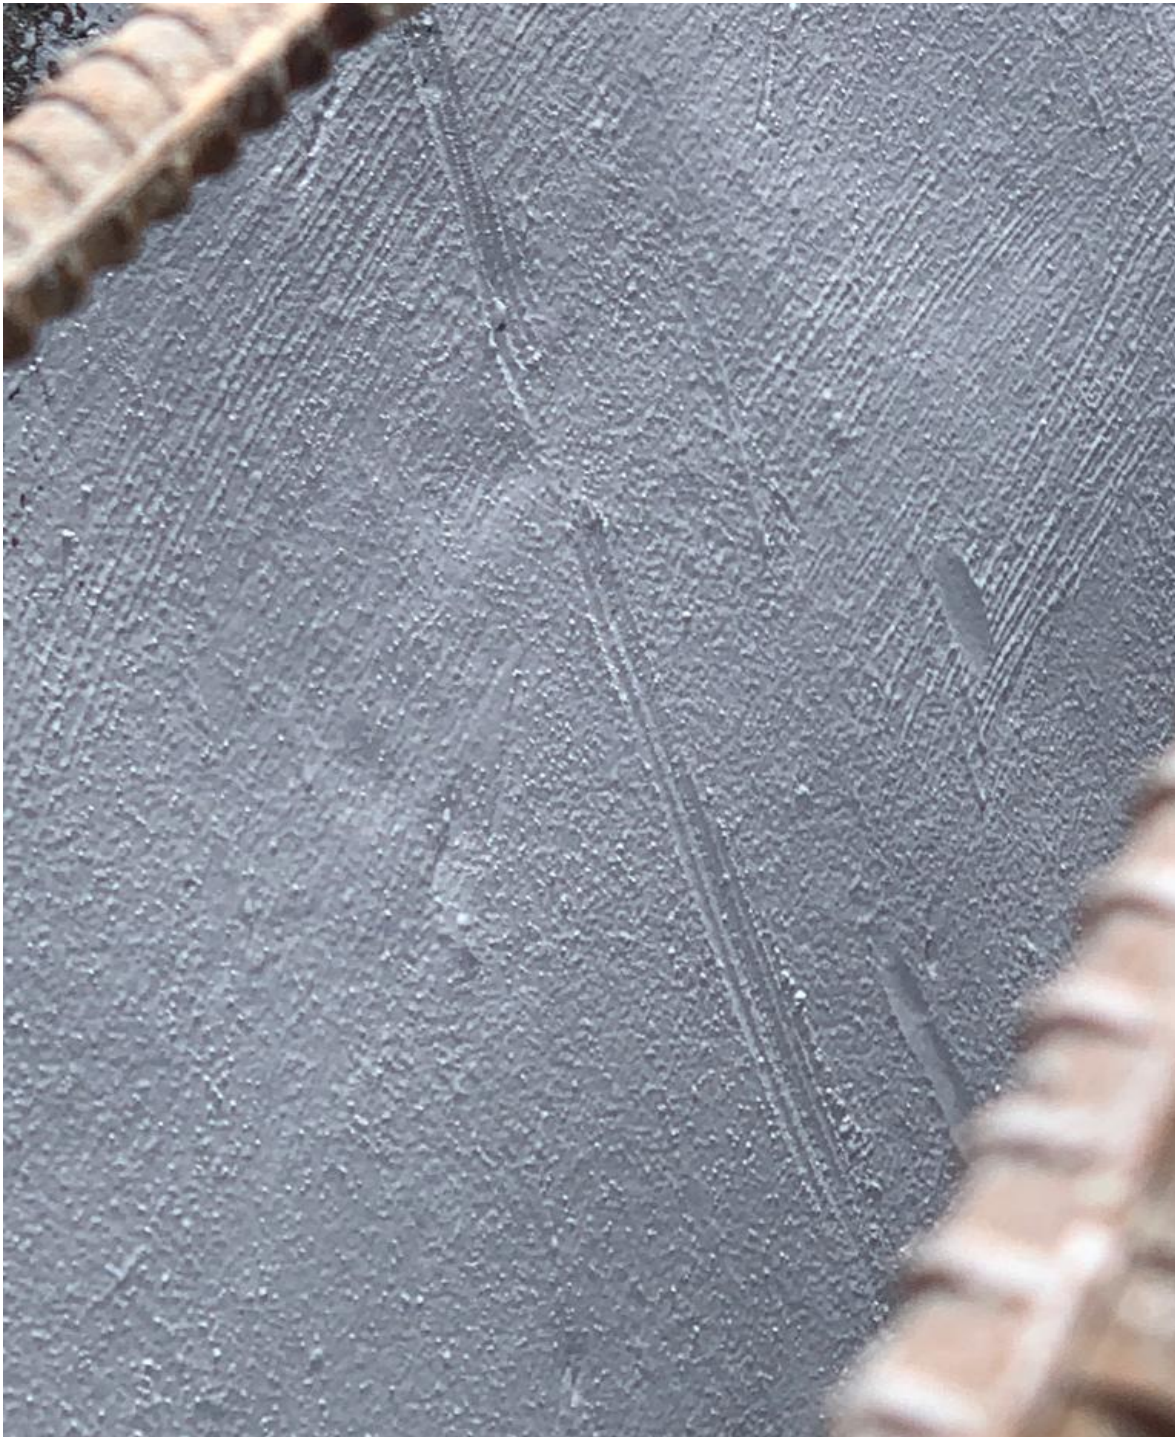
Epoxy paint for internal water tank wall

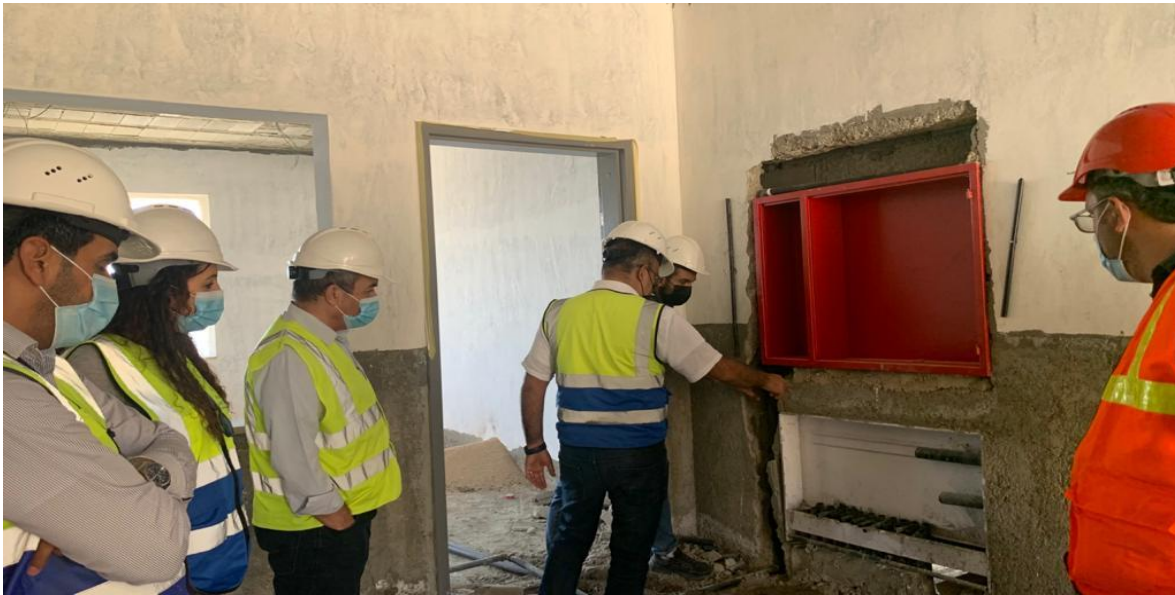
Defects around fire hose cabinet and mechanical cabinet
