Consultant	Wahib Medanat Consultant Engineer	Rep No.	12-16082021
Contractor	Derar Saraireh & Sons for Engineering & Contracting	Tender No.	(11/2019/USAID/SKEP/3/S) Schools for a Knowledge Economy Project (SKEP) - Phase (3) Package (1, 2)
Site Name	Al Khansa' Basic Mixed School- Al Balqa	Day/ Date	Mon. 16/08/2021
Duration of Project	450 Calendar Days	Total Project Budget	9,789,417.840 JD

Visit Notes

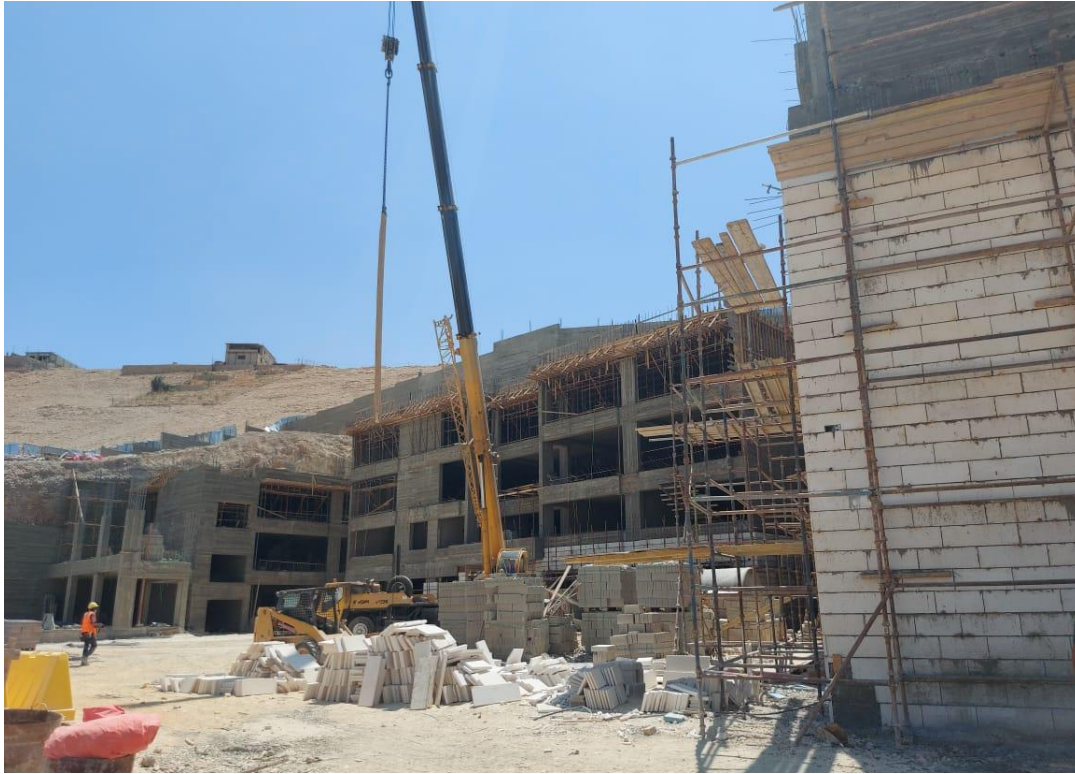
(Figure: 01 & Figure: 02)

General view of the casted slab of the roof floor

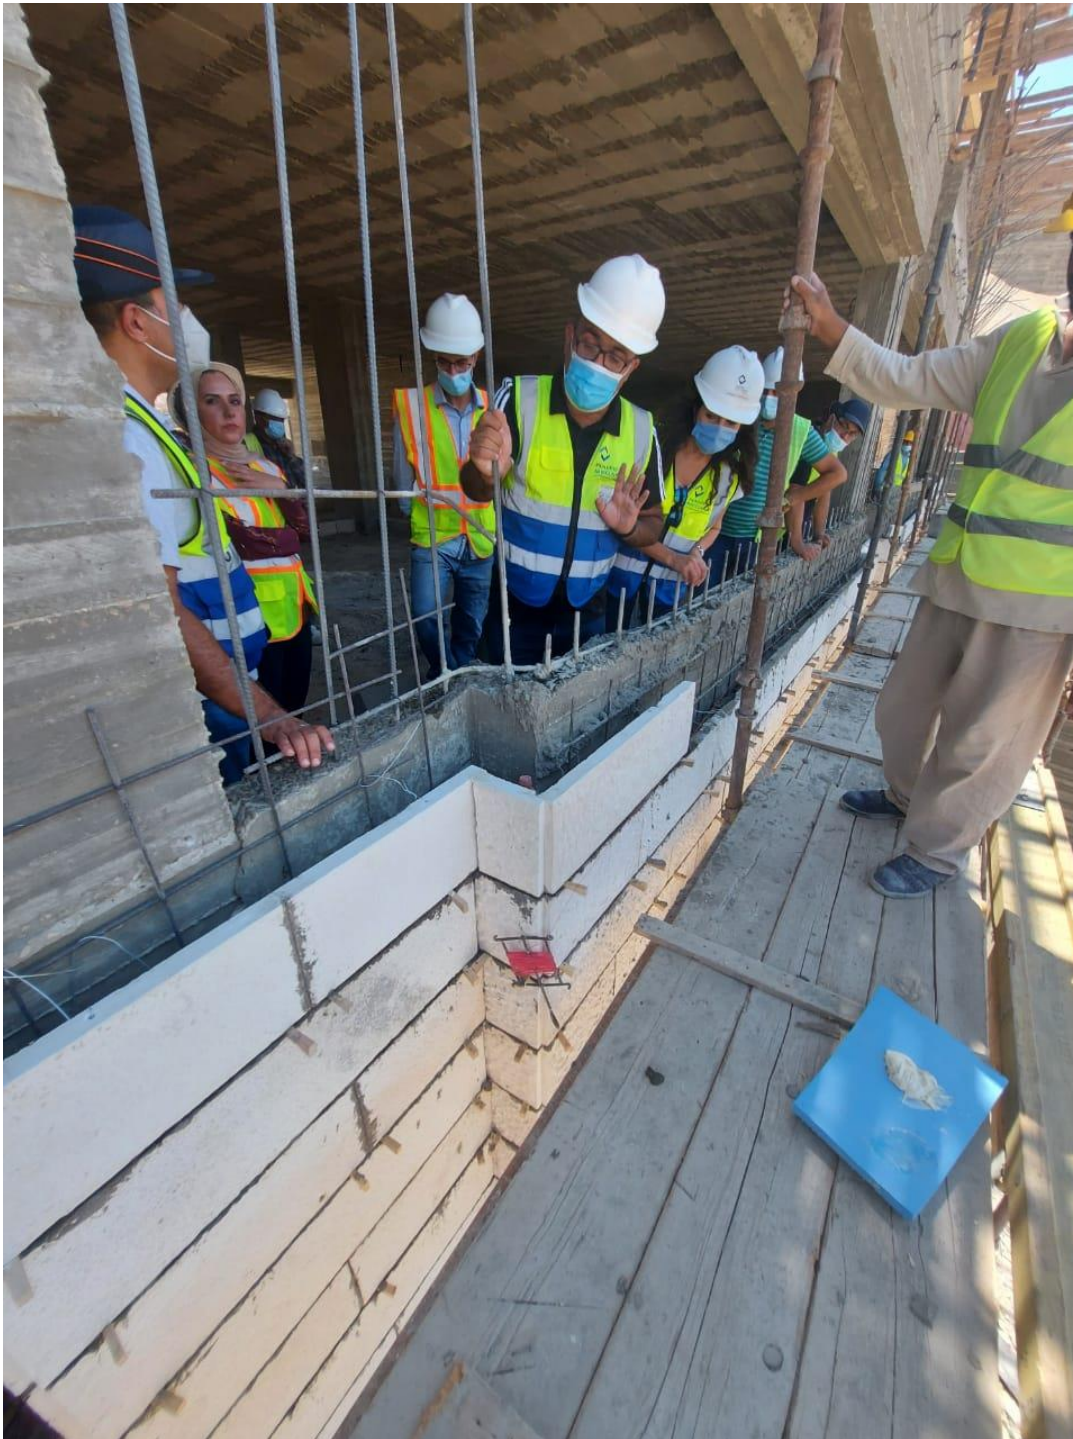
(Figure: 03)

The built stone courses-zone "A" have been inspected and show that the work in general is acceptable

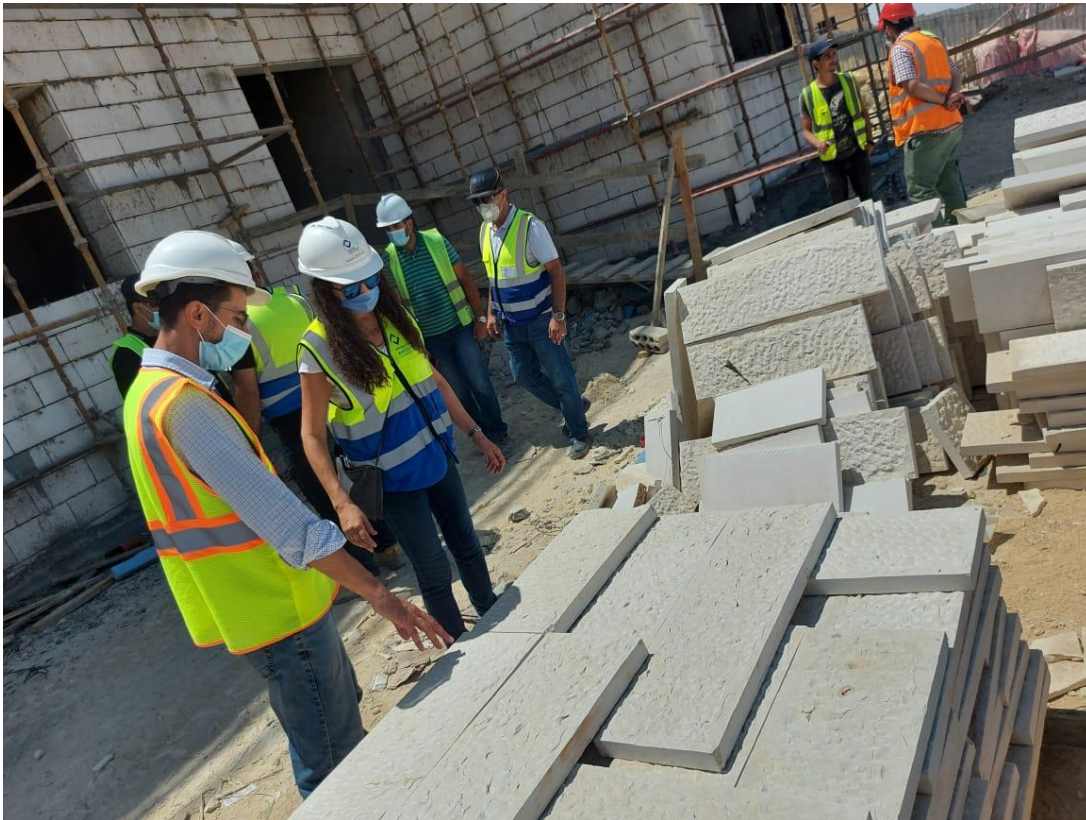
(Figure: 06)

A visual inspection has been conducted on the delivered quantities of building stones and the Contractor was reminded with number of remarks related to the compliance of stones

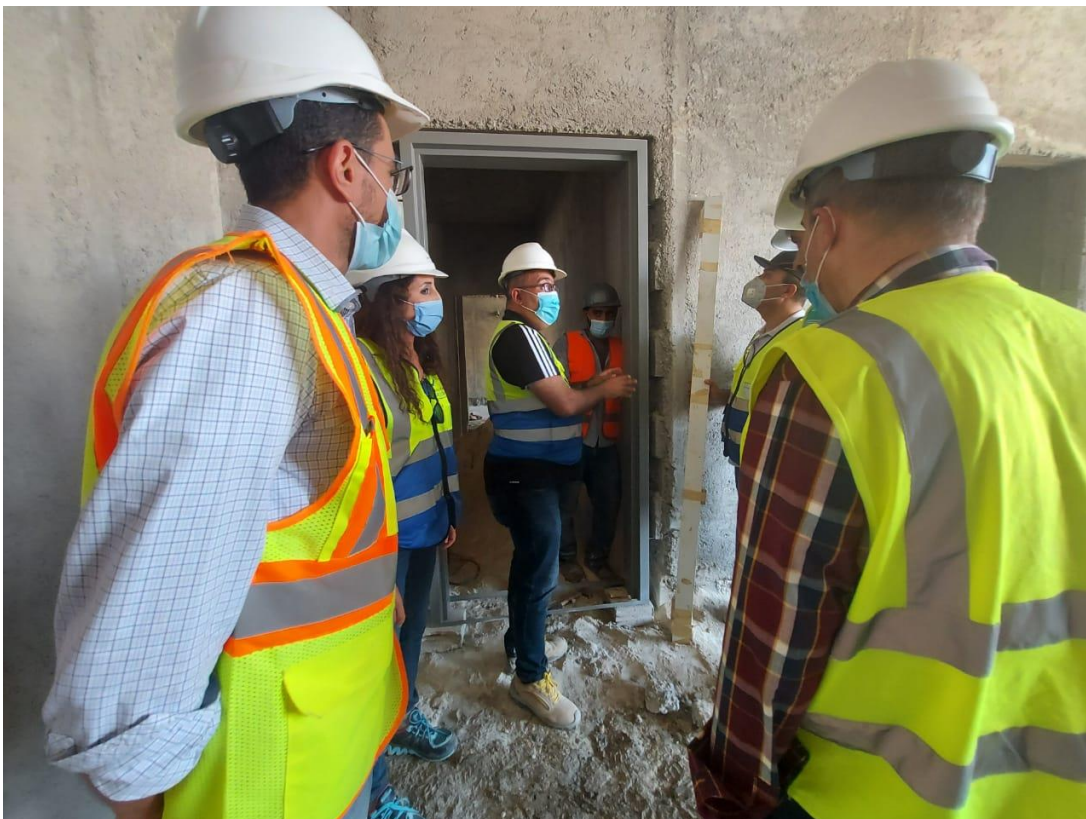
(Figure: 07)

A sample of installation a door frame at ground floor-zone "A" was observed. Eng. Natheer advised the Contractor to the right method of installation and stressed to follow the architectural workshop drawing, the direction of the door opening, the verticality and the connection with the blockwork and plastering

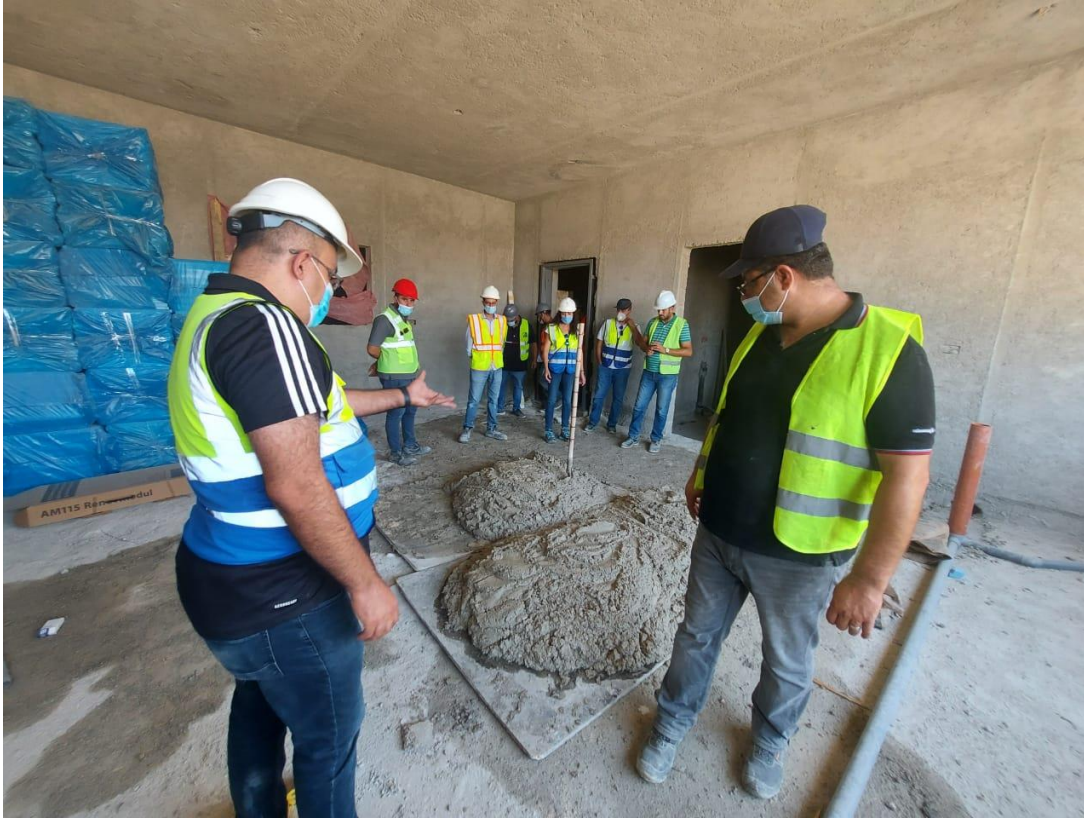
(Figure: 08)

Despite our written instructions the Contractor is not using a special container for mixing the mortar used for blockwork and plastering work

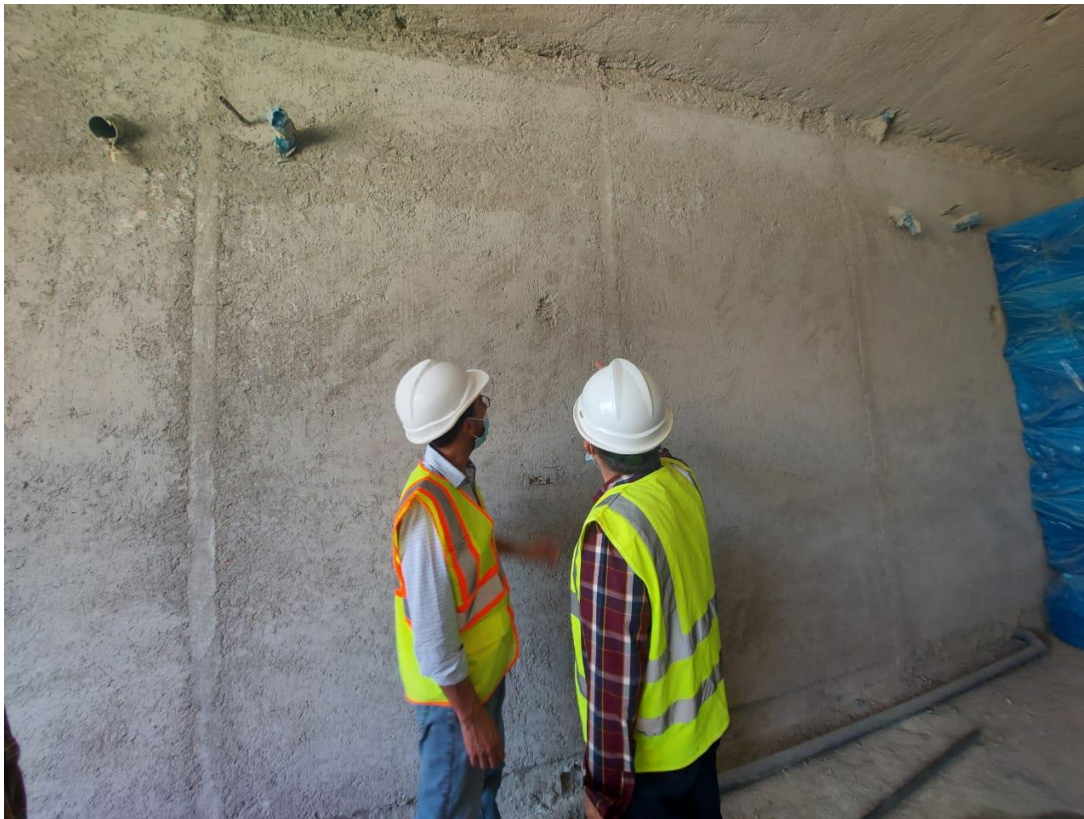
(Figure: 09)

Eng. Hassan discussing electrical work first fix with Medanat site engineer

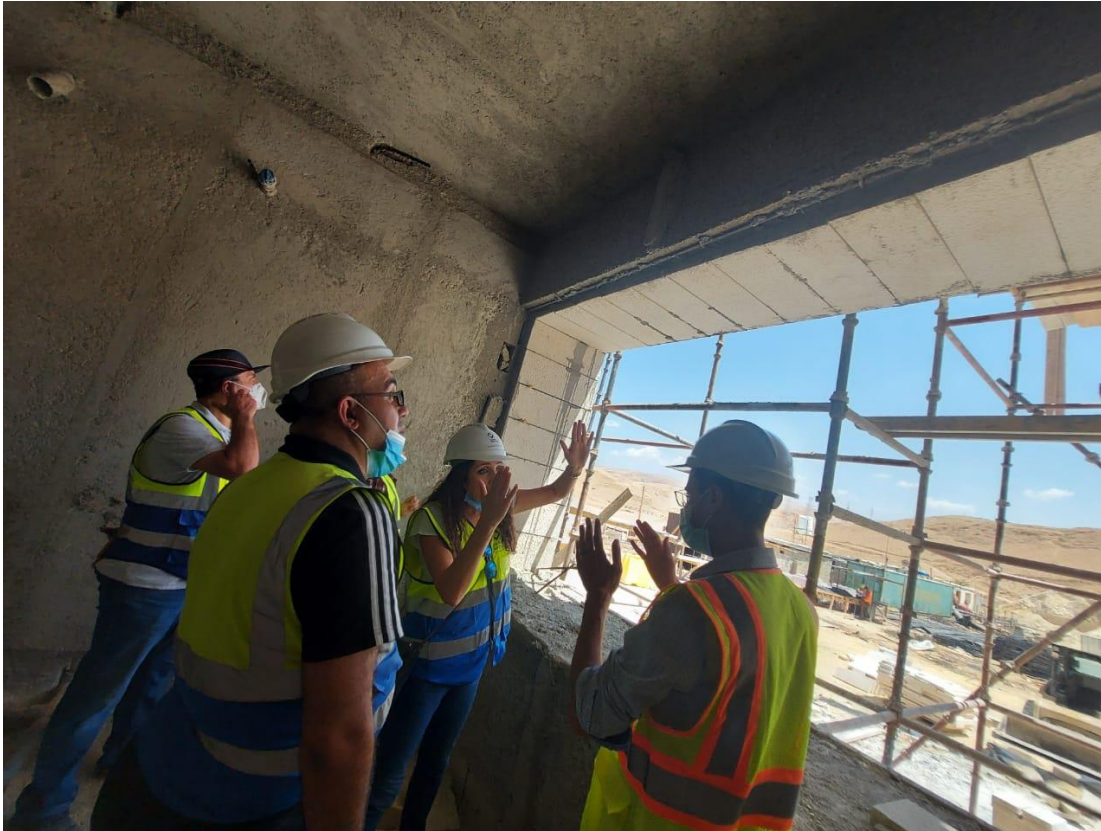
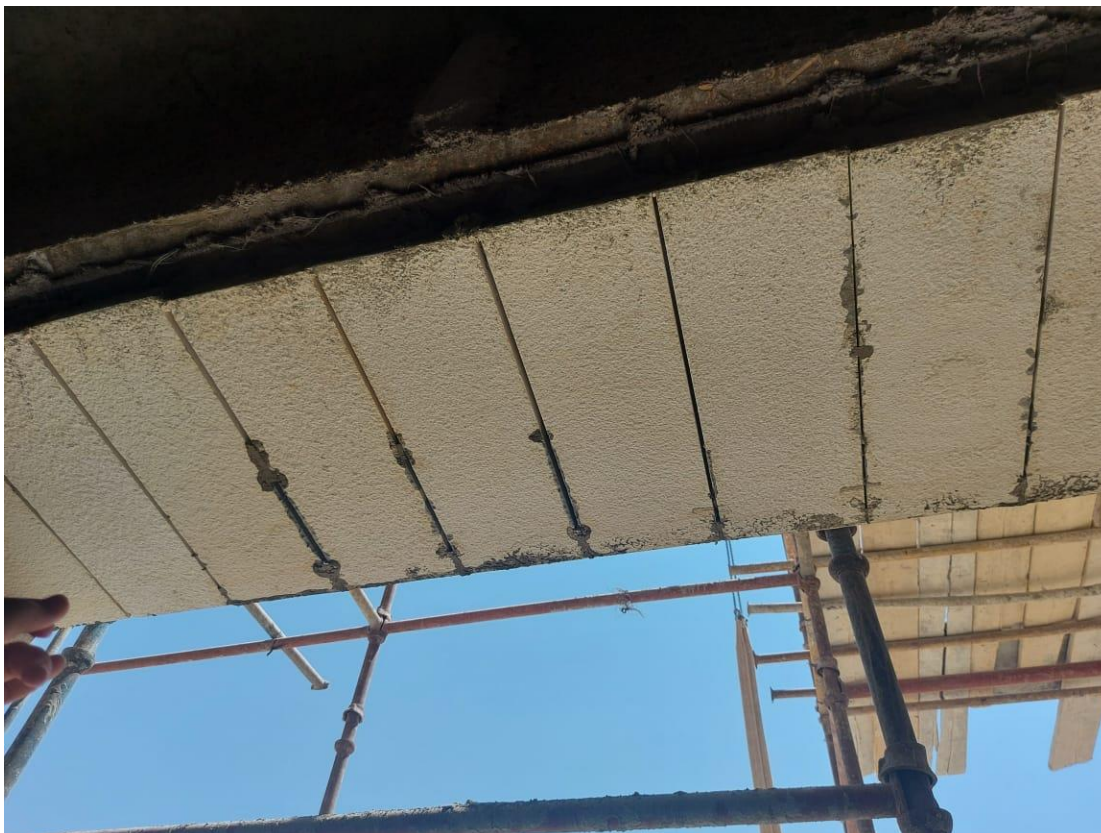
(Figure: 10 & Figure: 11)

A defect was observed in the stone soffit of one window related to deviation in the width of joints between stones, number of joints are over the specified width of 1 cm.

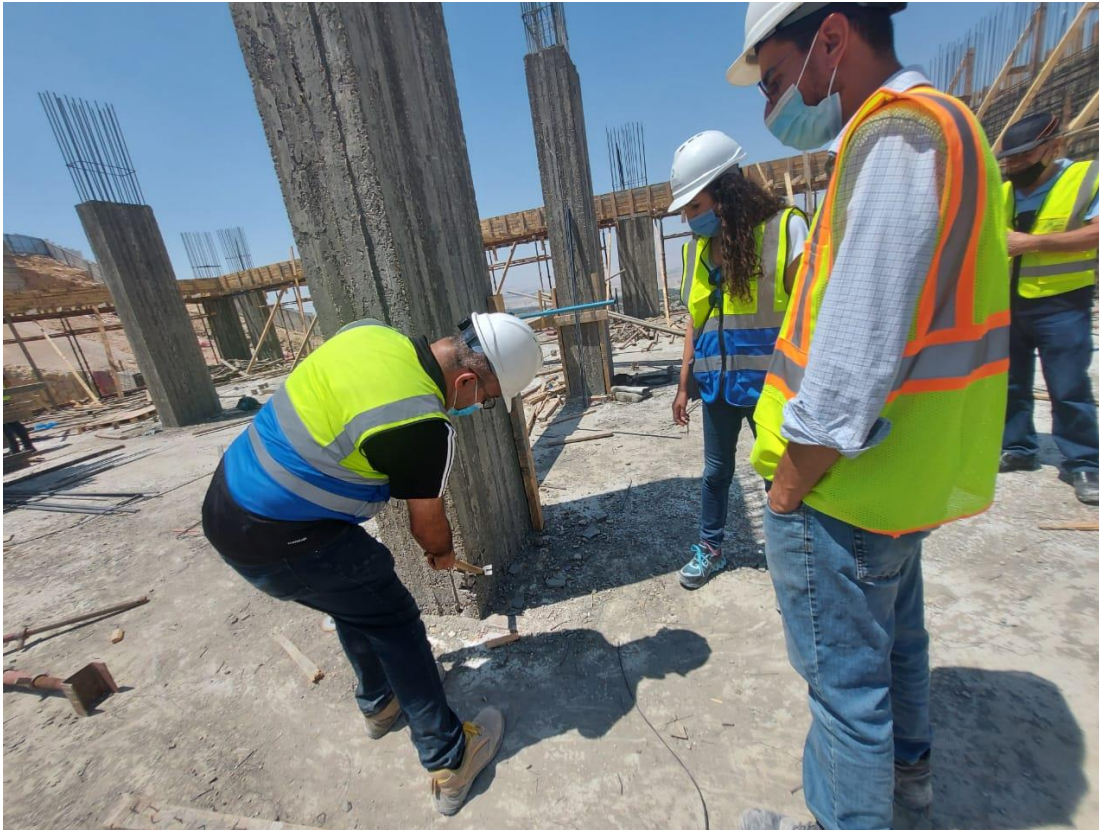
(Figure: 12)

Roughness was observed in number of columns in the ground floor-zone "A", Eng. Natheer conducted a visual inspection to ensure that there is no segregation

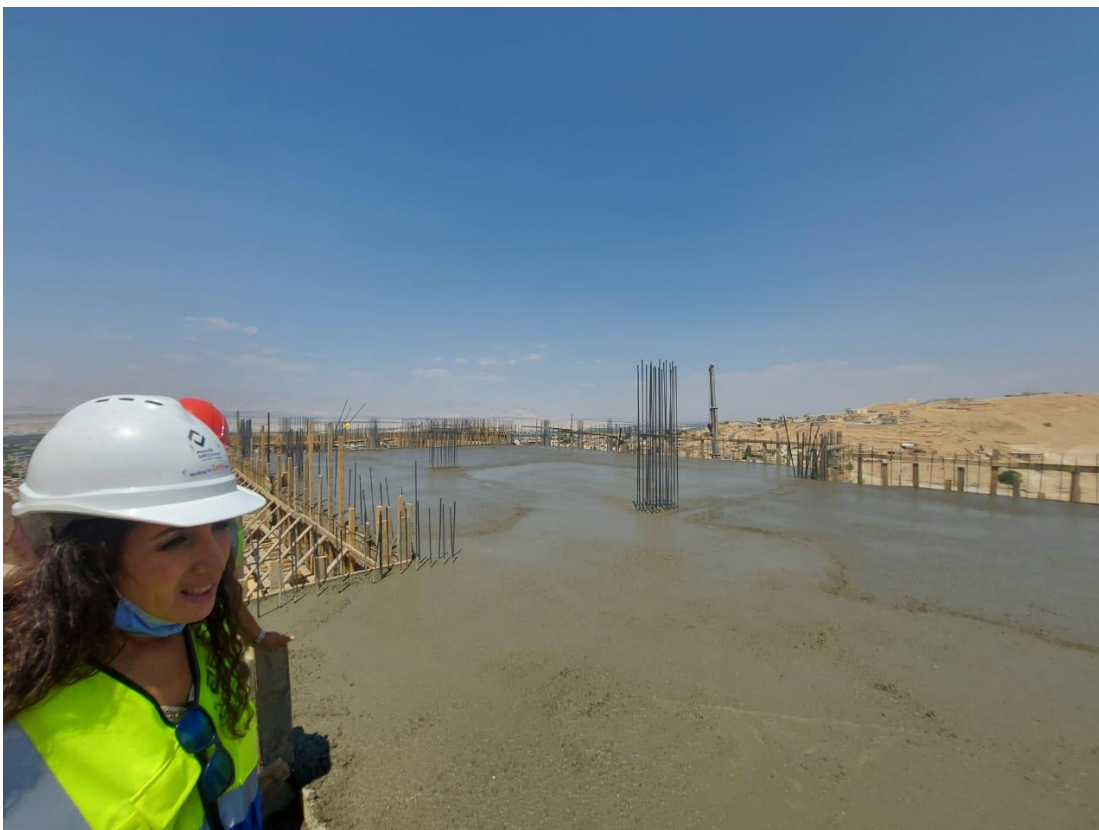
(Figure: 13)

Roof floor slab casting

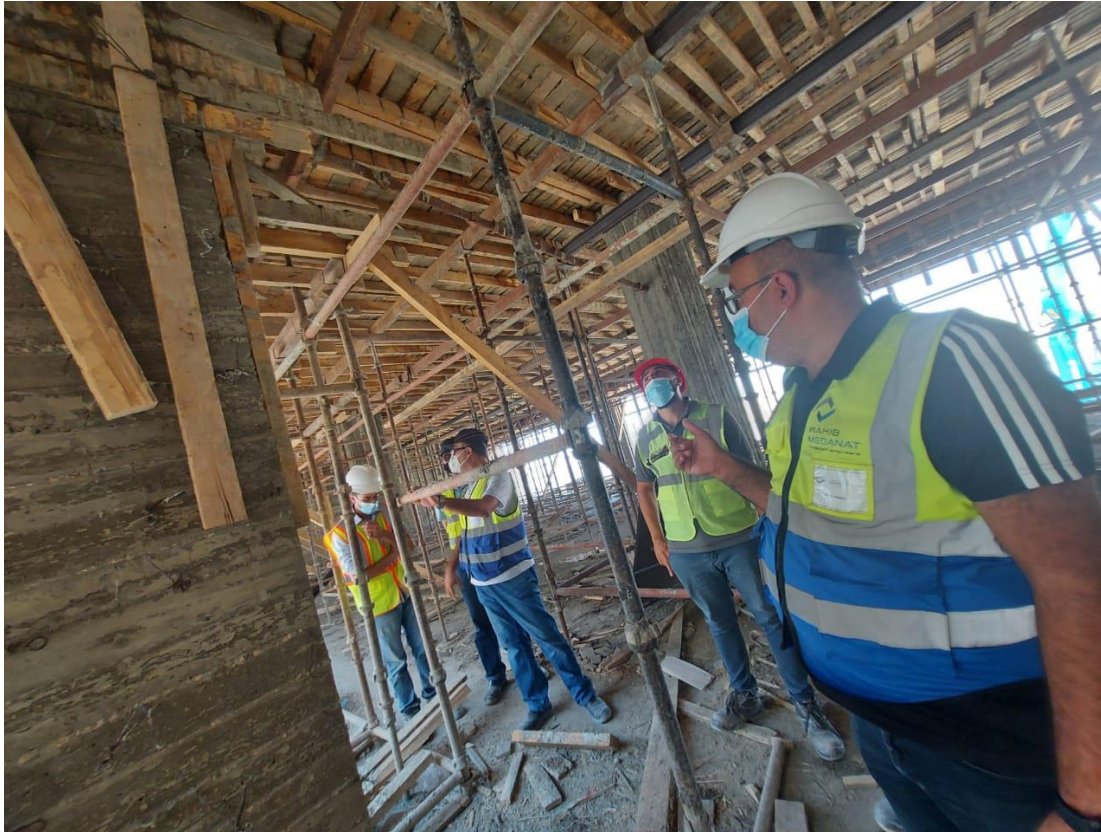
(Figure: 14)

Formwork for roof slab zone "B"

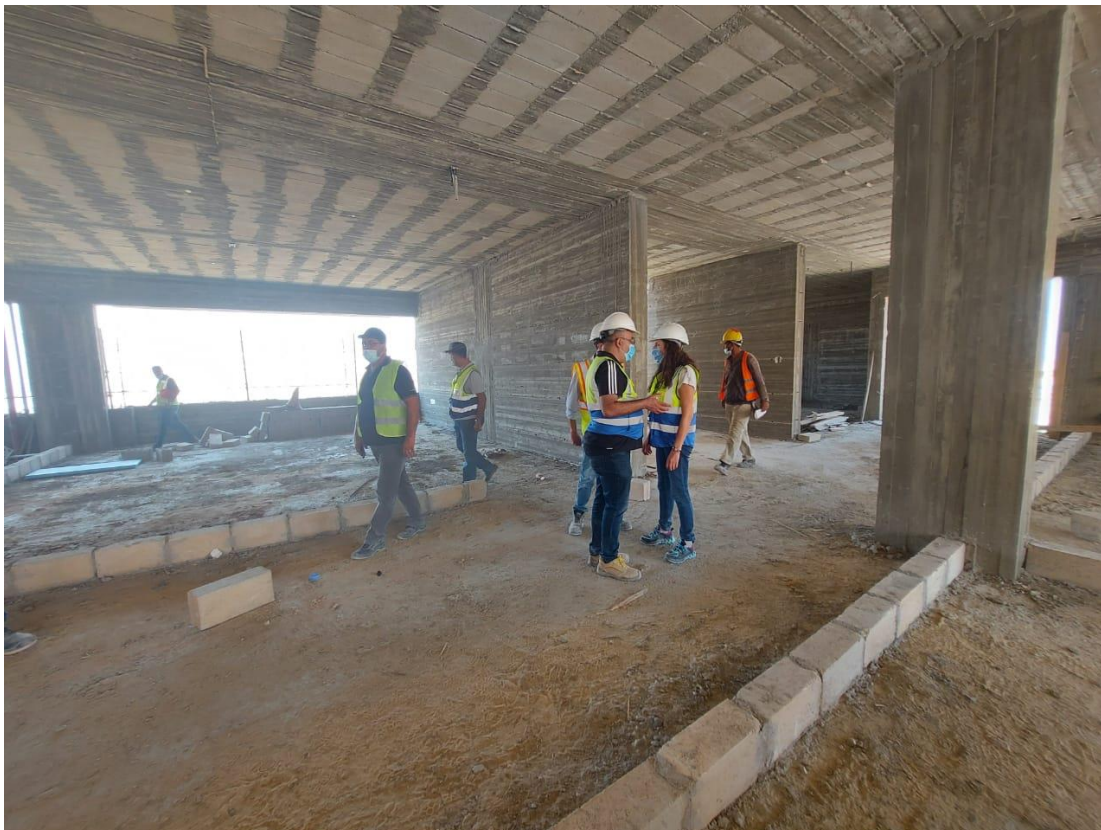
(Figure: 15)

Observing first course of blockwork-second floor zone "A"
