SKEP III Home Office Support Site Visit Report

Consultant	Wahib Medanat Consultant Engineer	Rep No.	21-06122021
Contractor	Dijlah Establishment Constr. Contracting	Tender No.	(11/2019/USAID/SKEP/3/S) Schools for a Knowledge Economy Project (SKEP) - Phase (3) Package (1, 2)
Site Name	Hay Al Iskan Basic Mixed School- Jerash	Day/ Date	Mon. 06/12/2021
Duration of Project	450 Calendar Days	Total Project Budget	8,314,983.735 JD

Visit Notes

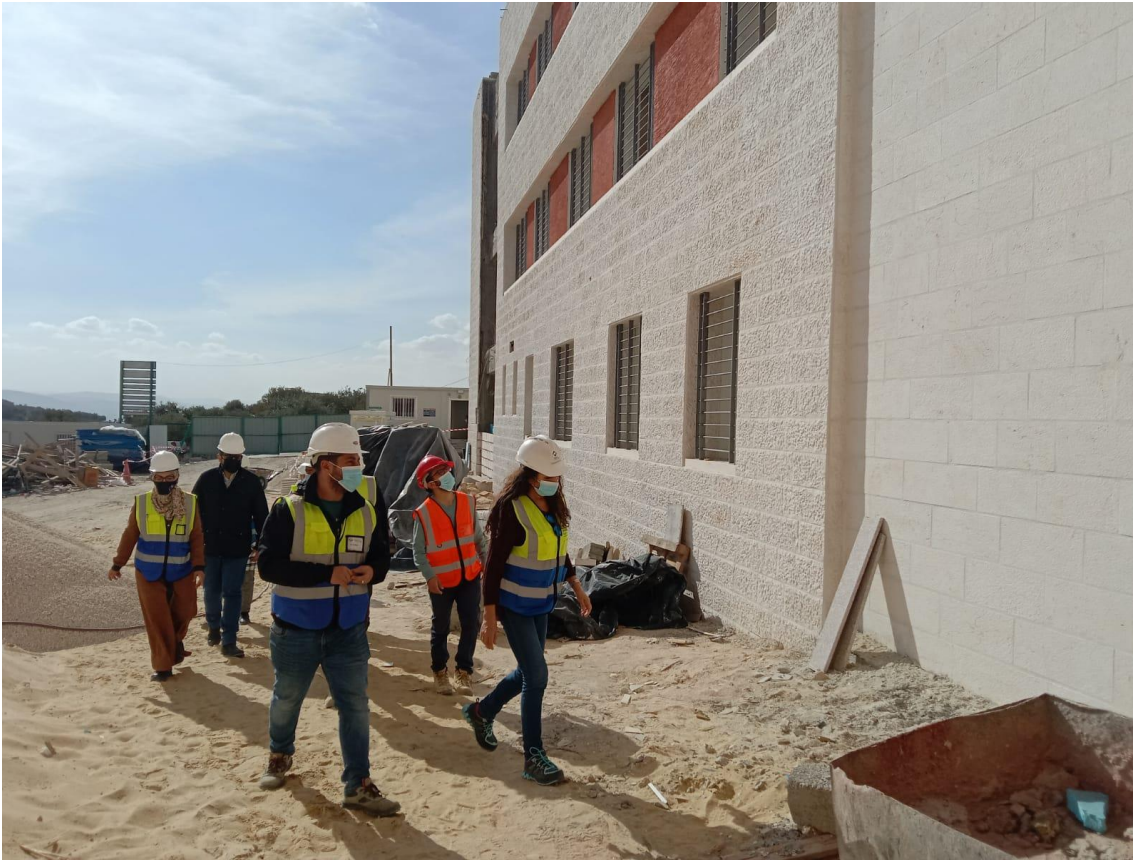
(Figure: 04)

The executed stones for facades have been inspected in general and remarks have been given to the Contractor to rectify where necessary

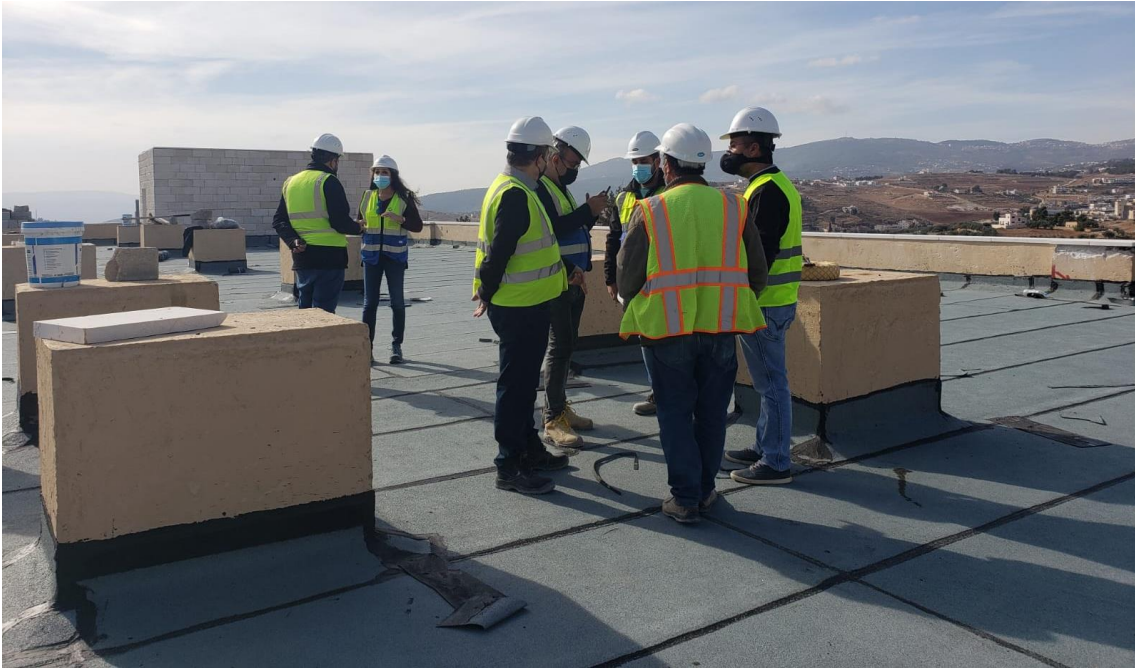
(Figure: 06)

It was observed that the Contractor has completed part of works related to the waterproofing layers for the roof. The executed works have been checked and also the continuation of work by the Contractor has been discussed

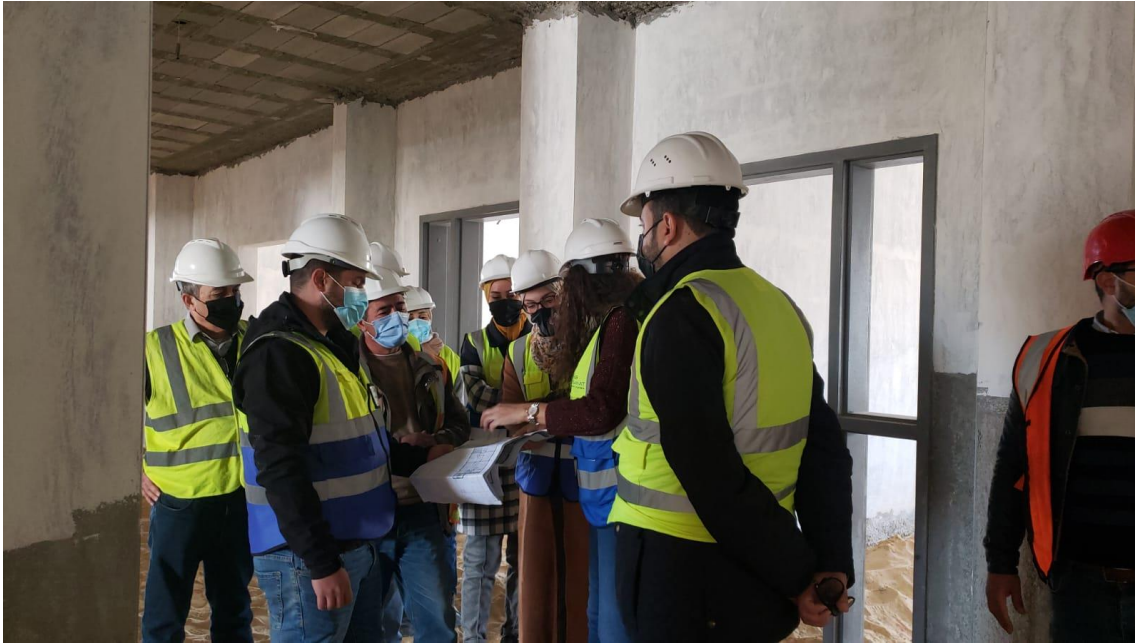
(Figure: 08)

No.	Description
3	Teething was observed in the granite tiling of staircases' landing. The Contractor was instructed was instructed to rectify.
4	It was observed that the workshop drawings for floor tiles have been prepared in accordance to the design drawings without considering executed works. Upon that, the Engineer instructed the Contractor to modify the drawings to match with the actual status on the site.
5	It was observed that the Contractor started with removing the executed wall tiles in some facilities rejected by the Engineer due to defects mainly that the vertical joint line over the middle strip is not in line with those below strip. The differences reaches 10cm.
6	The steel protection for windows executed in the site was observed. The Engineer informed the Contractor that the protection for number of windows (at the recess) are wrongly installed since the dimensions at the design drawings and the approved workshop drawings are not considered. This will lead to fix the aluminum sections wrongly and that cannot be accepted.

The Engineer instructed the Contractor to modify the floor tiles shop drawings to match the actual status on the site

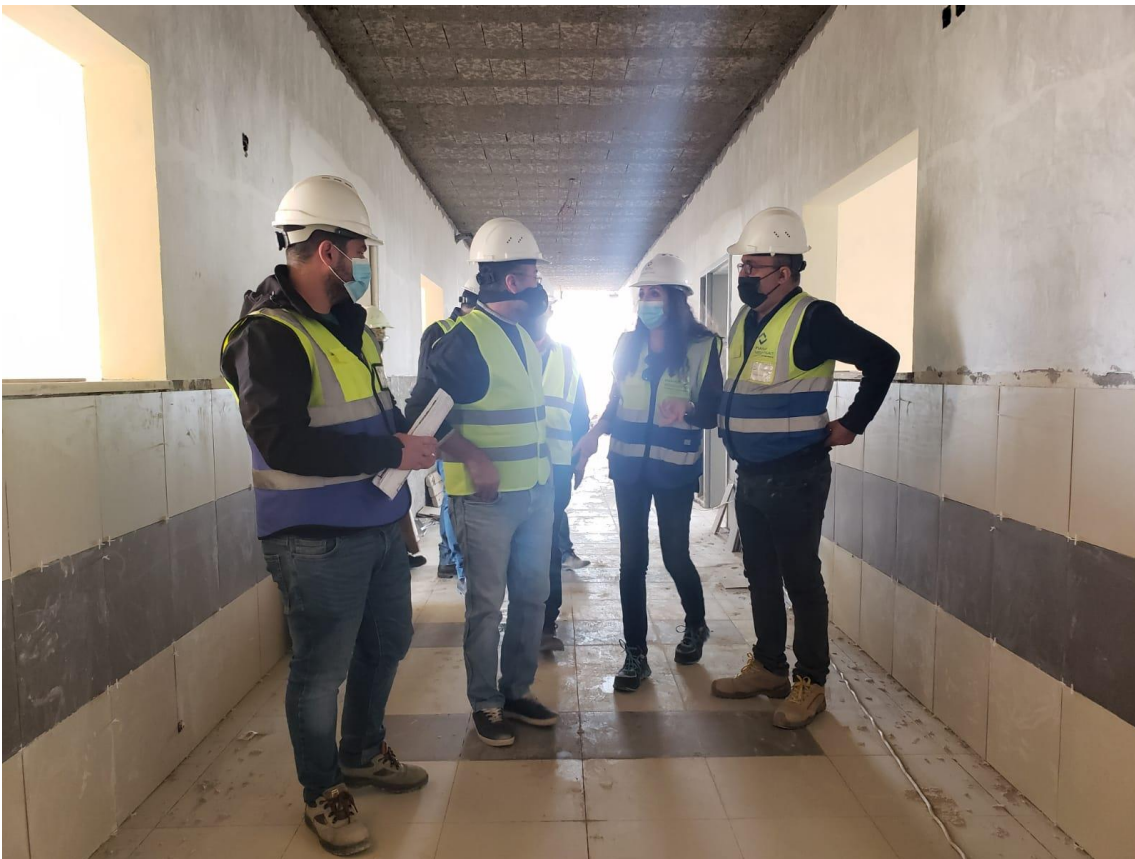
(Figure: 09)

The installed porcelain tiles for the corridor was inspected in general by the supervision team

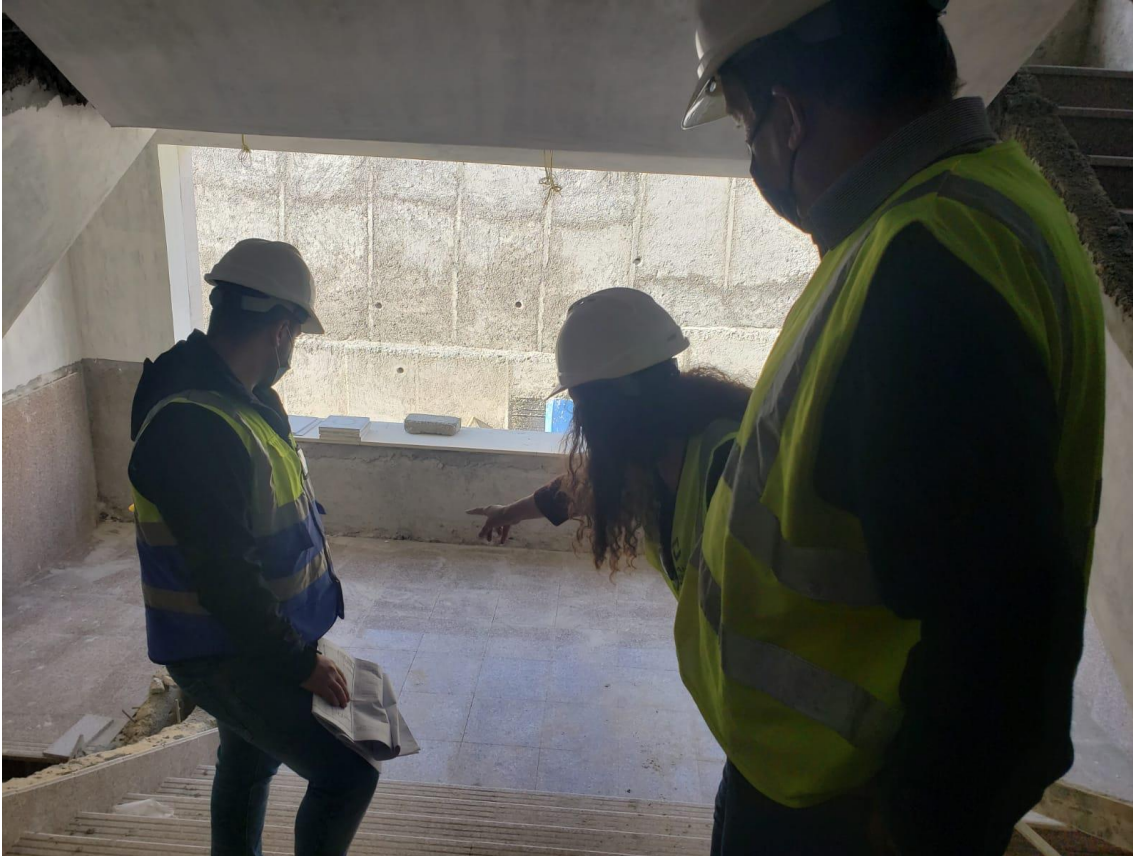
(Figure: 10)

Teething was observed in the granite tiling of staircases' landing. The Contractor was instructed to rectify

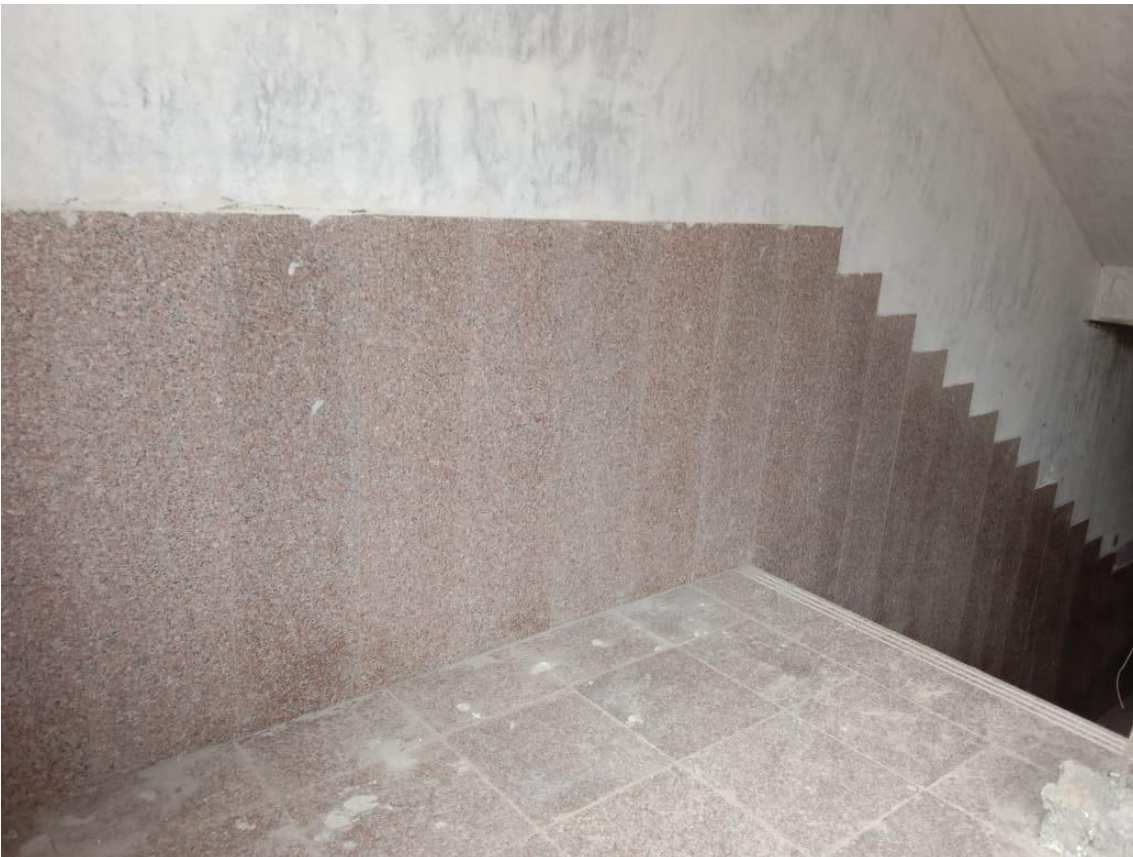
(Figure: 11)

It was observed that the Contractor started with fixing the granite tiles for staircases

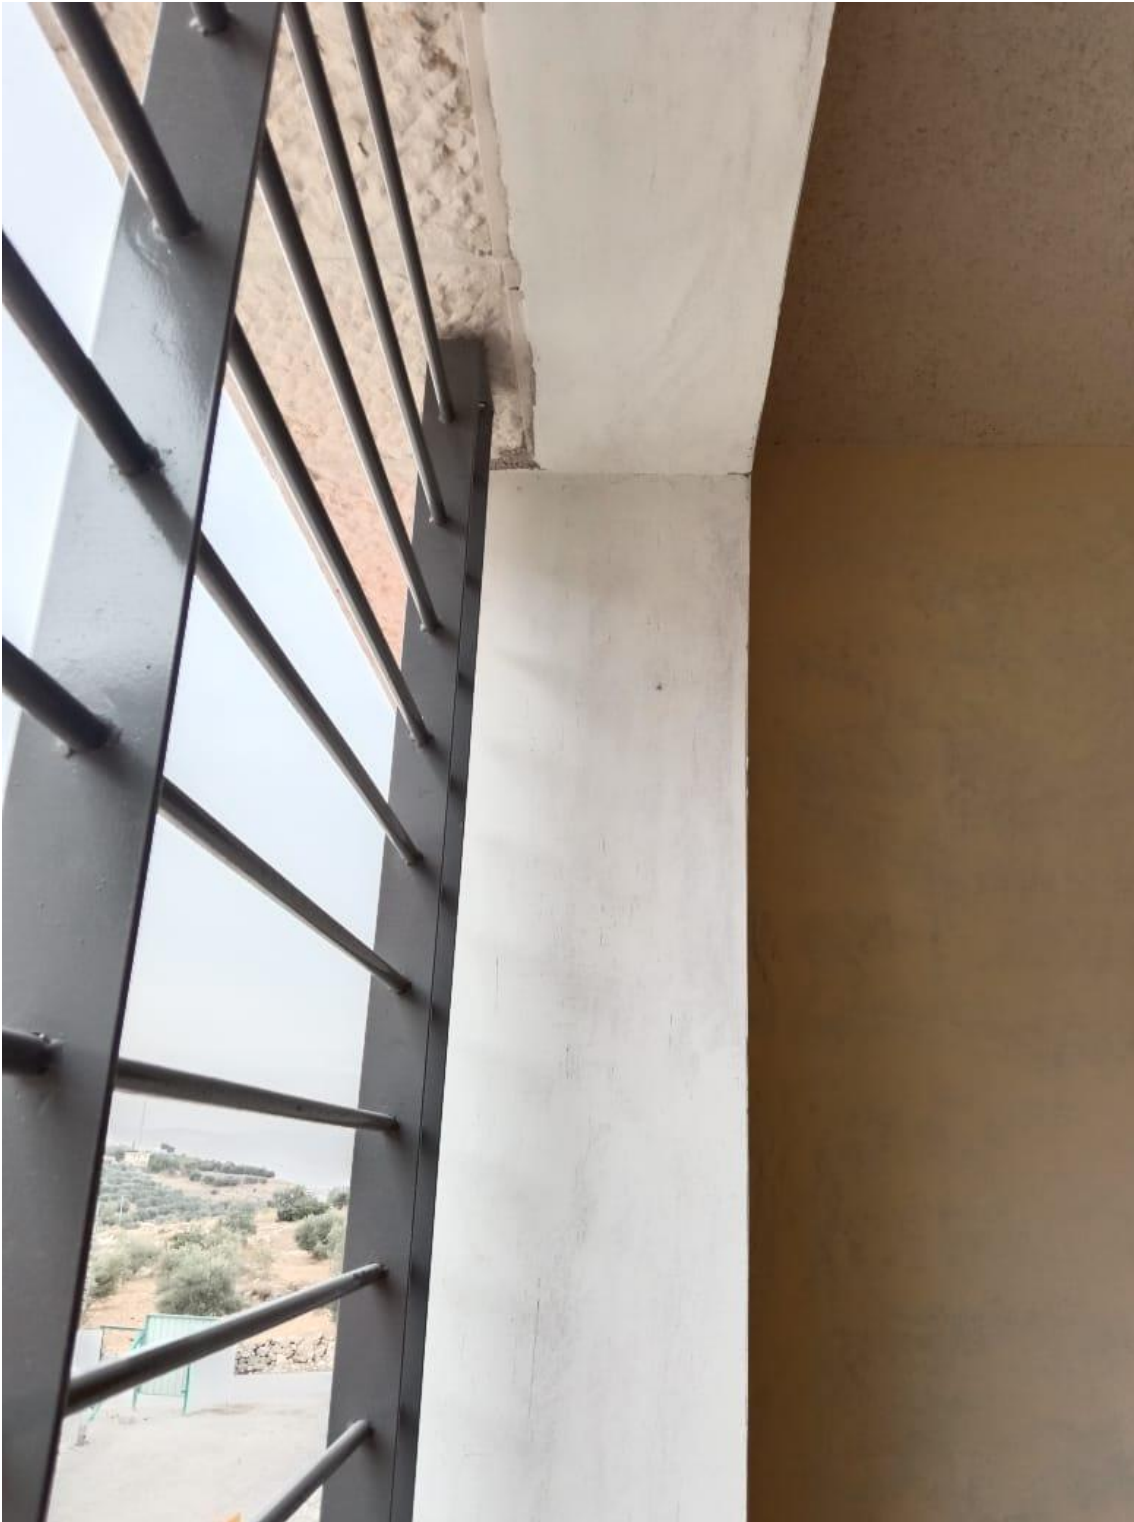
(Figure: 12)

The steel protection for windows executed in the site was observed. The Engineer informed the Contractor that the protection for number of windows (at the recess) are wrongly installed since the dimensions at the design drawings and the approved workshop drawings are not considered. This will lead to fix the aluminum sections wrongly and that cannot be accepted

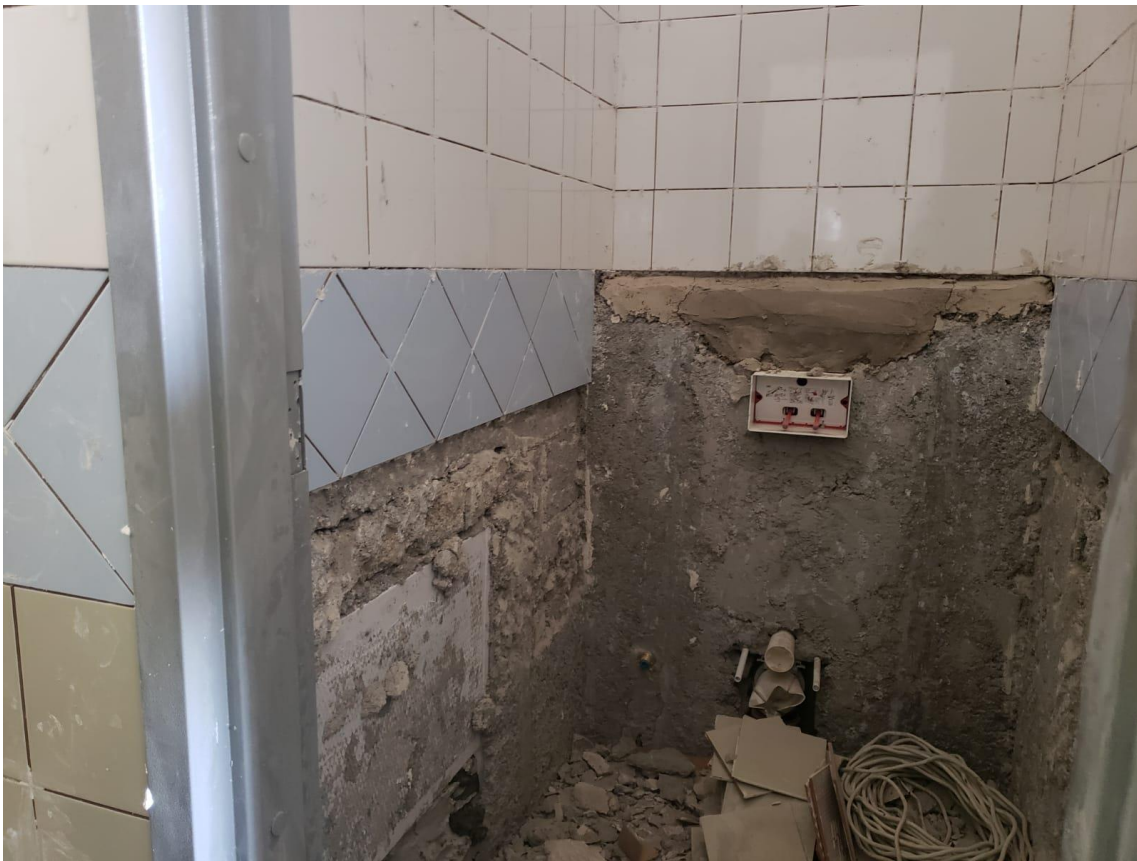
(Figure: 14)

It was observed that the Contractor started with removing the executed wall tiles in some facilities rejected by the Engineer due to defects mainly that the vertical joint line over the middle strip is not in line with those below strip. The differences reaches 10cm.

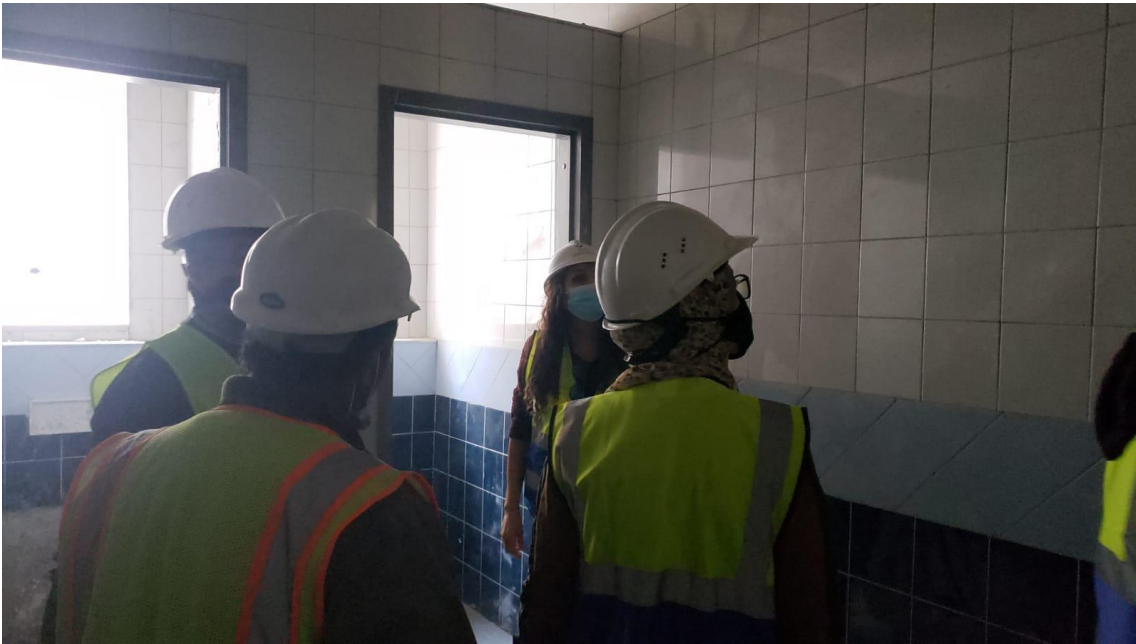
(Figure: 15)

The executed wall tiles have been observed in general and defects were observed in the tiling around the door frames. Defected tiles shall be replaced correctly

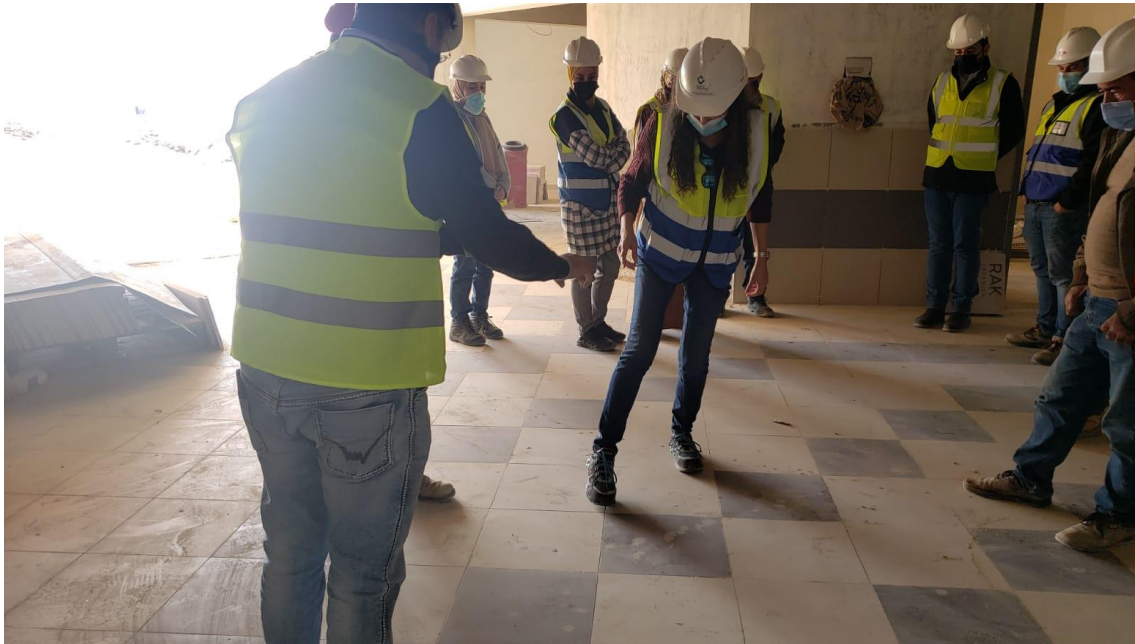
(Figure: 17)

Tiles were found uneven and sever defects in teething were noticed. The Engineer confirmed his rejection of most of the executed parts of floor tiling and stressed on him to start with rectification and the Contractor agreed to do so
