Consultant	Wahib Medanat Consultant Engineer	Rep No.	21-02012022
Contractor	Dijlah Establishment Constr. Contracting	Tender No.	(11/2019/USAID/SKEP/3/S) Schools for a Knowledge Economy Project (SKEP) - Phase (3) Package (1, 2)
Site Name	Hay Al Iskan Basic Mixed School- Jerash	Day/ Date	Sun. 02/01/2022
Duration of Project	450 Calendar Days	Total Project Budget	8,314,983.735 JD

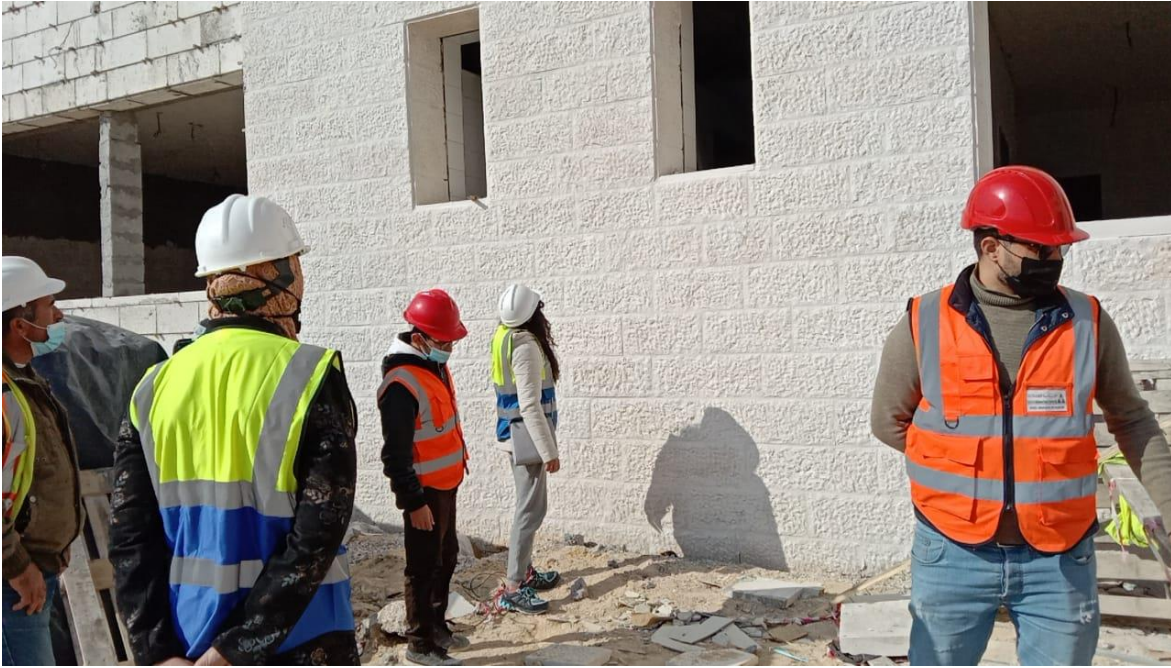
(Figure: 03)

The stone façades were inspected and defects in stone have been observed the Contractor was requested again to rectify

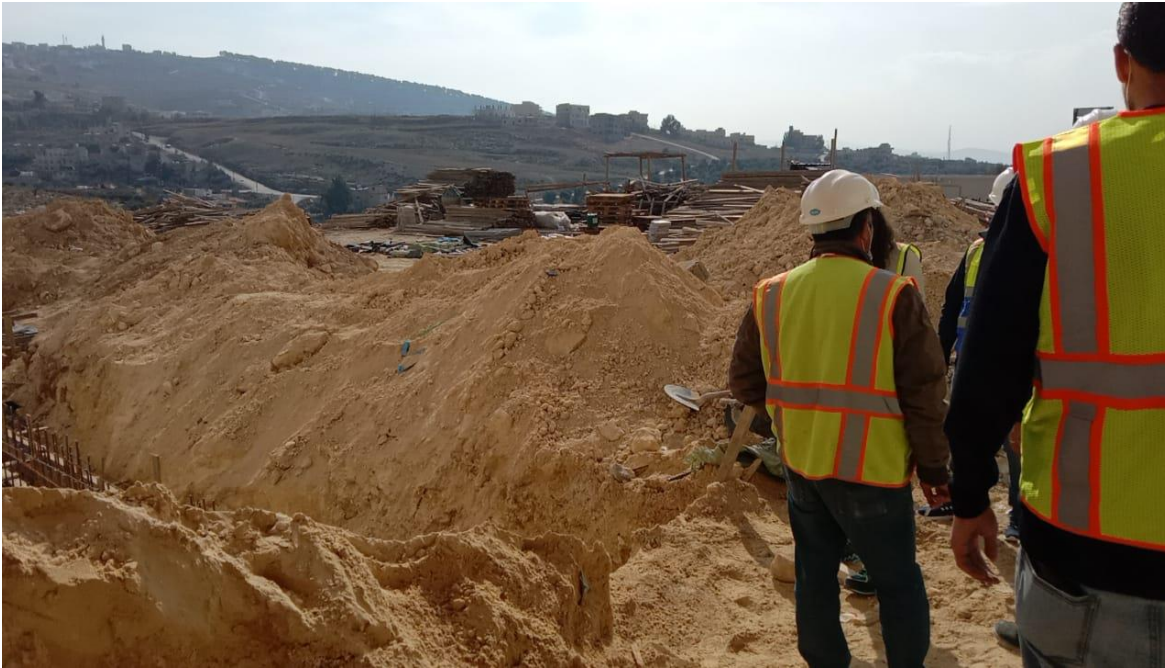
(Figure: 05)

The concrete casting for external works have been inspected

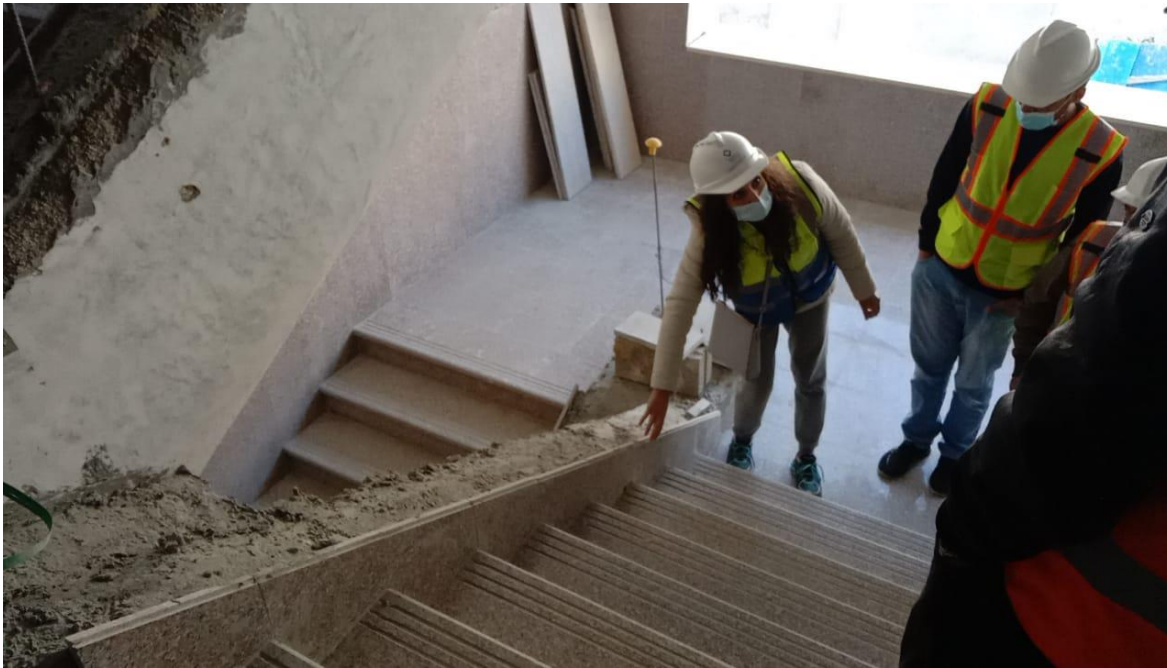
(Figure: 07)

The team observed that the granite pieces for staircases (wall granite and skirting) have a major defect since the cutting off to the required size is not done properly. The way of cutting should be factory made to result in sharp edges without any teething

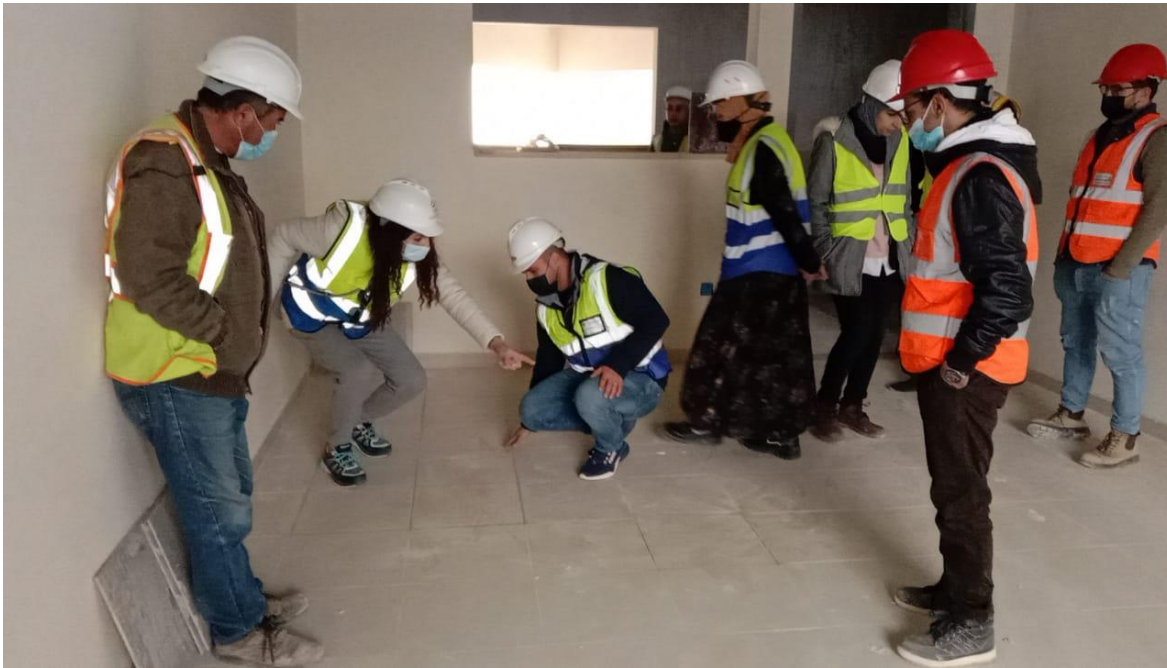
(Figure: 09)

The action of the Contractor to rectify the defective porcelain floor tiles was inspected. It was observed that the Contractor has not managed to rectify the defects and the previously observed defects still exist (uneven, Teething)

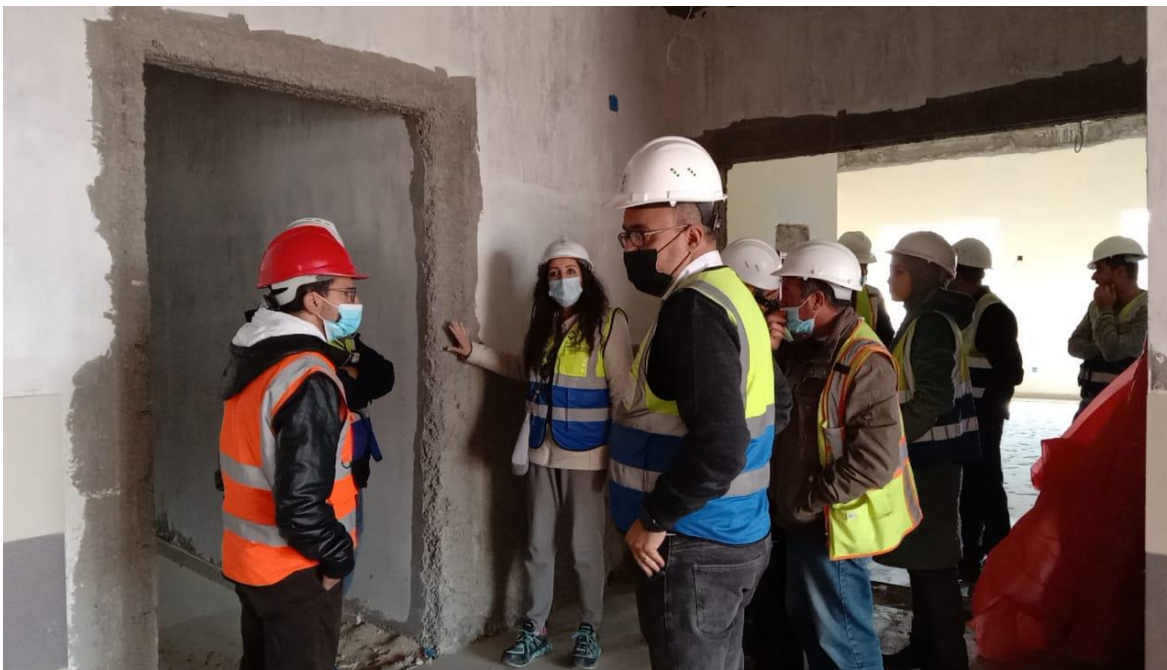
(Figure: 12)

The frames of fire rated doors still have not been delivered to the site

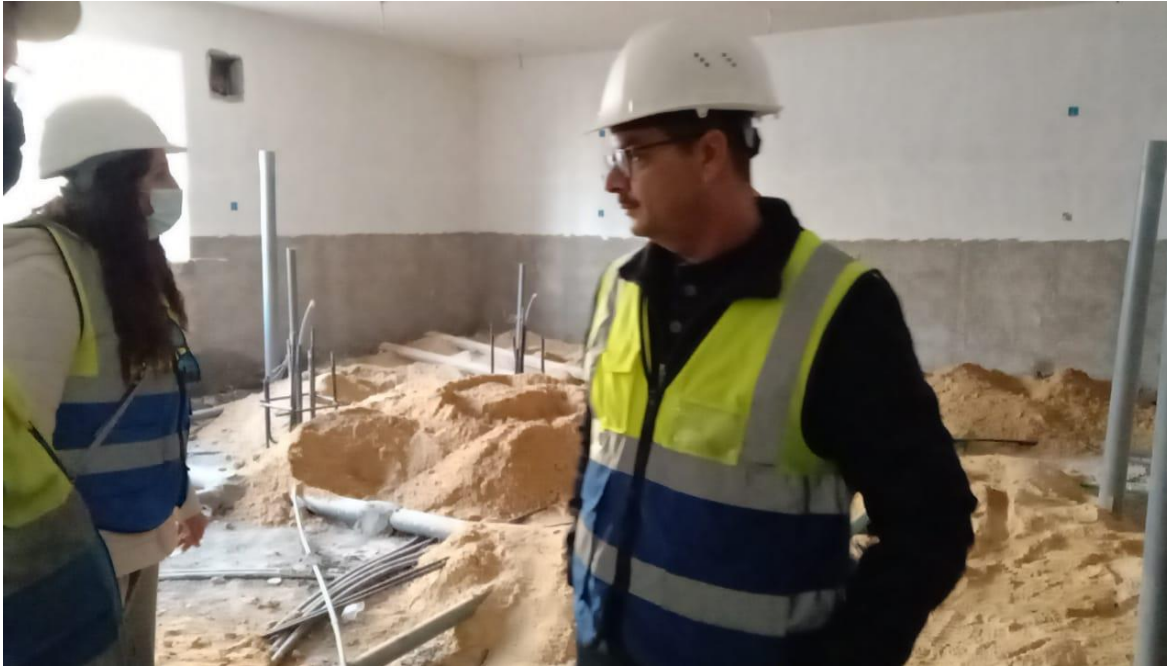
(Figure: 13)

The ongoing electro-mechanical works have been inspected in the presence of our electrical engineer

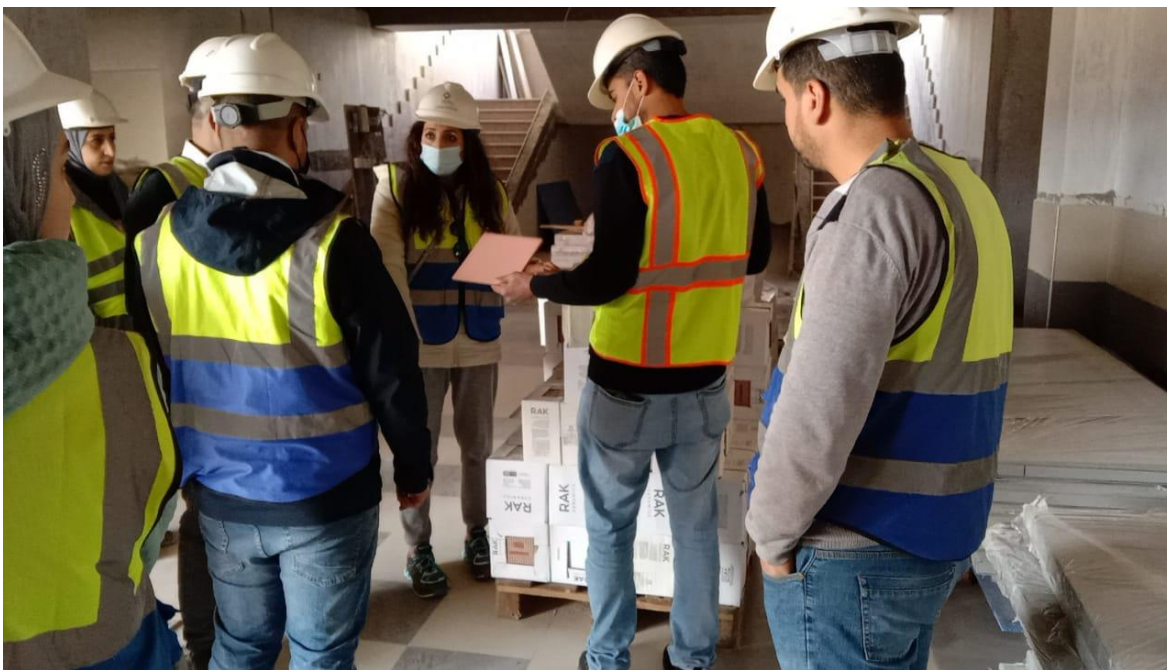
(Figure: 14)

The delivered tiles quantities have been checked by the supervision team

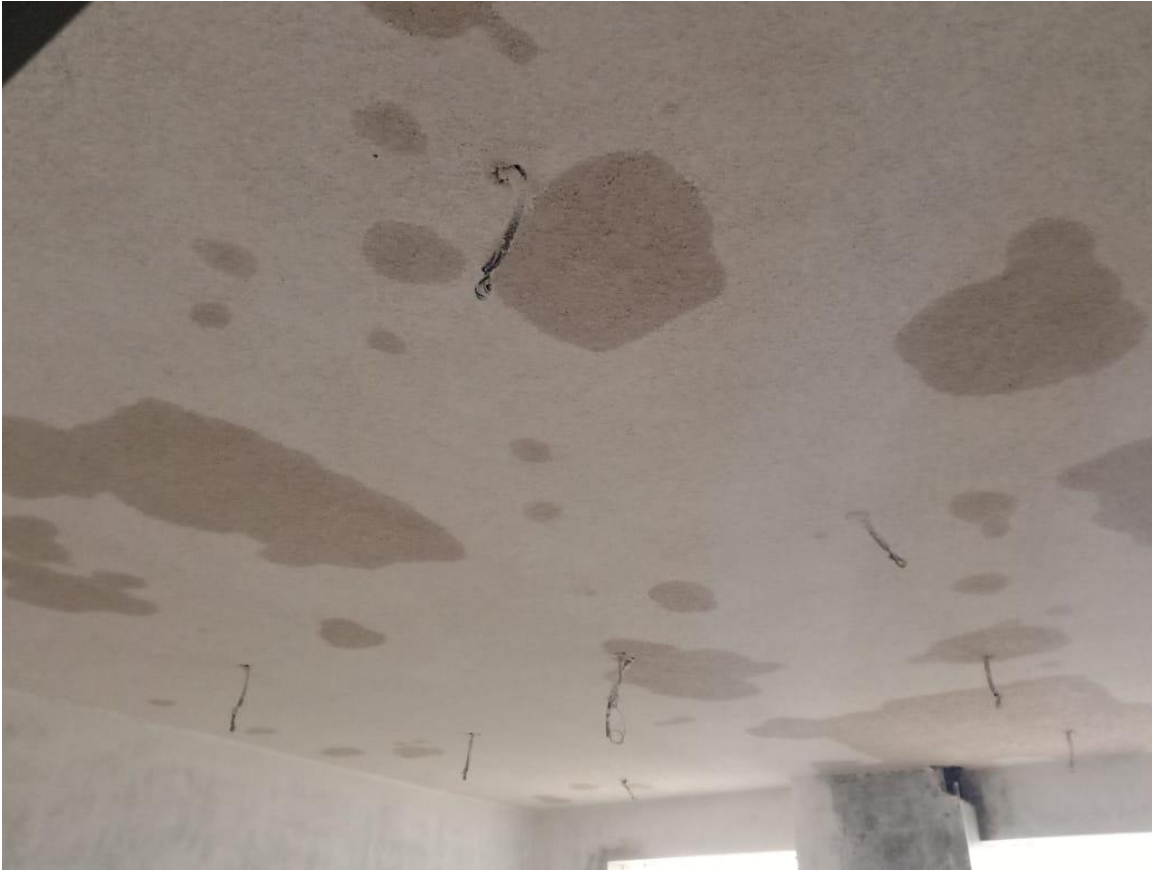
(Figure: 15)

During the water penetration test for the roof, the water entered to the pump room and penetrated the higher floor ceiling which caused damages to the painting work
