Consultant Wahib Medanat Consultant Engineers Rep No. QC-12 06

Site Name Al Khansa'a Basic Mixed - Balga **Date** 14 / 09 / 2021

Package Package 1

Descr	iption	of	Non-	
Co	nform	an	ce

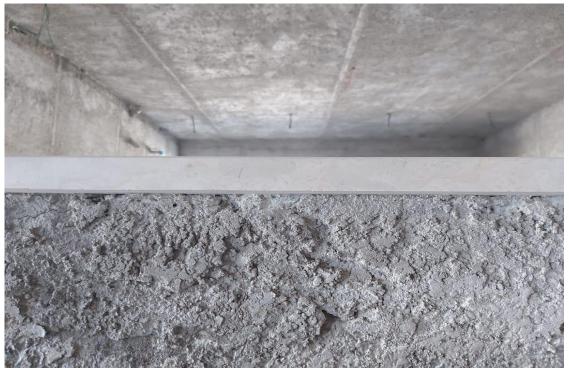
- 1. Window sill bottom edge is toothed and not straight.
- 2. No beads installed at corner for tiling work, no. of electrical outlets is not located right.
- 3. The level of window sill is not at design level to avoid conflict its design level precisely and without created groove at its bottom.
- 4. The sheet waterproofing for septic tank and water tank are exposed for long time.

Defects in the sill and installation at lower level

- 1. To be replaced.
- 2. Plastic beads should be installed at external corners. Outlets to be re-located.
- 3. The sill should be at its with furniture and corridor cabinets. A groove should be created below.
- 4. Cartonal should be fixed to protect the sheets and backfilling should be executed.

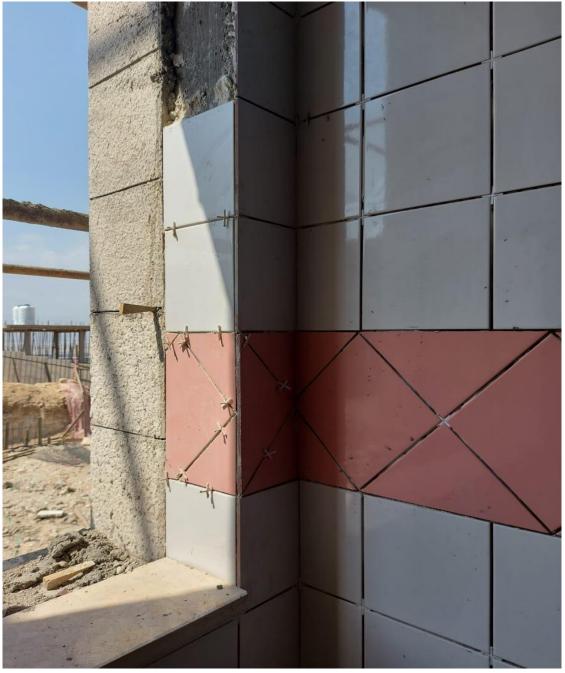
No tiles beads used in the tiling

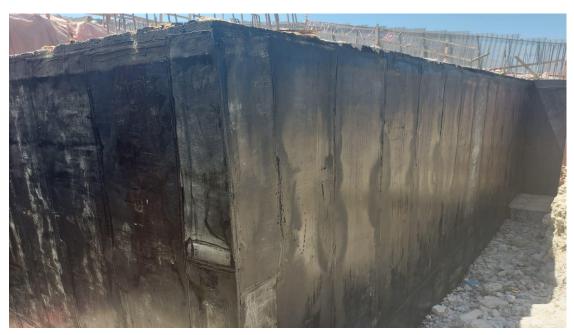
Unprotected waterproofing sheets for watertank and septic tank

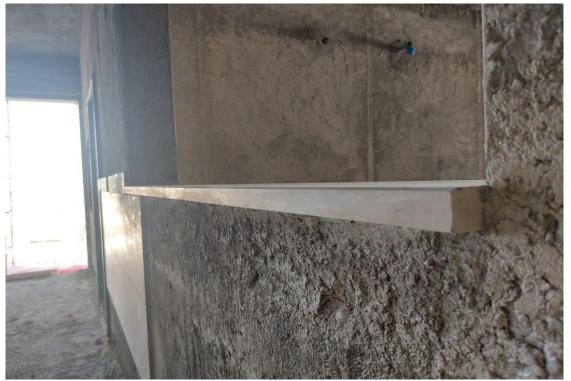
Complied sill at the right level installed

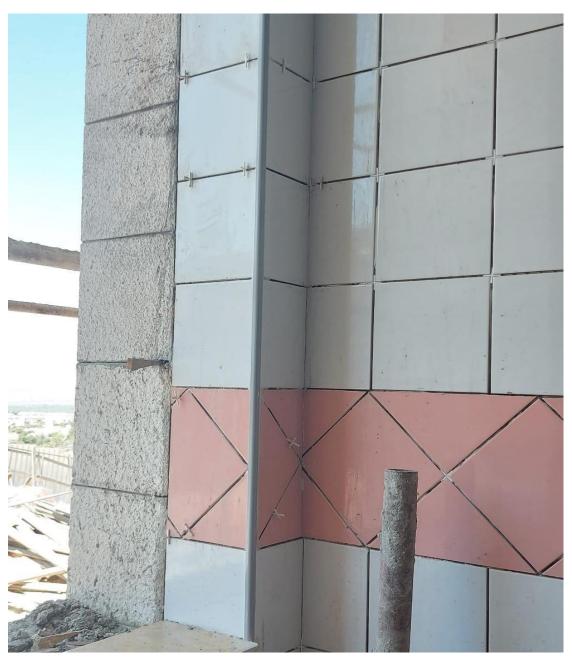
Installing corner beads for tiling works

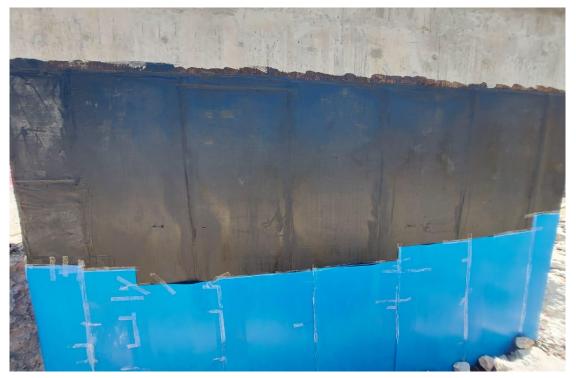
Protection for waterproofing for watertank and septic tank

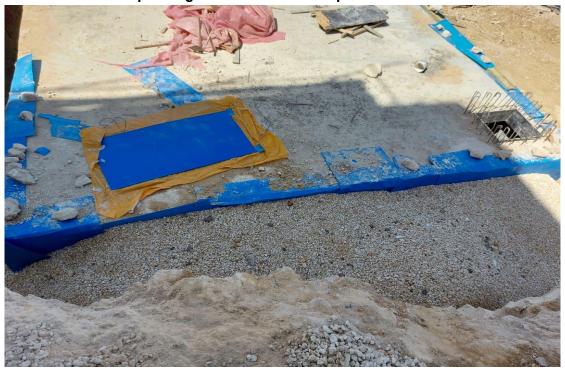
Back-filling for watertank and septic tank
