SKEP III Home Office Support Site Visit Report

Consultant	Wahib Medanat Consultant Engineer	Rep No.	23-12102021
Contractor	Dijlah Establishment Constr. Contracting	Tender No.	(11/2019/USAID/SKEP/3/S) Schools for a Knowledge Economy Project (SKEP) - Phase (3) Package (1, 2)
Site Name	Jumana Bint Abit Taleb Basic Mixed School - Jerash	Day/ Date	Tue. 12/10/2021
Duration of Project	450 Calendar Days	Total Project Budget	8,314,983.735 JD

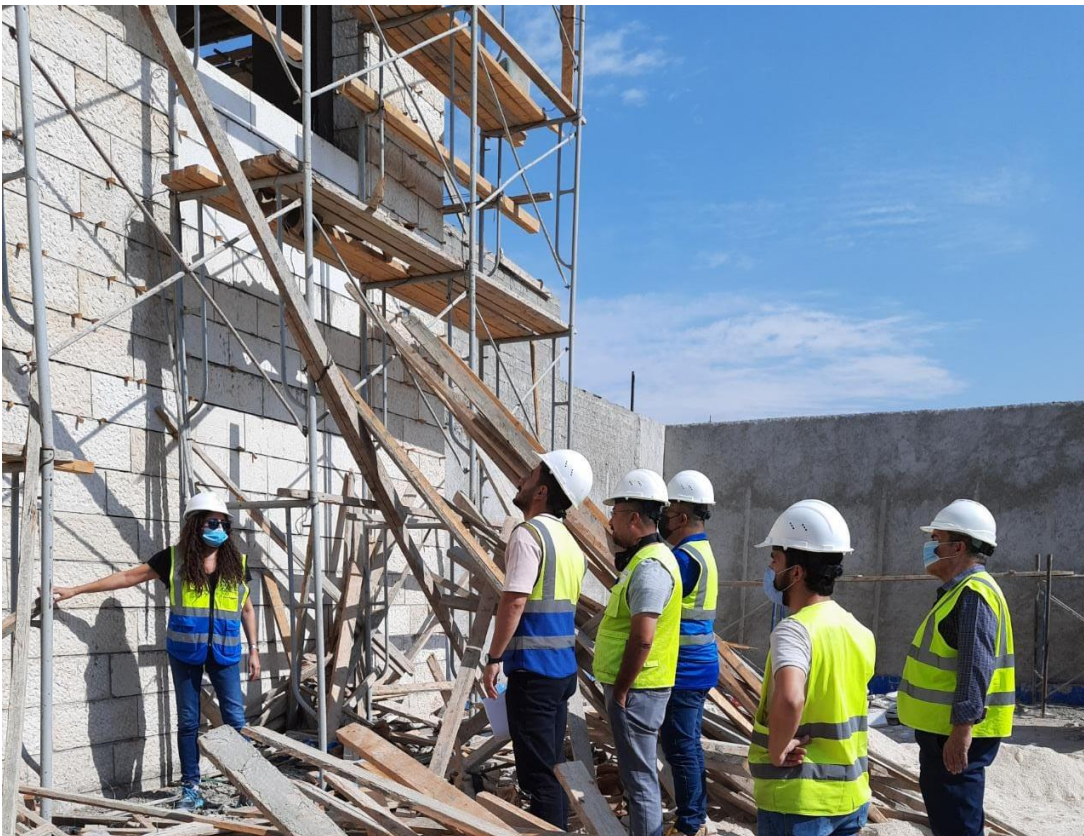
(Figure: 05)

It was observed that the Contractor conducted a cleaning (by sand blasting) to the painted stone part of the façade, but cleaning was not enough and the stone color is still not accepted. Previously, the supervision requested removing the said part but no response was taken by the Contractor.

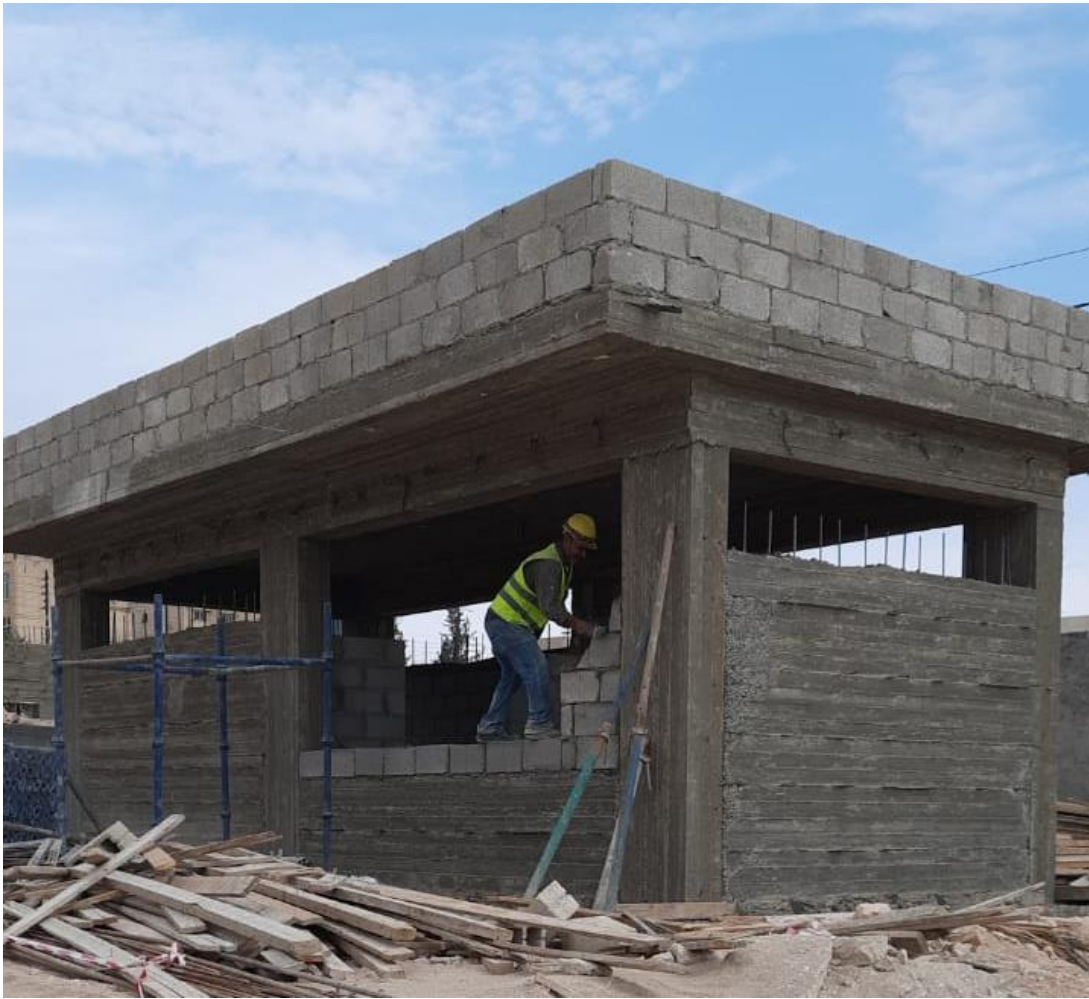
(Figure: 06)

Removing the defected blocks at the guard room according to Engineer representatives' instructions

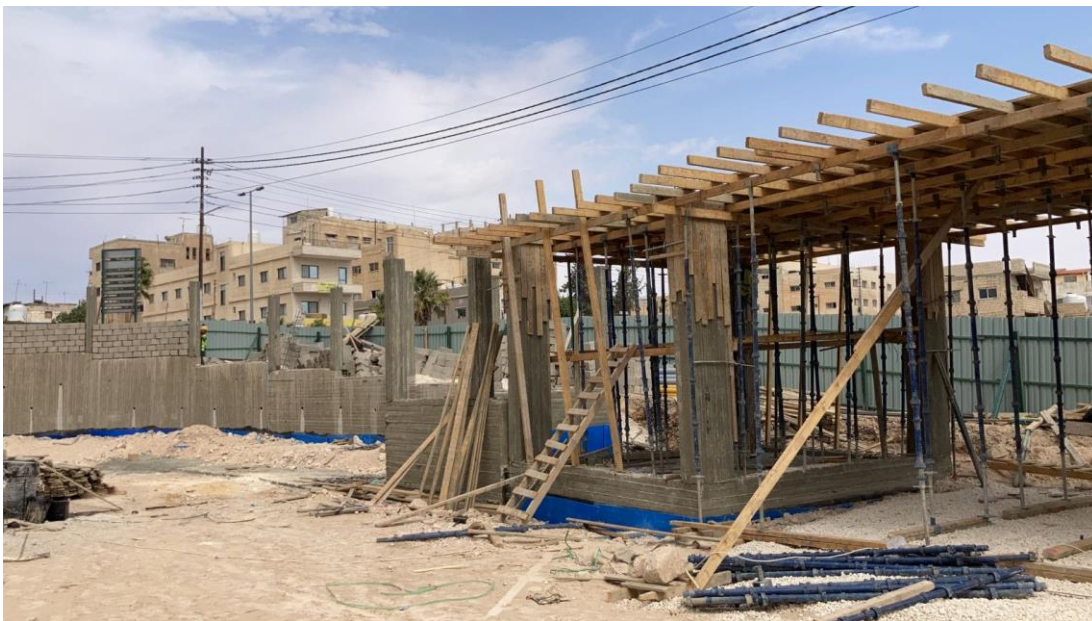
(Figure: 07)

The visiting team observed that the work in the boundary walls has been finished and the Contractor started with the execution of the guard room

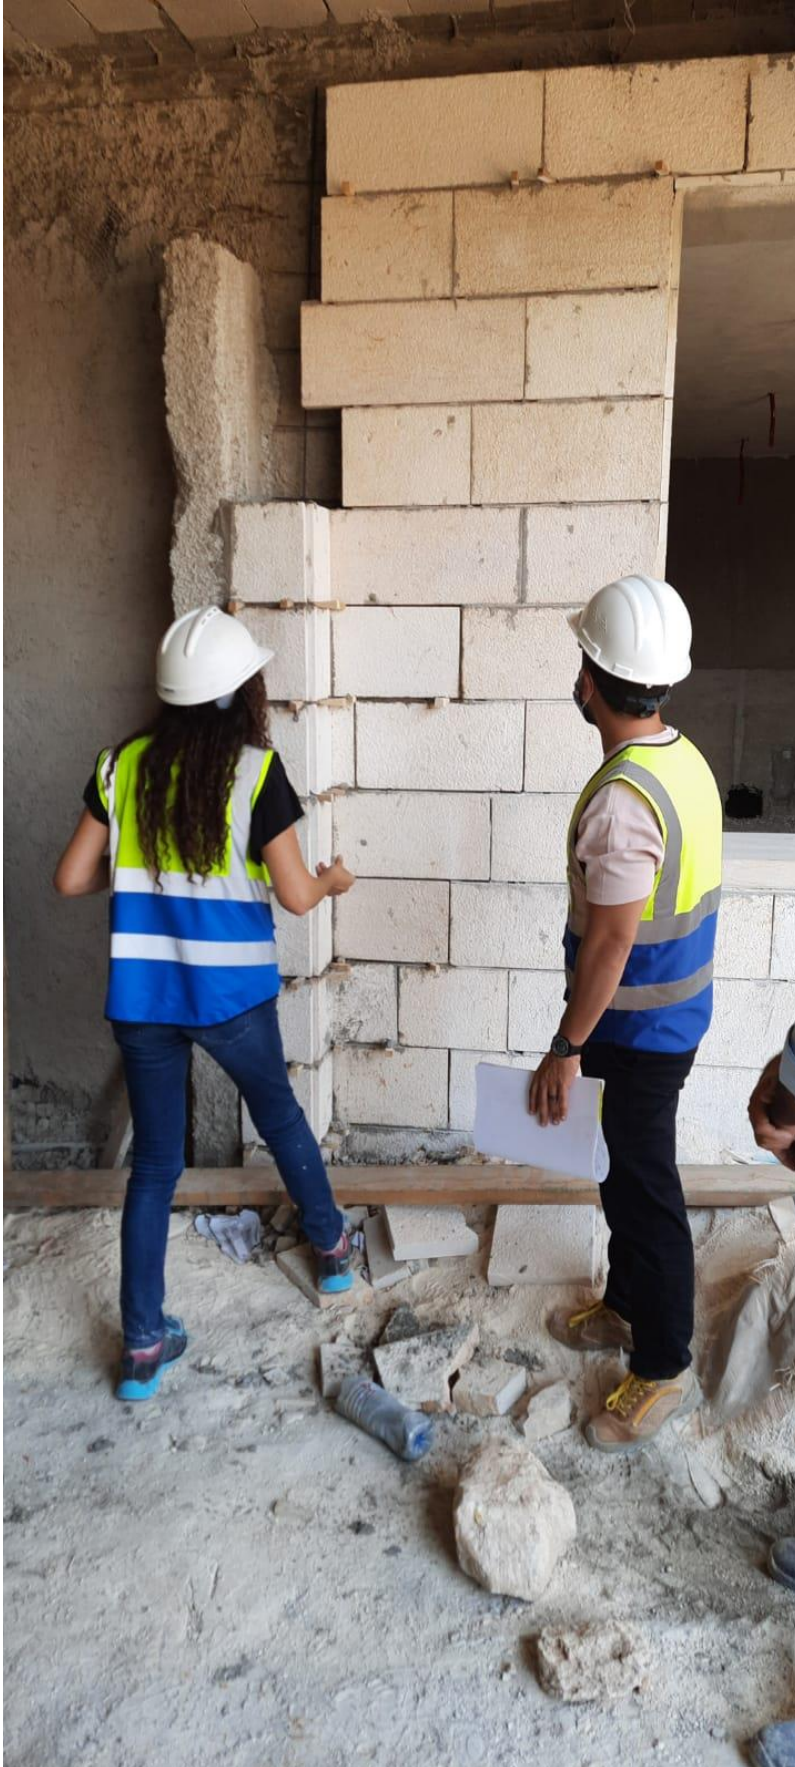
(Figure: 08)

It was observed that the built stones at the entrance are full of defects related to the stone as a material and the irregularity in the spaces between stones, and number of stones have less length than allowed and similar remarks

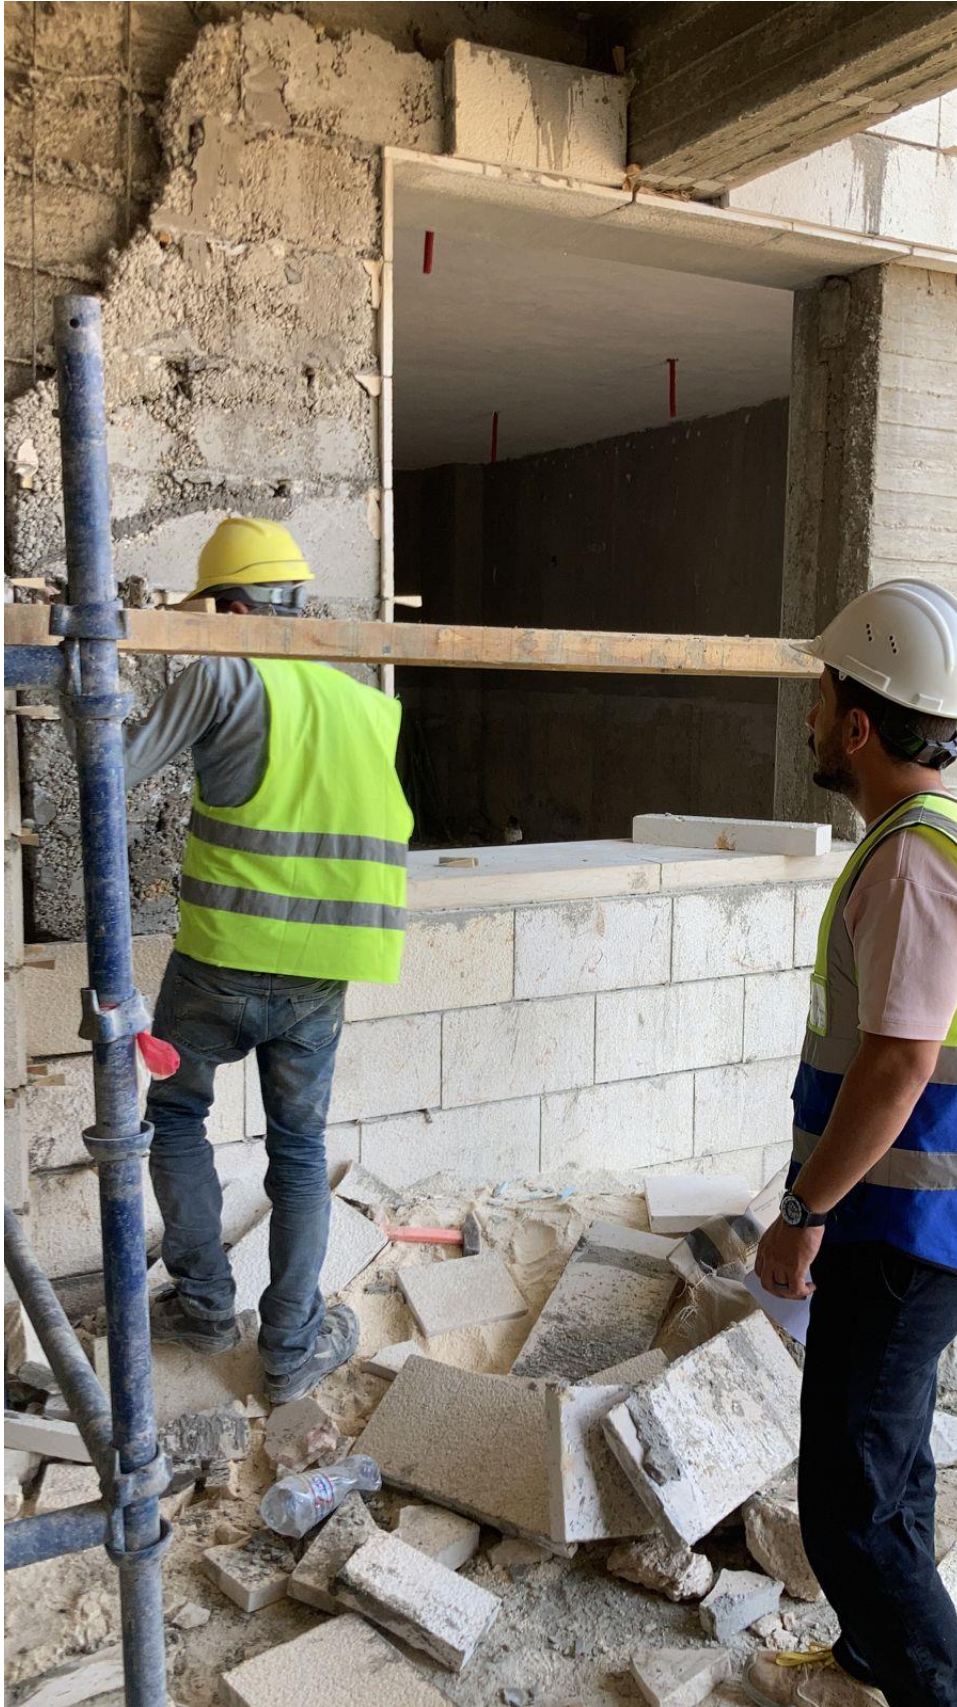
(Figure: 09)

The Contractor responded promptly during the team visit and removed the defected part

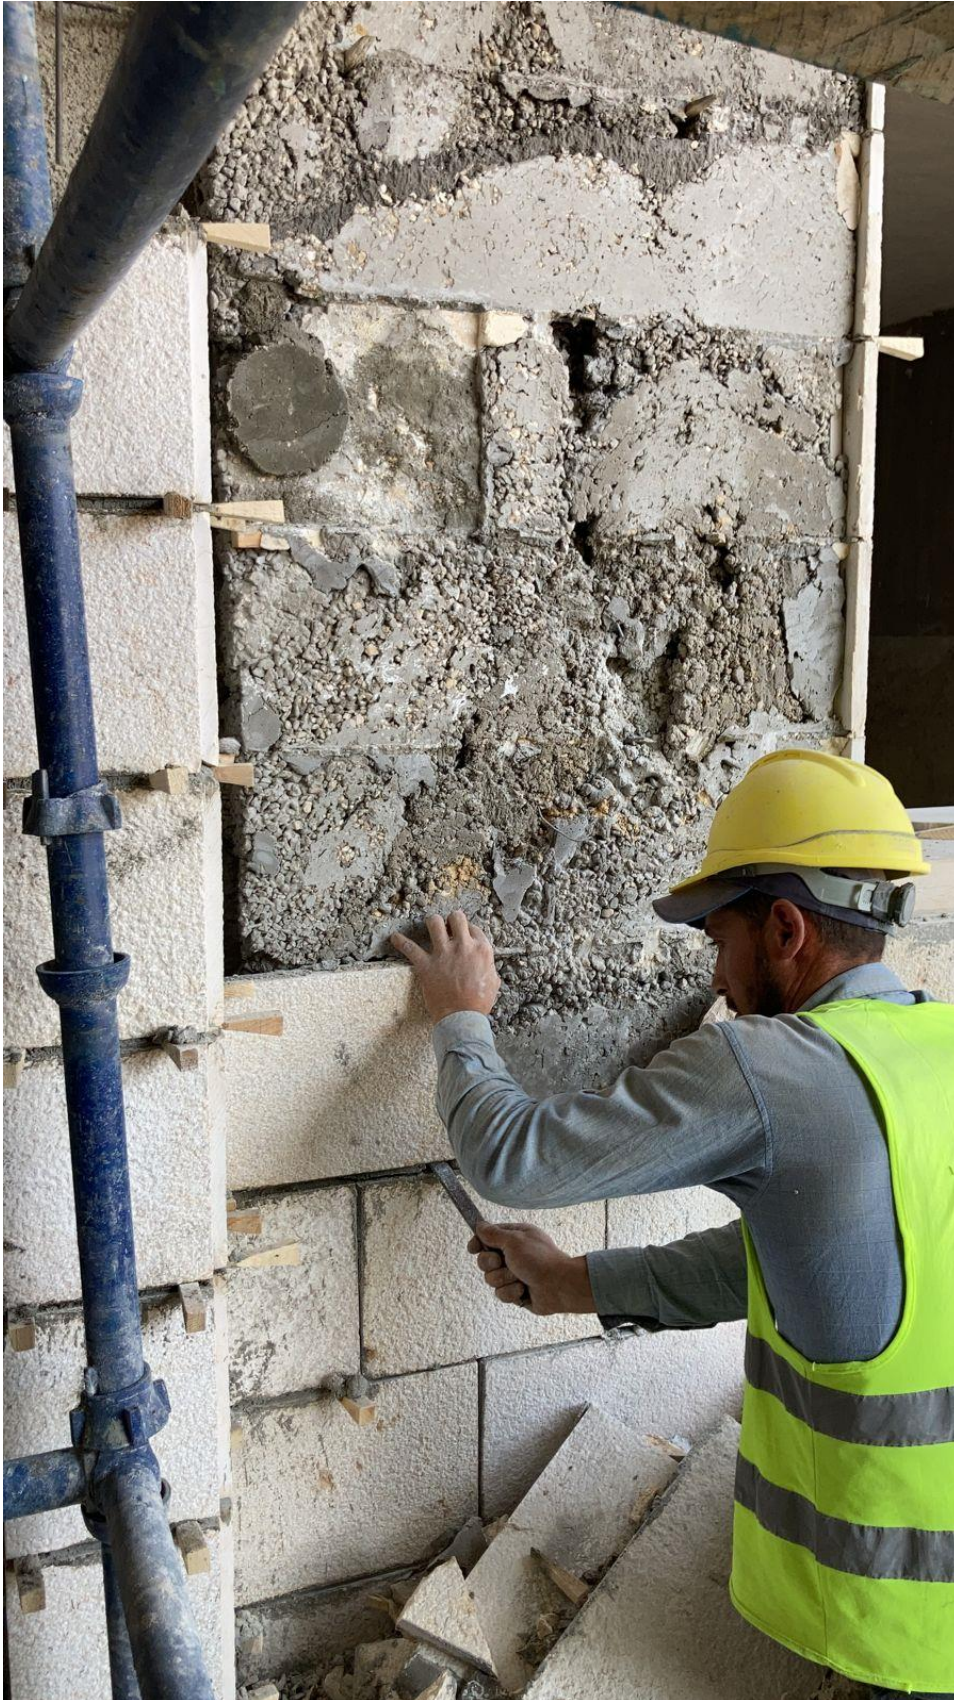
(Figure: 10)

The Contractor responded promptly during the team visit and removed the defected part

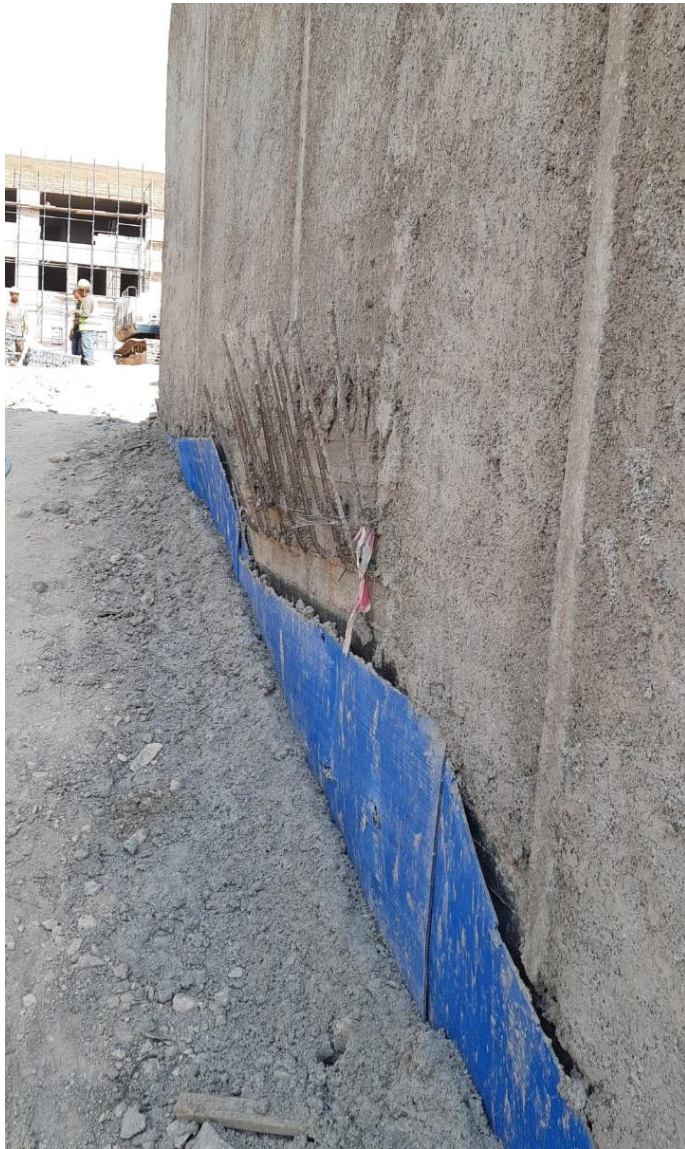
(Figure: 11)

Before applying safety caps on reinforcement steel bars

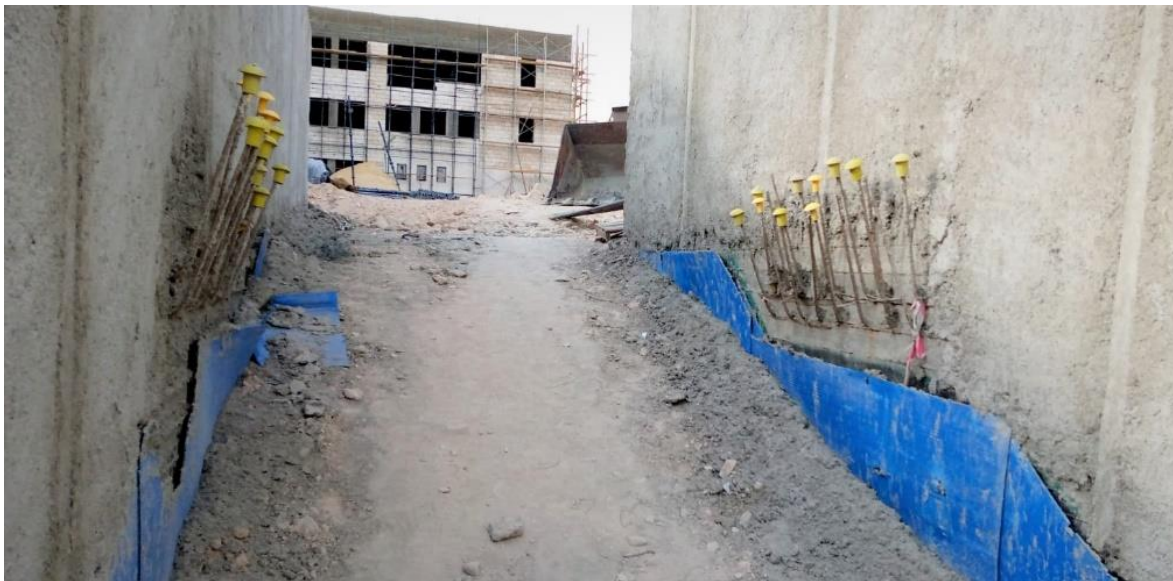
(Figure: 12)

The visiting team observed applying caps at the ends of reinforcement bars and stressed on their importance to insure safety

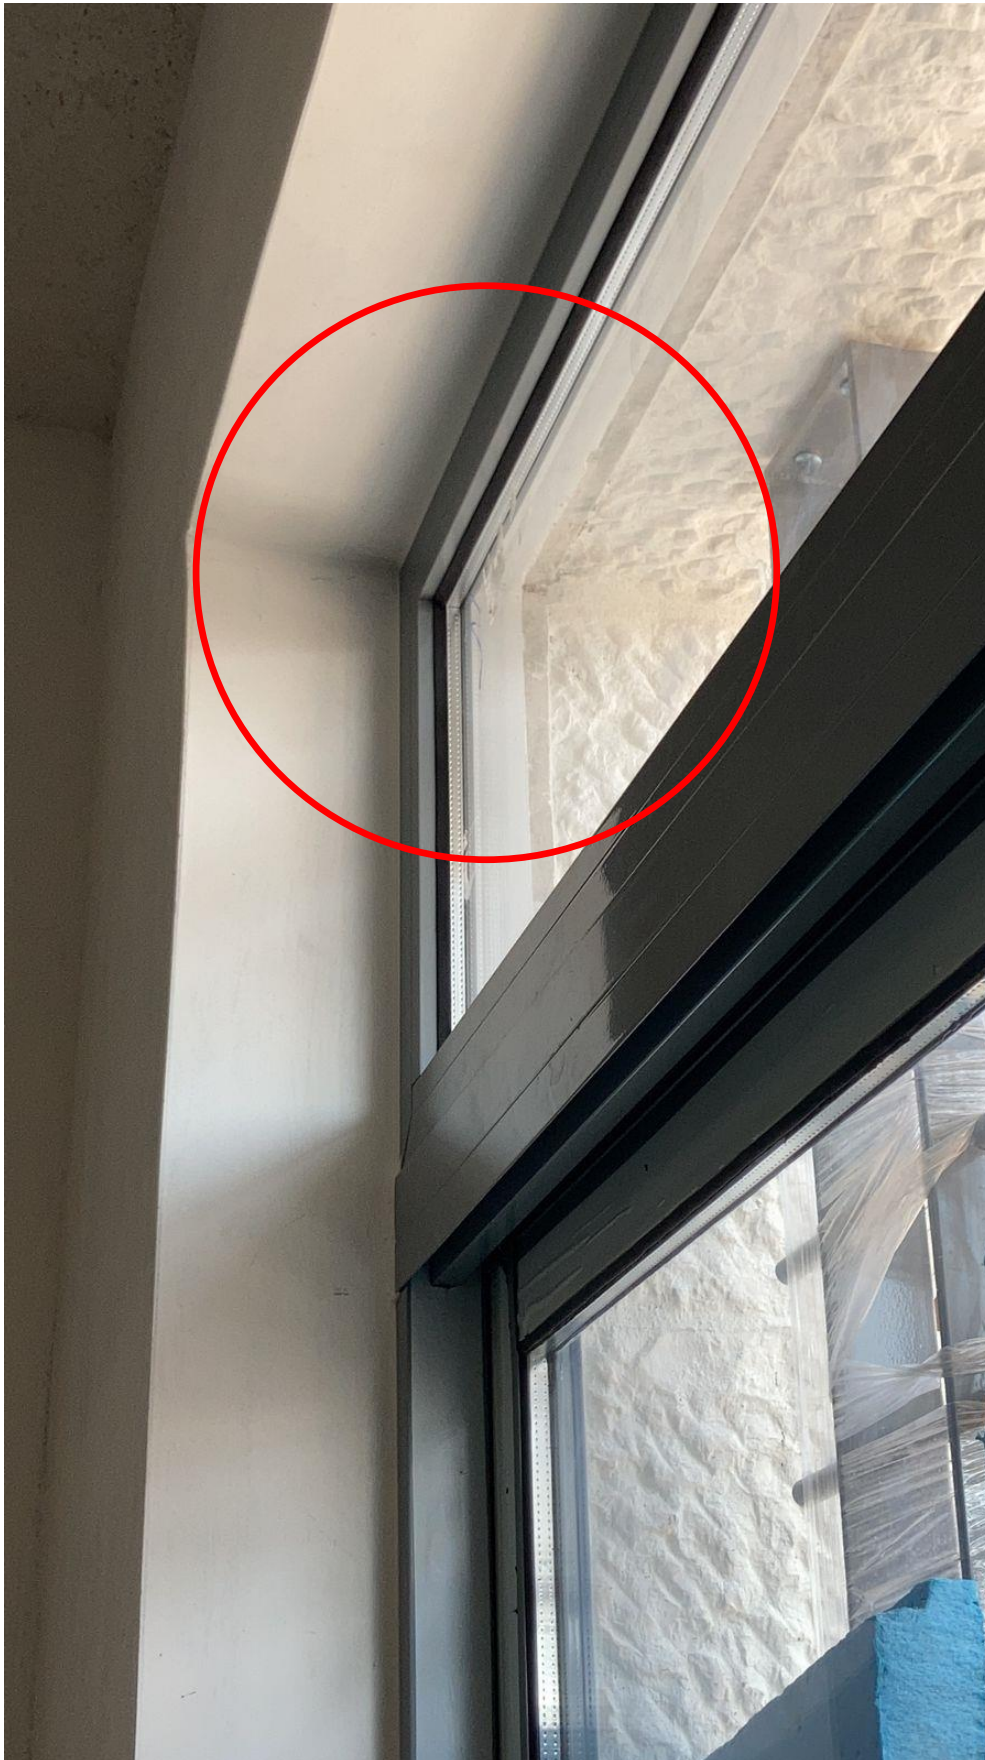
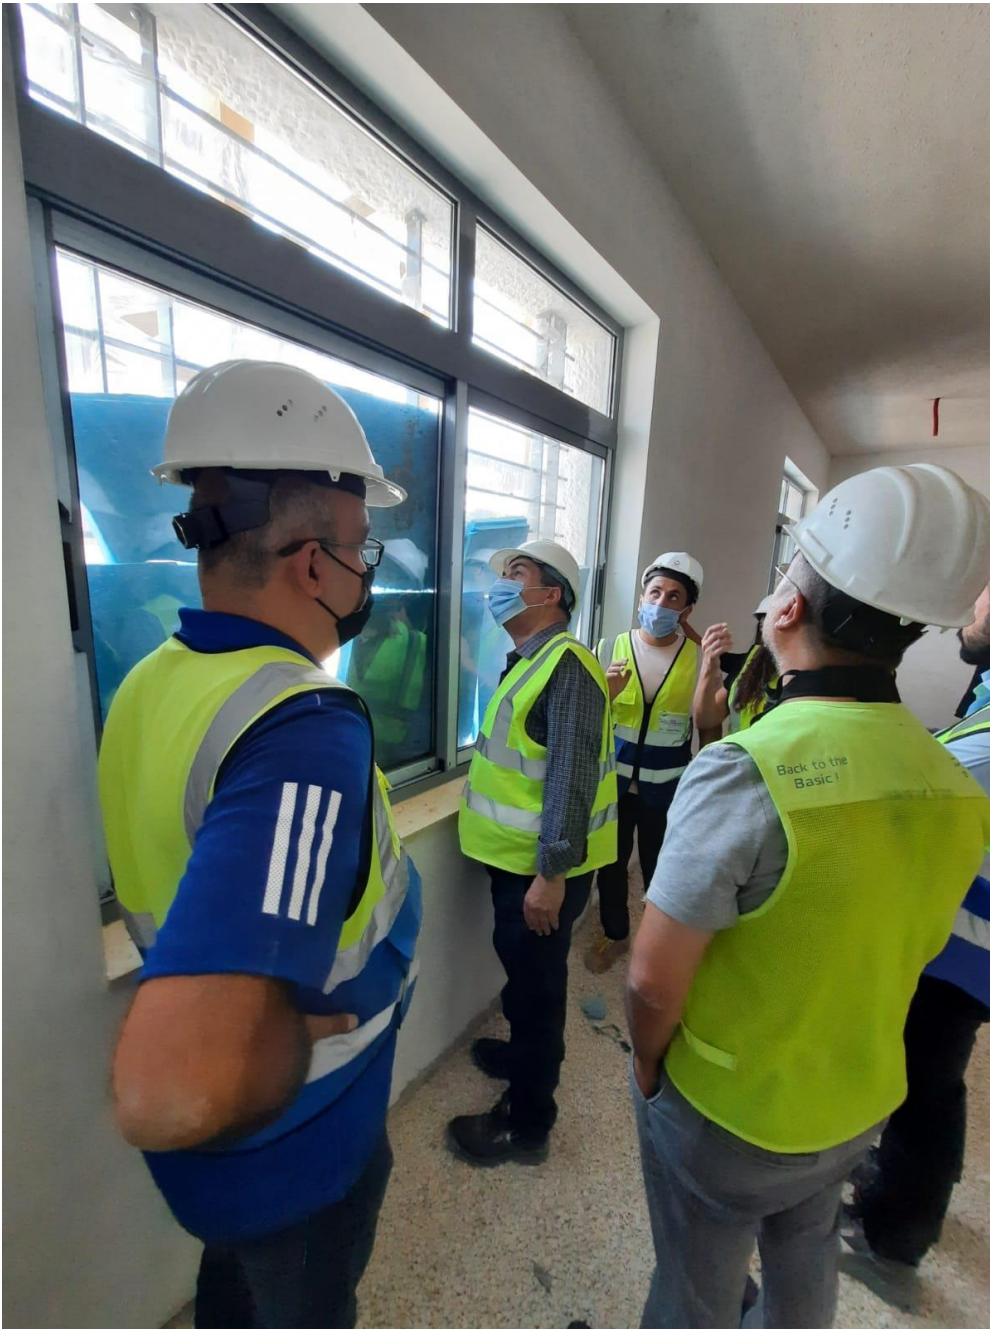
(Figure: 12 & 13)

The installation of the aluminum window external frame should cover the limit line between inside and outside. No paint should appear at the jamb-outside and no stone should appear inside. The Contractor was requested to rectify the fixed part accordingly

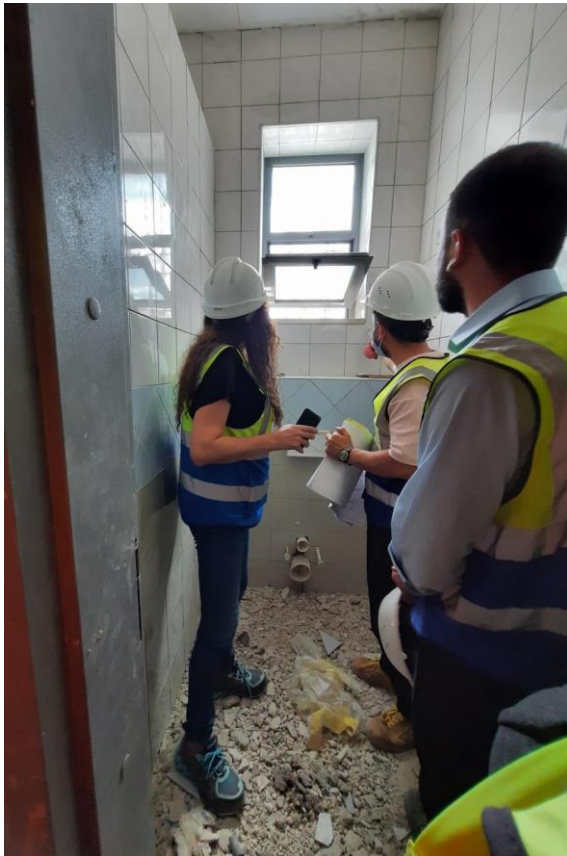
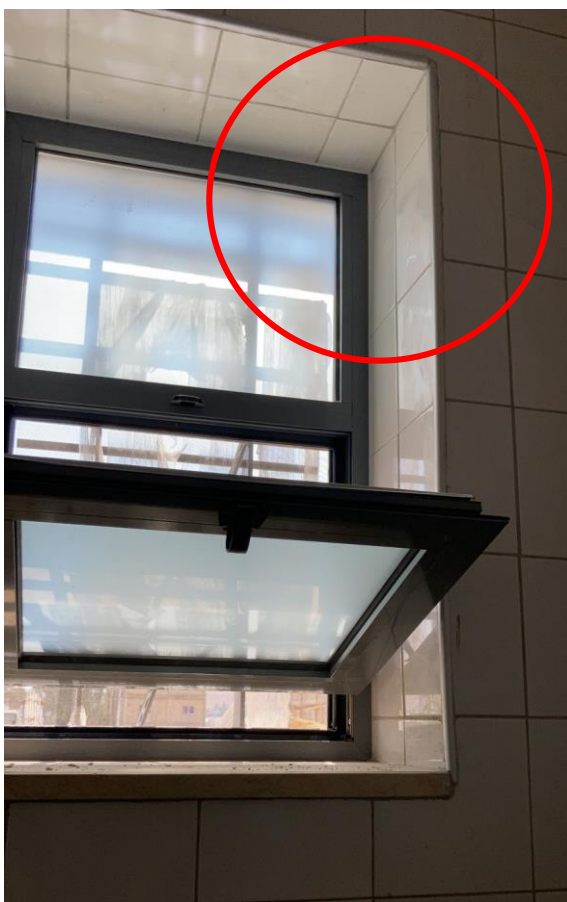
(Figure: 14 &15)

The toilet window installation is not in accordance to the details of the architectural drawings which require the installation to be at (10 cm) from the internal wall tiles not (25 cm) as the Contractor did. The Contractor was requested to rectify accordingly and insure the ceramic of the jamb to be only inside the window limit and to replace any outside ceramic with a stone similar to the external facades

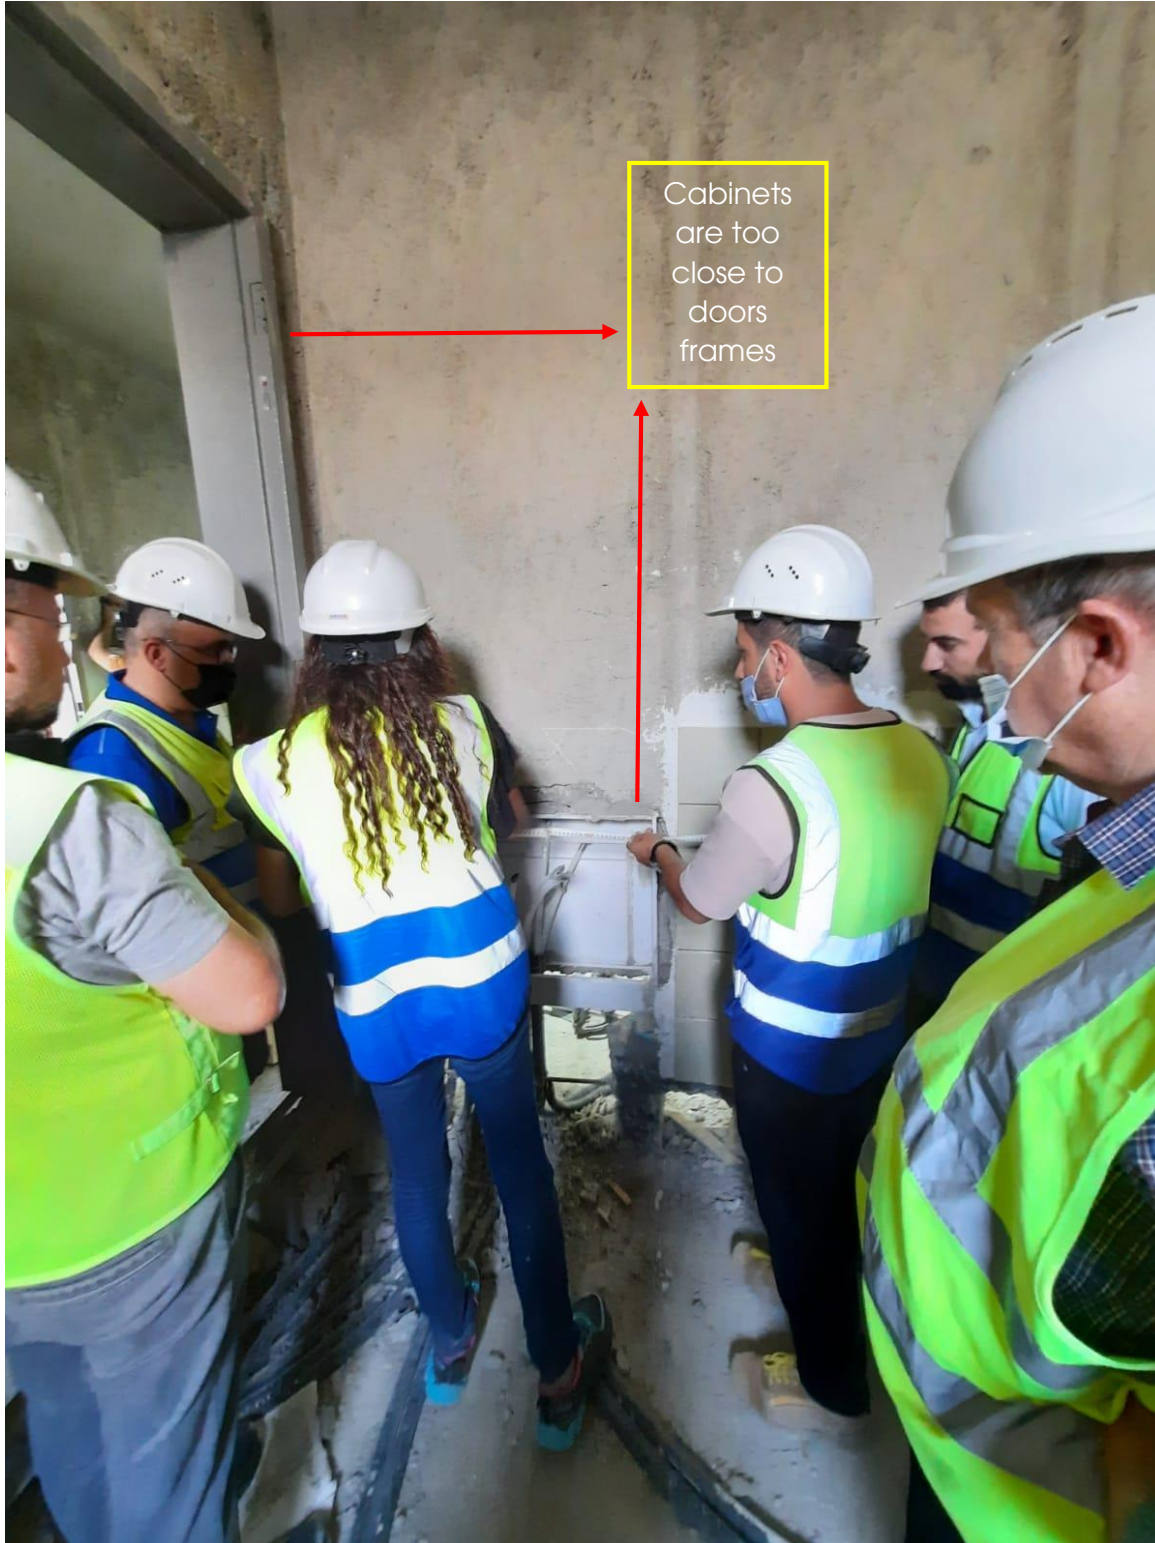
(Figure: 16)

Mechanical cabinets in the toilets area and their location in relation to the door frames

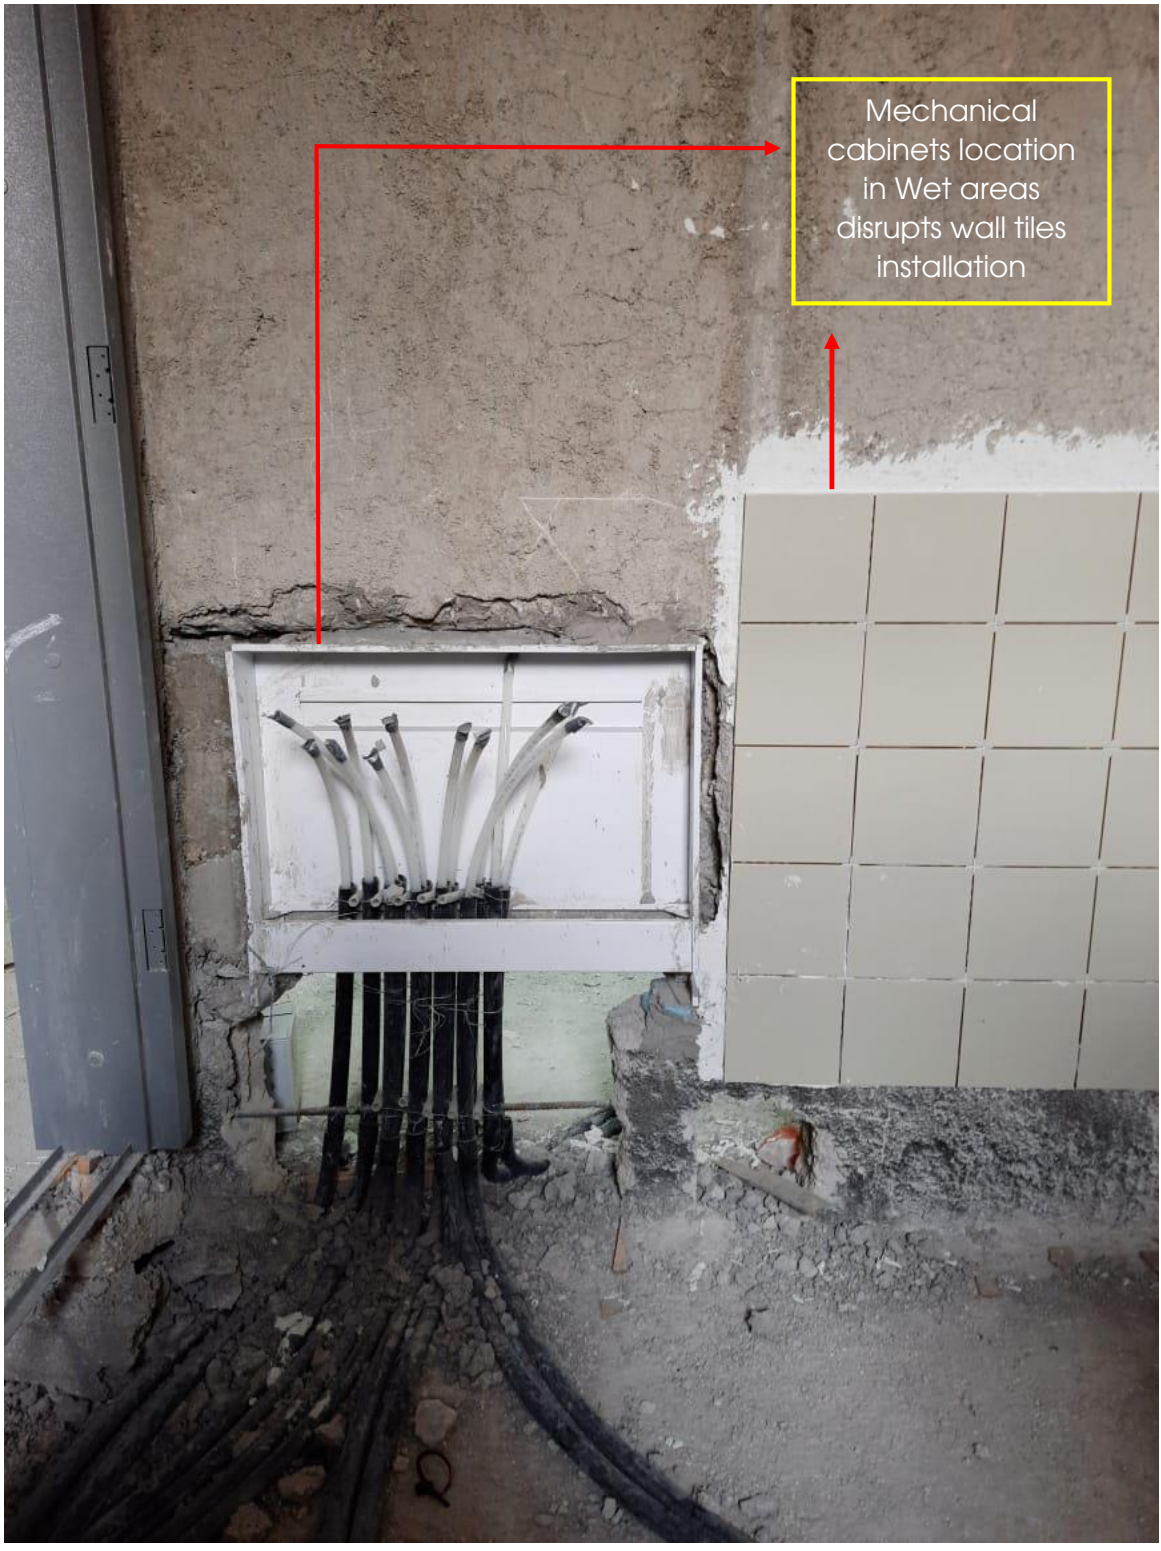
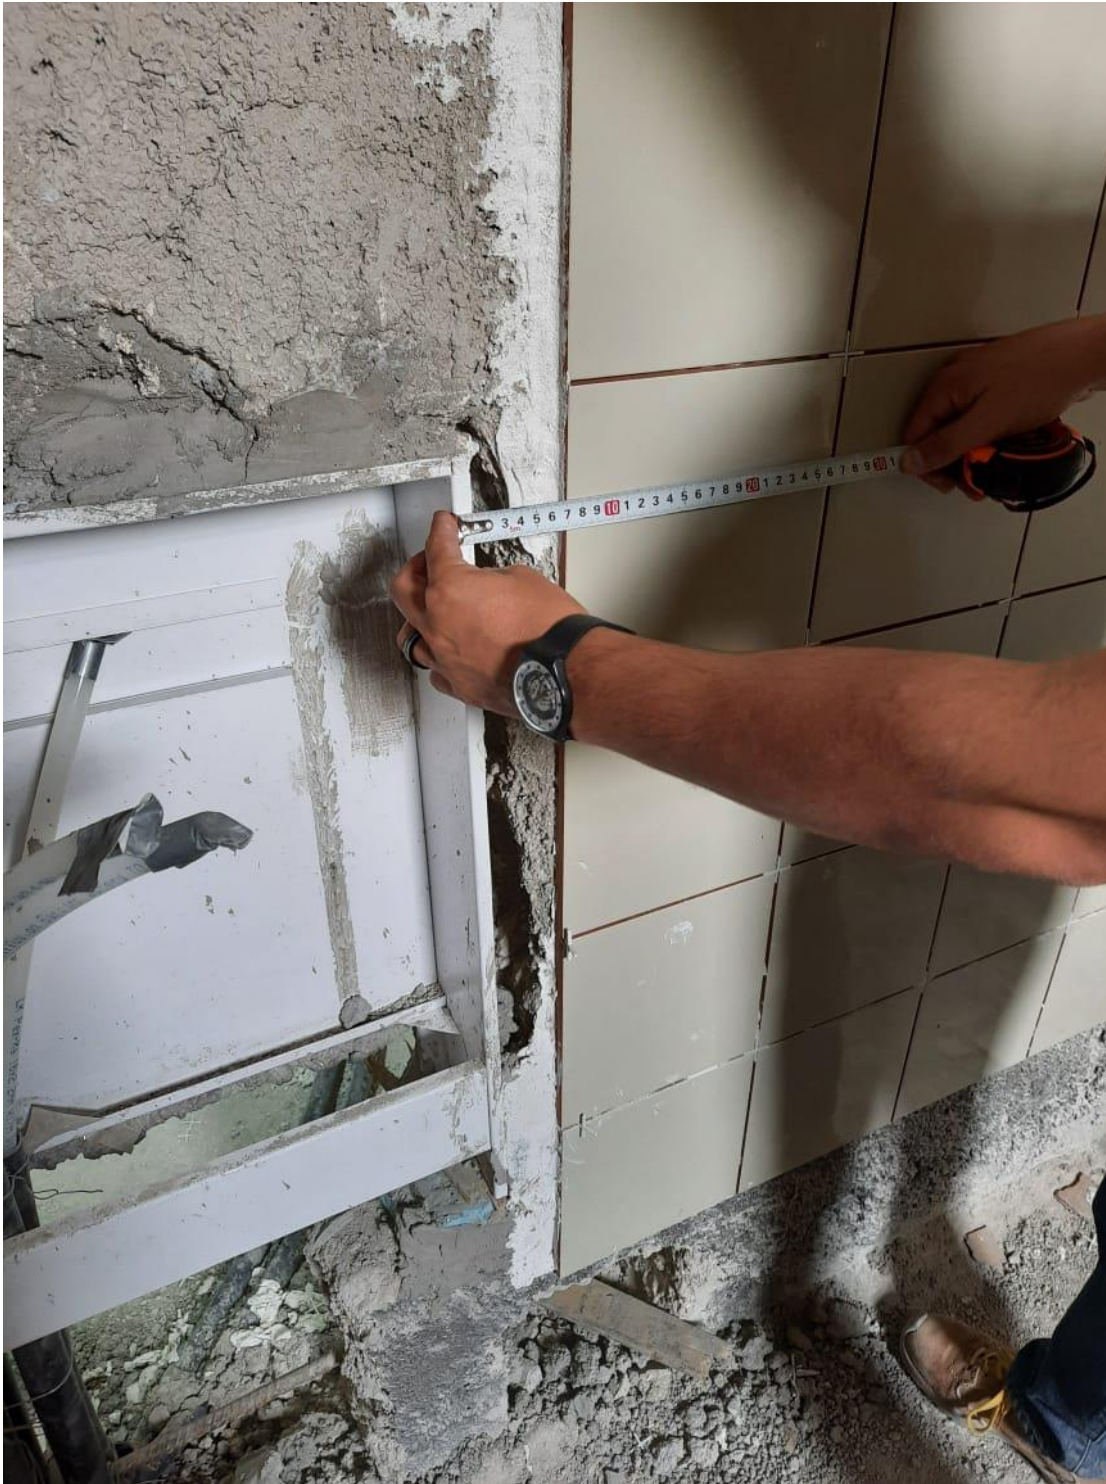
(Figure: 17 & 18)

Cabinets installation and their effect on the wall tiling and cut-off pieces

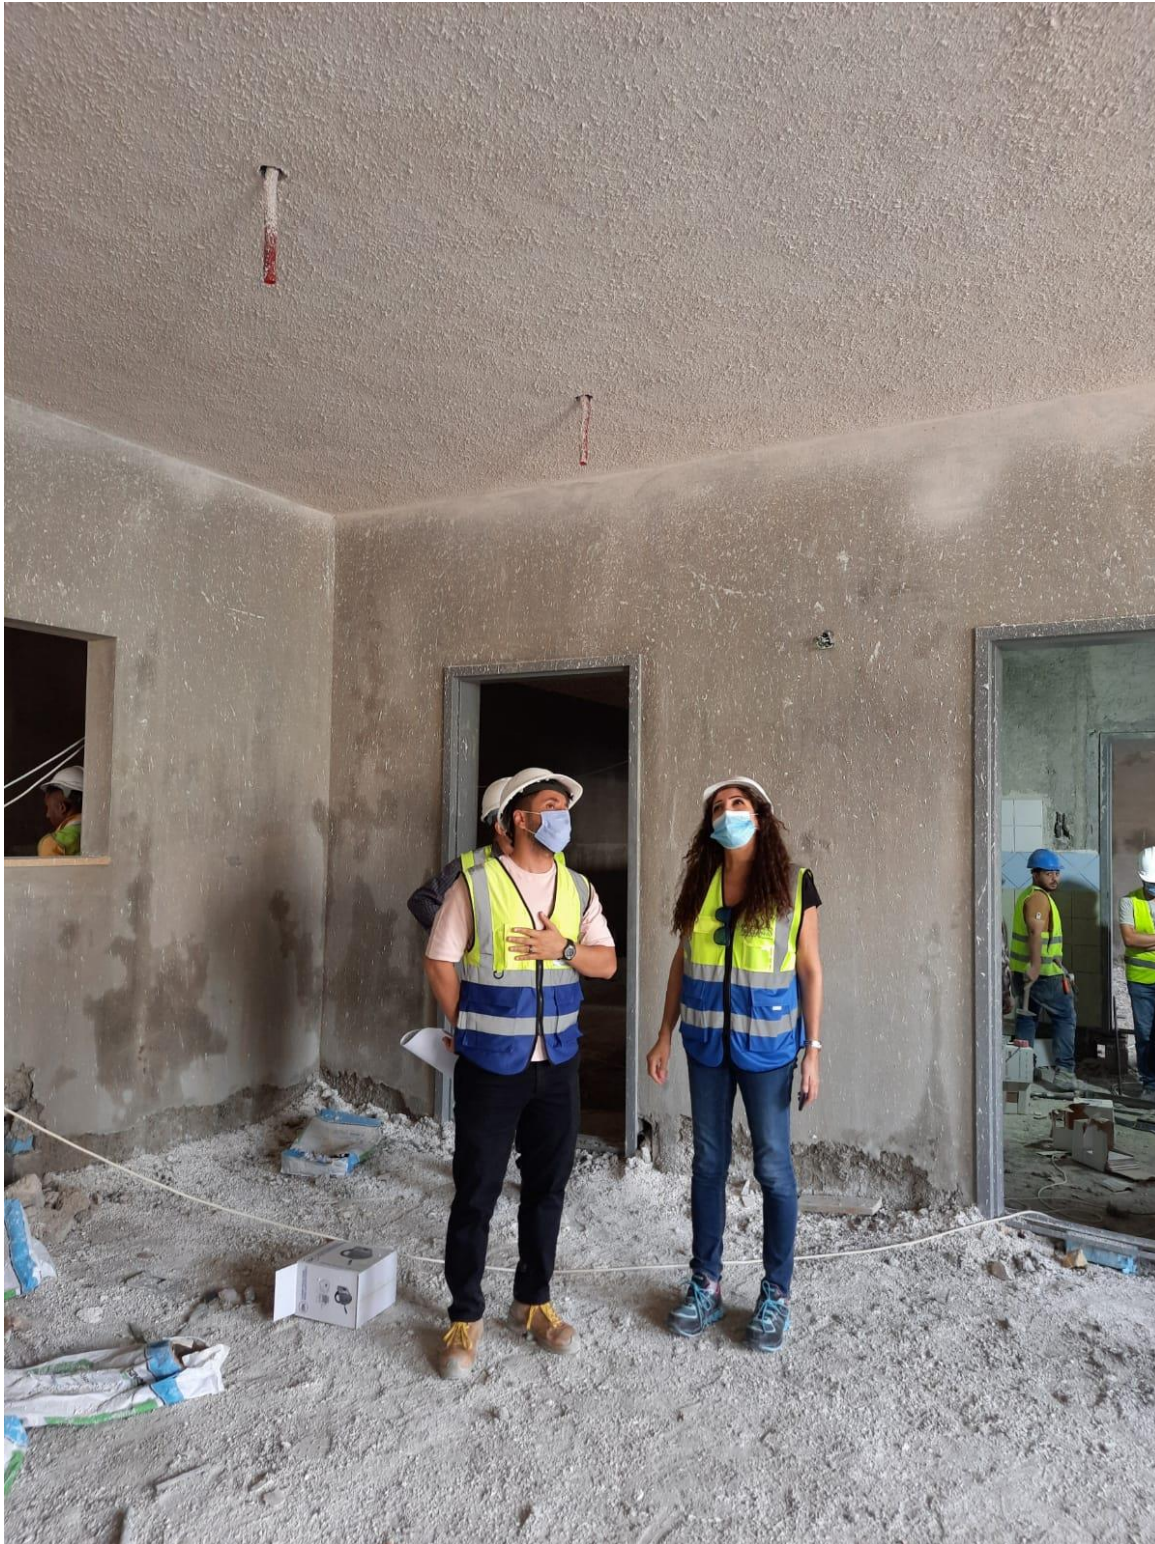
(Figure: 19)

The team observed the execution of the last stage of the acoustical plastering using the “Hopper Gun”

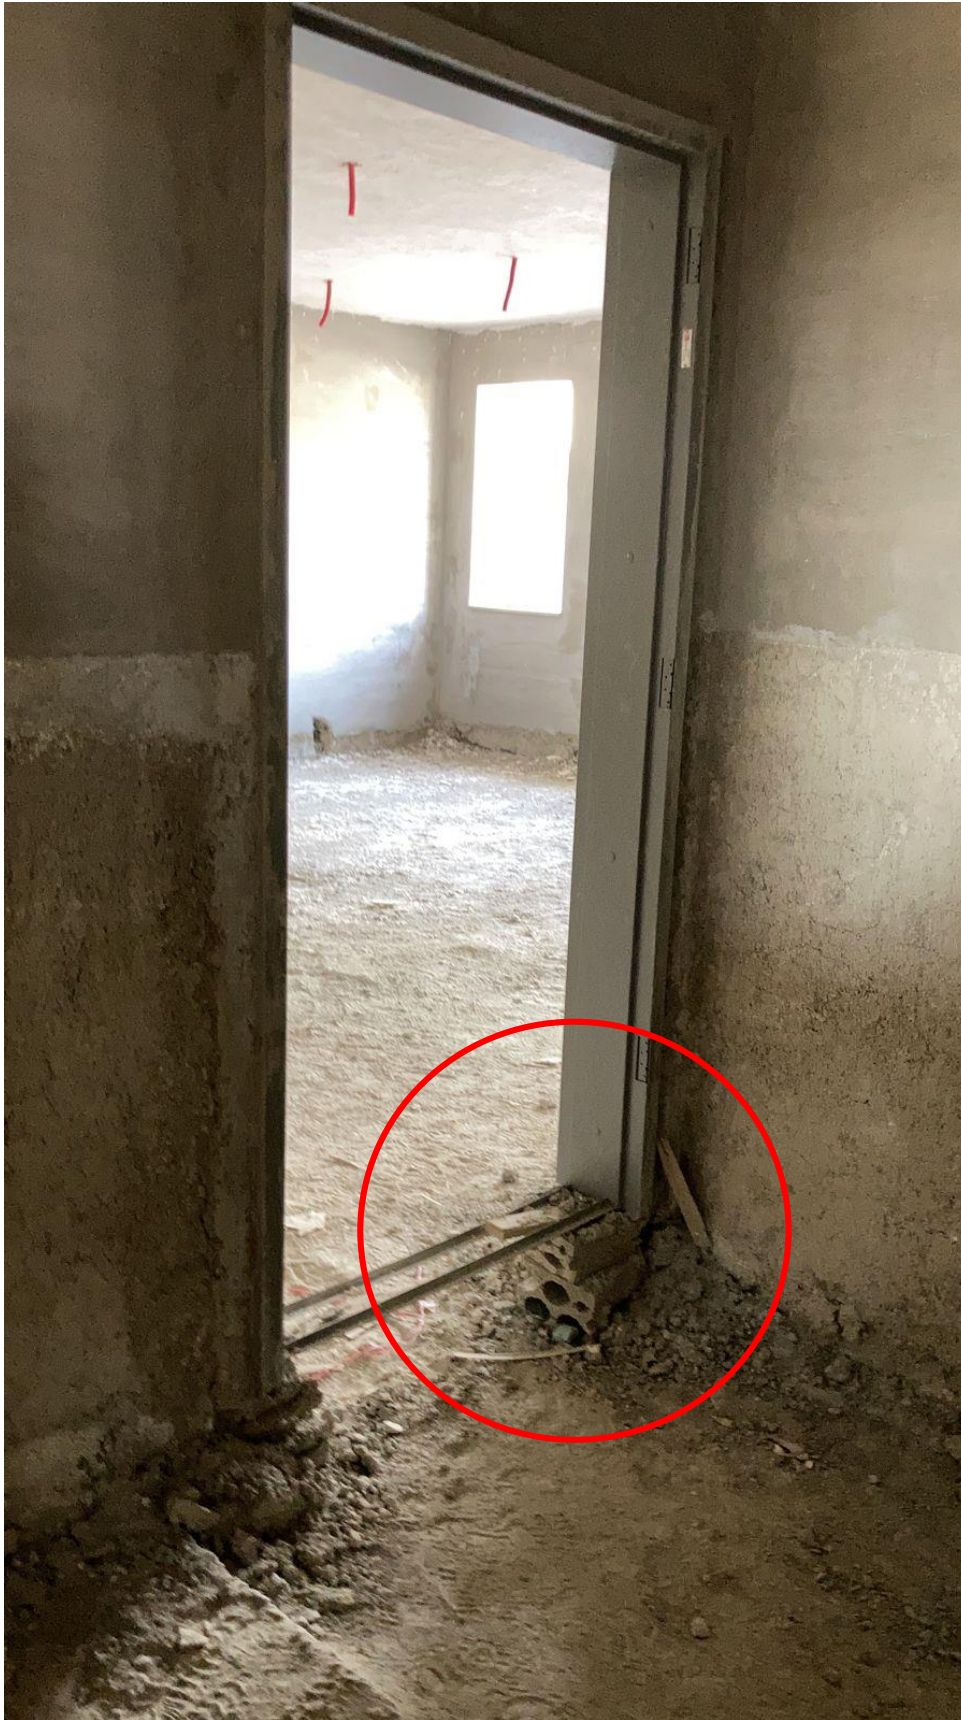
(Figure: 23)

The door frames should be supported by mass concrete with convenient dimensions. Also dismantling of the bracing at the door frames before starting with floor tiling to avoid defects in the frame during the tiling work
