Consultant	Wahib Medanat Consultant Engineer	Rep No.	13-10112021
Contractor	Derar Saraireh & Sons for Engineering & Contracting	Tender No.	(11/2019/USAID/SKEP/3/S) Schools for a Knowledge Economy Project (SKEP) - Phase (3) Package (1, 2)
Site Name	Khadija Bint Khwailed Basic Mixed School- Shouna Janoubia	Day/ Date	Wed. 10/11/2021
Duration of Project	450 Calendar Days	Total Project Budget	9,789,417.840 JD

Visit Notes

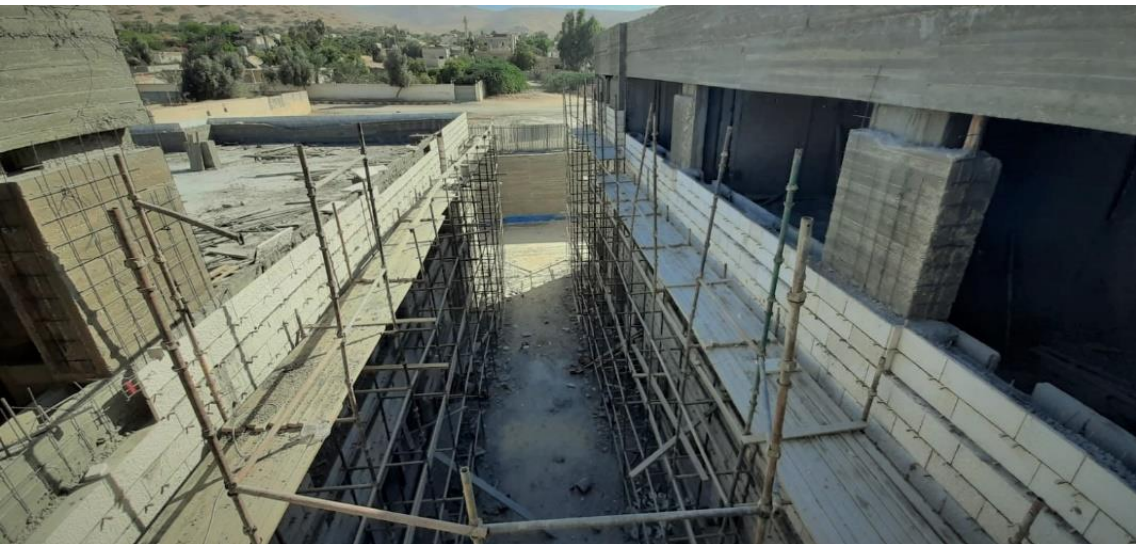
(Figure: 01)

General view of the project

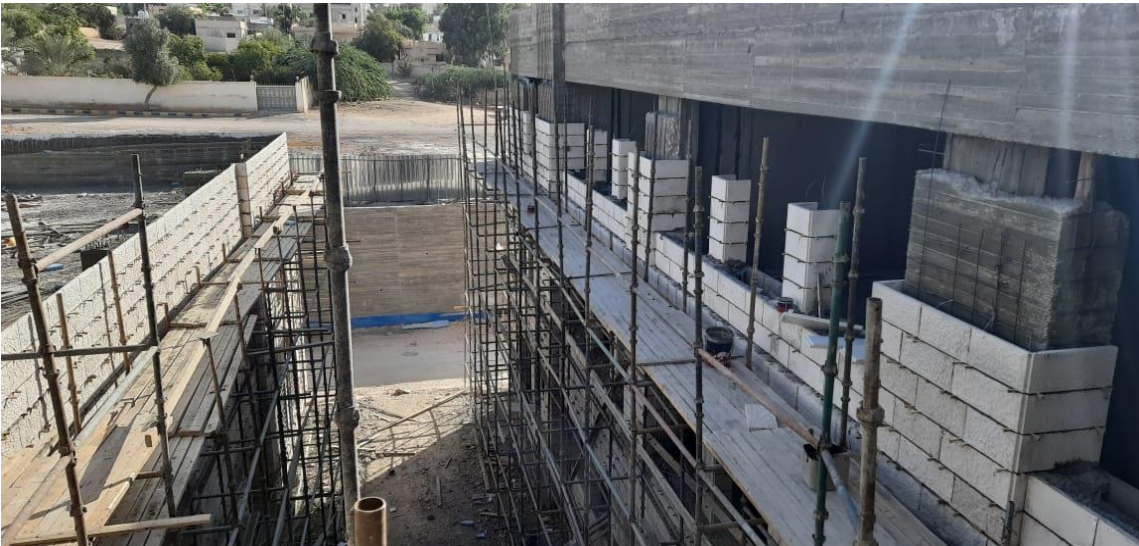
(Figure: 04)

General inspection was conducted on the stone building; notes were given to the Contractor in this regard

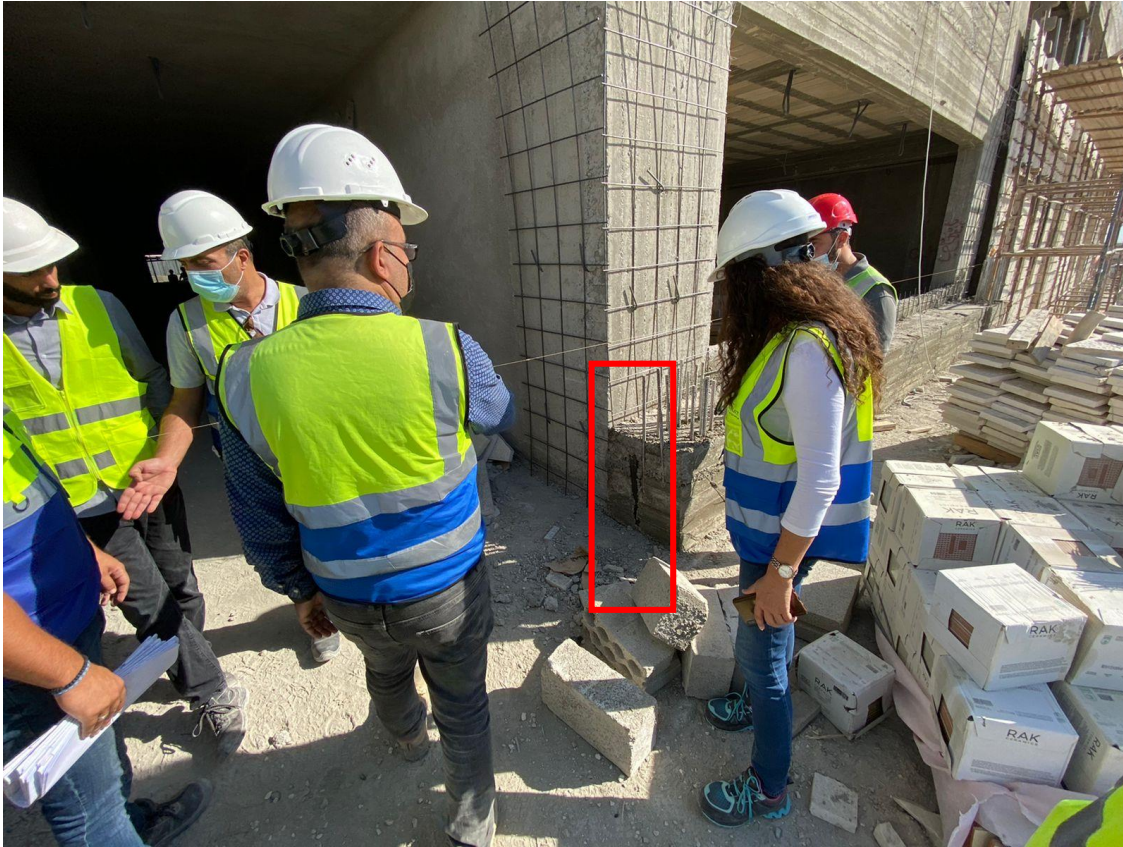
(Figure: 08)

It was observed that the Contractor executed an external expansion joint wrongly. The Contractor was requested to rectify as per Contract

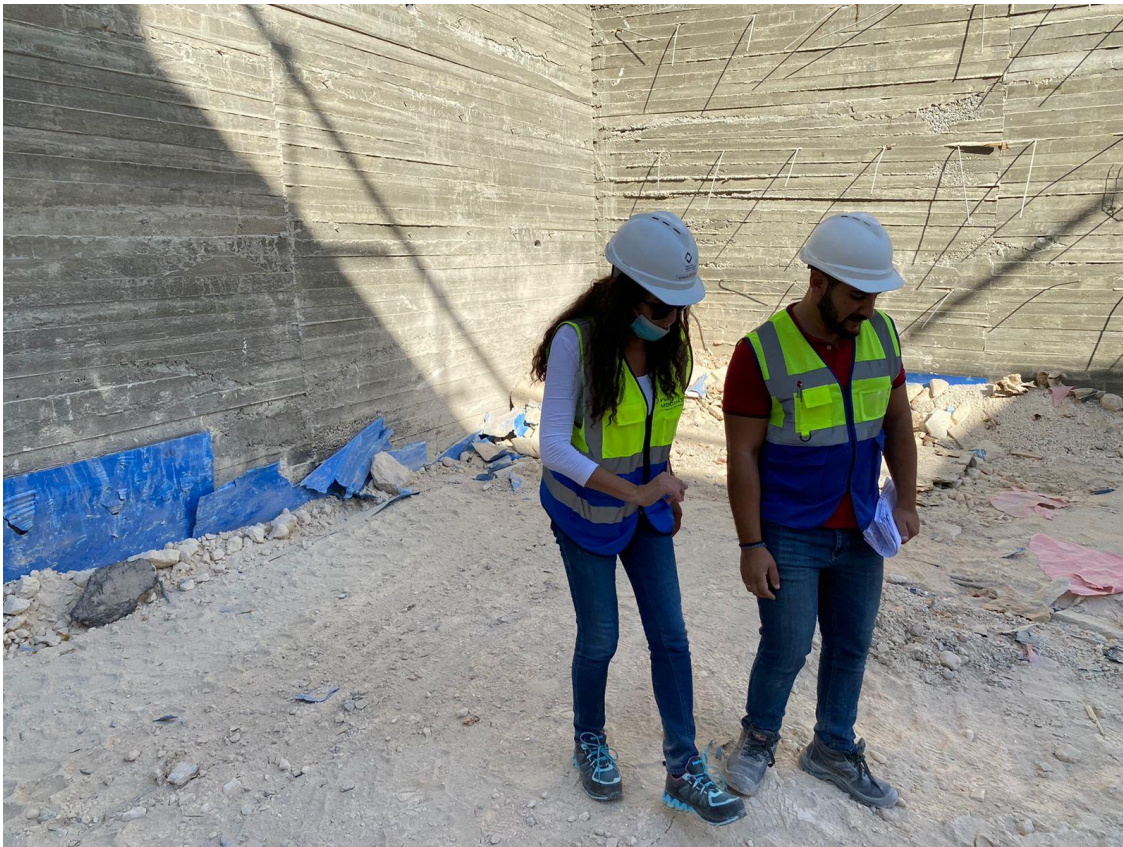
(Figure: 09)

It was observed that the Contractor started with removing the non-complying backfilling material the Contractor collected previously

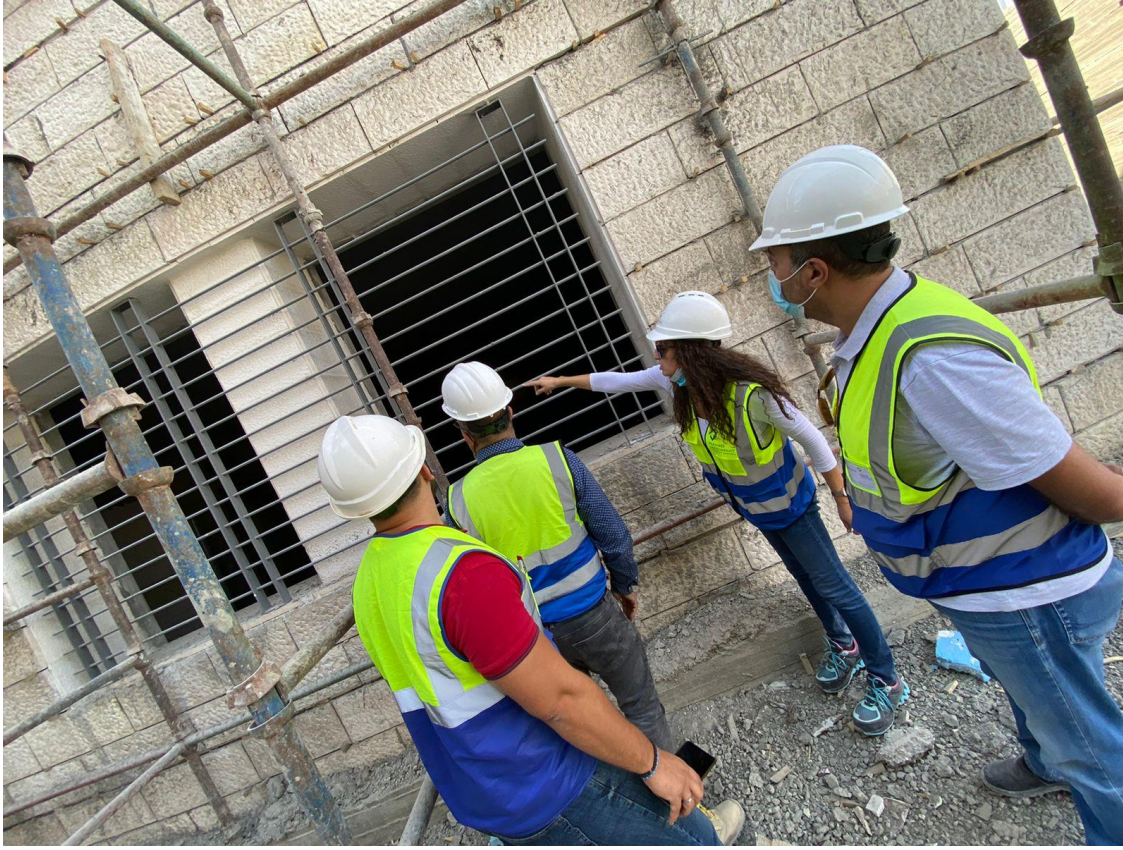
(Figure: 10)

The installed sample of steel protection grill for window was inspected by the visiting team

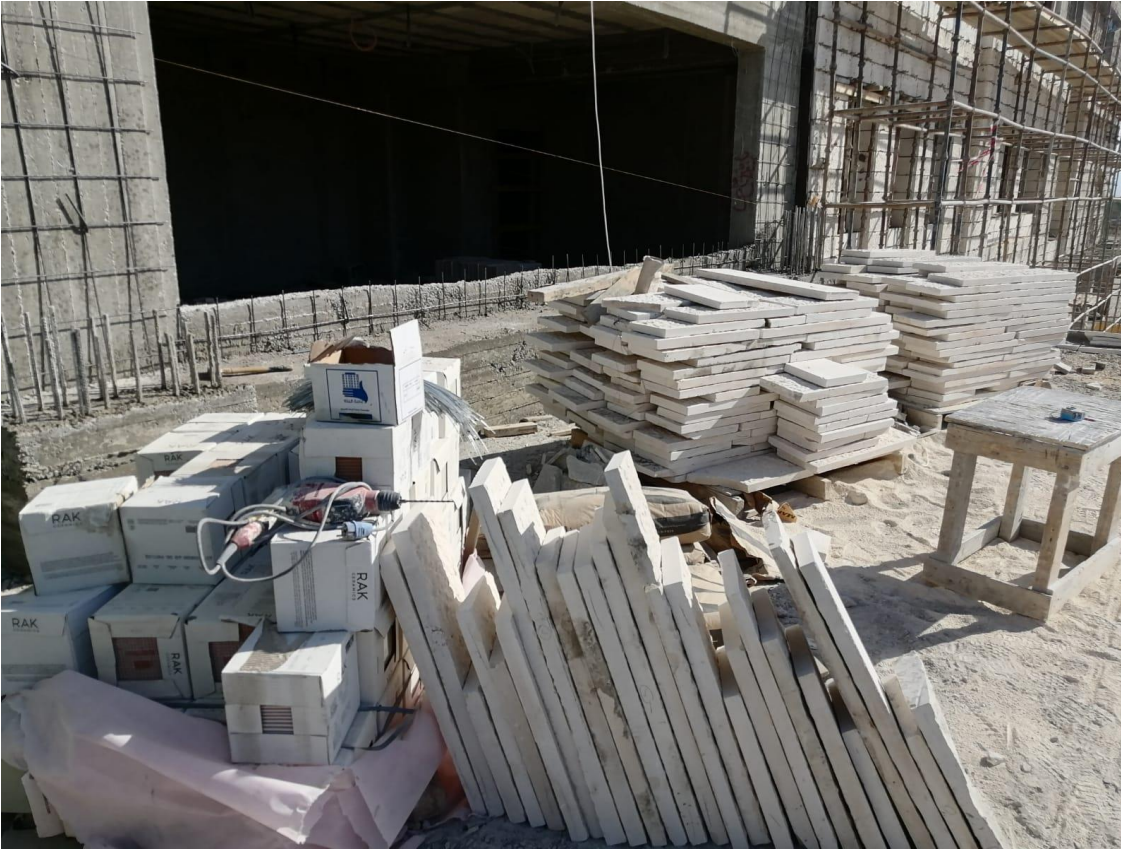
(Figure: 11)

The Supervision team inspected the imported stone pieces (Mufajar Texture), and provided the Contractor with general remarks

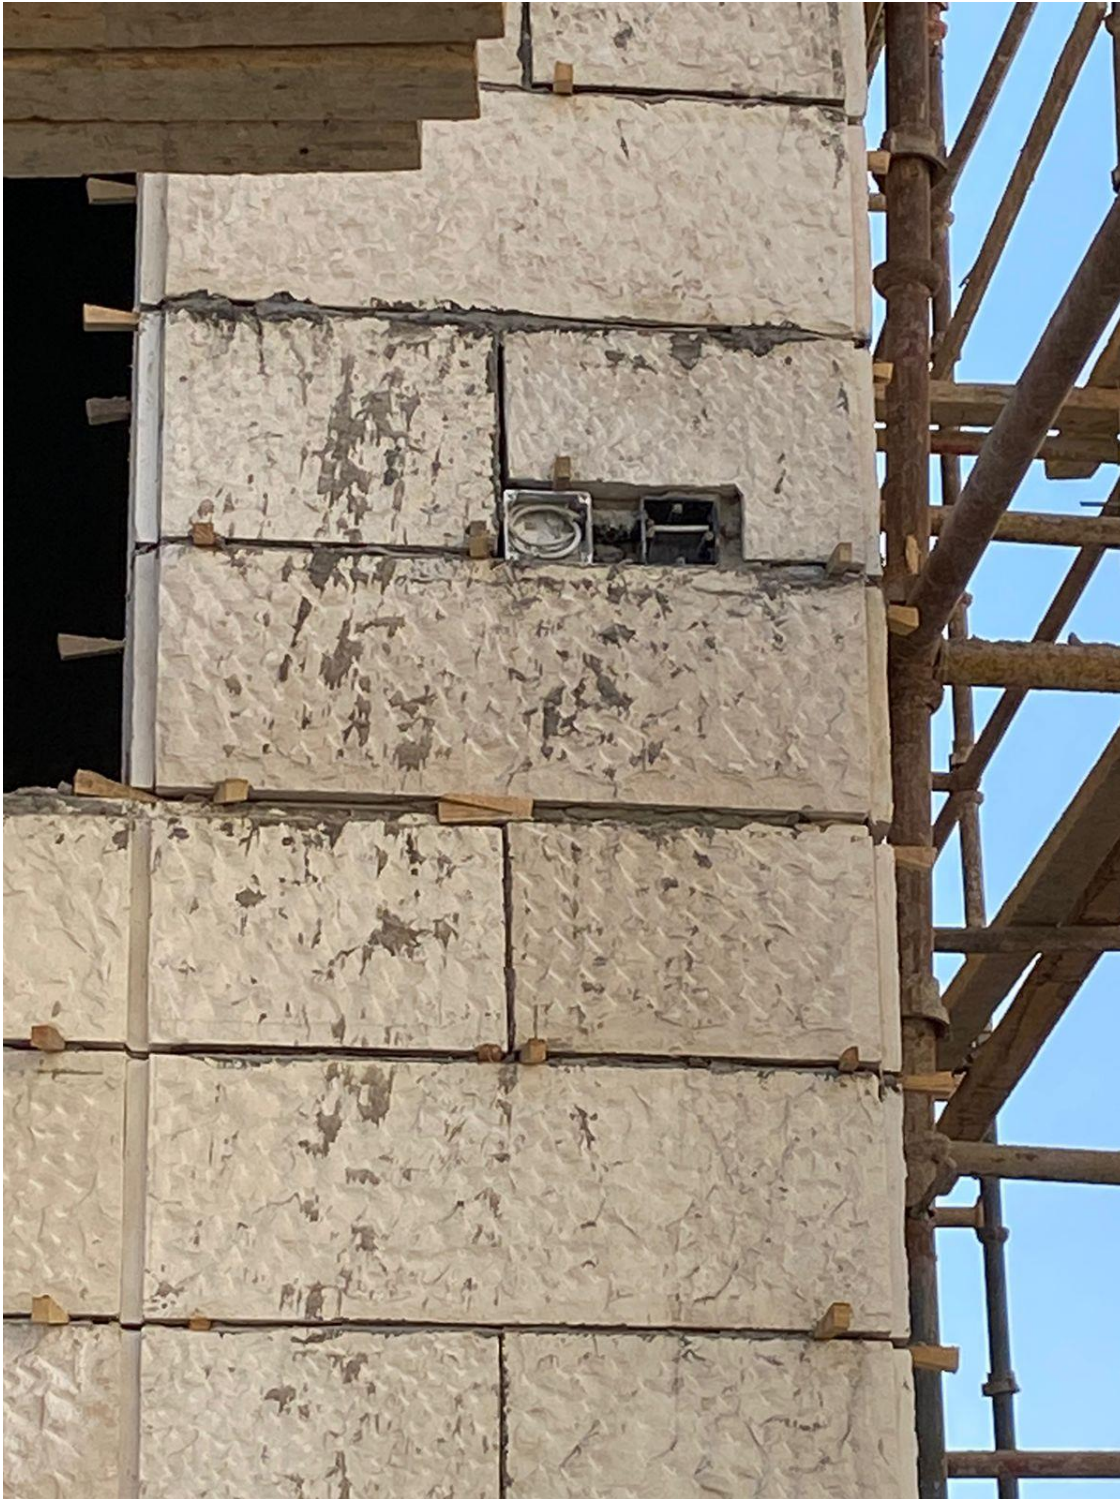
(Figure: 13)

It was observed that the Contractor installed electrical outlets at the façade in a wrong way. The Contractor was requested to rectify

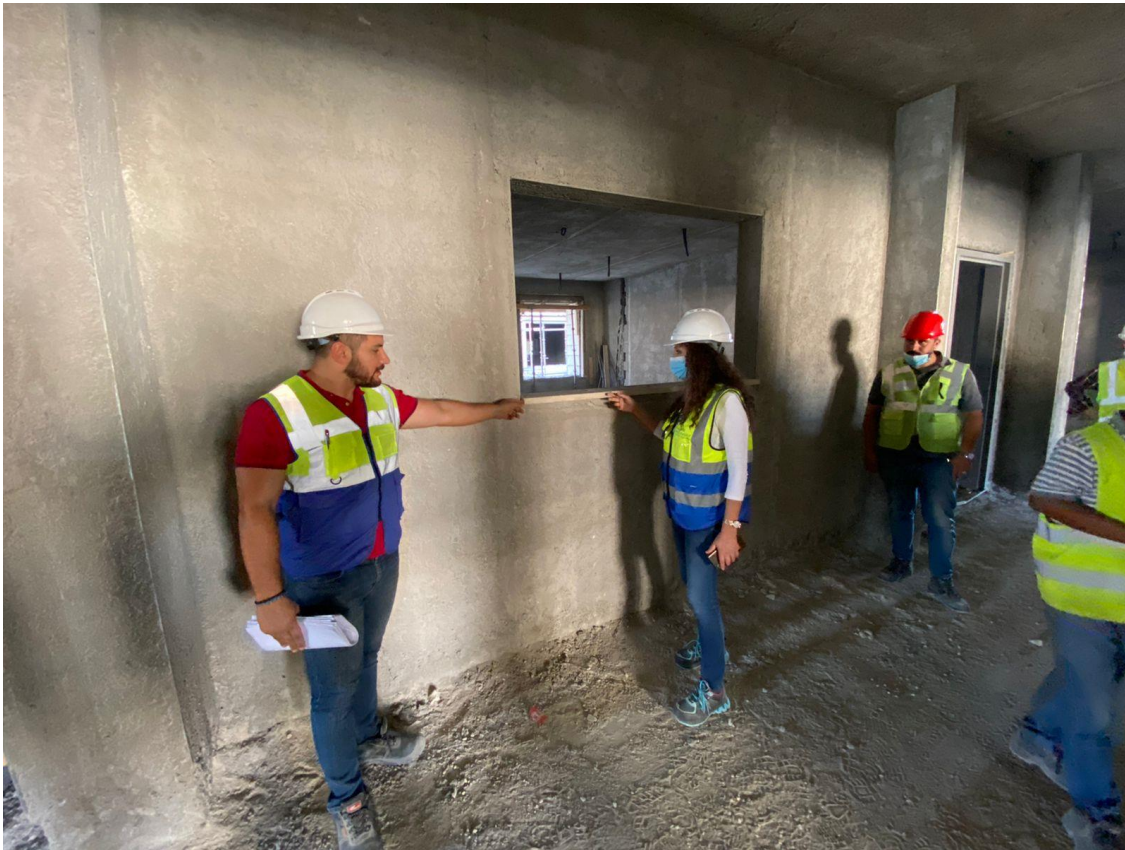
(Figure: 14)

Upon the inspection by the team, it was observed that number of installed window sills have a thickness different from the required (i.e. less or more). The Contractor was requested to replace those sills and install new sills as per Contract

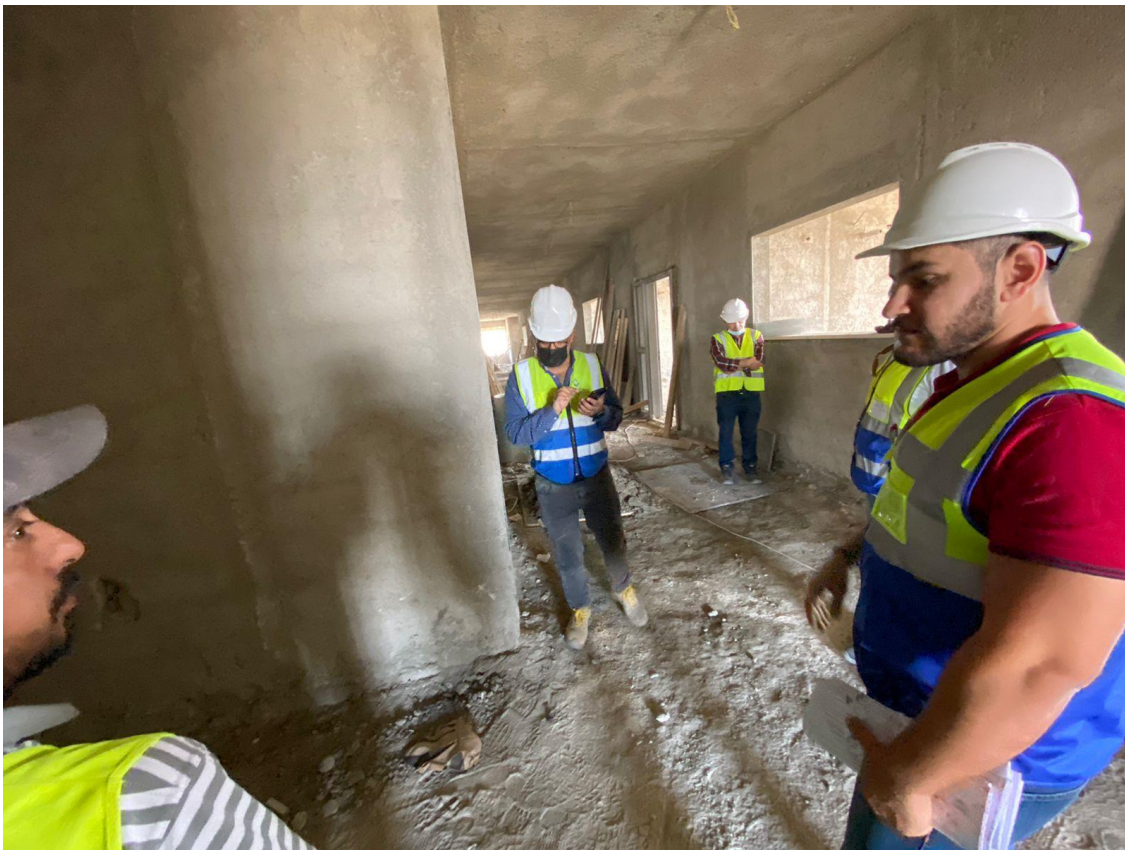
(Figure: 15)

The plastering finish coat at some areas has been inspected

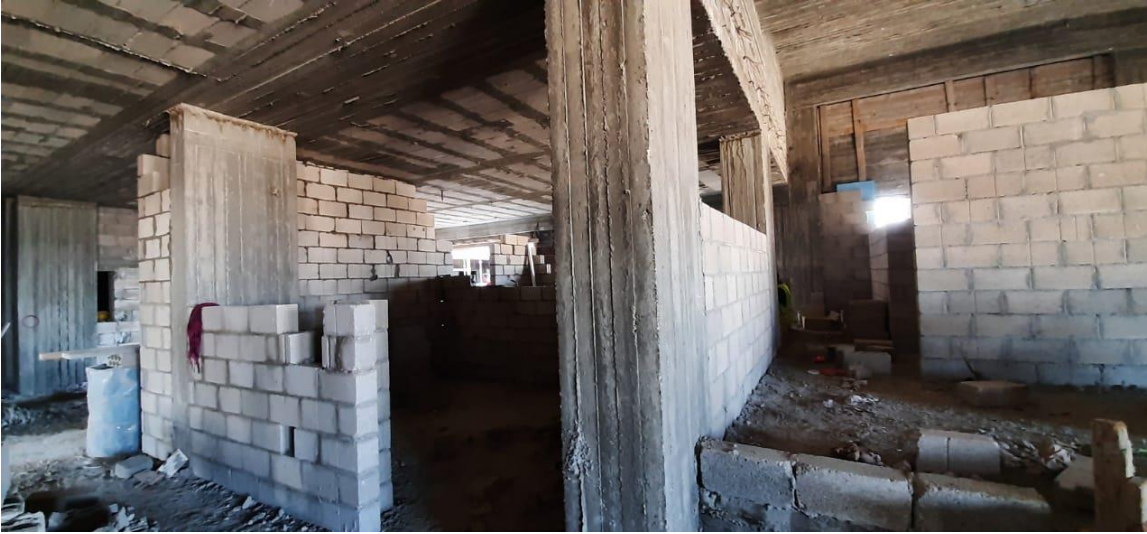
(Figure: 16)

Inspecting blockwork at the multi-purpose hall/ground floor

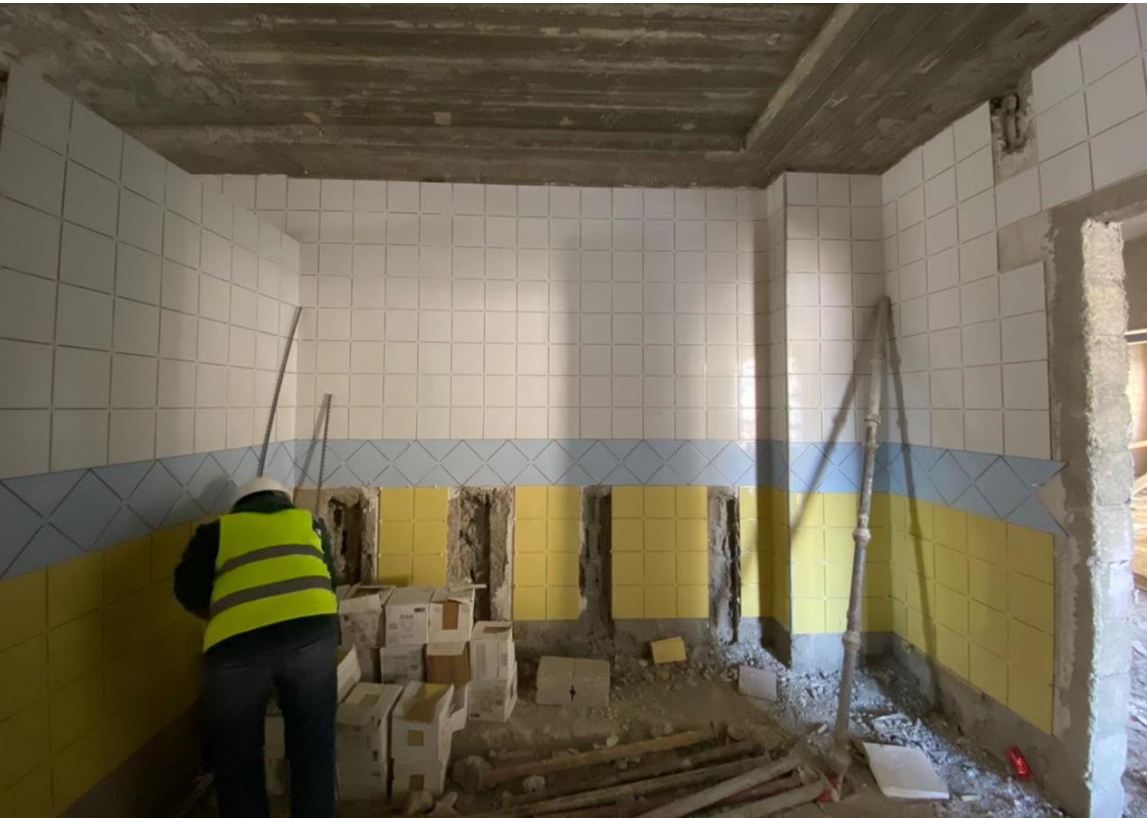
(Figure: 17)

The imported ceramic wall tiles

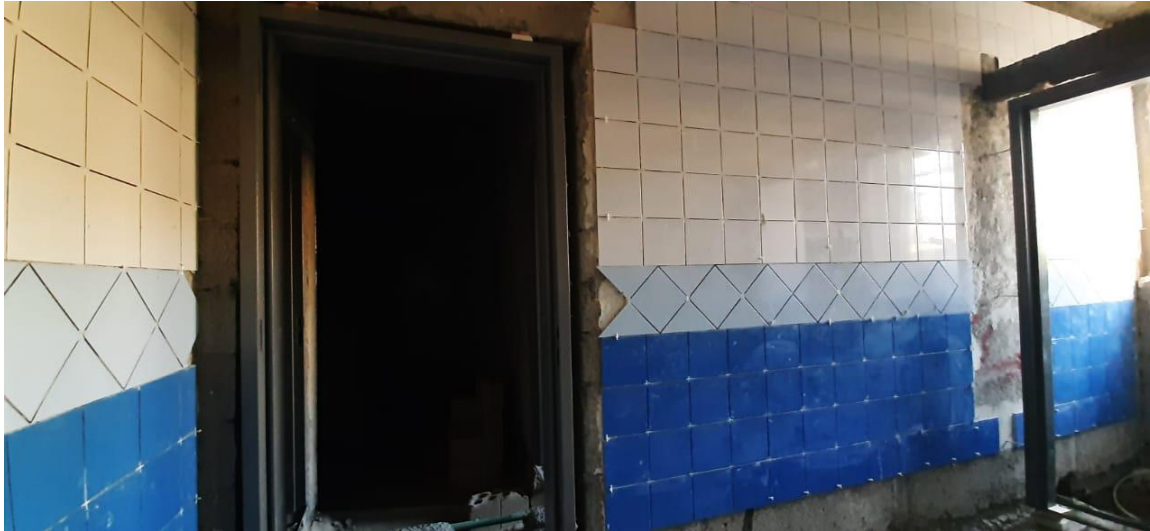
(Figure: 18)

The ceramic tiles for toilets walls have been inspected focusing on the relation of tiles with the door frames and the mechanical cabinets. The supervision team exerted considerable effort to avoid small cut-off ceramic pieces due to the installation of those items

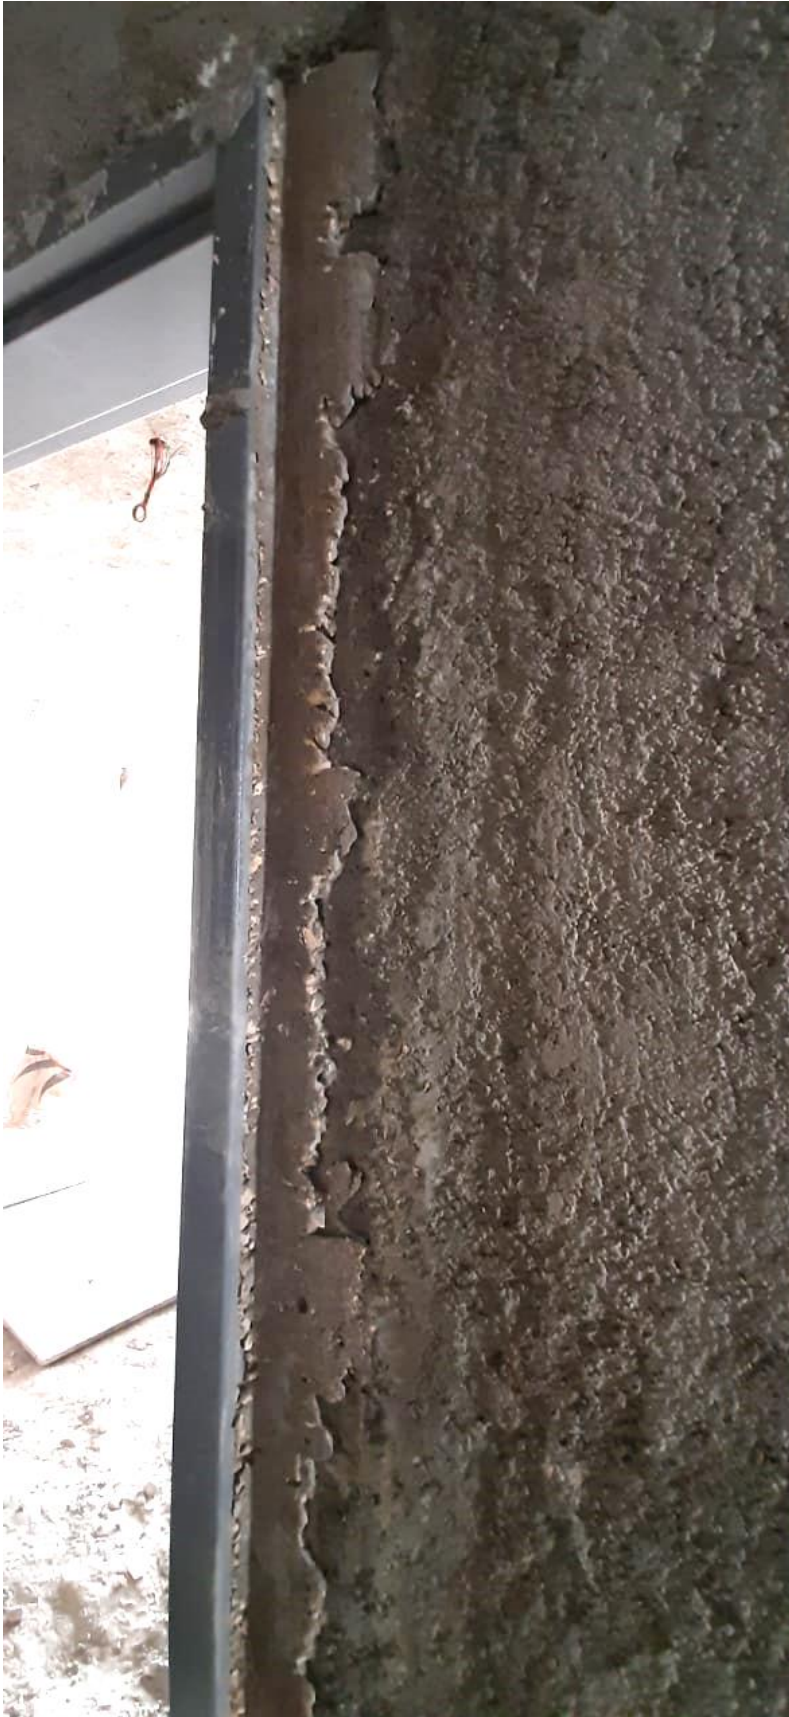
(Figure: 21)

It was observed that the Contractor installed number of steel door frames without taking into consideration the limits of concrete casting and plastering layers to insure good quality of executed works. The Contractor was requested to rectify

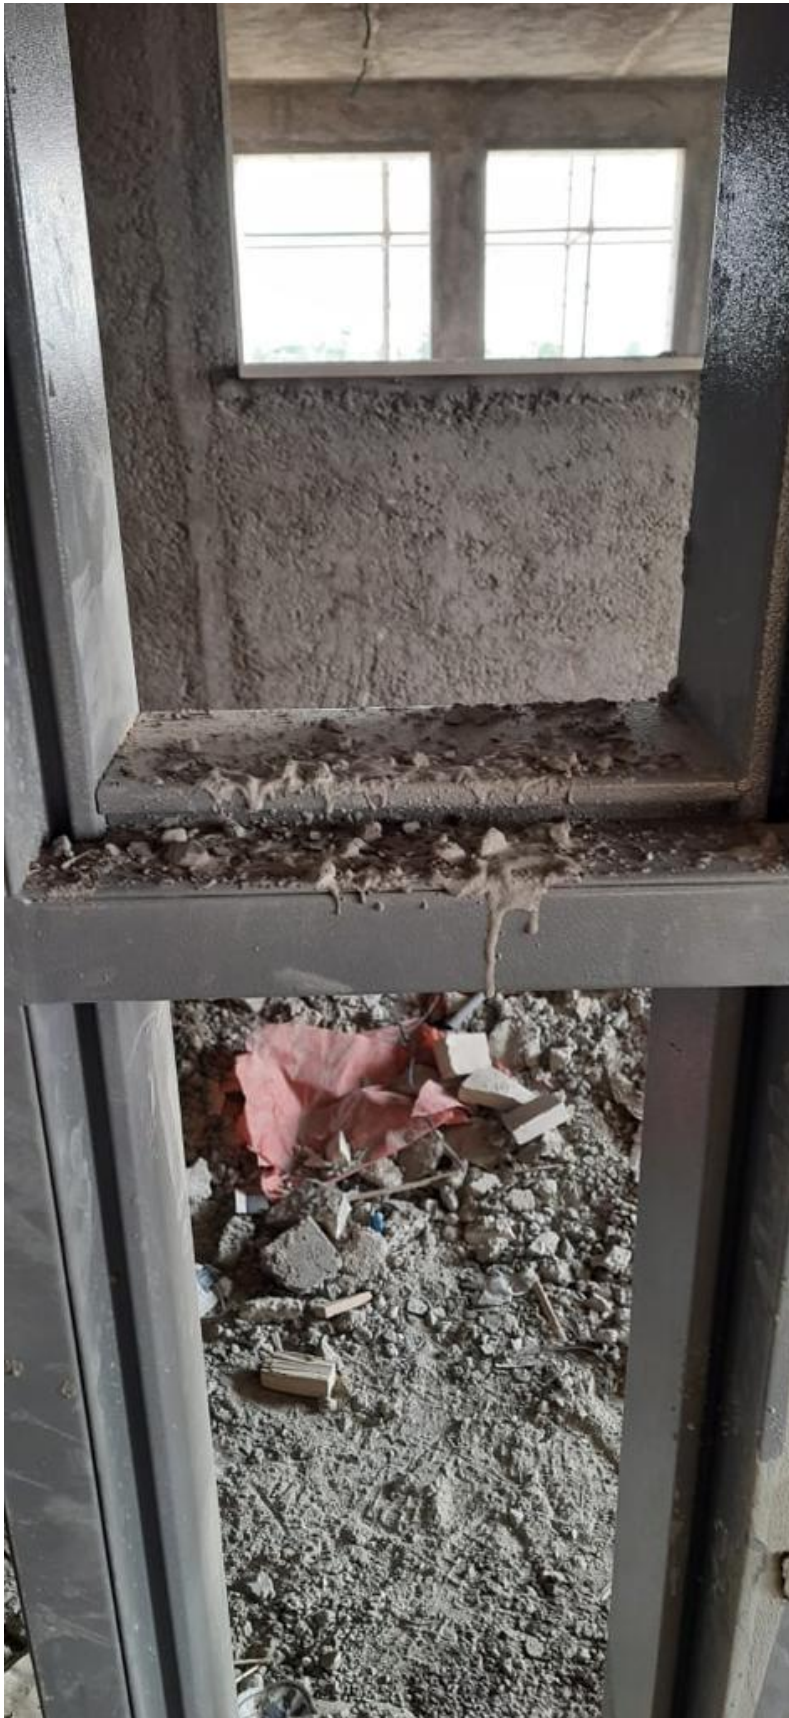
(Figure: 22)

The visiting team observed remaining concrete at the dismantled door frames due to the defects in those frames. To approve any frame, the remaining concrete should be removed without causing any scratches to those frames, otherwise they should be replaced with new ones
