Consultant	Wahib Medanat Consultant Engineer	Rep No.	11-21082021
Contractor	Derar Saraireh & Sons for Engineering & Contracting	Tender No.	(11/2019/USAID/SKEP/3/S) Schools for a Knowledge Economy Project (SKEP) - Phase (3) Package (1, 2)
Site Name	Um Al Dananir Basic Mixed School- Al Balqa	Day/ Date	Sat. 21/08/2021
Duration of Project	450 Calendar Days	Total Project Budget	9,789,417.840 JD

Visit Notes

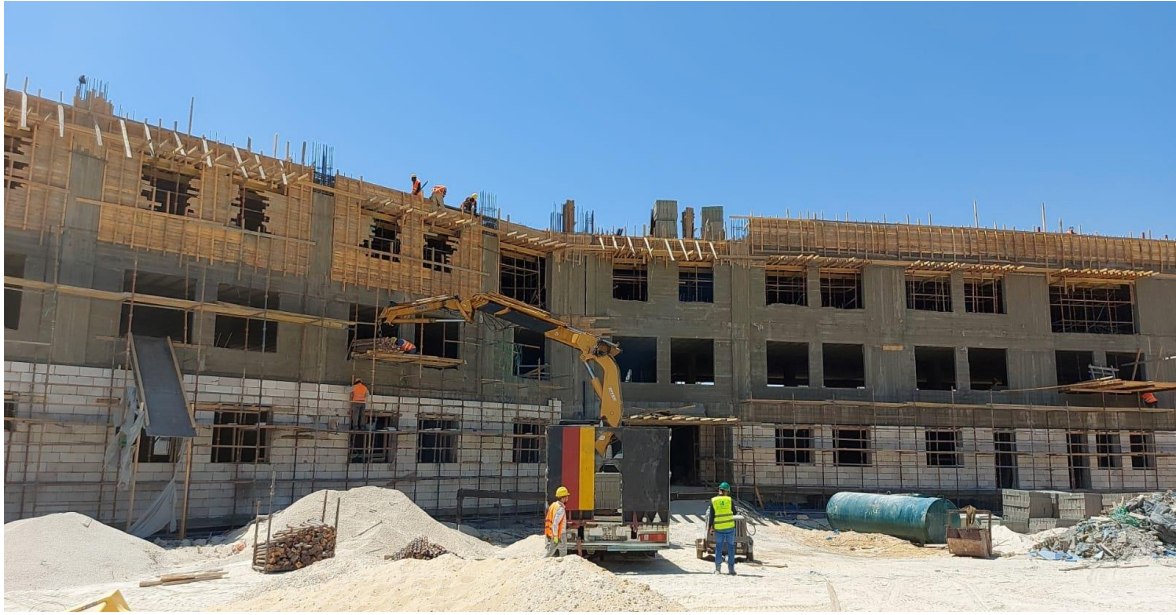
(Figure: 01)

General view of the preparation works for Second floor slab zone "B"

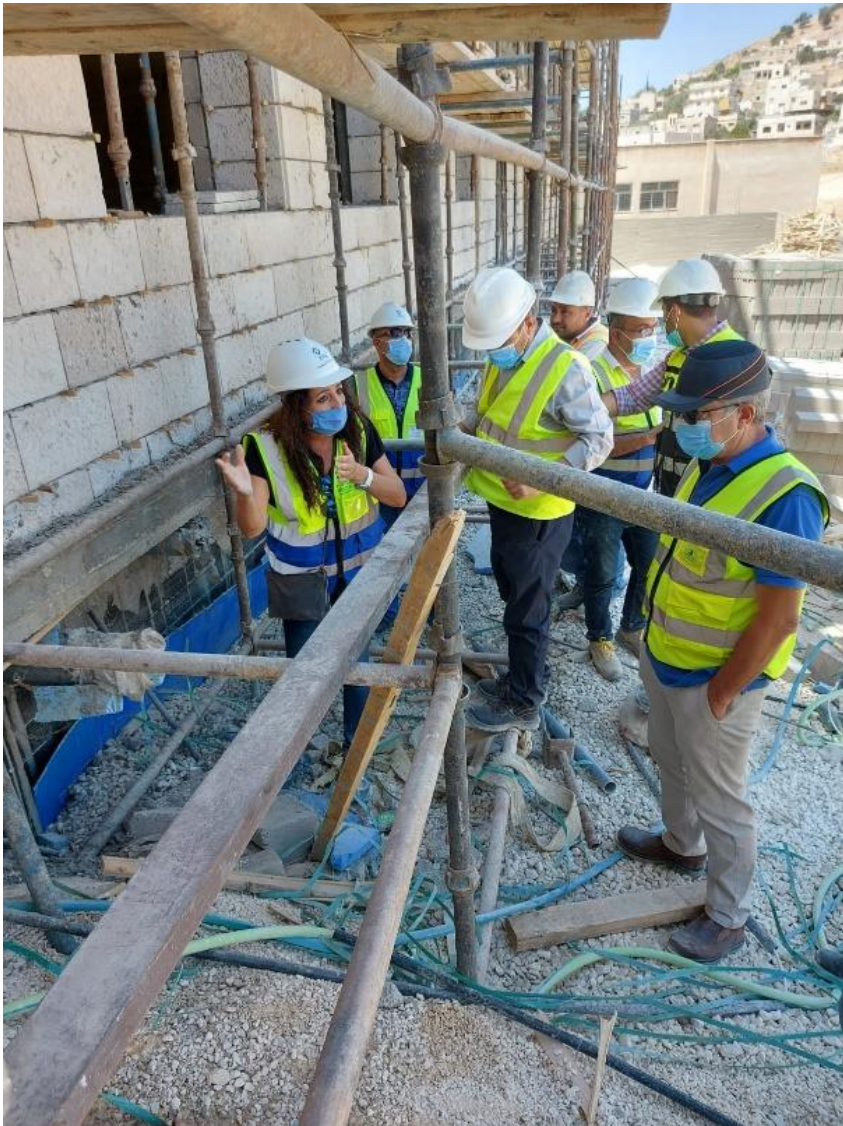
(Figure: 02)

Eng. Representatives observed the executed stone works at the northern, southern, and eastern elevations

Remarks have been given

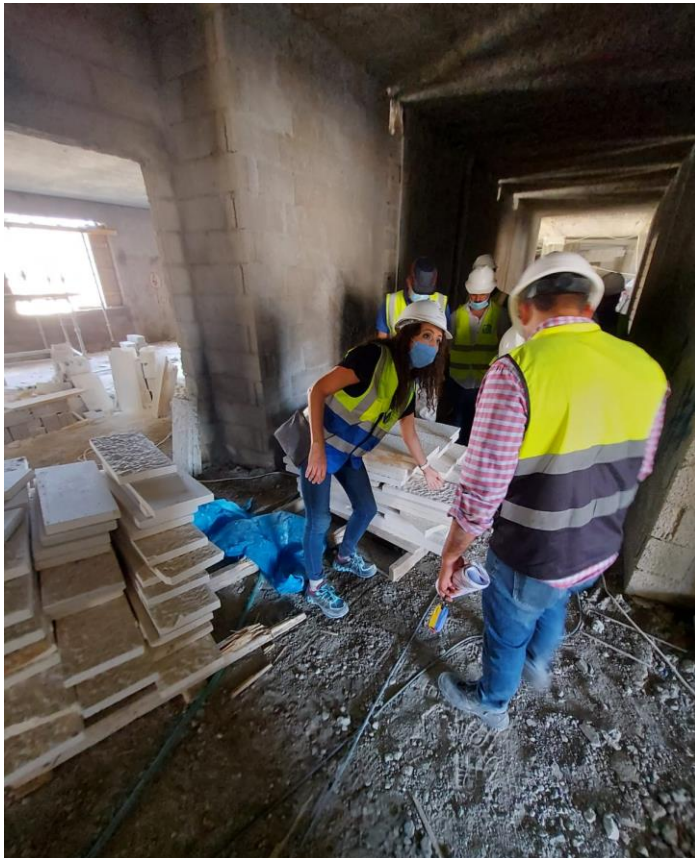
(Figure: 04)

The office support team checked the supplied stone to the site

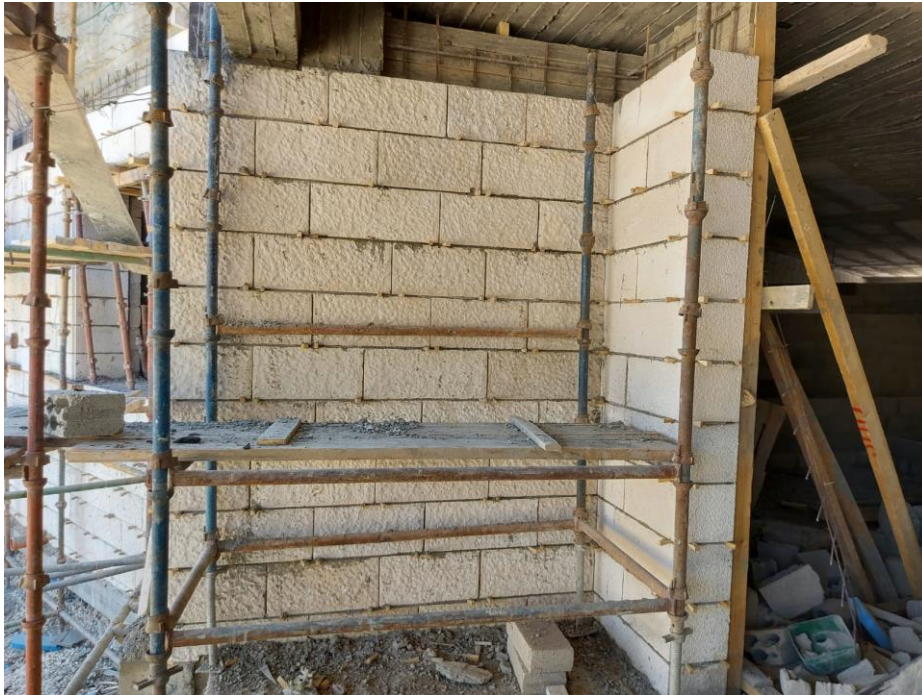
(Figure: 05)

Stone work for
School main
entrance

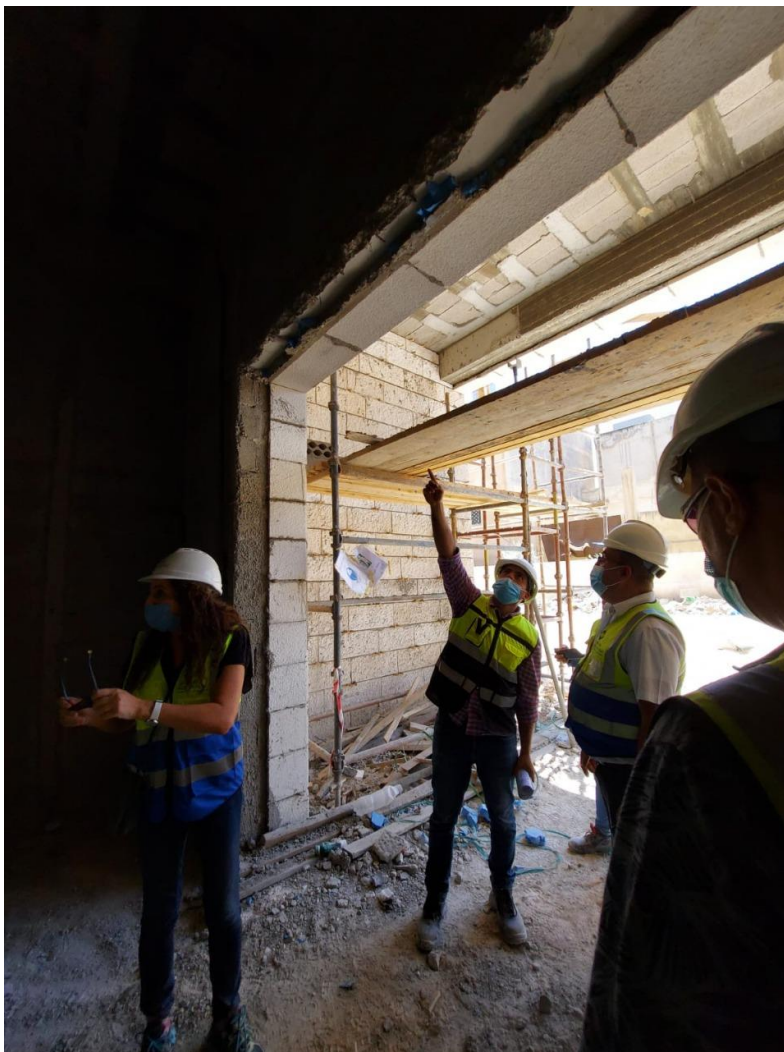
(Figure: 06)

Stone soffit detail
and its
dimensions over
the entry door at
entrance

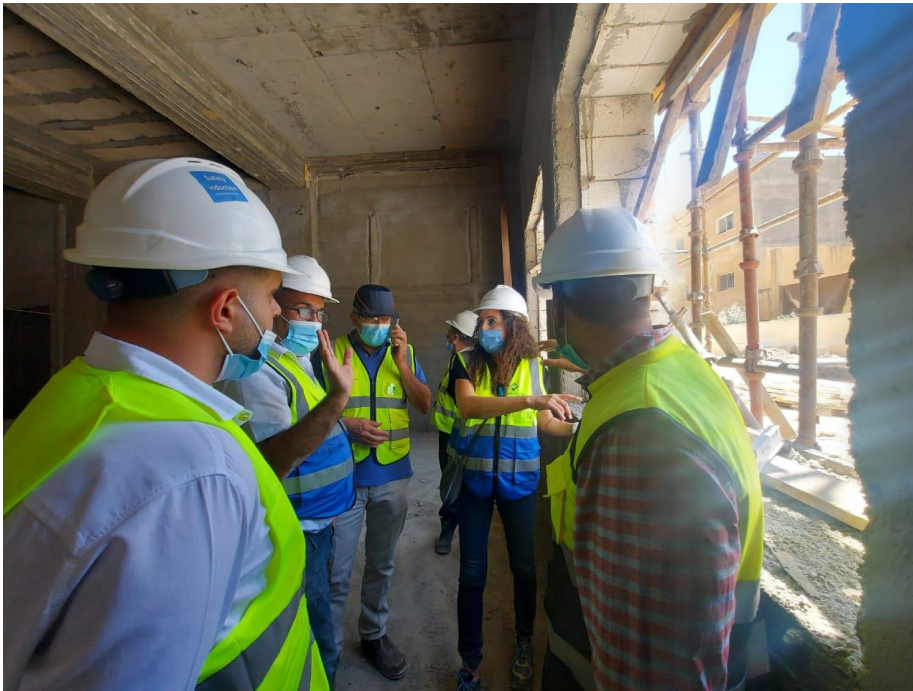
(Figure: 07)

The Consultant discussed with the Contractor window sills details at basement floor, marble/stone

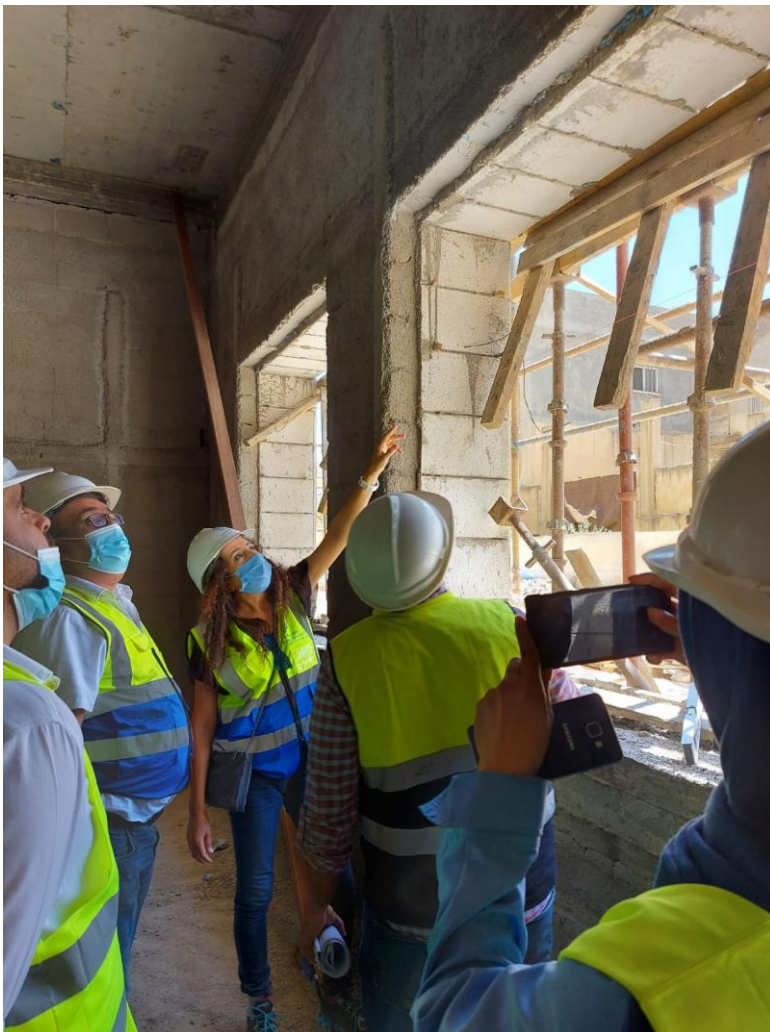
(Figure: 08)

The Consultant discussed with the Contractor the stone soffit detail of one window at basement floor

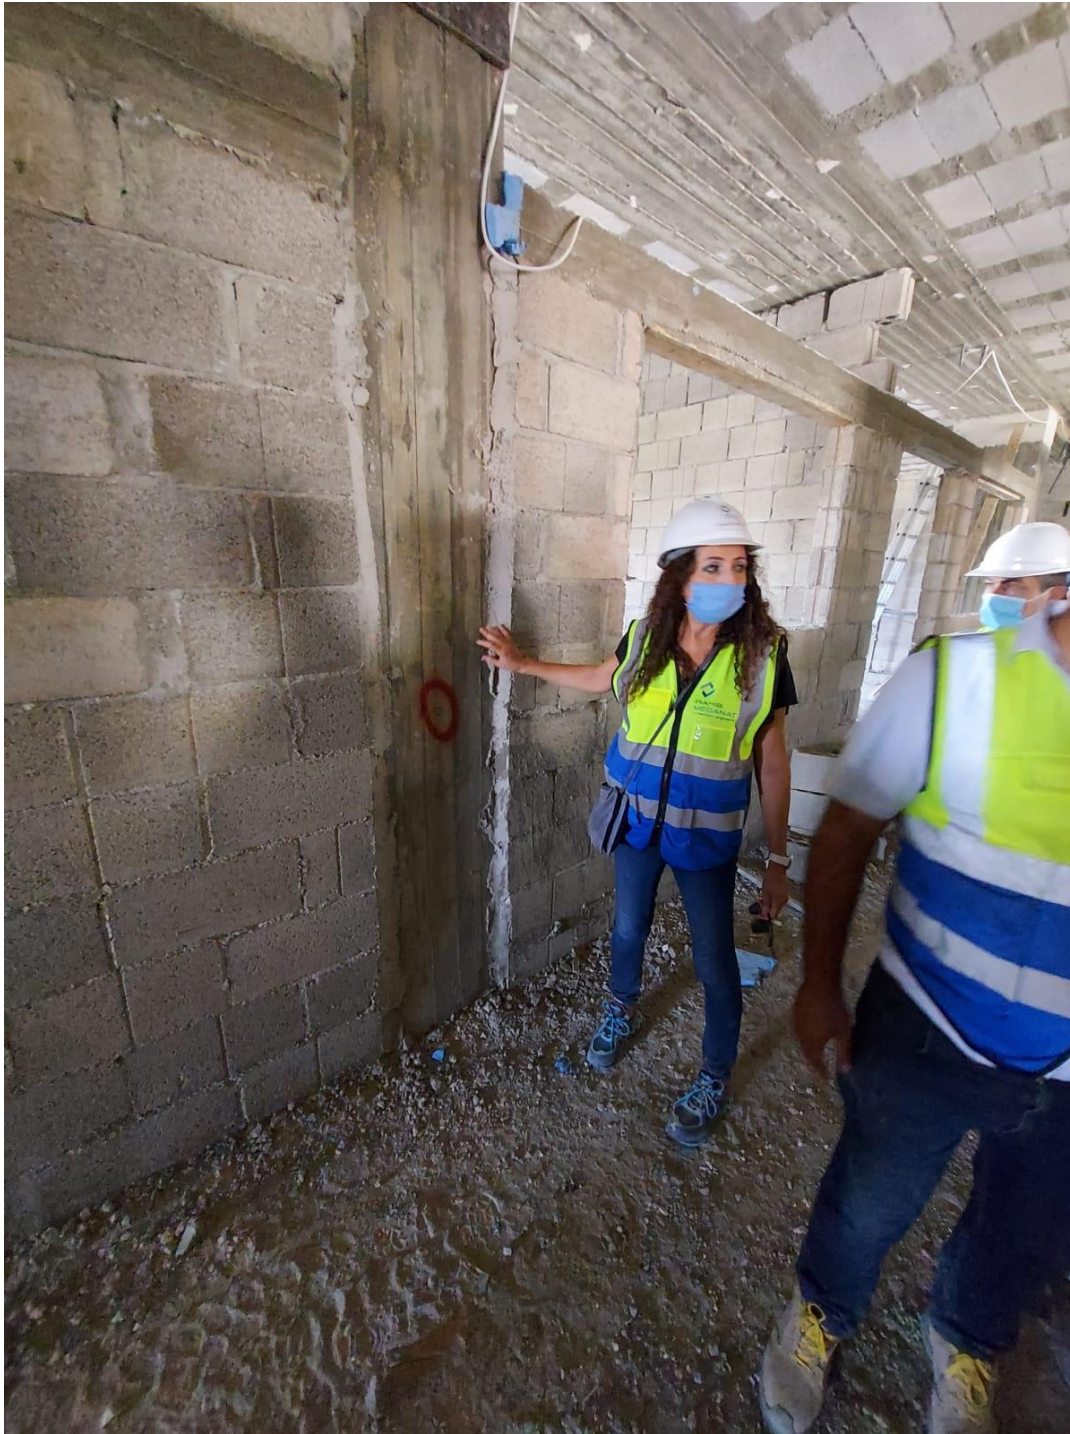
(Figure: 09)

It was observed that one block wall does not match with the concrete wall and the difference was found to be over 5cm. the Contractor was instructed to cast a concrete strip with the use of fixing accessories appropriate to the said case

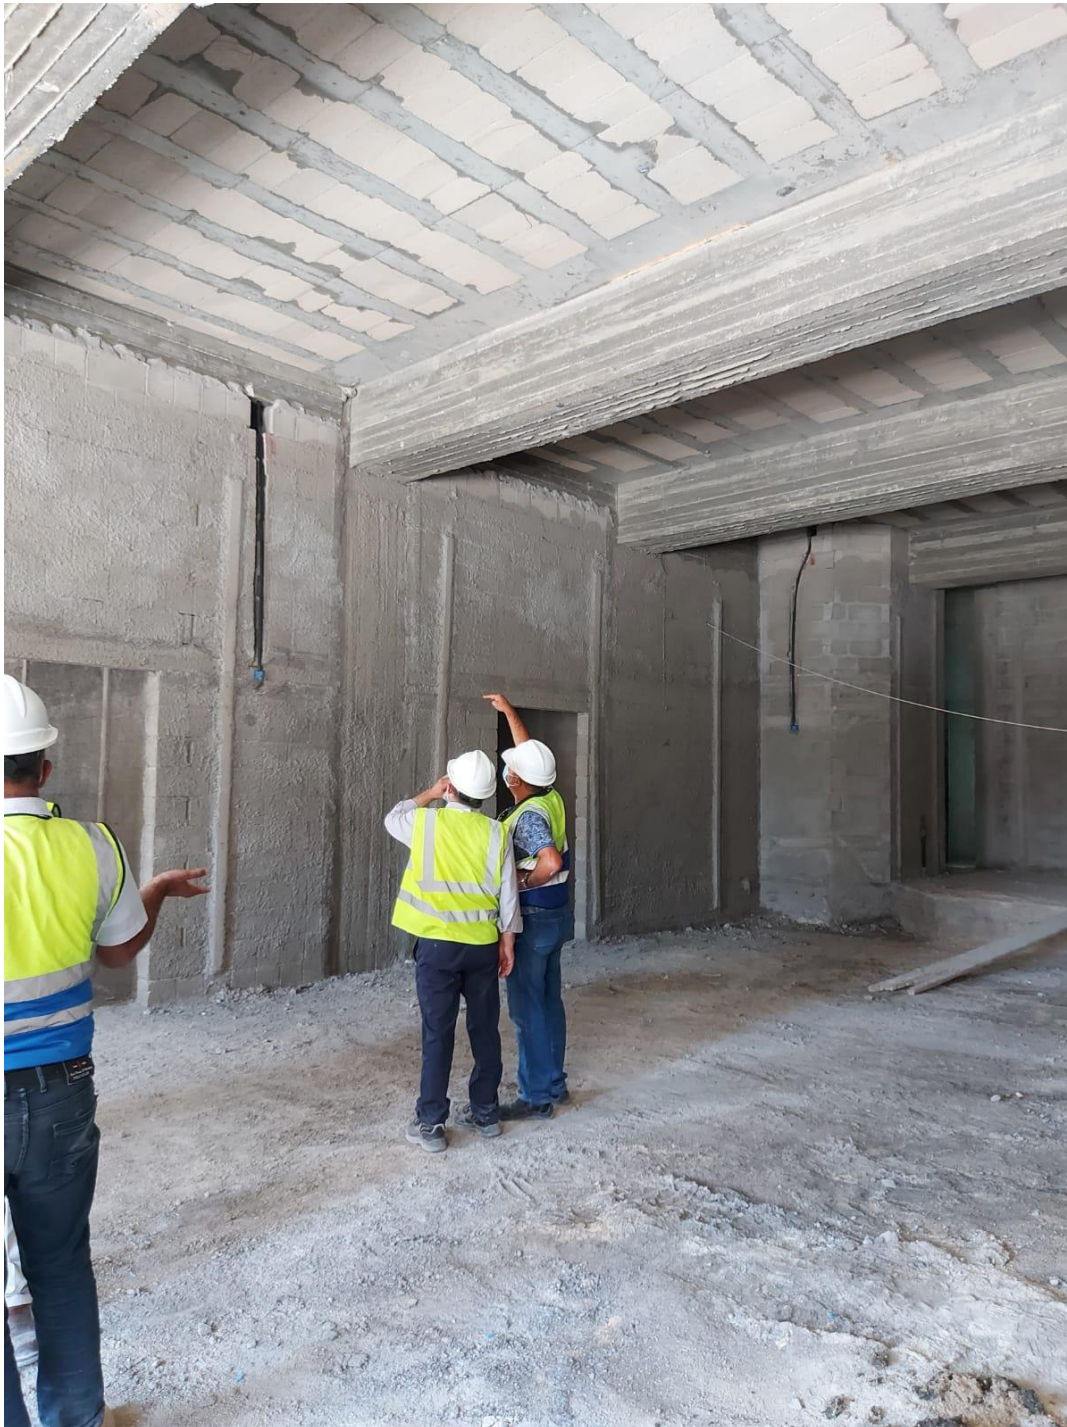
(Figure: 10)

Plastering works have been checked at basement floor and the Consultant stressed on the installation of external beads as an important accessory for plaster. Also MEP first fix and the relation with plaster was checked

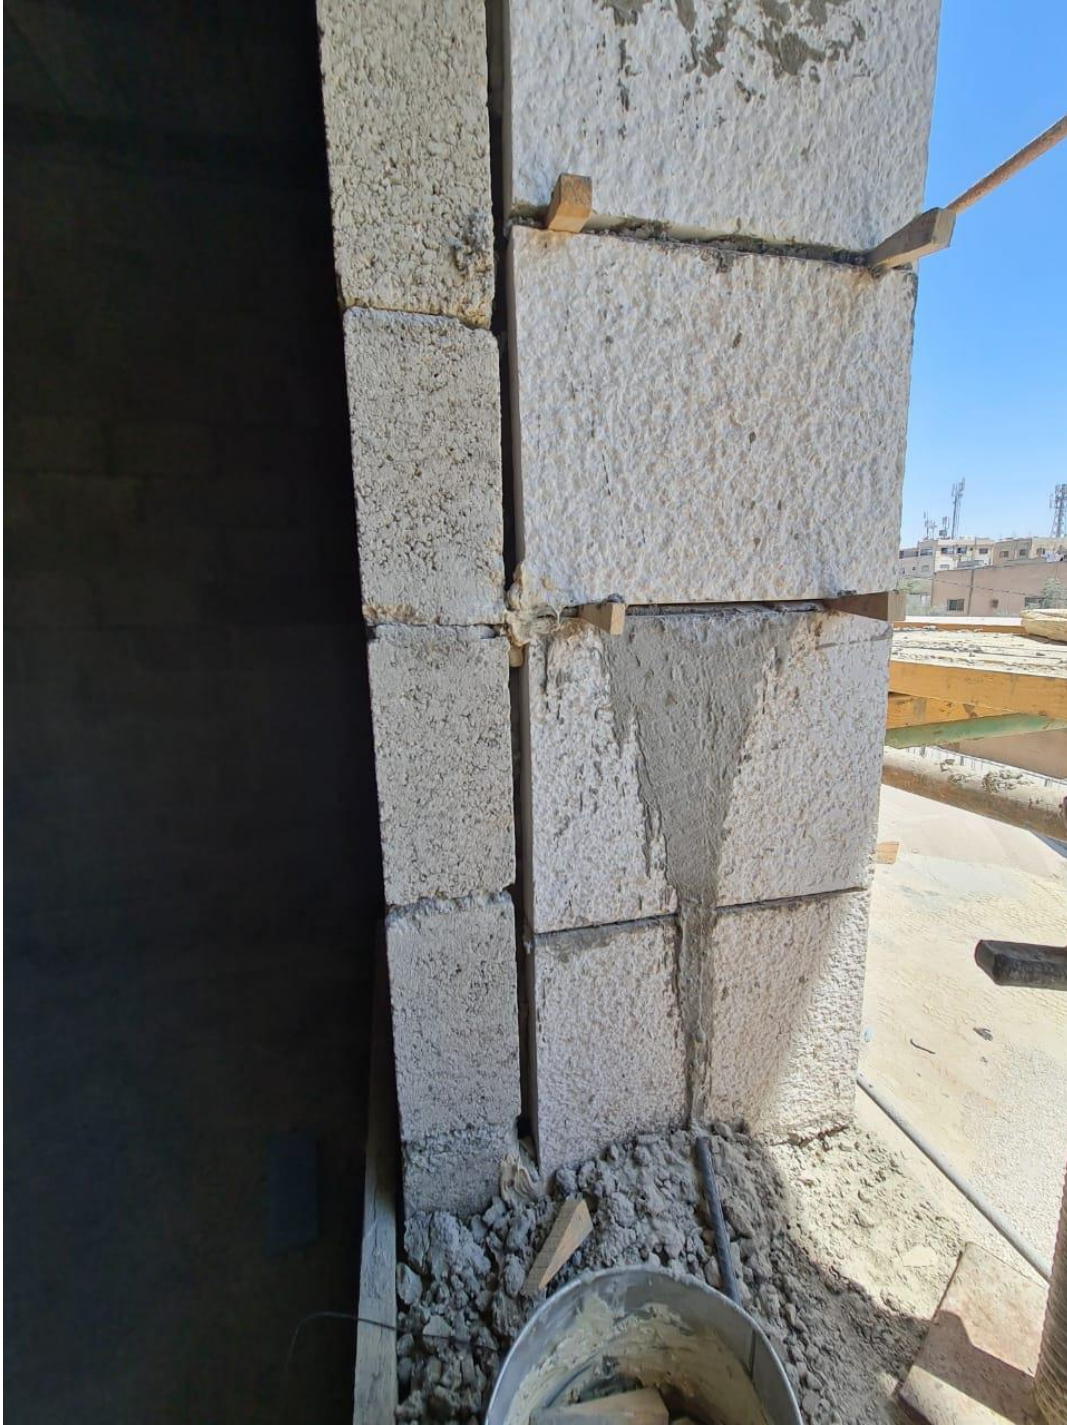
(Figure: 11)

The Consultant observed that, at the door, window jambs, the end of block wall is passing the end of stone limit.

The Contractor was requested to match the block wall with the stone end

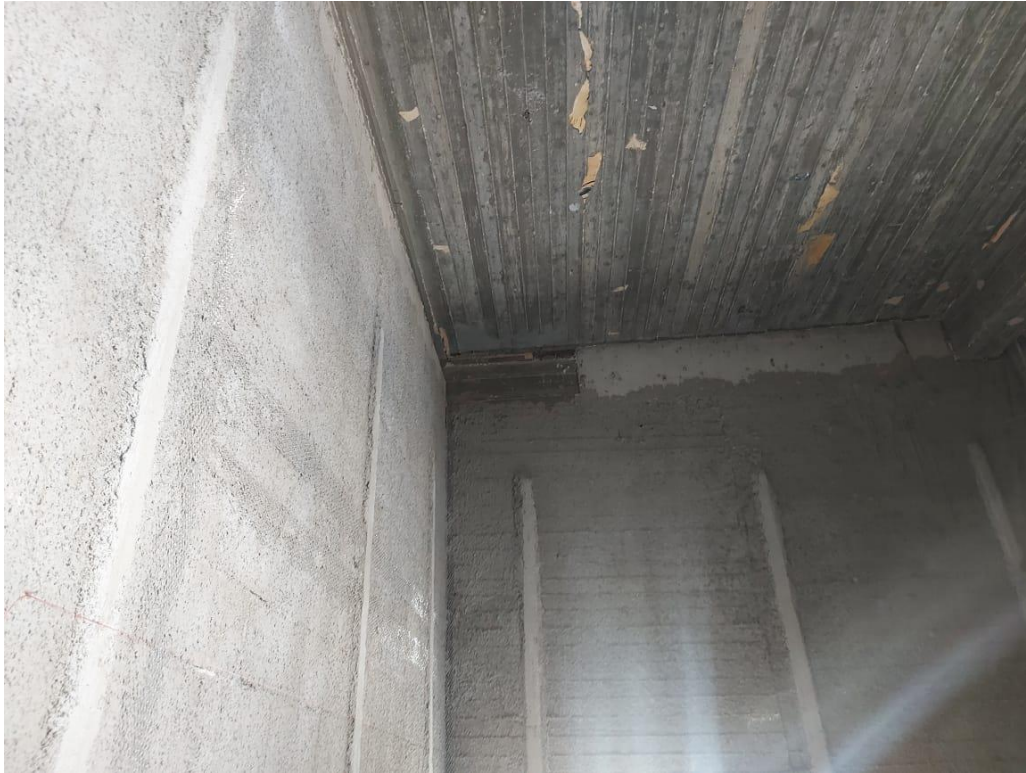
(Figure: 12)

The Consultant stressed that the Contractor should remove the remaining wood pieces at the basement ceiling

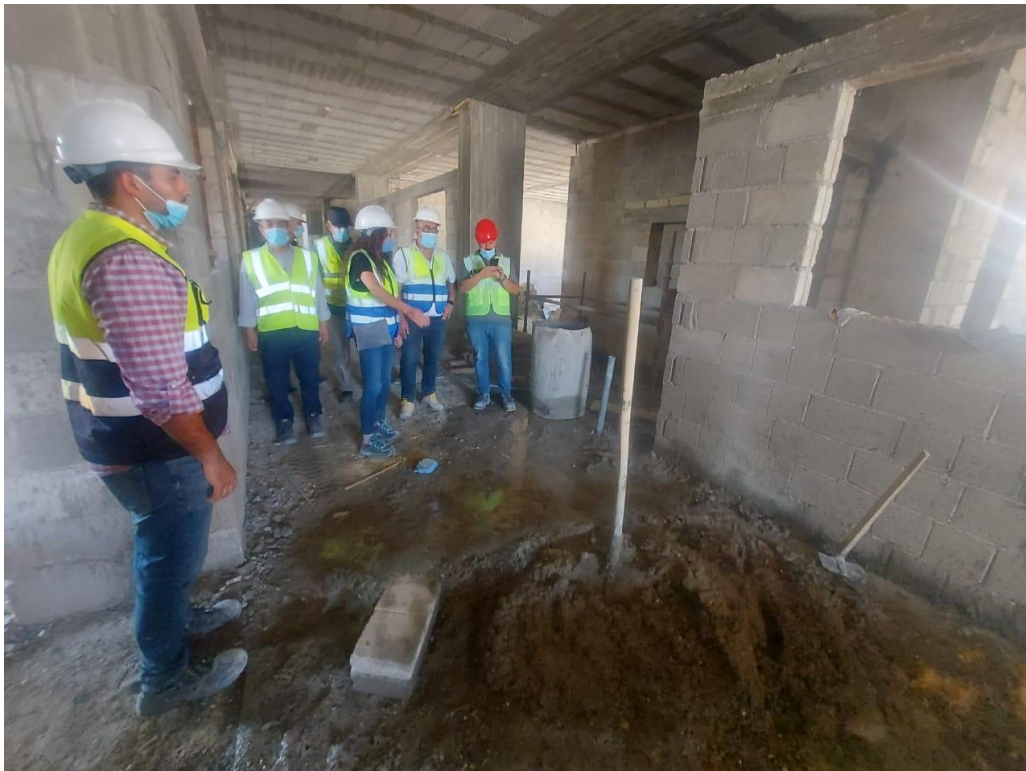
(Figure: 13)

Blockwork at ground floor has been checked and the Consultant stressed on using clean platform for mortar mixing as the available on site does not comply with what was requested

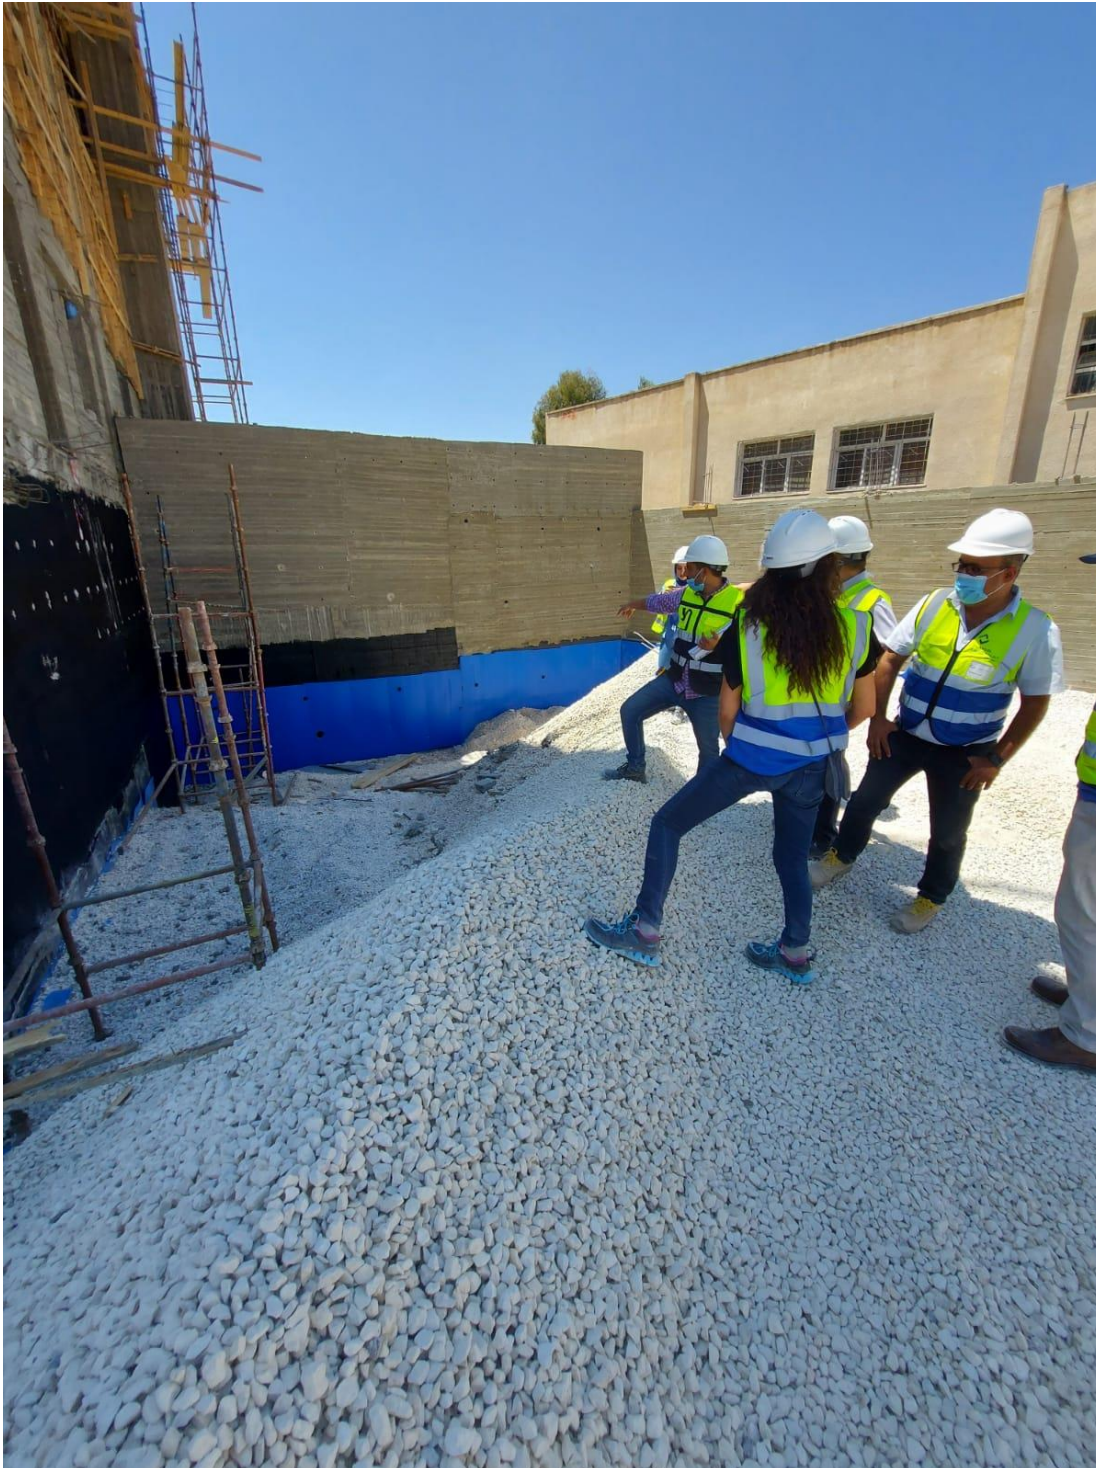
(Figure: 14)

The Consultant observed that the Contractor conducted back-filling work without doing the appropriate insulation work

During the site visit, Engineer representatives observed that remedy works was ongoing

The Contractor was instructed to remove the back-filling to execute the required insulation (bitumen paint and waterproofing sheets including the carton sheets) as per contract and the instruction of Supervision site engineer.

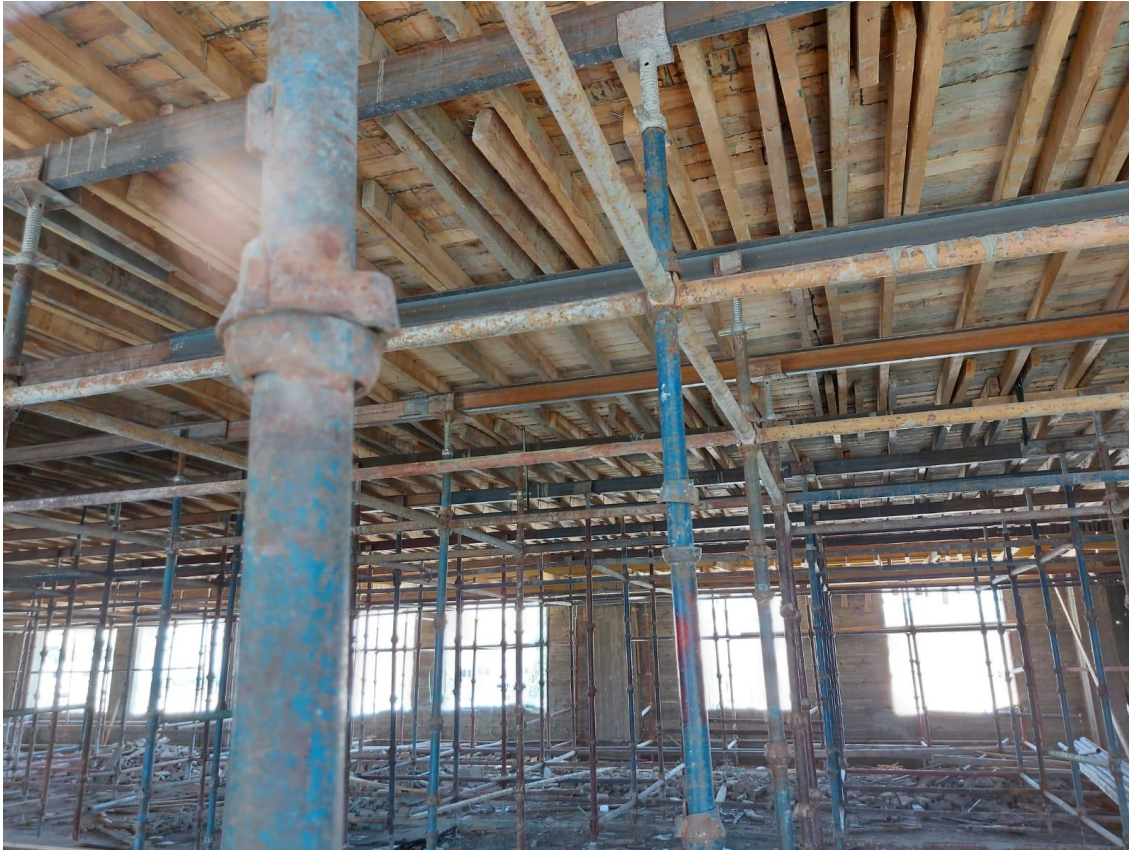
(Figure: 15)

Scaffolding and formwork for second floor slab zone "B"

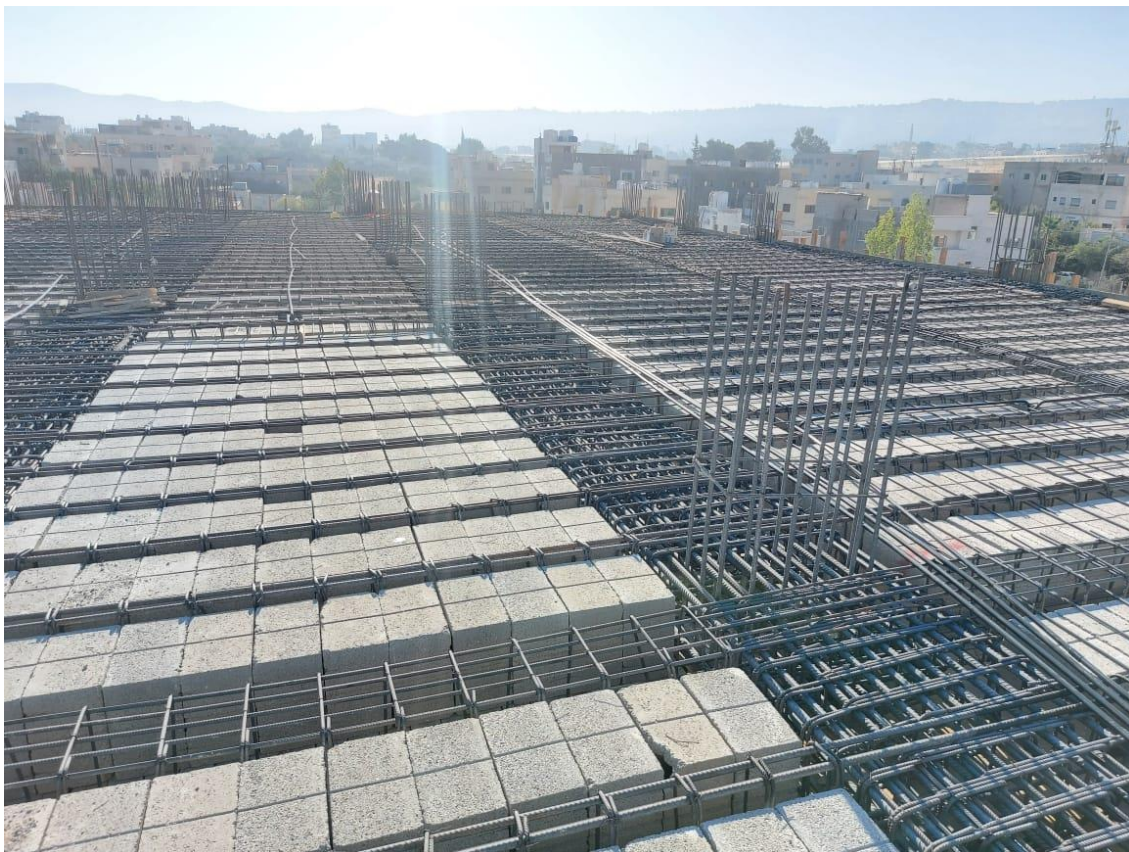
(Figure: 16)

Reinforcement work at second floor slab zone "B"

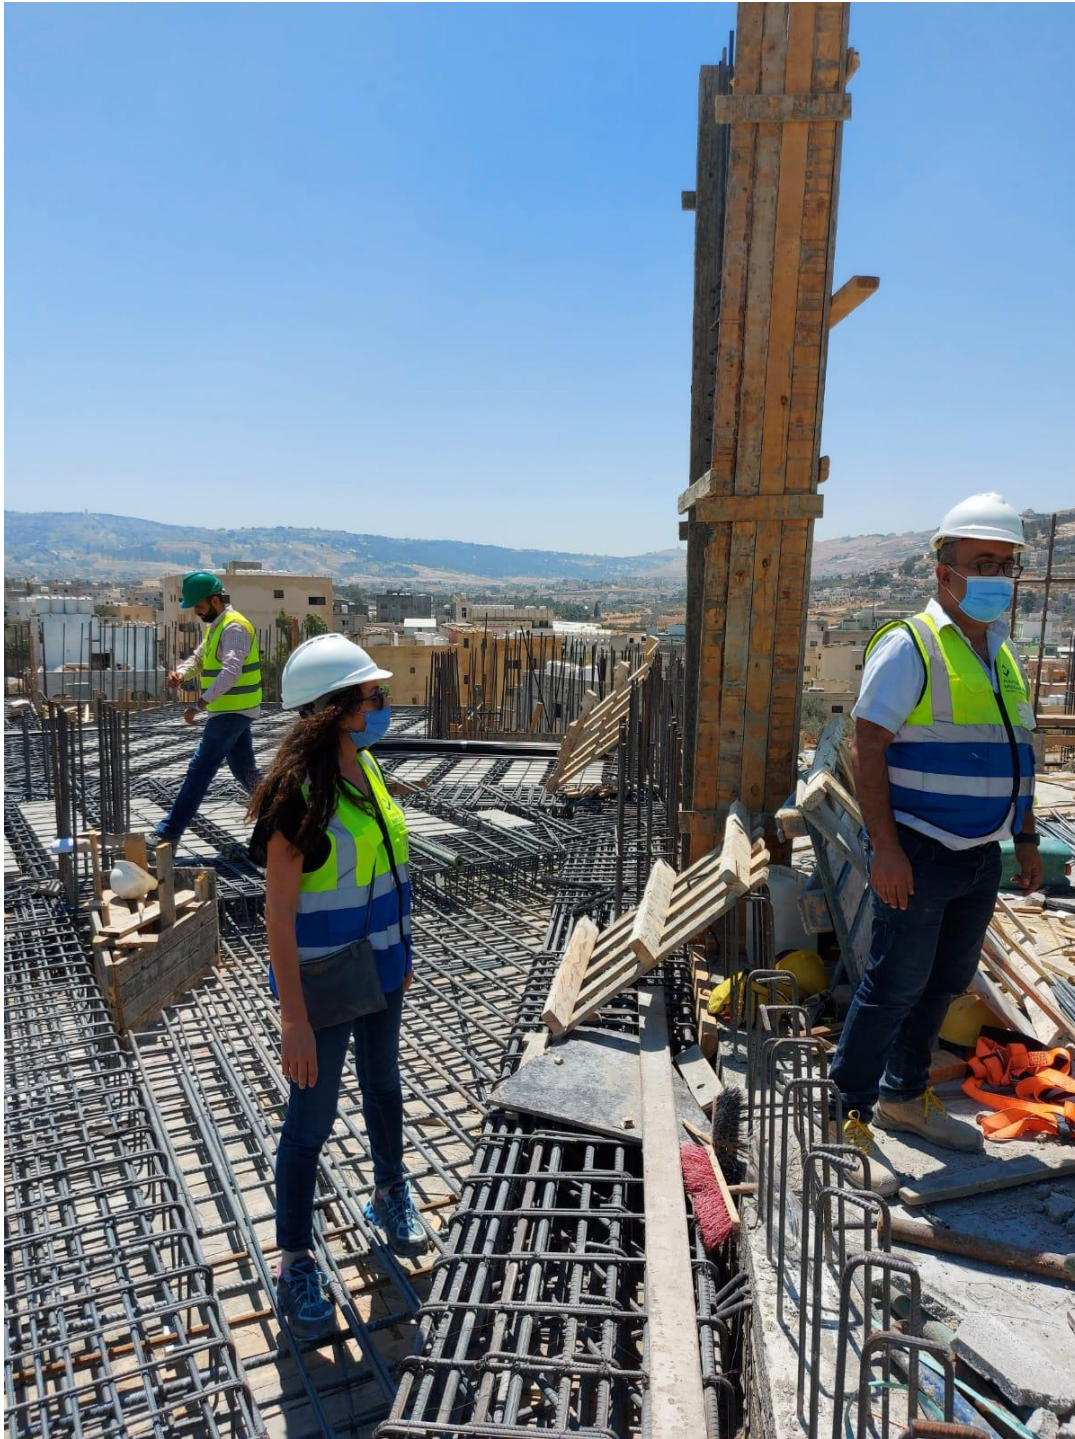
(Figure: 17)

The Consultant discussed with the Contractor the expansion joint details at second floor zone "B"

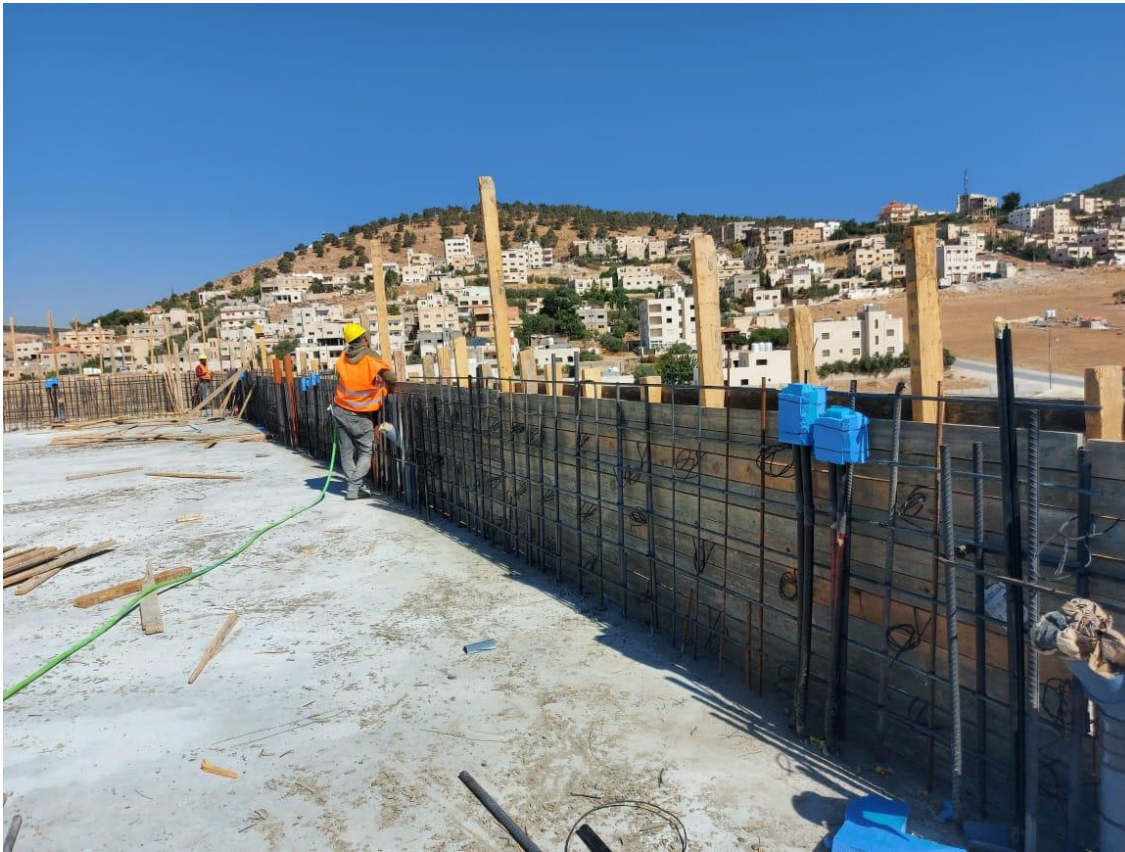
(Figure: 18)

The parapet detail at zone "A" under construction were checked

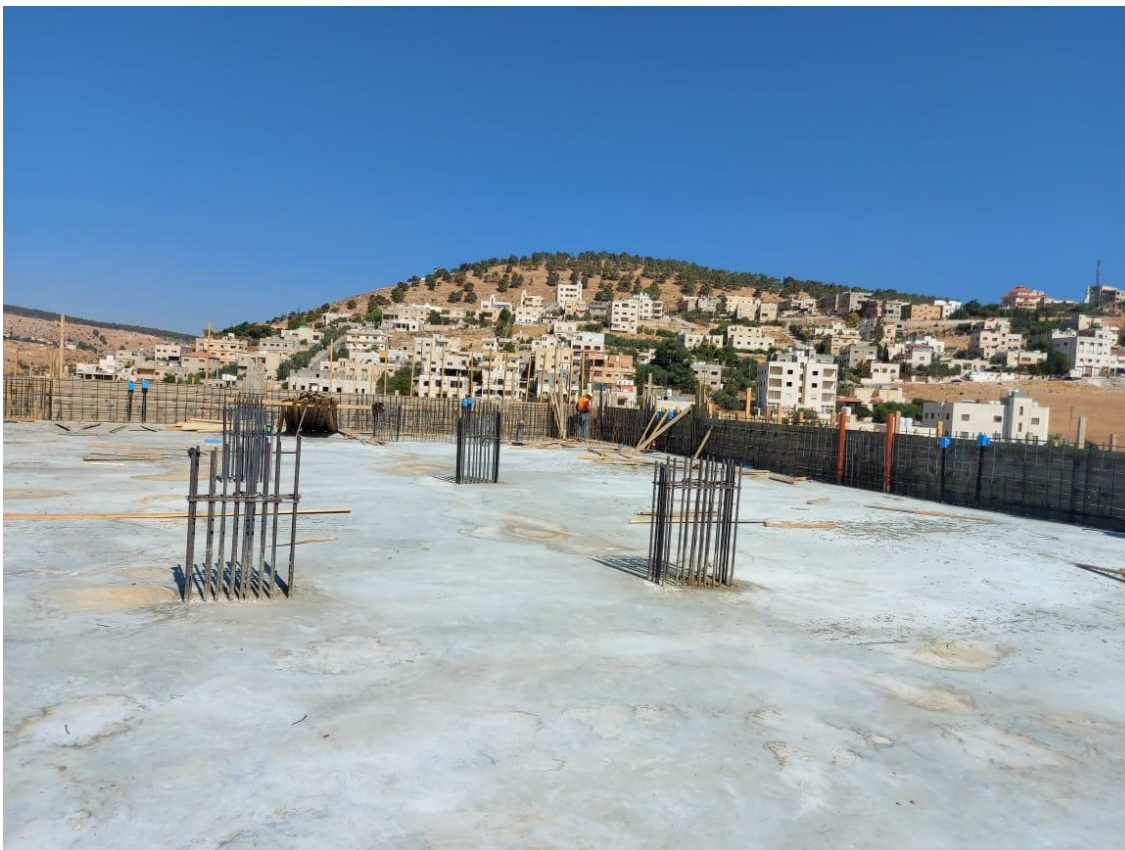
(Figure: 19)

The Consultant checked the quality of concrete after casting the roof framing slab at zone "A" and stressed on the necessity of concrete curing

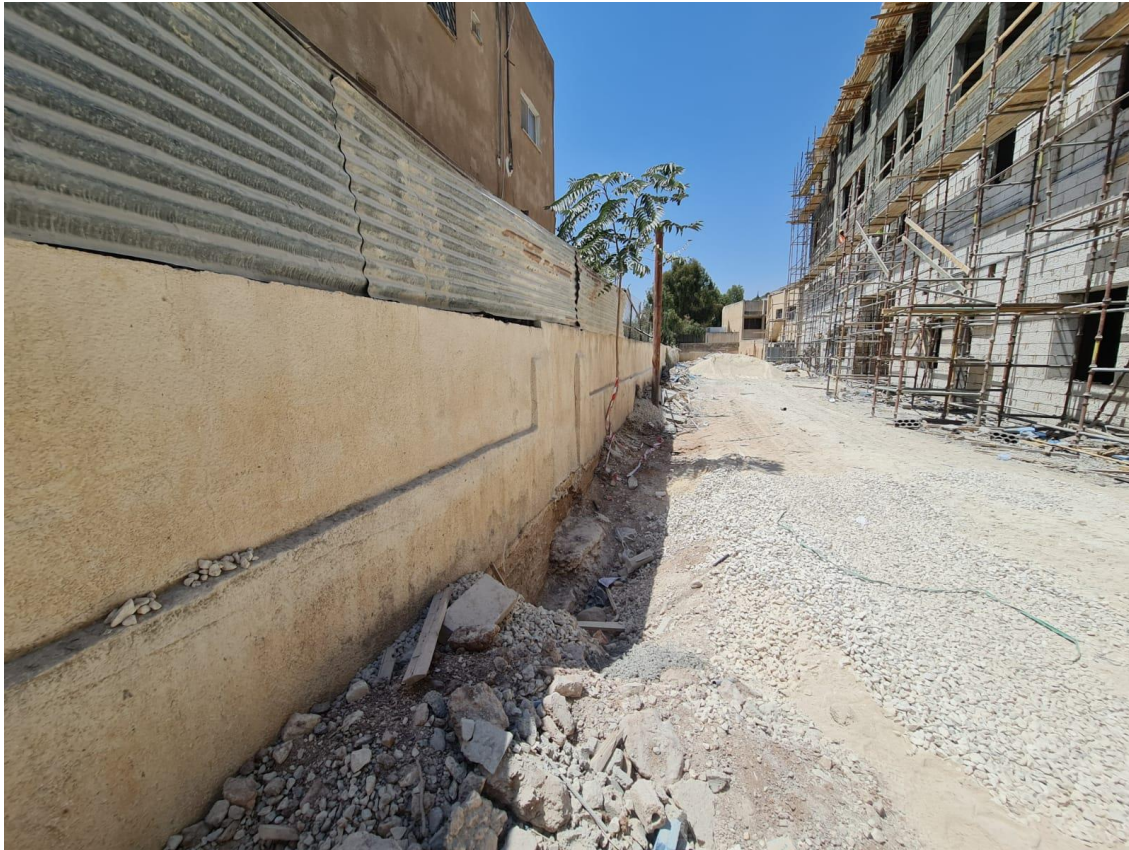
(Figure: 20)

The new adjacent wall work has not started yet
