Site Visit Report Form

SKEP PHASE: III PACKA
Hay Al Iskan Basic Mixed School
Medanat
Dijlah Contracting Co.
June 21,2021
June 24,2021
Sunny, 32 Degrees
Mohammad Sami Ali-Ahmad CMTO/Trigon
Osama Obeid CMTO/Trigon

FTR # QR 418

PHASE: III PACKAGE: 2

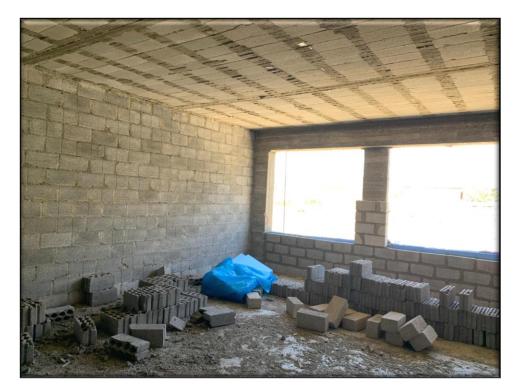
FIGURE #02&03:

The proposed school consists of five floor building, with an internal area of 5240.0 m2 and external area of 4522.0 m2, in addition to all related site works

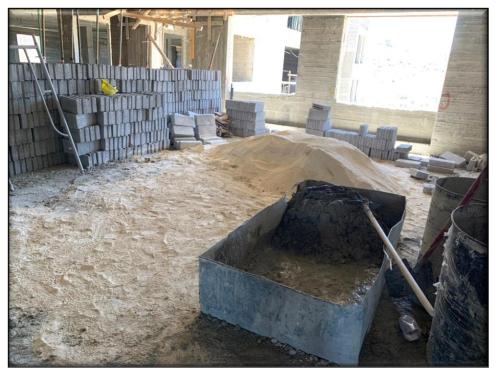
FIGURE #04:

Cement block walls works is ongoing

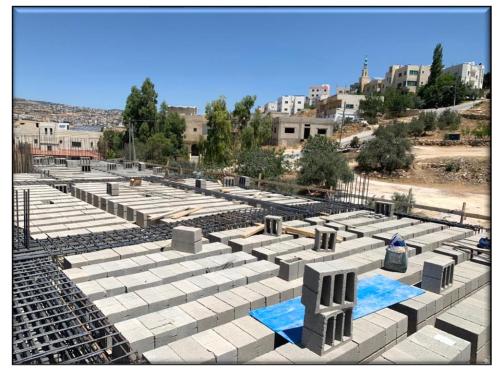
FIGURE #06:

Placing the 1st part of final slab is completed

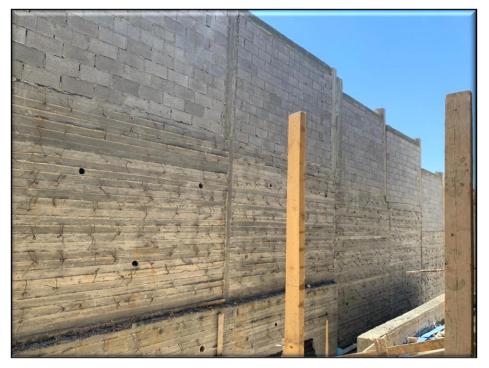
FIGURE #08:

Construction works for boundary wall is completed

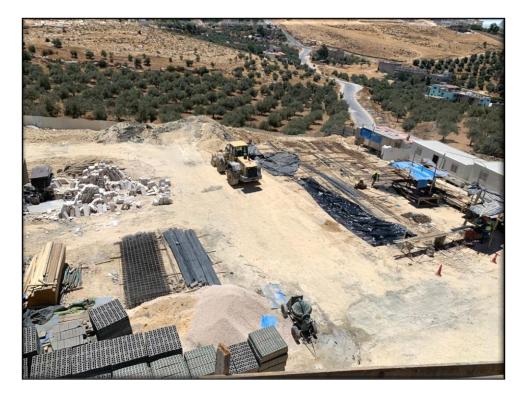
FIGURE #09:

Construction works for boundary wall is completed
