# Quality Control Report

**Consultant** **Wahib Medanat** Consultant Engineers  
**Site Name** **Um Al Dananir Basic Mixed - Balqa**  
**Package** **Package 1**  
**Contractor** **Derar Saraireh & Sons for Engineering & Contracting**  
**Tender No.** **1/2020/USAID/SKEP/3/1**

**Rep No.** **QC-11 07**  
**Date** **15 / 06 / 2021**

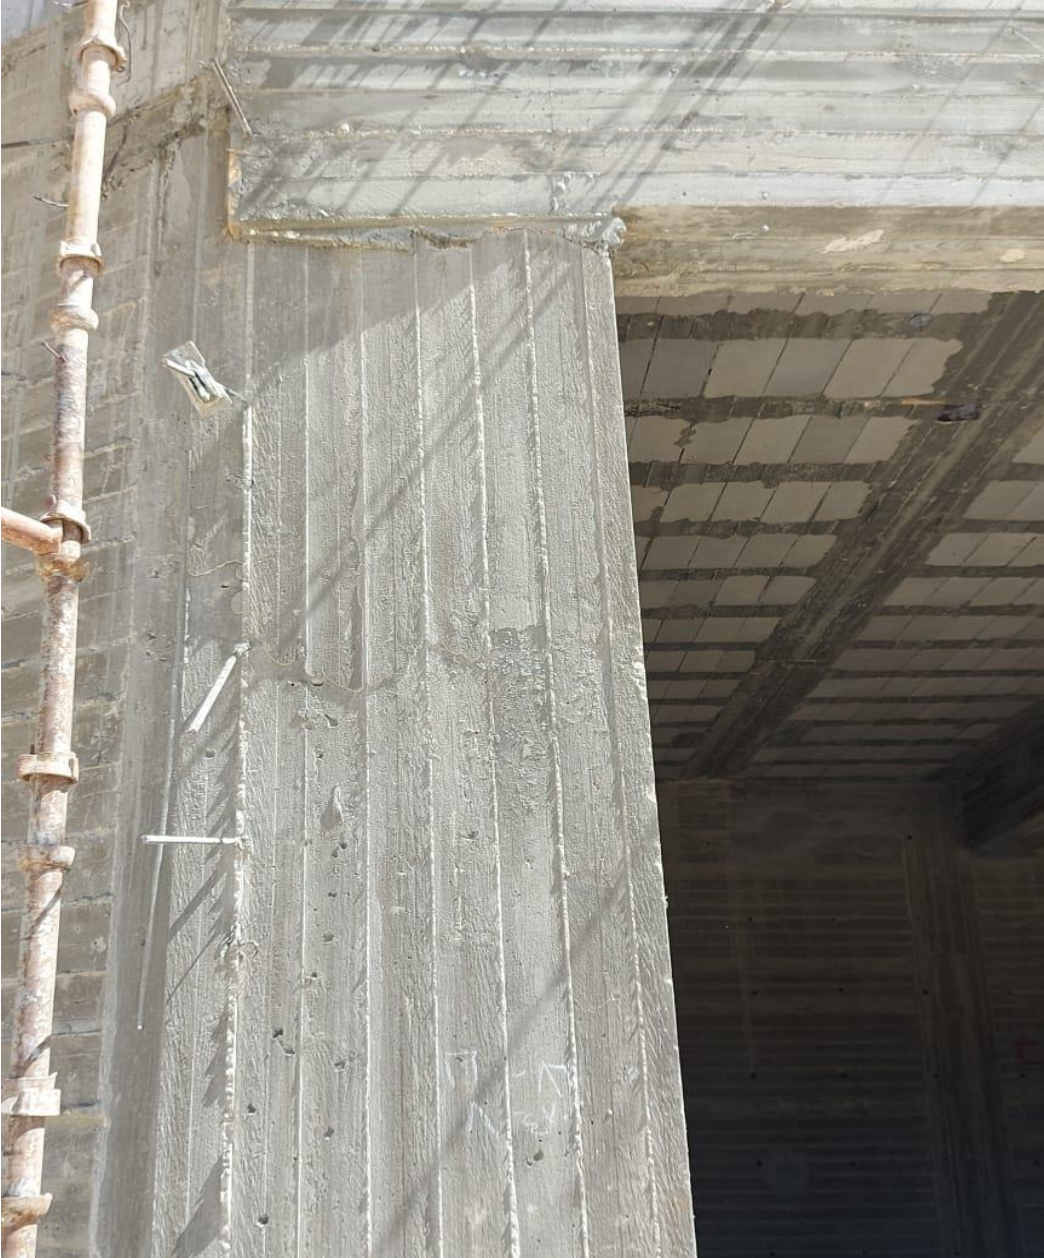
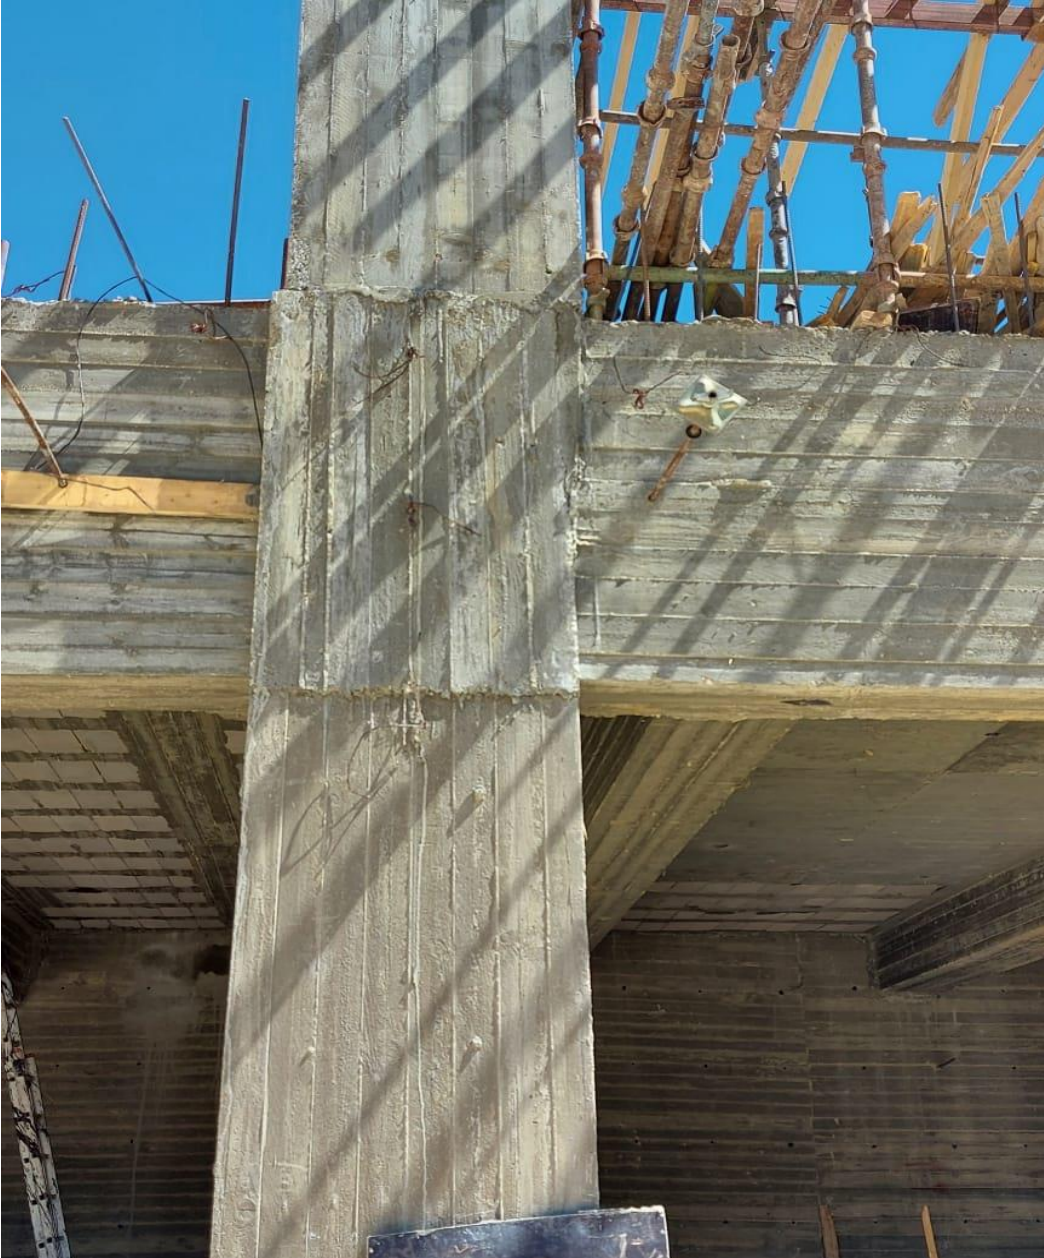
Description of Non Conformance	Corrective Action	Required by / When
<p>In some locations, walls, columns and roof external beams are not in line together. Teething were observed. The teething is expected to be within the space allocated for building stones.</p>	<p>Chipping is needed for limited locations.</p>	<p>The Contractor/Immediately</p>
