#### Schools for Knowledge Economy Project SKEP III

### **Quality Control Report**

Consultant Wahib Medanat Consultant Engineers Rep No. QC-11 14

Site Name Um Al Dananir Basic Mixed - Balqa Date 4 / 12 / 2021

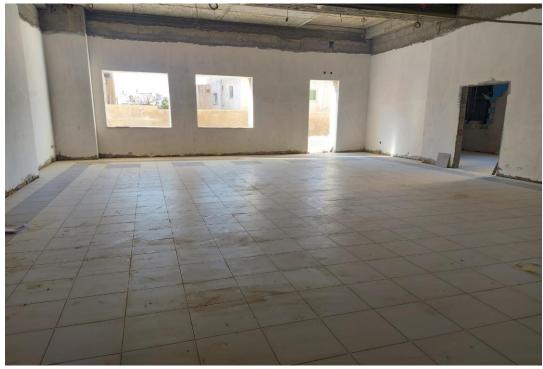
Description of Non Conformance	Corrective Action	Required by / When
	1. Defects in floor tiling.	1. Removal/Replacing the whole tiles.	The Contractor/Immediately
	Report Prepared by	Hassan Shaqbua, Supervision Quality Control Manager	
	Contractor's Response		
	It was observed that the Contractor rectified the following: 1. Starting with removal of defected floor tiles. 2. Wrapping steel door frames with protective cover.		
Notes

**Defected Porcelain floor tiles**

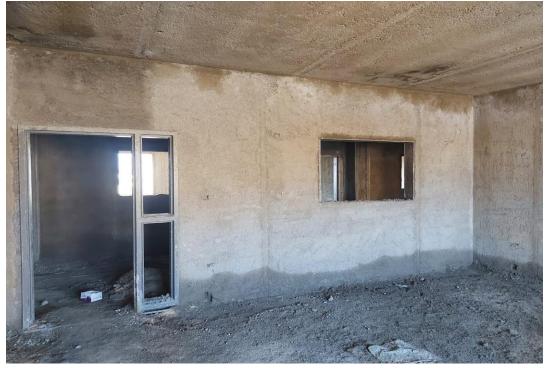
Unwrapped steel door frame
