Consultant	Wahib Medanat Consul	tant Engineers	Rep No.	QC-21 12
Site Name	Hay Al Iskan Basic mixed -	Jerash	Date	21 / 09 / 2021
Package	Package 2			
Contractor	Dijlah Est. Construction Co.			
Tender No.	10/2019/USAID/SKEP/3/2			
Doc	wintion of Non	Corrective Action	Pog	uirad by / Whan

Quality Control Report Before Photos

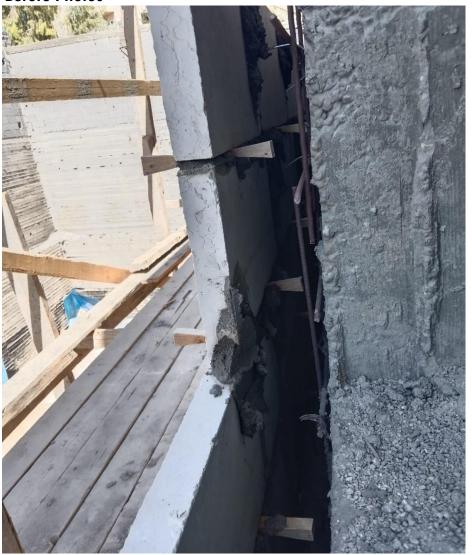
Wooden wedges within backing concrete space

Removing wedges out of the backing concrete space

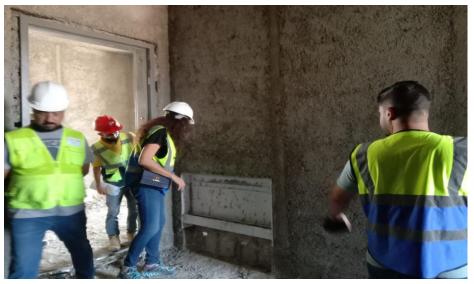
Mechanical cabinet very close to the door frame

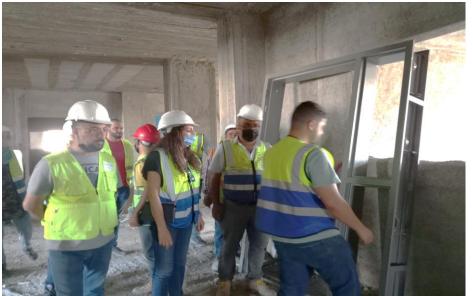
Defected door frames

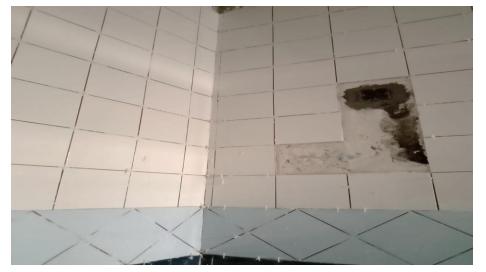
Tiled wall not complying with shop drawings

Retiled wall in accordance to the shop drawings
