# Quality Control Report

**Consultant** **Wahib Medanat** Consultant Engineers  
**Site Name** Hay Al Iskan Basic mixed - Jerash  
**Package** Package 2  
**Contractor** Dijlah Est. Construction Co.  
**Tender No.** 10/2019/USAID/SKEP/3/2

**Rep No.** QC-21 10  
**Date** 17 / 07 / 2021

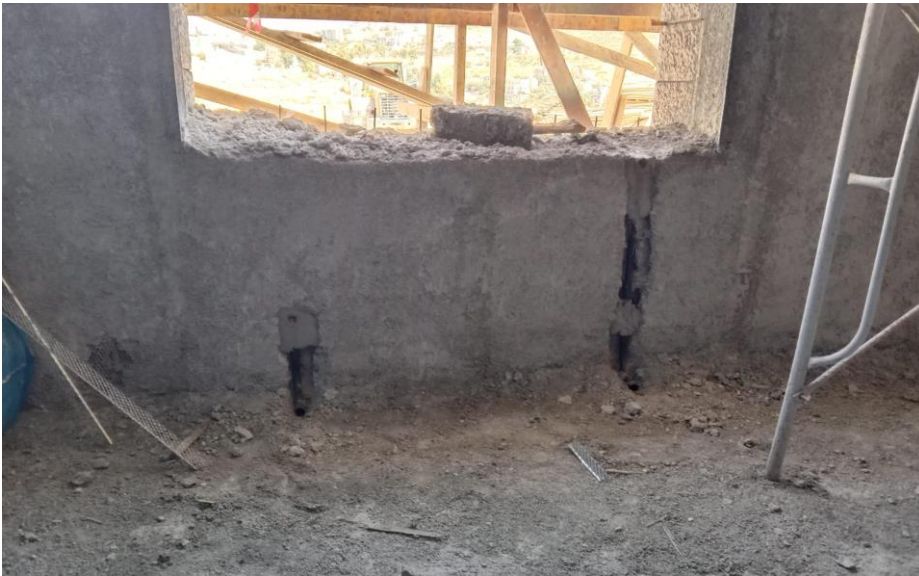
**Radiators first fix have been installed top- bottom without approval**

Contractor responded immediately. The Contractor submitted method statement for chipping for MEP first fix and prepared a sample for fixing radiators

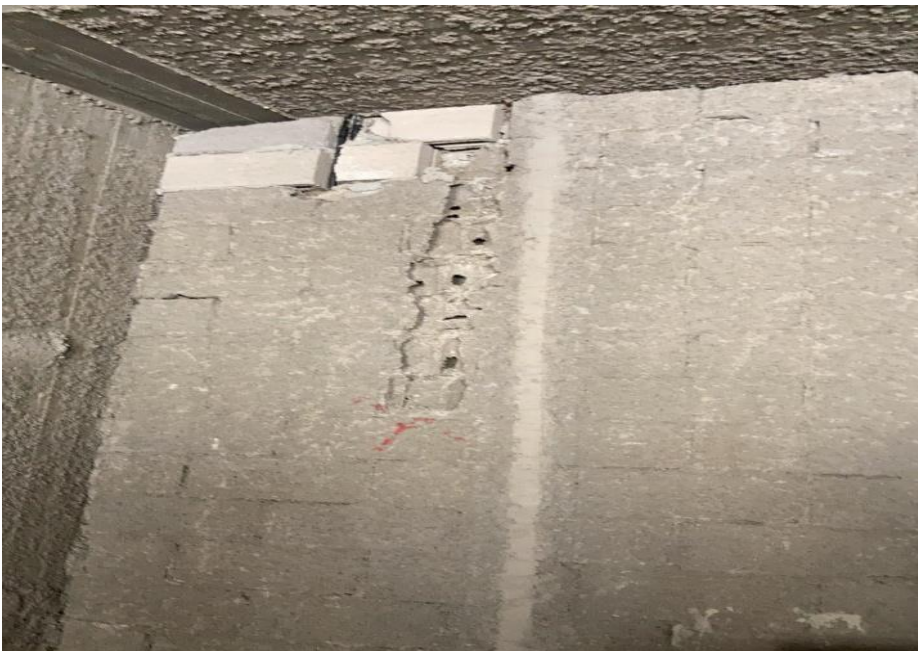
**Top layers in block walls are built with defects need to be replaced correctly**

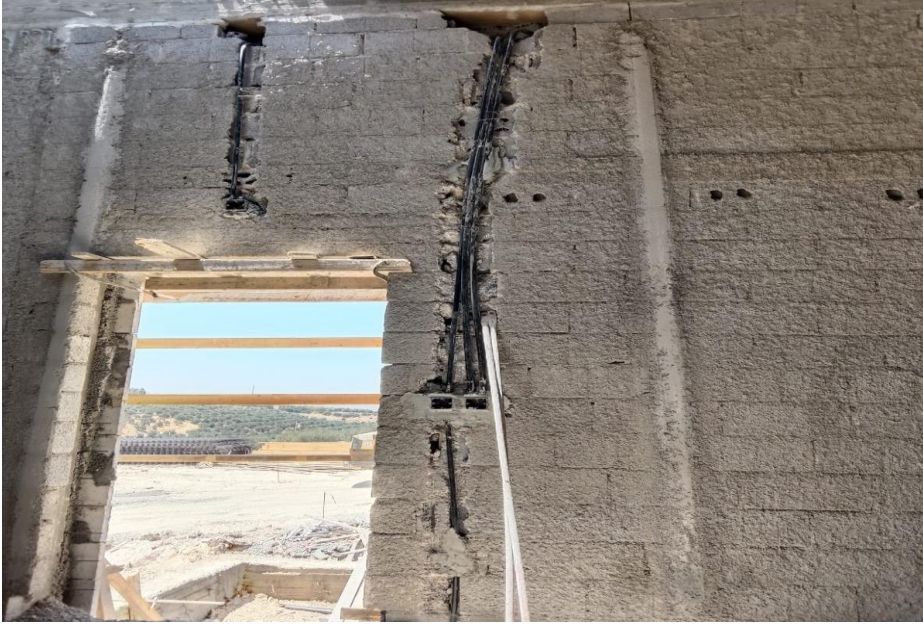
**Chipping in block walls are done not saw cut**

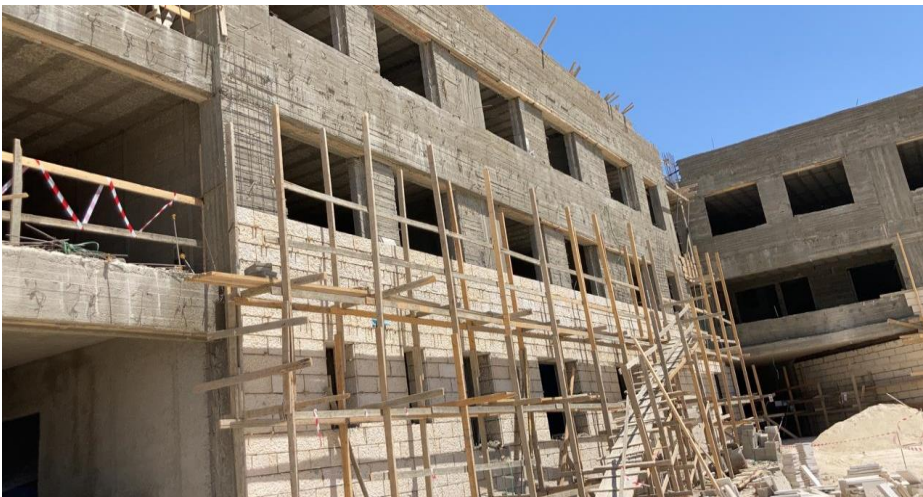
**The pattern of stone chiseling should be unified as per the approved sample**

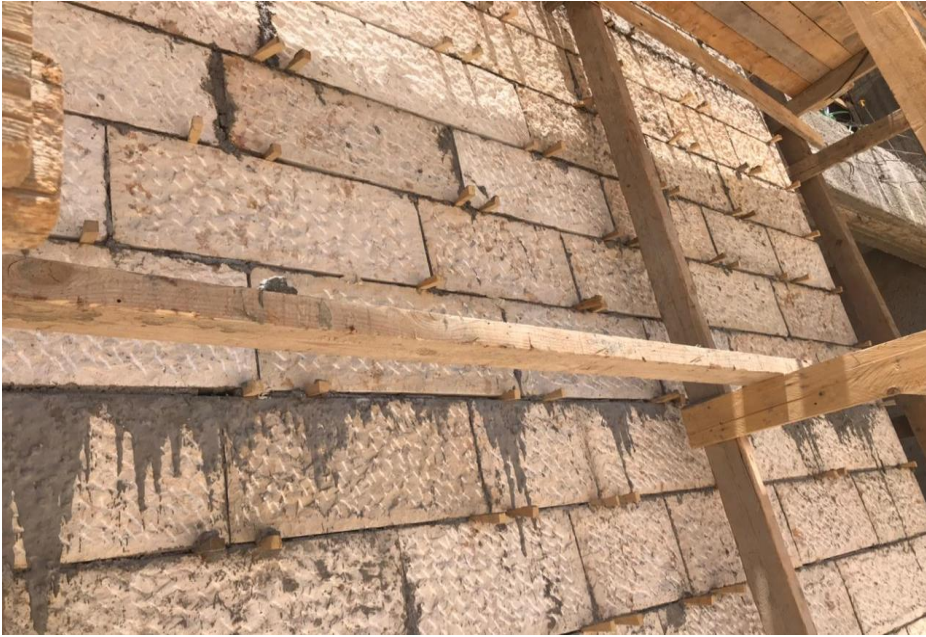
**Number of stones are broken, the gaps should be unified and the part of façade is full of cement mortar**
