# Quality Control Report

**Consultant** **Wahib Medanat** Consultant Engineers  
**Site Name** **Jumana Bint Abi Taleb Basic Mixed - Marka**  
**Package** **Package 2**  
**Contractor** **Dijlah Est. Construction Co.**  
**Tender No.** **10/2019/USAID/SKEP/3/2**

**Rep No.** **QC-23 08**  
**Date** **7 / 09 / 2021**

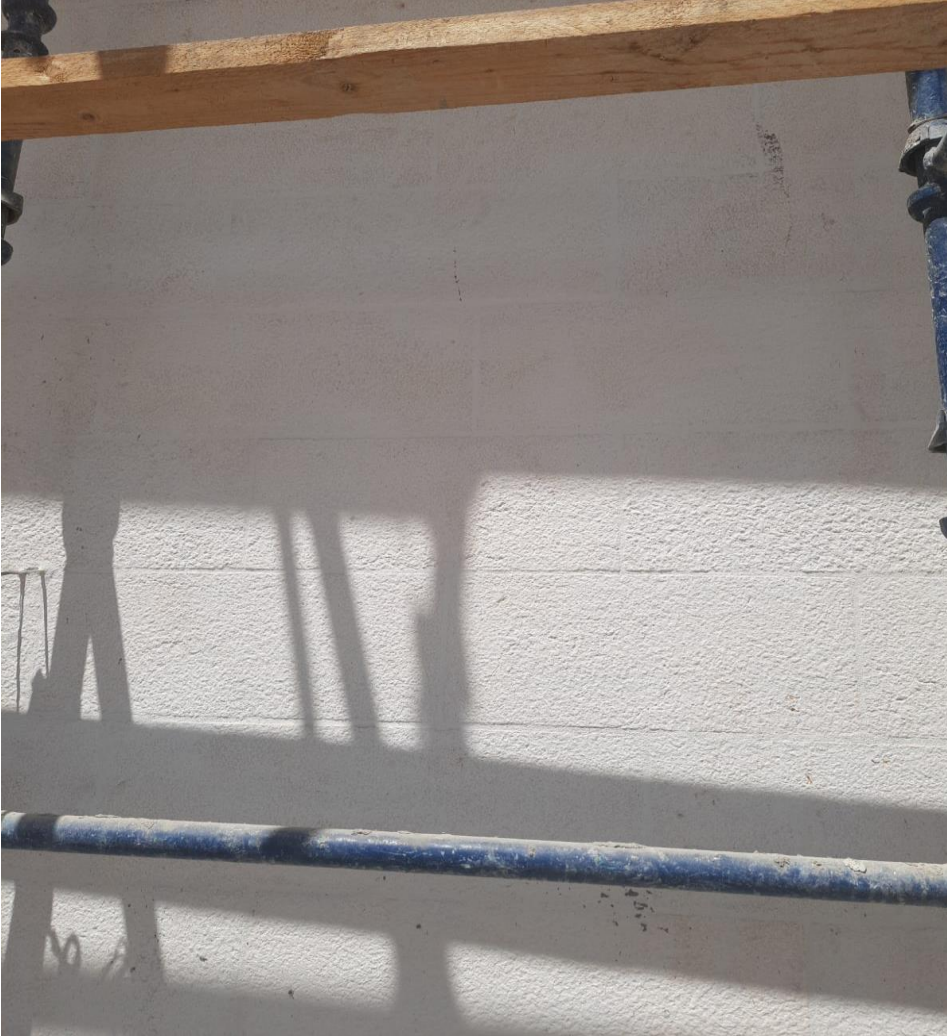
Painted stone façade to hide the defects

Stone façade after removing the paint and rectifying the defects

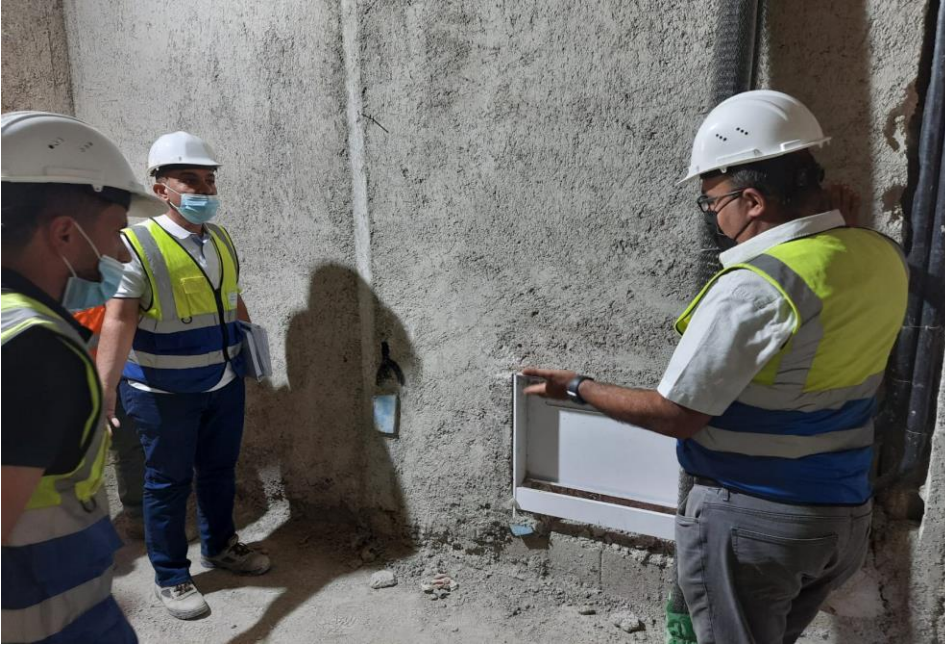
**Mechanical cabinet not matching with plastering face**

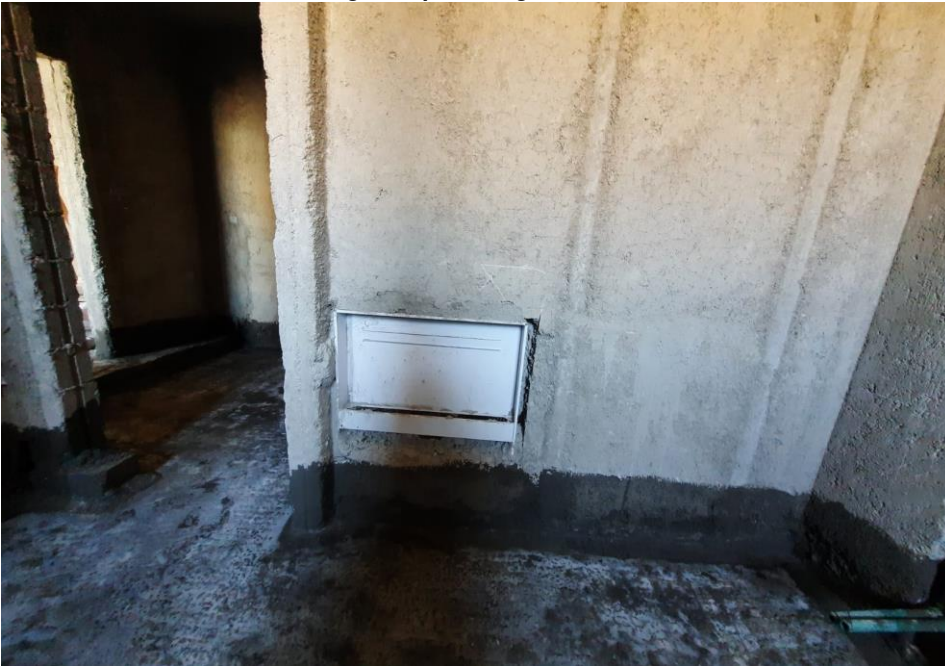
**Mechanical cabinet close to the door frame.**

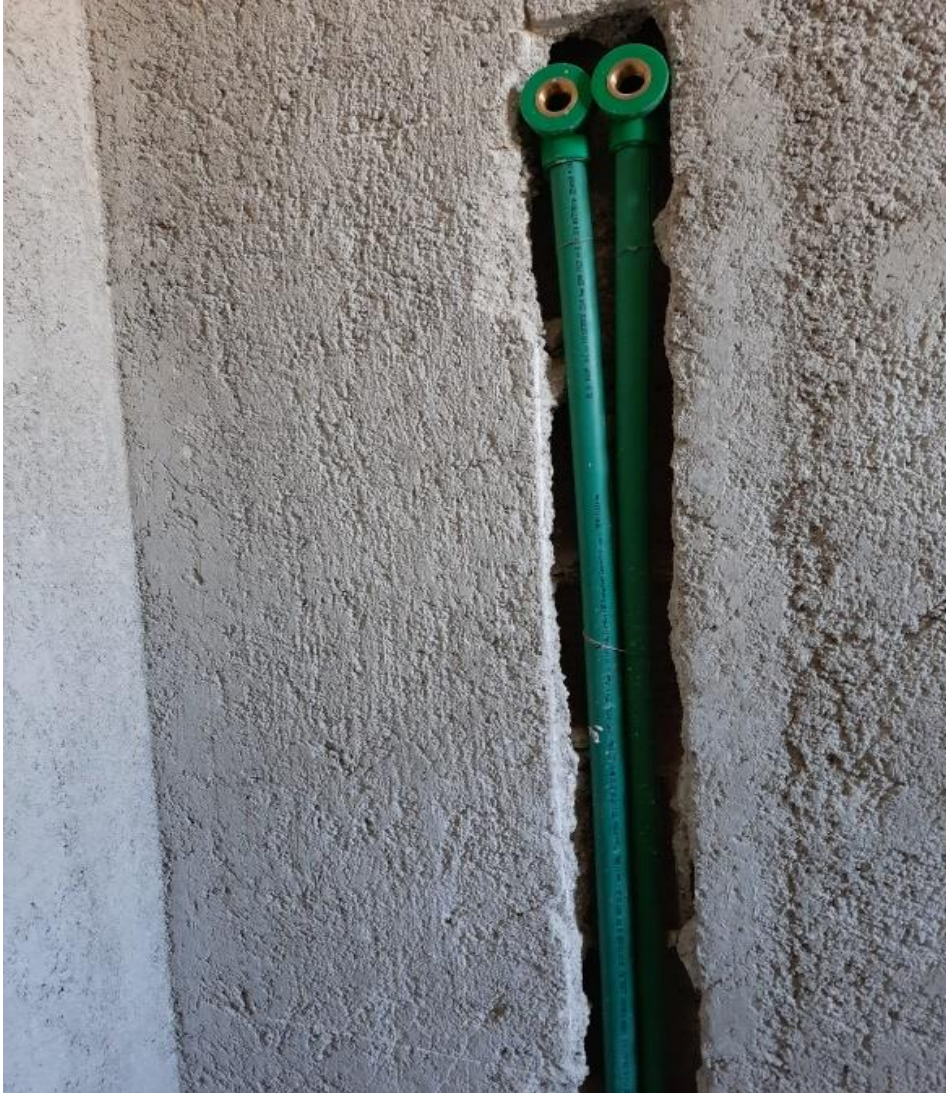
**Hot and cold water pipes close together**

**Creating a space between hot and cold water pipes and insulation to the hot water pipe**

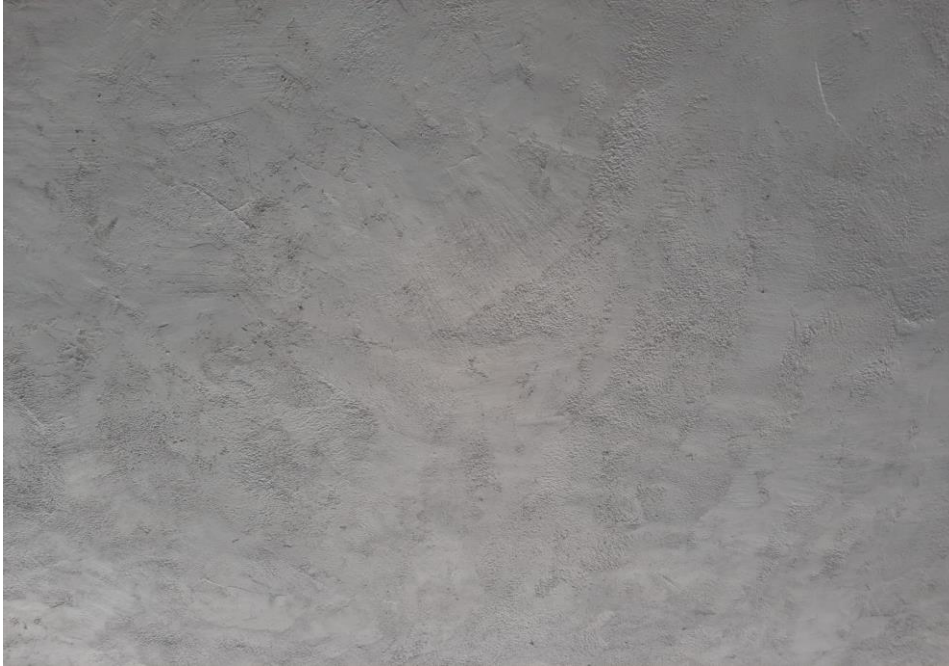
**Voids in the acoustic ceiling**
