ConsultantWahib Medanat Consultant EngineersRep No.QC-13 09Site NameKhadija Bint Khwailed Basic Mixed - BalqaDate14 / 09 / 2021PackagePackage 1

Contractor Derar Saraireh & Sons for Engineering & Contracting
Tender No. 1/2020/USAID/SKEP/3/1

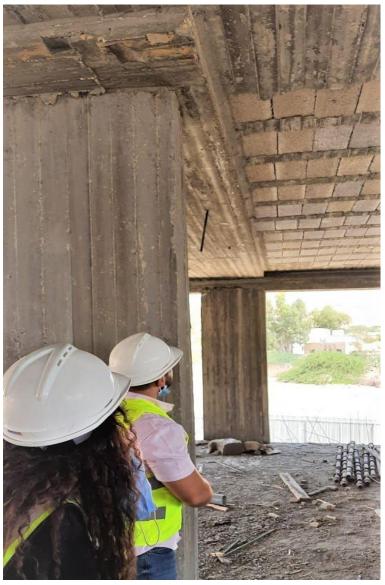
Segregation and roughness in the concrete of slab
