Quality Control Report

Consultant Site Name Package Contractor Tender No.	Wahib Medanat Consultant Engineers Khadija Bint Khwailed Basic Mixed - Balqa Package 1 Derar Saraireh & Sons for Engineering & Contracting 1/2020/USAID/SKEP/3/1		Rep No. Date	QC-13 11 10 / 11 / 2021
Description of Non Conformance		Corrective Action	Required by / When	
 Door frames are not protected. Dimensions of sills are not complying. Installing electrical outlets at elevations is wrong. Executing expansion joint wrongly. 		 To be cleaned and protected by nylon or appropriate sheets. To be replaced. To be rectified. To be rectified. 	The Contractor/Immediately	
Report Prepared by		Hassan Shaqbua, Supervision Quality Control Manager		
Contra	ictor's Response			
No response by The Contractor.

Schools for Knowledge Economy Project SKEP III Quality Control Report

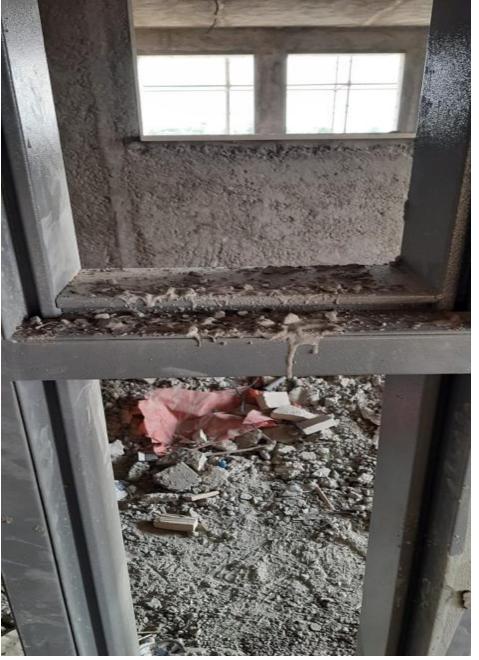
Door frames are not protected

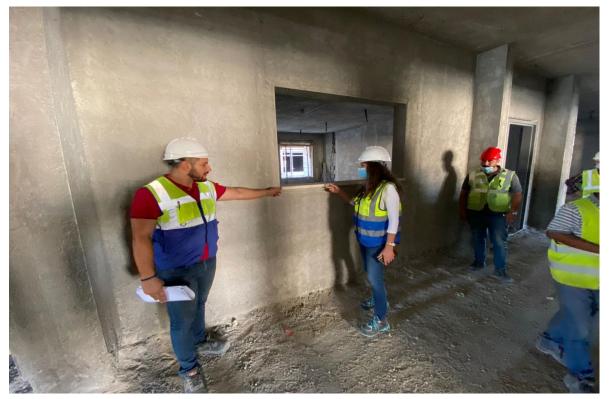
Dimensions of sills are not complying

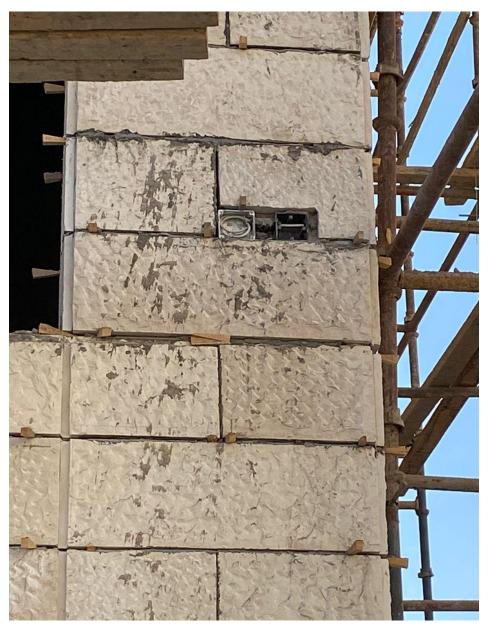
Installing electrical outlets at elevations is wrong

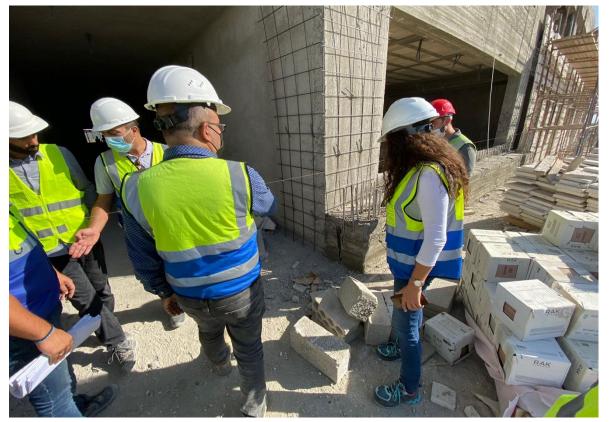
Executing expansion joint wrongly

process to re-excute the expantion joint

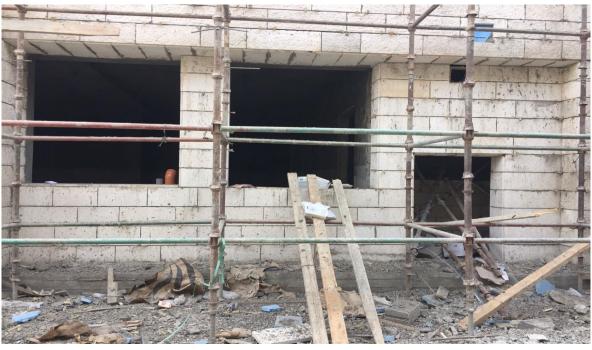
The limit of the elevation needs rectification

Process of rectification for the elevation limit

Finalizing the rectification for the elevation limit

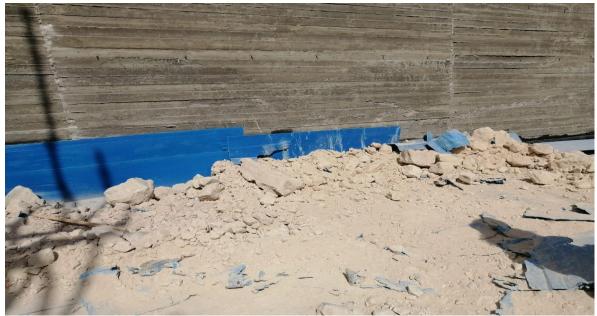
Uncomplied backfilling full of boulders

Removal of uncomplied backfilling
