SKEP III Home Office Support Site Visit Report

Consultant	Wahib Medanat Consultant Engineer	Rep No.	12-14092021
Contractor	Derar Saraireh & Sons for Engineering & Contracting	Tender No.	(11/2019/USAID/SKEP/3/S) Schools for a Knowledge Economy Project (SKEP) - Phase (3) Package (1, 2)
Site Name	Al Khansa' Basic Mixed School- Al Balqa	Day/ Date	Tue. 14/09/2021
Duration of Project	450 Calendar Days	Total Project Budget	9,789,417.840 JD

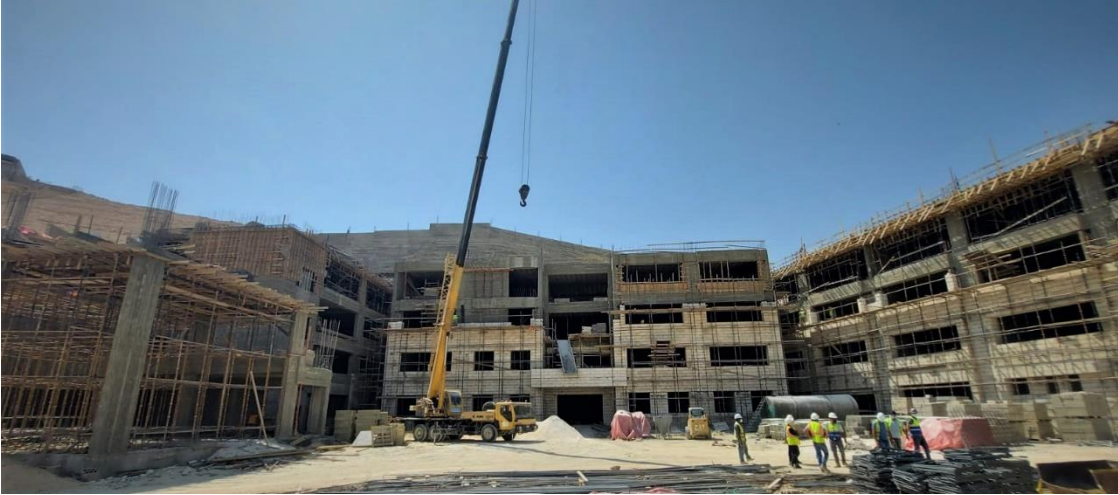
(Figure: 01)

General view of the casted slab of the roof floor

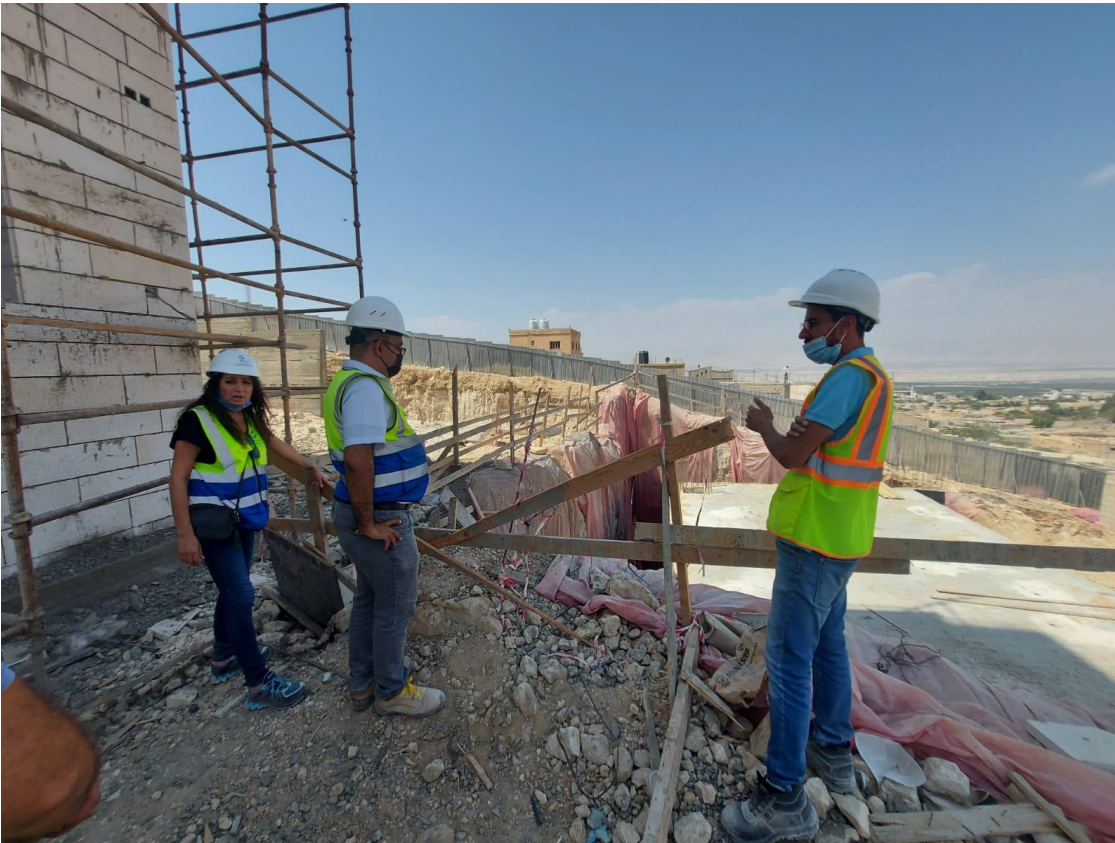
(Figure: 03)

The sheet waterproofing insulation for the external water tank and for the septic tank were observed. The supervision team stressed on the Contractor to fix the cartonal sheets and backfill to avoid damage to the waterproofing

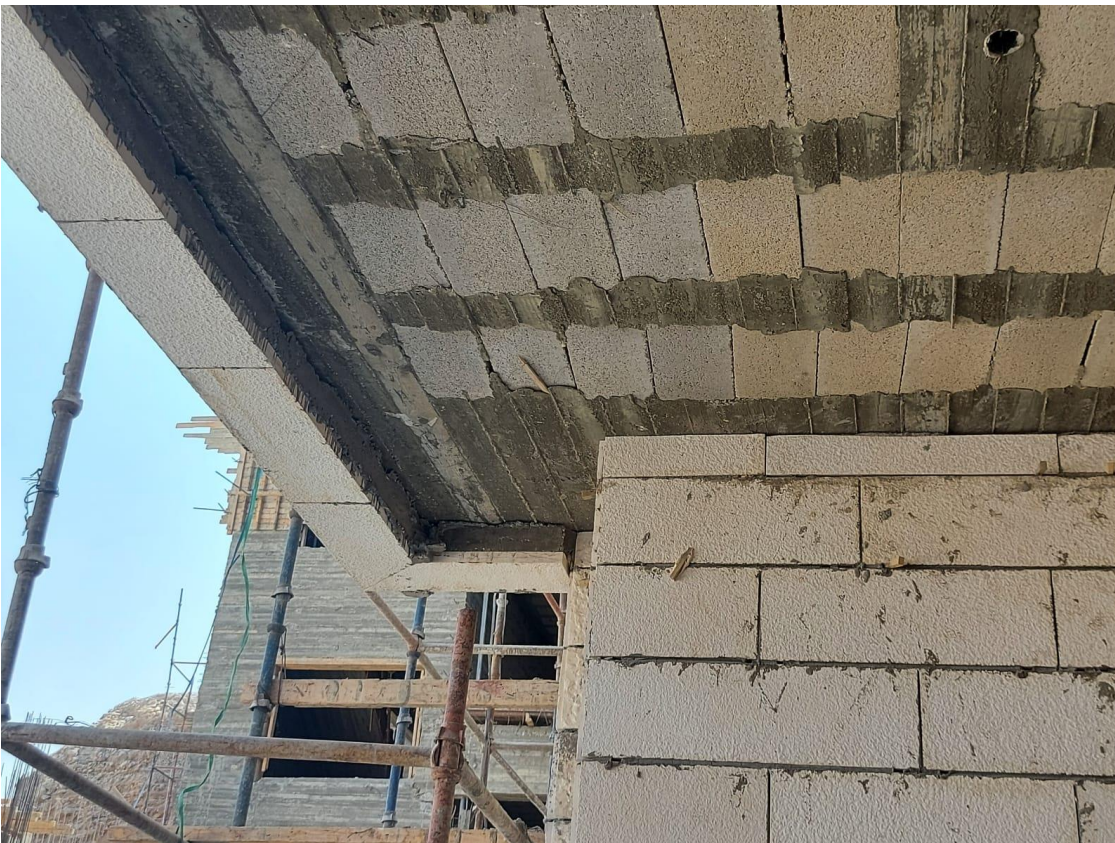
(Figure: 04)

The supervision team discussed the connection between the stone fixing of the canopy at the main entrance and the internal finishing. Instructions were given to the supervision and Contractor site engineers to conduct the finishing work accordingly

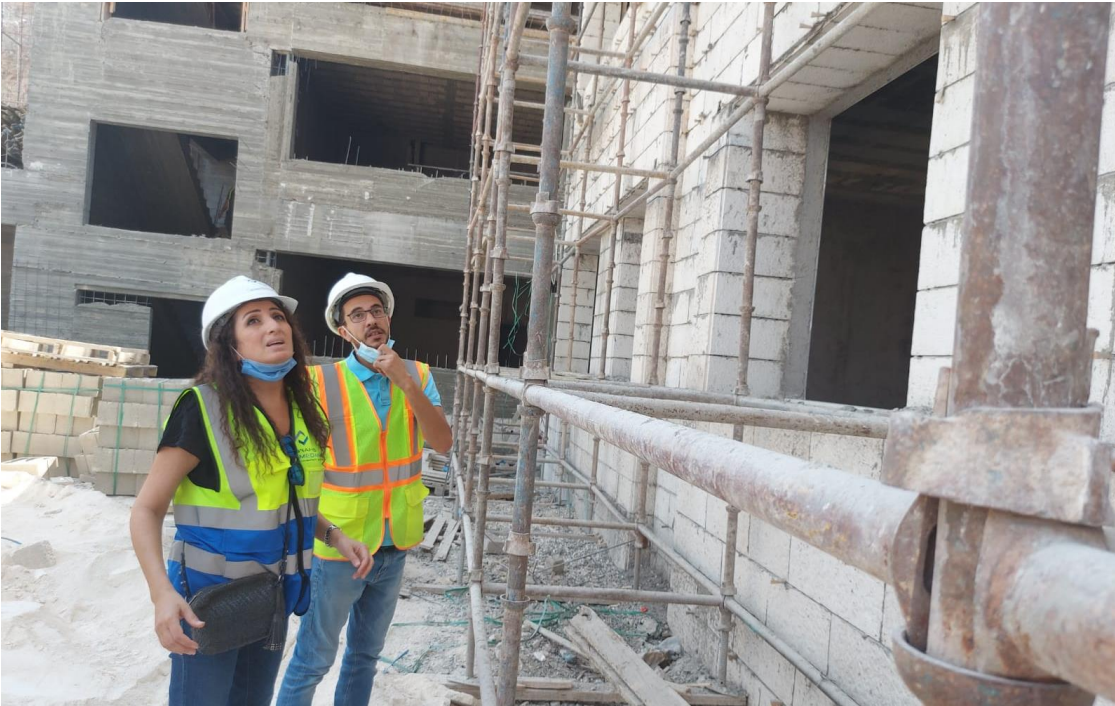
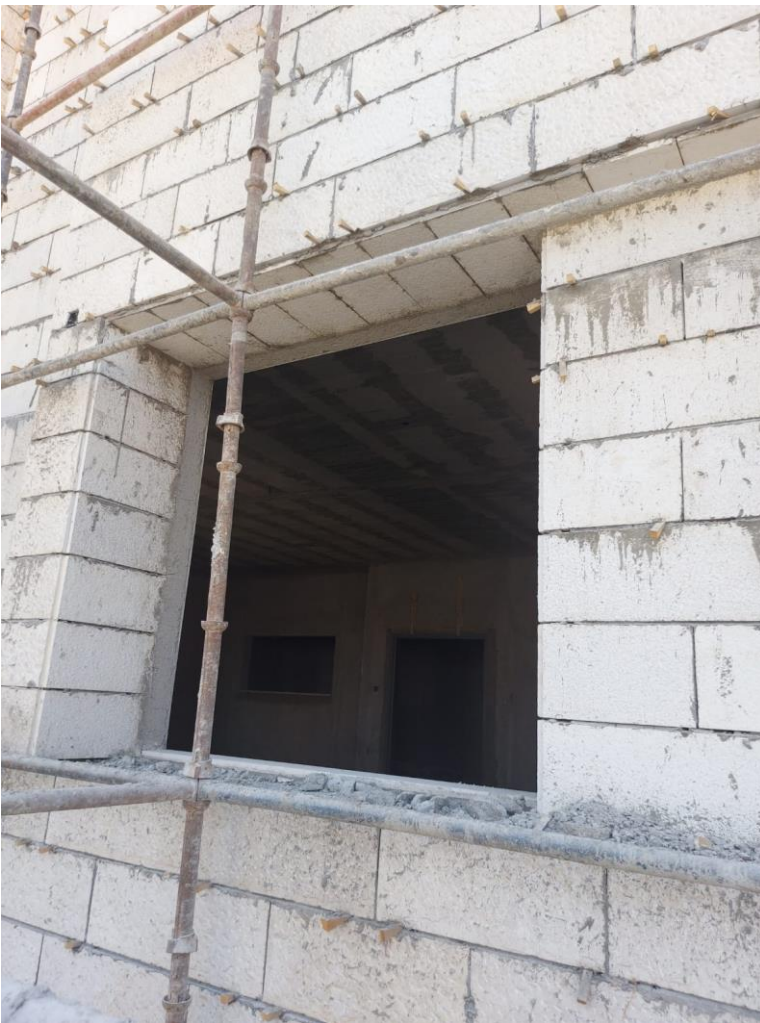
(Figure: 05 & 06)

Supervision team inspected the stone work in general and observed compliance with drawings and specifications. Also, the relation between the stone texture (Musamsam & Mufajar) at window jambs was inspected and discussed with the Contractor

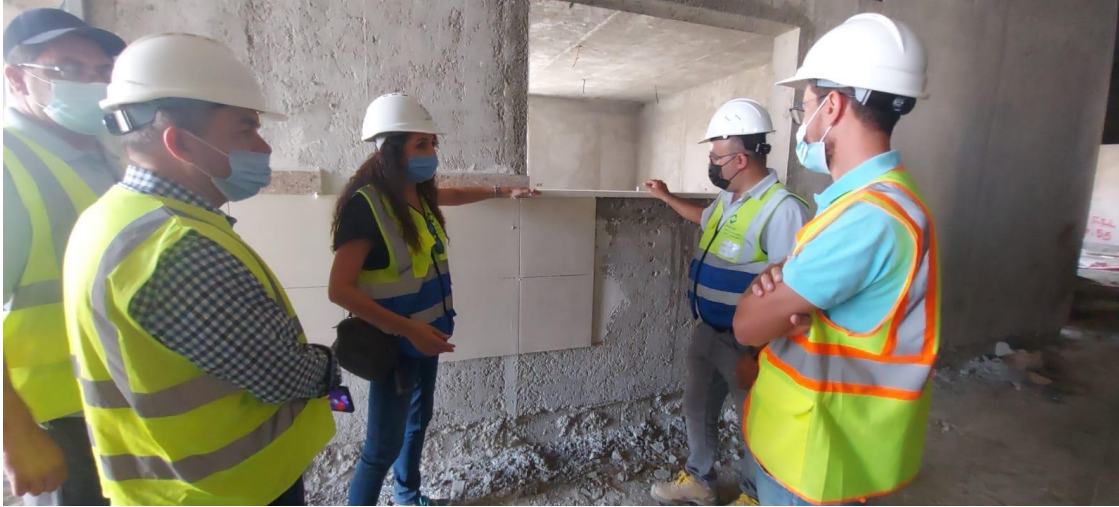
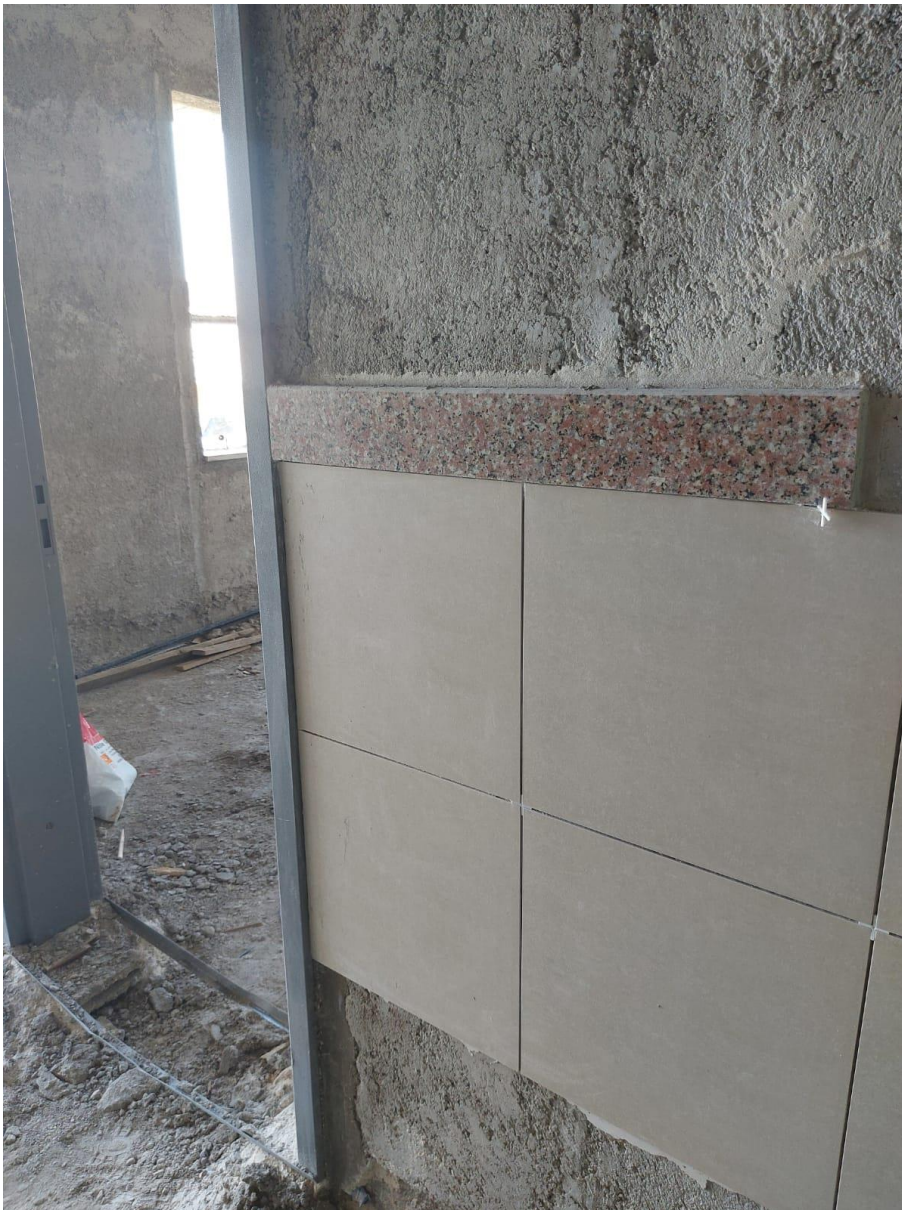
(Figure: 08 & 09)

3	<p>Conducting an inspection to the mock-up tiled wall at corridors and the relation between windows, porcelain wall cladding, granite coping and door frames, stressing on the following:</p> <ul style="list-style-type: none"> - The window sills should be installed at its specific level to avoid conflict with the plans of furniture and corridor cabinets. - The home office supporting team instructed the Contractor regarding the relation between the door frame and the tiling at the walls of corridors and the plastering of the rooms. The prepared mock-up for this complies with the requirements. - Also, the ending of tiling at the limit of steel door frame was discussed and the supervision team stressed that the tiles end should be straight and neat without any gaps. The Contractor shall avoid installing electrical sockets within the colored tile strip. - A groove should be created in the window sill at the corridor side as per requirement.

Inspecting the mock-up tiled wall at corridors and the relation between windows, porcelain wall cladding, granite coping and door frames. Remarks were given to the Contractor

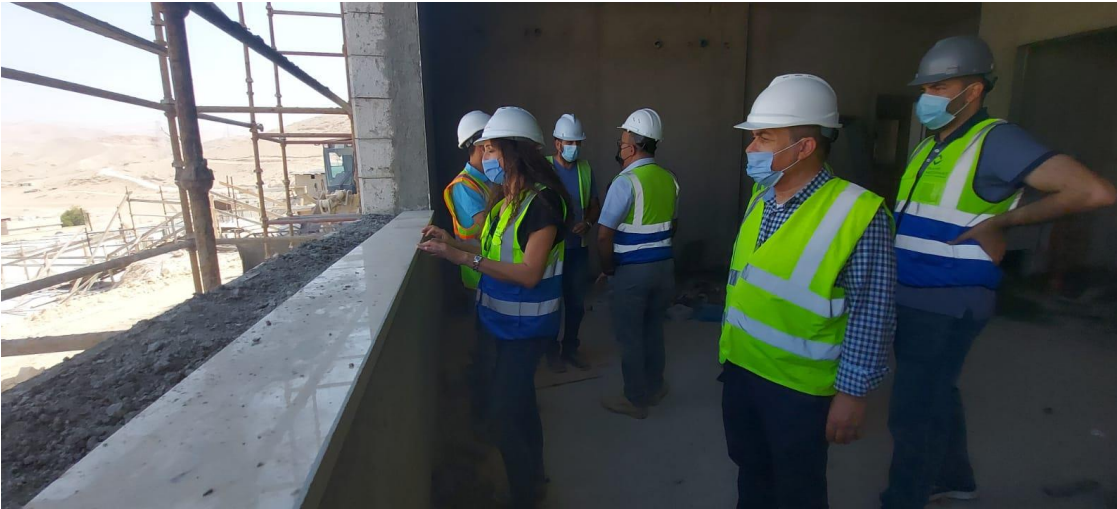
(Figure: 10)

The bottom edge of window sills is toothed and not straight

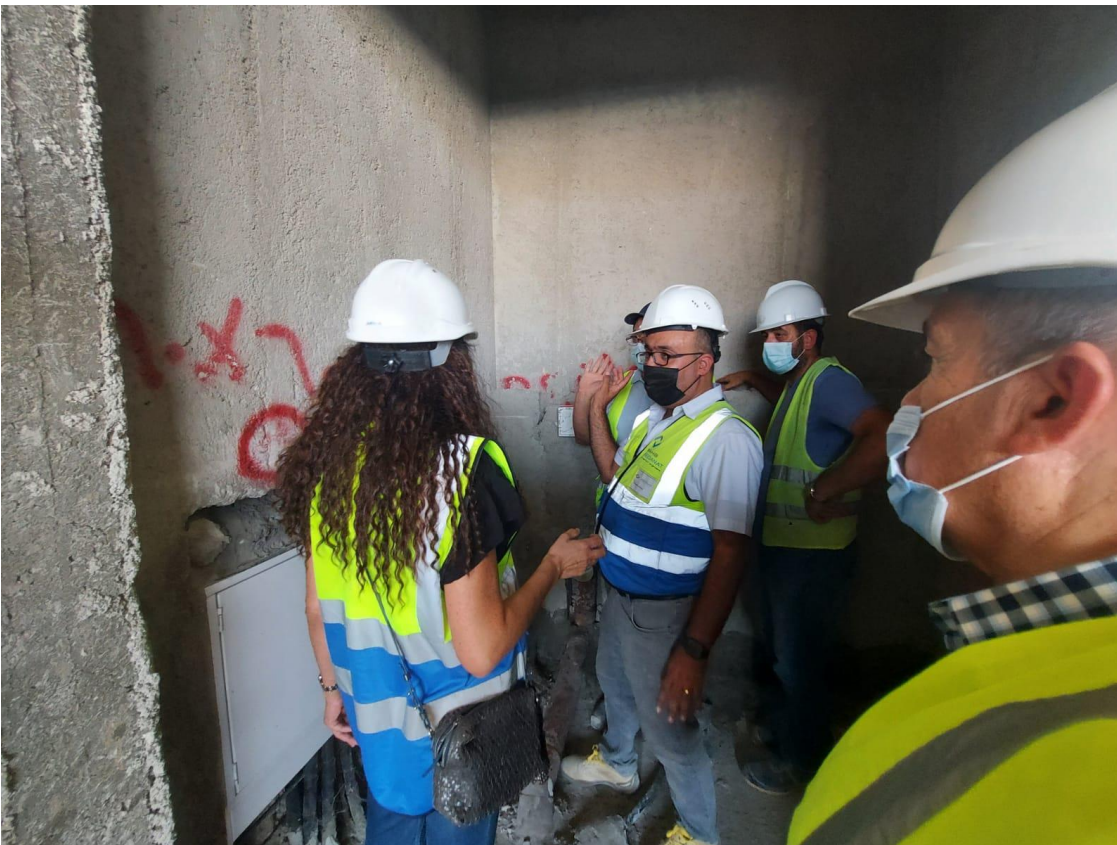
(Figure: 11)

Discussing the appropriate way to install walls tiles

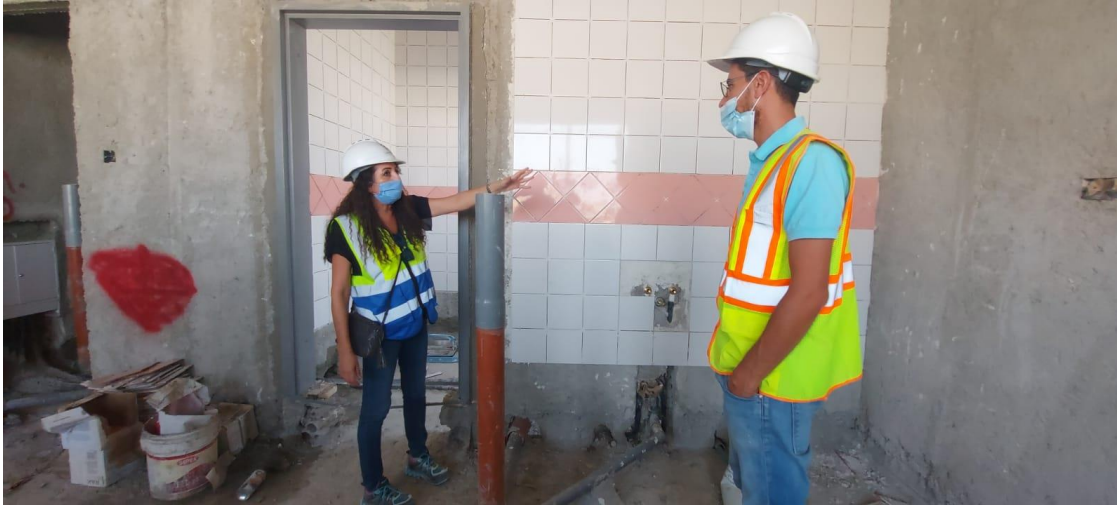
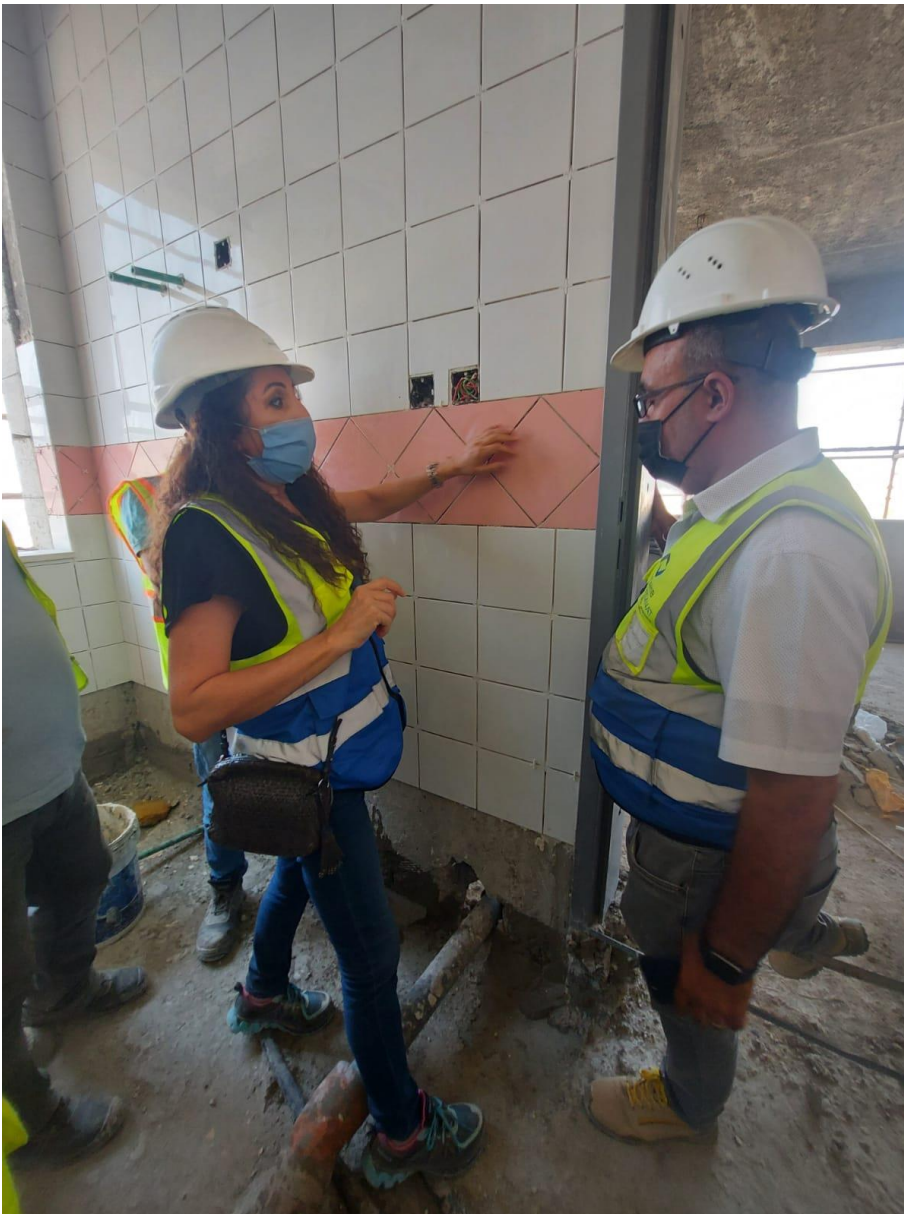
(Figure: 12 & 13)

the ending of tiling at the limit of steel door frame was discussed and the supervision team stressed that the tiles end should be straight and neat without any gaps. The Contractor shall avoid installing electrical sockets within the colored tile strip

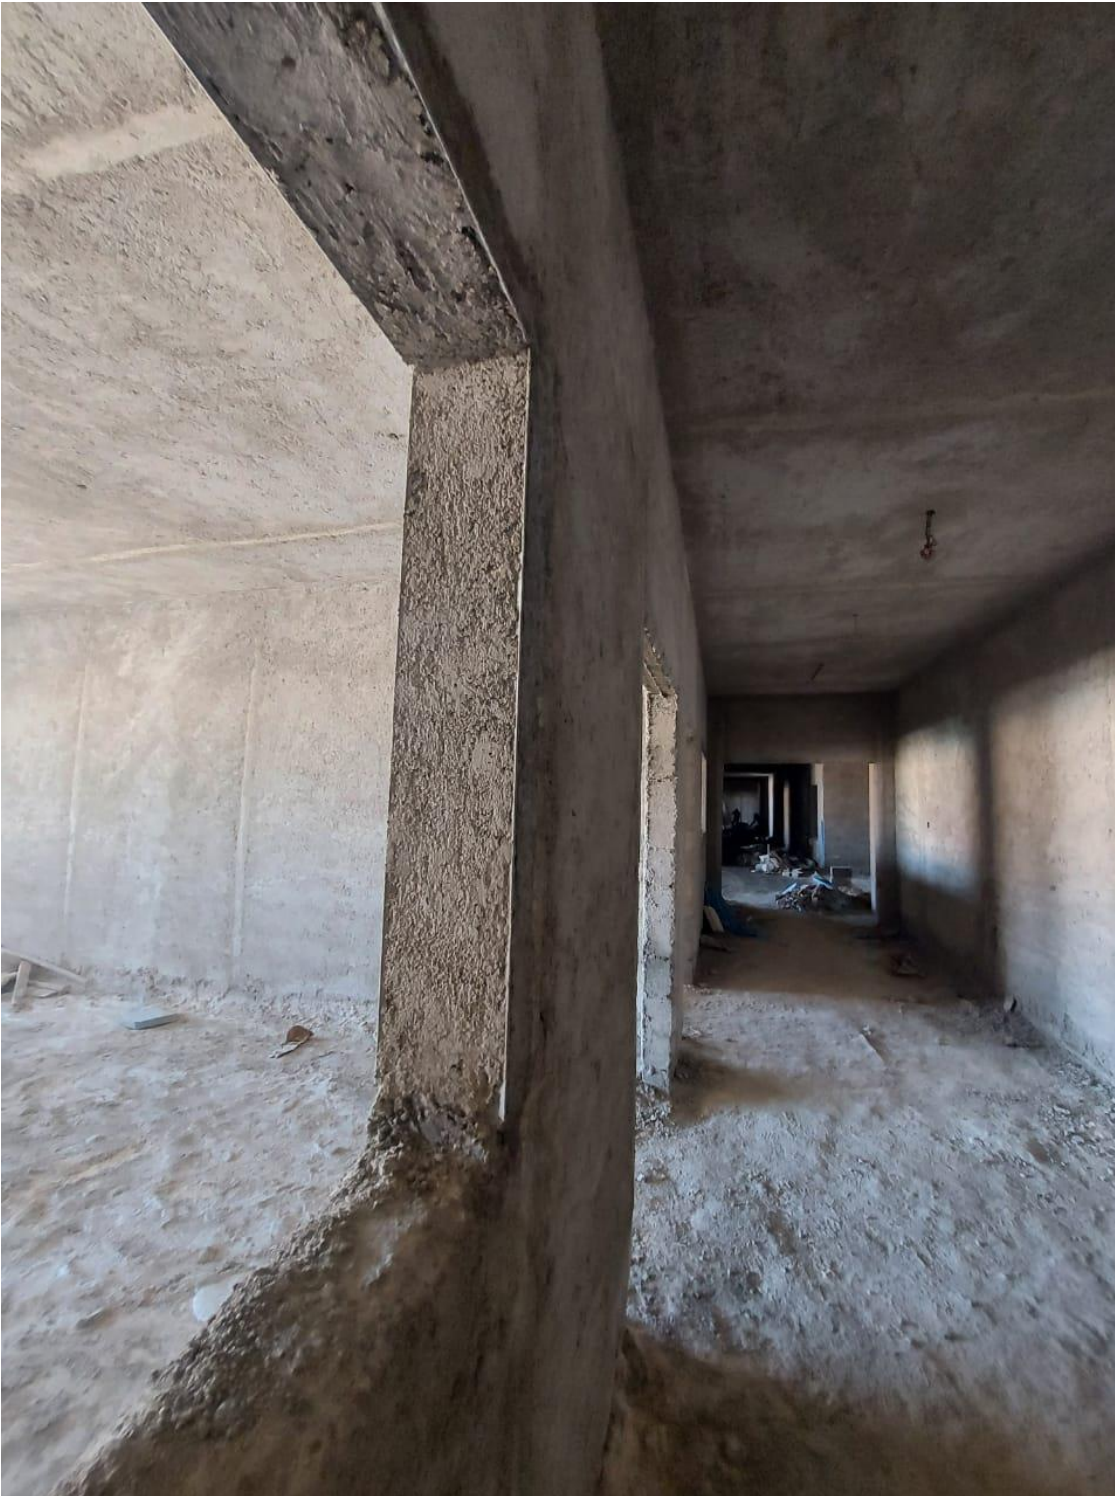
(Figure: 14)

It was observed that the Contractor removed the installed mesh at the corners and
