Quality Control Report

Consultant **Wahib Medanat** Consultant Engineers
Site Name **Jumana Bint Abi Taleb Basic Mixed - Marka**
Package **Package 2**
Contractor **Dijlah Est. Construction Co.**
Tender No. **10/2019/USAID/SKEP/3/2**

Rep No. **QC-23 07**
Date **11 / 08 / 2021**

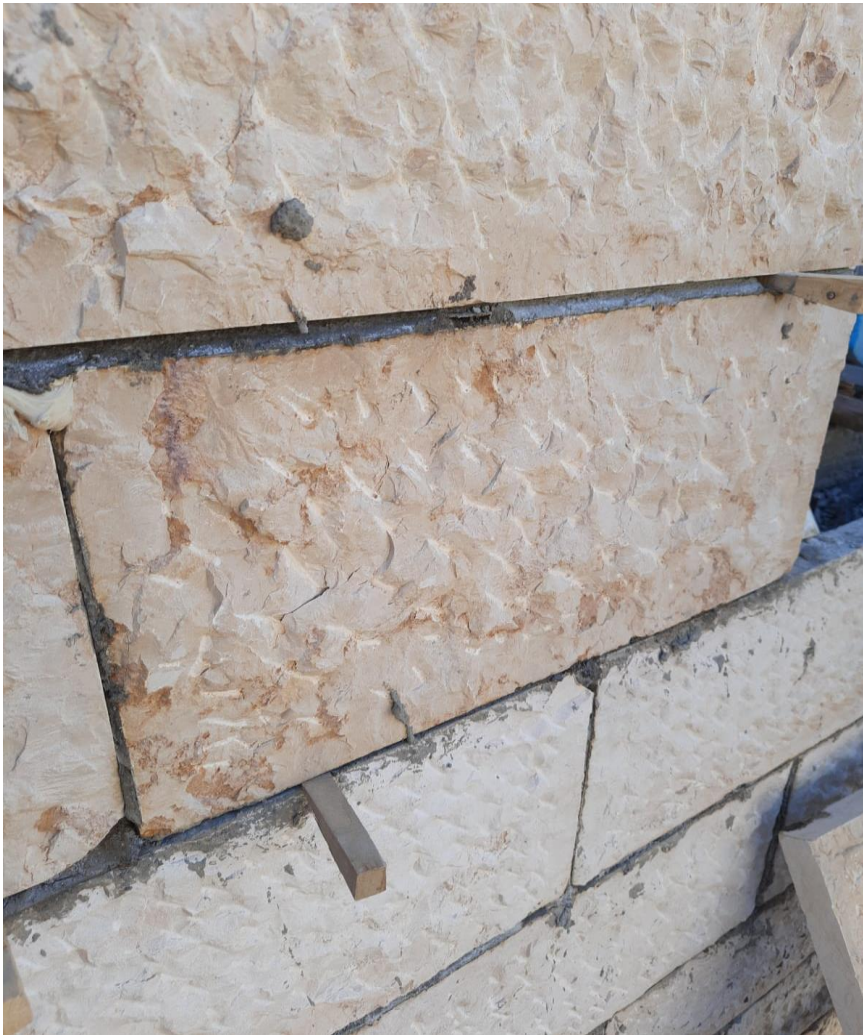
Before Photos:

Remarks on the stone work as per report

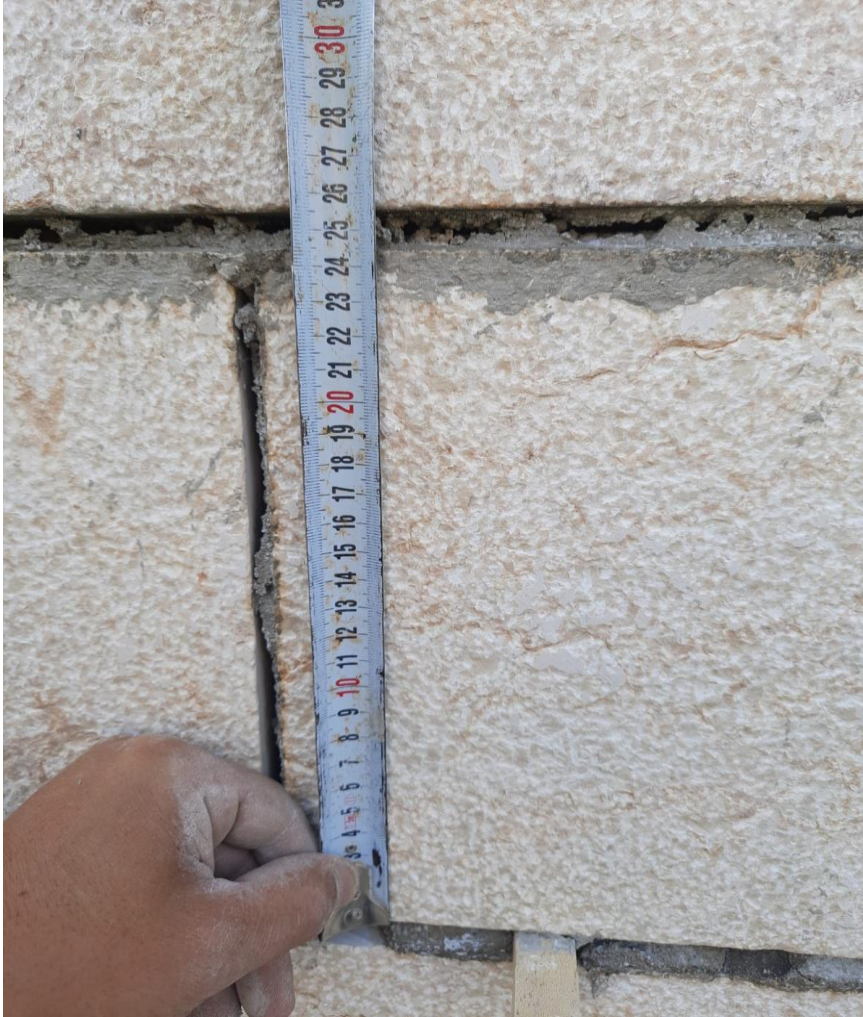
Stones of Different Heights

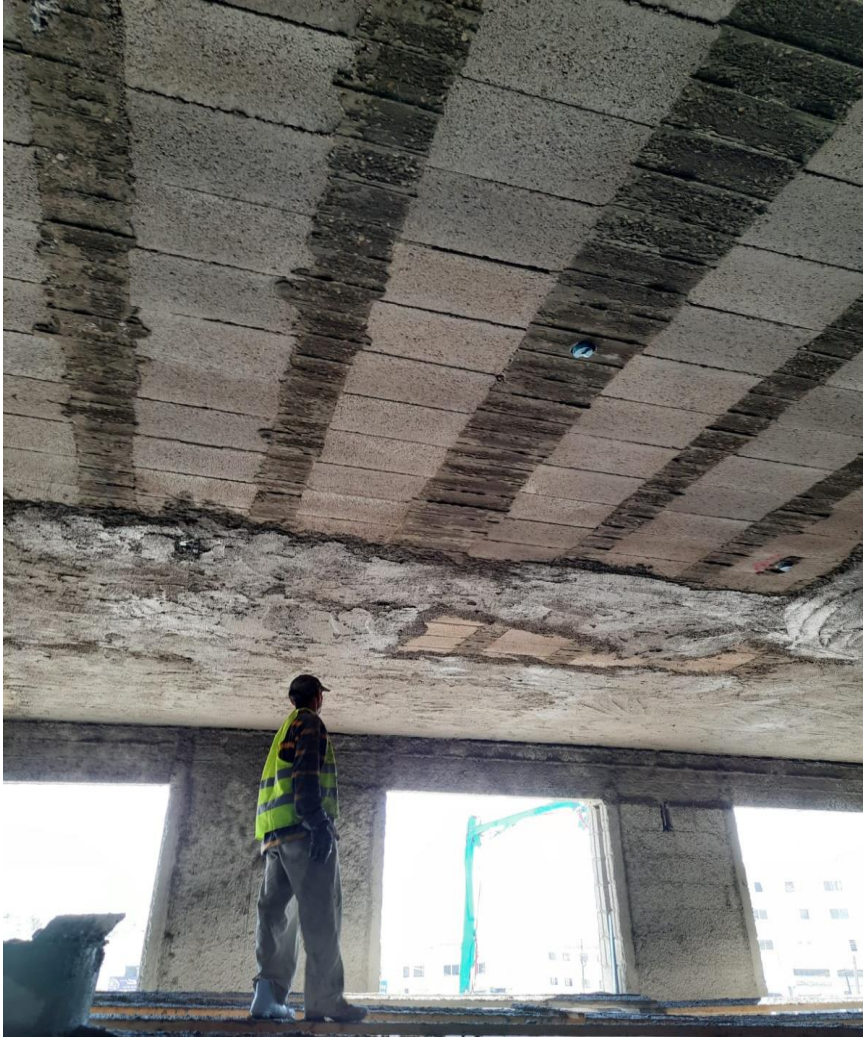
Executing second plastering layer before the first plastering layer
