SKEP III Home Office Support Site Visit Report

Consultant	Wahib Medanat Consultant Engineer	Rep No.	22-06122021
Contractor	Dijlah Establishment Constr. Contracting	Tender No.	(11/2019/USAID/SKEP/3/S) Schools for a Knowledge Economy Project (SKEP) - Phase (3) Package (1, 2)
Site Name	Thahr Al Sarow Basic School for Boys- Jerash	Day/ Date	Mon. 06/12/2021
Duration of Project	450 Calendar Days	Total Project Budget	8,314,983.735 JD

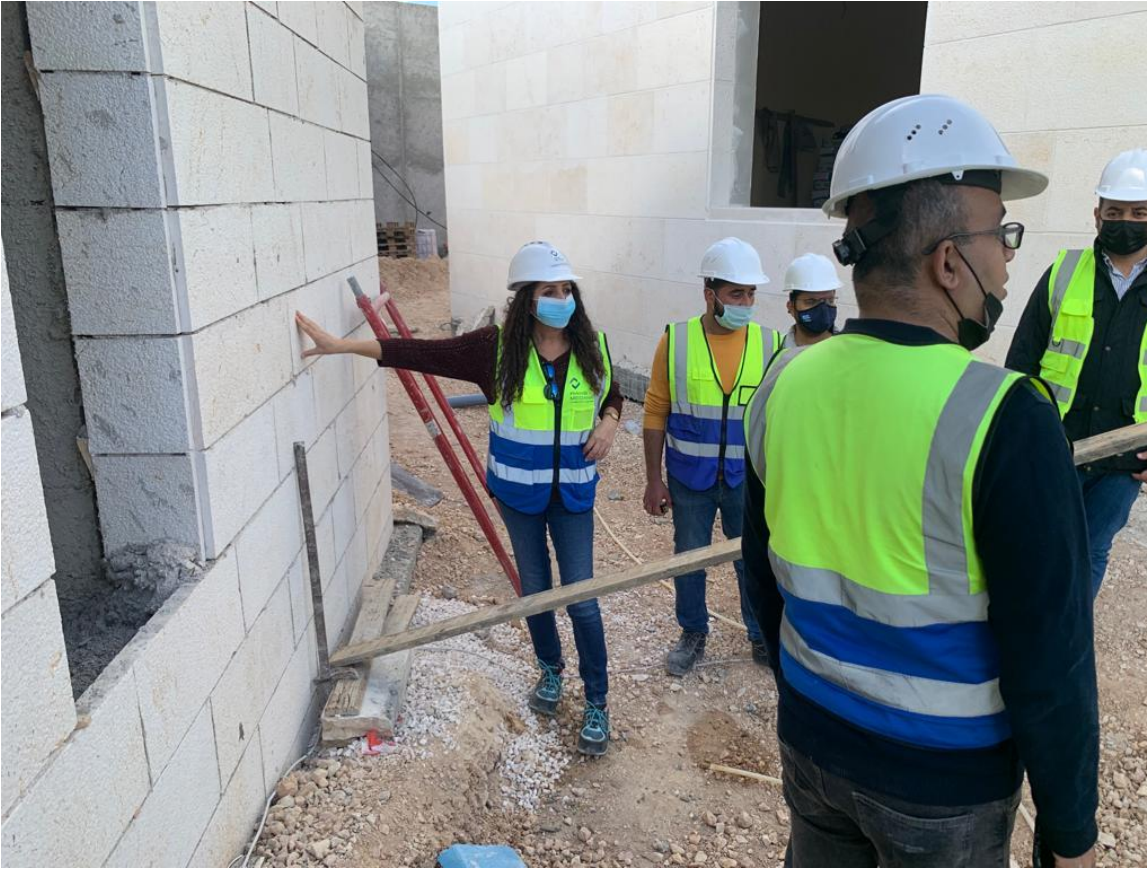
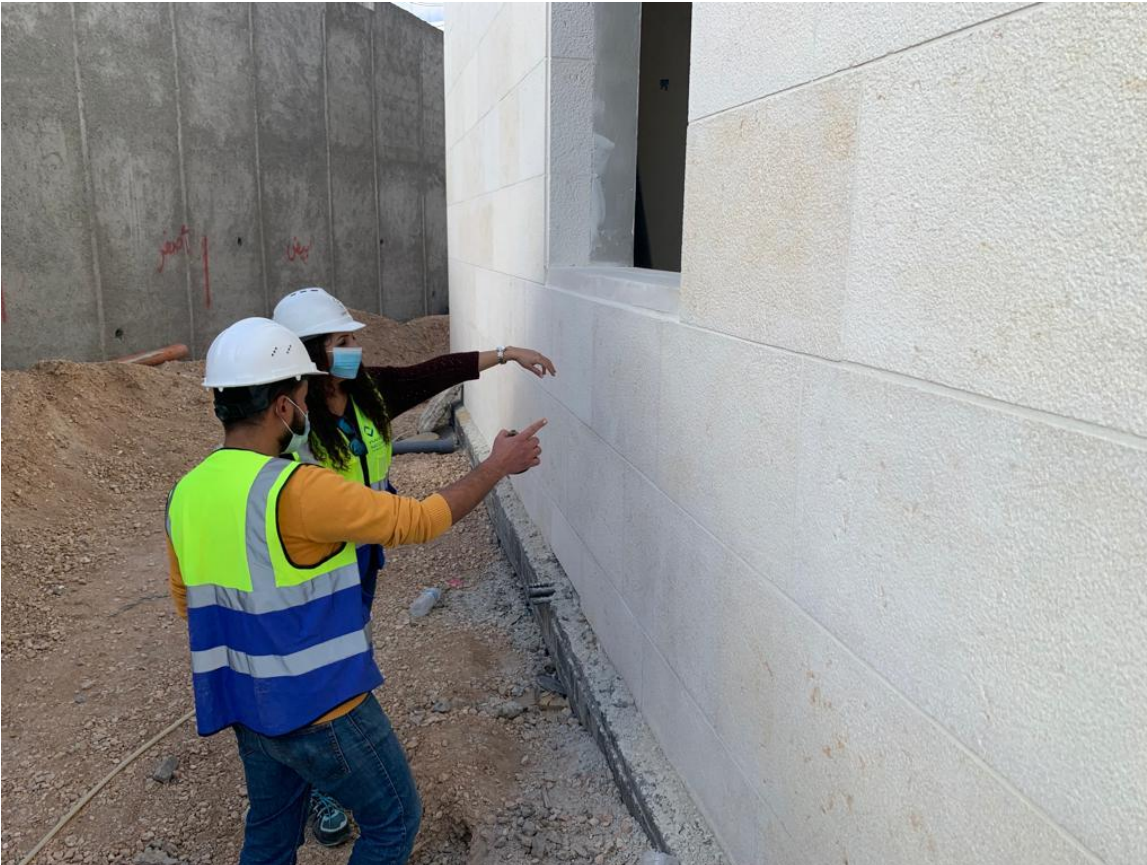
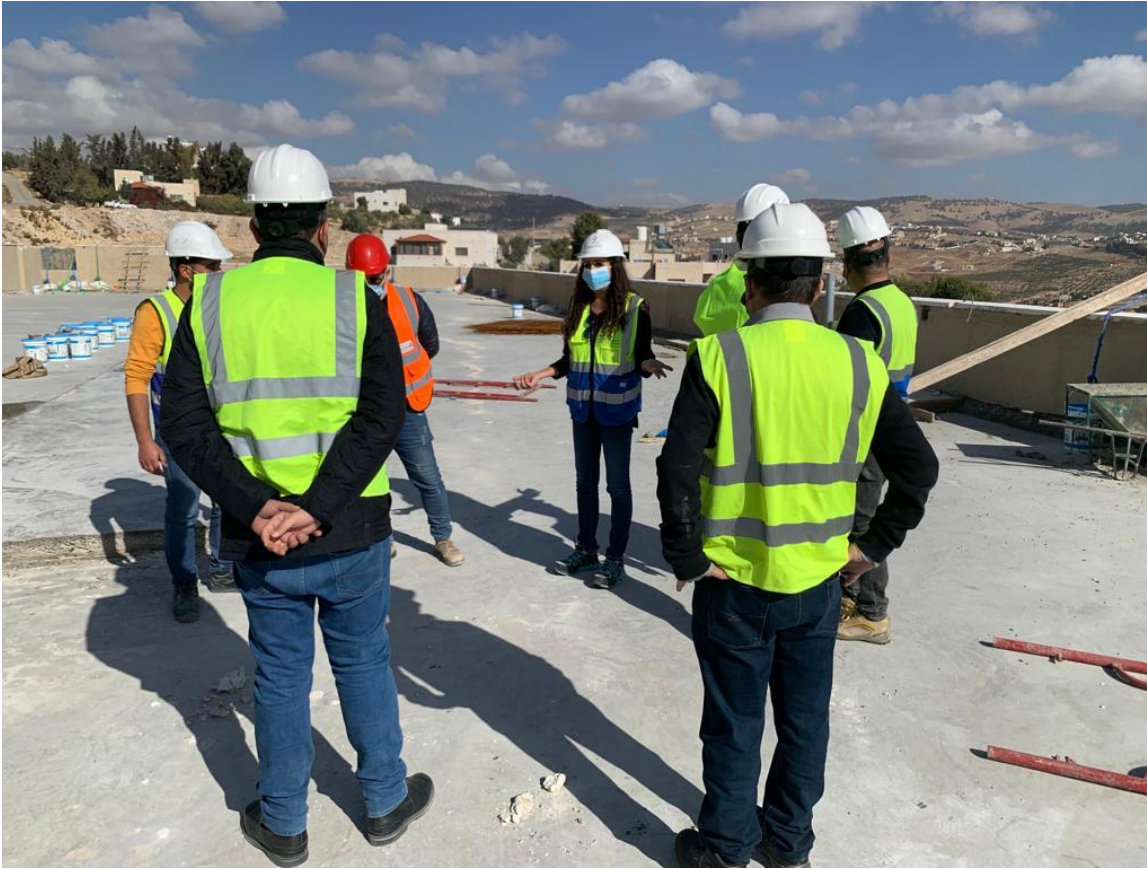
(Figure: 04, 05 & 06)

The executed stones for facades have been inspected in general and remarks have been given to the Contractor to rectify where necessary

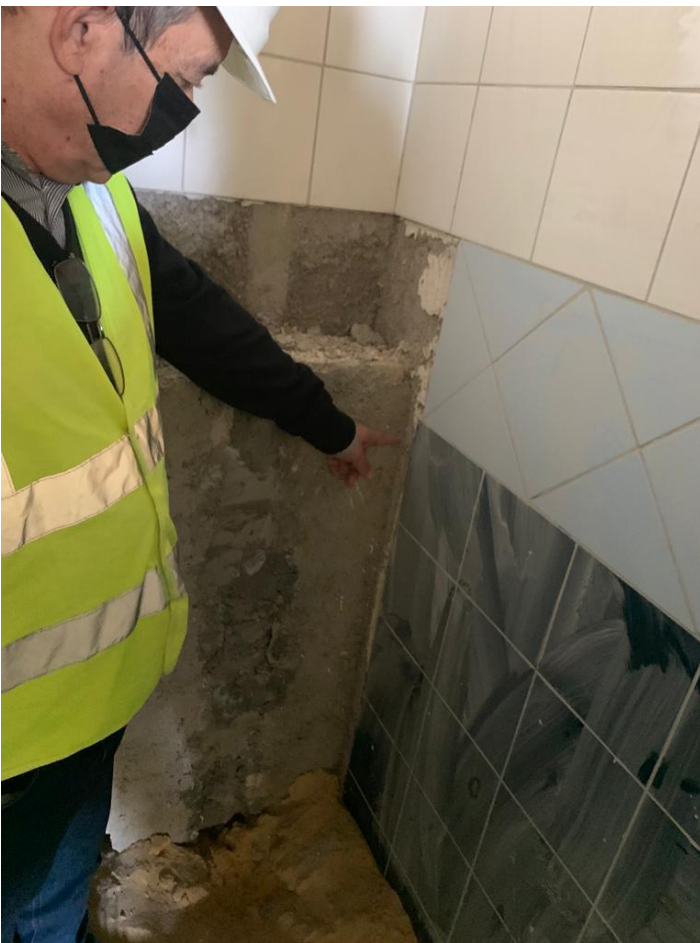
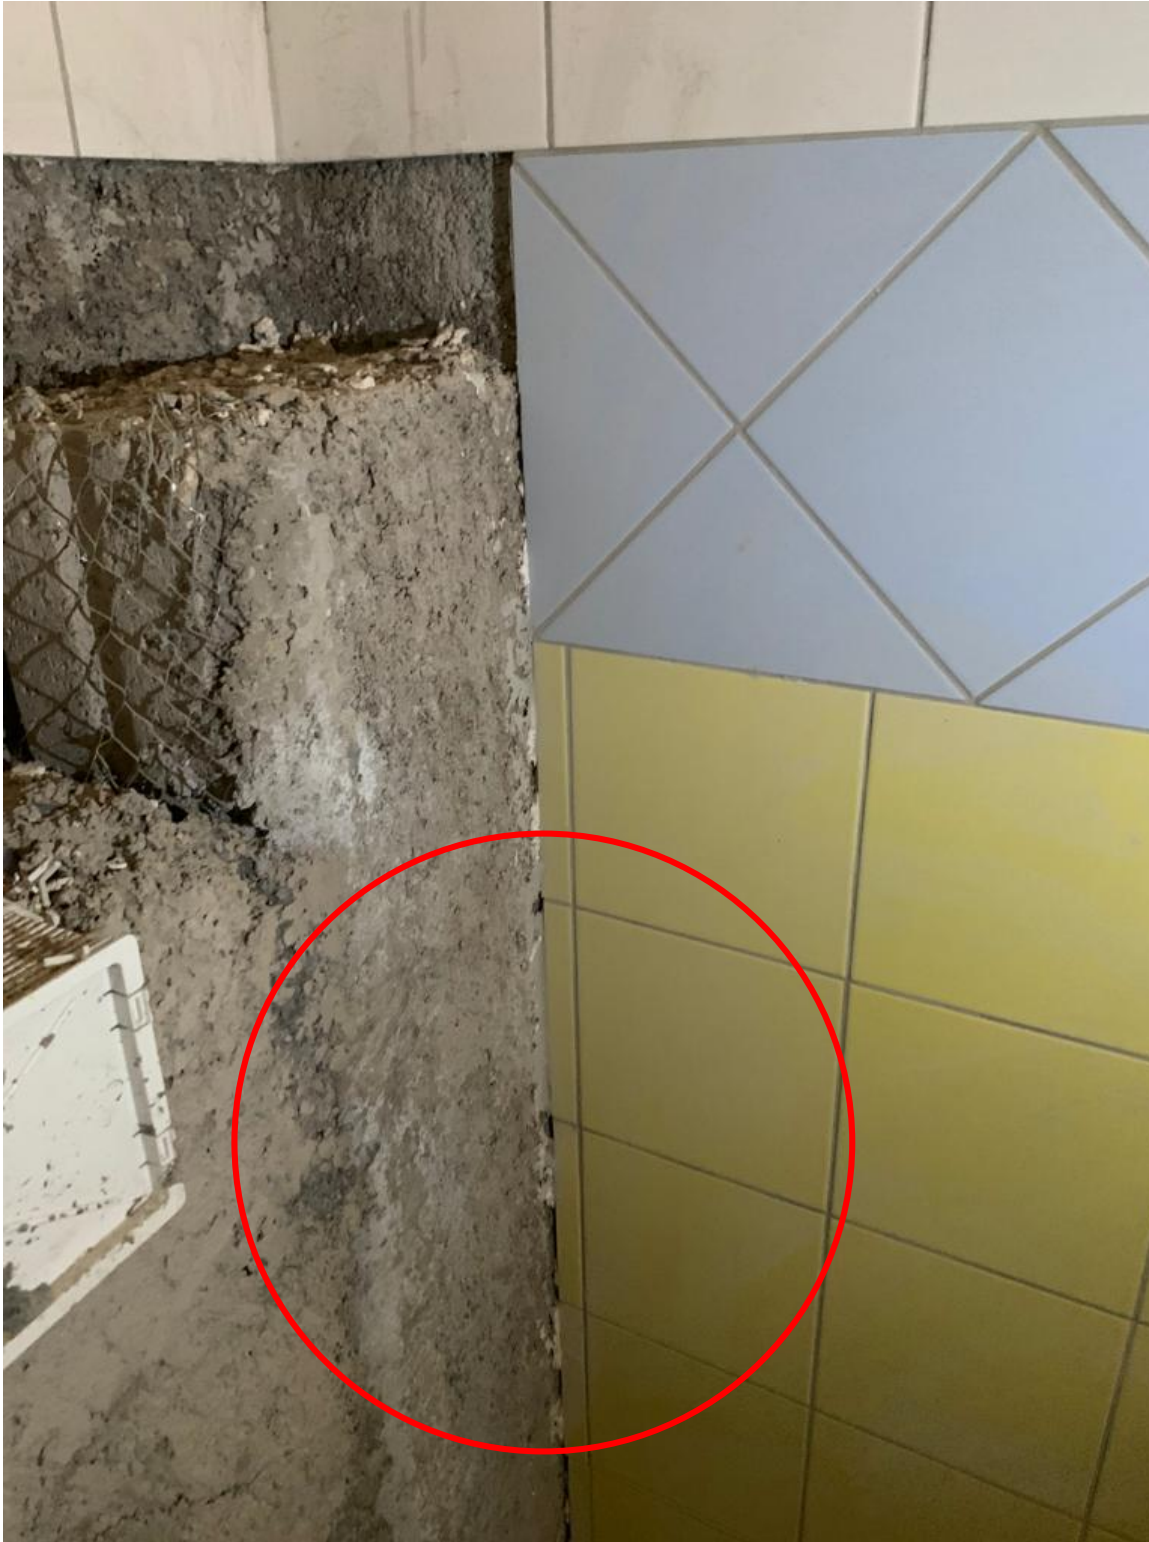
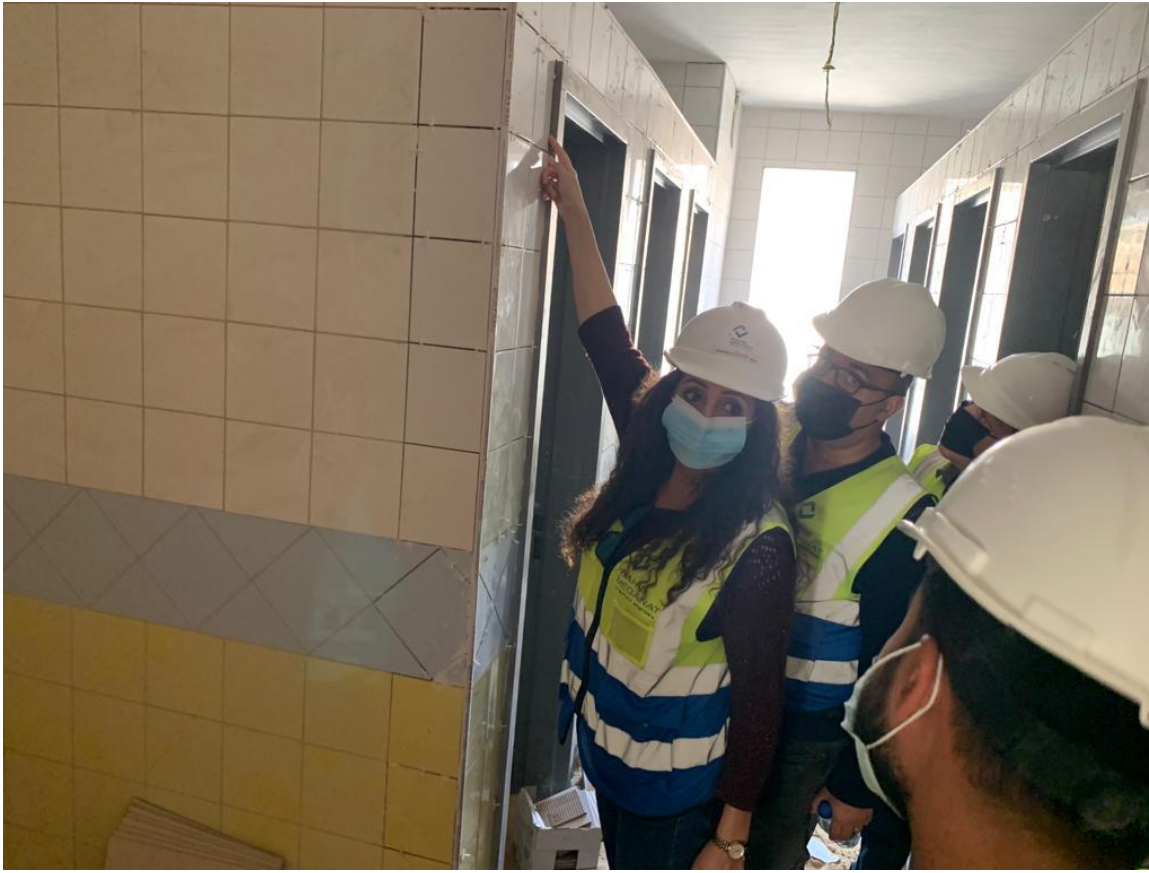
(Figure: 09, 10 & 11)

The Engineer instructed the Contractor to avoid very small cut-off pieces of wall tiles. The way to do so was discussed with the Contractor

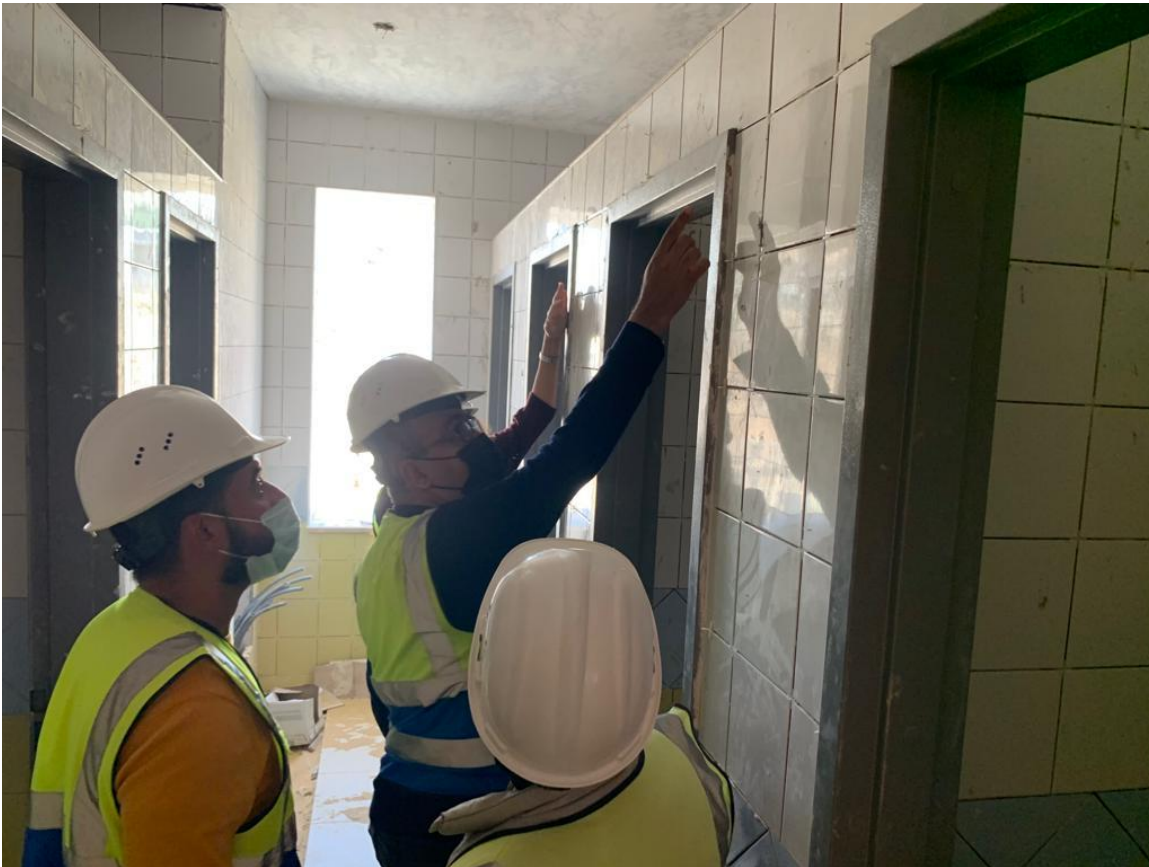
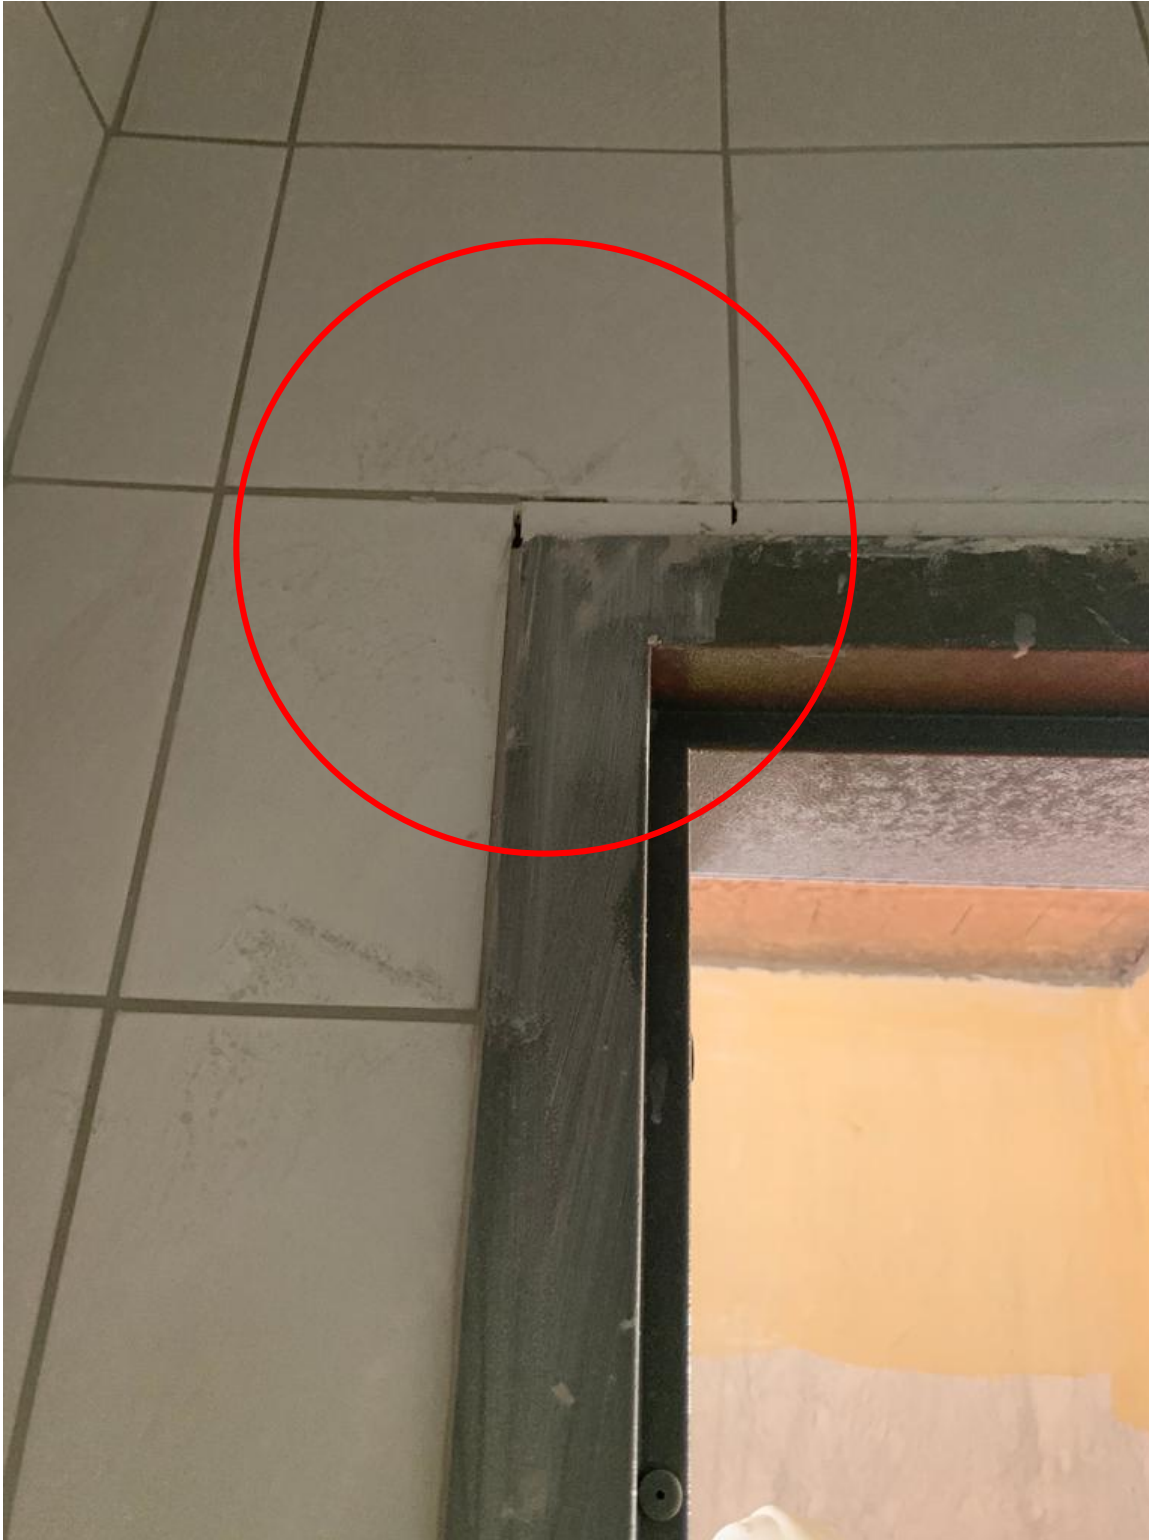
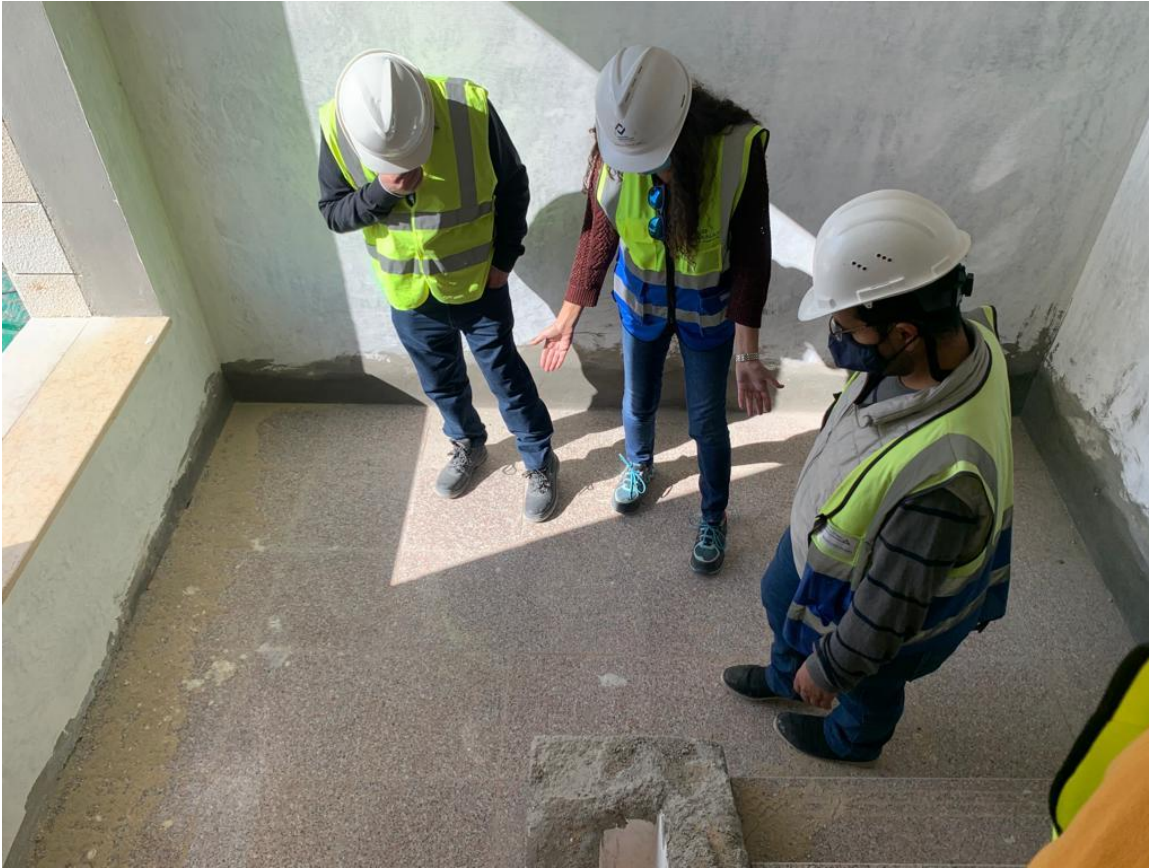
(Figure: 12, 13 & 14)

The executed wall tiles have been observed in general and defects were observed in the tiling around the door frames. Defected tiles shall be replaced correctly

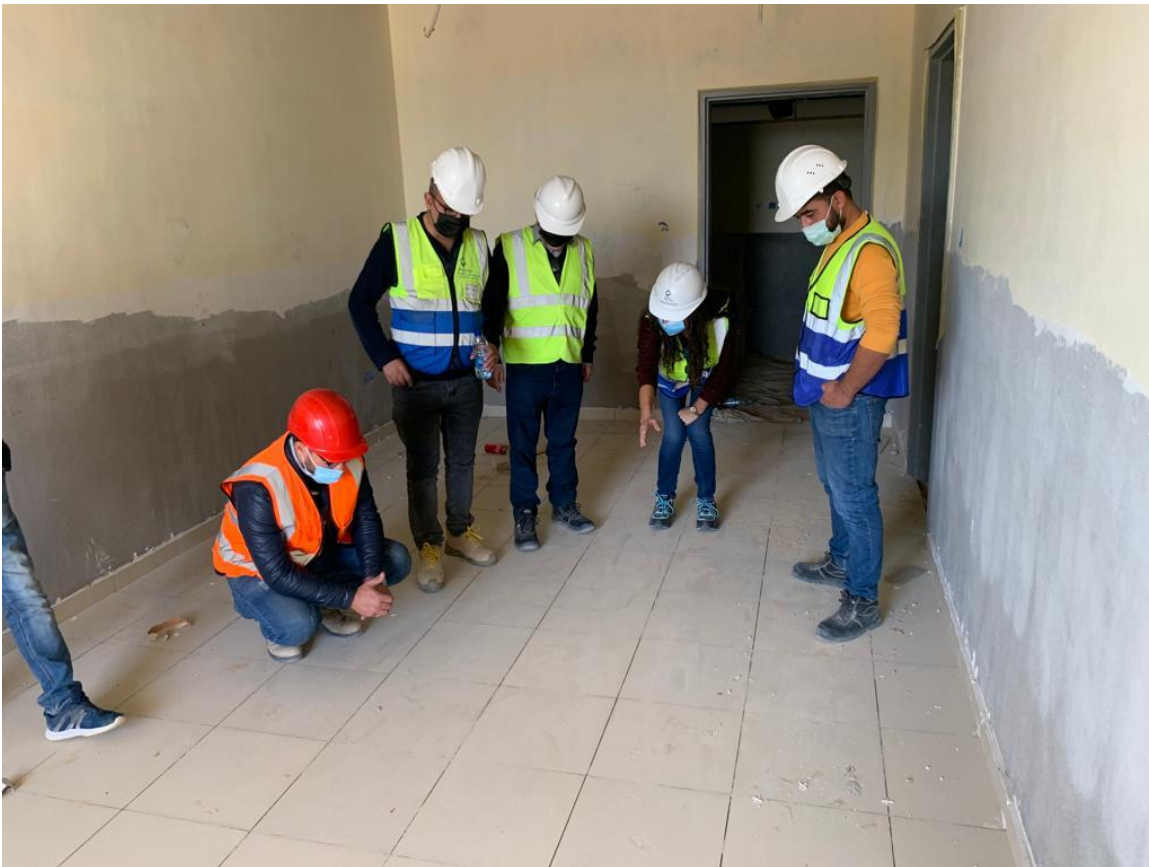
(Figure: 15)

Teething was observed in the granite tiling of staircases' landing. The Contractor was instructed to rectify

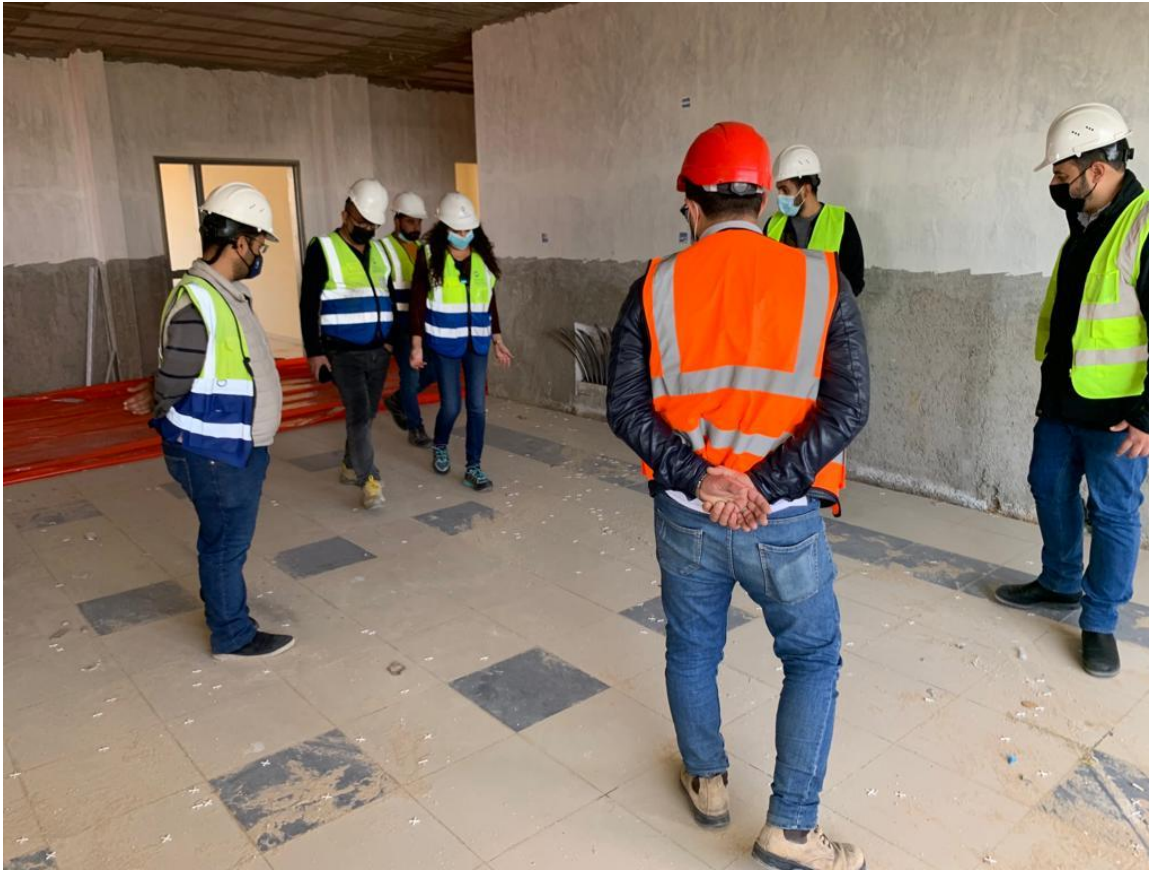
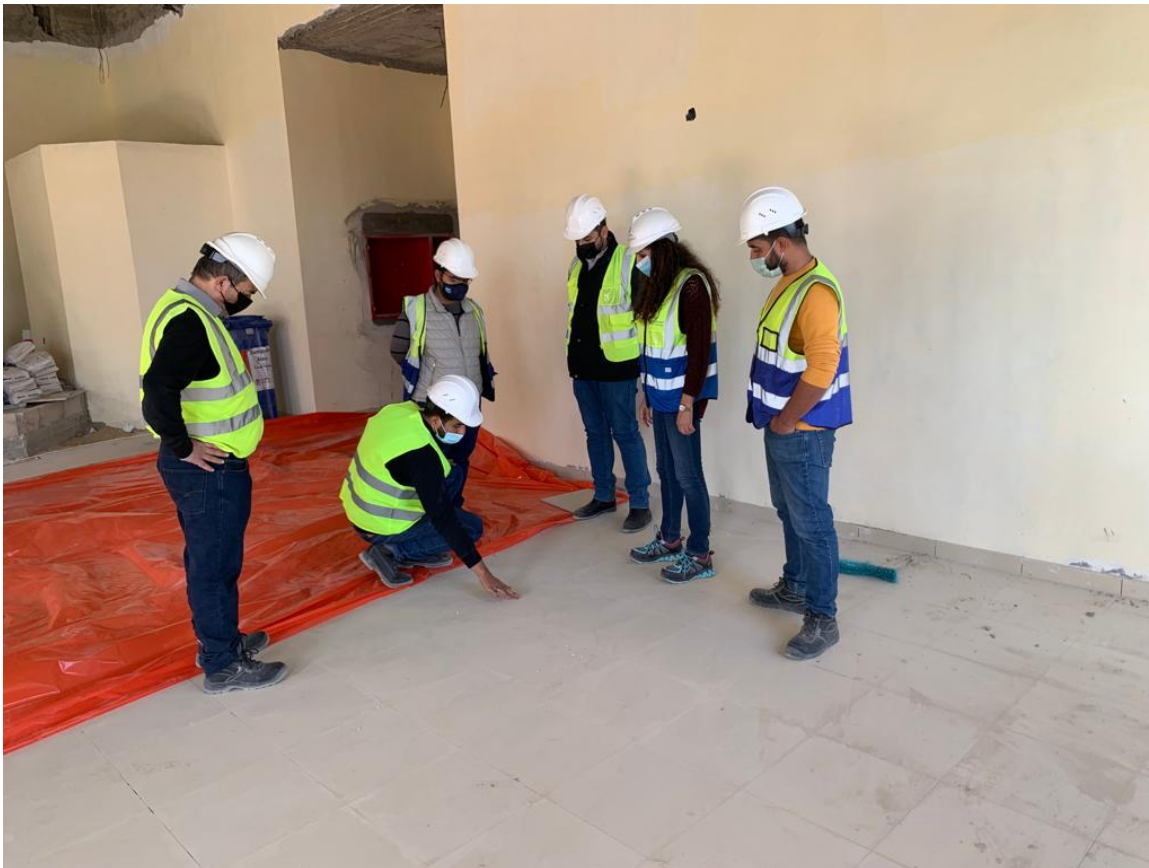
(Figure: 16, 17 & 18)

The executed tiling work was intensive and the considerable defects in the tiles was under discussion with the Contractor. Tiles were found uneven and sever defects in teething were noticed too, which might be due to defects in manufacturing and workmanship
