Consultant	Wahib Medanat Consultant Engineer	Rep No.	12-20122021
Contractor	Derar Saraireh & Sons for Engineering & Contracting	Tender No.	(11/2019/USAID/SKEP/3/S) Schools for a Knowledge Economy Project (SKEP) - Phase (3) Package (1, 2)
Site Name	Al Khansa' Basic Mixed School- Al Balqa	Day/ Date	Mon. 20/12/2021
Duration of Project	450 Calendar Days	Total Project Budget	9,789,417.840 JD

Visit Notes

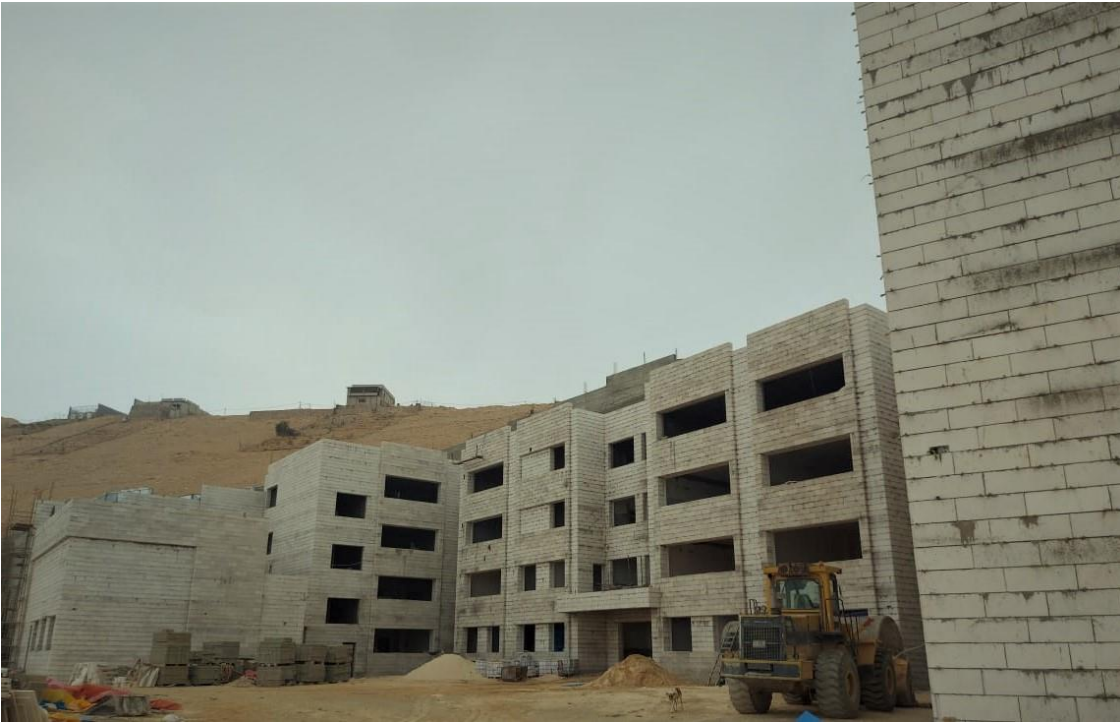
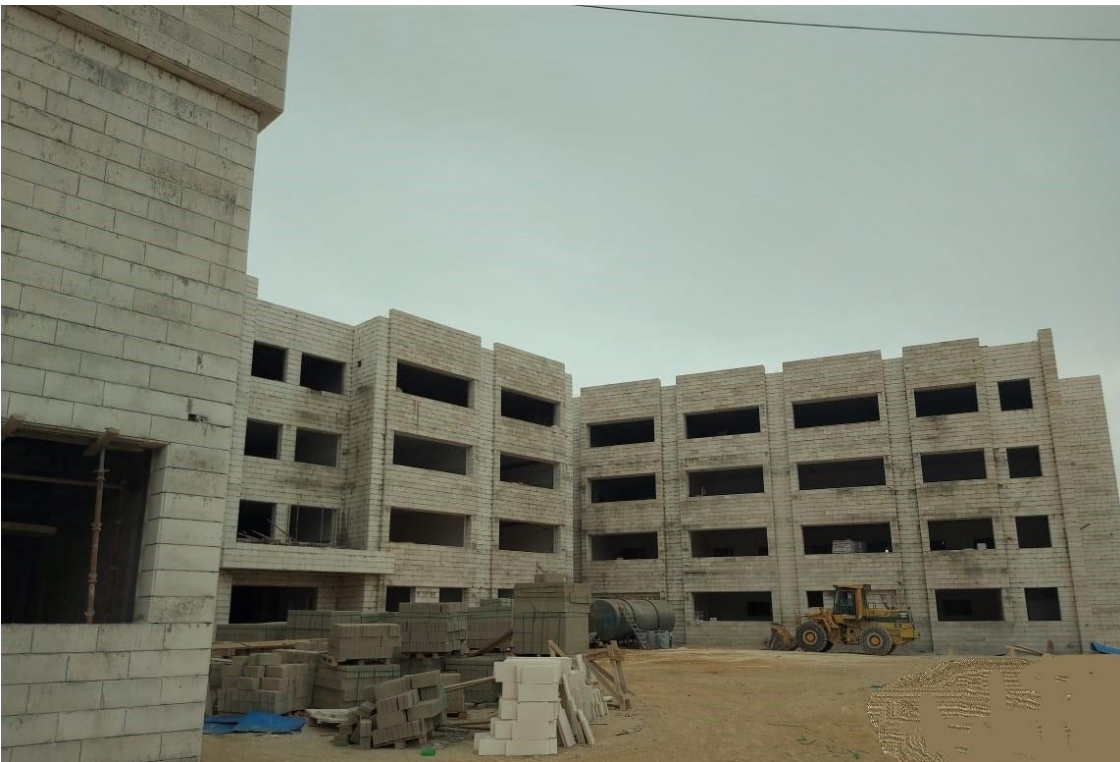
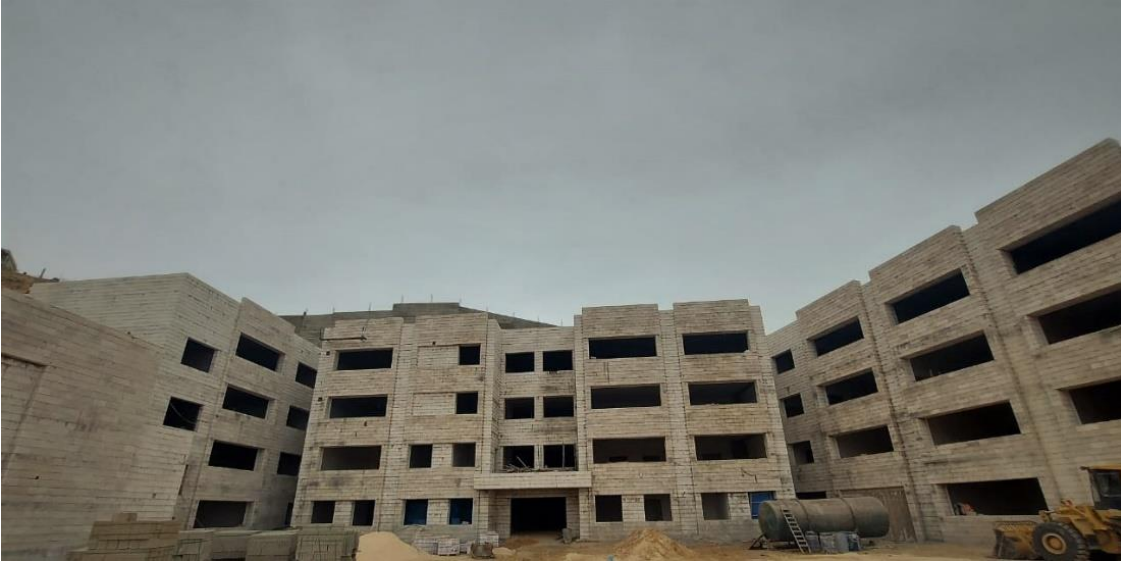
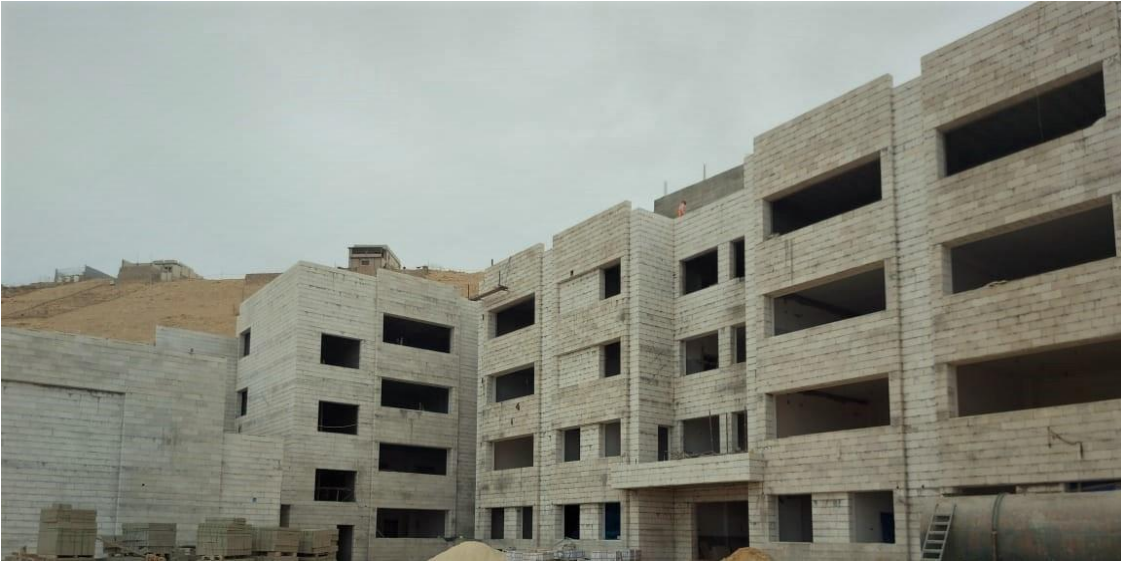
(Figure: 01, 02, 03 & 04)

General view of the project

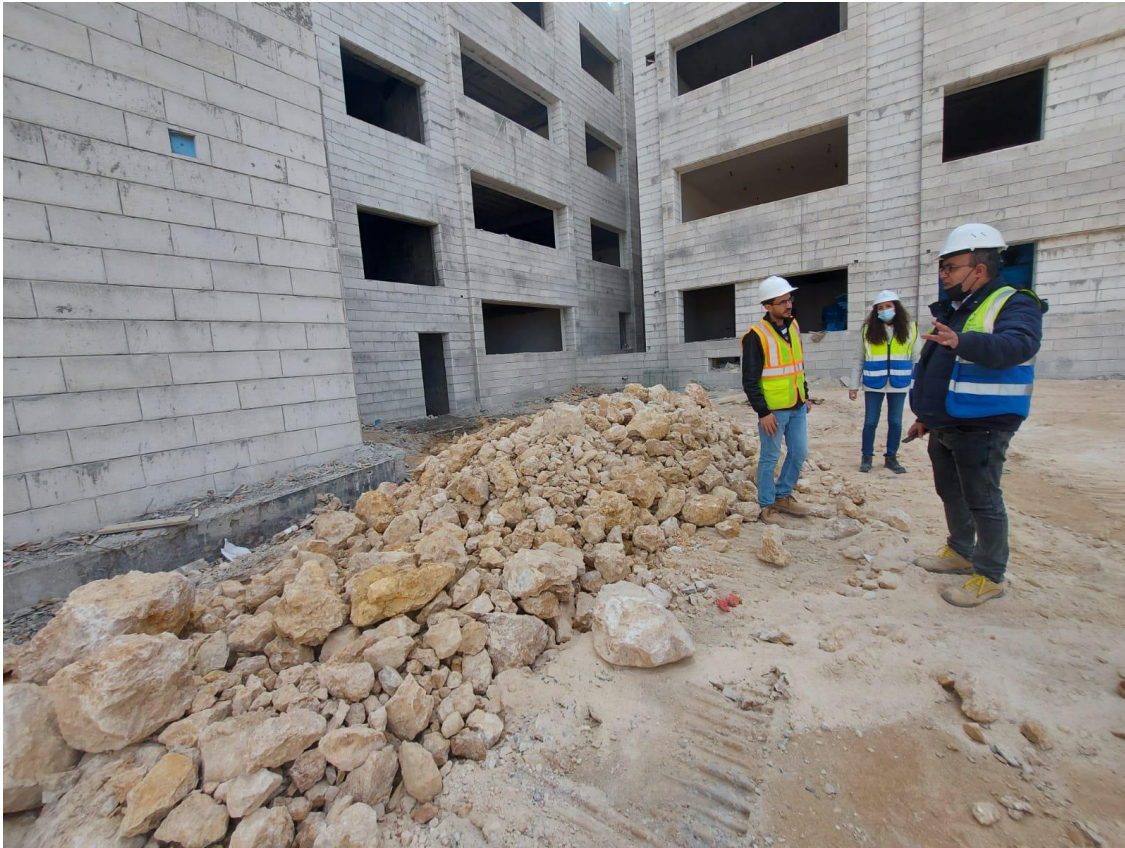
(Figure: 05)

The supervision team instructed the Contractor to keep in stock the boulders resulted from the excavated soil to use it in the cyclopean concrete or the riprap

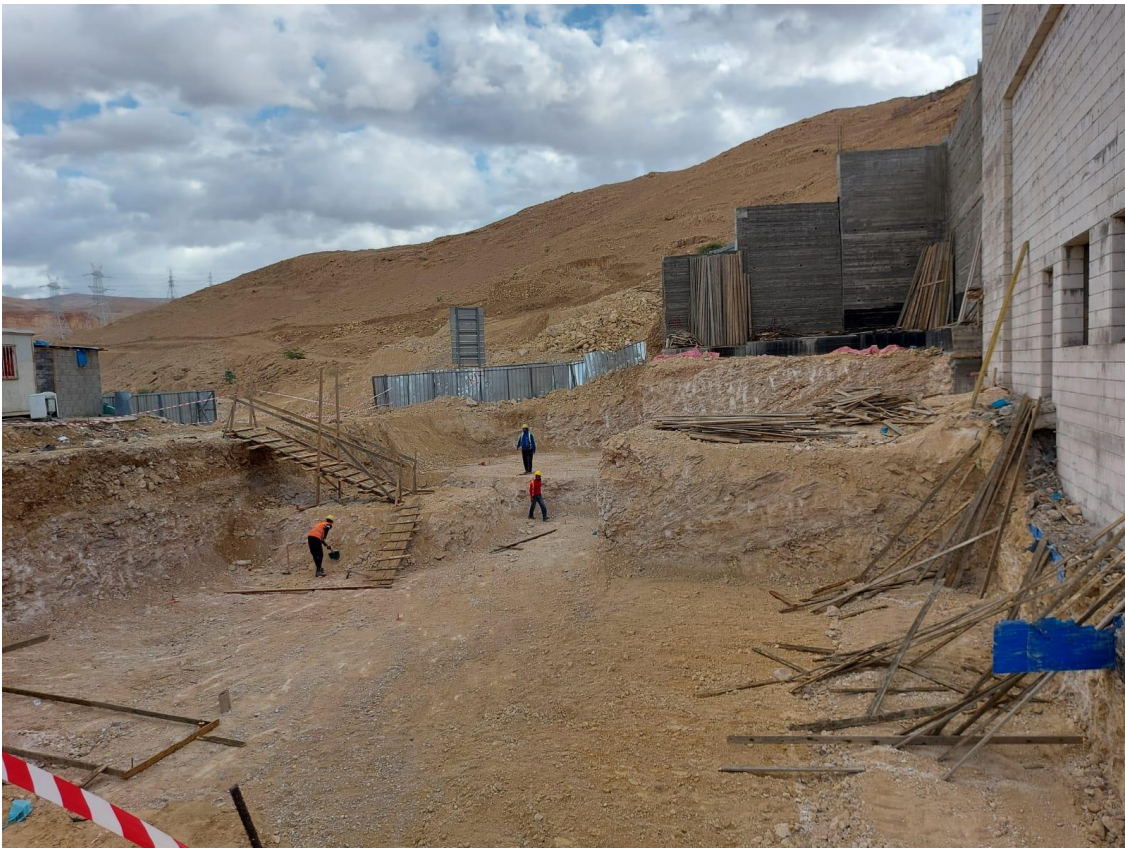
(Figure: 06)

It was observed that the Contractor completed the excavation work for the guard room

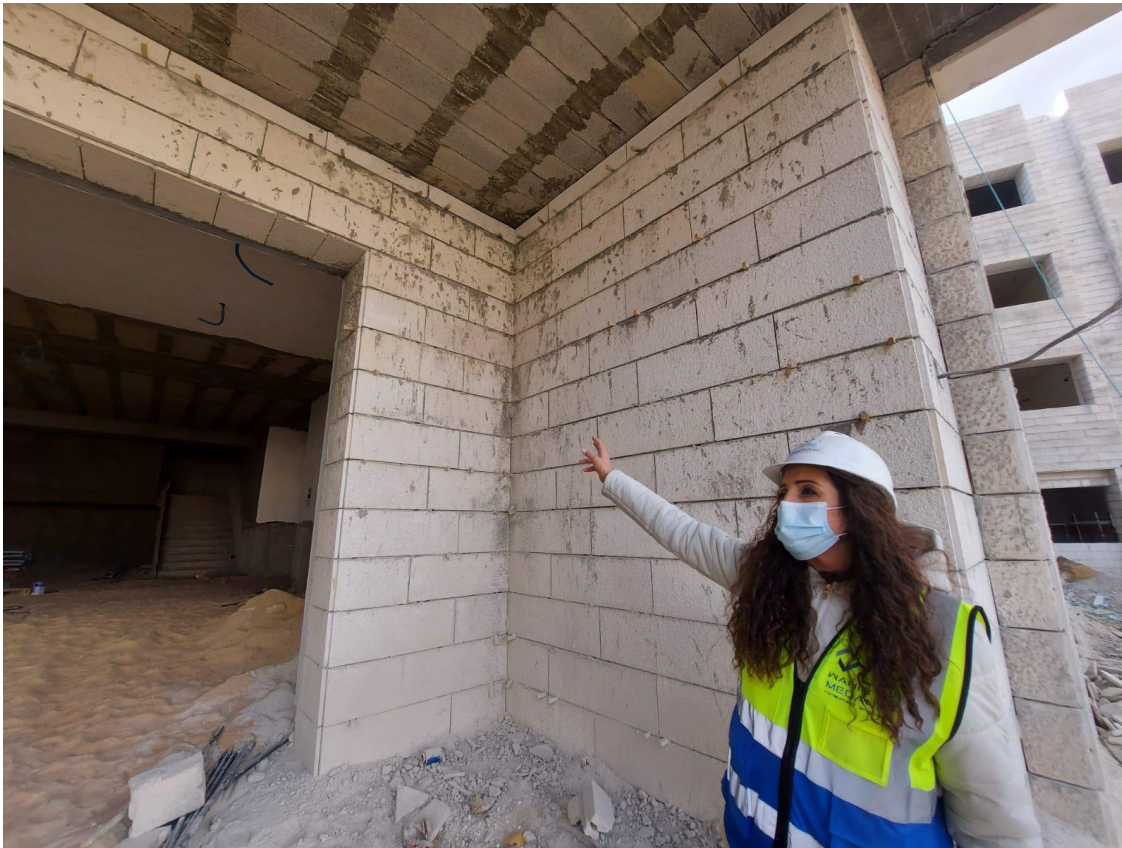
(Figure: 07)

The supervision team inspected the stone facades and comments were given to the Contractor

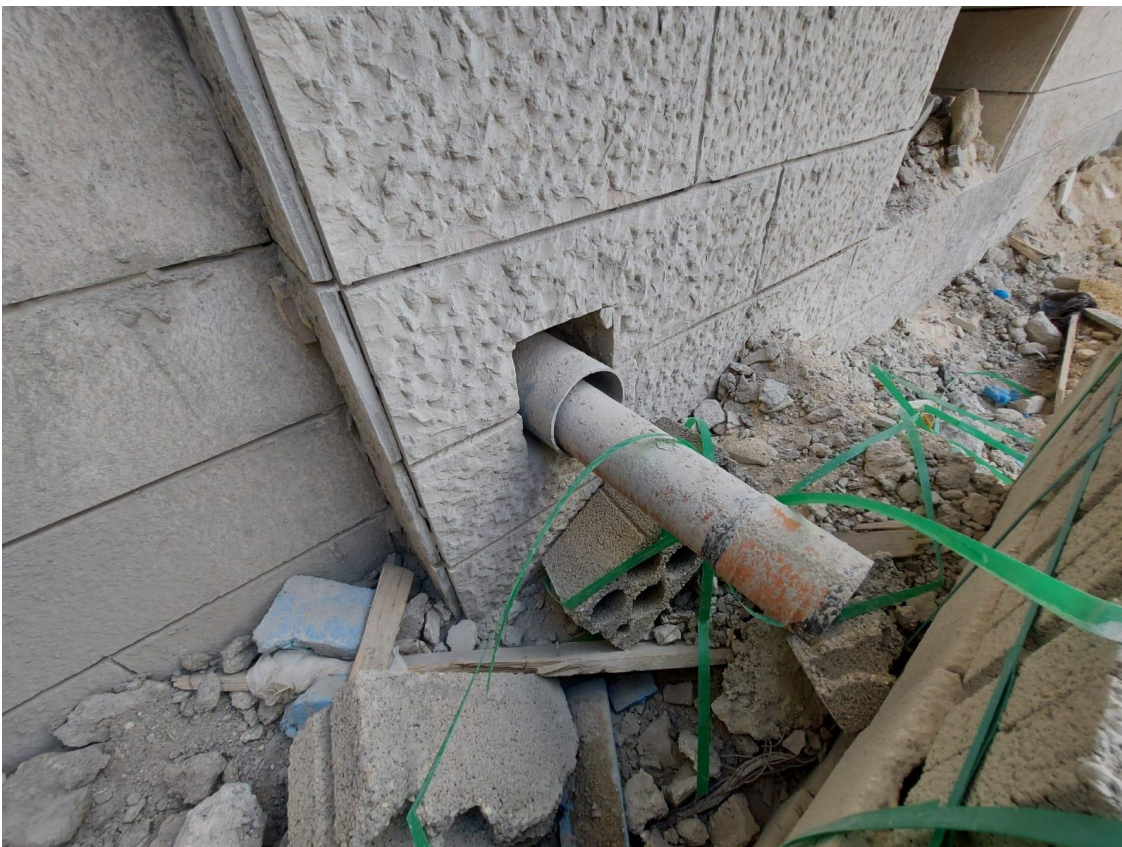
(Figure: 08)

Defects were observed in built stones around the outlet of rain water pipes

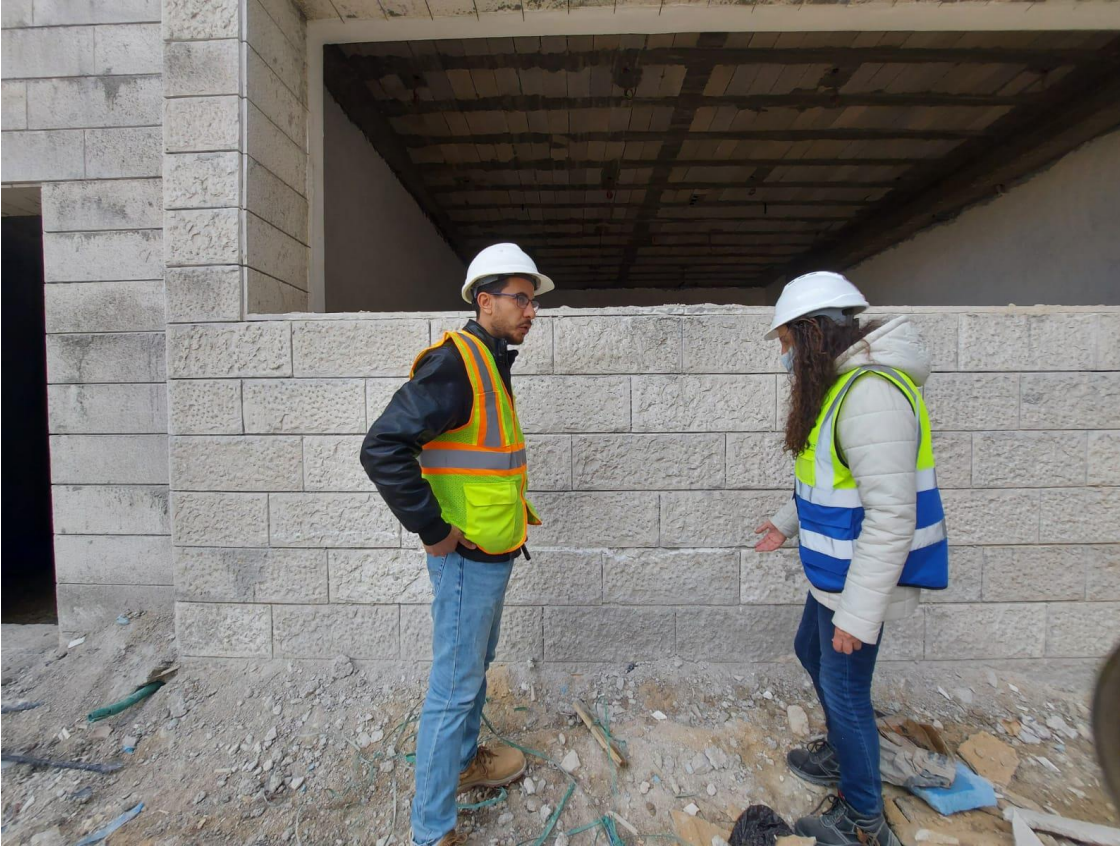
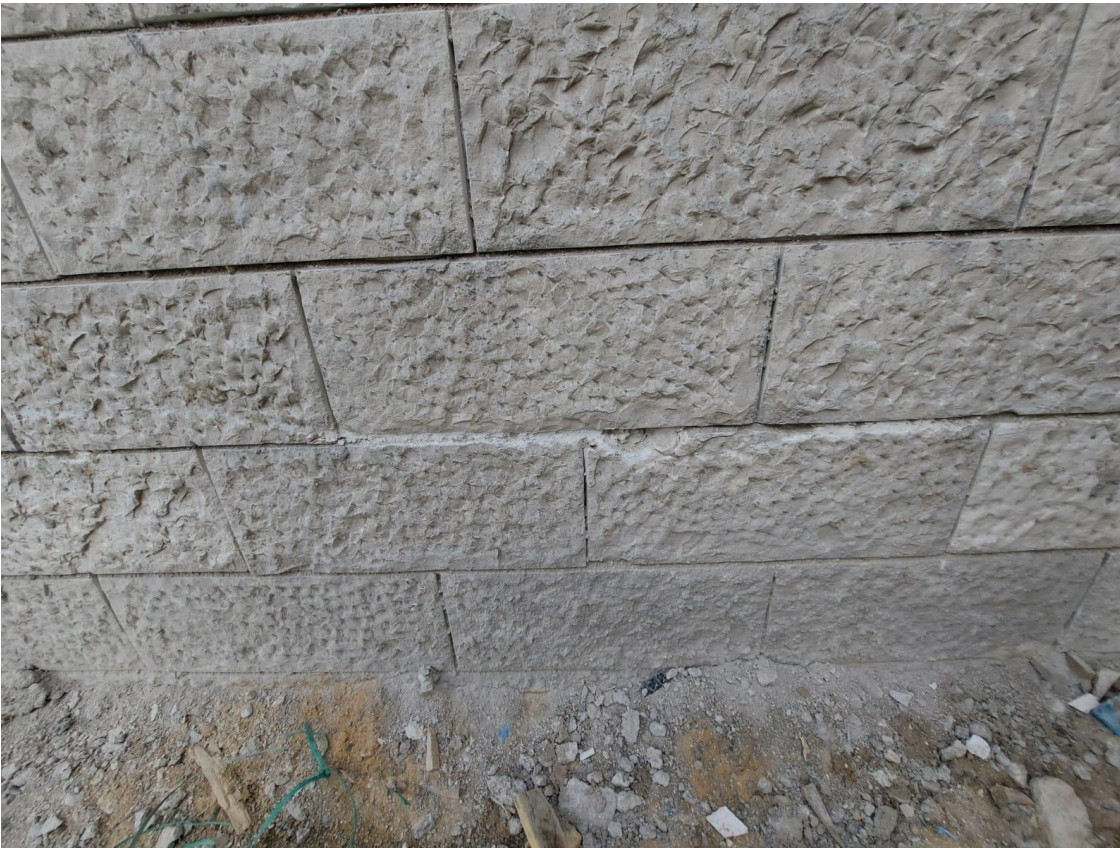
(Figure: 09 & 10)

The supervision team inspected the built stones for facades and observed damages in parts of the stones due to the excavators working nearby

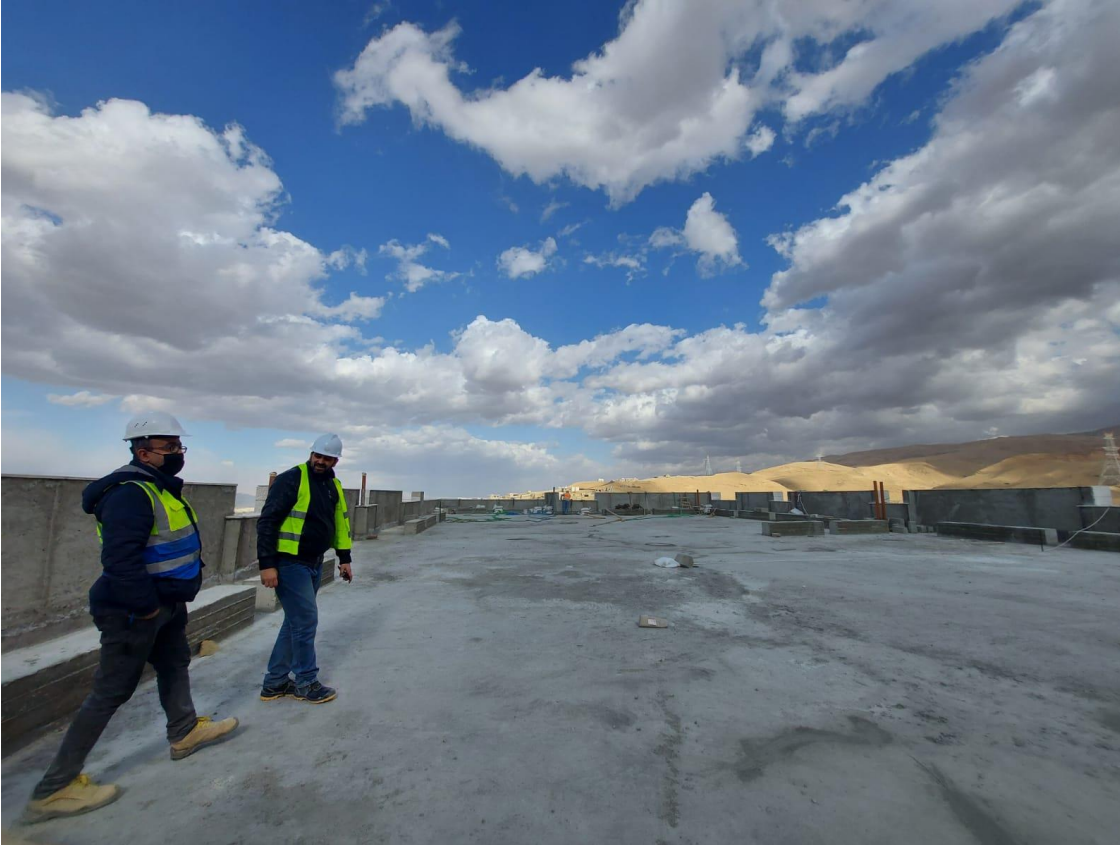
(Figure: 11)

The team inspected the preparation work for insulation at the roof

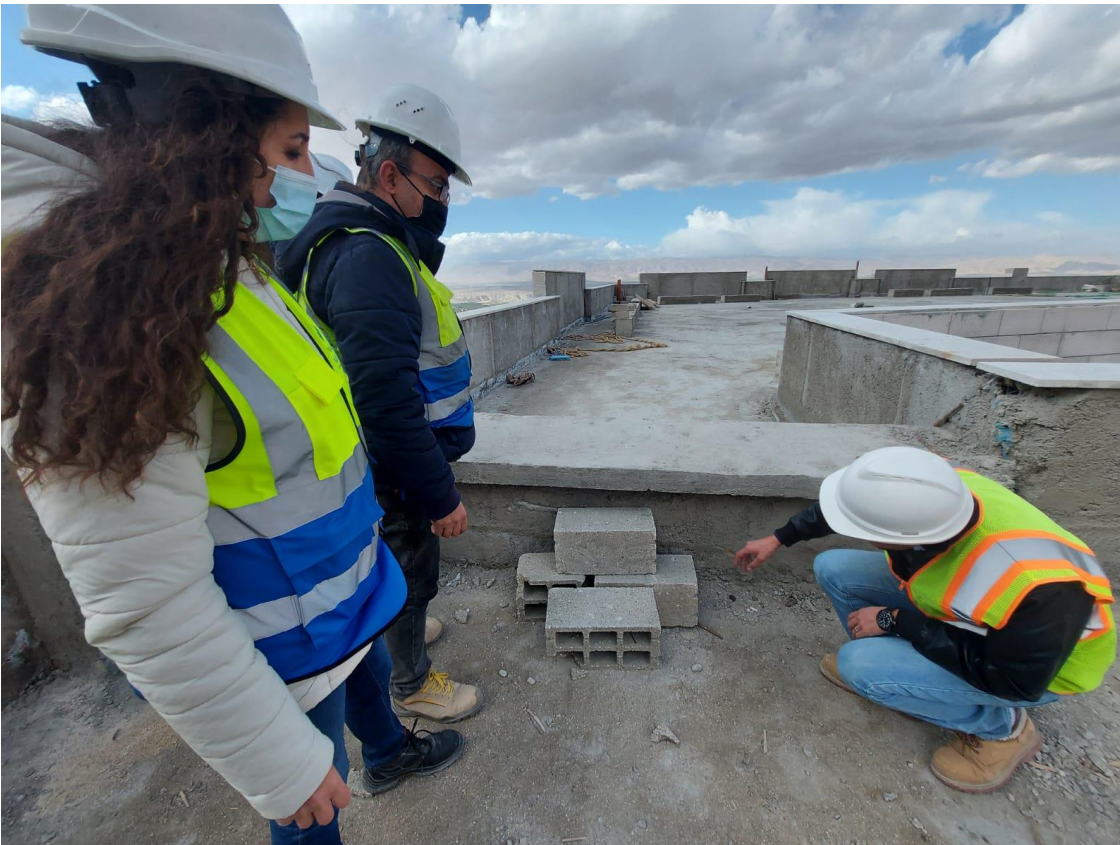
(Figure: 12)

The supervision team observed that the Contractor progressed in the work of expansion joints at the roof between zones A and B

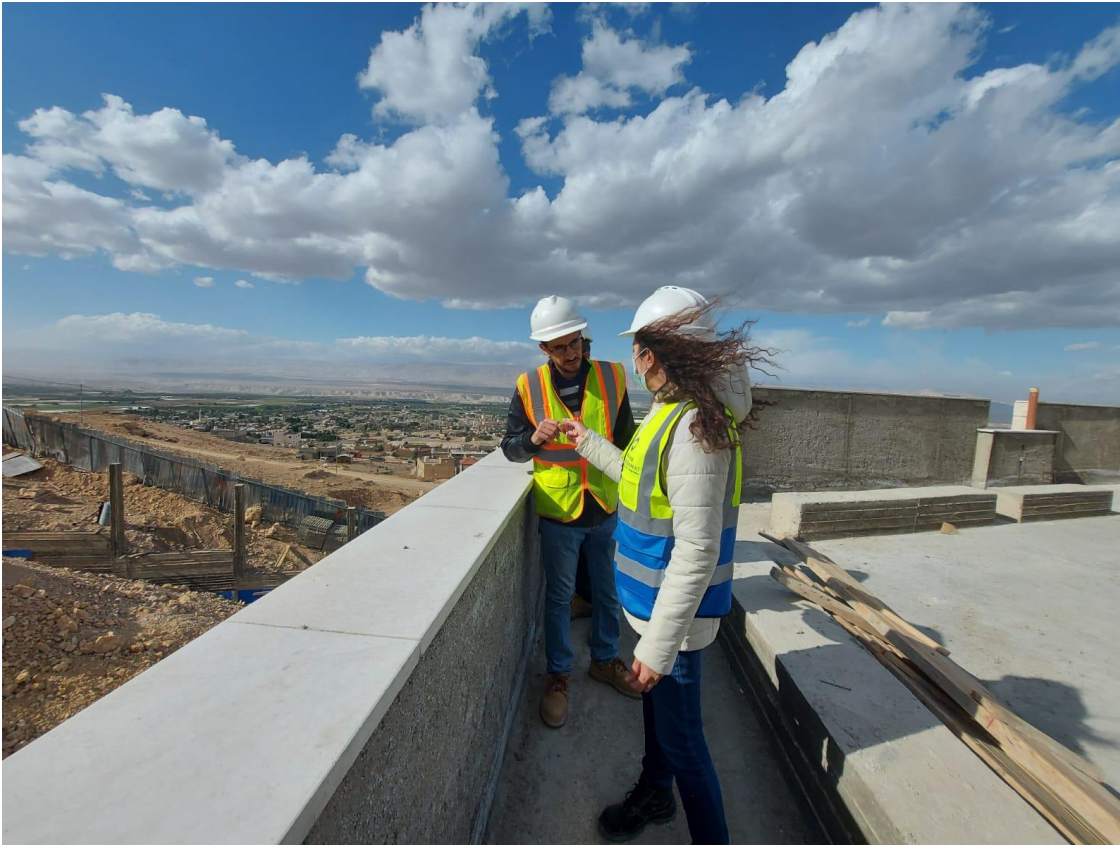
(Figure: 13)

The supervision team observed stone coping work for the parapet

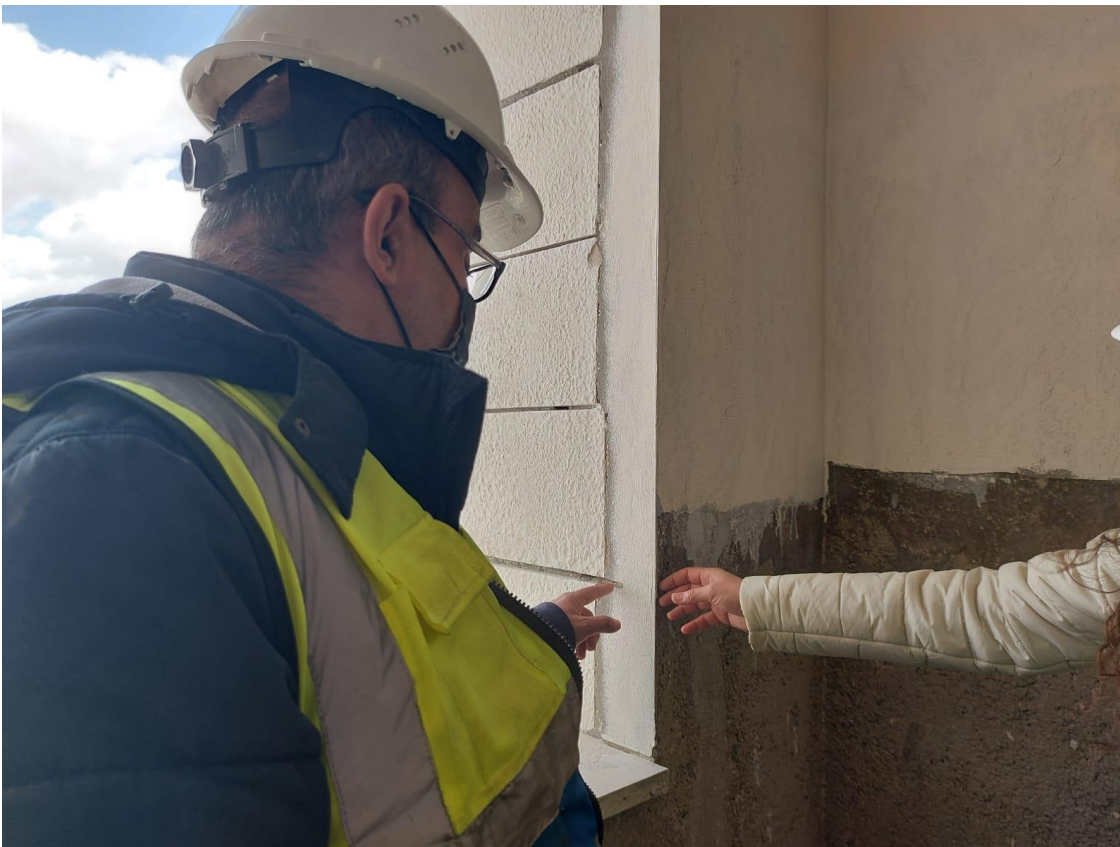
(Figure: 14)

Defects were observed in the plastering of window jambs as a result of cleaning the joints between the built stones prior to the pointing. The Contractor was requested to rectify using special repair material

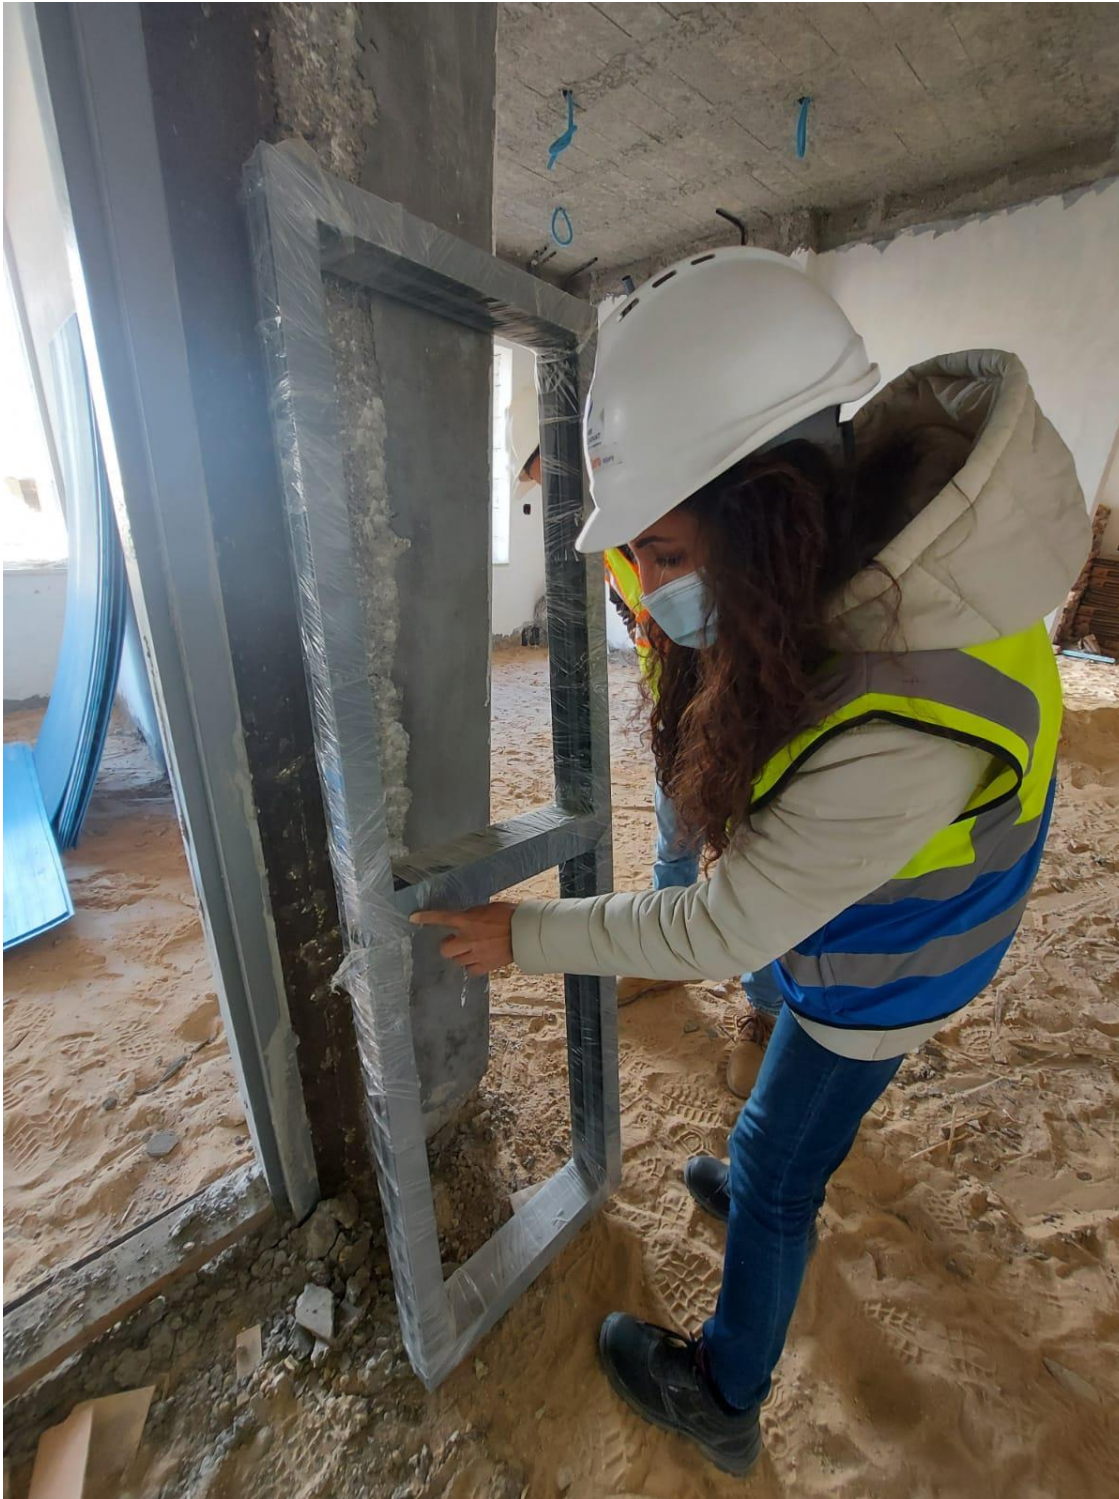
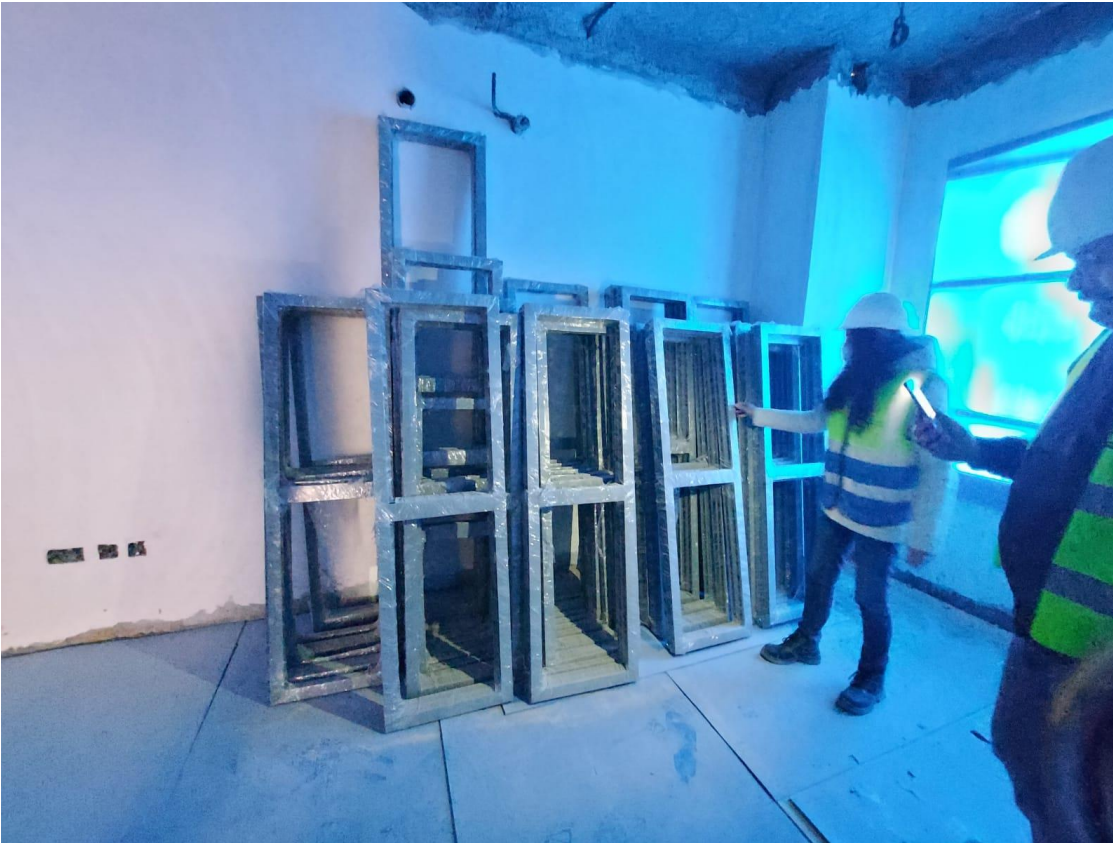
(Figure: 15 & 16)

The supervision team inspected the delivered aluminum window sections. Remarks at the joints of sections and other remarks were observed and the Contractor was requested to rectify

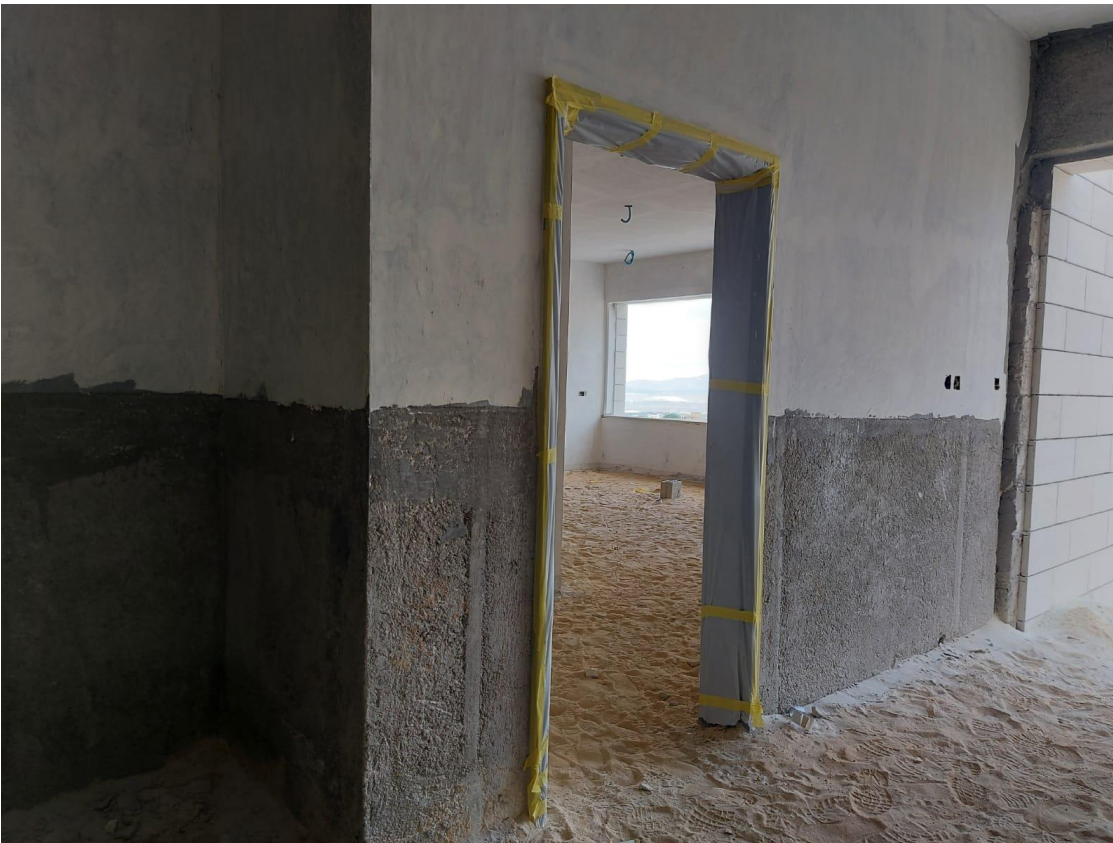
(Figure: 17)

It was observed that the Contractor has responded positively to the previous supervision instruction to wrap the installed steel door frames as necessary for protection purposes

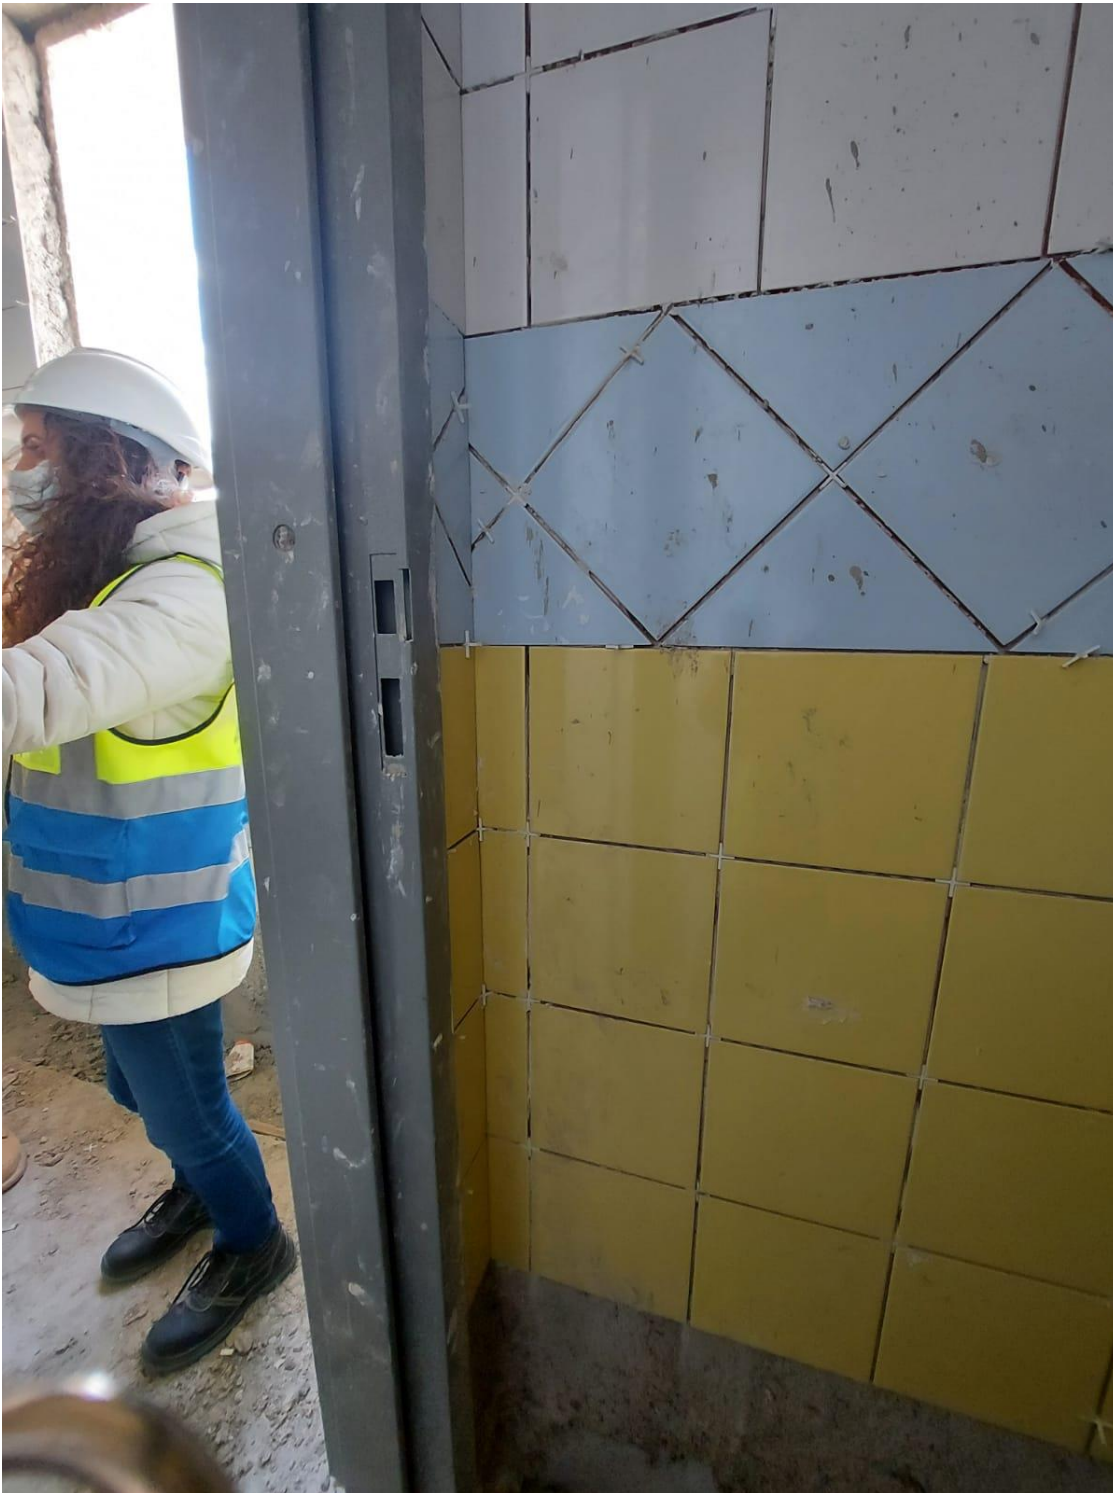
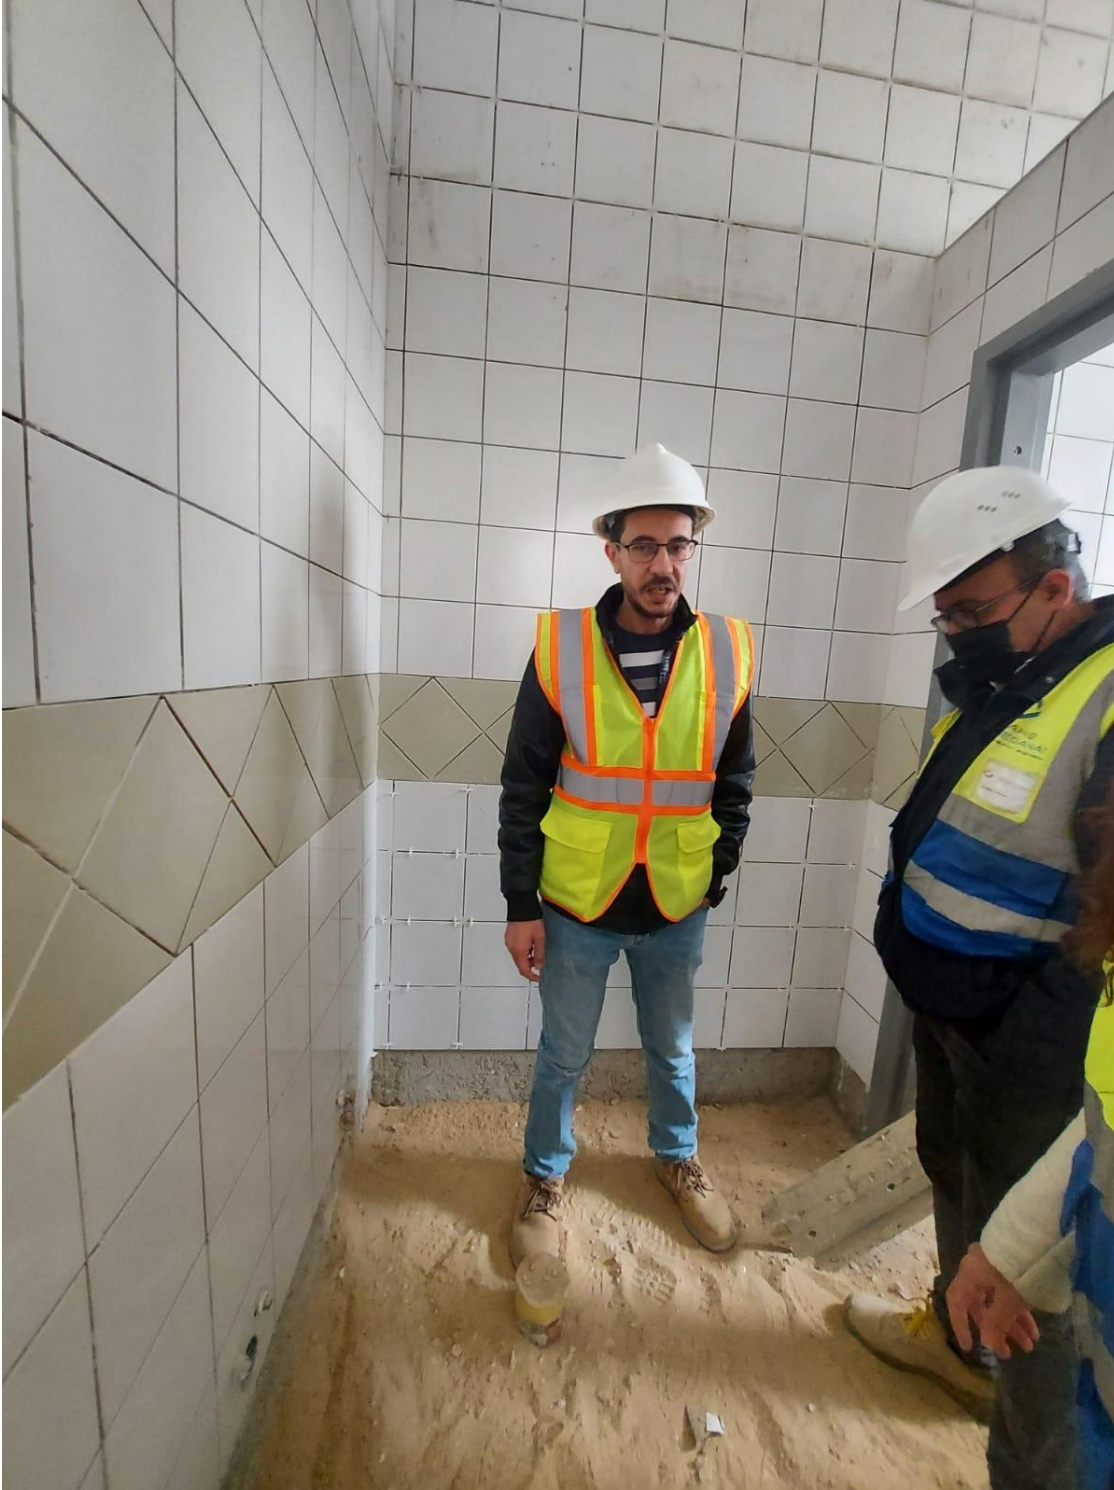
(Figure: 18 & 19)

The supervision team observed that the Contractor started with the tiling work for a considerable part of the wet areas walls without workshop drawings and without inspection requests for the first row to guide the rest of tiling work

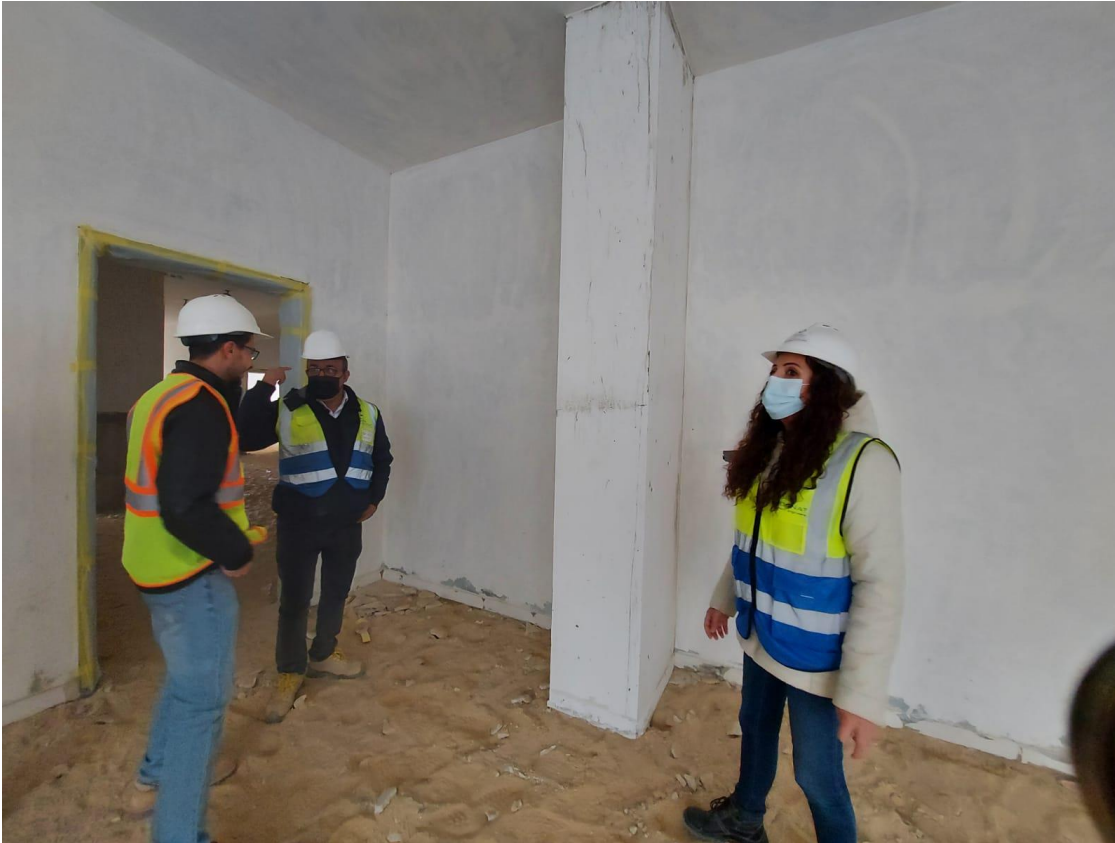
(Figure: 20)

The supervision team stressed on the Contractor to install plastering beads for all external corners of the building, a number of corners were observed without those beads

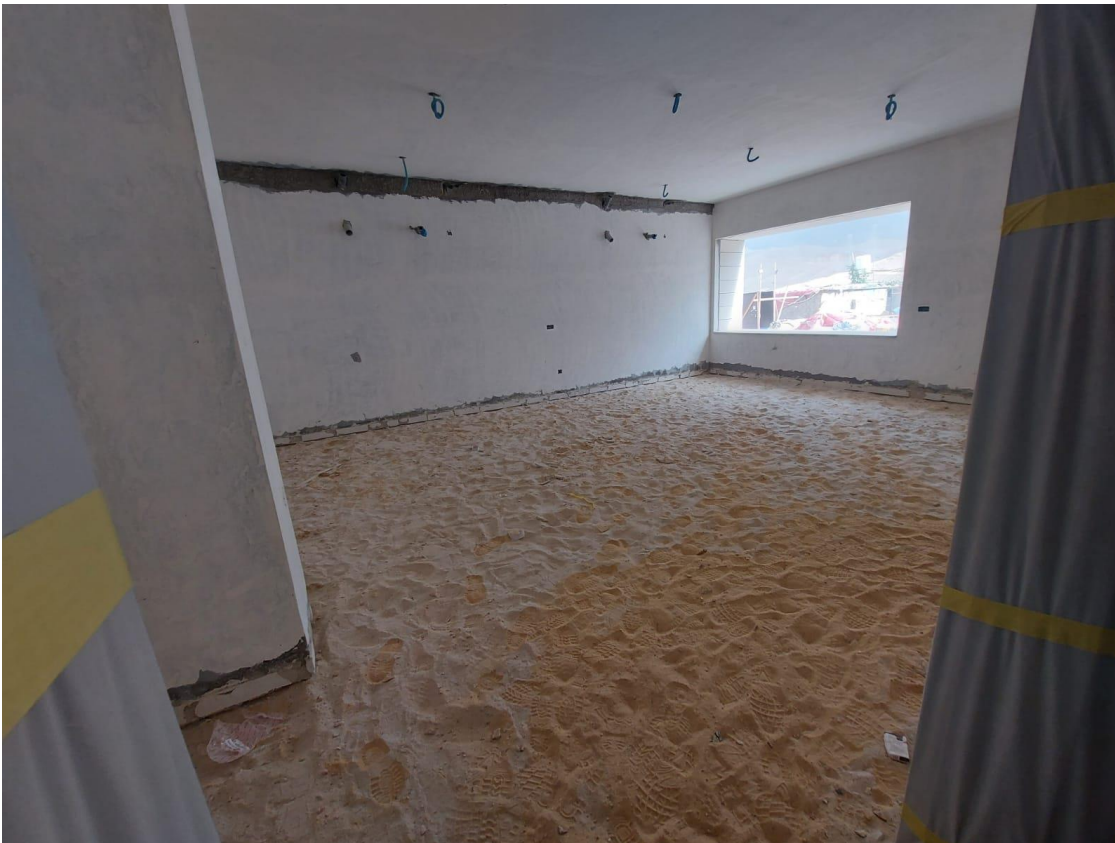
(Figure: 21)

The supervision team observed that the Contractor removed all the porcelain floor tiles out of the site, that was due to the incompilance of the said material observed previously

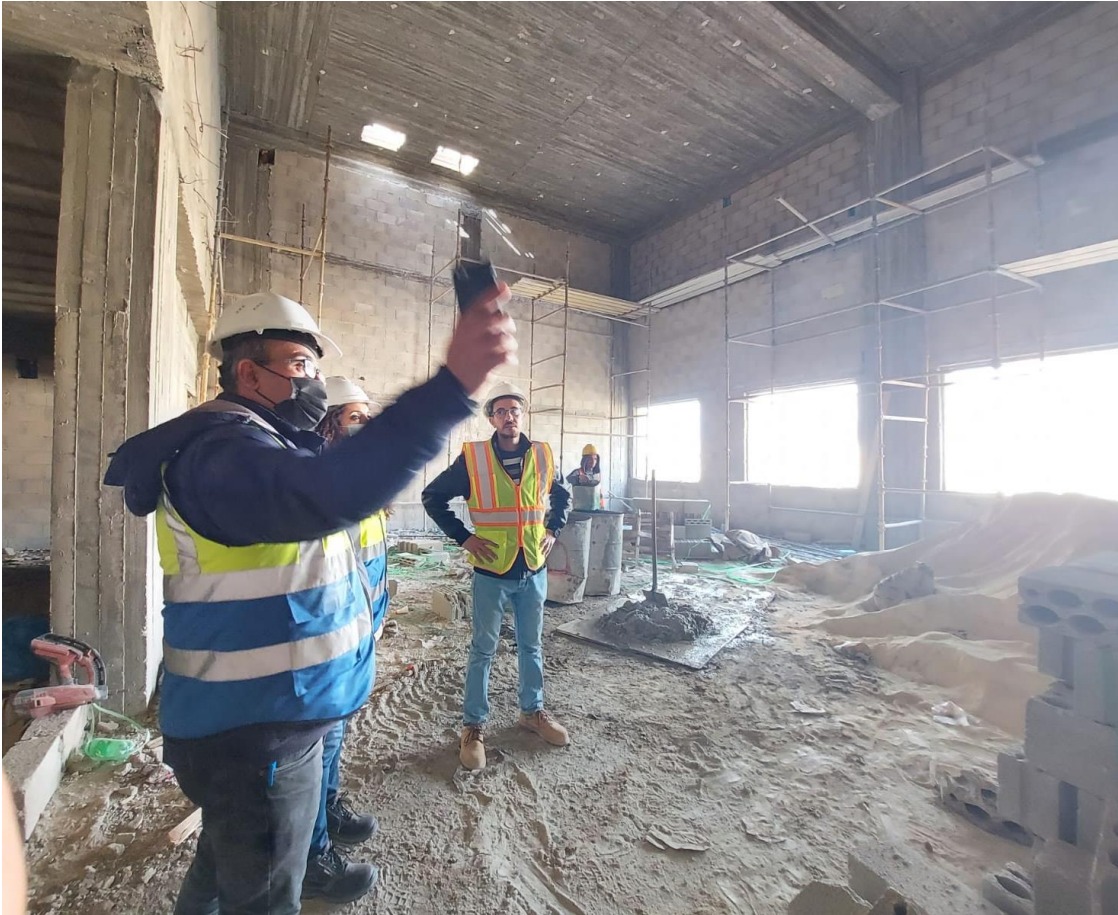
(Figure: 22)

The team inspected the blockwork going on in the multi-purpose hall
