# Quality Control Report

**Consultant** **Wahib Medanat** Consultant Engineers  
**Site Name** **Al Khansa'a Basic Mixed - Balqa**  
**Package** **Package 1**  
**Contractor** **Derar Saraireh & Sons for Engineering & Contracting**  
**Tender No.** **1/2020/USAID/SKEP/3/1**

**Rep No.** **QC-12 10**  
**Date** **20 / 12 / 2021**

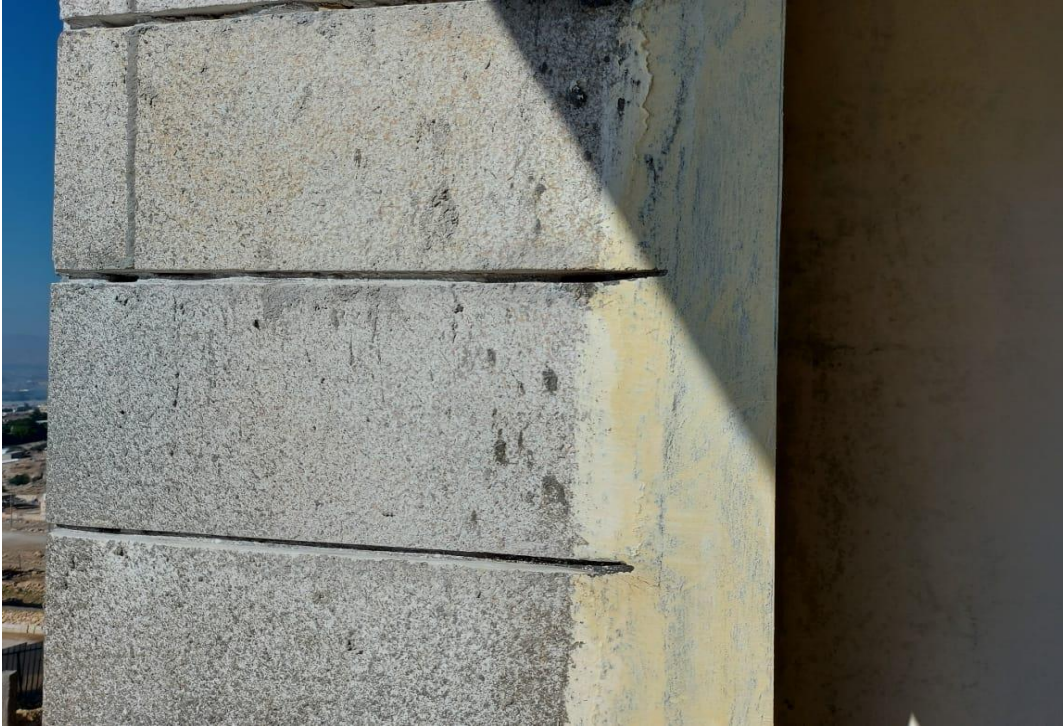
**Defected plastering work**

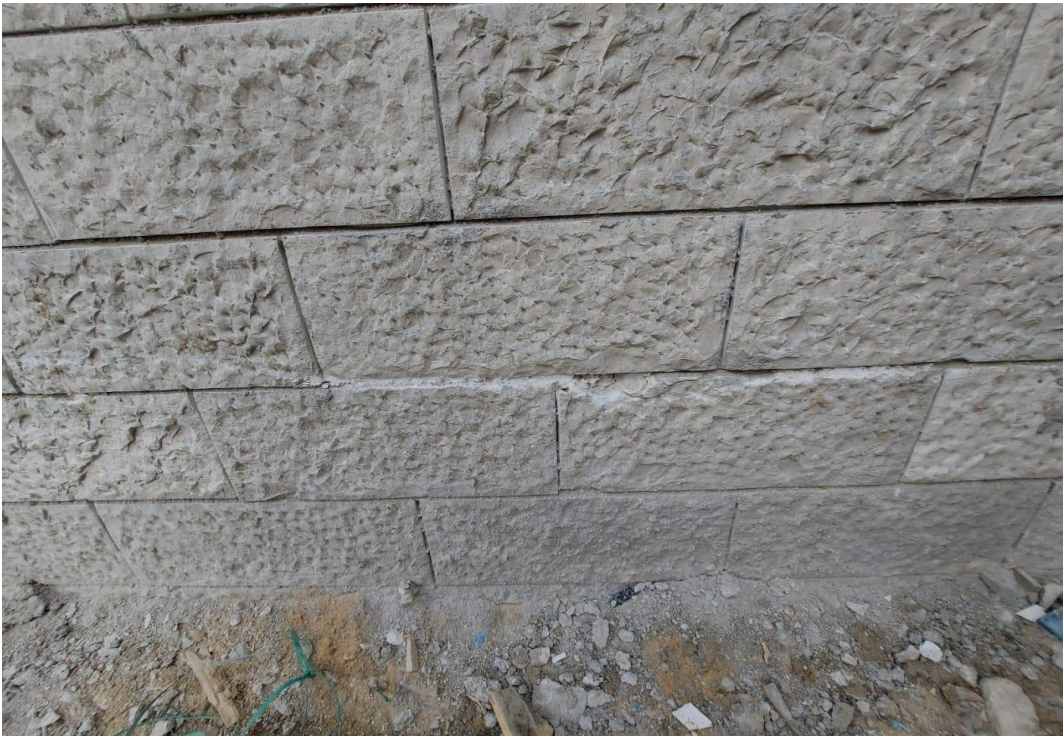
**Defected stone work**

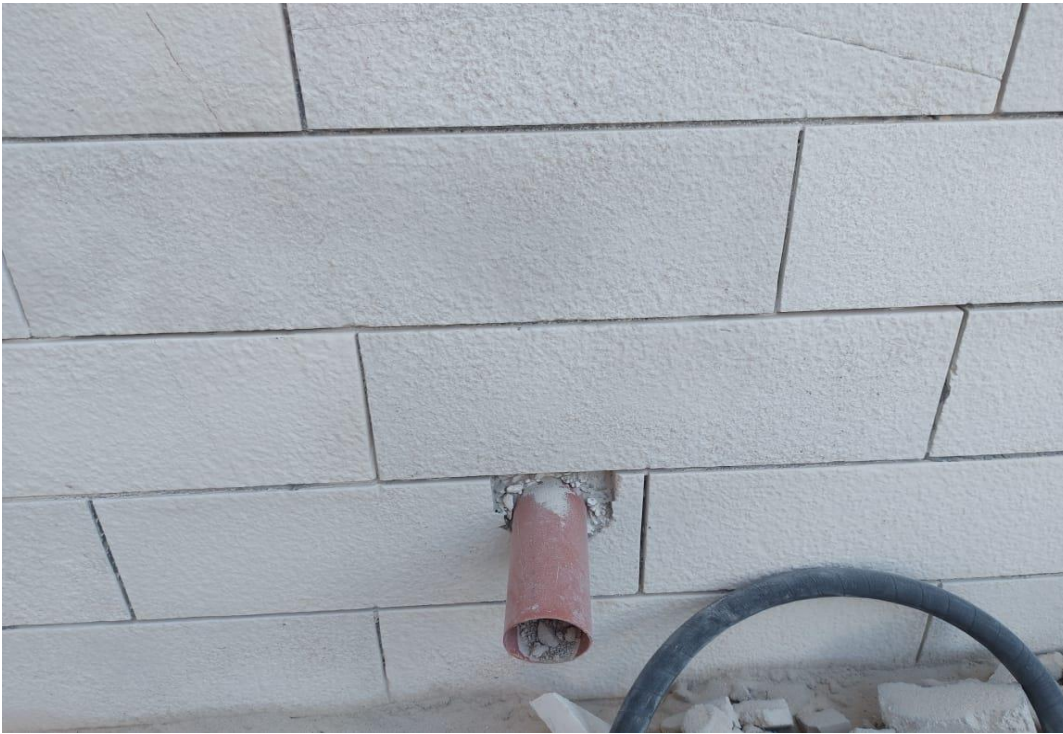
**Defected stone around the pipe**

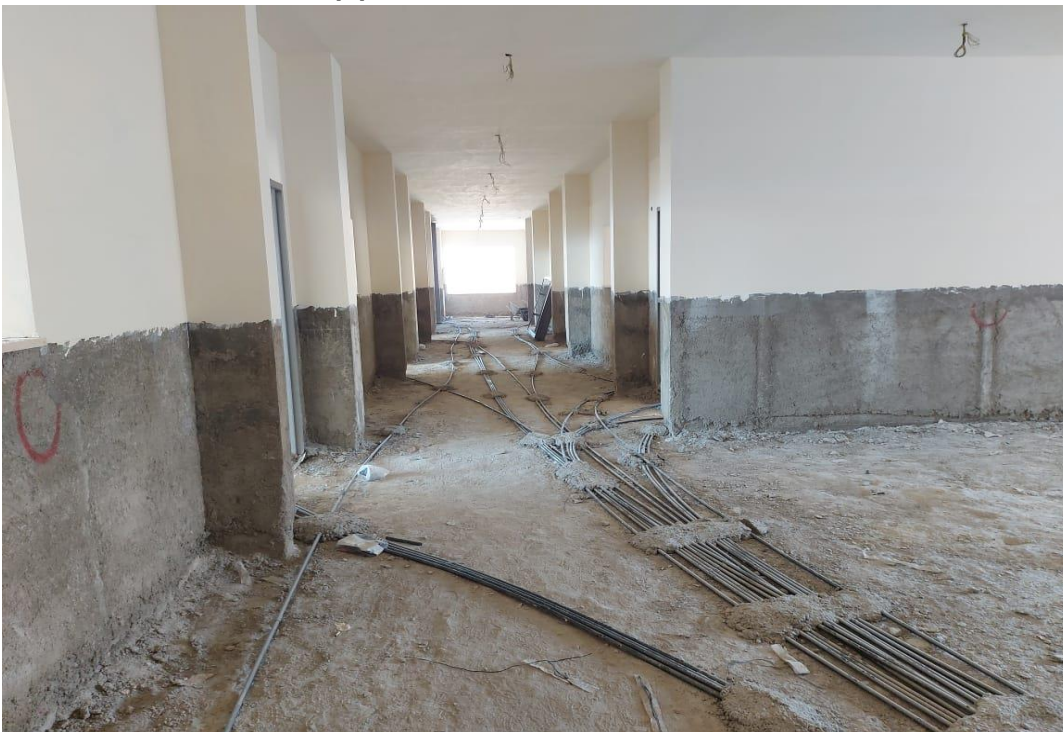
**Un-protected electrical pipes**

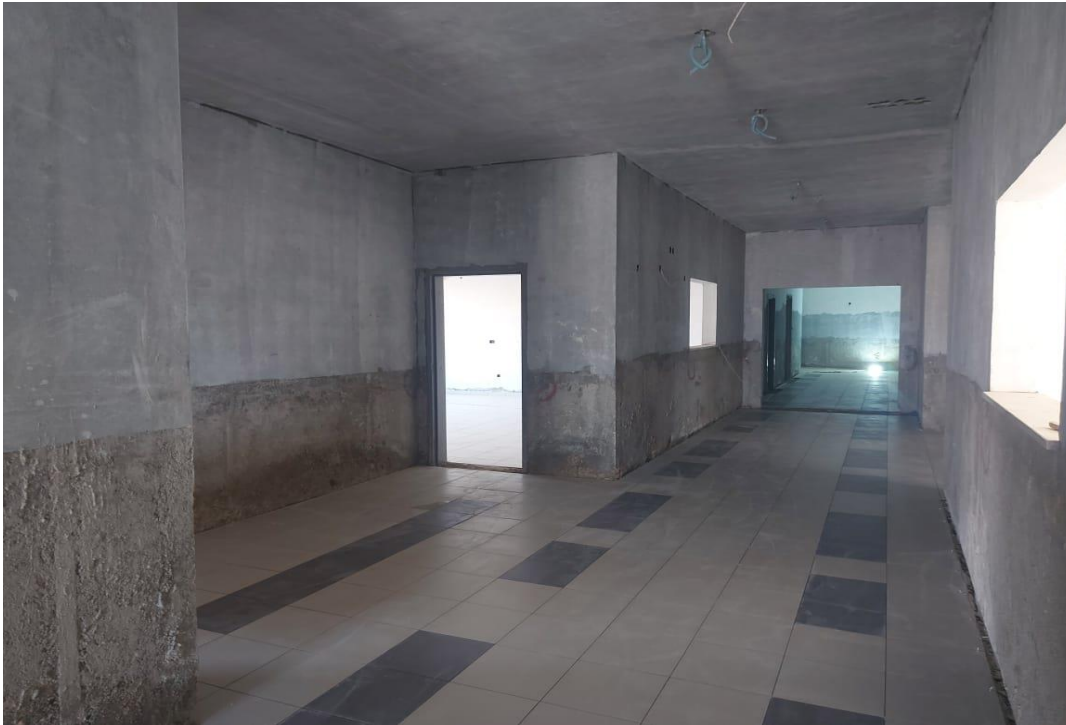
**Defected floor tiles**

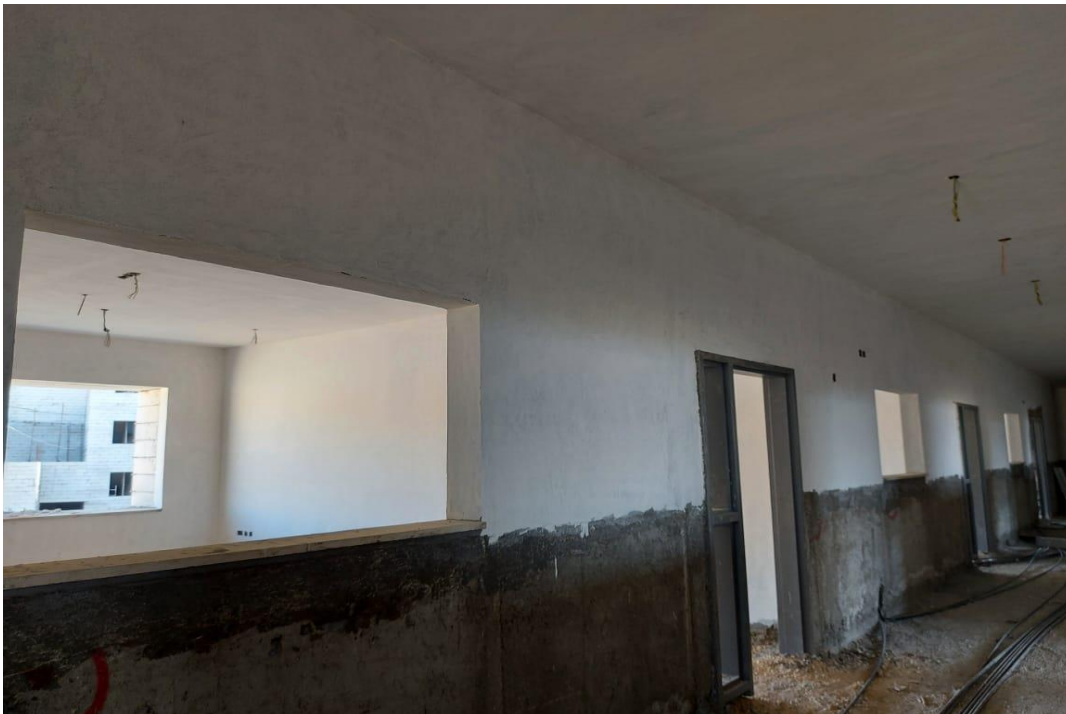
**Unwrapped steel door frames**
