SKEP III Home Office Support Site Visit Report

Consultant	Wahib Medanat Consultant Engineer	Rep No.	22-27102021
Contractor	Dijlah Establishment Constr. Contracting	Tender No.	(11/2019/USAID/SKEP/3/S) Schools for a Knowledge Economy Project (SKEP) - Phase (3) Package (1, 2)
Site Name	Thahr Al Sarow Basic School for Boys- Jerash	Day/ Date	Wed. 27/10/2021
Duration of Project	450 Calendar Days	Total Project Budget	8,314,983.735 JD

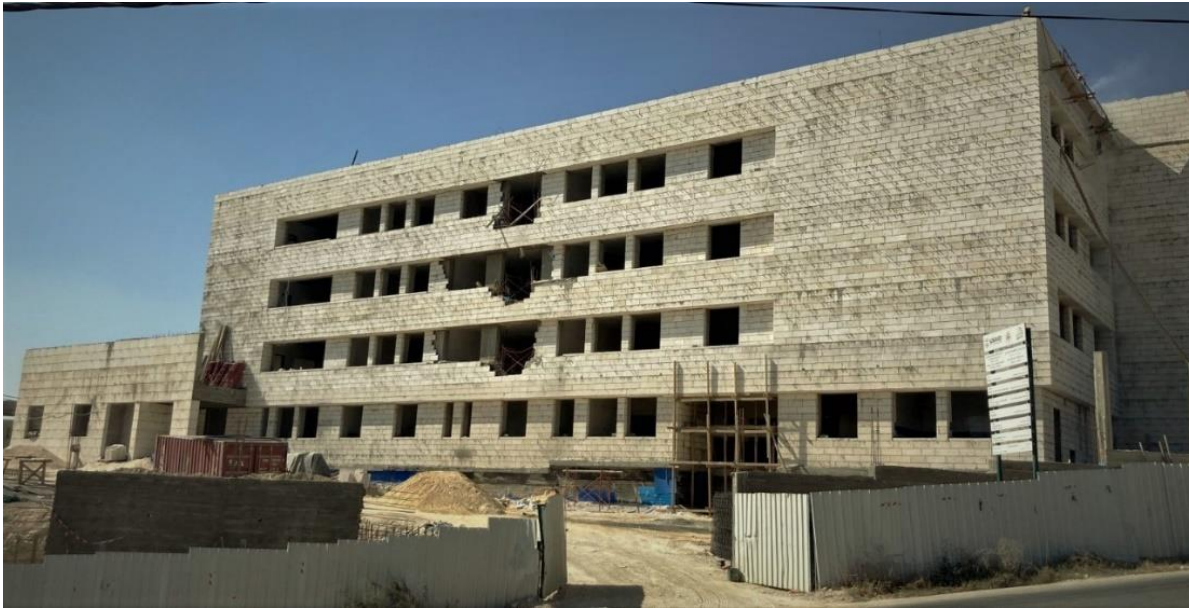
(Figure: 01)

General view of the project

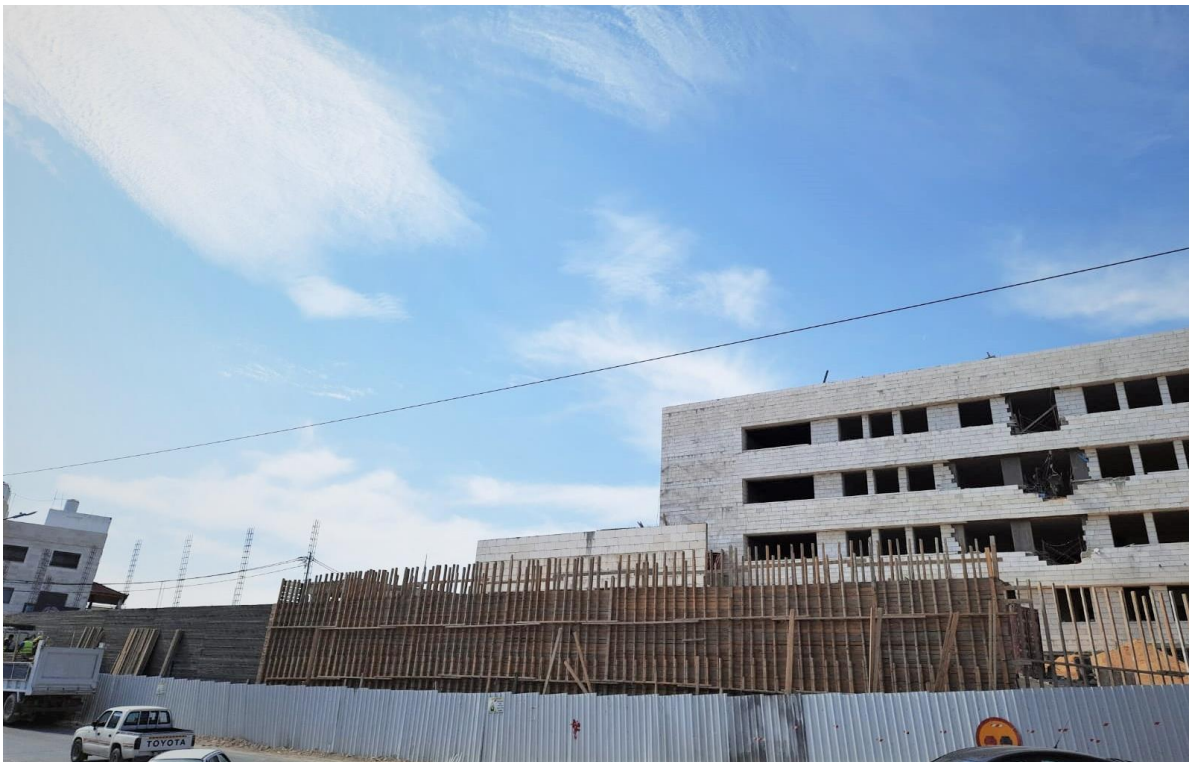
(Figure: 02)

After removing the electrical poles (previous obstacle) on 03/10/2021, the external works continued as shown

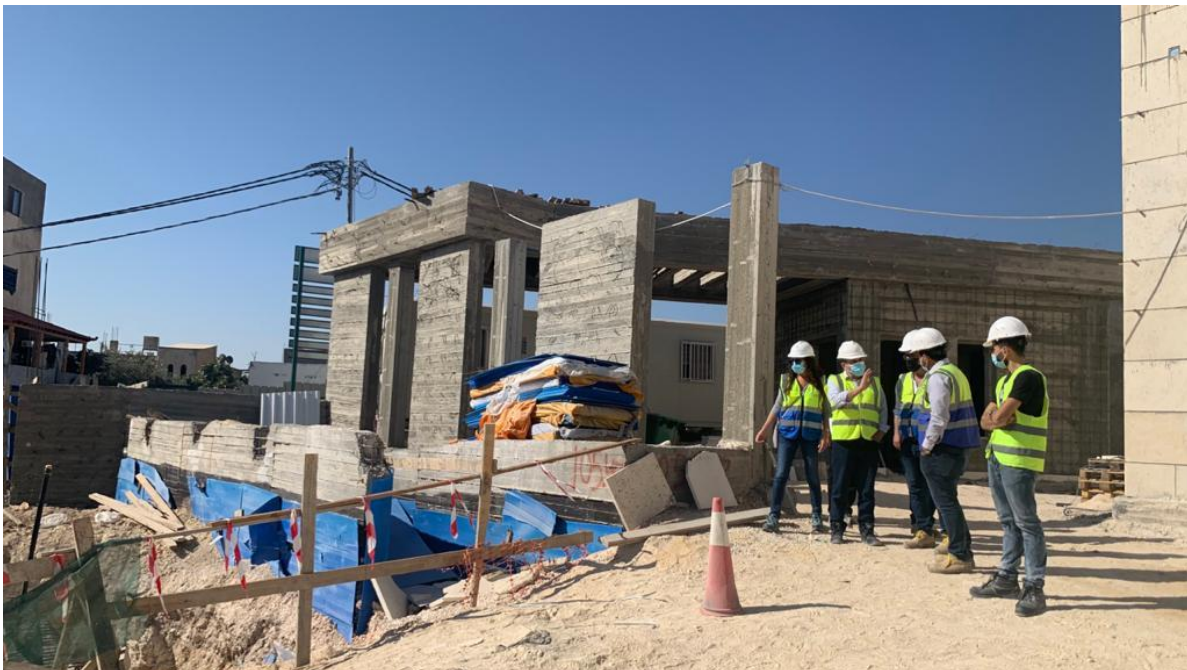
(Figure: 04)

The executed epoxy paint for underground water tank was discussed and the Contractor was requested to rectify the observed defects in plastering and painting

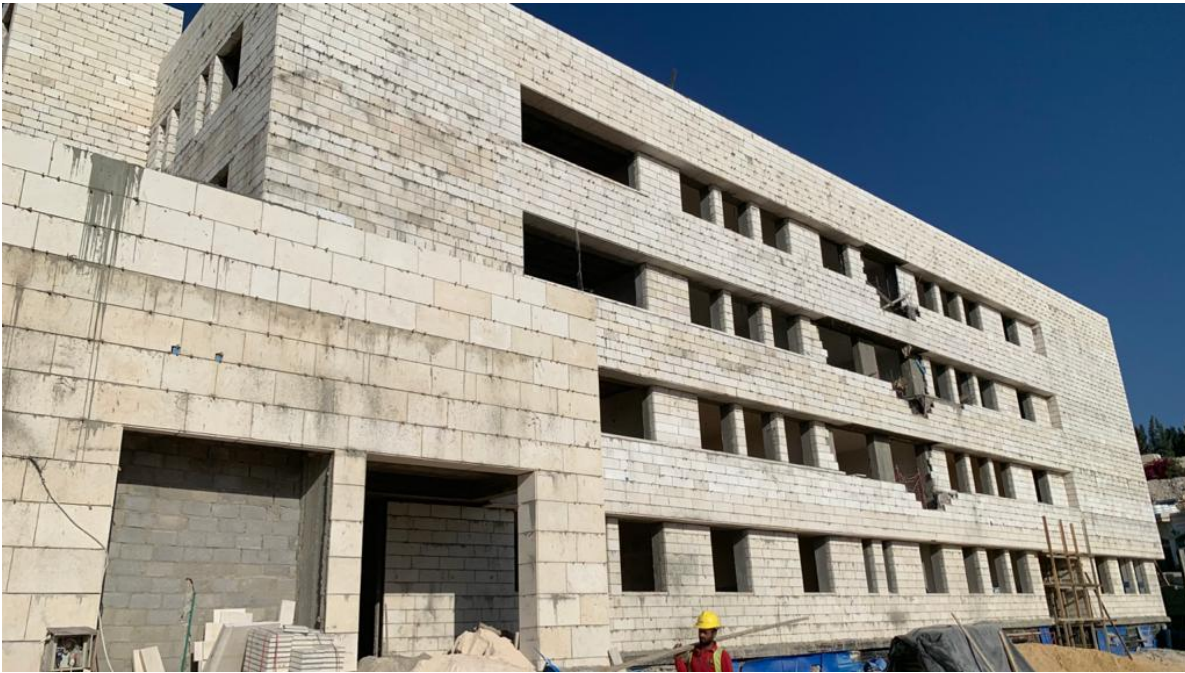
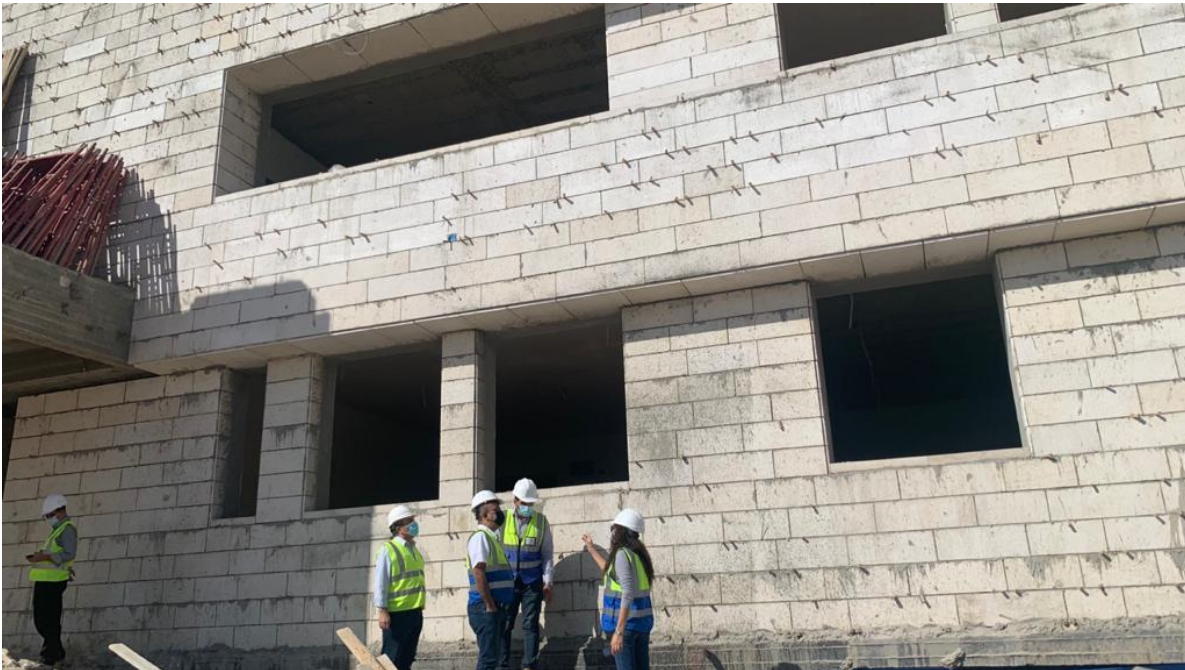
(Figure: 05 & 06)

General
check to the
stone facades

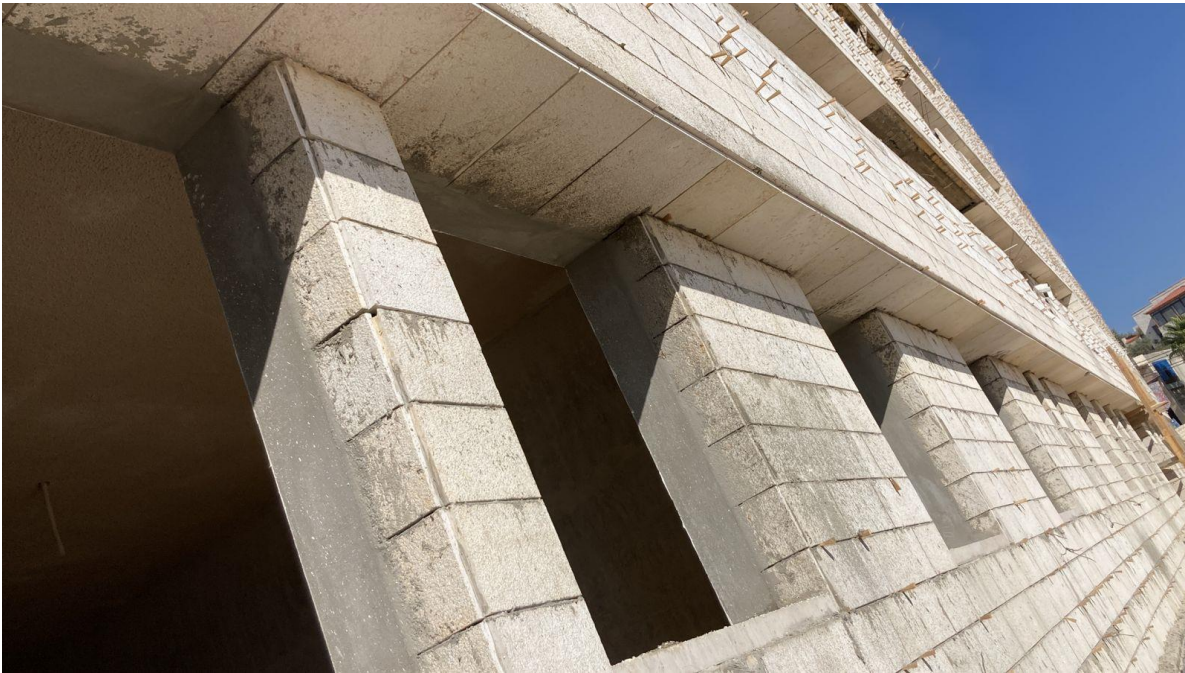
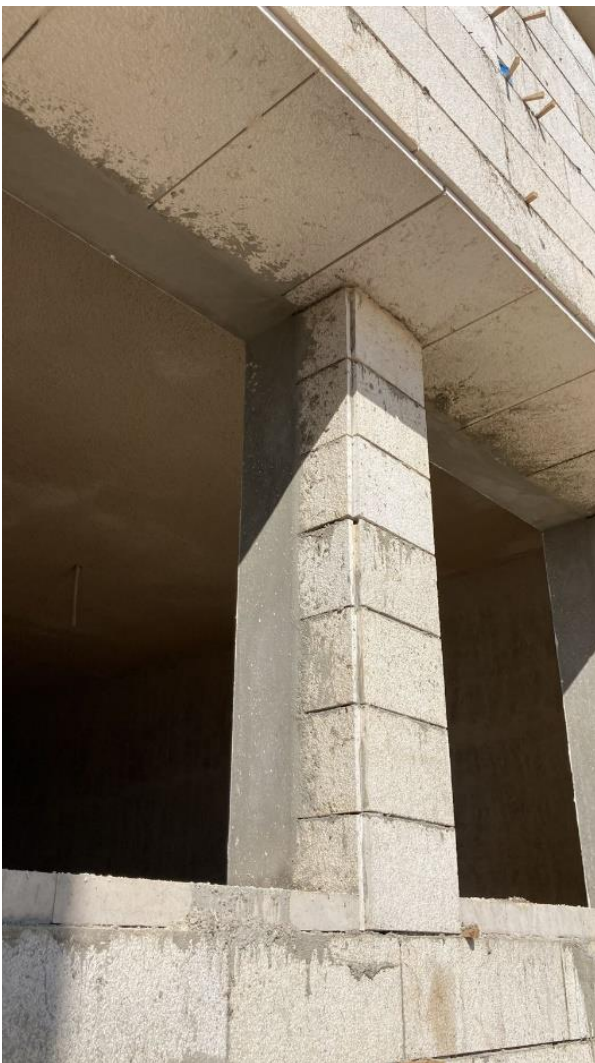
(Figure: 07 & 08)

and window
stone lintels

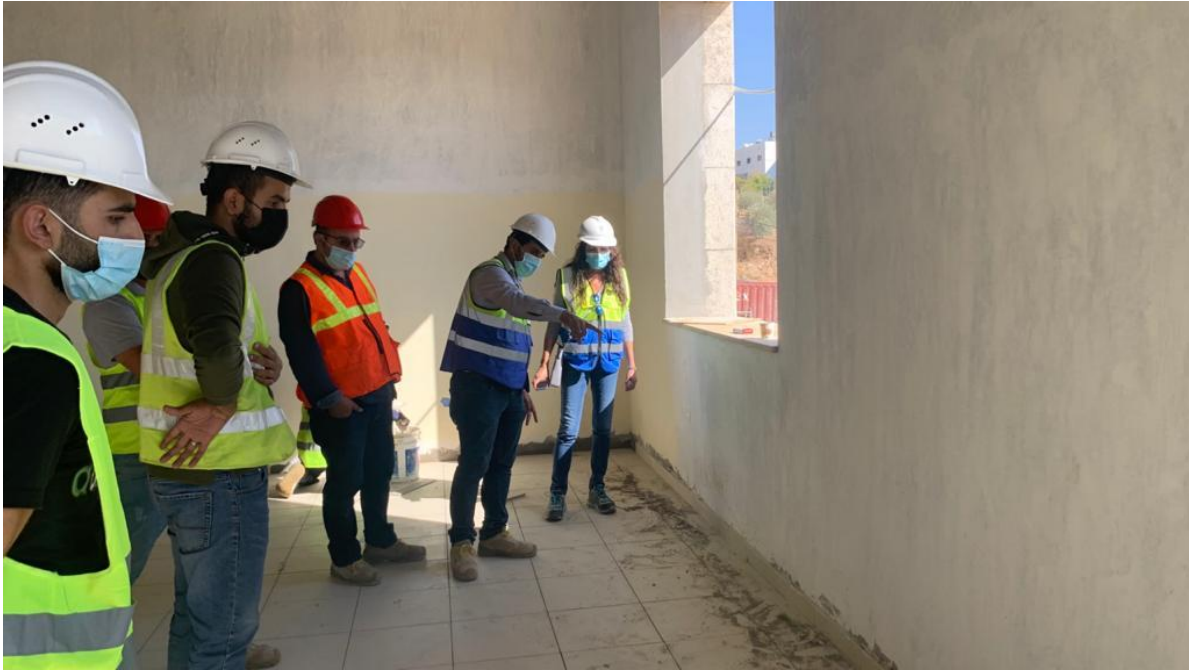
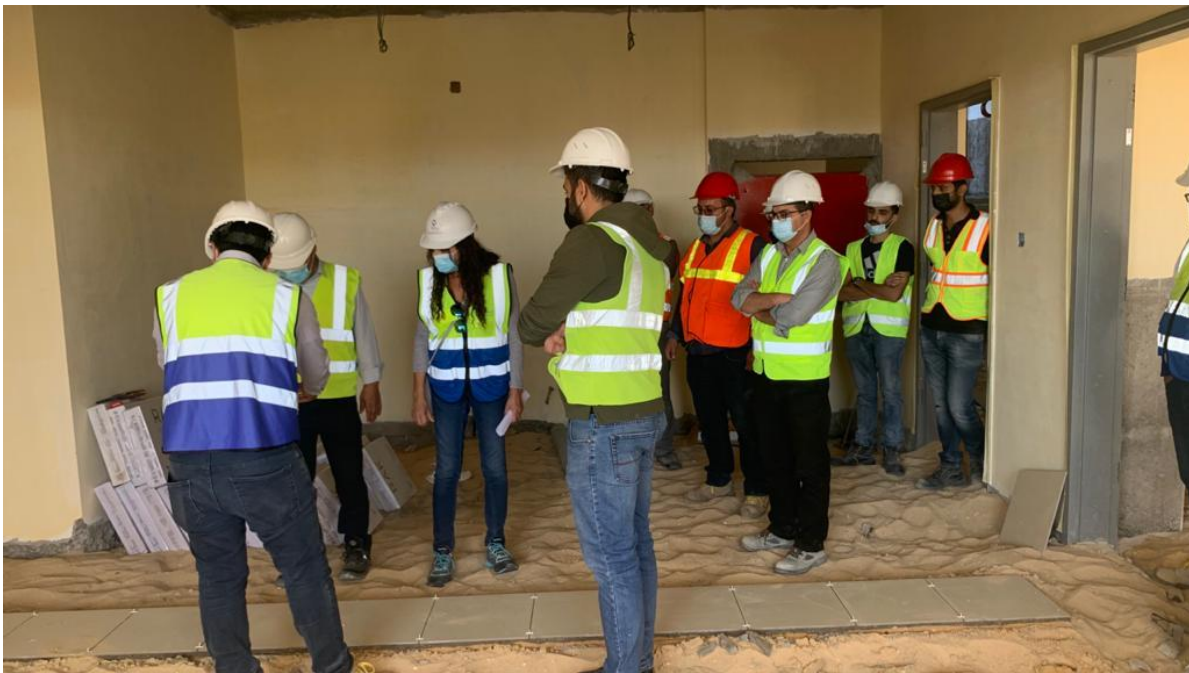
(Figure: 09 & 10)

It was observed that the Contractor started with the execution of the porcelain floor tiles. General remarks were given to the Contractor. The Contractor was requested to protect the executed tiles in a convenient way

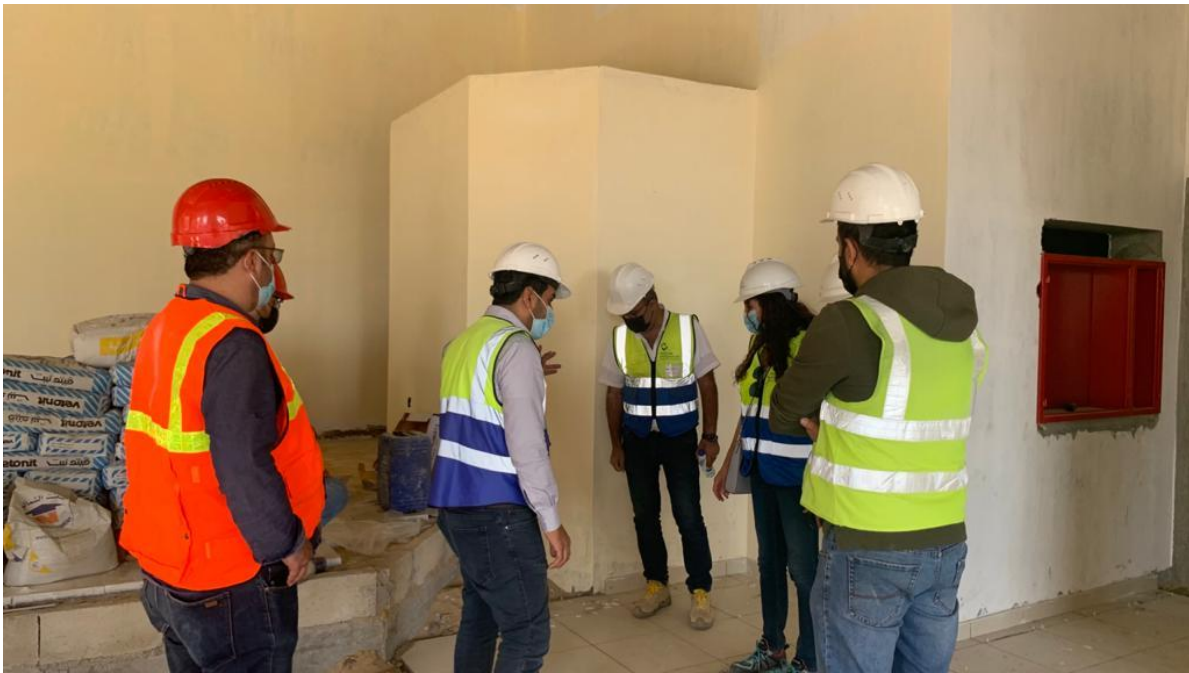
(Figure: 11)

Instructions were given to the Contractor regarding the execution of stairs inside the multi-purpose hall

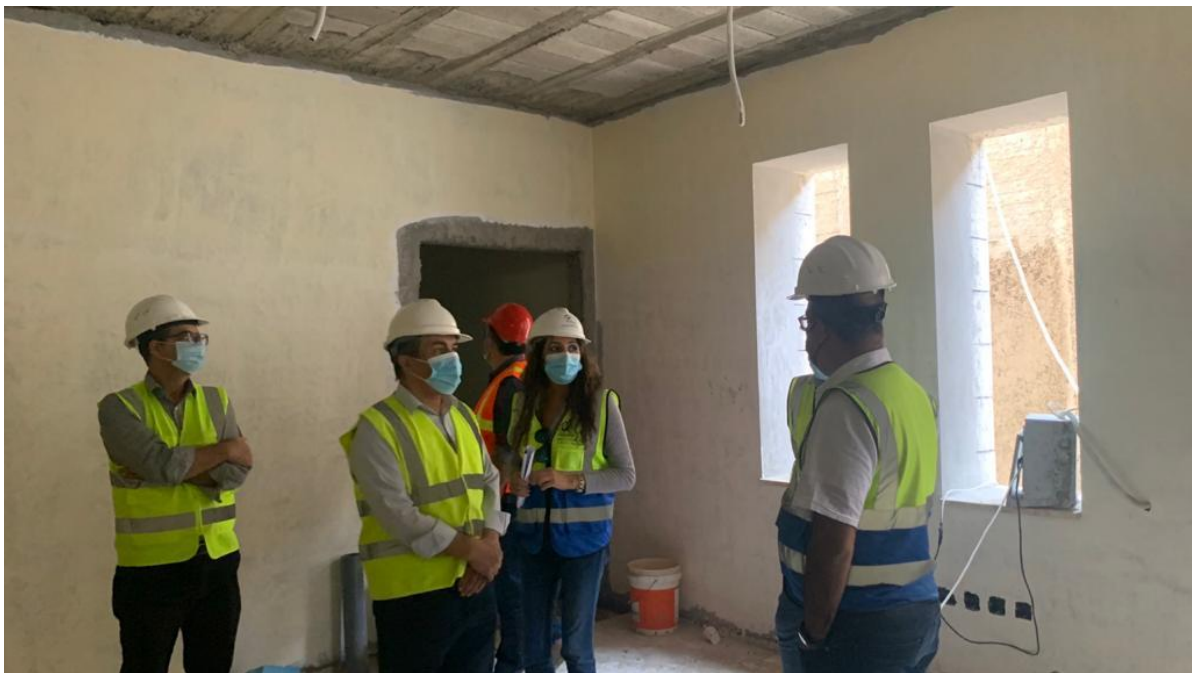
(Figure: 12)

The team observed that the Contractor has not removed temporary sockets panel from one room despite our several requests

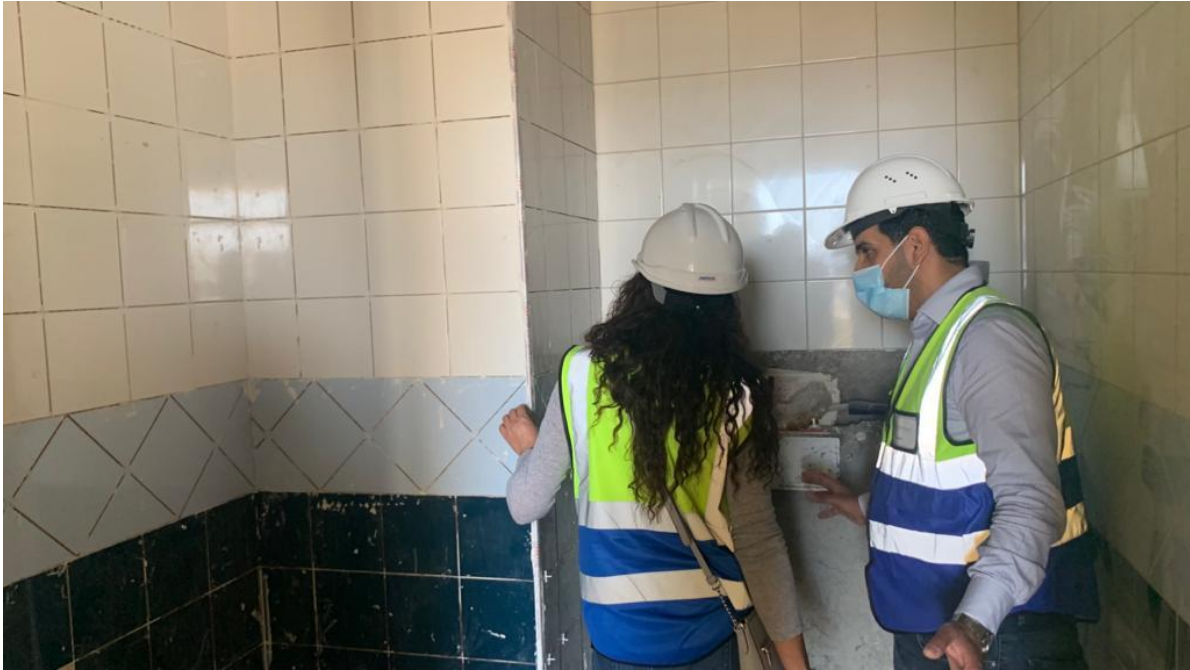
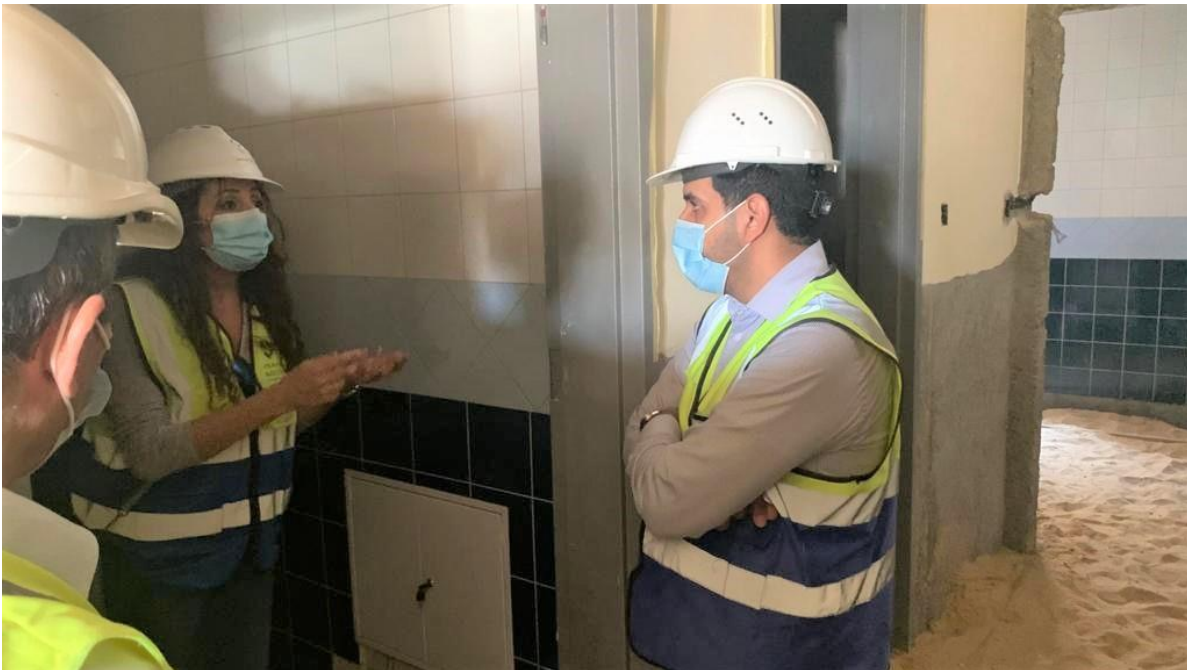
(Figure: 13 & 14)

The installation of mechanical cabinets was checked after execution of the ceramic wall files. It was agreed that the cabinets shall be moved slightly higher to avoid small cut off pieces of ceramic

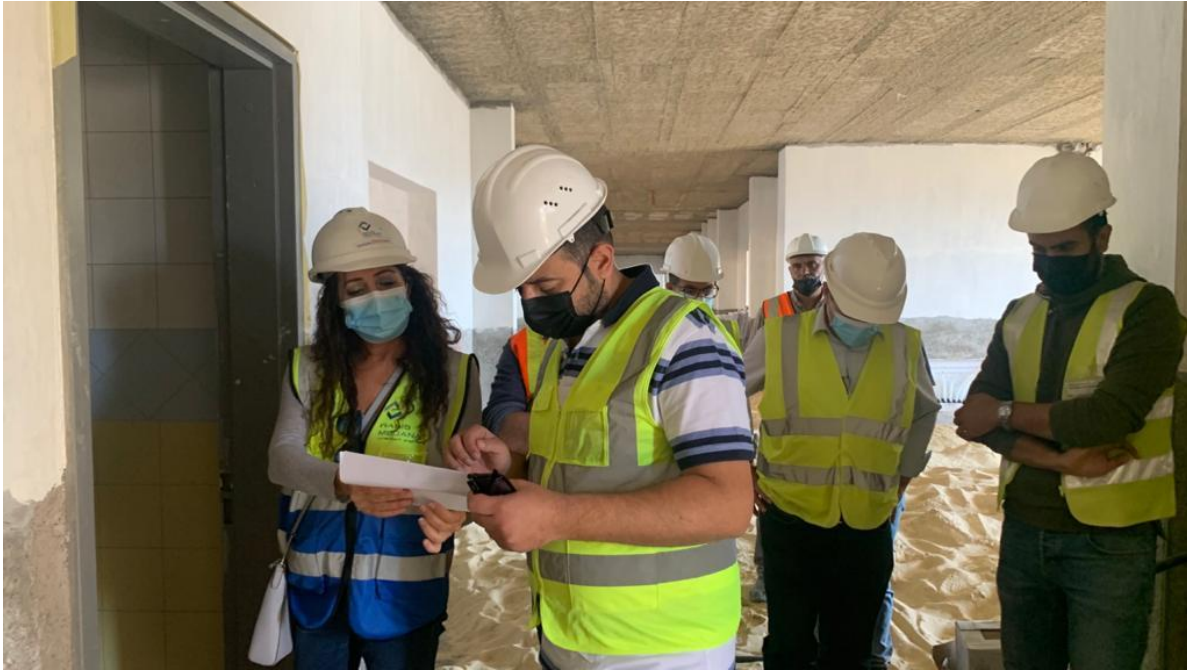
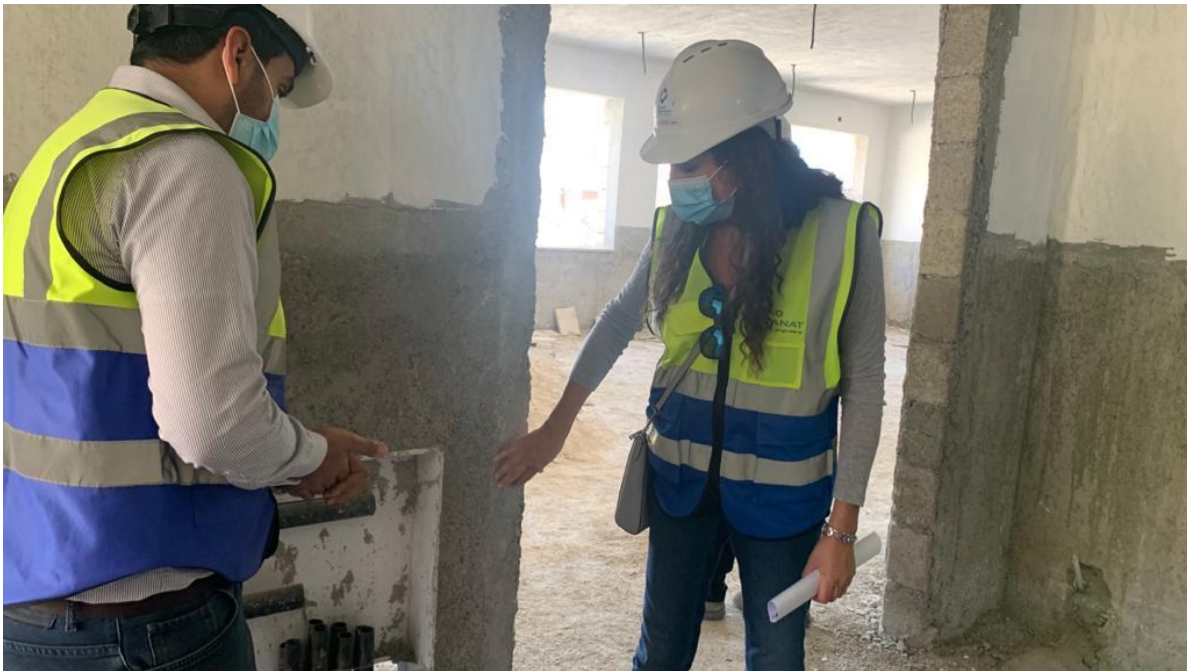
(Figure: 15 & 16)

The visiting team discussed with the Contractor's representative the installation of mechanical cabinets in relation to the wall tiles and the steel door frames. The Contractor agreed to the supervision request to raise the level of mechanical cabinets to avoid the small cut-off ceramic and pieces

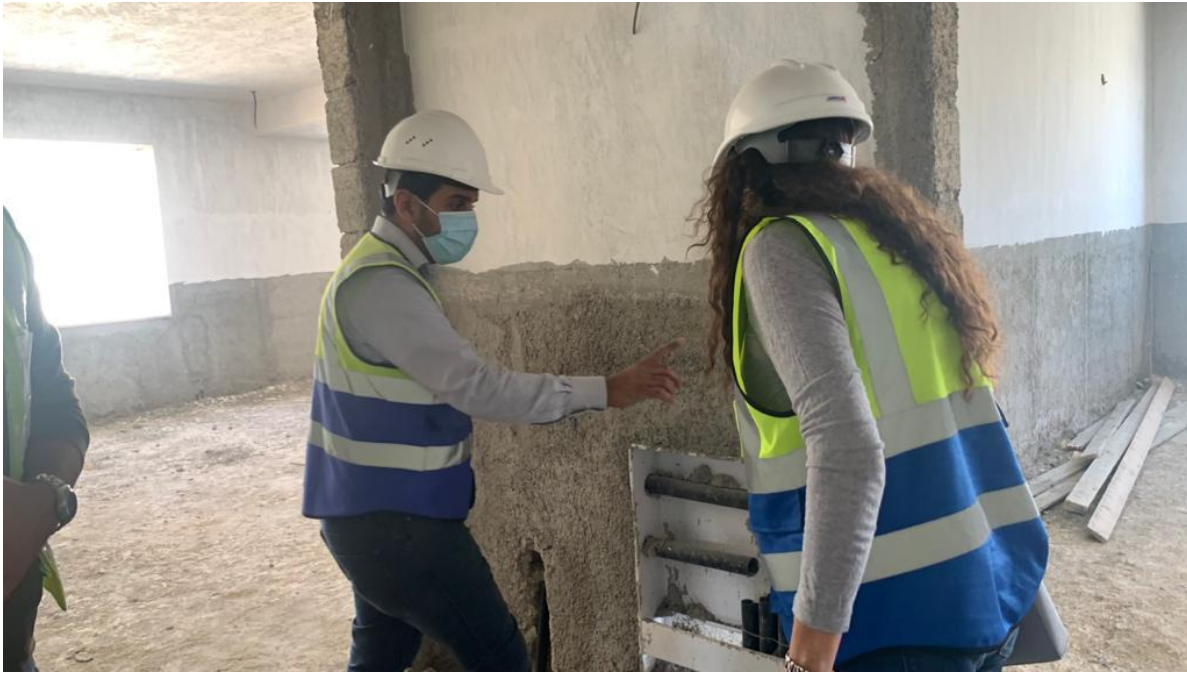
(Figure: 17)

The installation of mechanical cabinets was checked also at the corridors

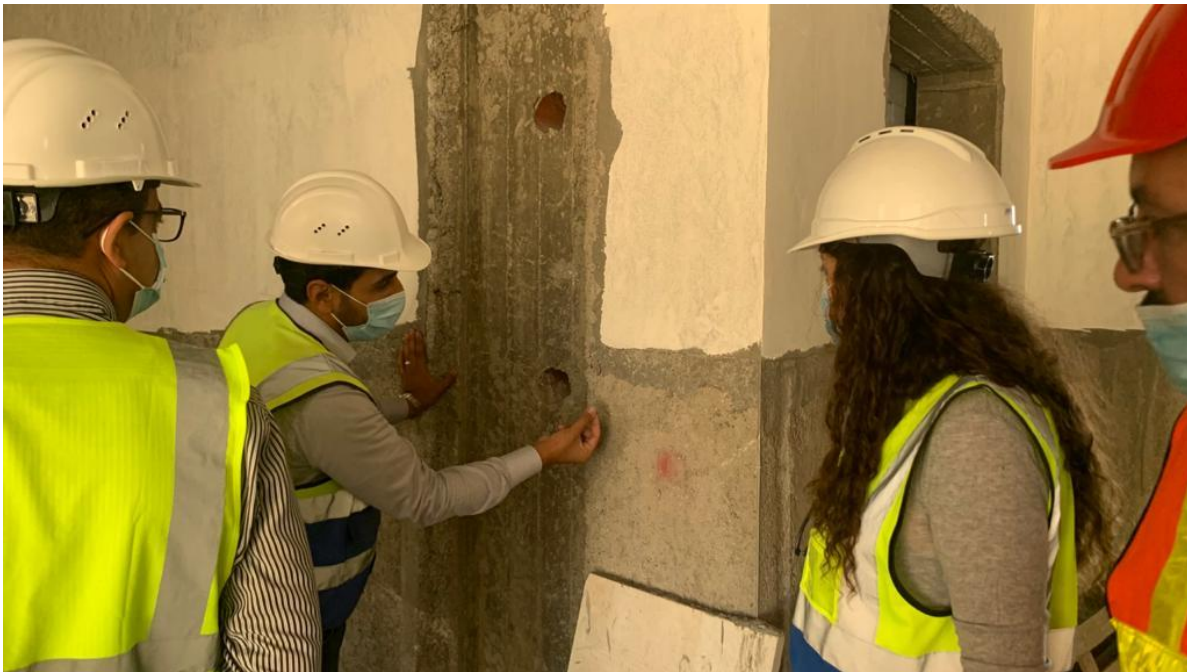
(Figure: 18)

The electrical engineers from the supervision and the Contractor discussed the location and the method of installation for the elevator control panel

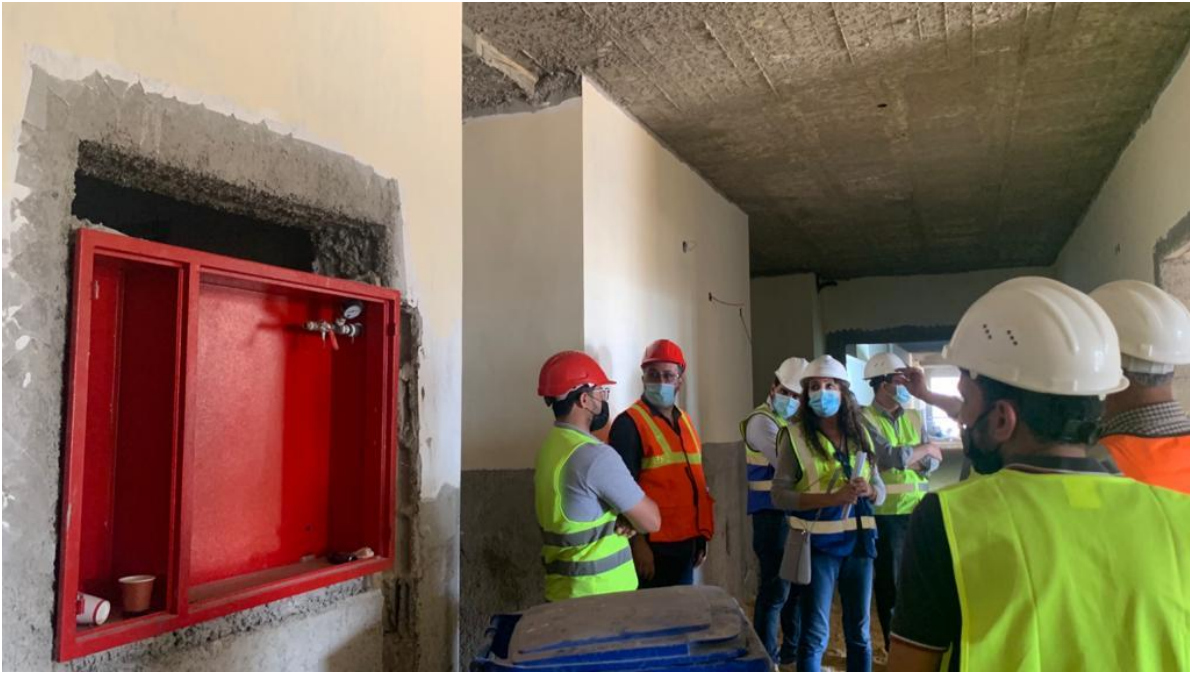
(Figure: 19)

The installation of the fire hose cabinets was discussed regarding the closing at the top of cabinets in a way not to exert concrete load on those cabinets

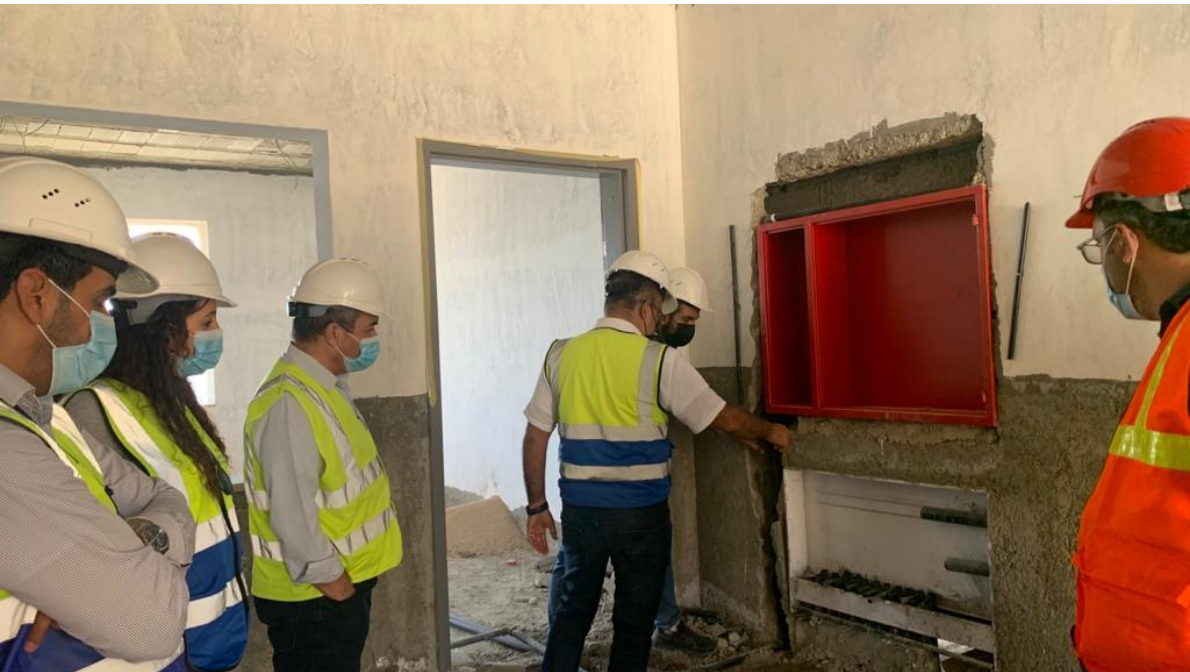
(Figure: 20)

The supervision requested the Contractor to rectify the defected mechanical cabinet

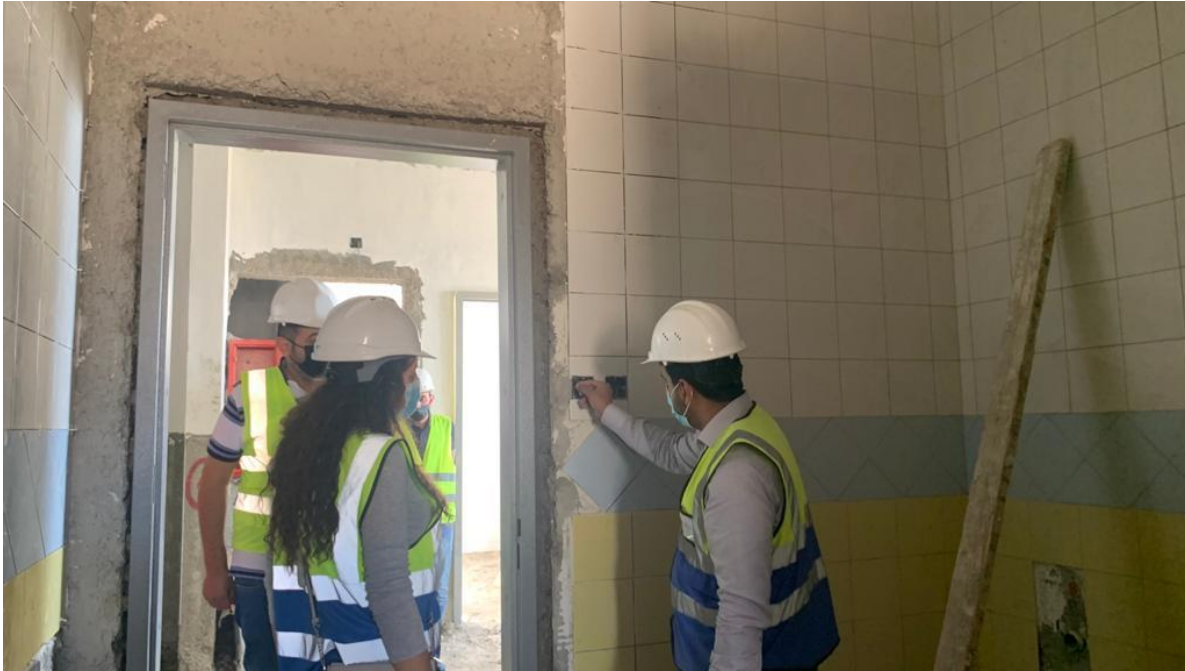
(Figure: 21)

The location of electrical sockets was discussed in relation to the wall tiles

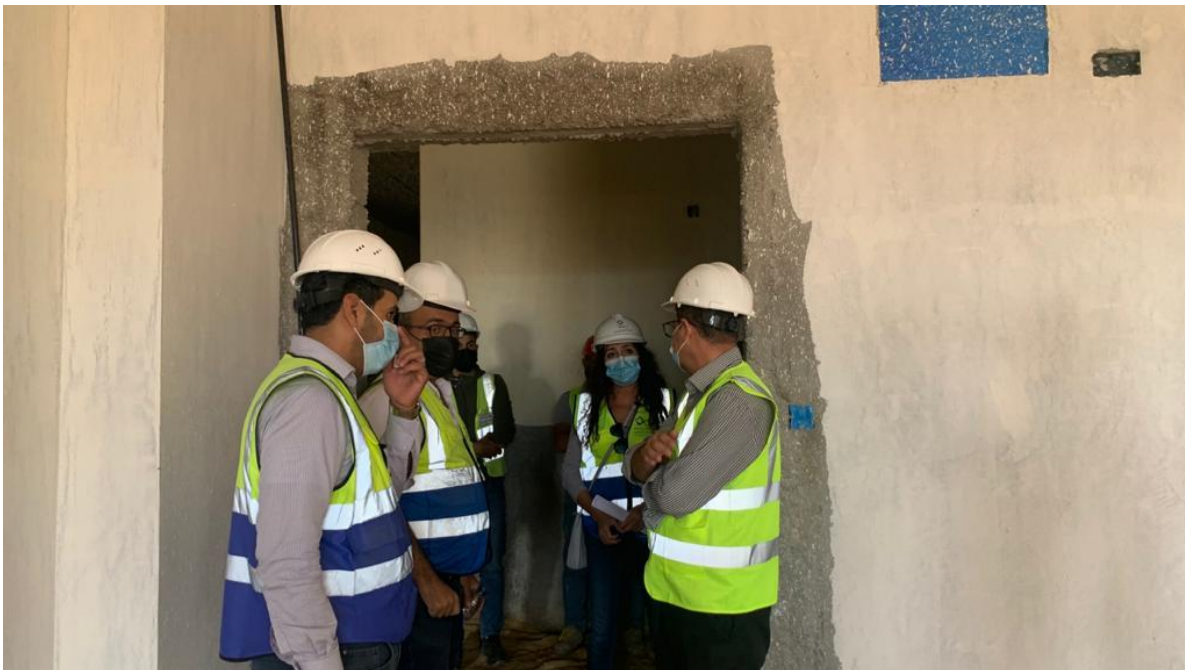
(Figure: 22)

The visiting team observed the delay in delivering the remaining steel door frames

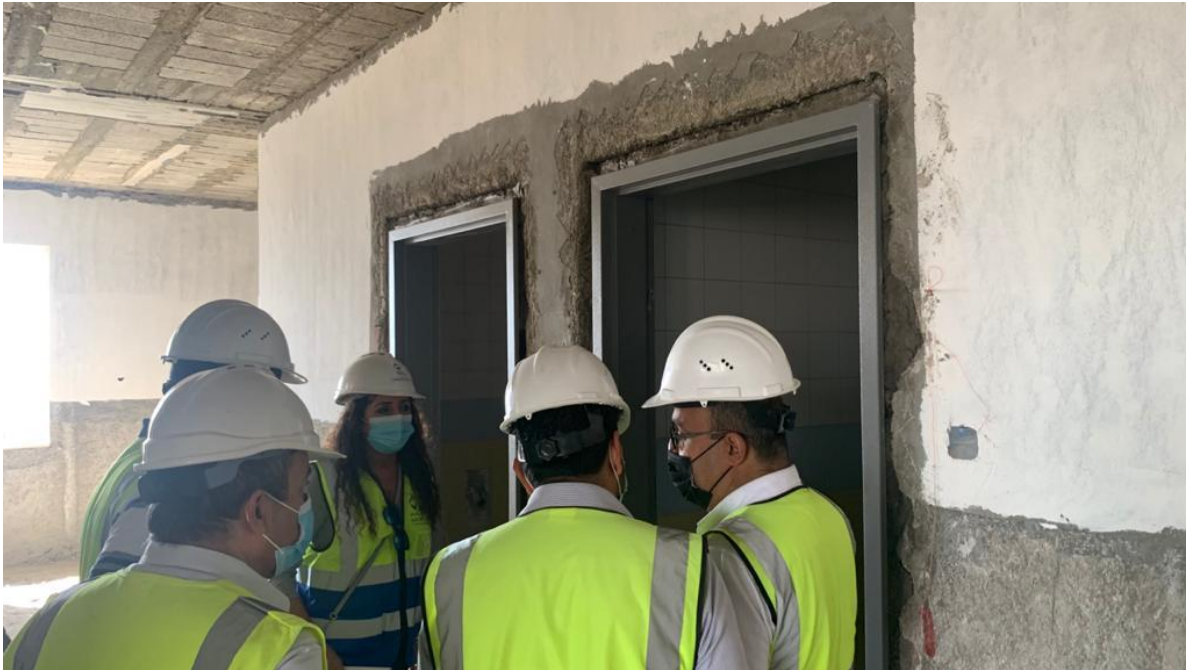
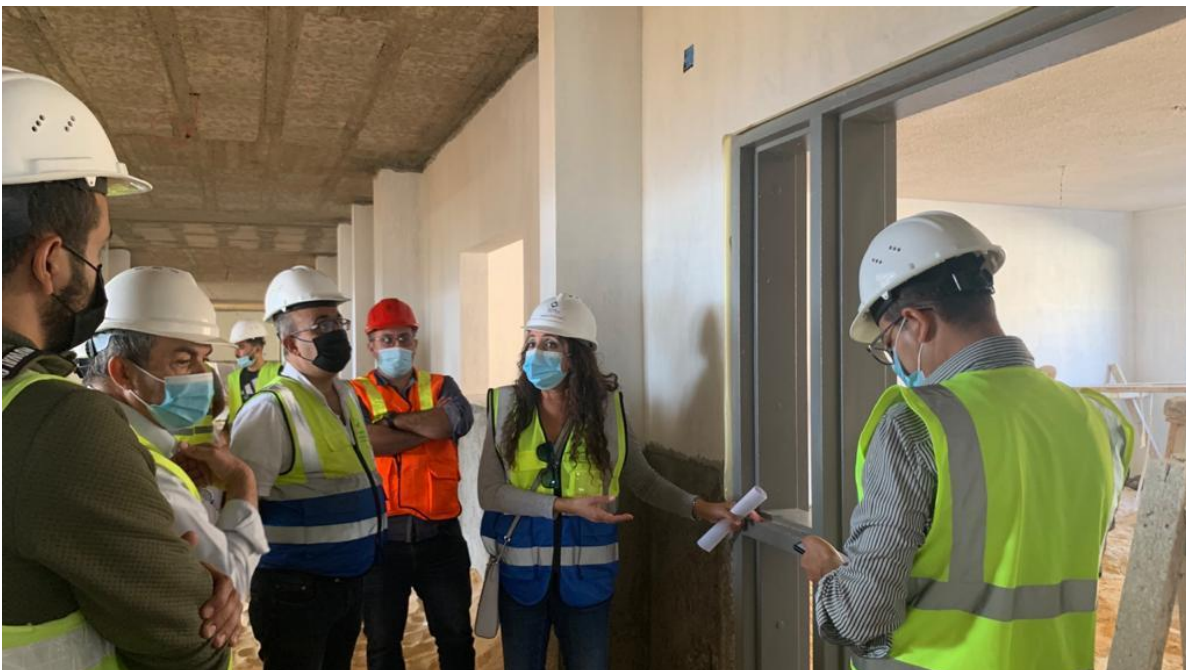
(Figure: 23 & 24)

The installed steel door frames were checked and the Contractor was requested to protect those frames from any defects during the construction work

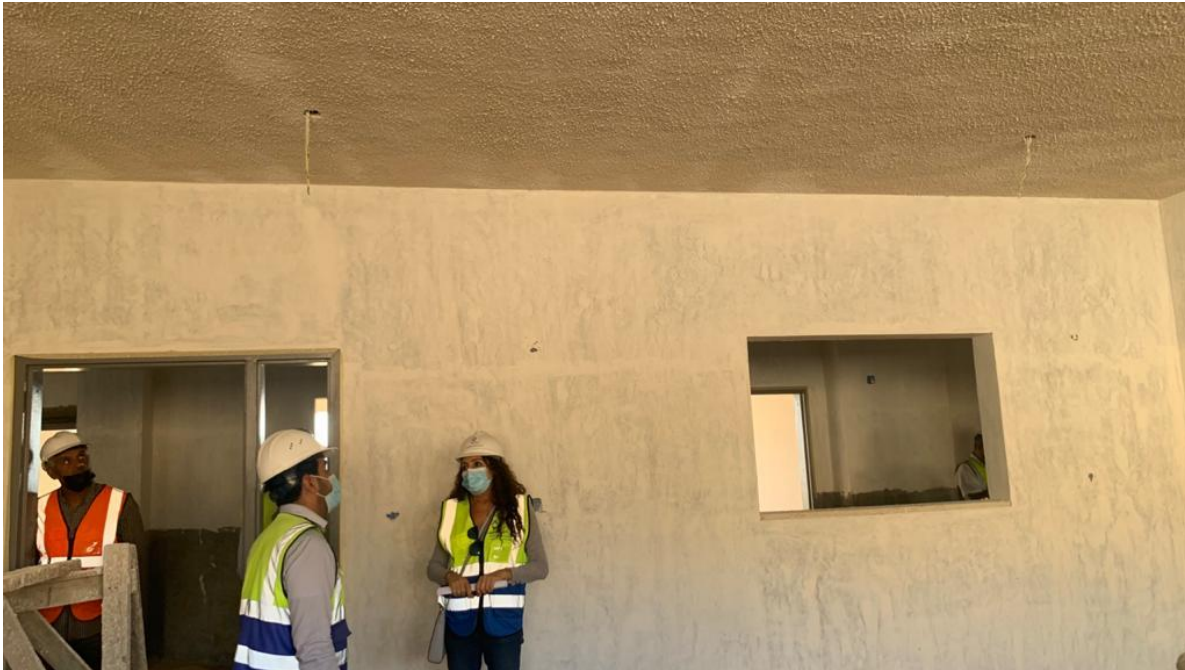
(Figure: 25)

The acoustical plastering for ceilings were checked and general remarks were given to the Contractor
