SKEP III Home Office Support Site Visit Report

Consultant	Wahib Medanat Consultant Engineer	Rep No.	23-07092021
Contractor	Dijlah Establishment Constr. Contracting	Tender No.	(11/2019/USAID/SKEP/3/S) Schools for a Knowledge Economy Project (SKEP) - Phase (3) Package (1, 2)
Site Name	Jumana Bint Abit Taleb Basic Mixed School - Jerash	Day/ Date	Tue. 07/09/2021
Duration of Project	450 Calendar Days	Total Project Budget	8,314,983.735 JD

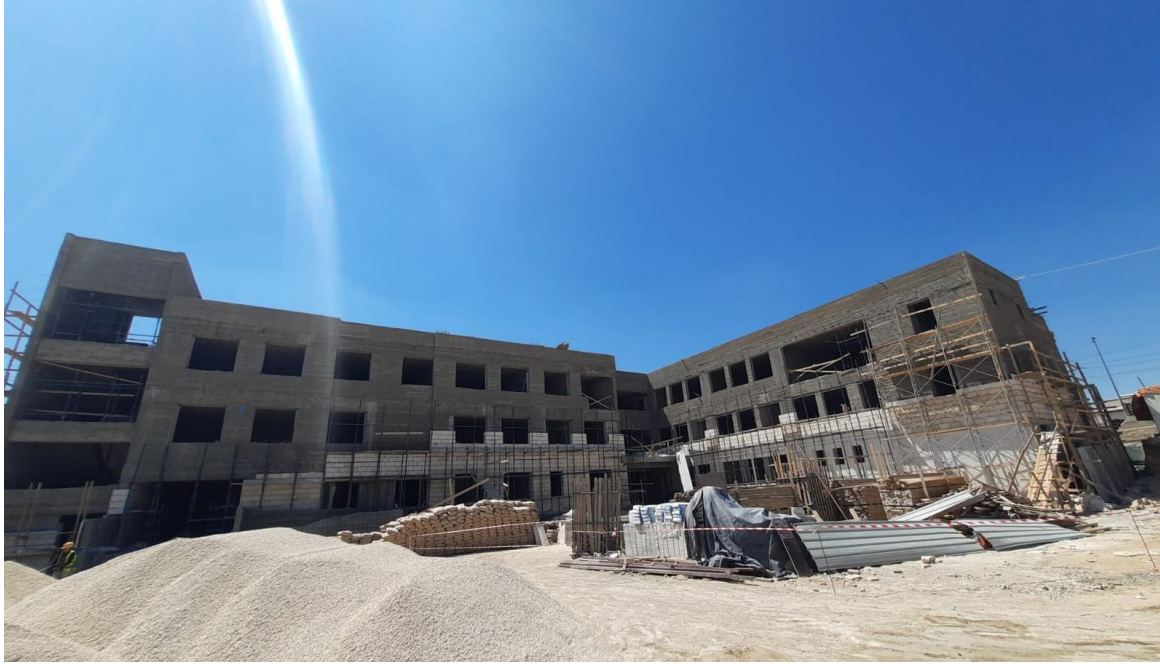
(Figure: 01)

General view of the completed roof floor casting (the last slab)

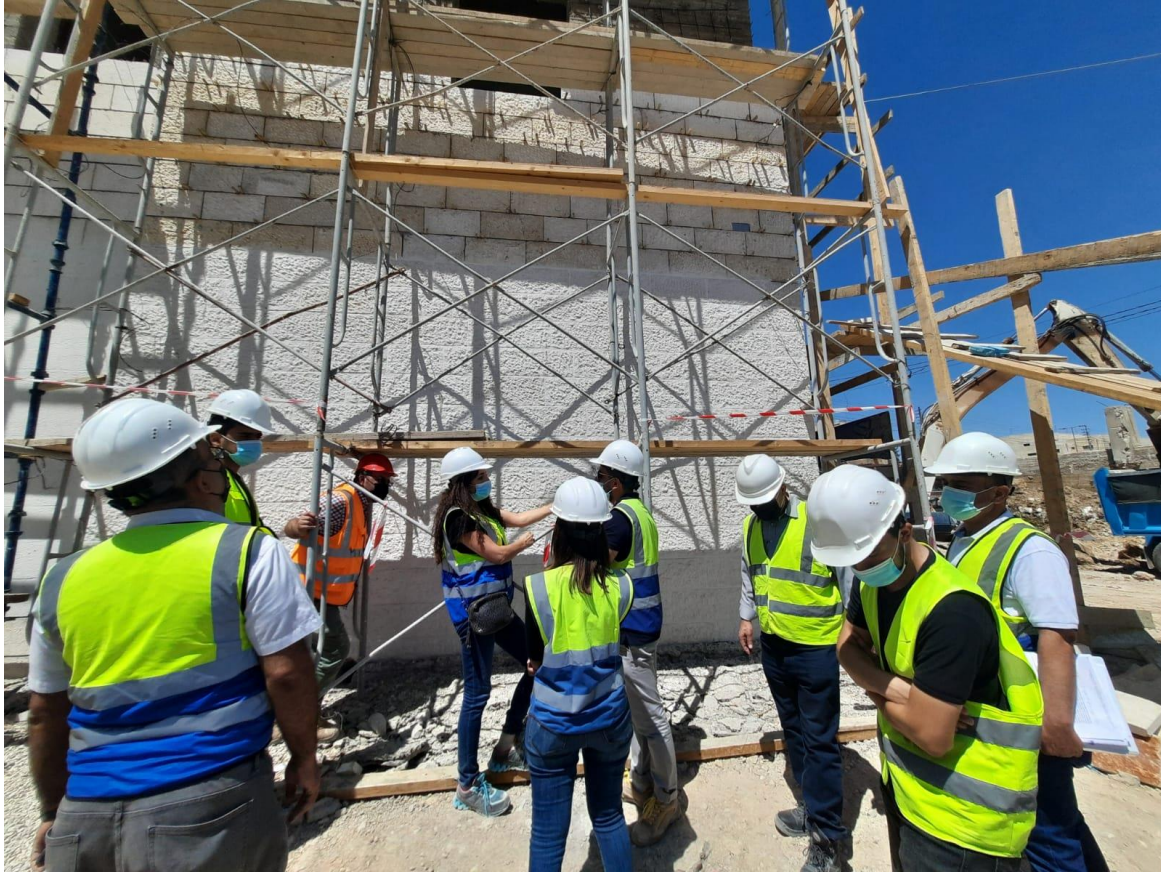
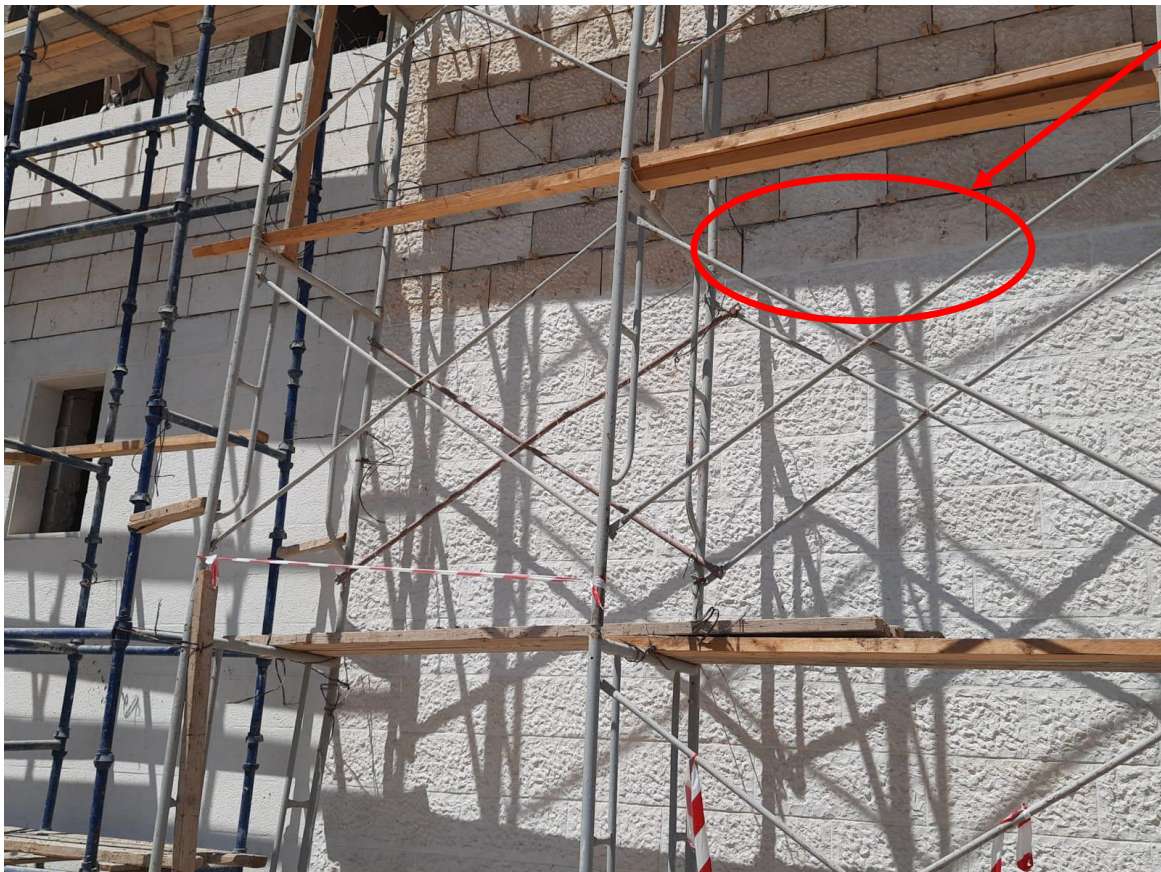
(Figure: 03)

the Contractor applied a painting material on the mock-up façade built with stones which is against specifications and changes the stone nature

Engineer representative rejected the work

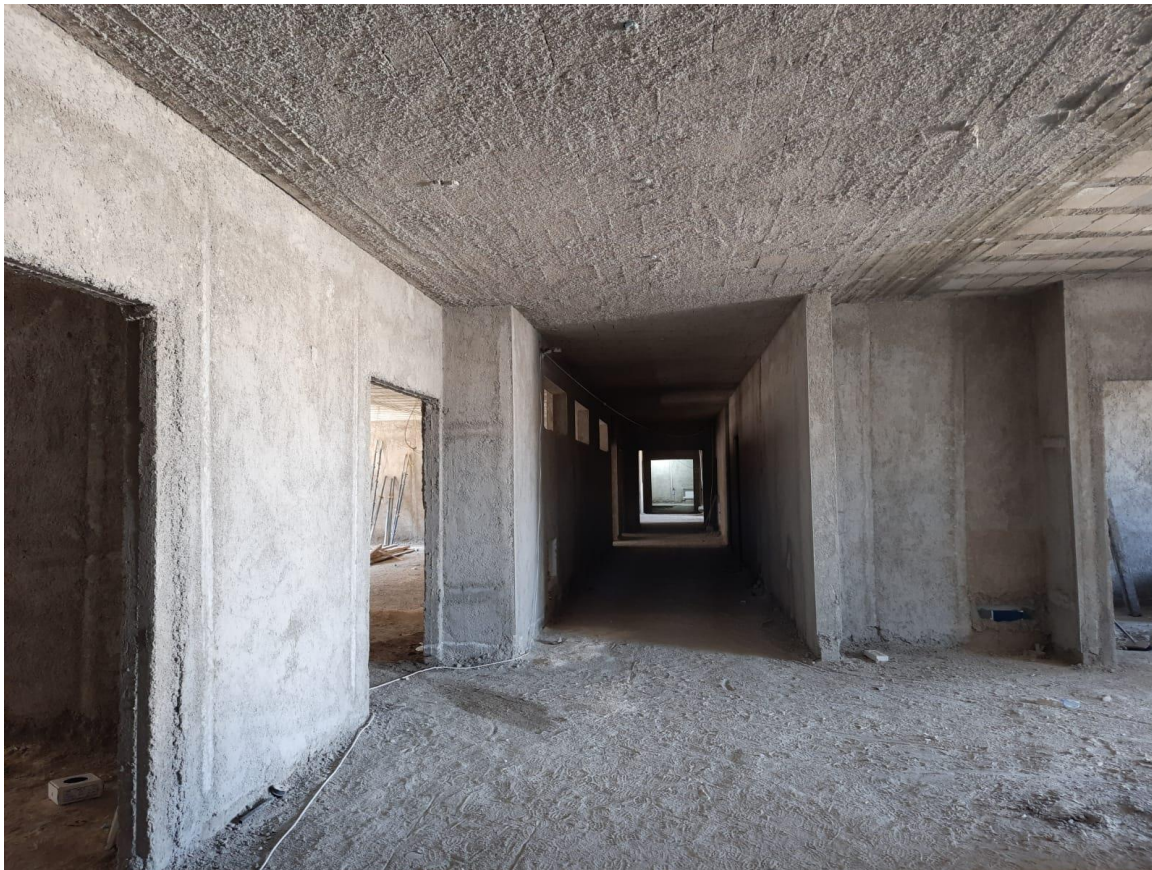
(Figure: 05)

General view showing the plastering work

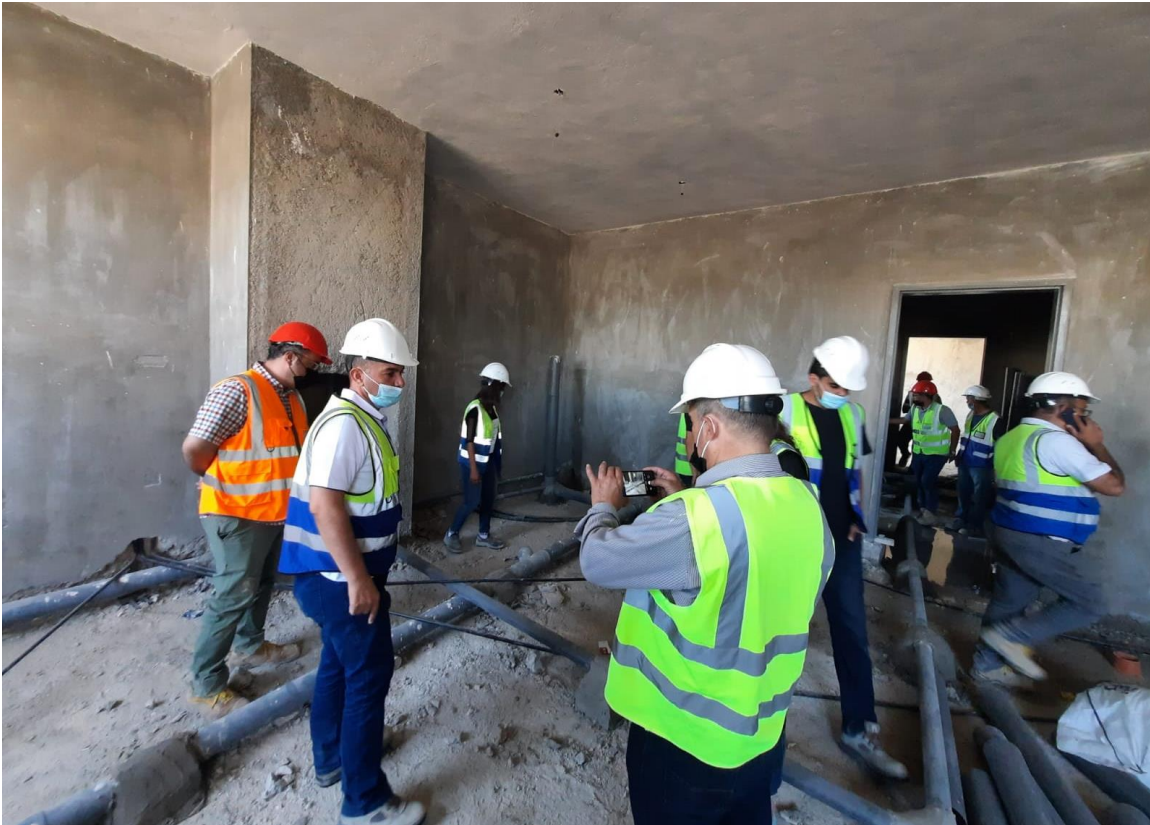
(Figure: 06)

The Contractor was requested to check the executed MEP first fix at wet area to avoid contradiction with the fixed finished floor level

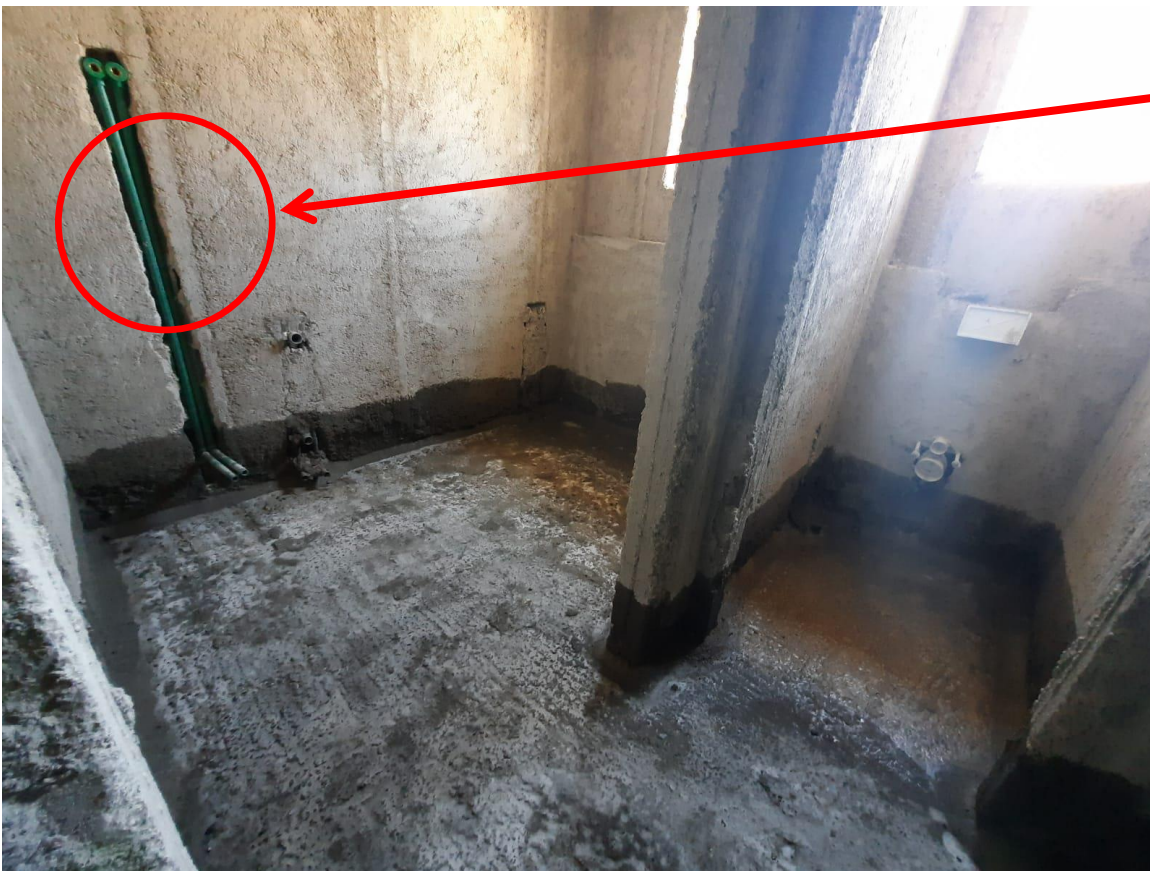
(Figure: 07)

Medanat team observed that the Contractor installed cold water and hot water polypropylene pipes in the wet areas jointly.

The Contractor finished first layer of cementitious waterproof

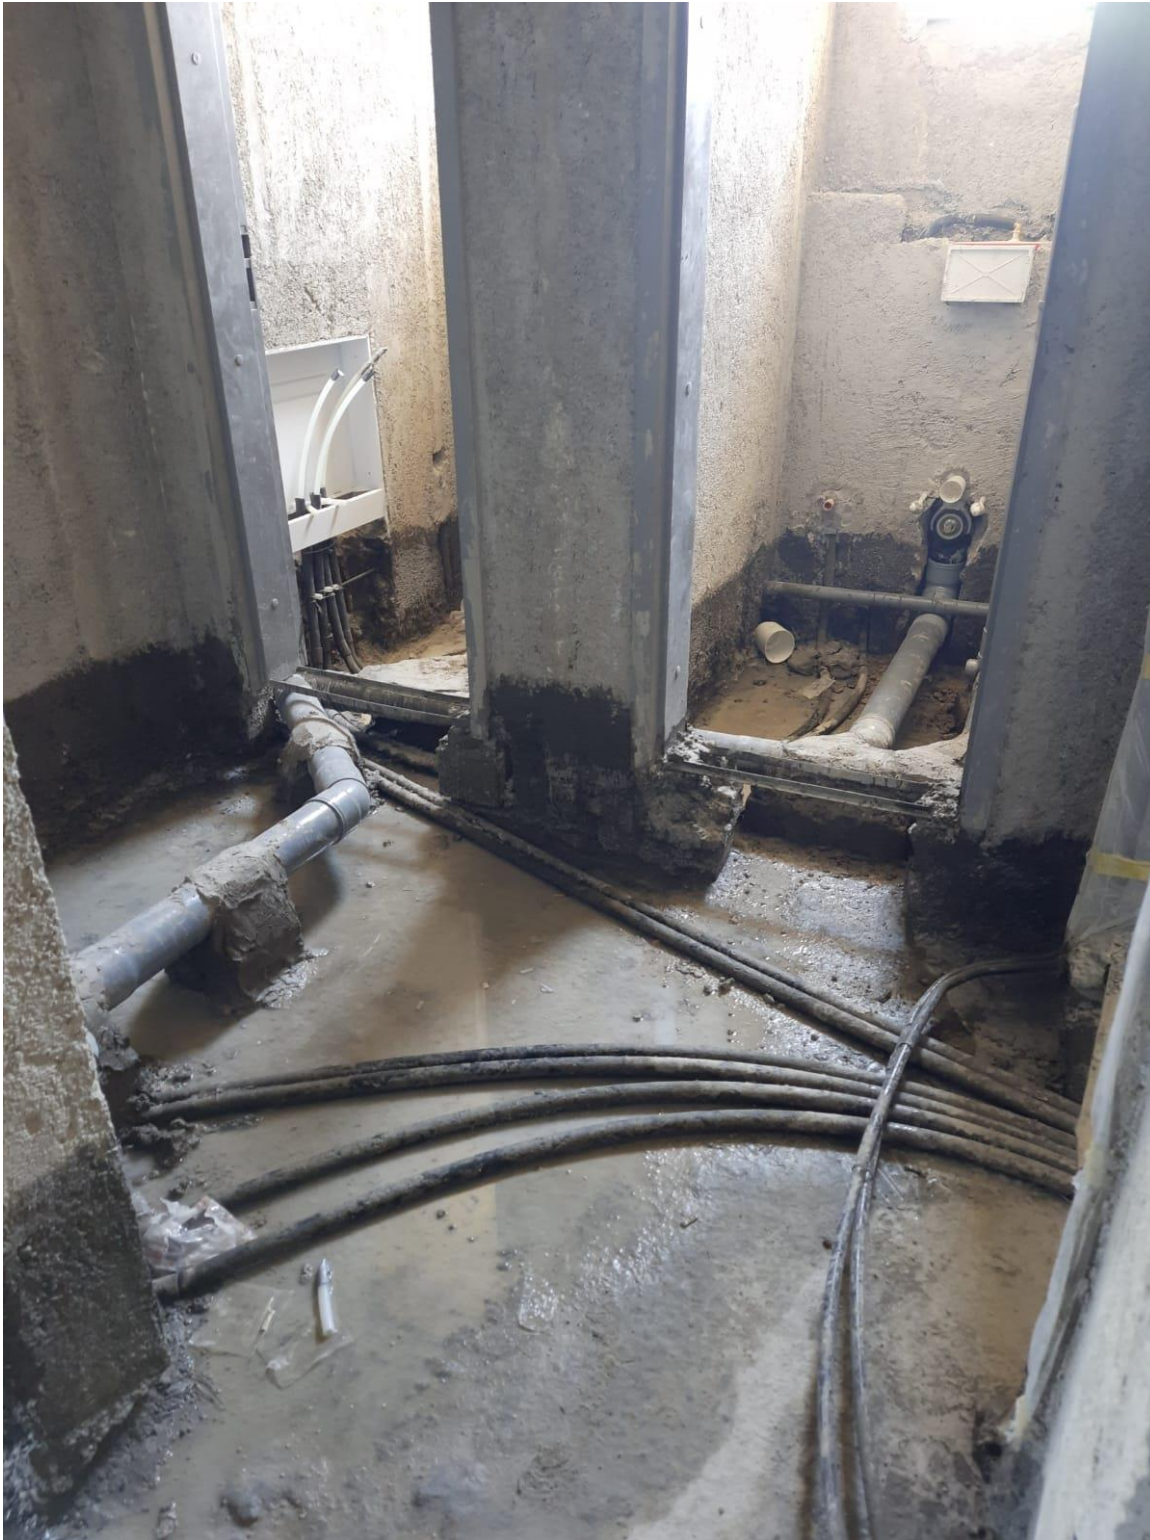
(Figure: 08)

The concrete encasement below the drainage pipes and over the PEX pips should be larger in order to strengthen the network and to avoid defects by labors before executing the tiling work.

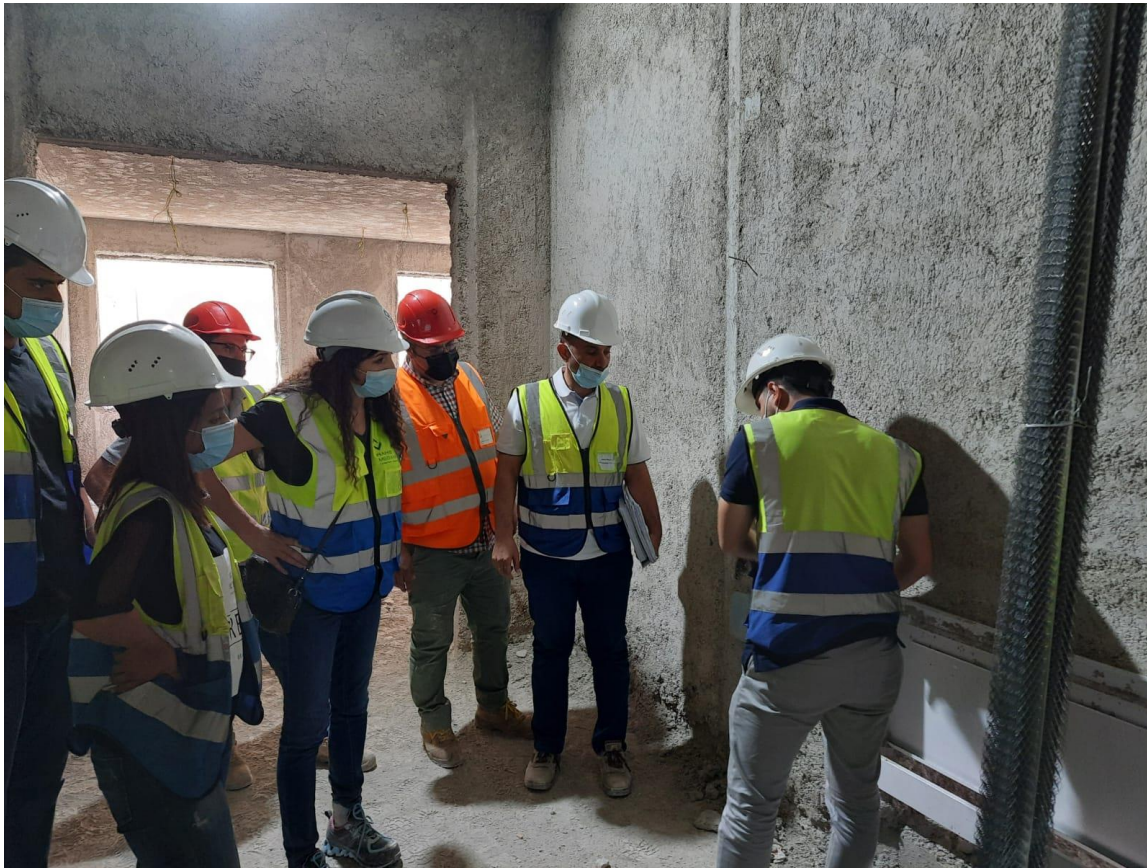
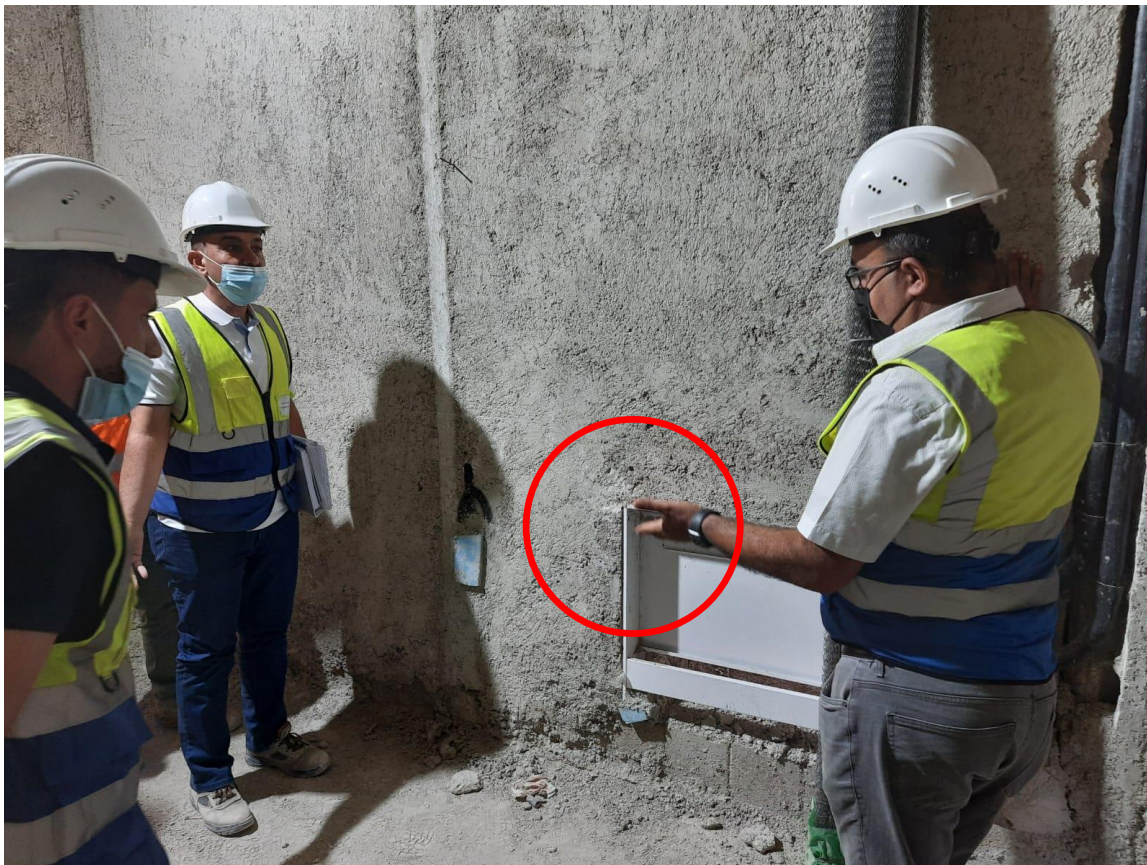
(Figure: 09)

It was observed that the mechanical cabinets in the corridors were installed irregular with the plastering layer. It was stressed that the cabinets should be rectified to match with the plastering face

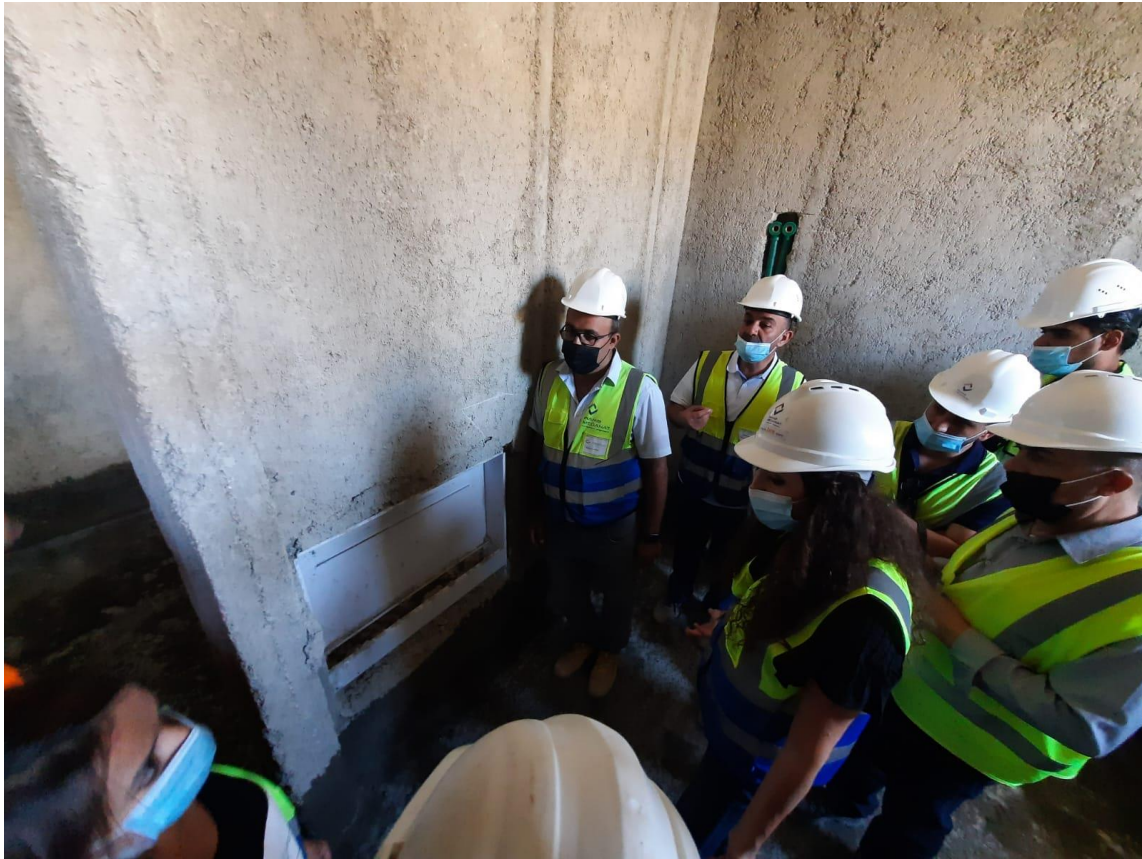
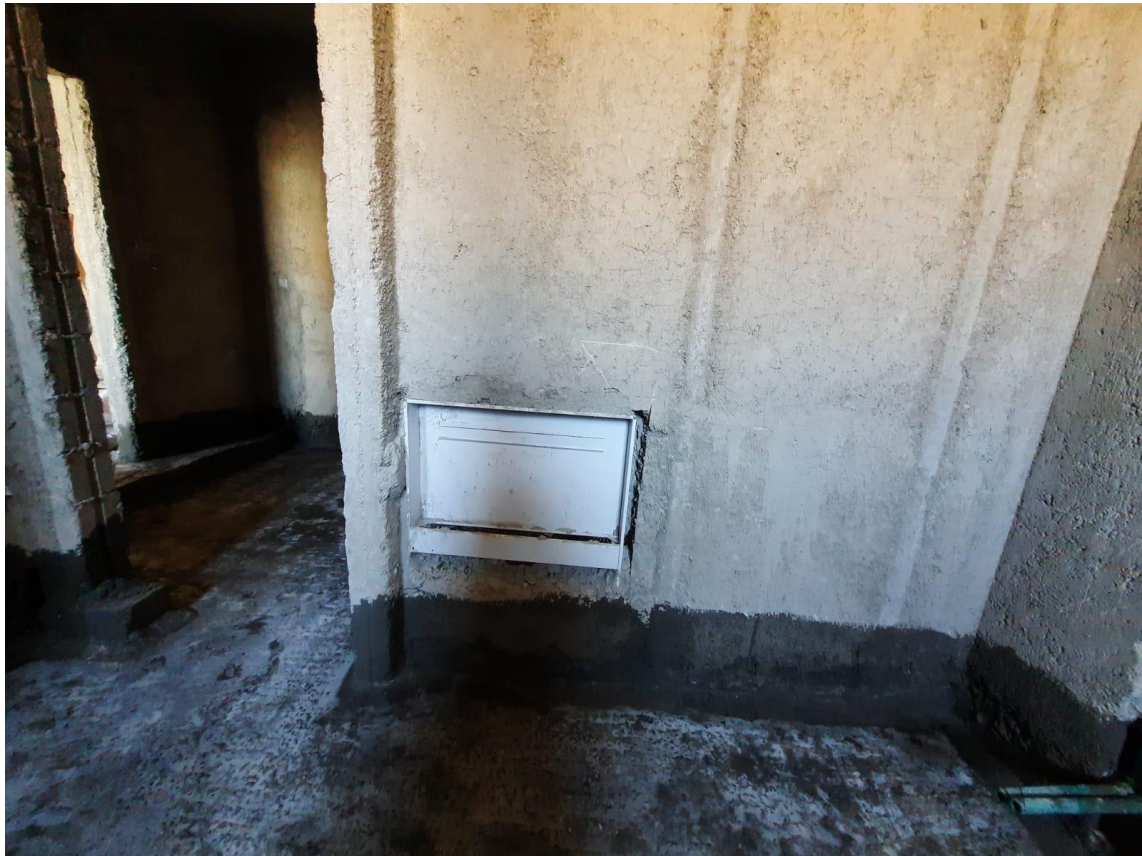
(Figure: 11)

Medanat team observed that one mechanical cabinet was installed in the wet area direct at the corner adjacent to door jamb. The cabinet should be removed inside by at least 20cm to allow for wall tile fixation and easy opening as stated on the approved workshop drawings.

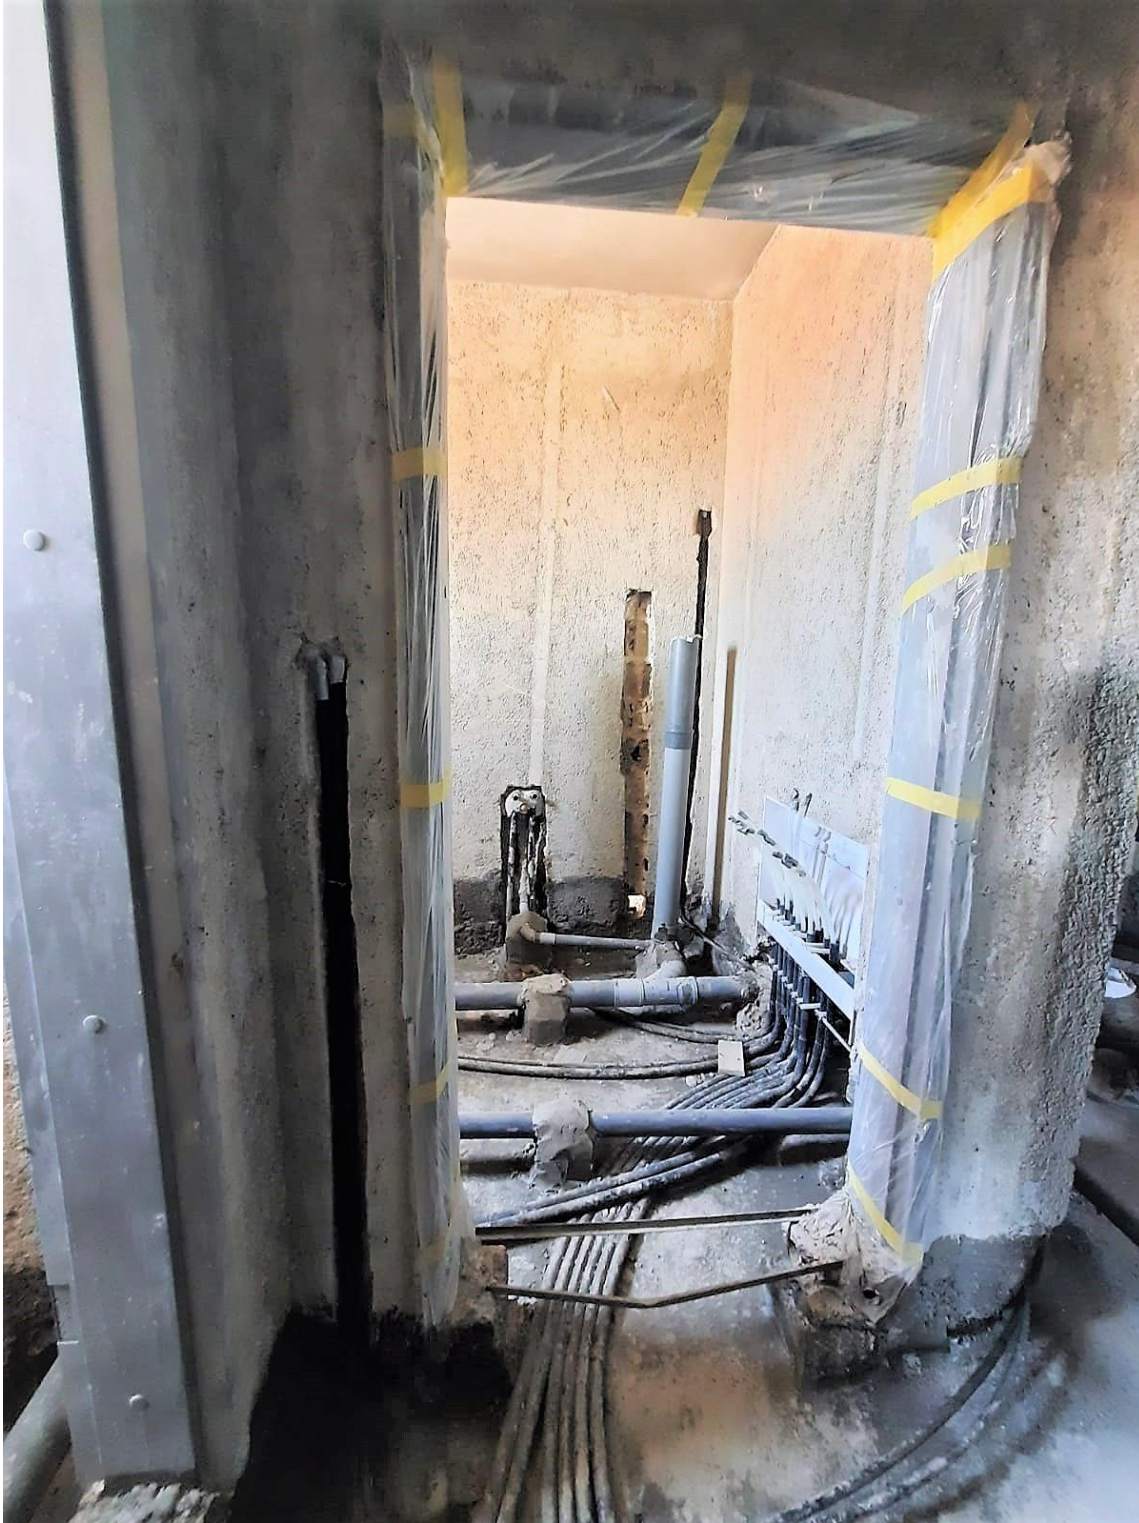
(Figure: 13)

Medanat team observed that the Contractor has installed the door frames in the mock-up room

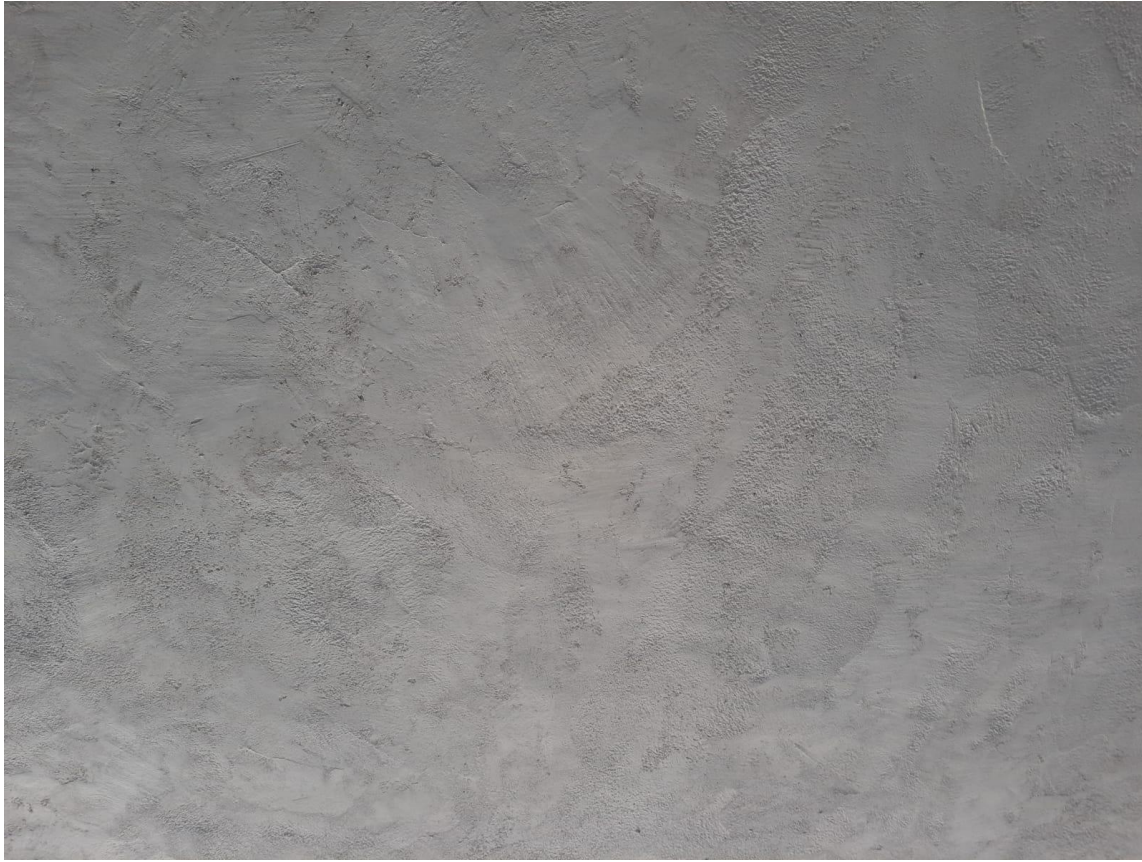
(Figure: 14)

Medanat team observed voids in the acoustical plastering layer done for one ceiling. The Contractor was requested to rectify

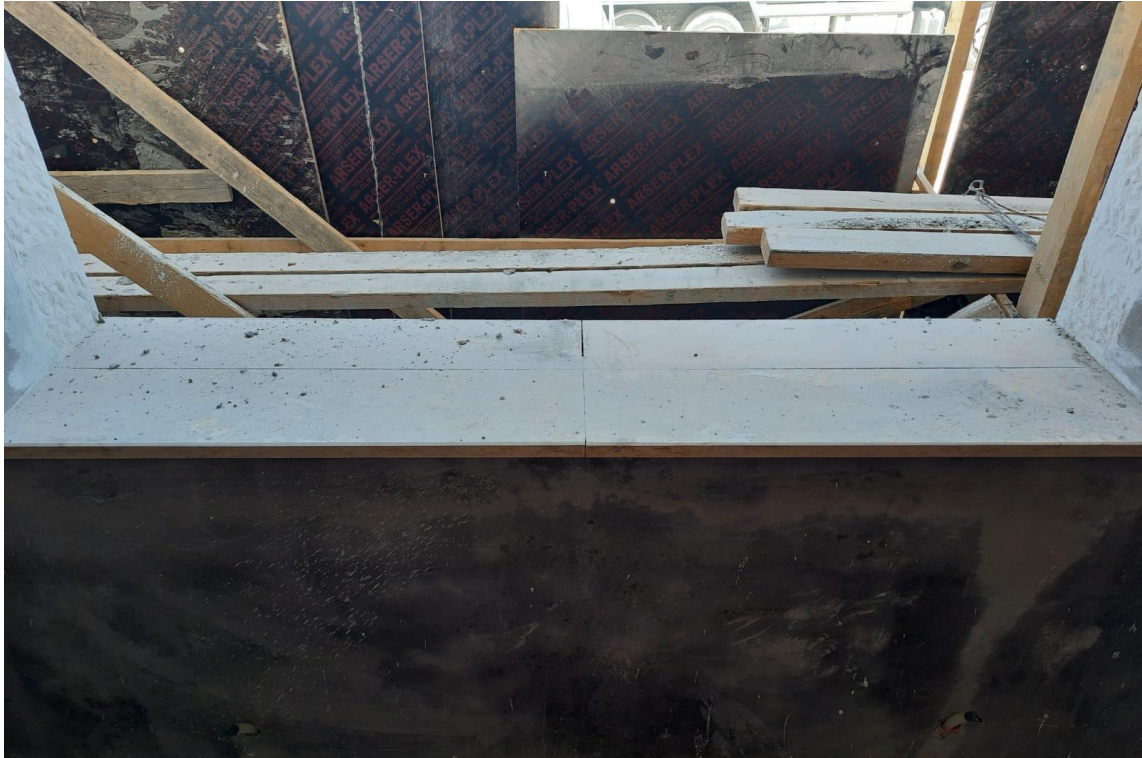
(Figure: 16)

Medanat team observed that the Contractor has delivered and installed window sills in the mock-up room and remarks were given on the minimum and maximum dimensions

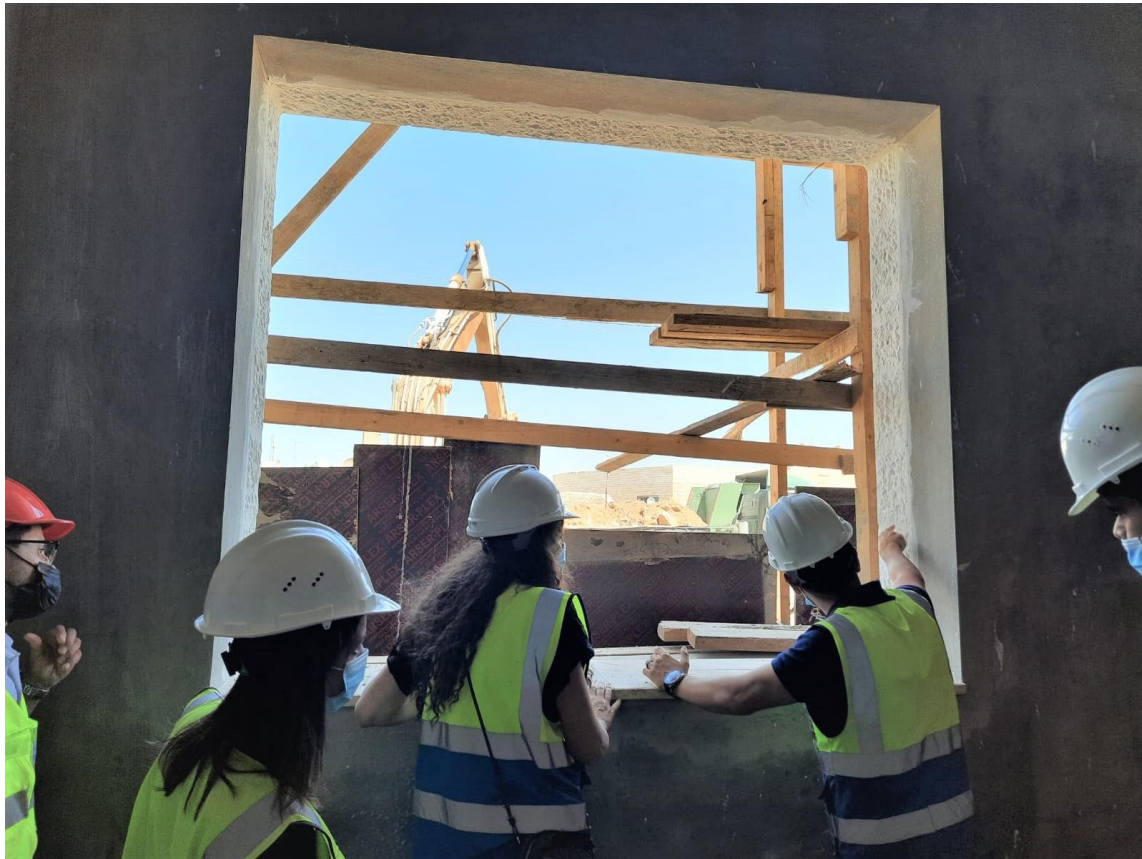
(Figure: 17)

The erection of stone for the window frame at the top and for the two sides were discussed

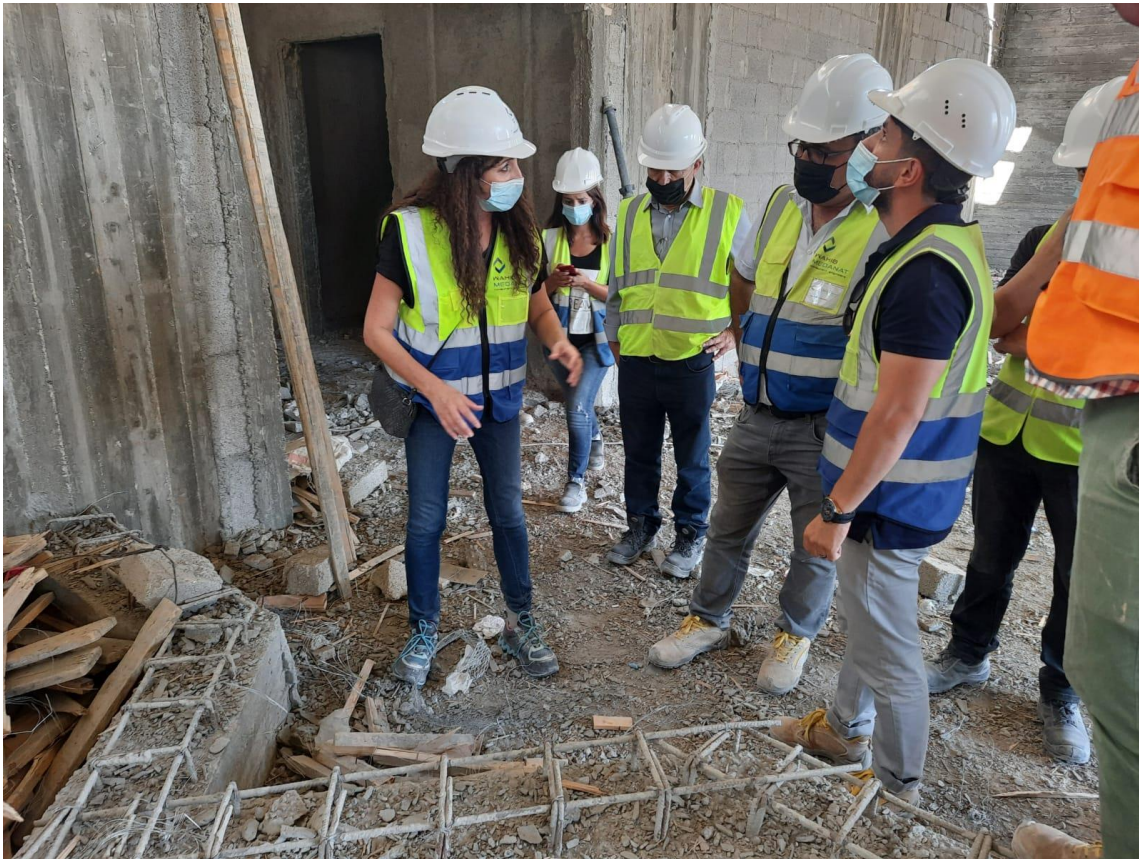
(Figure: 18)

The execution stairs at the theater was discussed

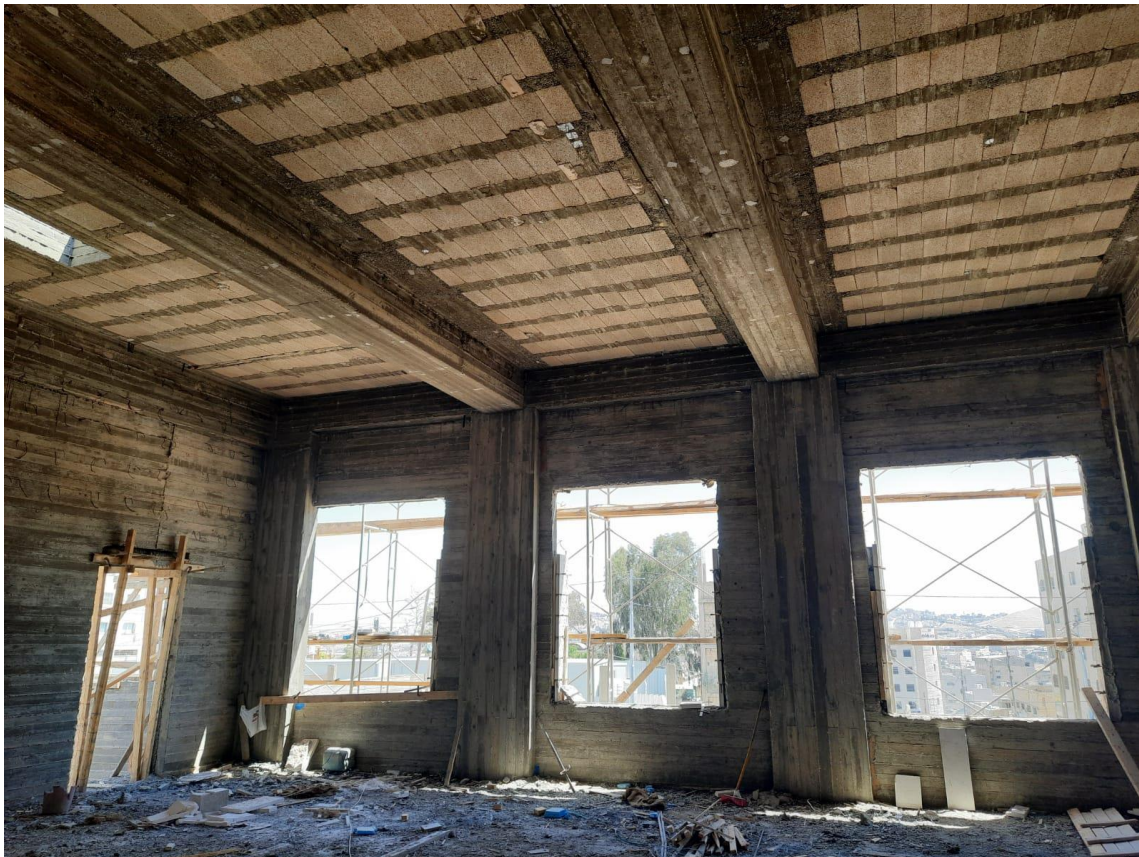
(Figure: 20)

It was observed that the Contractor is striking the formwork of the multipurpose hall (theater) roof
