Quality Control Report

Consultant **Wahib Medanat** Consultant Engineers
Site Name **Hay Al Iskan Basic mixed - Jerash**
Package **Package 2**
Contractor **Dijlah Est. Construction Co.**
Tender No. **10/2019/USAID/SKEP/3/2**

Rep No. **QC-21 14**
Date **15 / 11 / 2021**

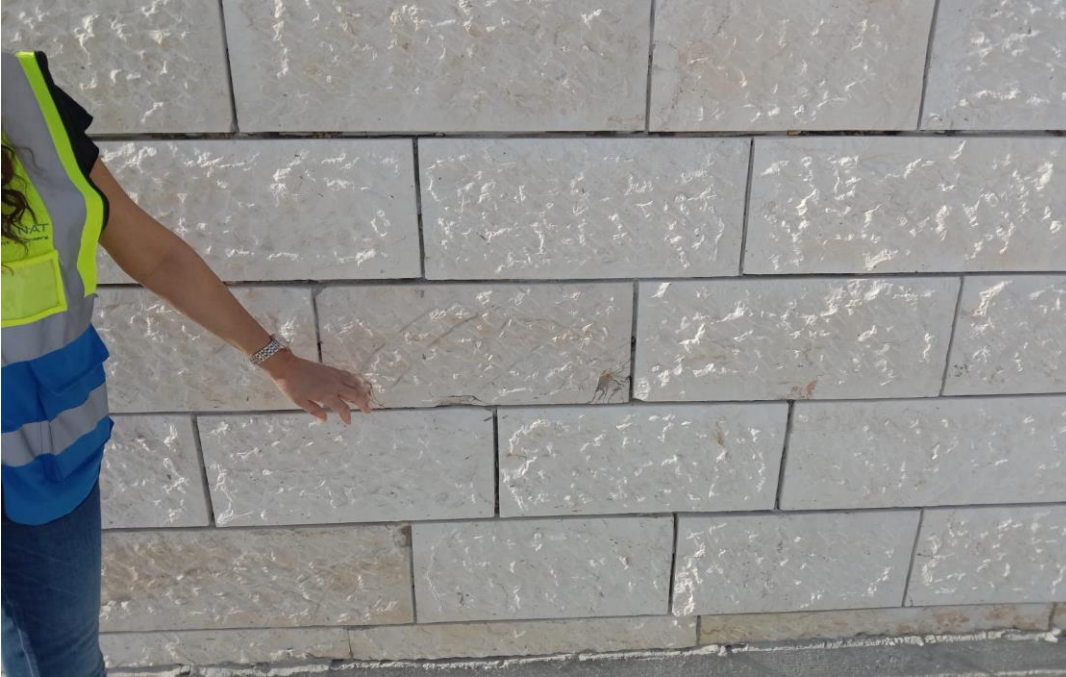
Defected built stones

Description of Non Conformance	Corrective Action	Required by / When
1. Defected built stones. 2. Sills having wrong dimensions.	1. Replace. 2. Replace.	The Contractor/Immediately
Report Prepared by	Hassan Shaqbua, Supervision Quality Control Manager	
Contractor's Response	The Contractor has not responded yet to the two above mentioned defects.	
Notes	It was observed that the Contractor rectified the tiled ceramic elevation in accordance to previous instructions.

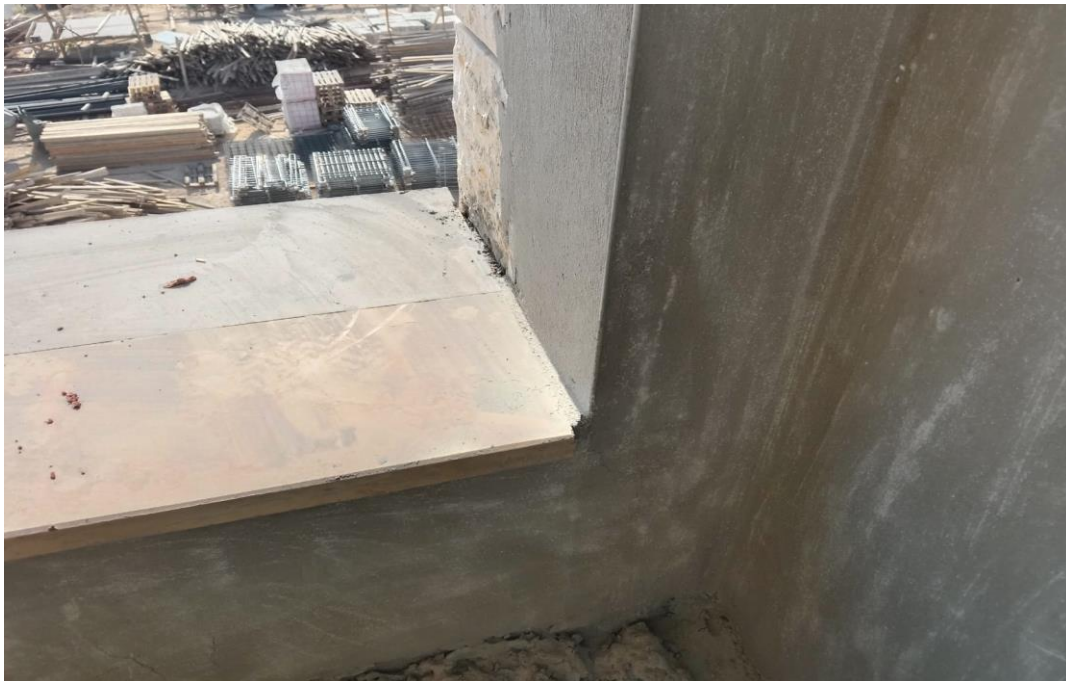
Sills having wrong dimensions

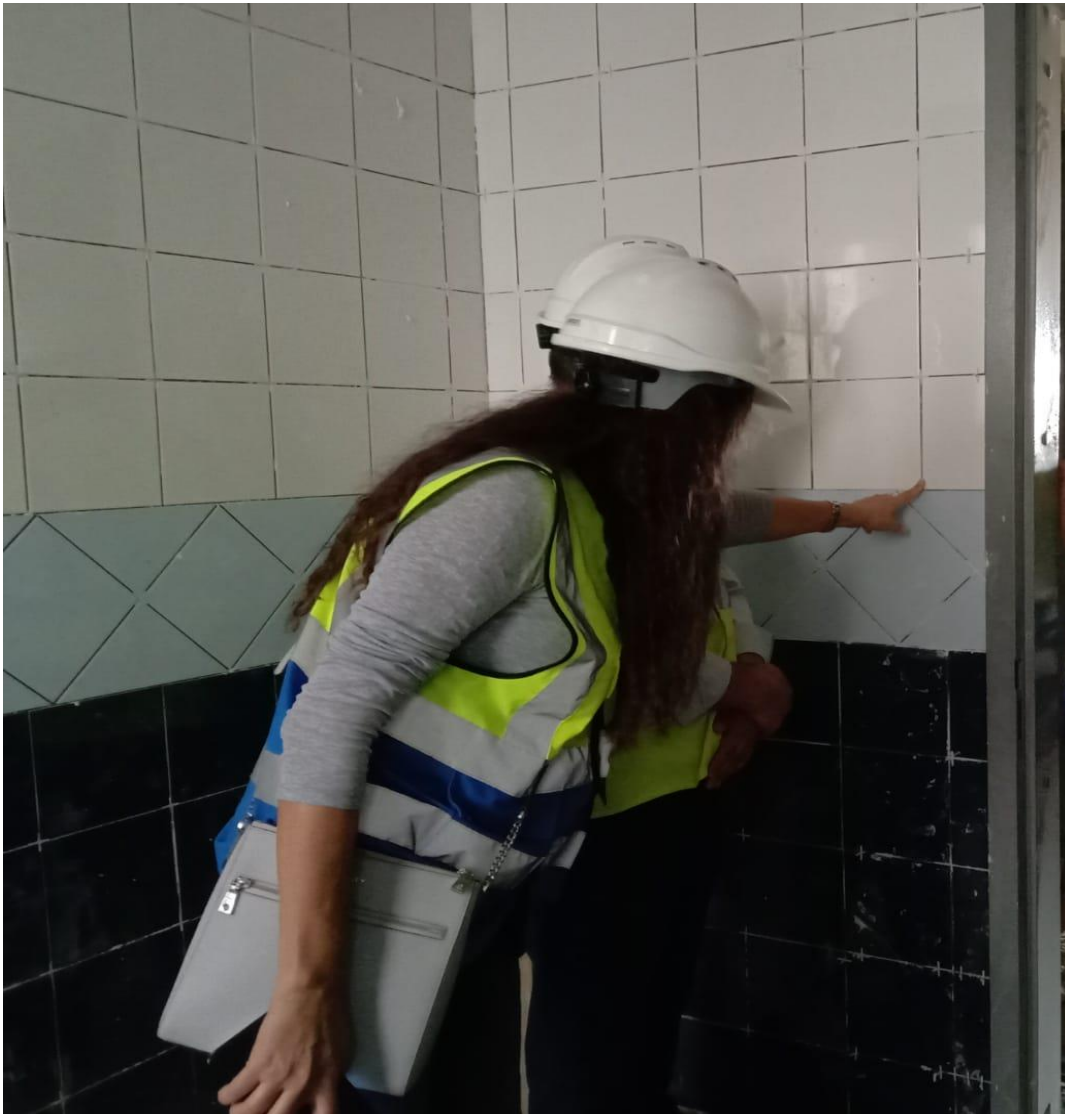
Not coordinated tiled cut-off pieces

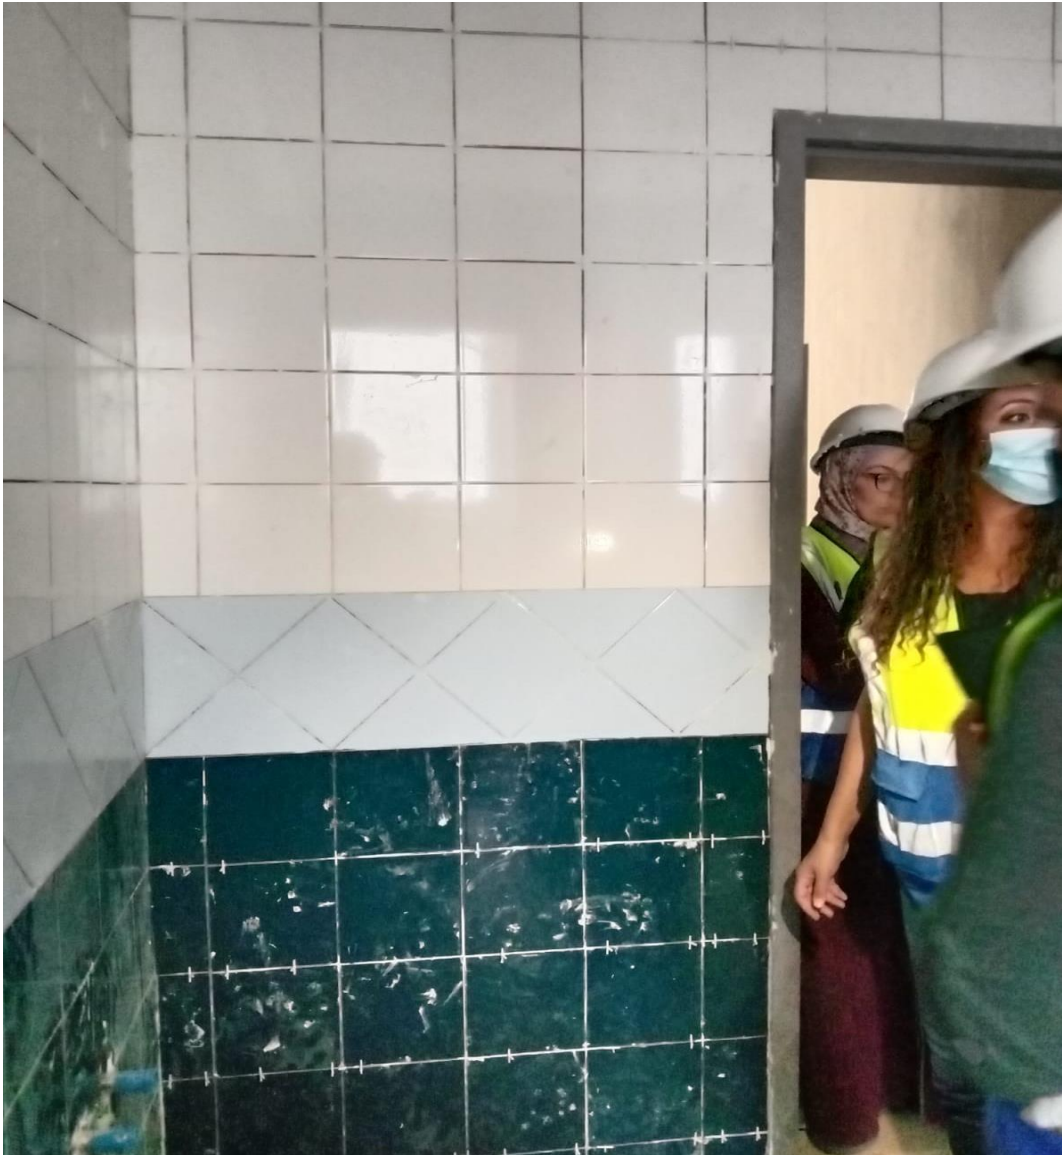
Coordinated tiled cut-off pieces
