SKEP III Home Office Support Site Visit Report

**WAHIB
MEDANAT**
consultant engineers

Consultant	Wahib Medanat Consultant Engineer	Rep No.	13-17102021
Contractor	Derar Saraireh & Sons for Engineering & Contracting	Tender No.	(11/2019/USAID/SKEP/3/S) Schools for a Knowledge Economy Project (SKEP) - Phase (3) Package (1, 2)
Site Name	Khadija Bint Khwailed Basic Mixed School- Shouna Janoubia	Day/ Date	Sun. 17/10/2021
Duration of Project	450 Calendar Days	Total Project Budget	9,789,417.840 JD

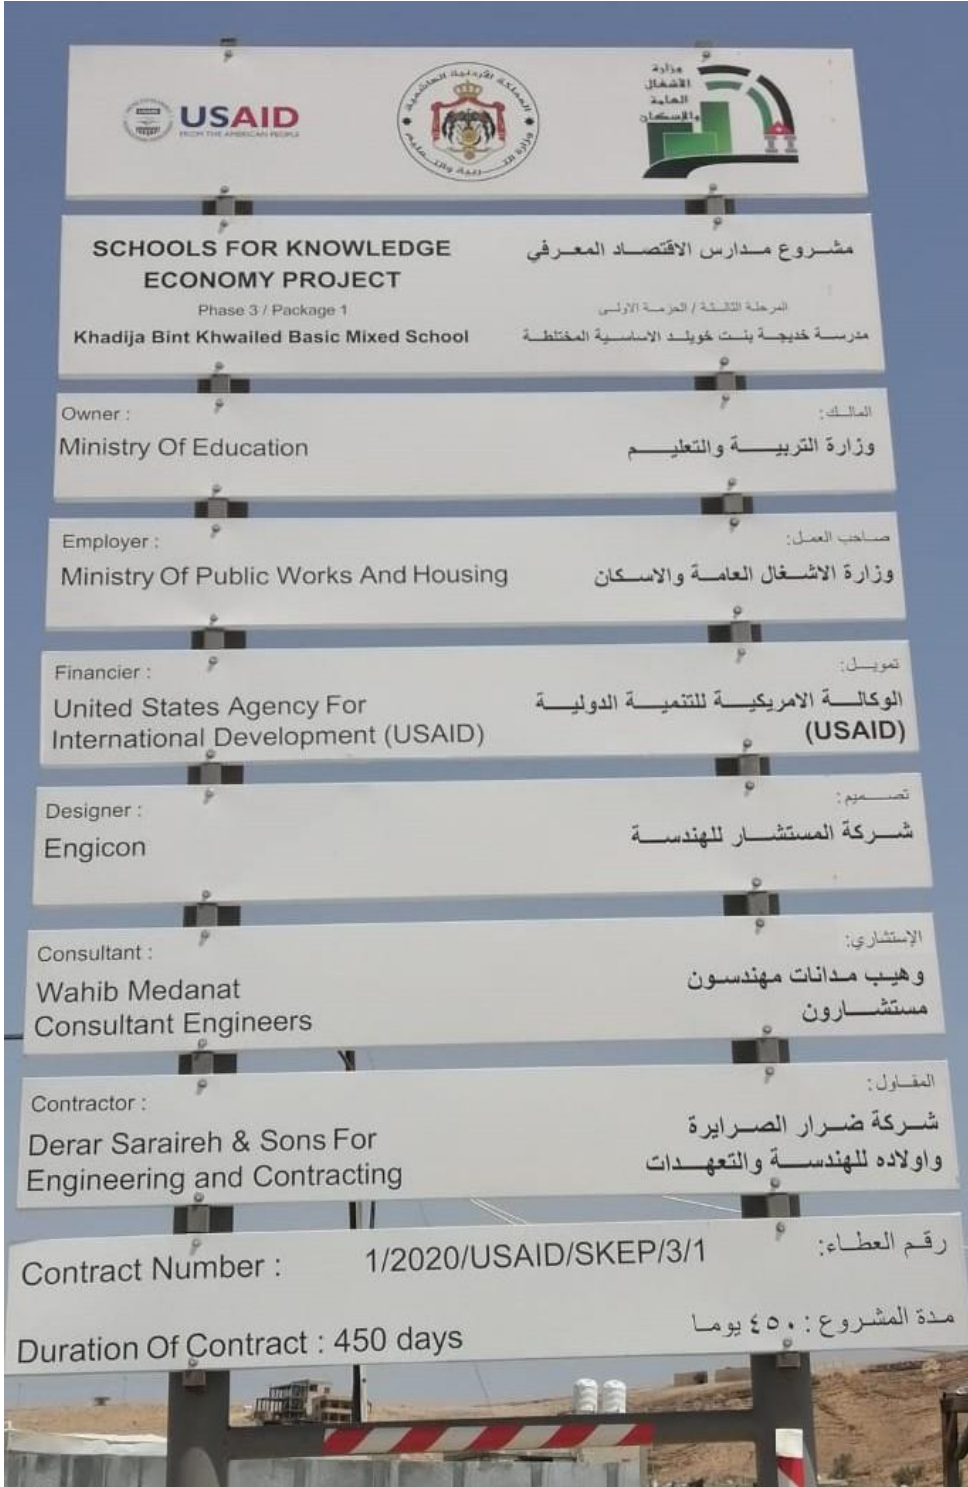
Project ID
Sign on Site

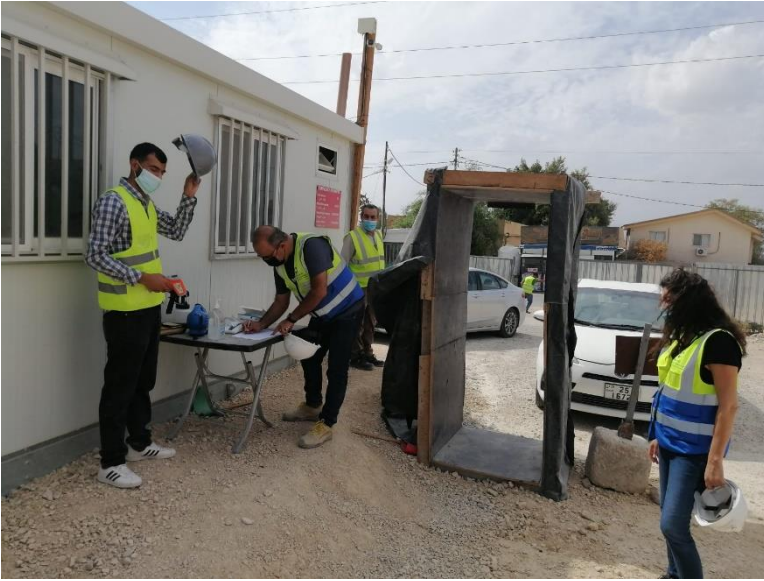
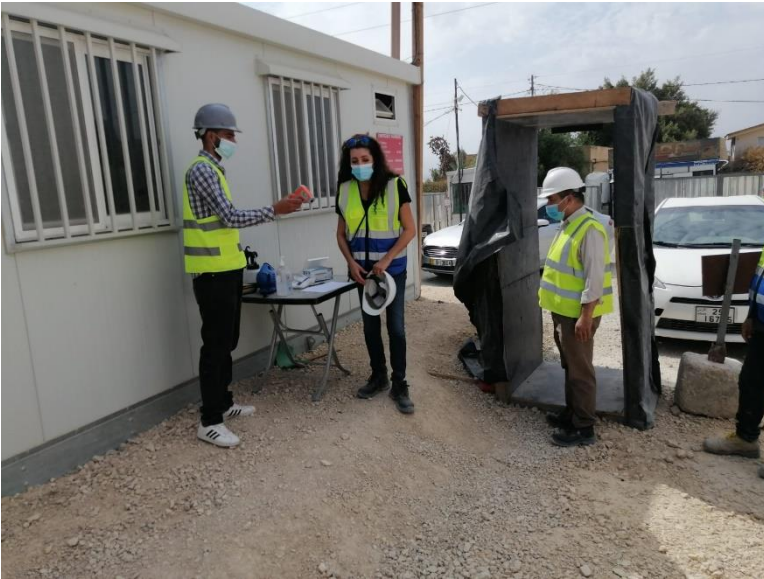
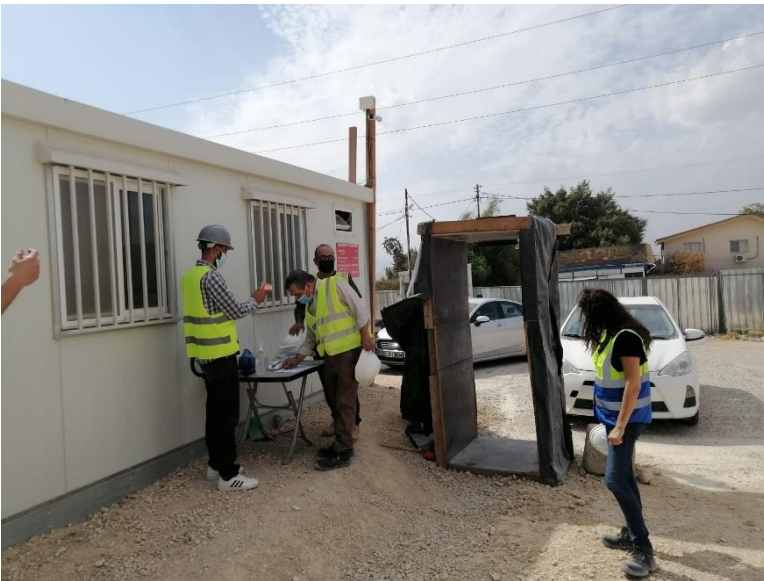
Temperature check, sterilization and signing visitors' attendance sheet at the entrance of the site, complying with Covid-19 Protocol

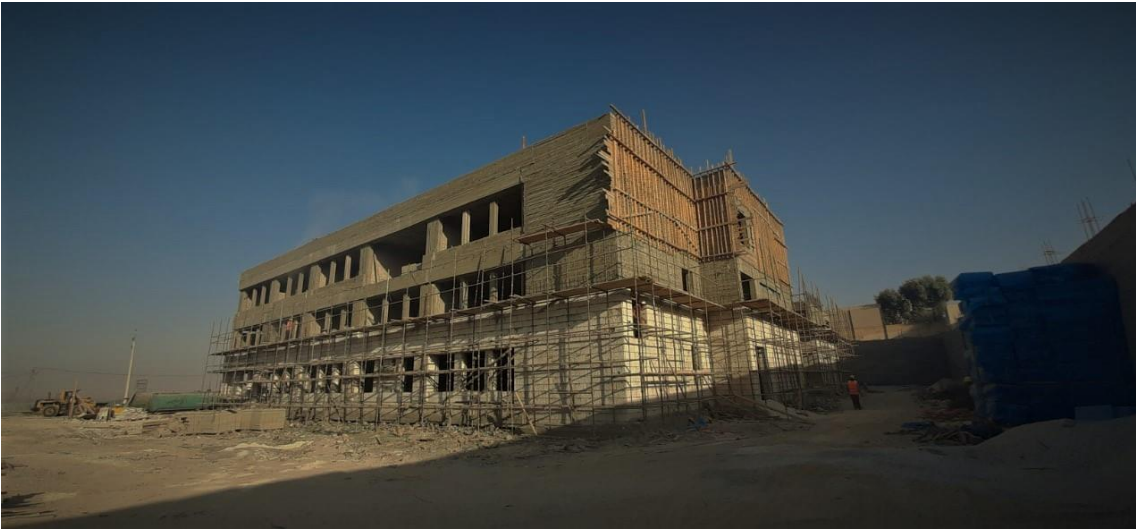
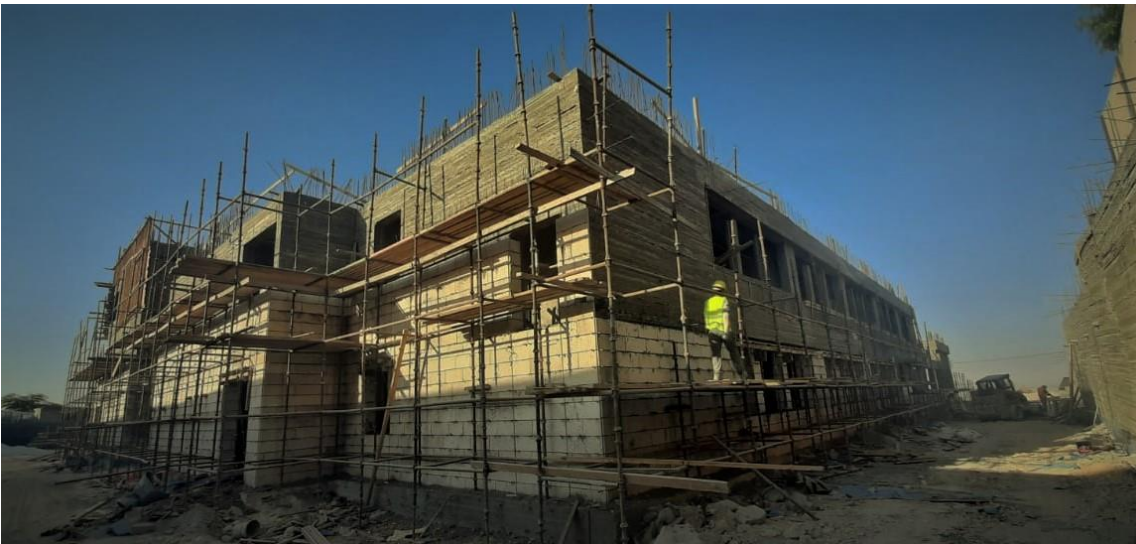
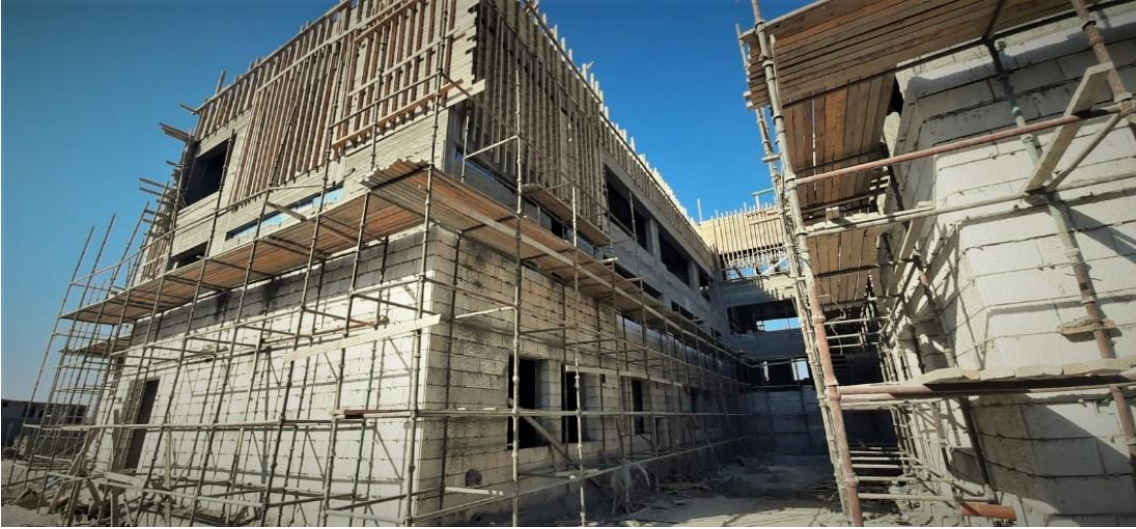
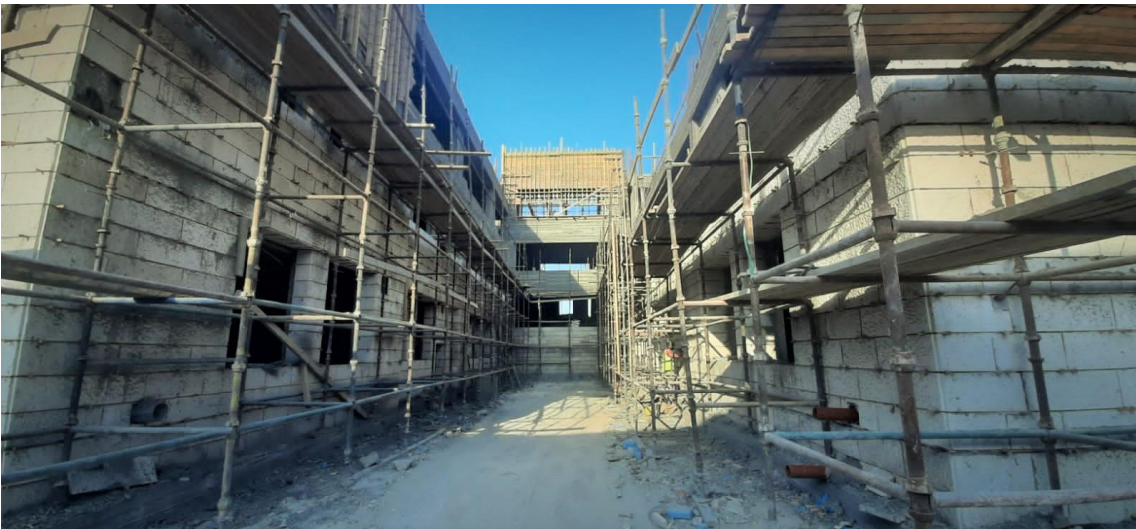
(Figures: 01, 02, 03 & 04)

General view of the project

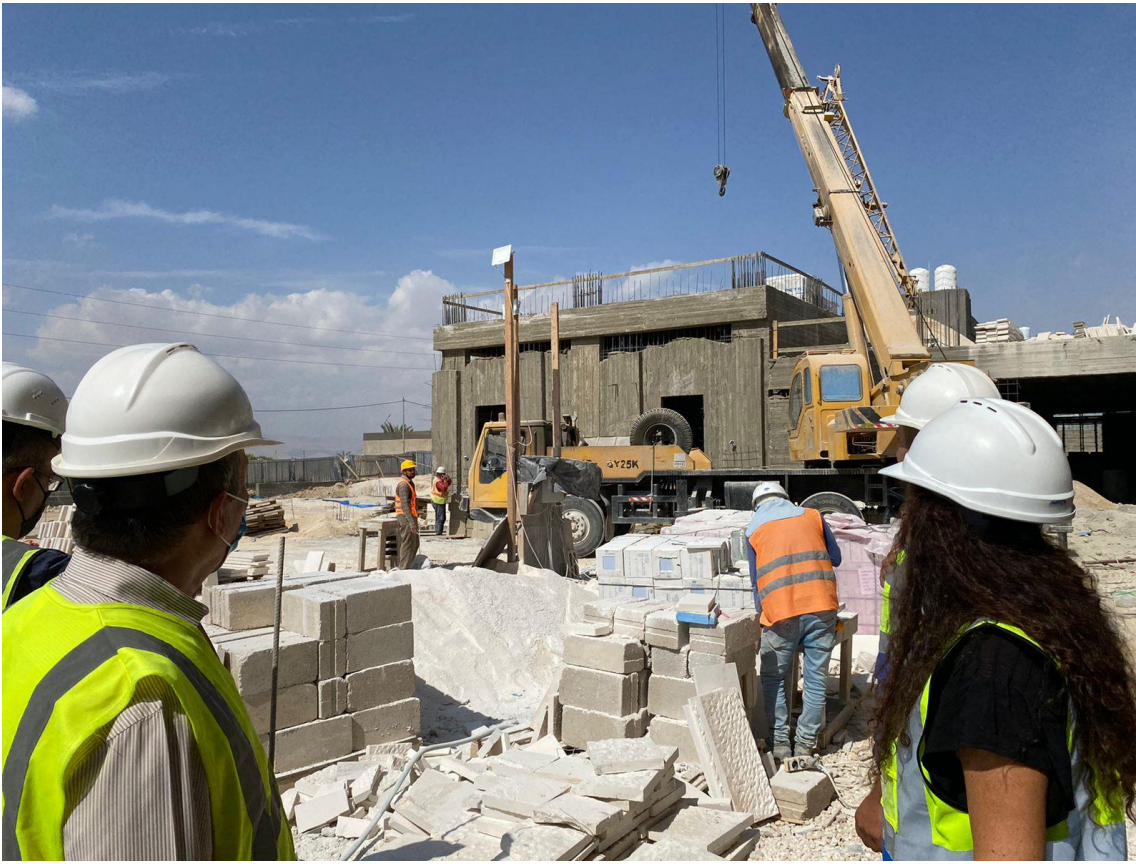
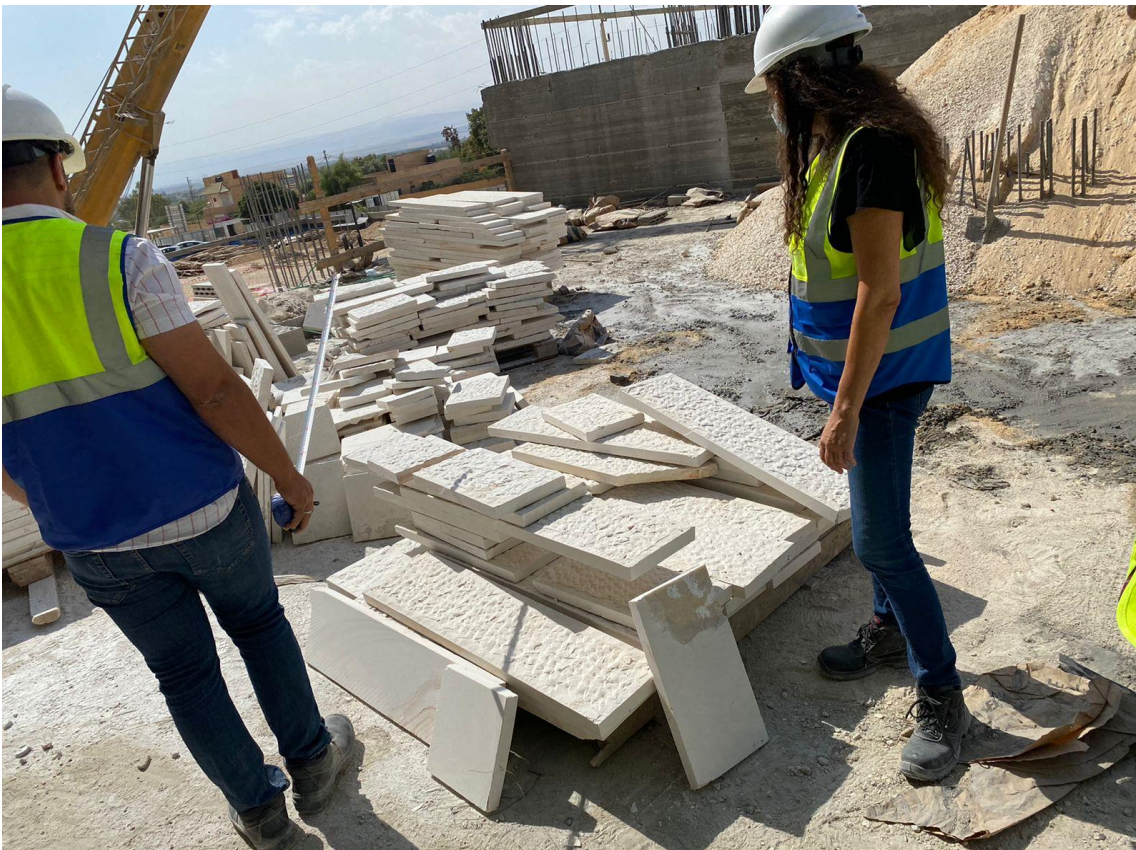
(Figures: 05 & 06)

The Supervision team inspected the imported stone and provided the Contractor with general remarks

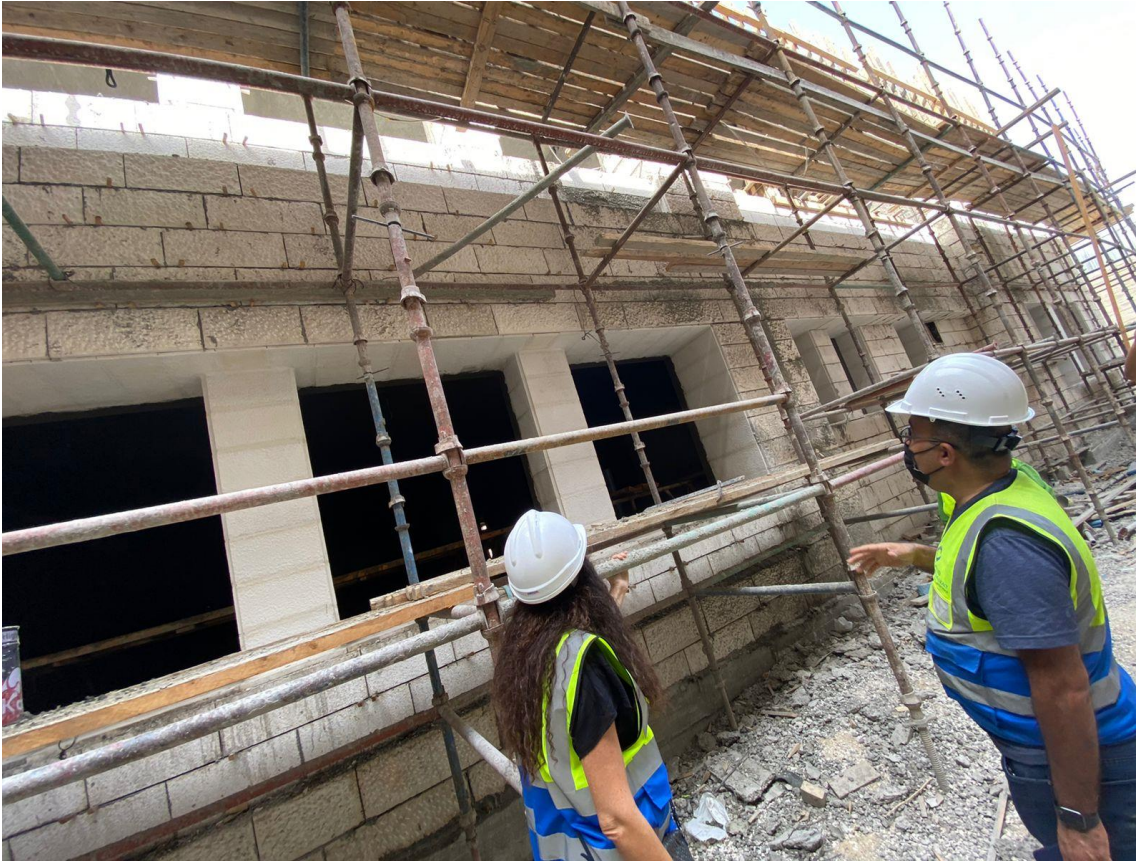
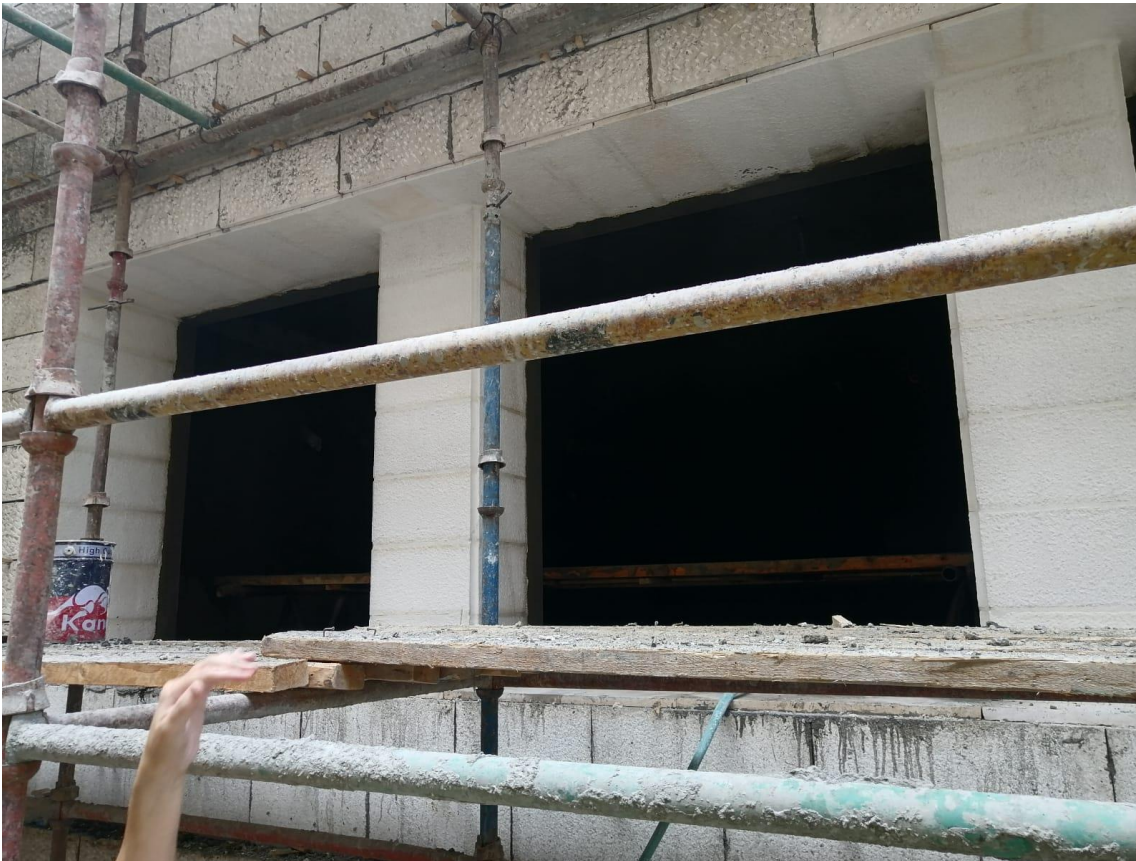
(Figures: 07 & 08)

Inspecting stone pointing sample

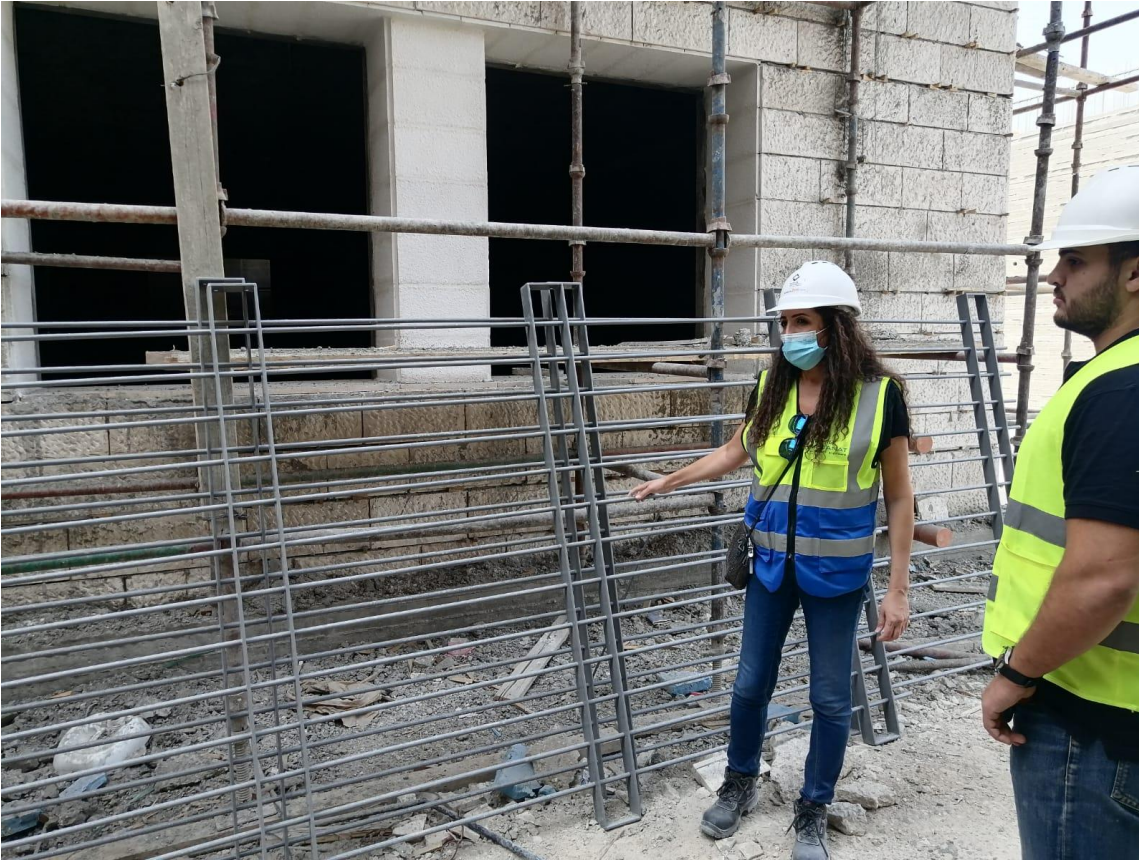
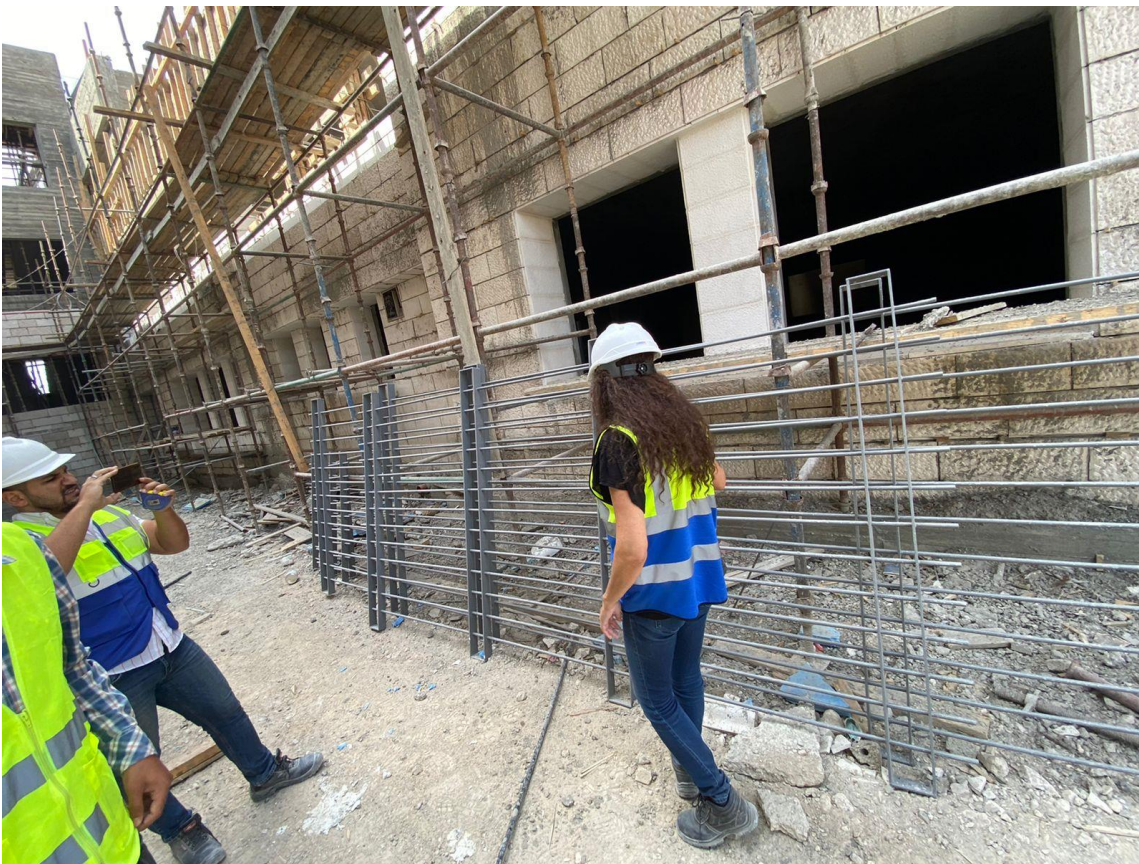
(Figures: 09 & 10)

The Contractor imported the steel grill protection and the supervision team inspected before installation

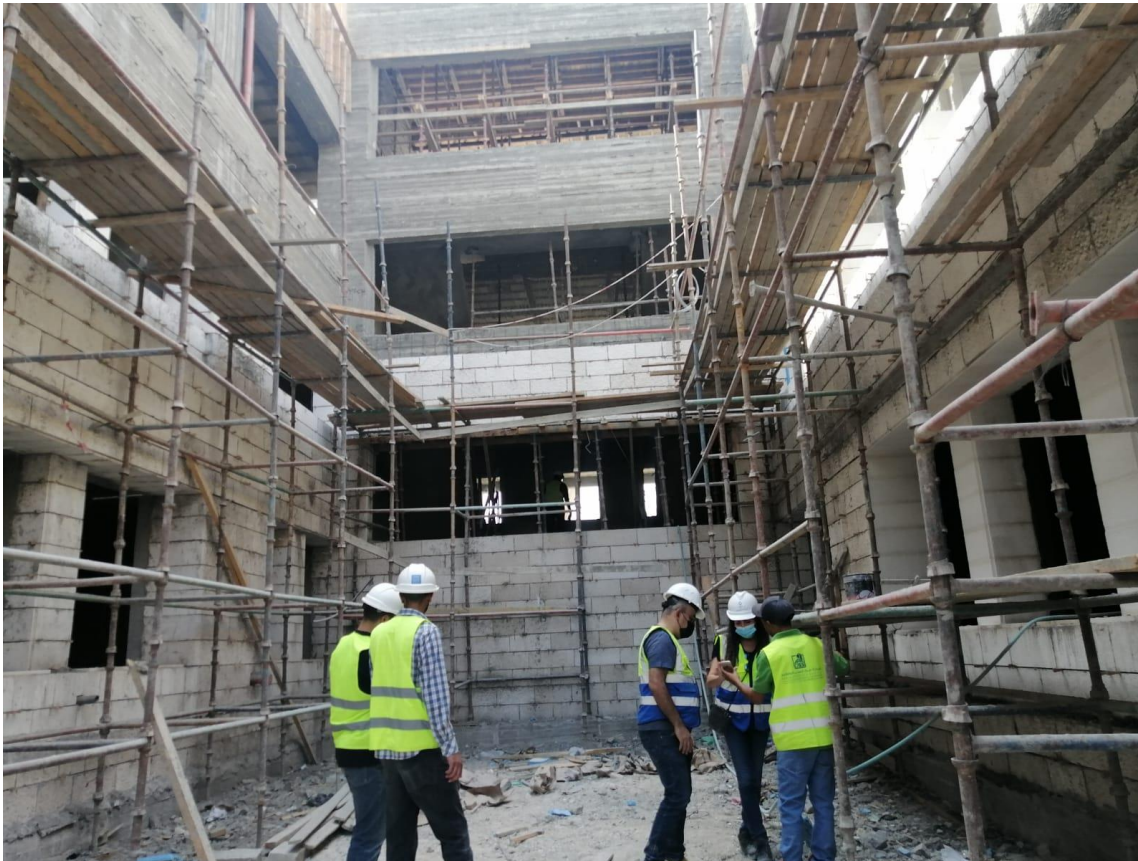
(Figure: 11)

General inspection was conducted on the stone building for facades

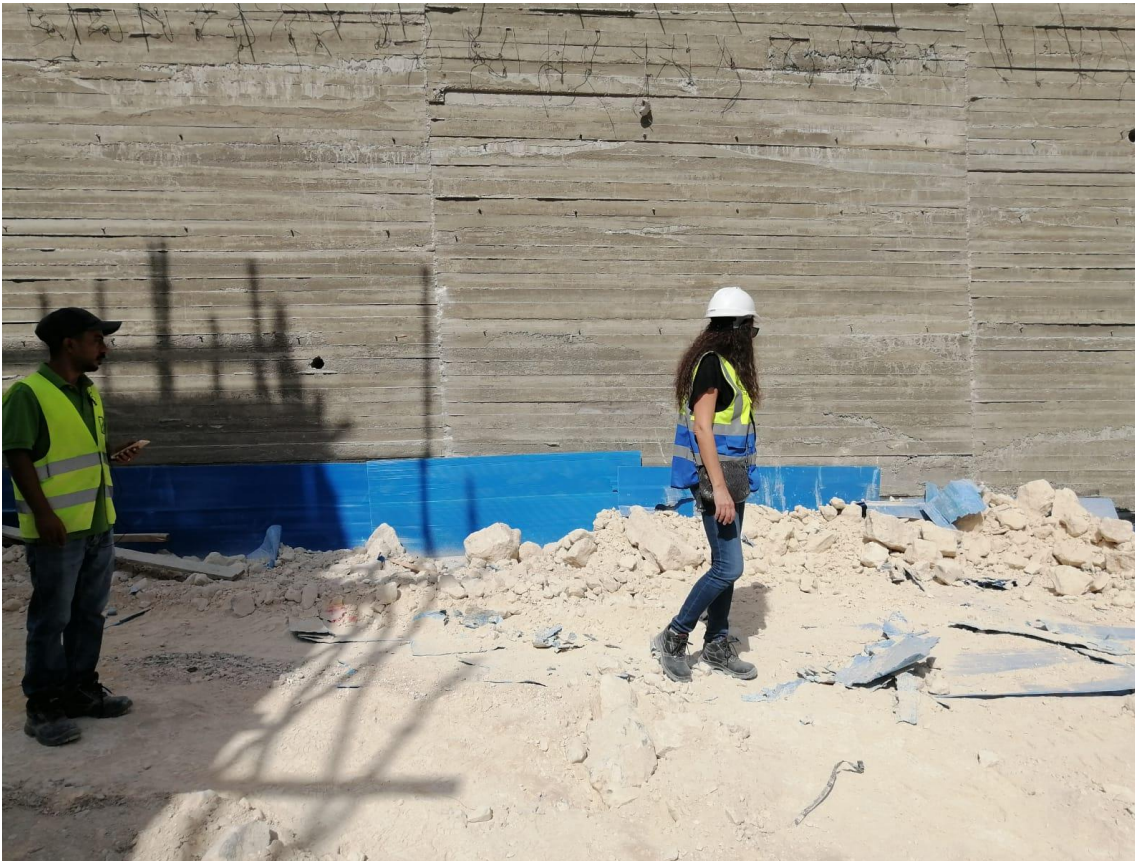
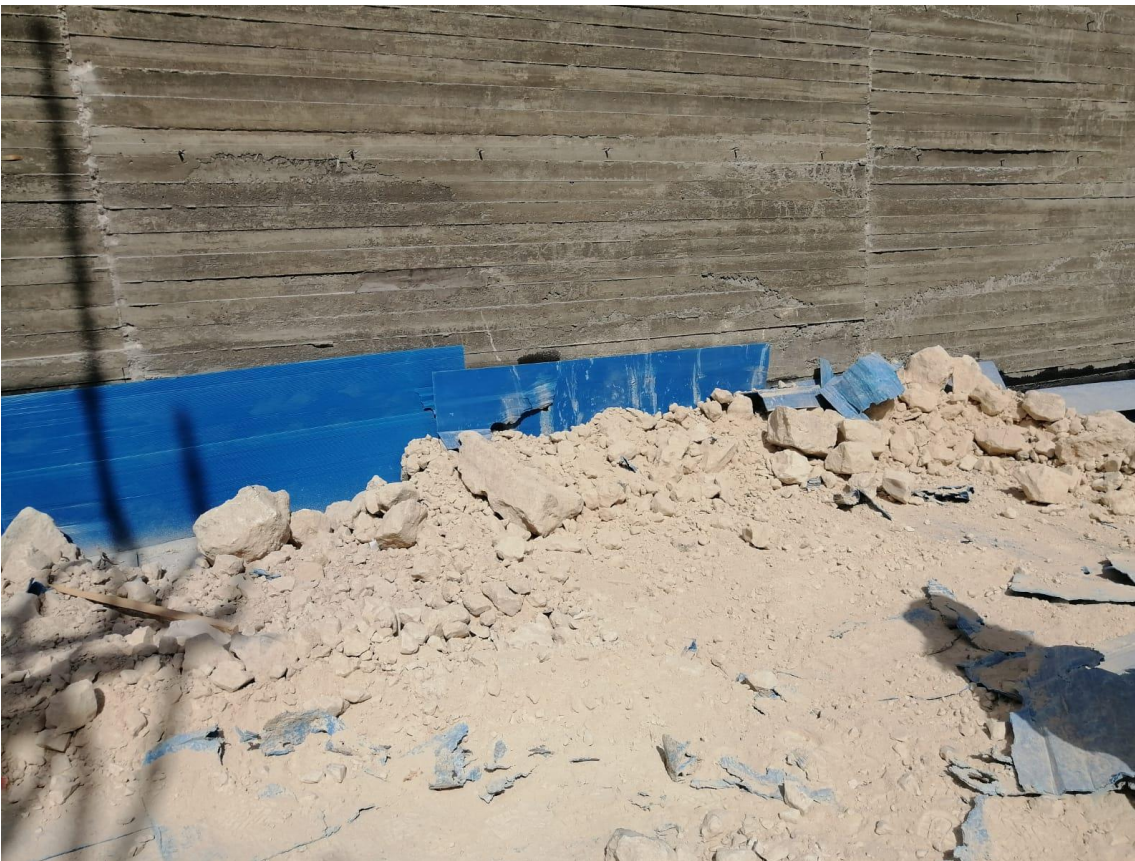
(Figures: 13 & 14)

9	The supervision team observed that the Contractor collected in stock boulders to be used for backfilling. The team informed the Contractor of the rejection of the material to be used for backfilling since it does not comply with the technical specifications.
10	It was observed that the Contractor is working in the execution of the external walls of the multi-purpose hall. Casting of part of those walls was observed and the supervision team provided the Contractor with a remark to insure a smooth and top levelled casting.
11	The Blockwork in the second floor has been inspected by the supervision team and remarks were provided to the Contractor.
12	It was noticed that the Contractor has delivered the HVAC outdoor units for the multi-purpose hall.
13	At the end of the site visit, a meeting was held at the site offices to discuss the observations and the required actions with the Contractor.

The supervision team observed that the Contractor collected in stock boulders to be used for backfilling. The team informed the Contractor of the rejection of the material to be used for backfilling since it does not comply with the technical specifications

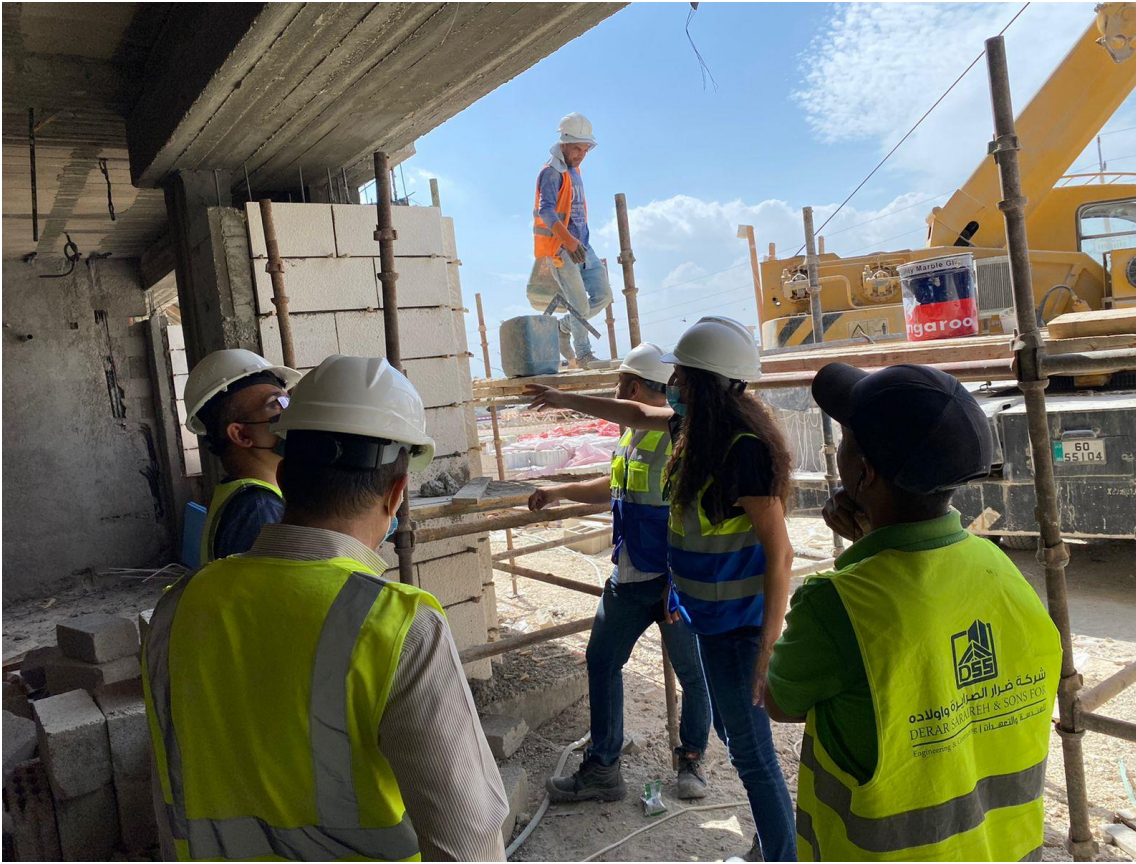
(Figure: 15)

Discussion was conducted regarding the stone building at the entrance of the building. The soffit of the lintel/outside to be stone or external paint. This will be reviewed and decided

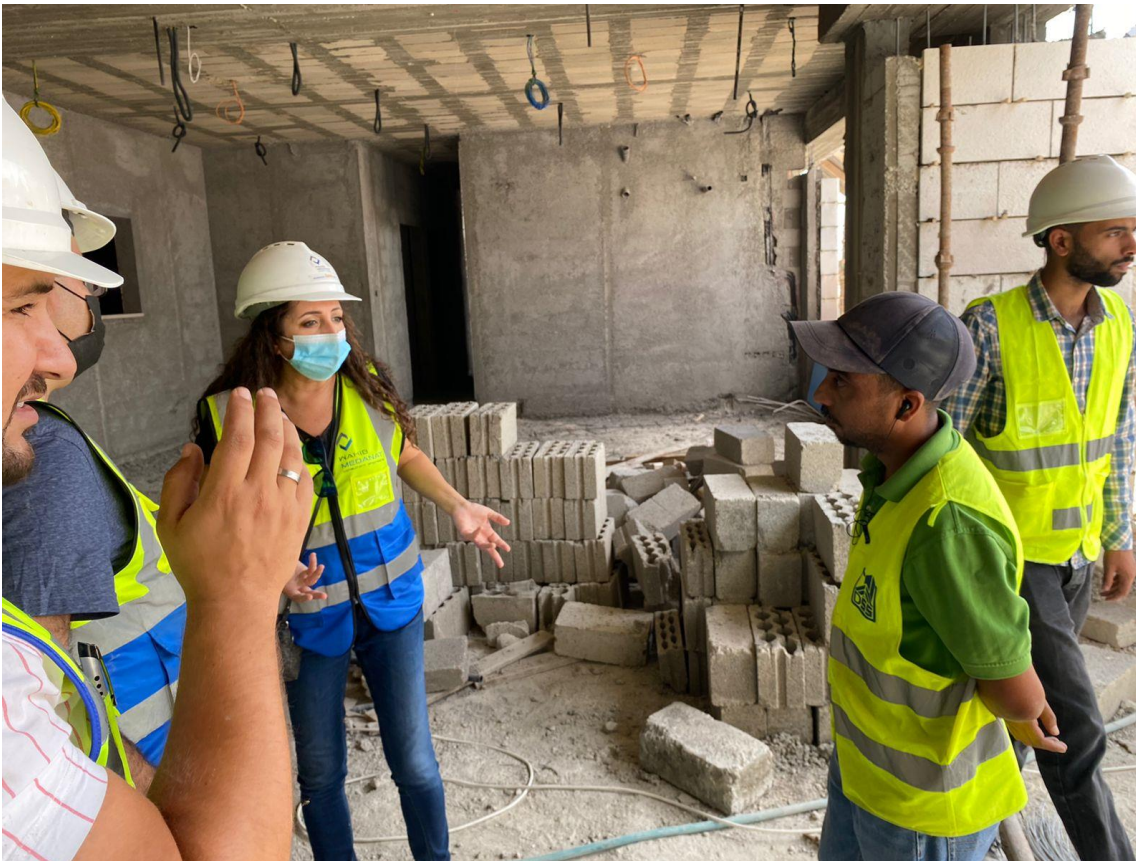
(Figure: 16)

The Supervision team inspected the imported blocks and provided the Contractor with general remarks

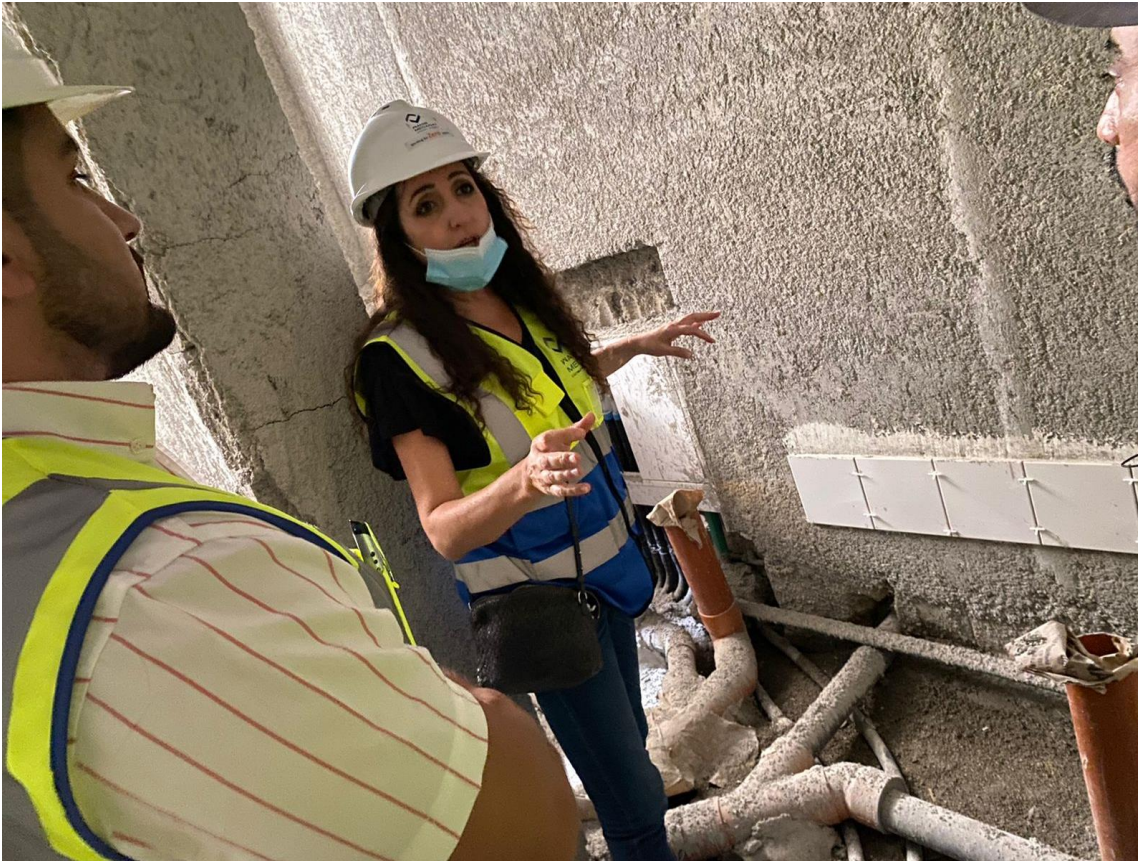
(Figure: 17)

The installation of mechanical cabinets in the toilet area was inspected to insure the compatibility with tiling and proper cut-off tile pieces

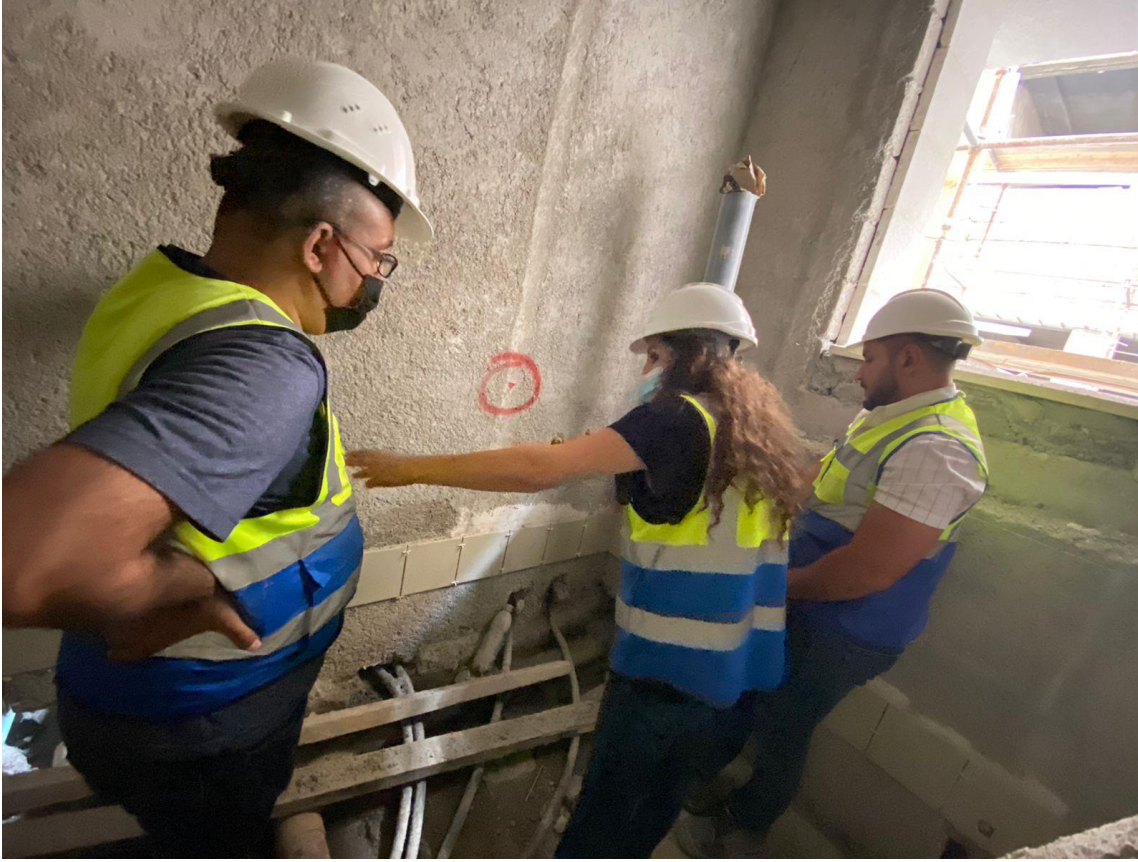
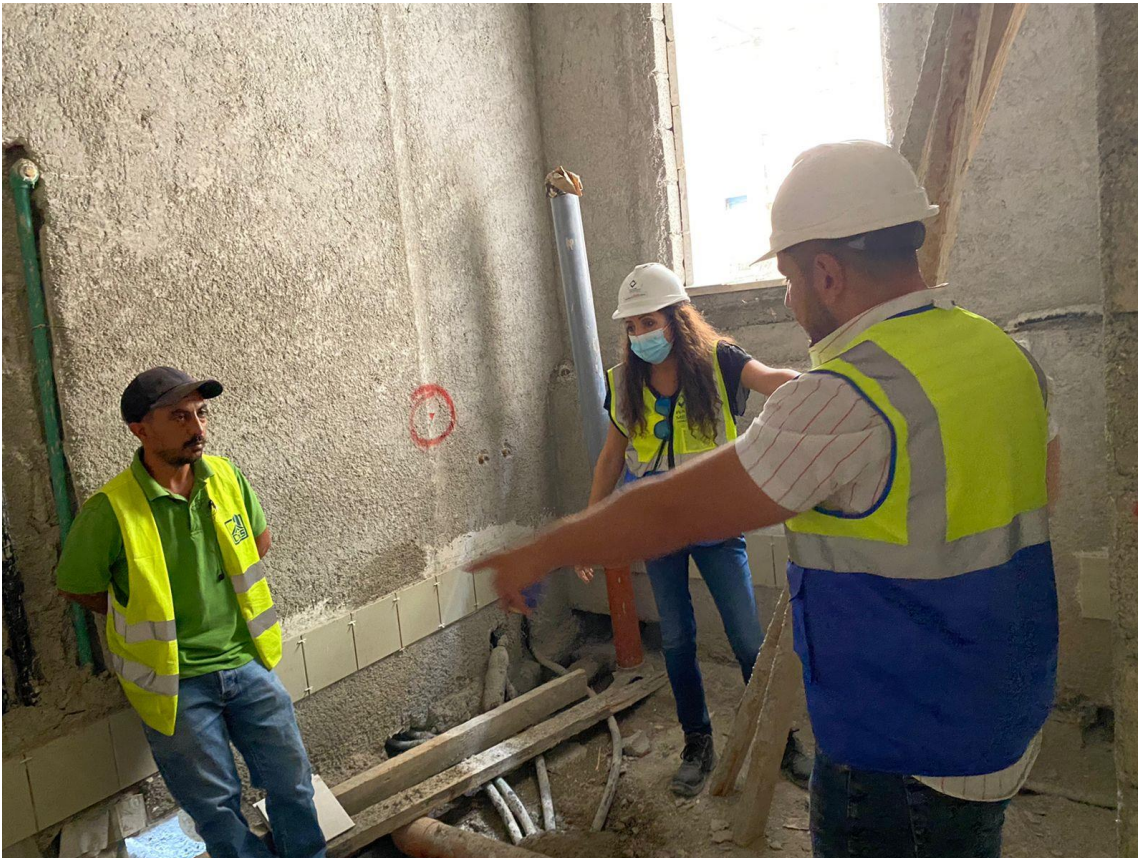
(Figures: 19 & 20)

The supervision team inspected the executed tiles in the toilets and provided the Contractor with general remarks and the process of tiling

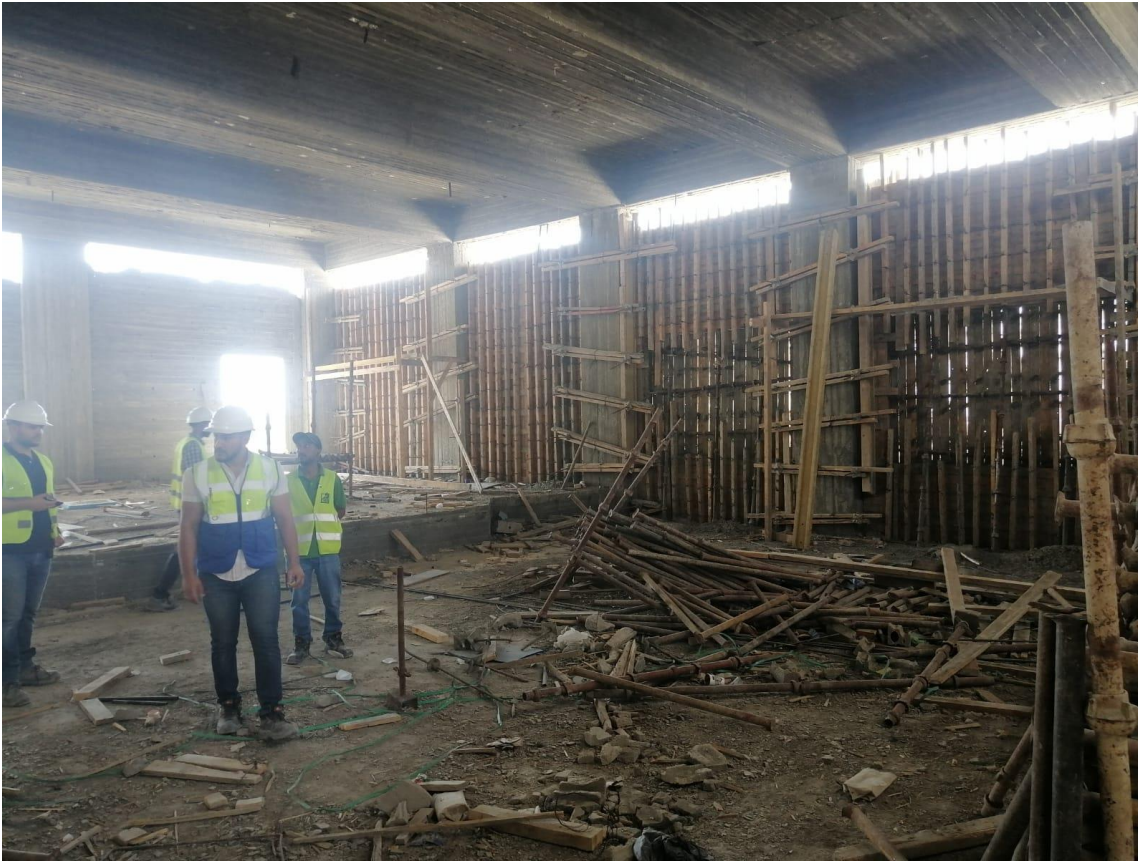
(Figure: 21)

It was observed that the Contractor is working in the execution of the external walls of the multi-purpose hall. Casting of part of those walls was observed

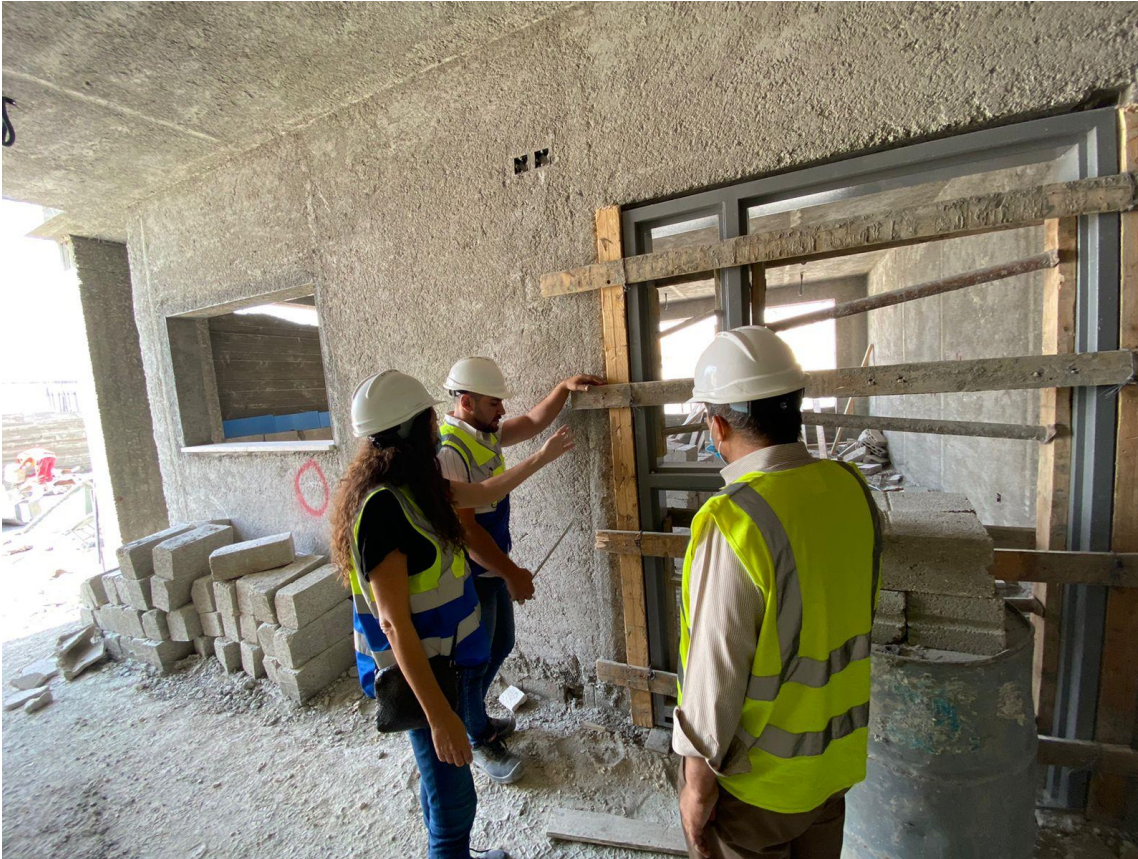
(Figure: 23)

The removal of frames which do not comply regarding the dimensions.

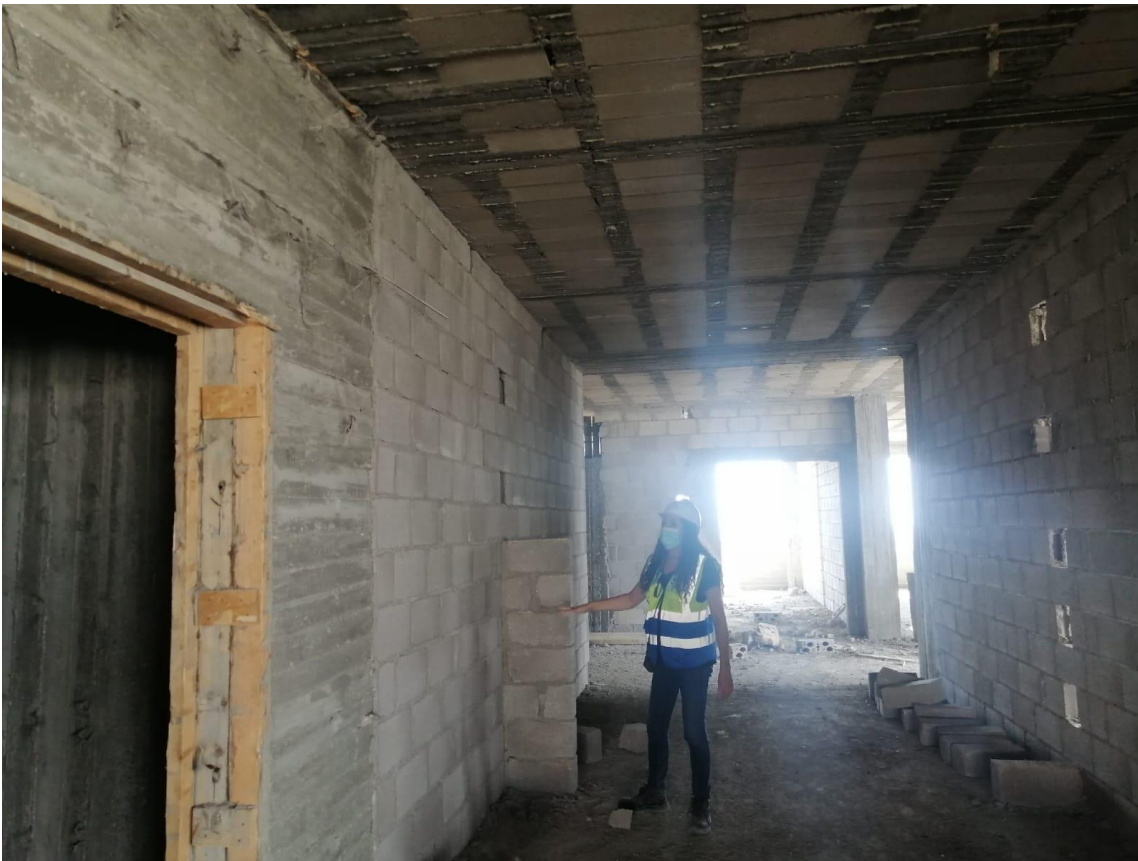
(Figure: 24)

Inspecting blockwork
