Consultant	Wahib Medanat Consultant Engineer	Rep No.	12-10112021
Contractor	Derar Saraireh & Sons for Engineering & Contracting	Tender No.	(11/2019/USAID/SKEP/3/S) Schools for a Knowledge Economy Project (SKEP) - Phase (3) Package (1, 2)
Site Name	Al Khansa' Basic Mixed School- Al Balqa	Day/ Date	Wed. 10/11/2021
Duration of Project	450 Calendar Days	Total Project Budget	9,789,417.840 JD

Visit Notes

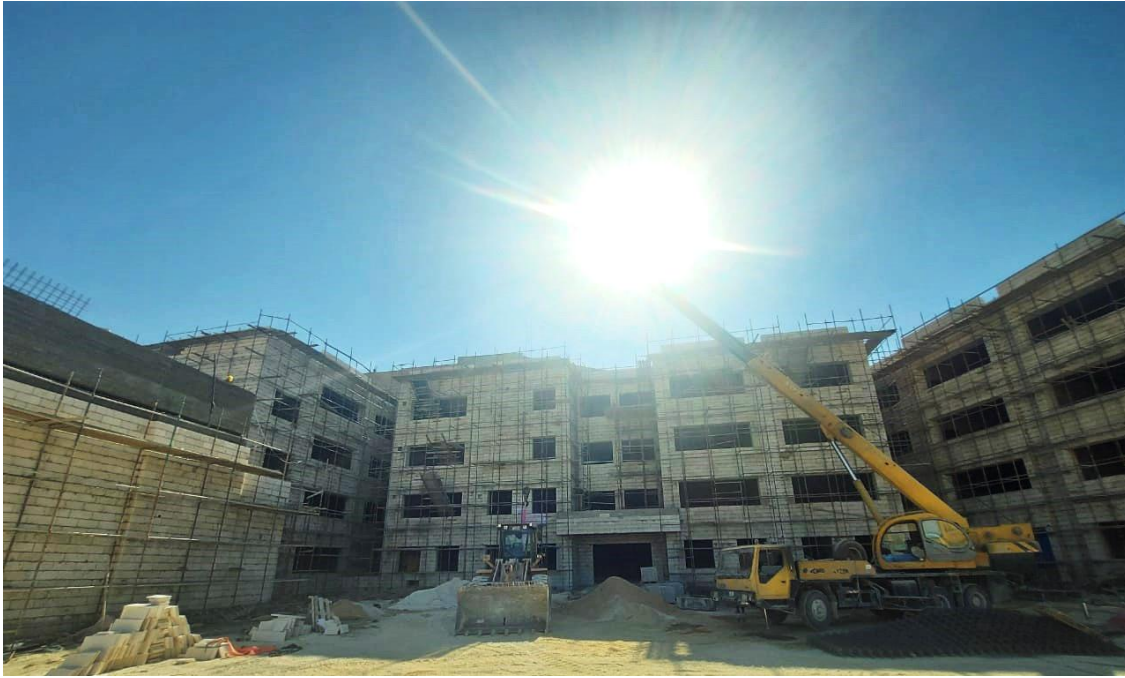
(Figure: 01)

General view of the project

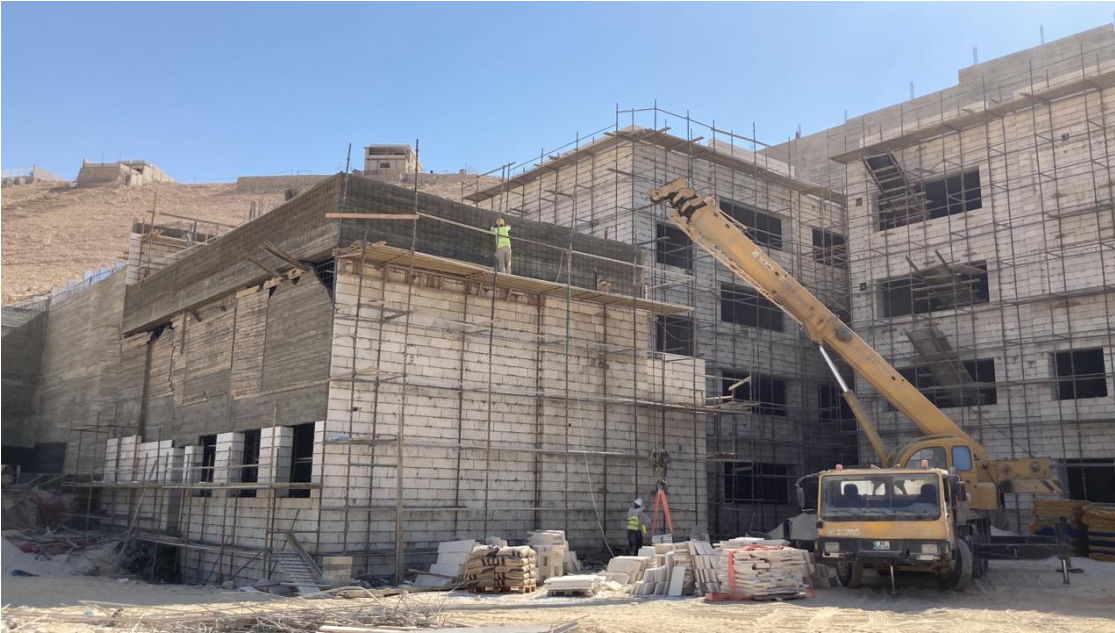
(Figure: 03)

General inspection was conducted on the stone building; notes were given to the Contractor in this regard

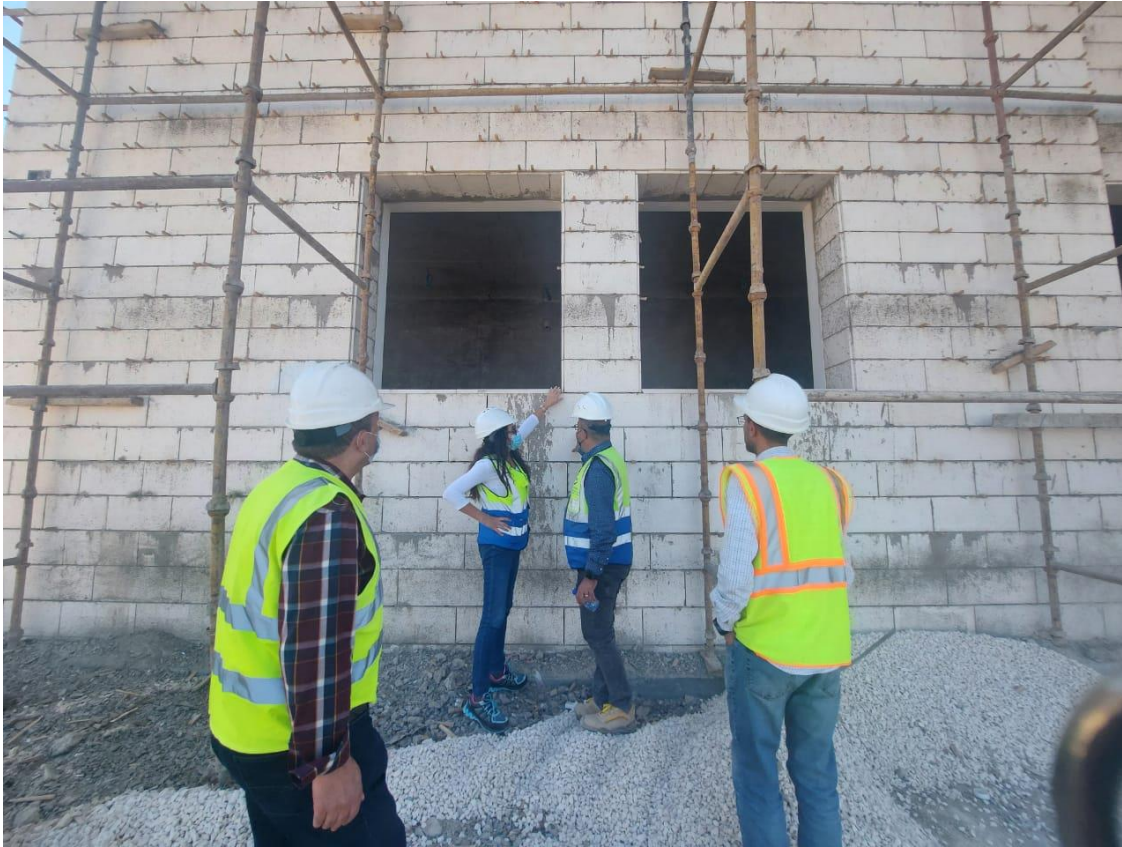
(Figure: 05)

During the inspection of built stones for facades, broken window sills were observed. The Contractor was requested to replace them

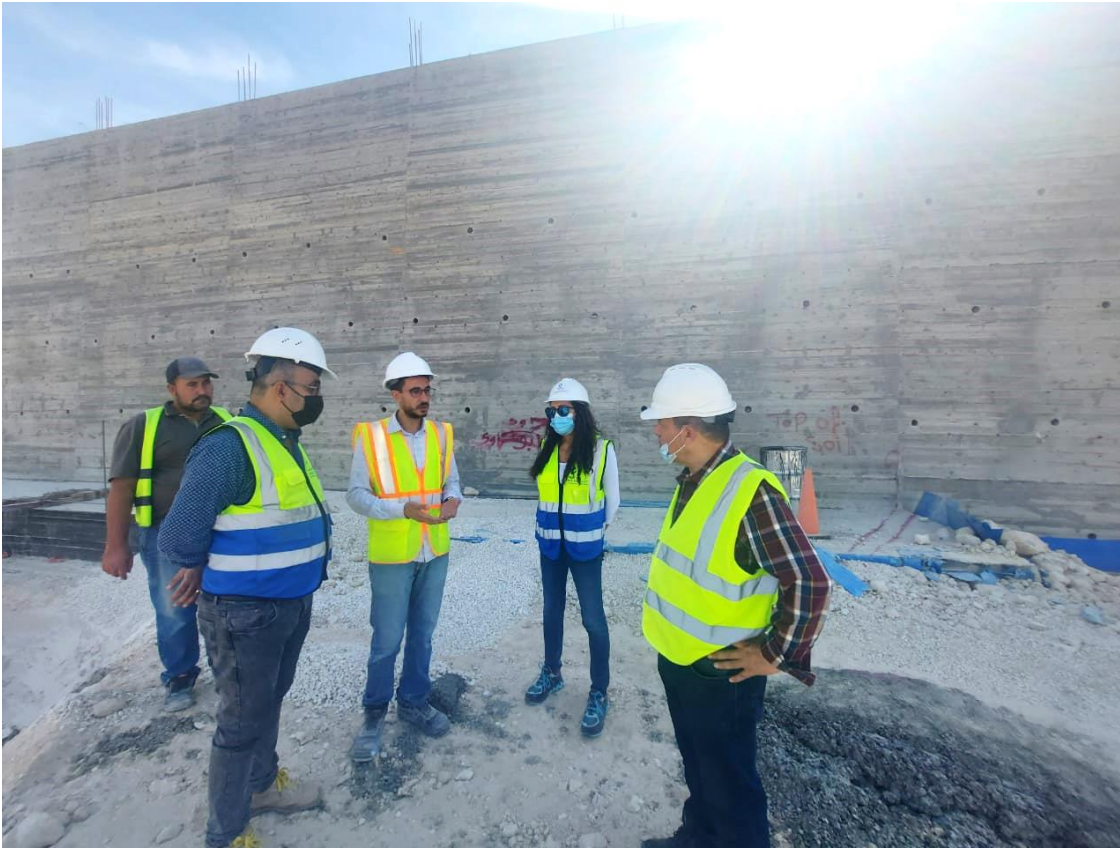
(Figure: 07)

The visiting team inspected the area where a contradiction was observed in relation to the final leveling for the southern area in relation to the storm water drainage

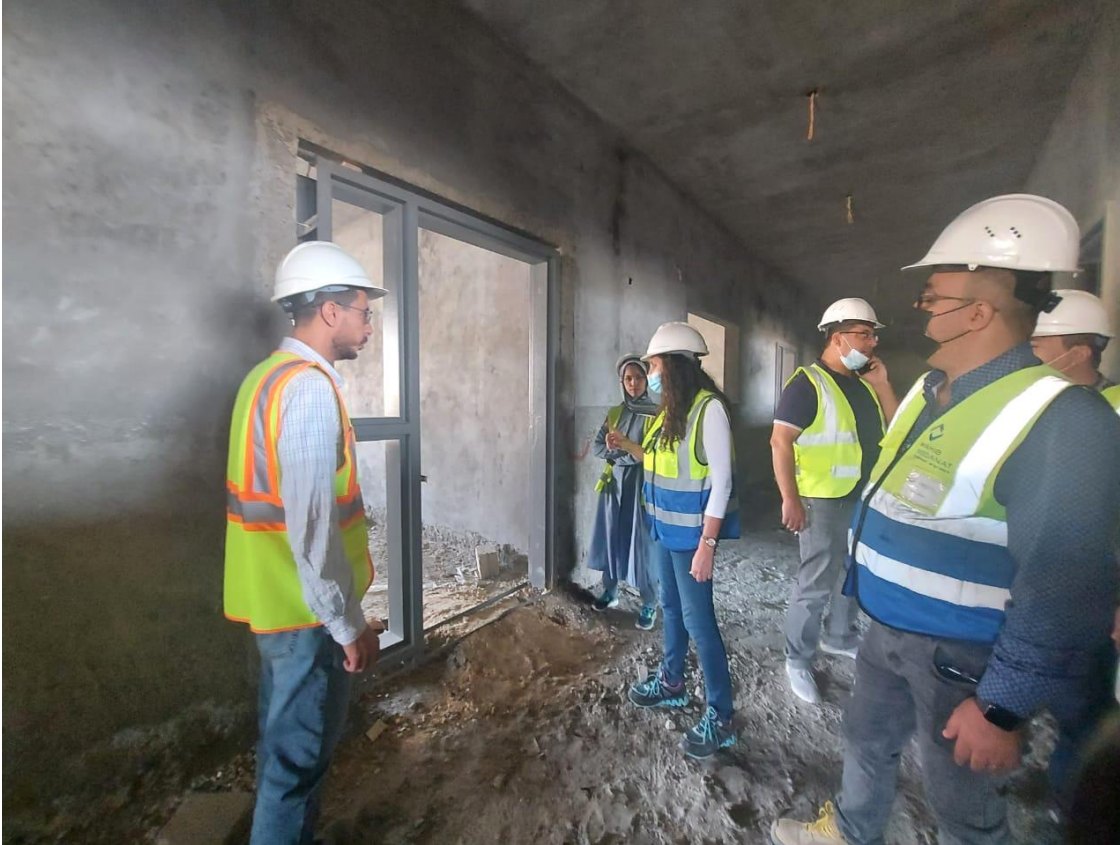
(Figure: 09)

General inspection was conducted on the steel door frames and remarks were given to the Contractor to rectify

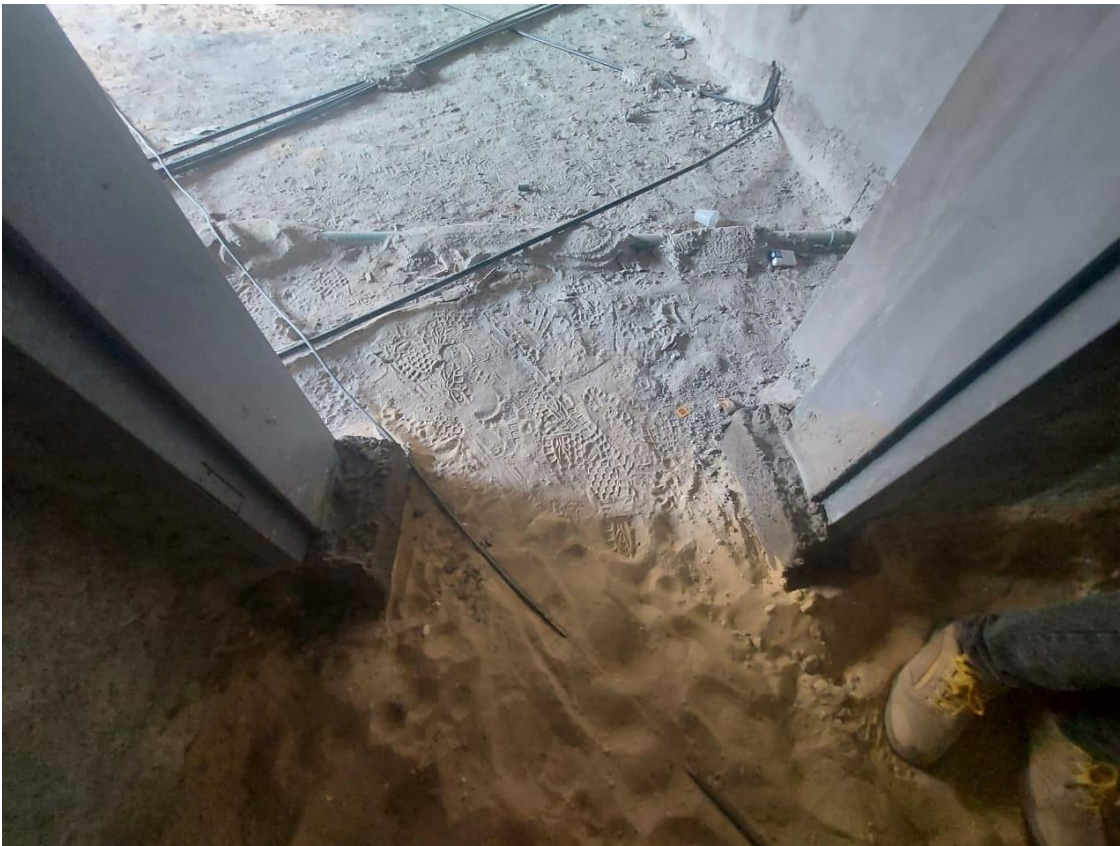
(Figure: 10)

The door frames were supported by mass concrete with convenient dimensions

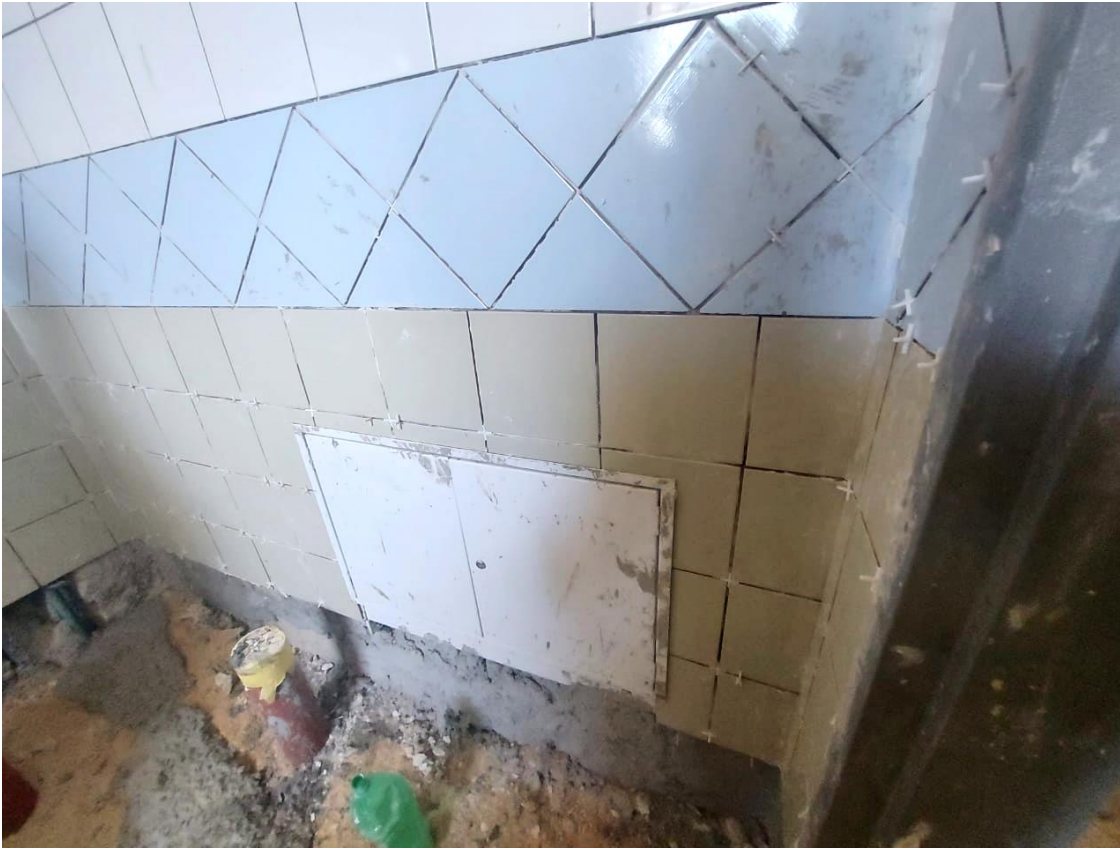
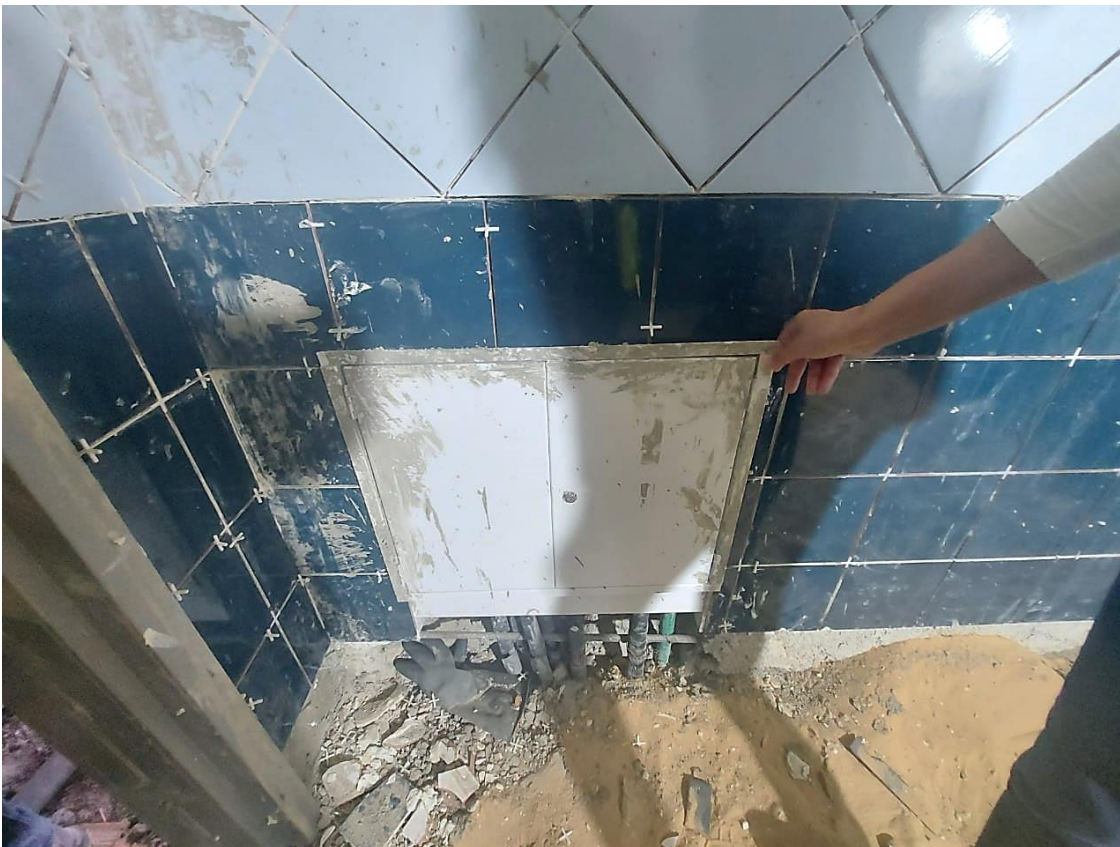
The Contractor was requested to rectify the location of cabinets slightly to avoid small cut-off tile pieces

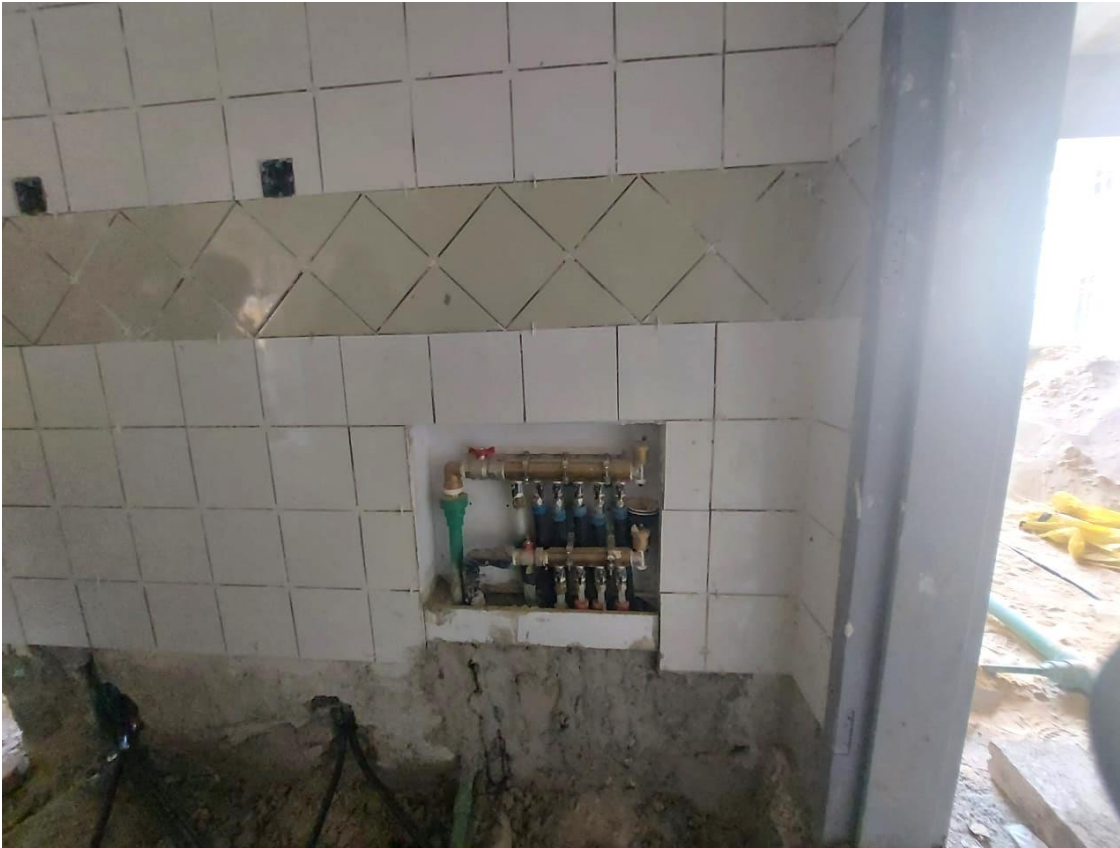
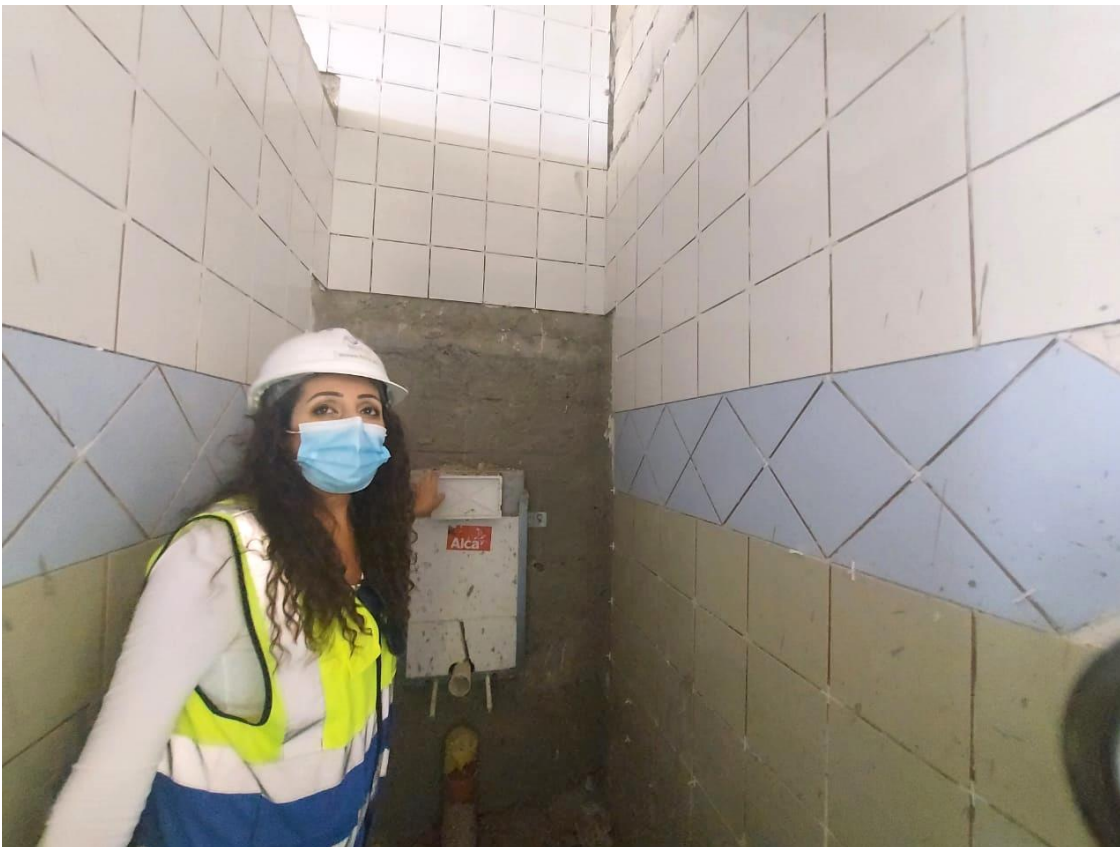
It was observed that the Contractor coordinated the mechanical works in the wet areas/first floor in relation to the ceramic walls, door frames and the water cabinets

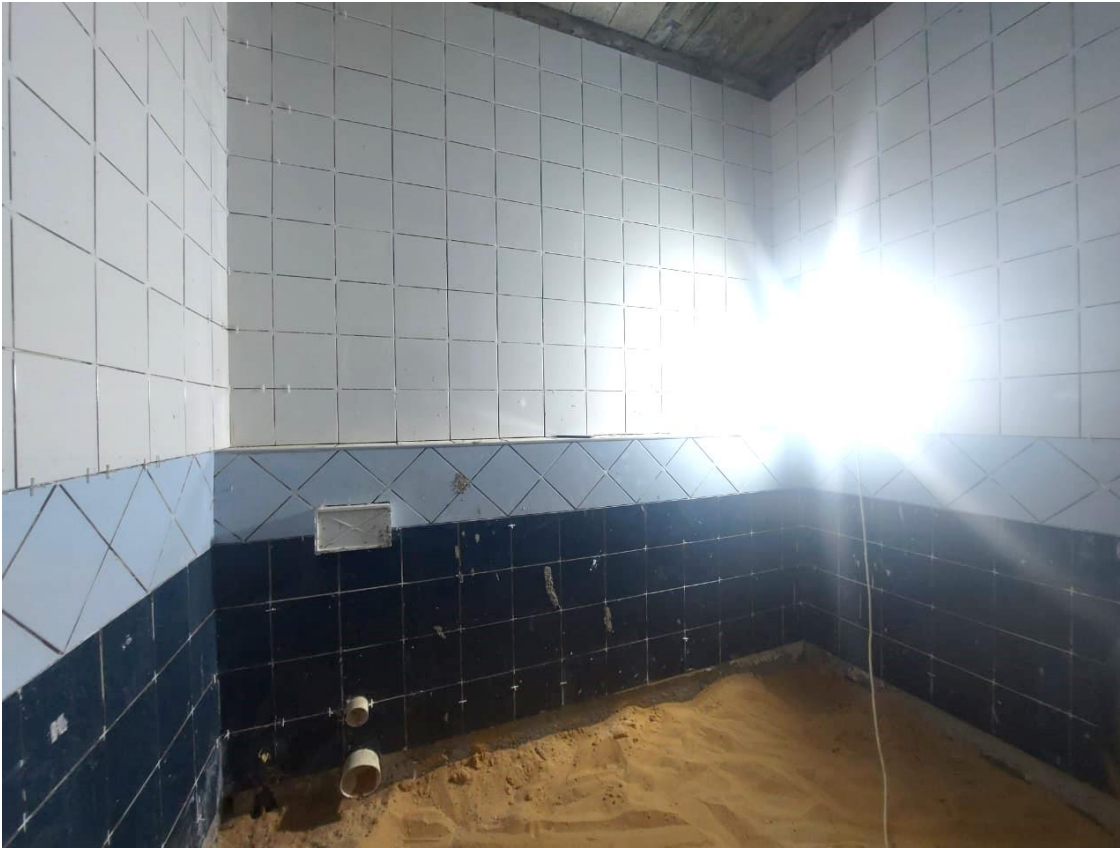
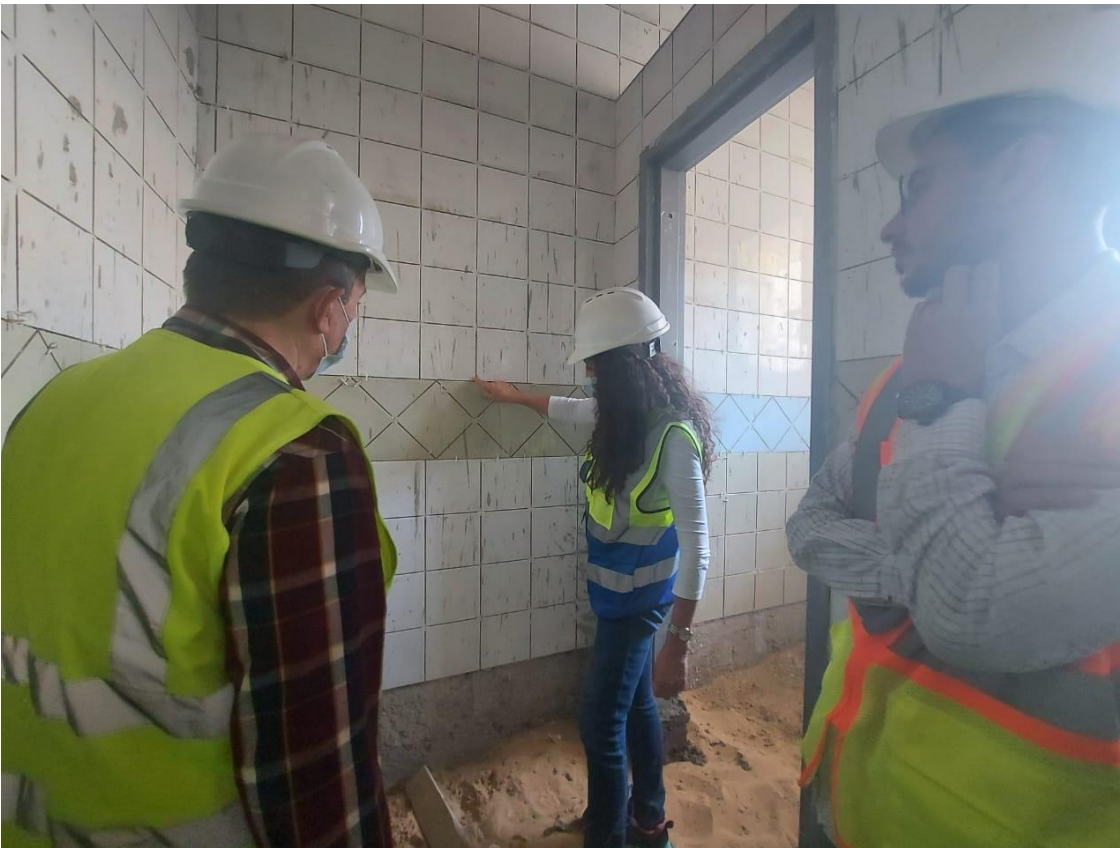
The team inspected the tiling work at the wet areas

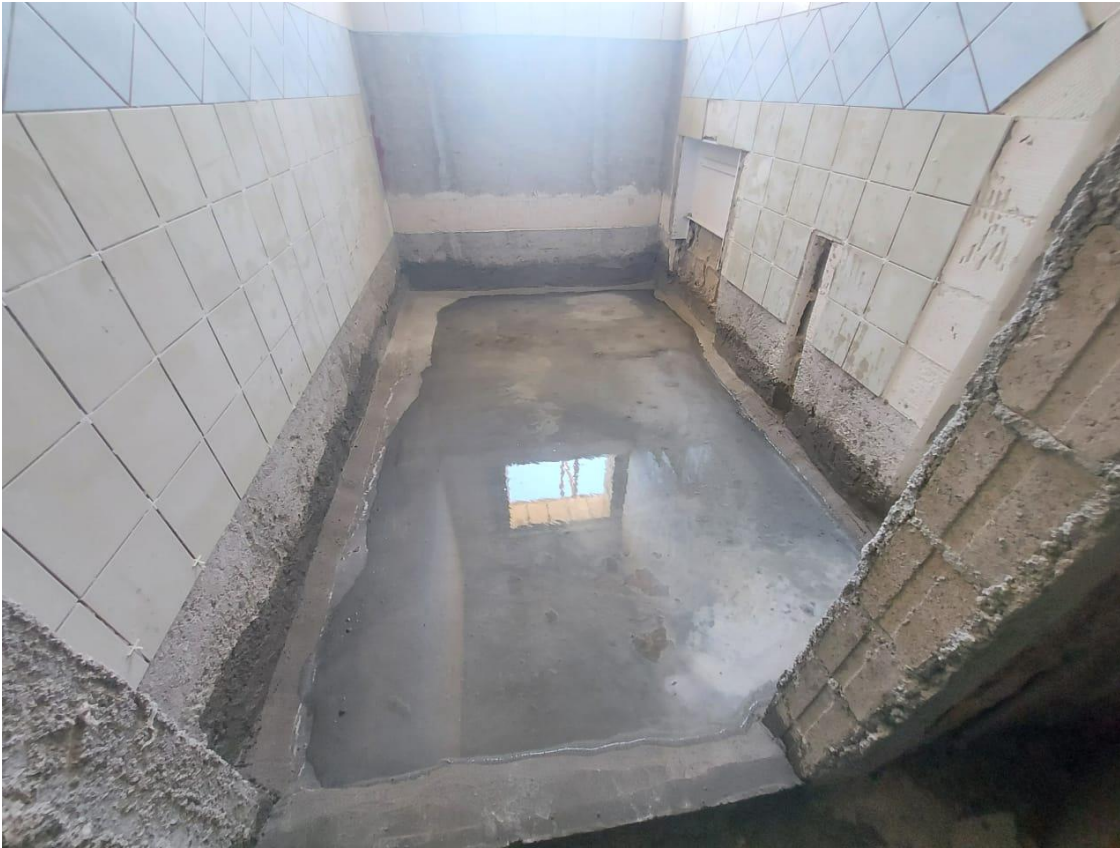
(Figure: 17)

The team observed that a water penetration test has been conducted for the floor of one of the toilets

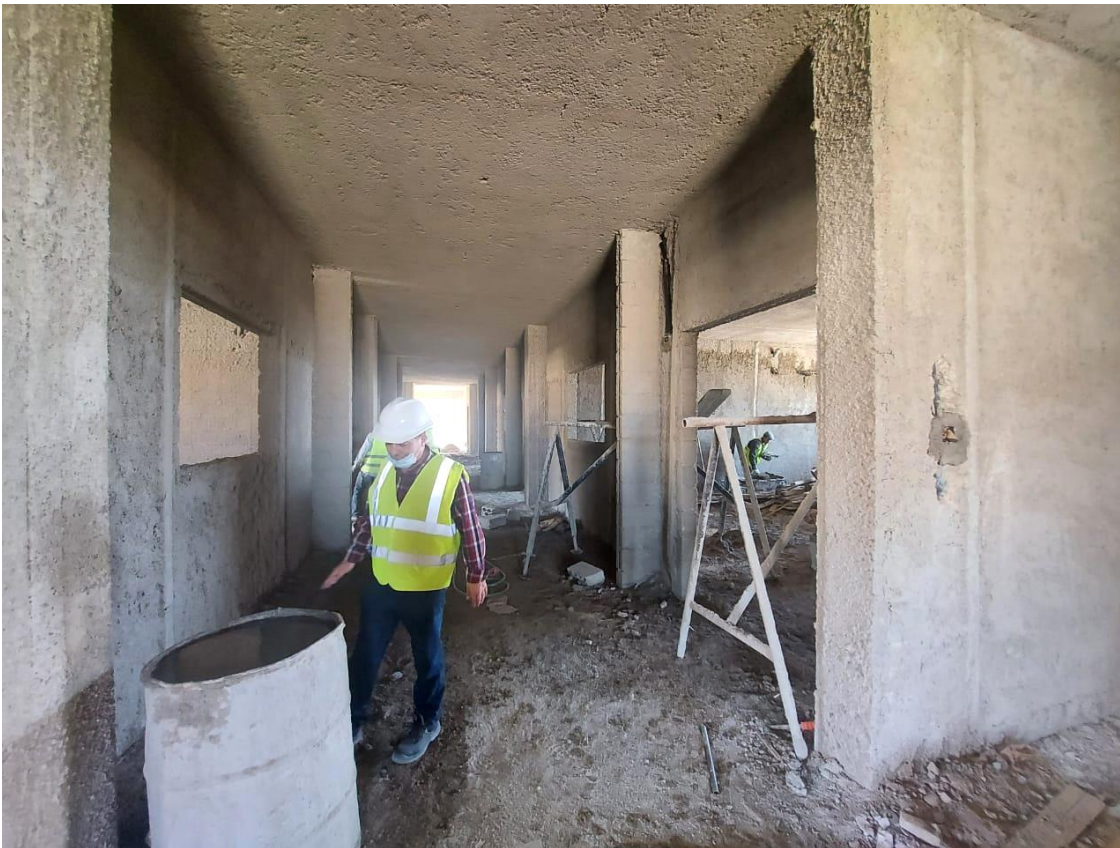
(Figure: 18)

The team inspected the plastering works at the corridors

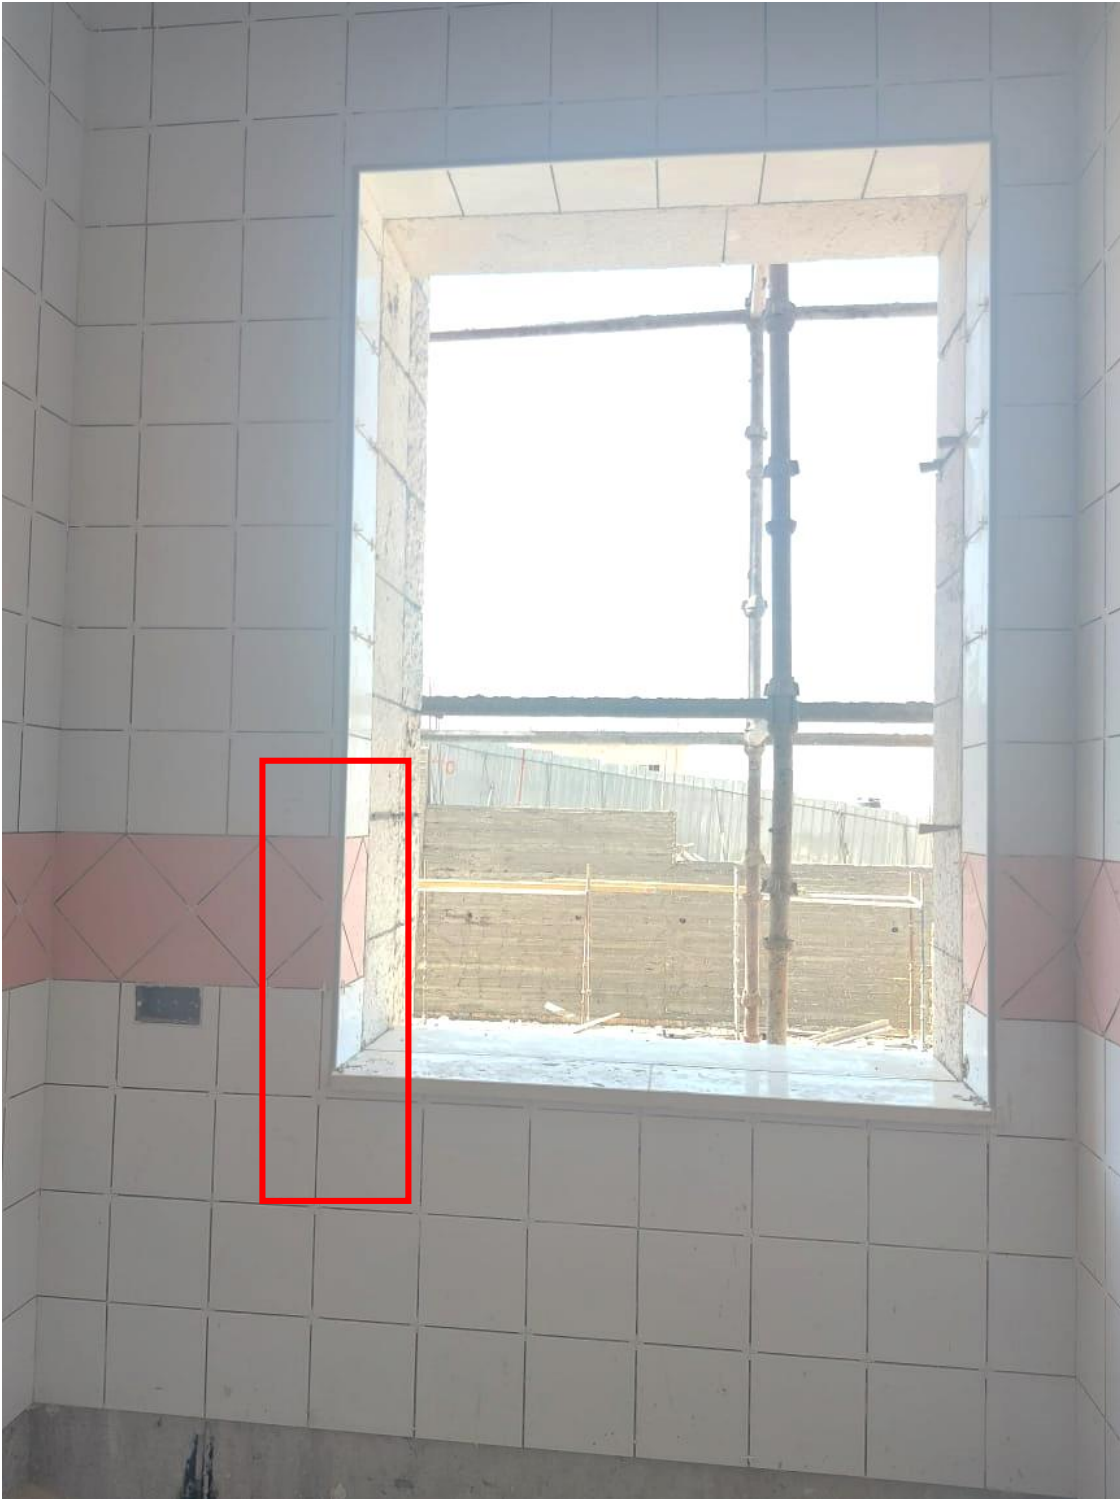
(Figure: 19)

The supervision team observed that the tiling work at one wall does not comply with the shop drawings due to installing small cut-off tile pieces

It was agreed that the Contractor will remove the defected areas and re-fix tiles correct

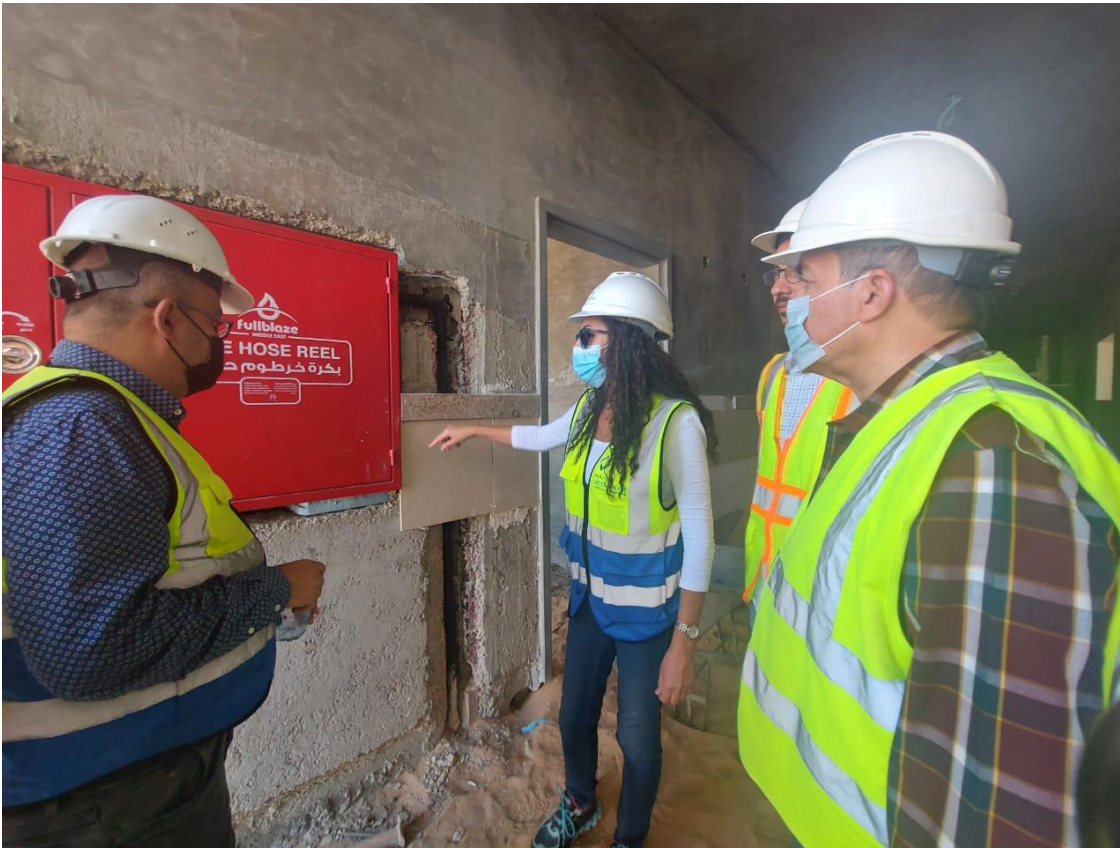
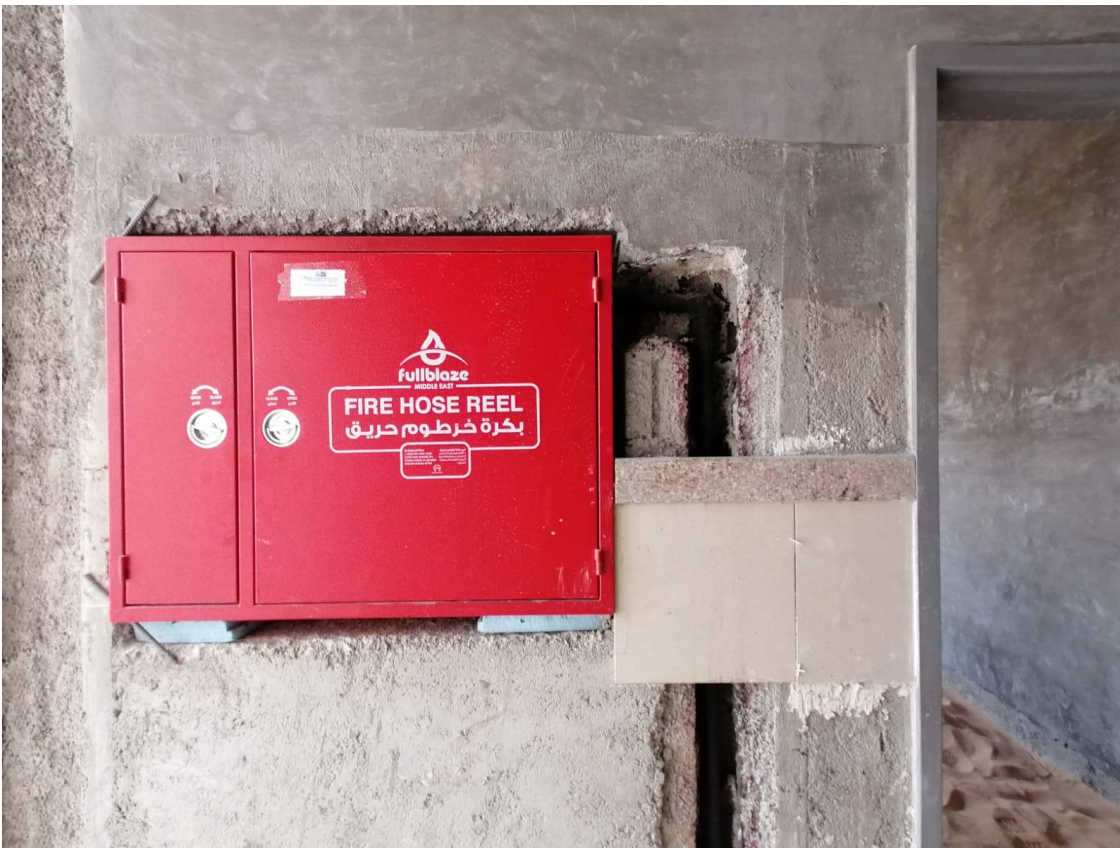
The visiting team inspected the installation of fire hose cabinets at the corridors focusing on the relation between those cabinets and the granite coping and the door frames. The prepared sample is approved and comply with civil defense regulations

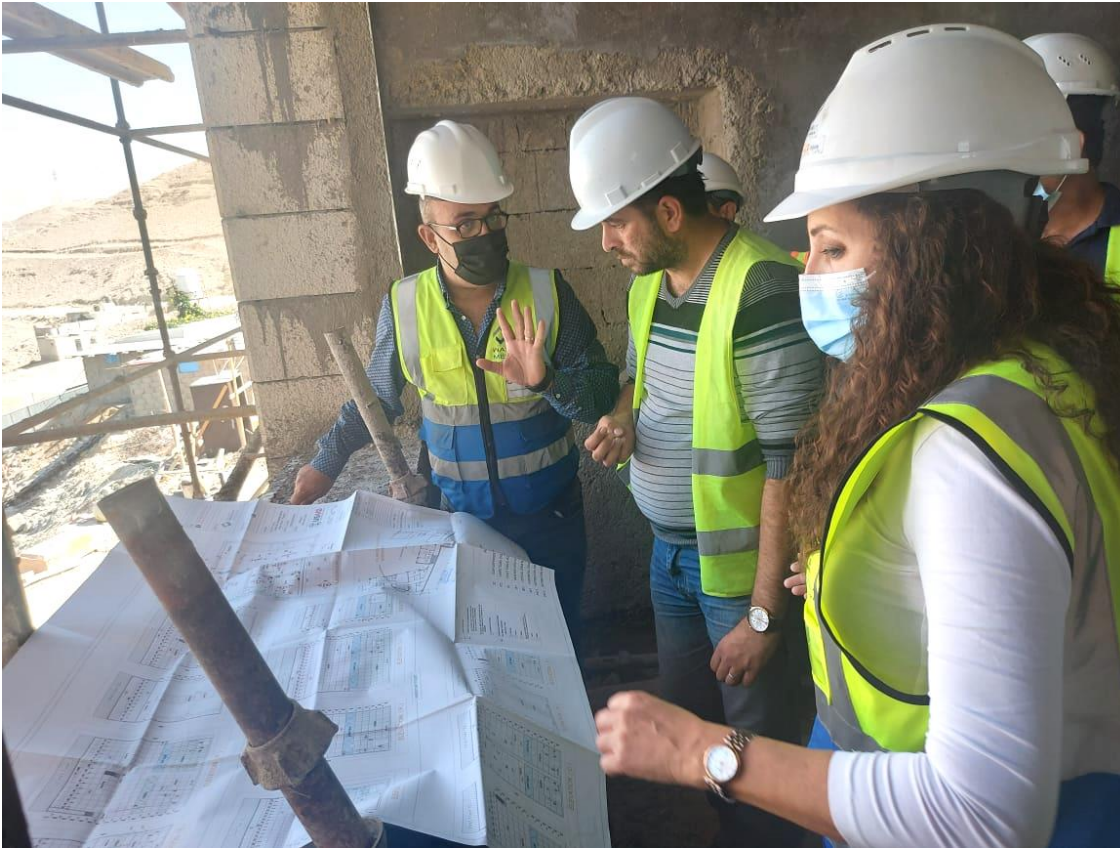
(Figure: 22)

A general check was conducted to insure that the executed works comply with the approved workshop drawings

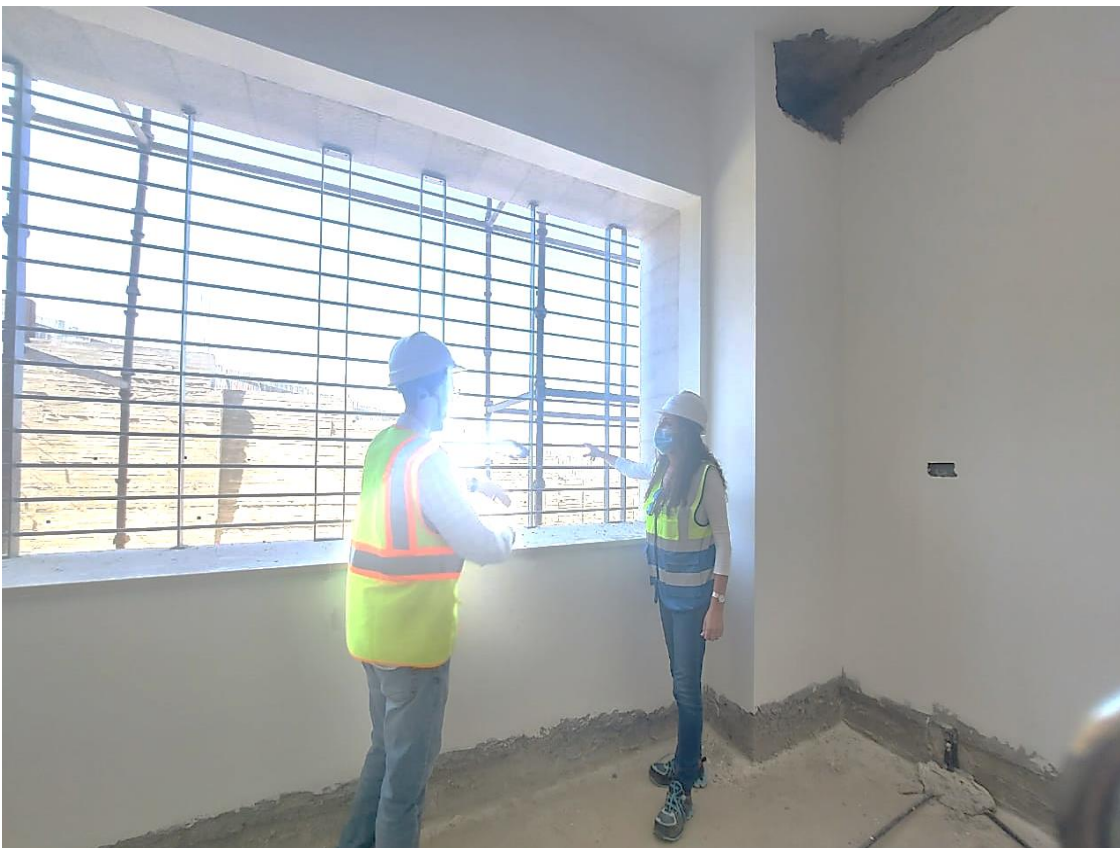
(Figure: 23)

The installed sample of steel protection grill for window at the mock-up room was inspected by the visiting team

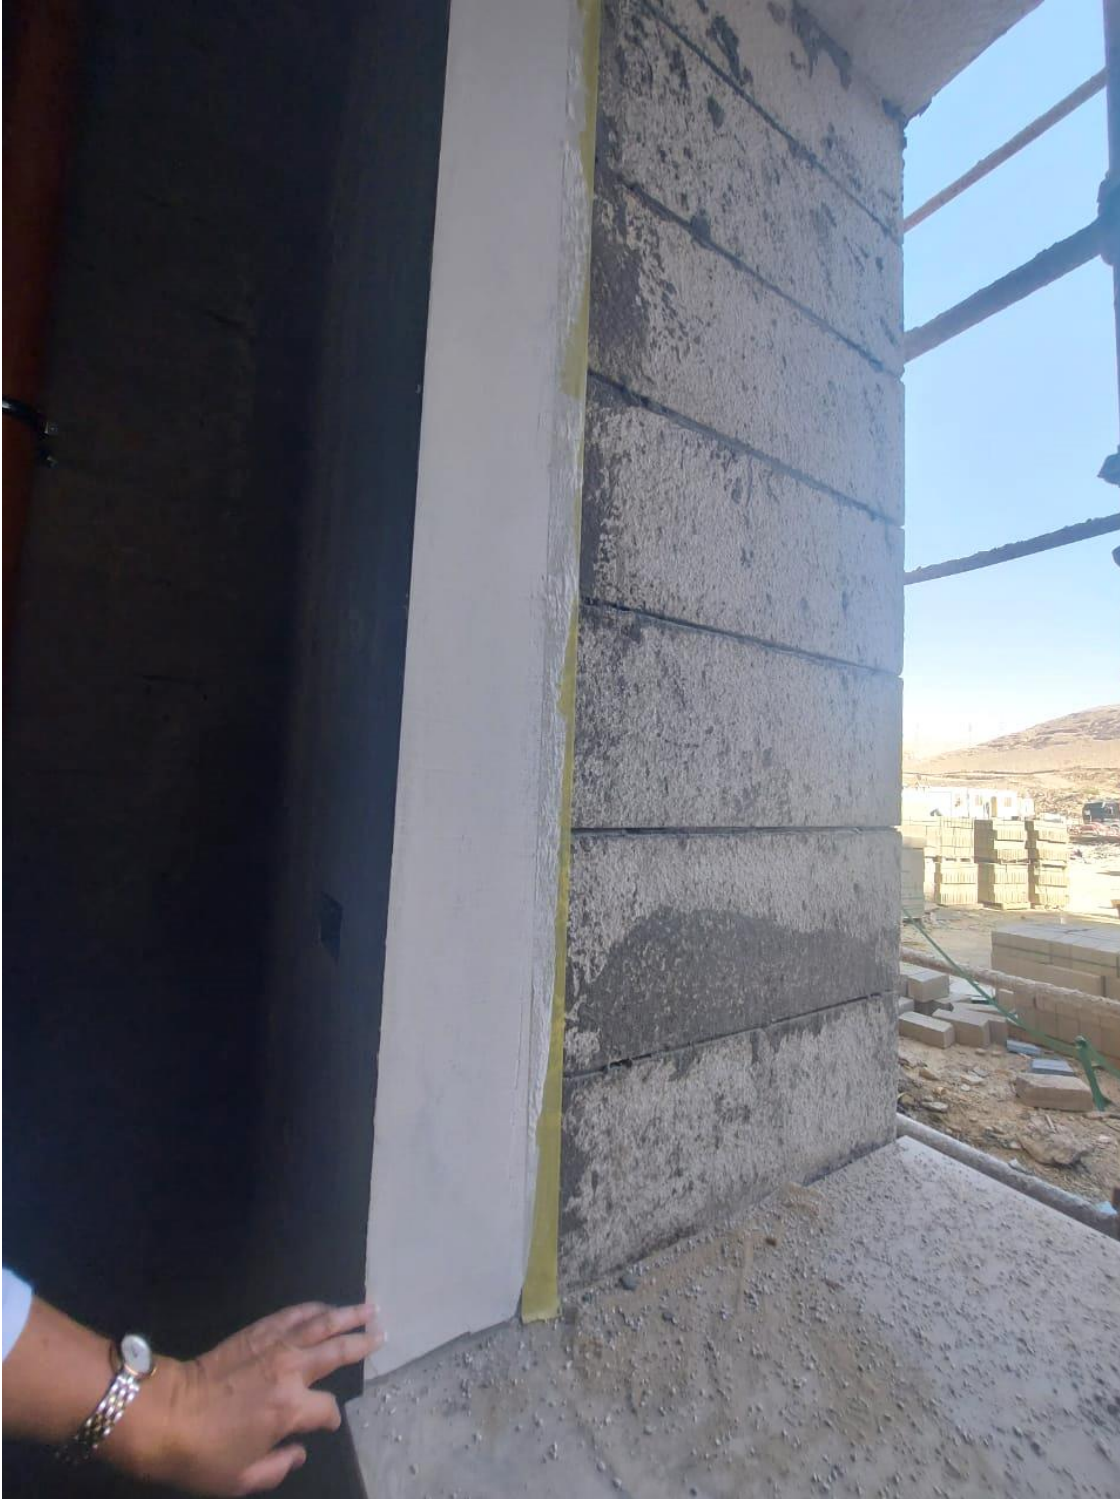
(Figure: 24)

The team observed that the Contractor started with the painting work for window jambs before preparing the plastering to be ready for painting

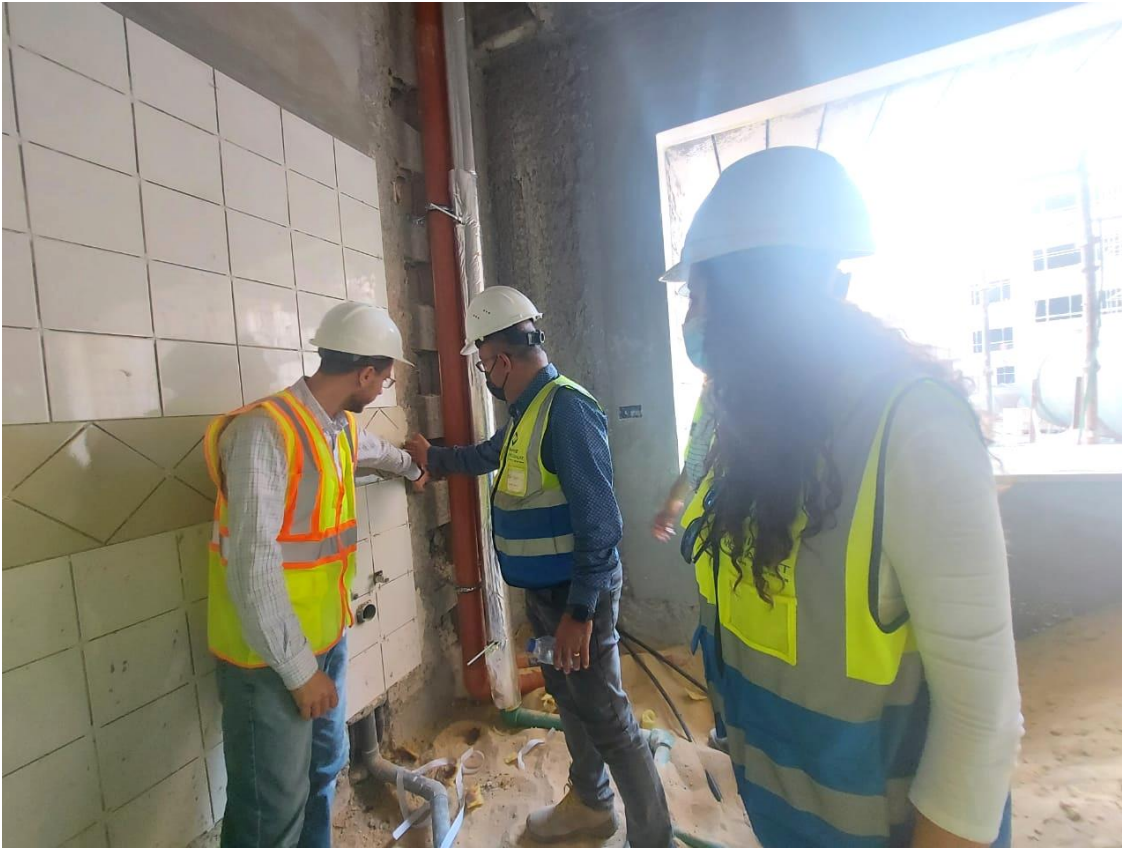
(Figure: 26)

It was observed that the Contractor installed the mechanical PVC pipes at one of the shafts wrongly

4	A general check was conducted to insure that the executed works comply with the approved workshop drawings.
5	It was observed that the Contractor coordinated the mechanical works in the wet areas/first floor in relation to the ceramic walls, door frames and the water cabinets.
6	A general check was conducted on the installed door frames.
7	It was observed that the Contractor executed the first fix of mechanical works at the library while the first fix of electrical works still awaiting.
8	The team observed that the Contractor started with the painting work for window jambs before preparing the plastering to be ready for painting.
9	The installed sample of steel protection grill for window at the mock-up room was inspected by the visiting team.
10	It was observed that the Contractor shifted number of water cabinets as per the supervision team previous instructions.
11	It was observed that the Contractor installed the mechanical PVC pipes at one of the shafts wrongly in relation to its location and accordingly the block partition for the shaft cannot be executed. The Contractor was requested to shift those pipes inside the shaft to allow for the block to be built.

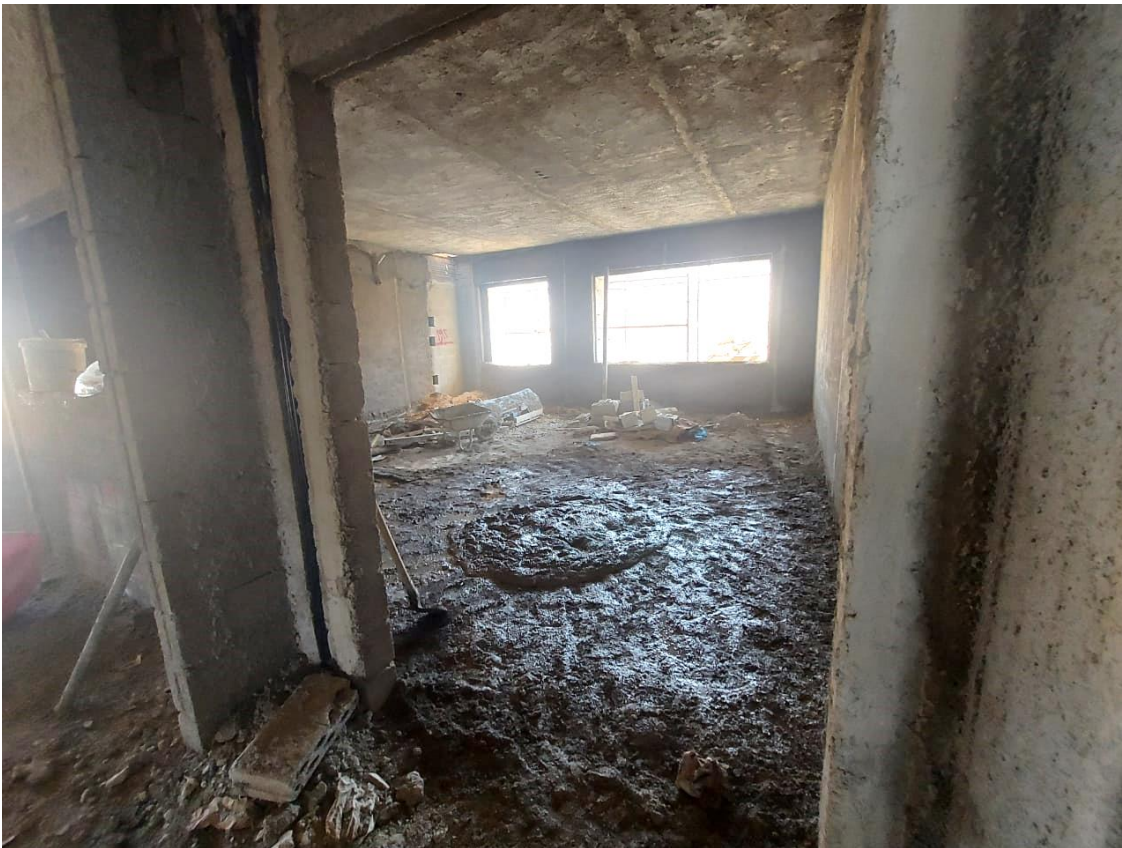
(Figure: 27)

the Consultant stressed on using clean platform for mortar mixing as the available on site does not comply with what was requested
