Quality Control Report

Consultant **Wahib Medanat** Consultant Engineers
Site Name **Thahr Al Sarow Basic Boys - Jerash**
Package **Package 2**
Contractor **Dijlah Est. Construction Co.**
Tender No. **10/2019/USAID/SKEP/3/2**

Rep No. **QC-22 10**
Date **15 / 11 / 2021**

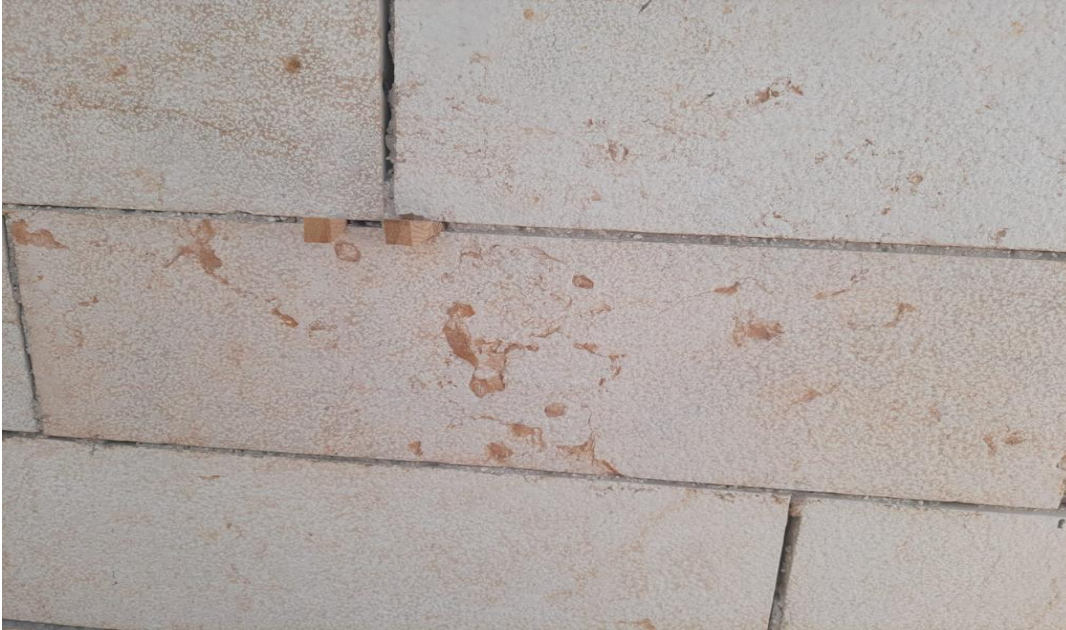
Defected built stones

Description of Non Conformance	Corrective Action	Required by / When
1. Defected built stones. 2. Defects in accoustical plastering. 3. Unacceptable finishing of ceramic tiles at the door frames.	1. Replace. 2. Rectify. 3. Replace tiles.	The Contractor/Immediately
Report Prepared by	Hassan Shaqbua, Supervision Quality Control Manager

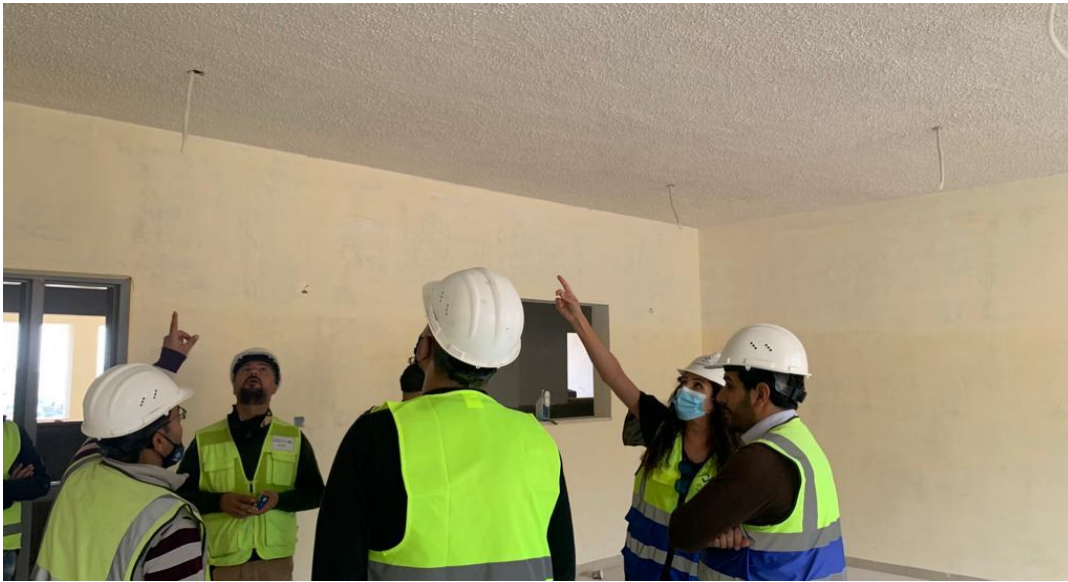
Defects in accoustical plastering

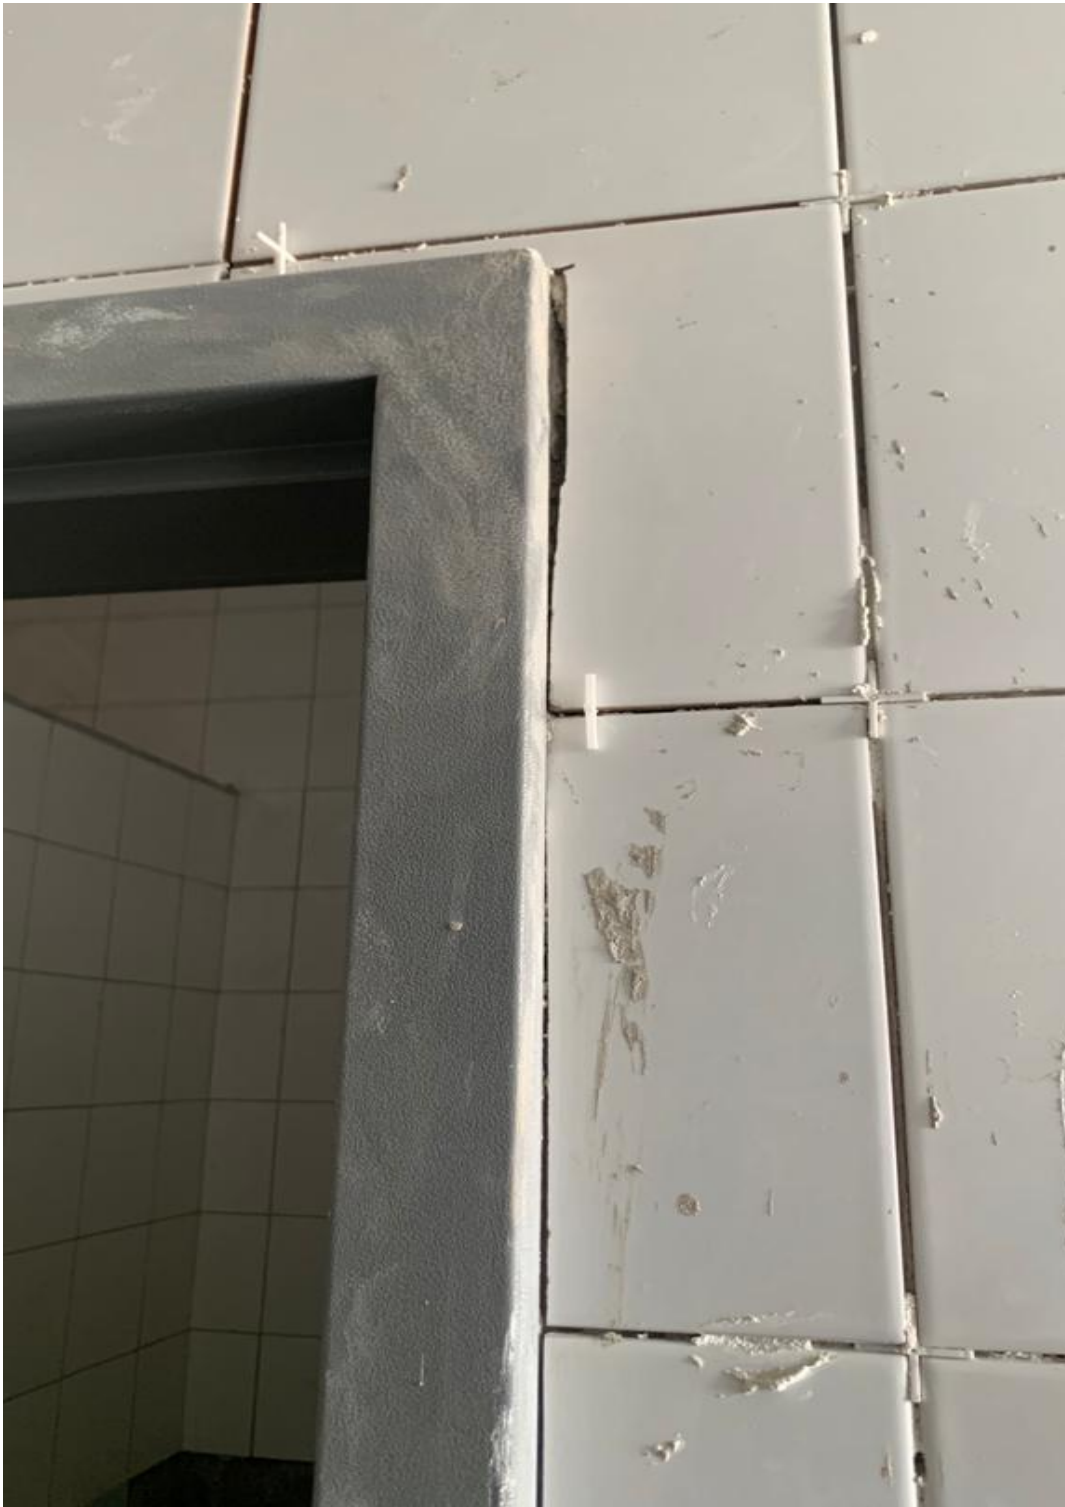
Unacceptable finishing of ceramic tiles at the door frames

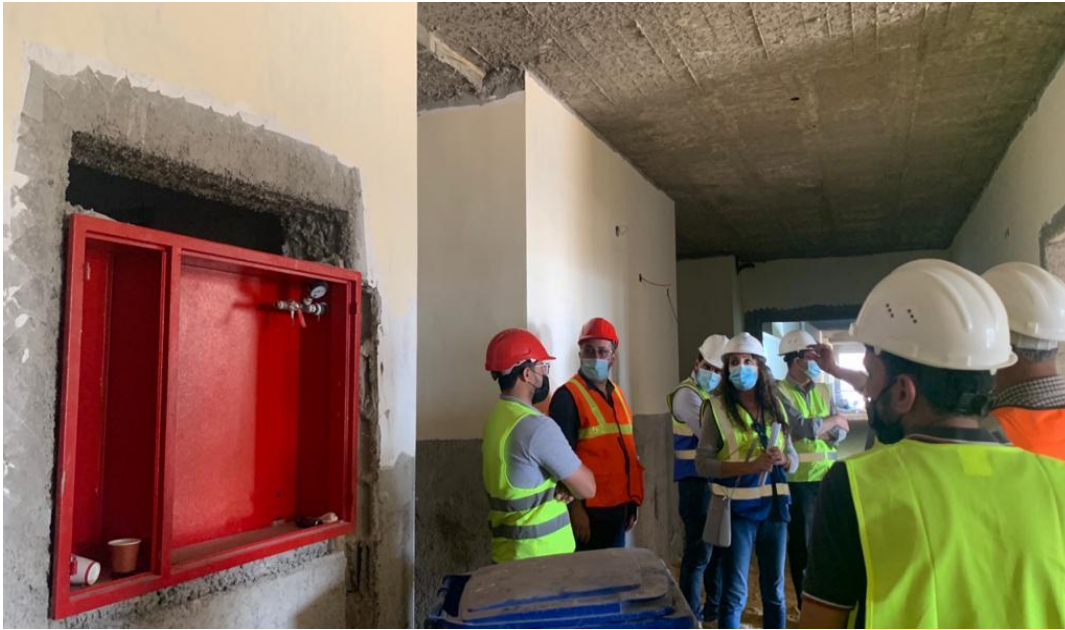
Space over the fire hose cabinet needs to be casted

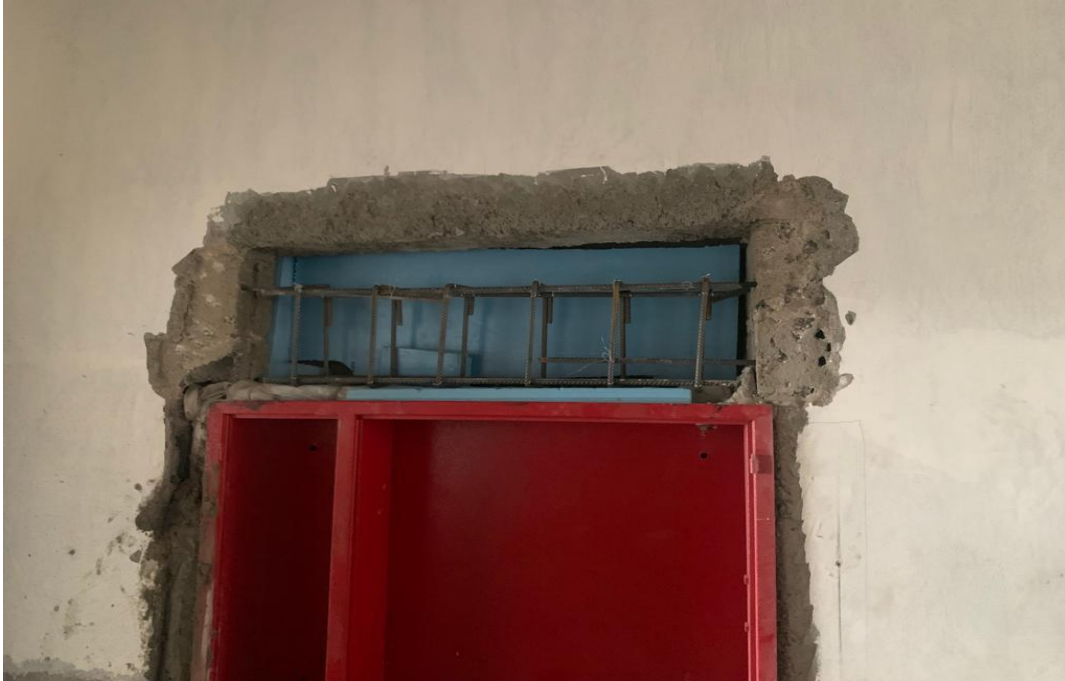
Steel reinforcement for lintel over the fire hose cabinet

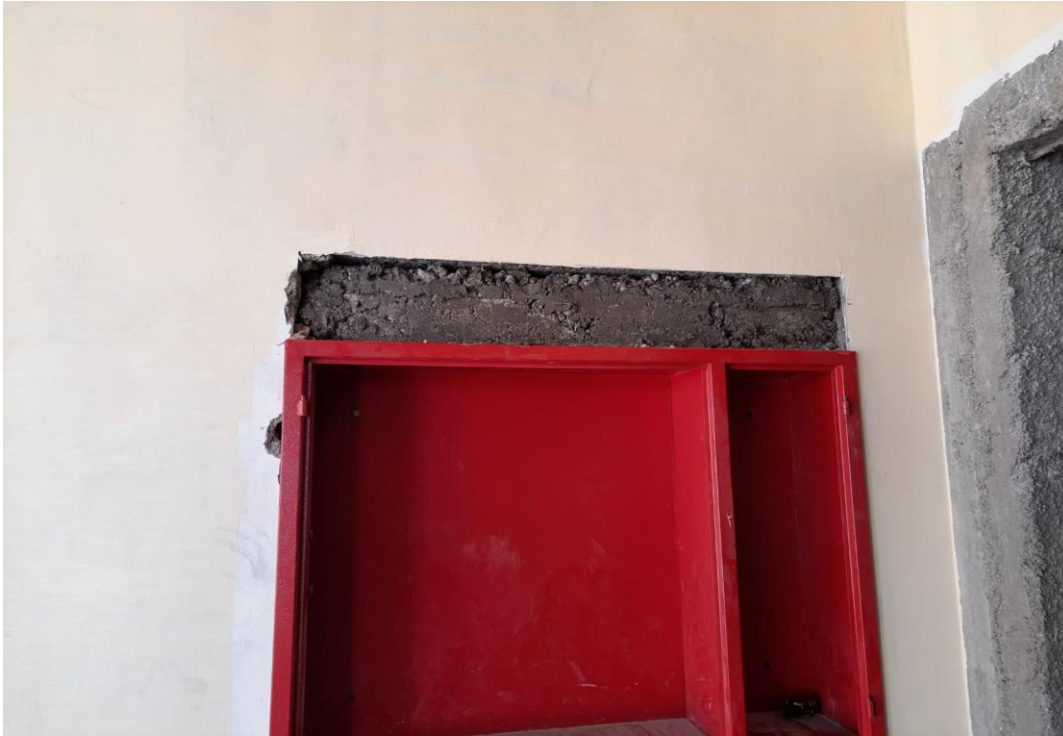
Casting concrete for the lintel over the fire hose cabinet
