Quality Control Report

Consultant **Wahib Medanat** Consultant Engineers
Site Name **Jumana Bint Abi Taleb Basic Mixed - Marka**
Package **Package 2**
Contractor **Dijlah Est. Construction Co.**
Tender No. **10/2019/USAID/SKEP/3/2**

Rep No. **QC-23 12**
Date **22 / 11 / 2021**

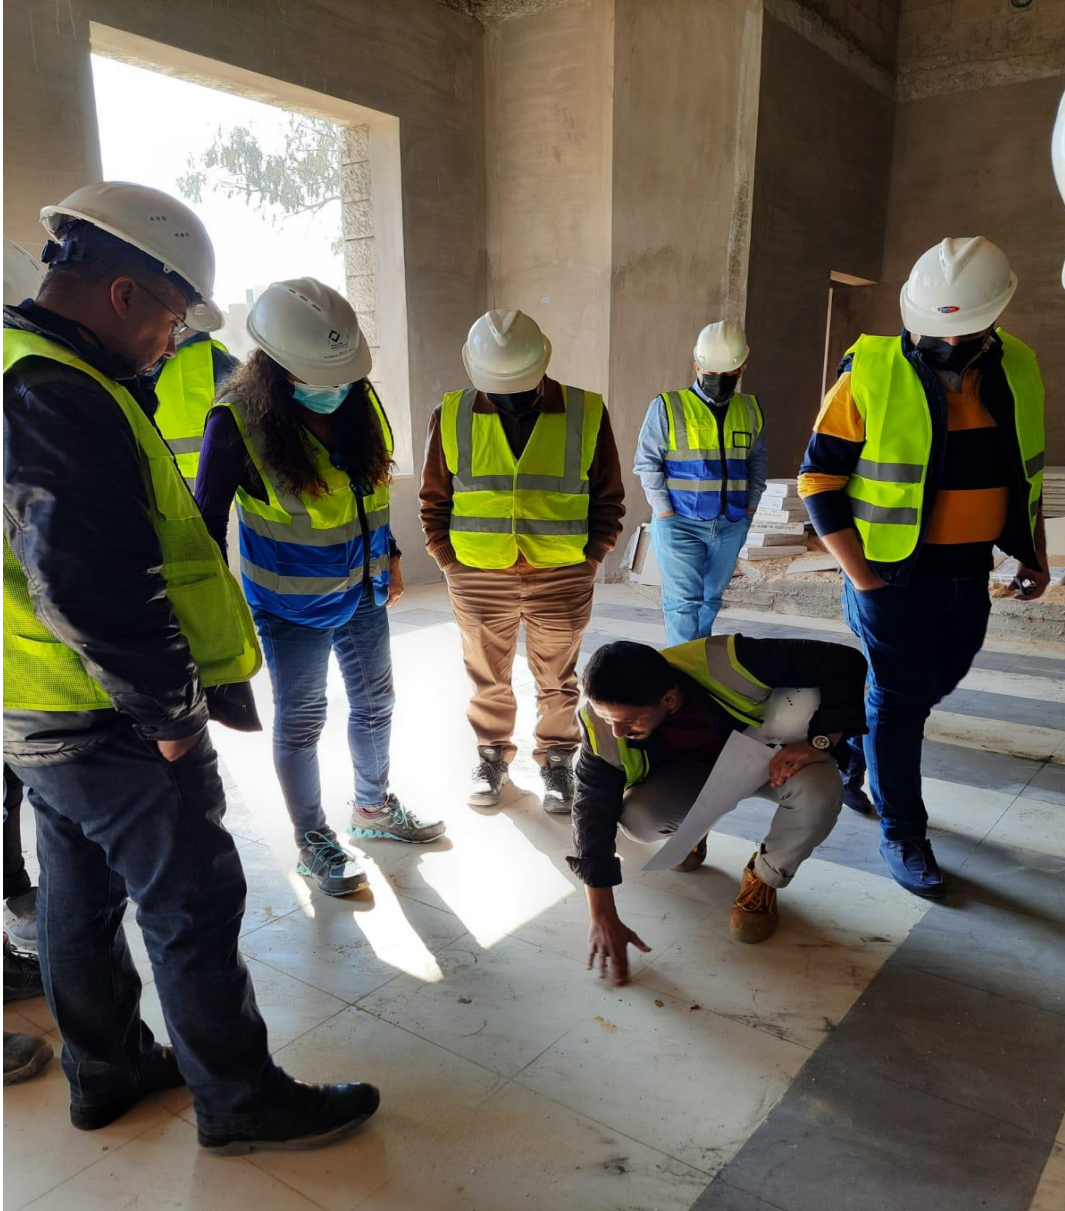
Teething observed at floor tiles

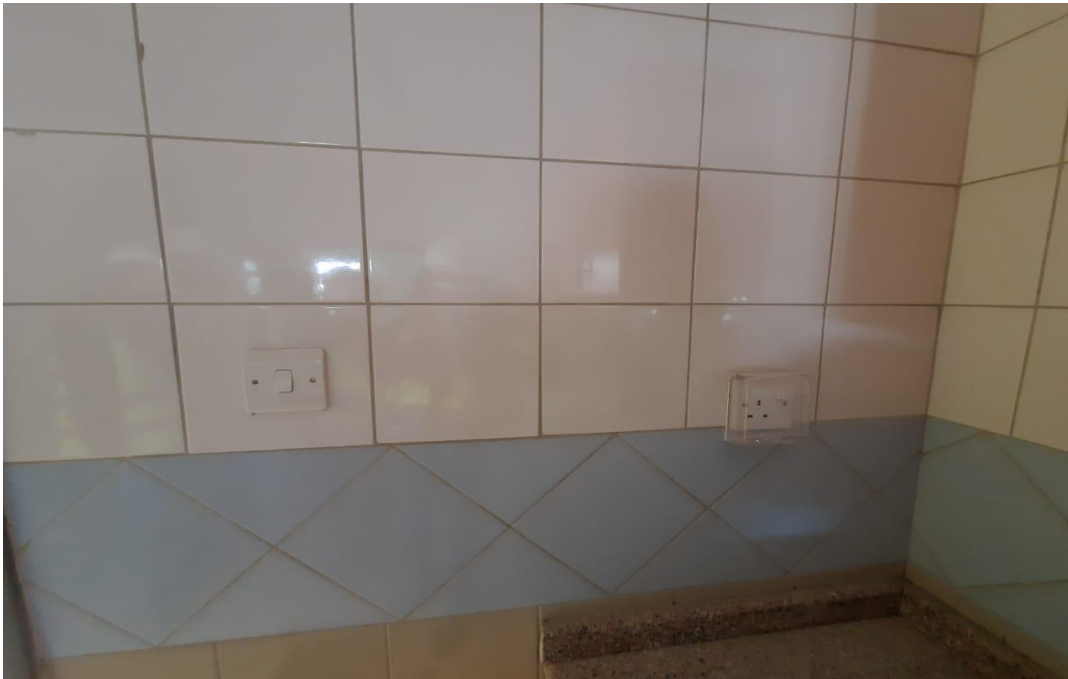
Inappropriate electrical sockets location at the internal façade

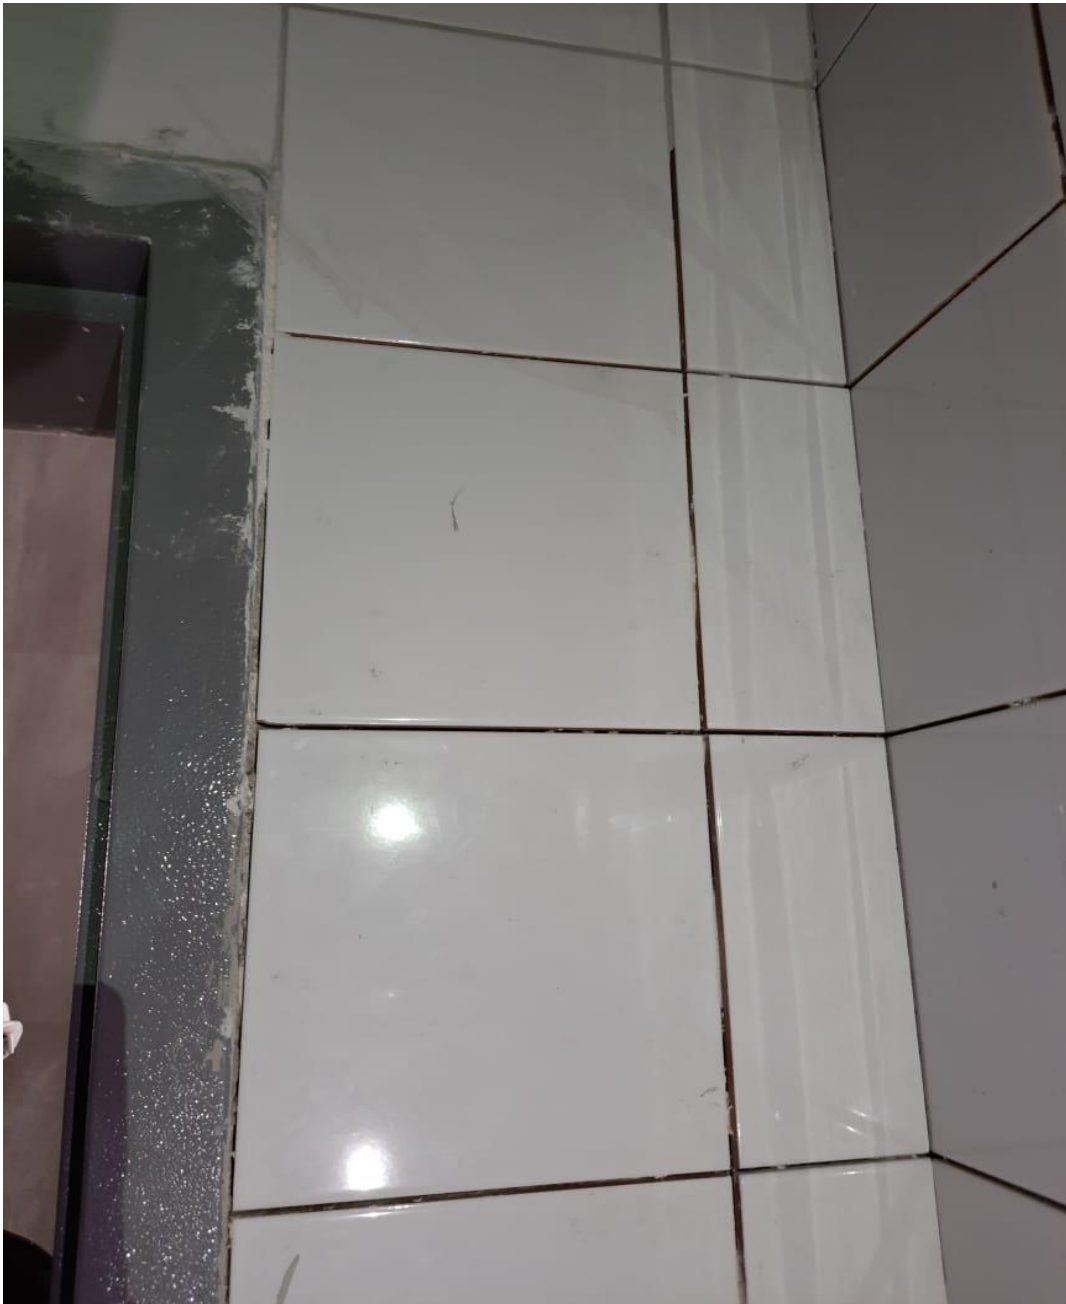
Inappropriate finishing of tiles at the door frames

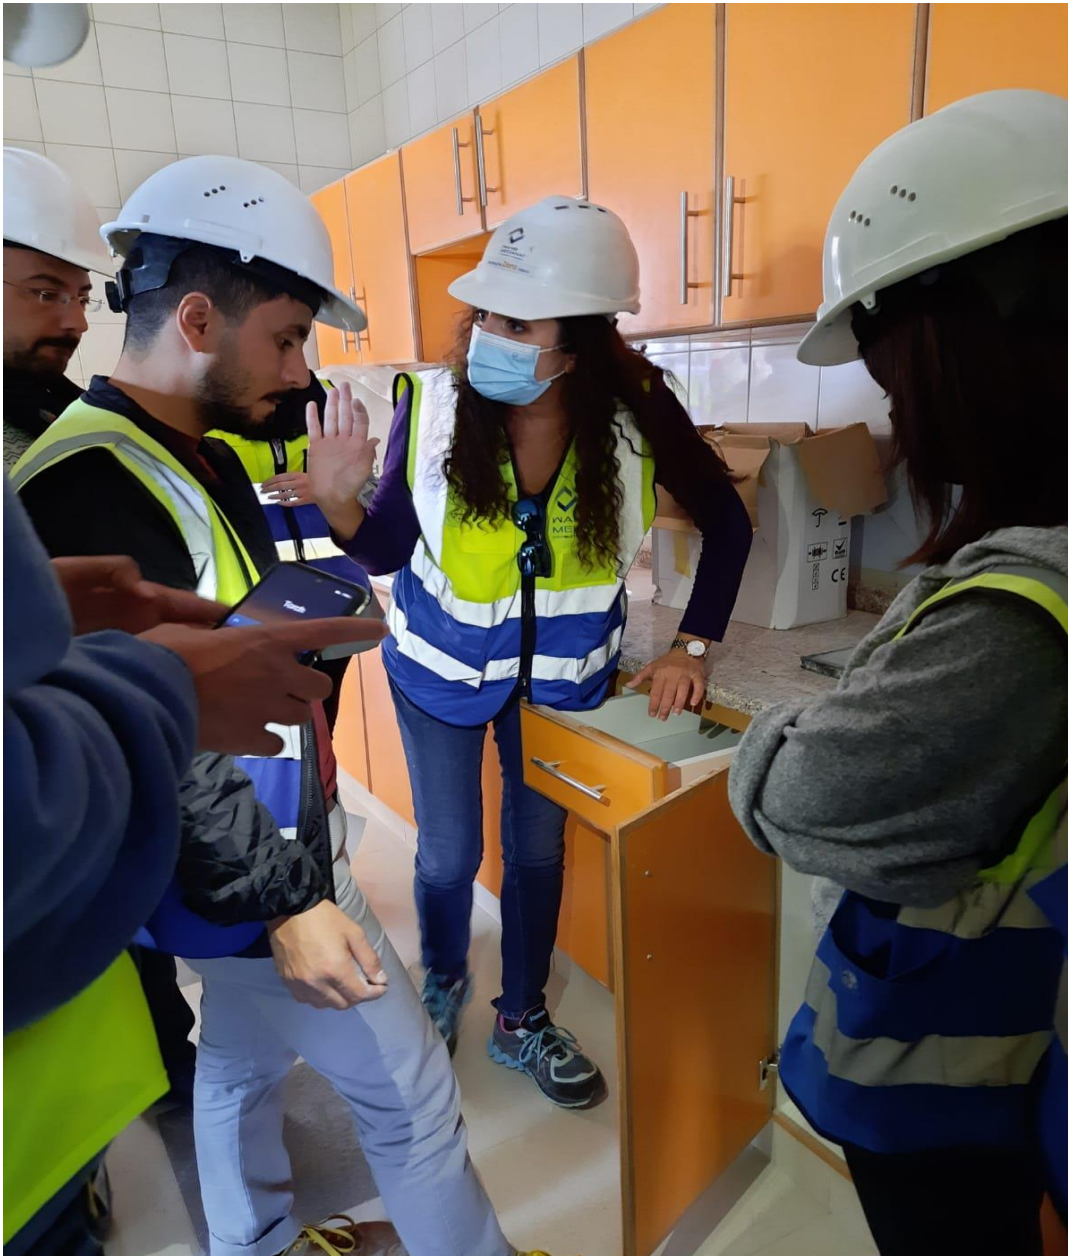
uncomplied beach wood frames

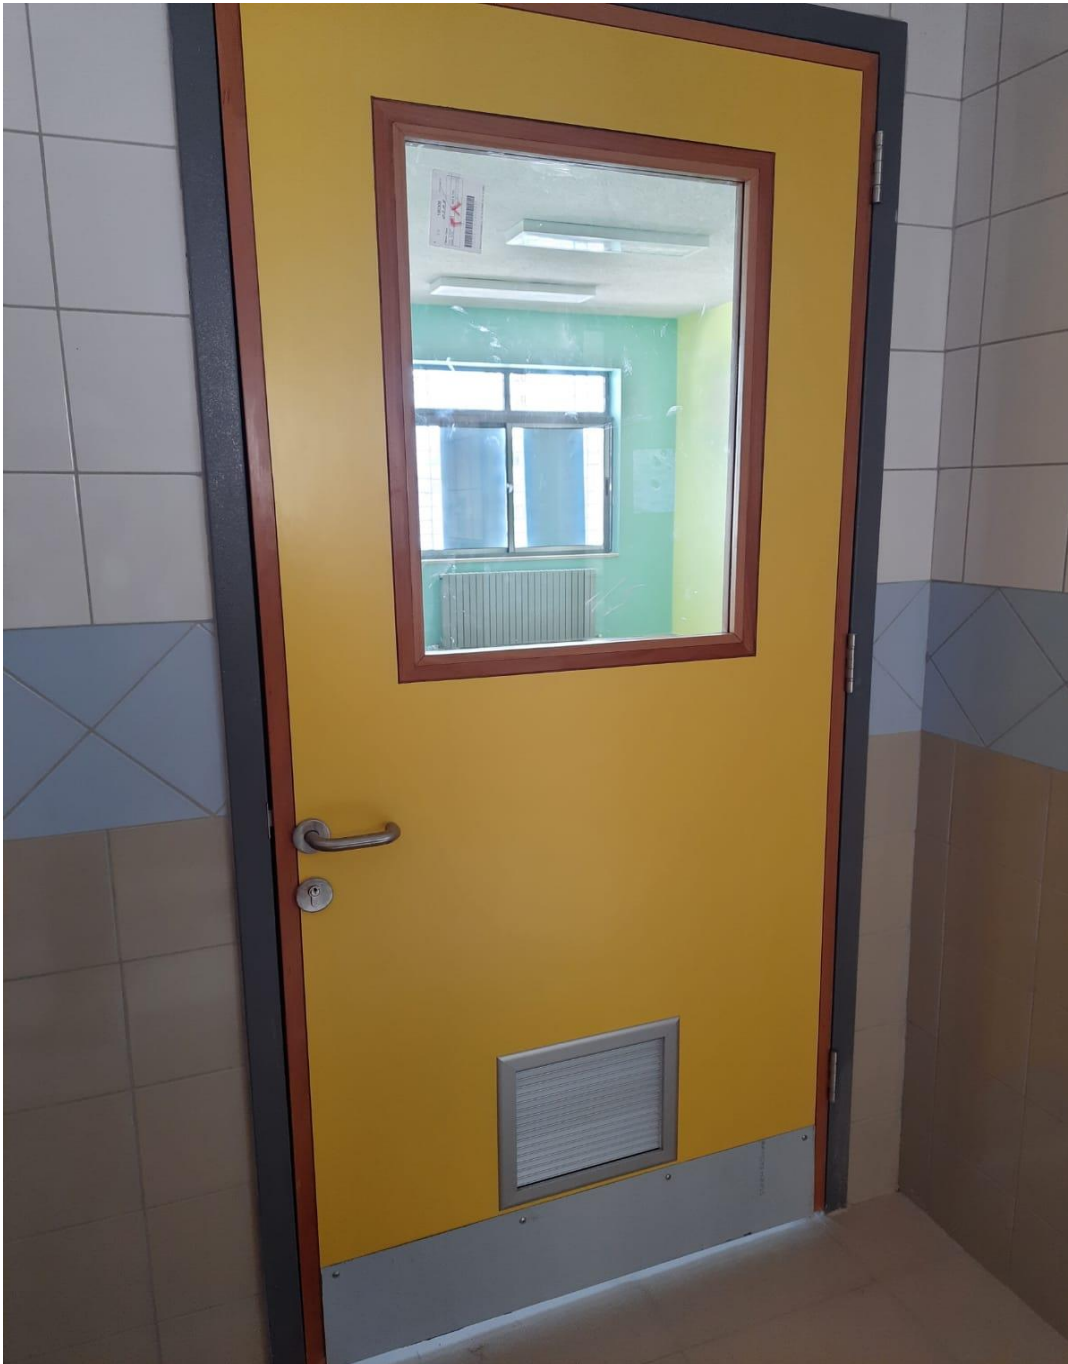
Uncomplied beach wood frames

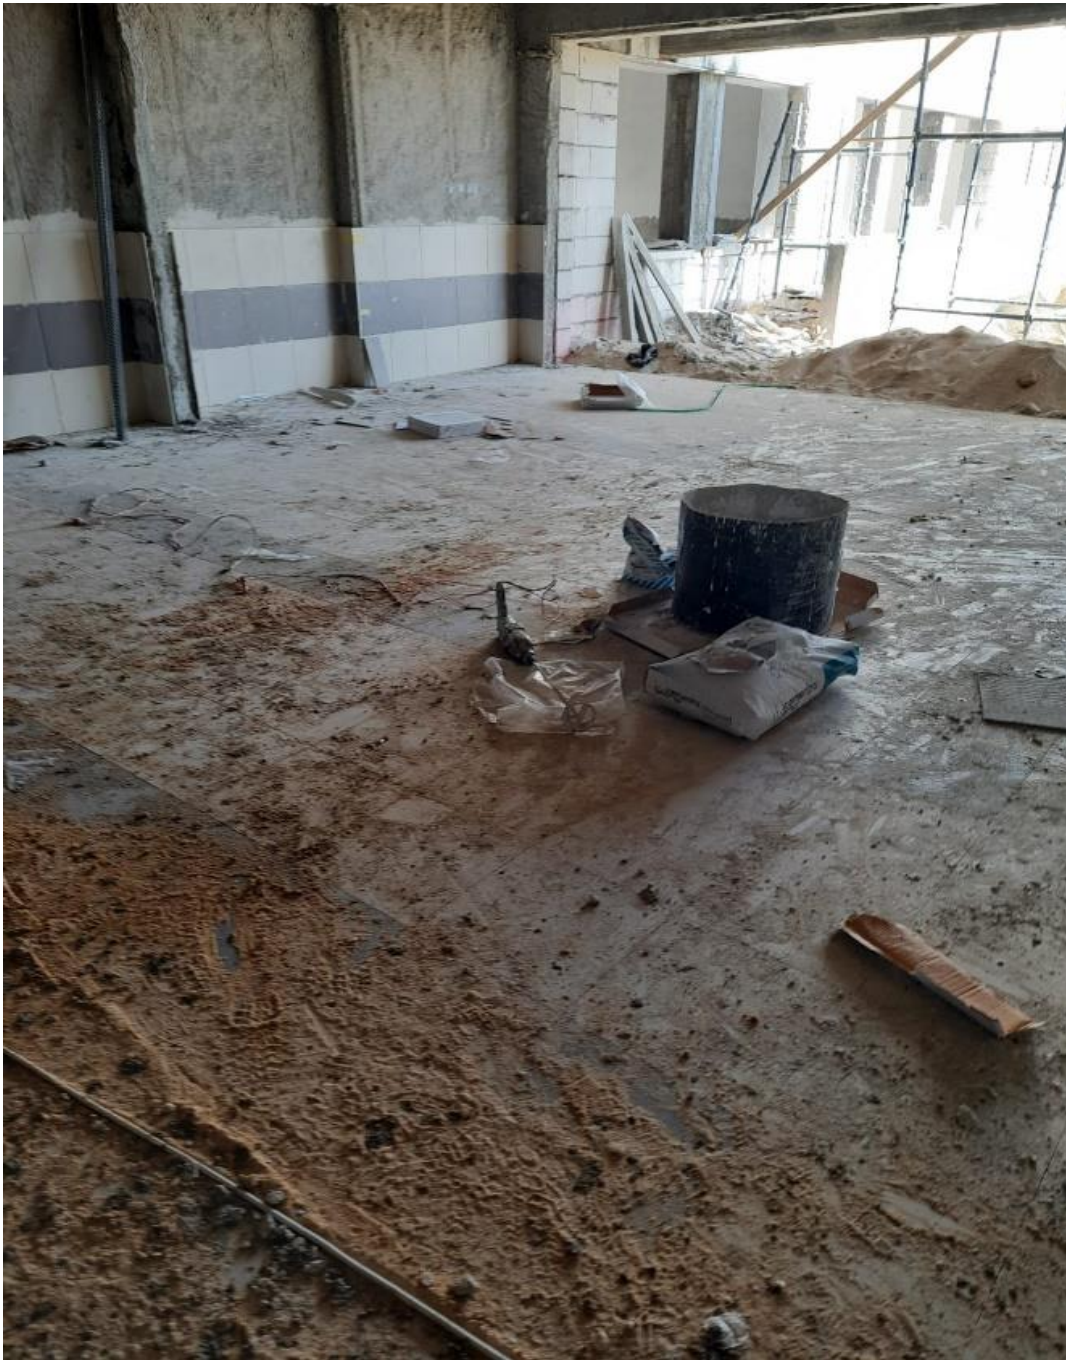
Unprotected tiling

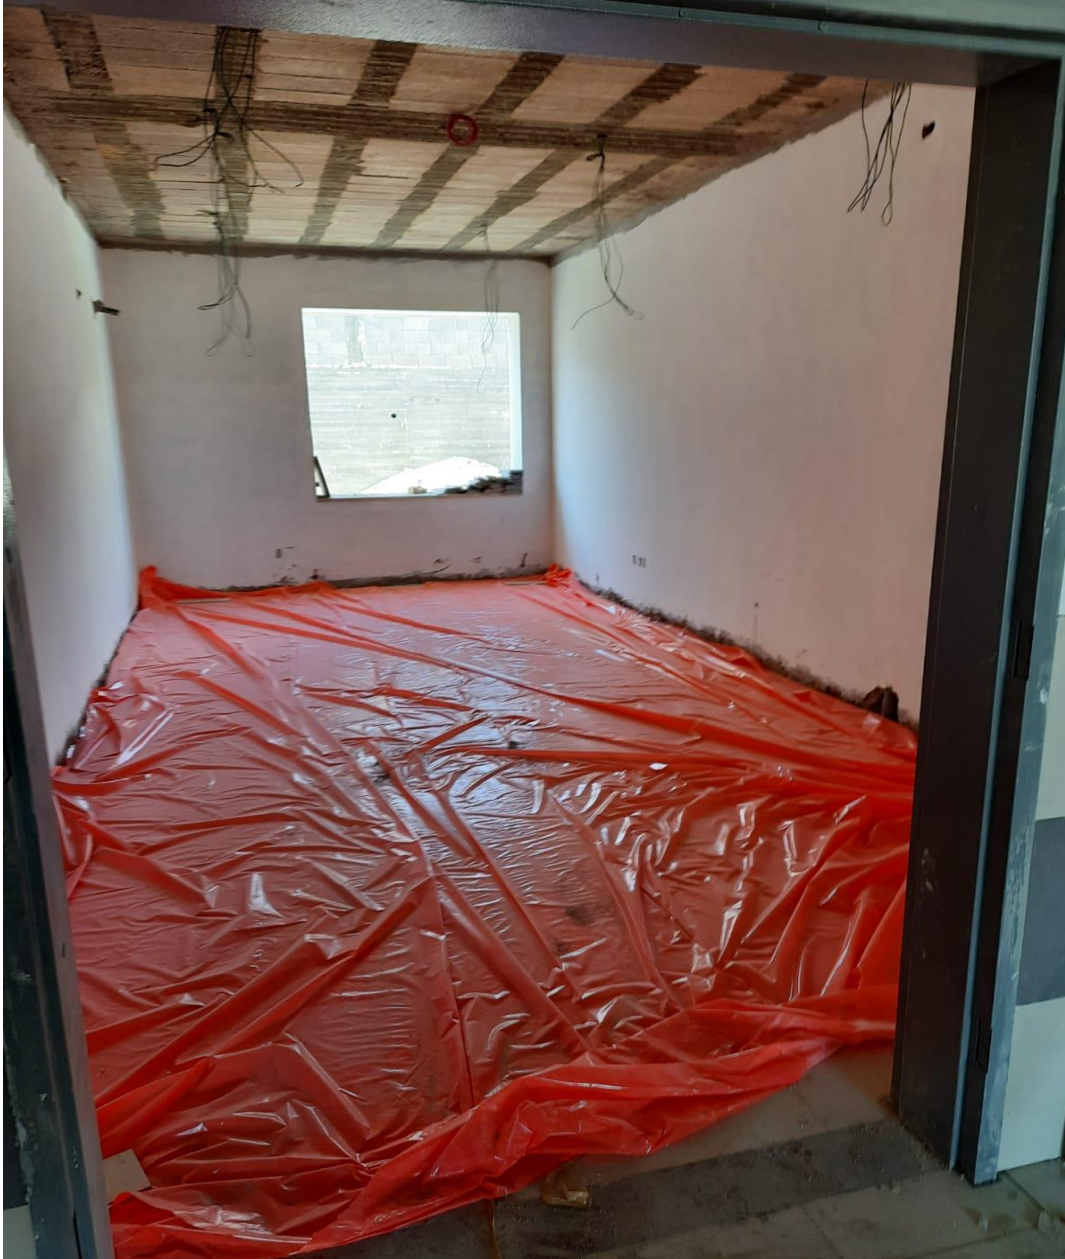
Protected tiling
