| Consultant | Wahib Medanat Consultant Engineer | Rep No. | 11-22112021 |
| Contractor | Derar Saraireh & Sons for Engineering & Contracting | Tender No. | (11/2019/USAID/SKEP/3/S) Schools for a Knowledge Economy Project (SKEP) - Phase (3) Package (1, 2) |
| Site Name | Um Al Dananir Basic Mixed School- Al Balqa | Day/ Date | Mon. 22/11/2021 |

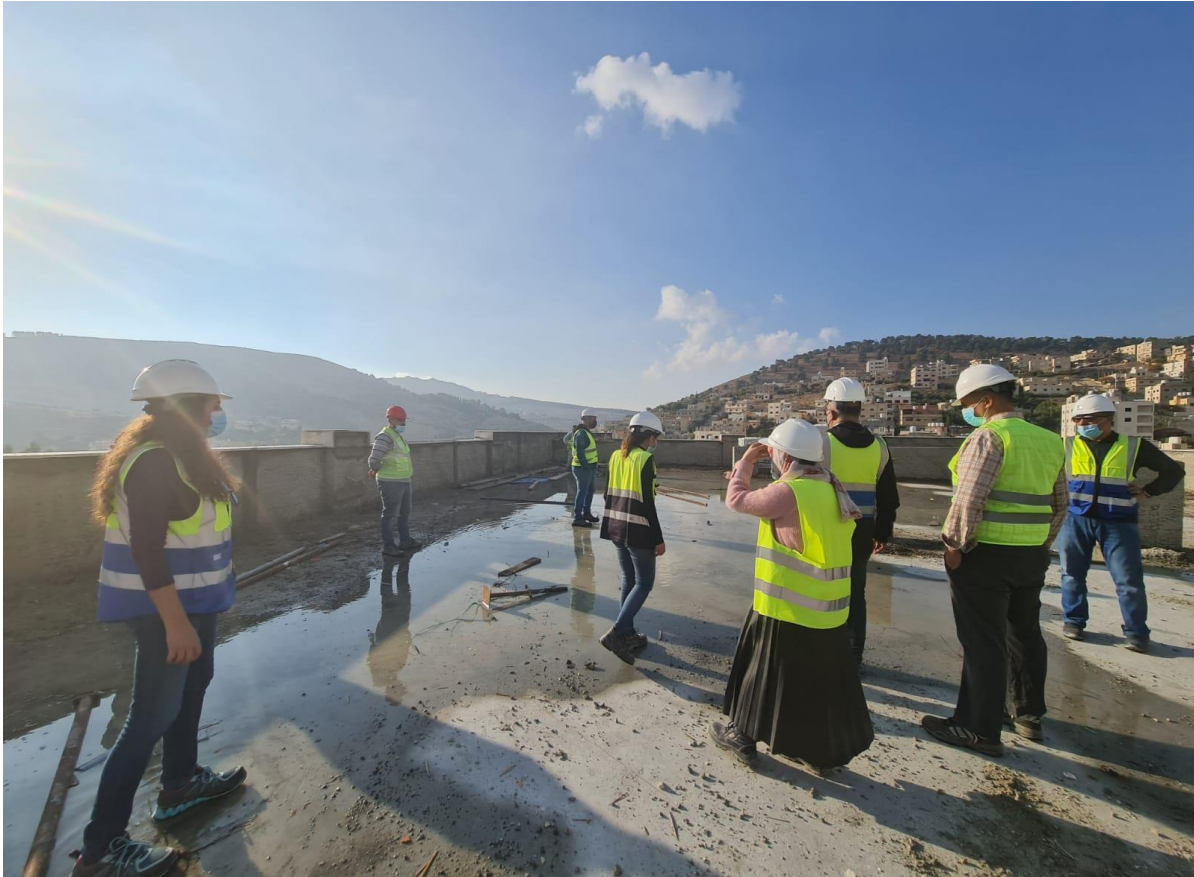
(figure:05)

| No. | Description |
|---|--|
| 1 | Due to that the roof is still not waterproofed despite our reminder to the Contractor, it was observed that the rain water is gathering in some areas at the roof and a leakage of this water through the roofs and walls of the building. |

It was observed that the rain water is gathering in some areas at the roof and leakage of this water through the roofs and walls of the building

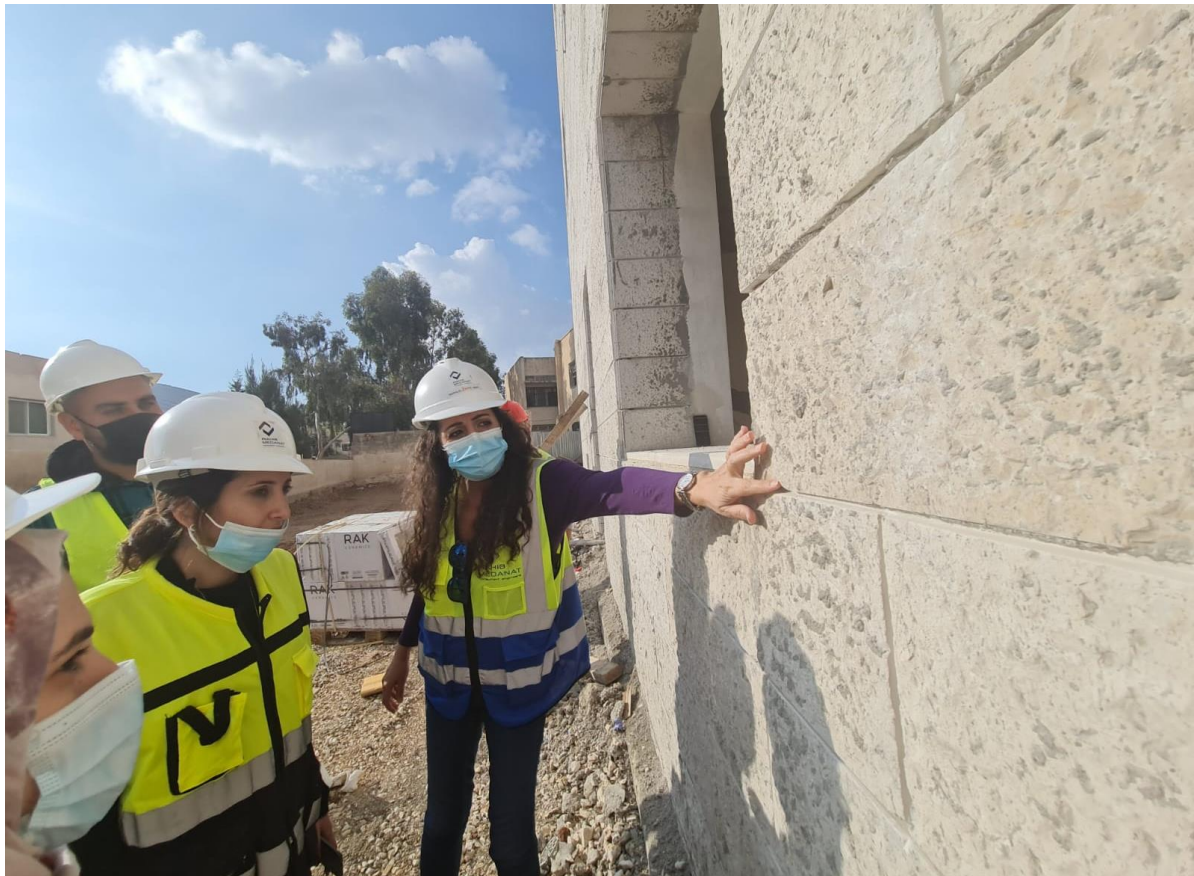
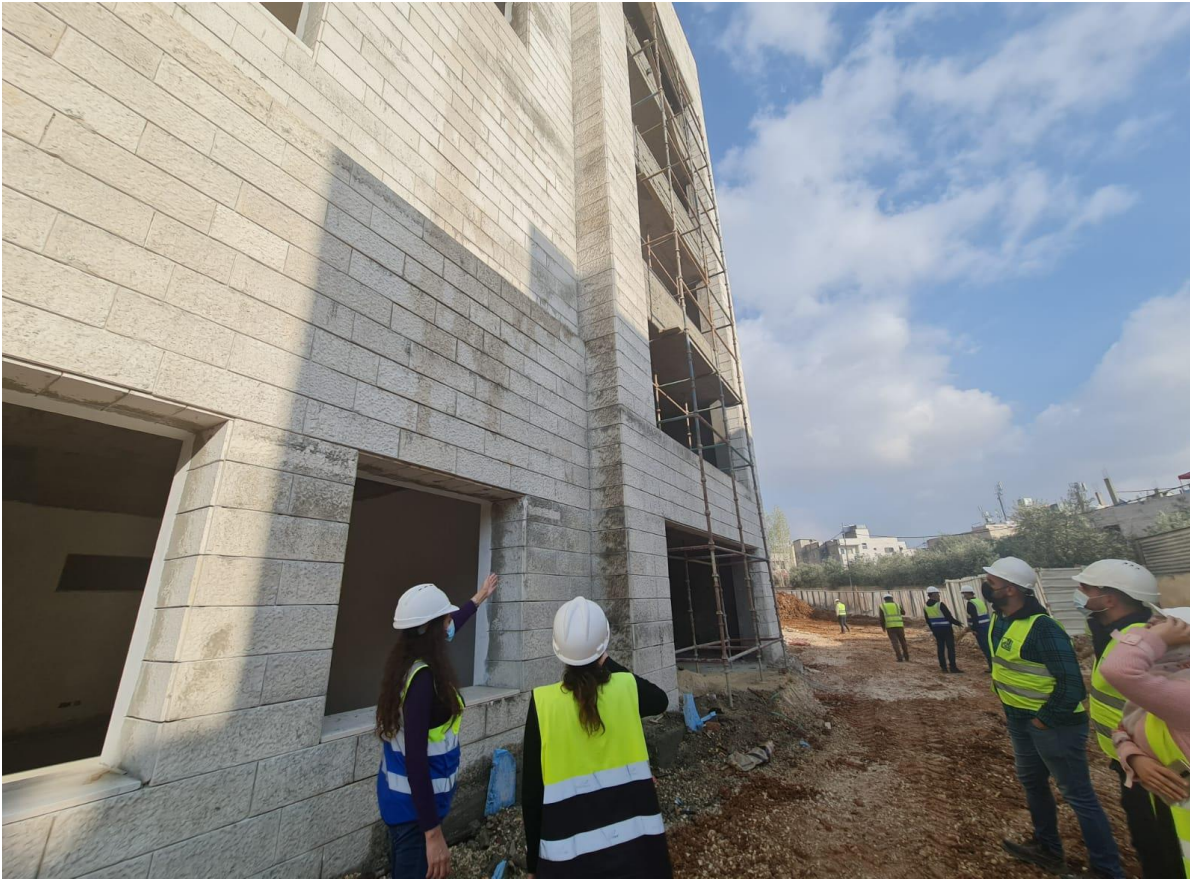
(figure:06 & 07)

| 6 | General inspection has been conducted on the built stones at facades and general remarks were provided to the Contractor. |

General inspection has been conducted on the built stones at facades and general remarks were provided to the Contractor

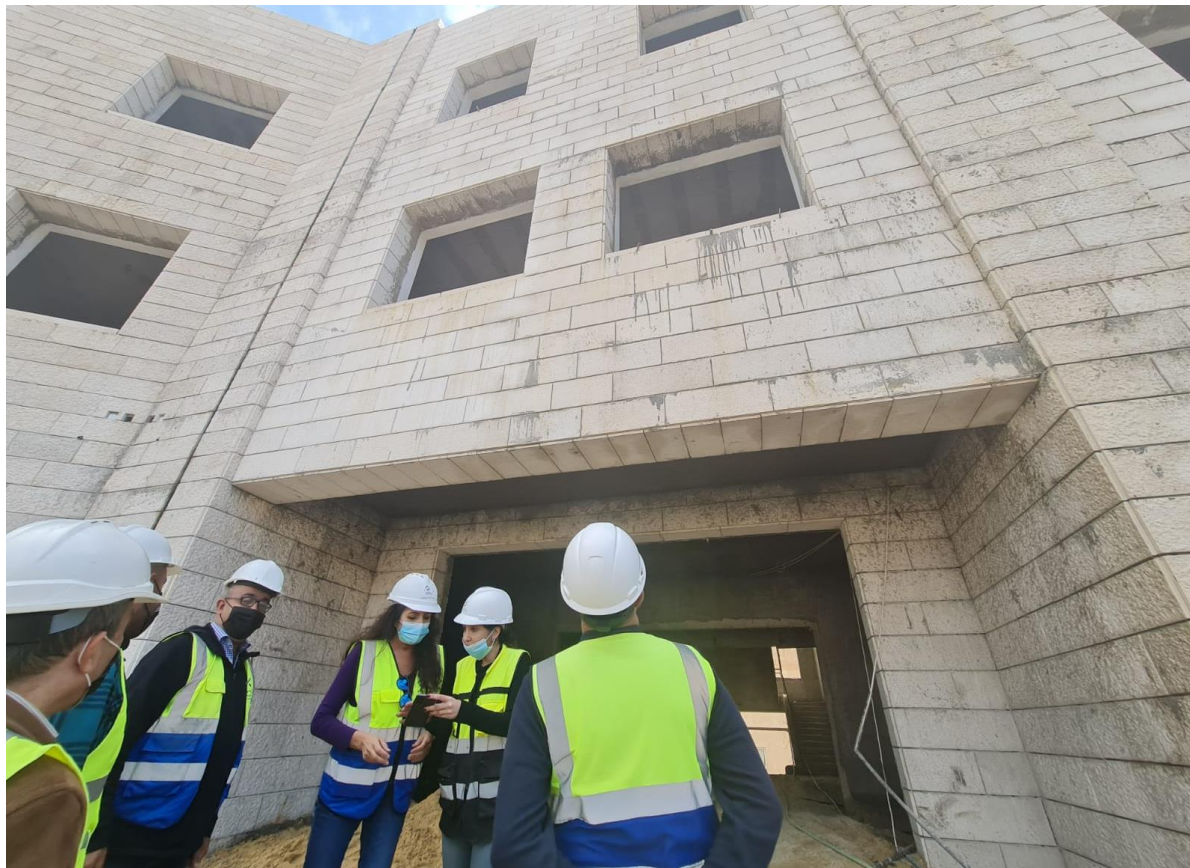
(figure:08)

At the main entrance of the building, amount of rainwater coming down from the water gathered at the roof slabs, this due to that works are not completed especially the waterproofing items

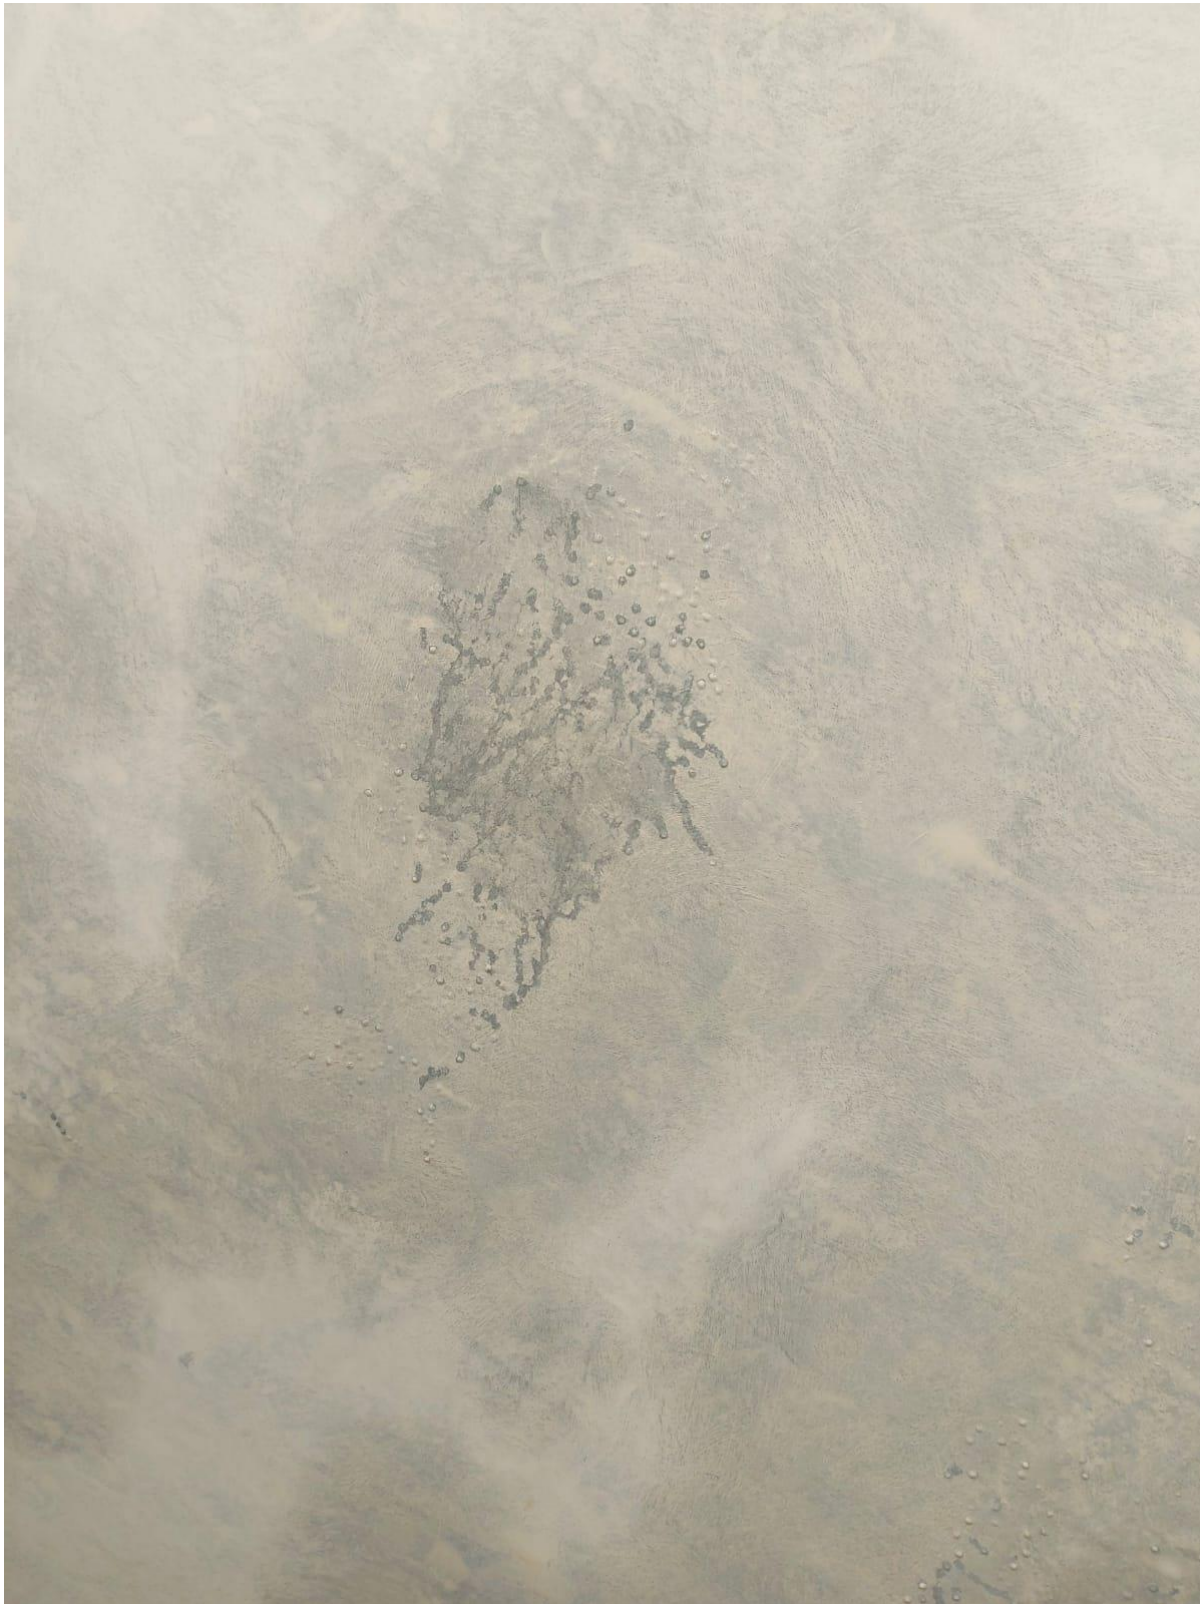
(figure:09)

This is due to water penetration, the Contractor should repair such defects and avoid similar defects before starting with painting work

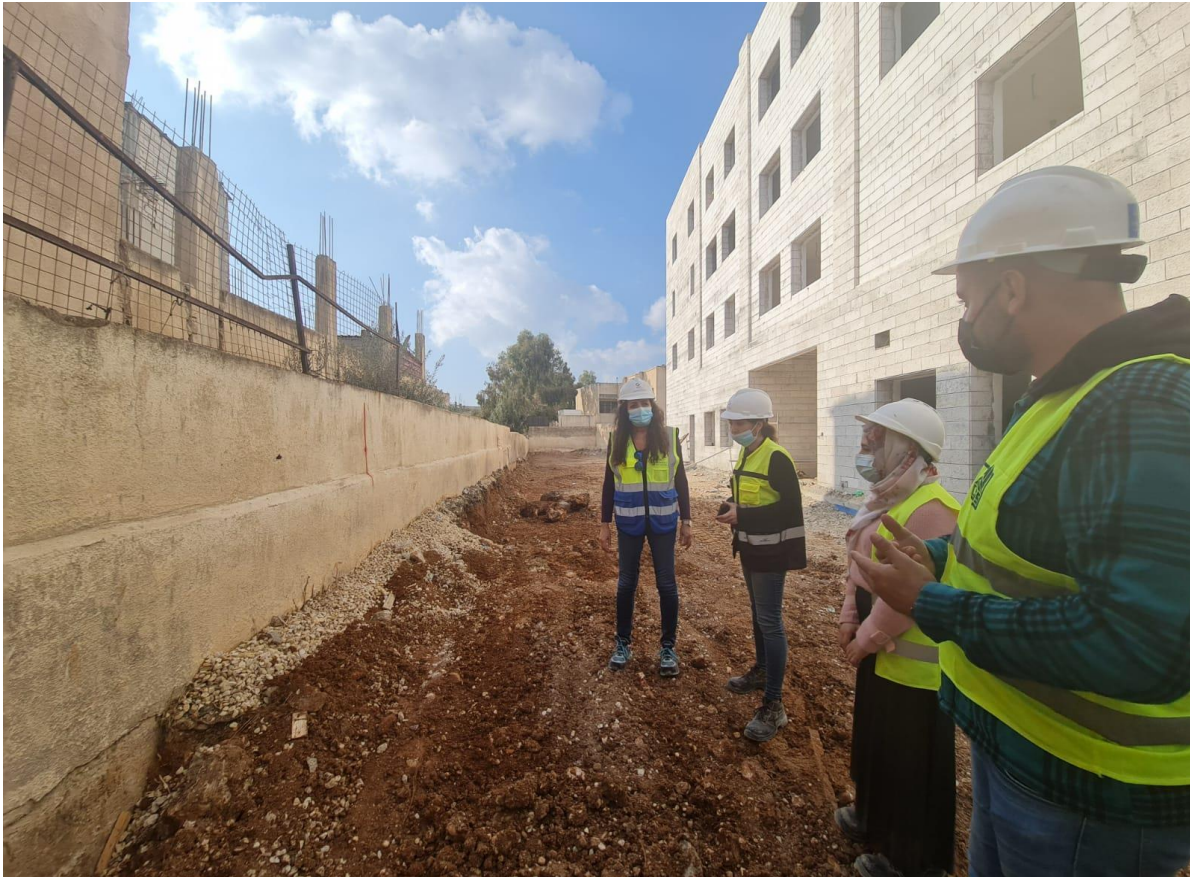
(figure: 10)

| 5 | It was observed that the Contractor started with the excavation work for the boundary wall adjacent to the neighbor. |

It was observed that the Contractor started with the excavation work for the boundary wall adjacent to the neighbor

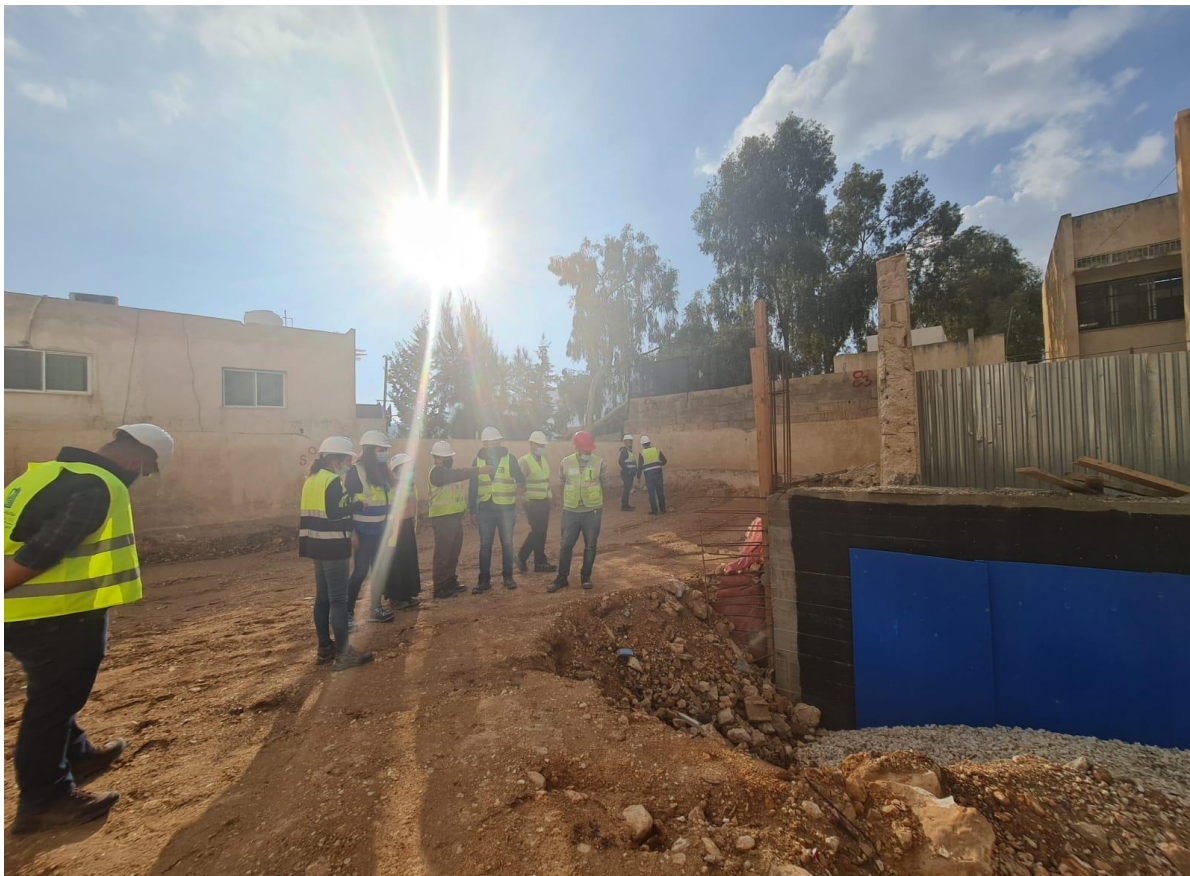
(figure: 11)

| 7 | The single size backfilling activity for external boundary walls was inspected. Remarks were provided to the Contractor such as finalizing the cartonal layer before backfilling. |

The single size backfilling activity for external boundary walls was inspected. Remarks were provided to the Contractor such as finalizing the cartonal layer before backfilling

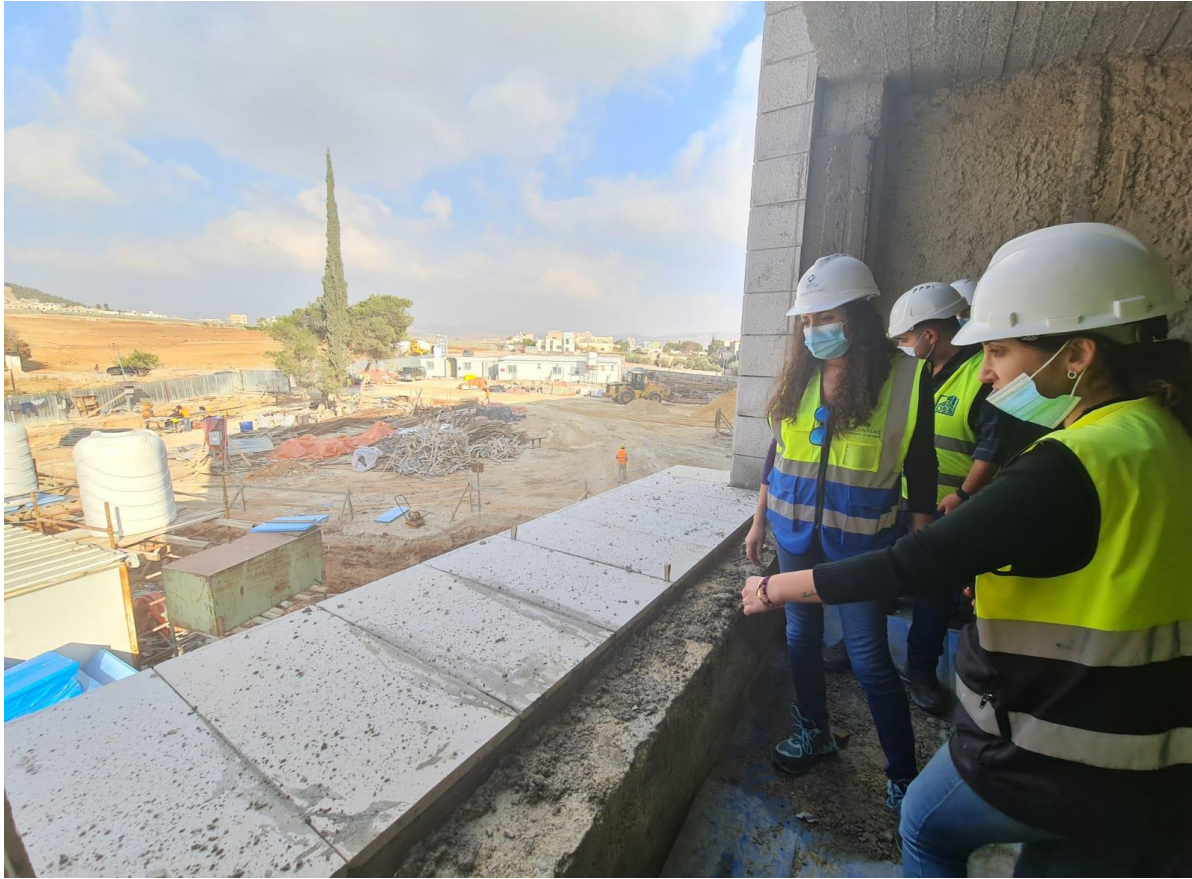
(figure:12)

| 4 | It was observed that the Contractor installed stone at the window sills and that he will start installing the marble soon to hold the curtain walls. |

It was observed that the Contractor installed stone at the window sills and that he will start installing the marble soon to hold the curtain walls

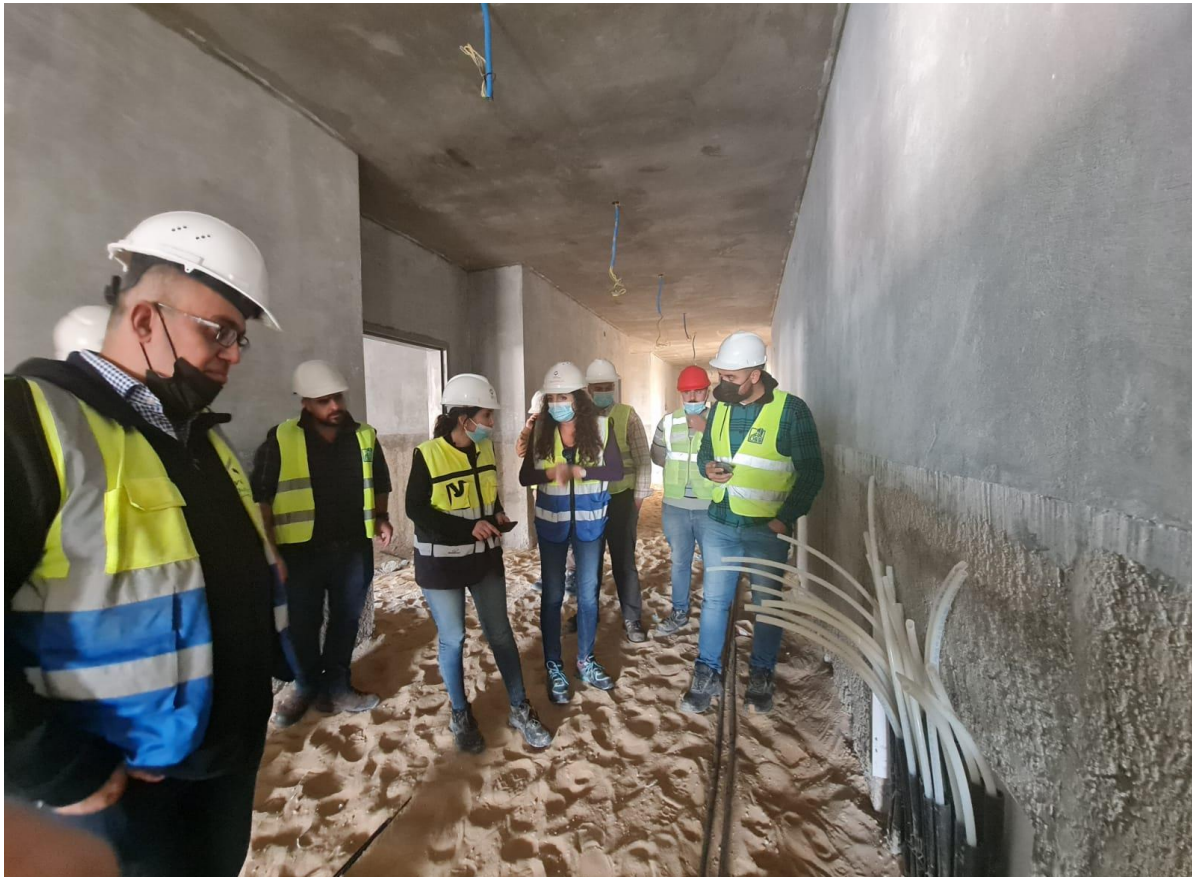
(figure:13)

| 11 | The location of fire hose cabinet in the corridor was discussed to ensure appropriate Porcelain cut-off pieces. |

The location of fire hose cabinet in the corridor was discussed to ensure appropriate ceramic cut-off pieces

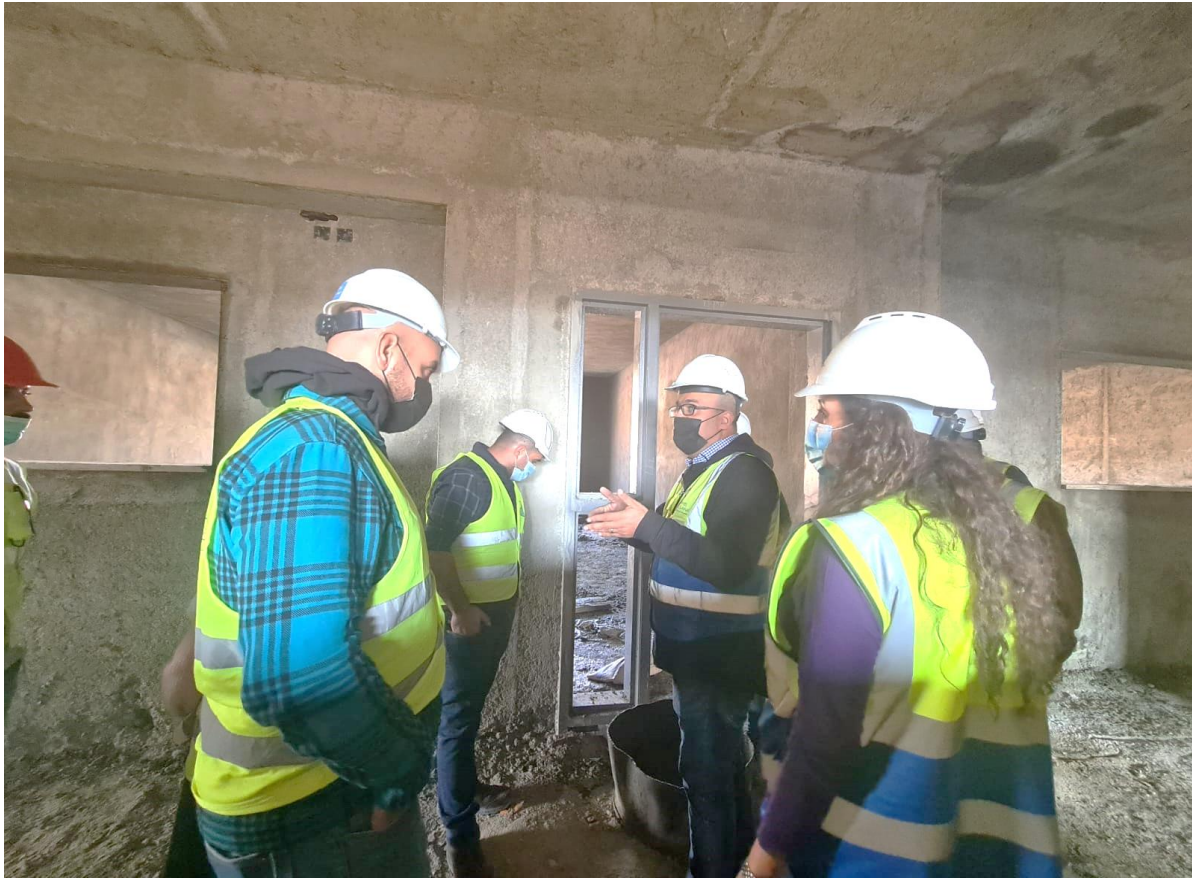
(figure:14)

| No. | Description |
|---|--|
| 3 | It was observed that there were cement mortar residues and other dirt on the installed door frames. The Contractor was reminded with the need to cover and protect those frames and he promised to implement the protection without delay. |

It was observed that there were cement mortar residues and other dirt on the installed door frames. The Contractor was reminded with the need to cover and protect those frames and he promised to implement the protection without delay

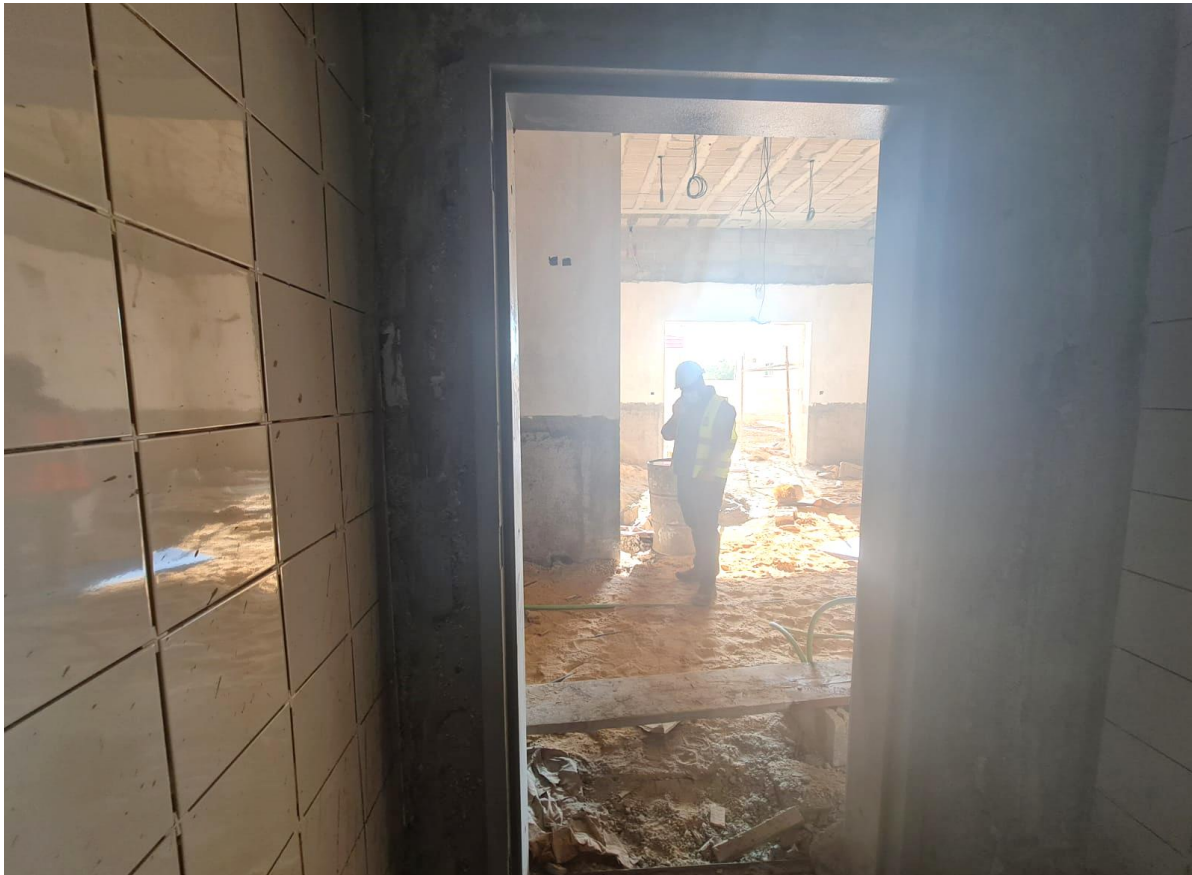
(figure:15)

| 8 | It was observed that the Contractor replaced defected door frame by complied one. The new frame is installed insuring appropriate ceramic cut-off pieces. |

It was observed that the Contractor replaced defected door frame by complied one. The new frame is installed insuring appropriate ceramic cut-off pieces

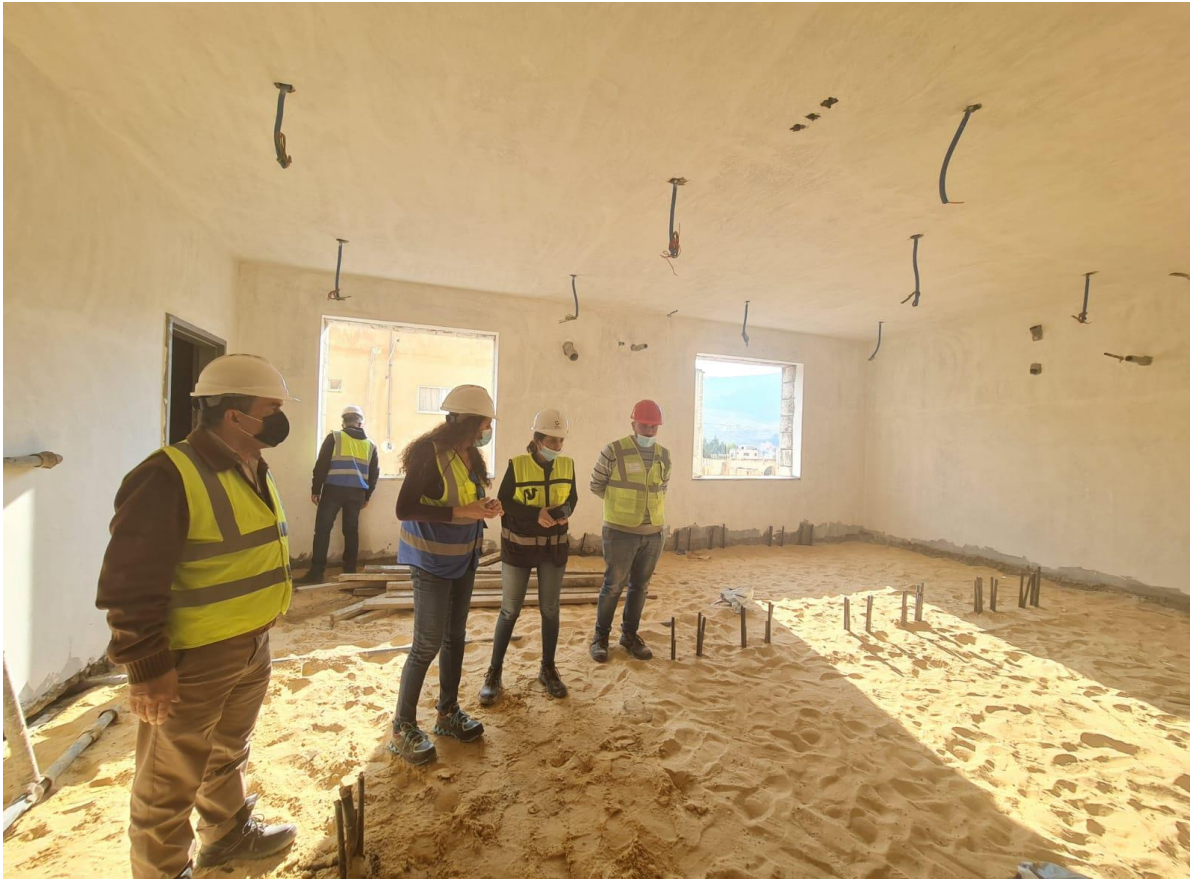
(figure:16)

| 12 | It was observed that the Contractor completed the electromechanical installations at the laboratories with the inspection and approval of the supervision. |

It was observed that the Contractor completed the electro-mechanical installations at the laboratories with the inspection and approval of the supervision

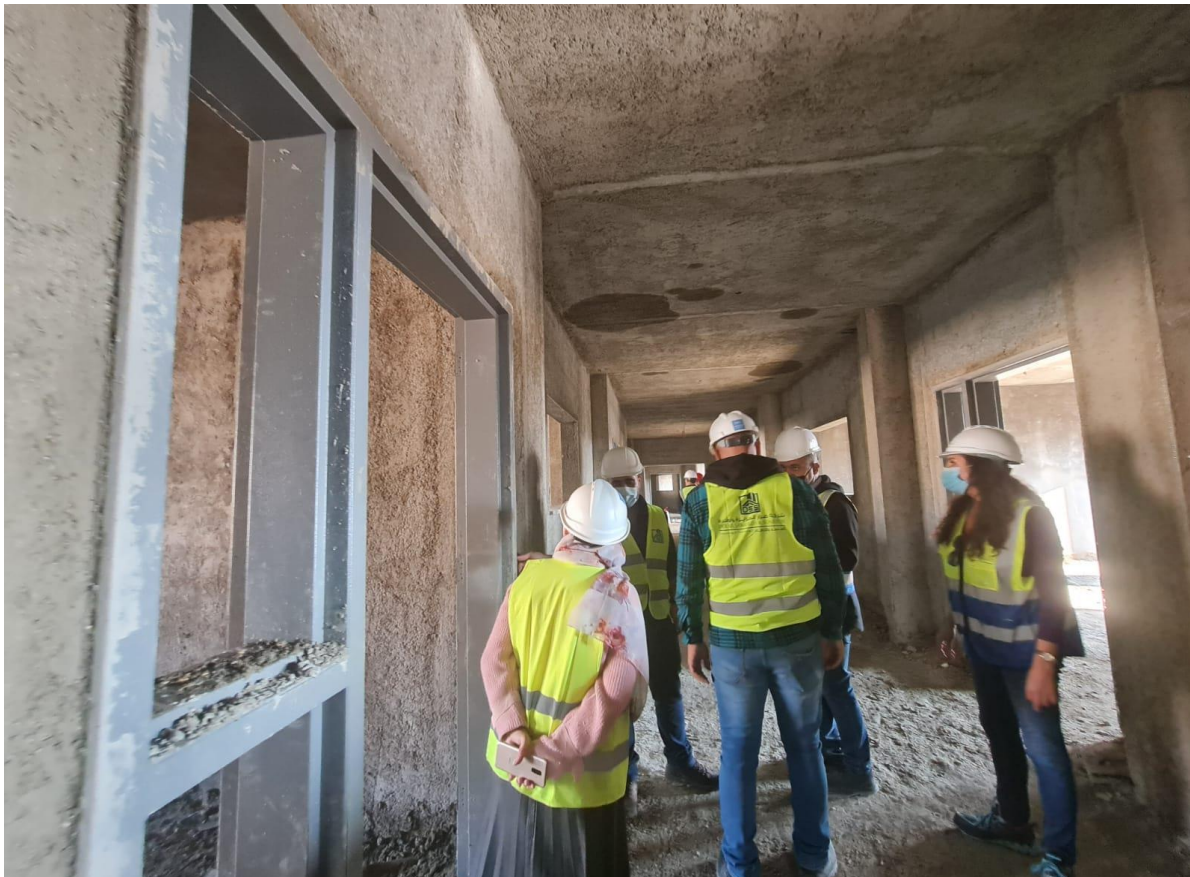
(figure:17)

| 13 | The team inspected the plastering works at the corridors |

The team inspected the plastering works at the corridors

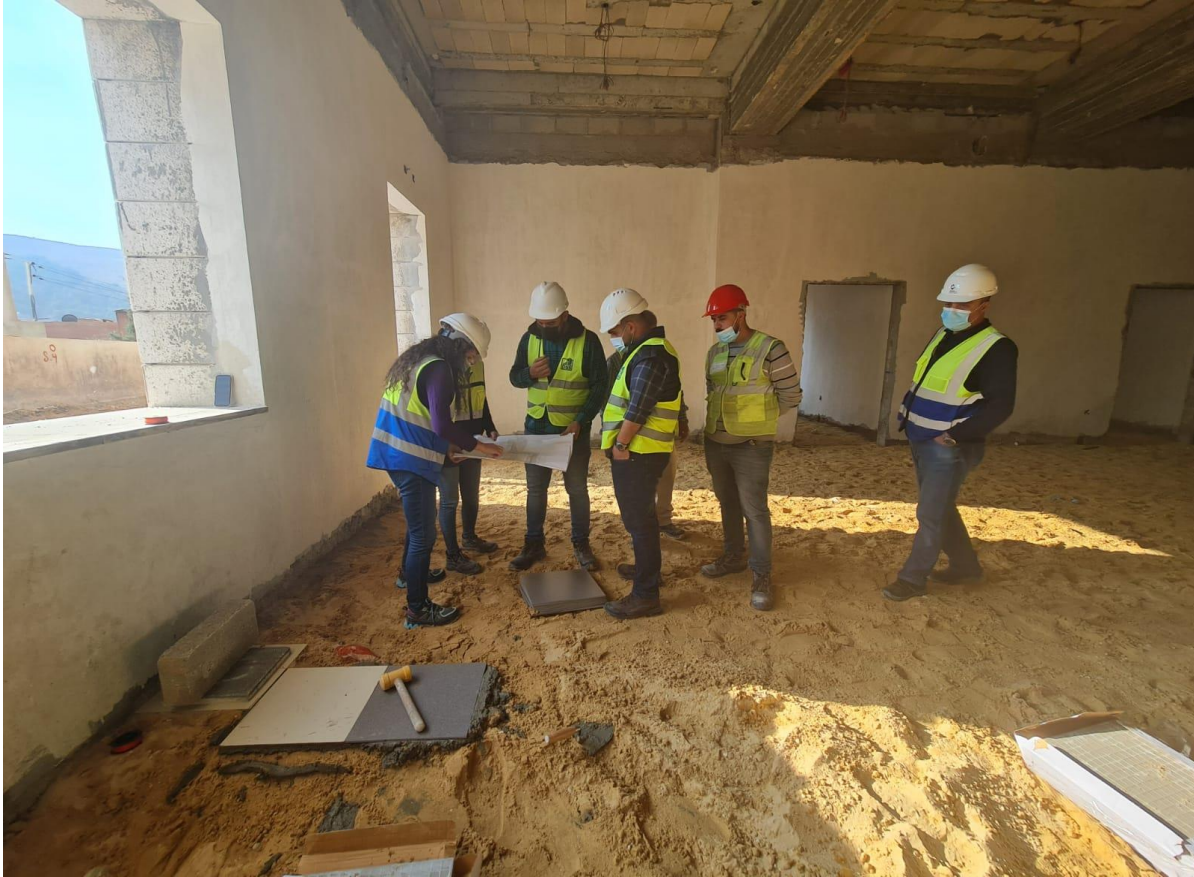
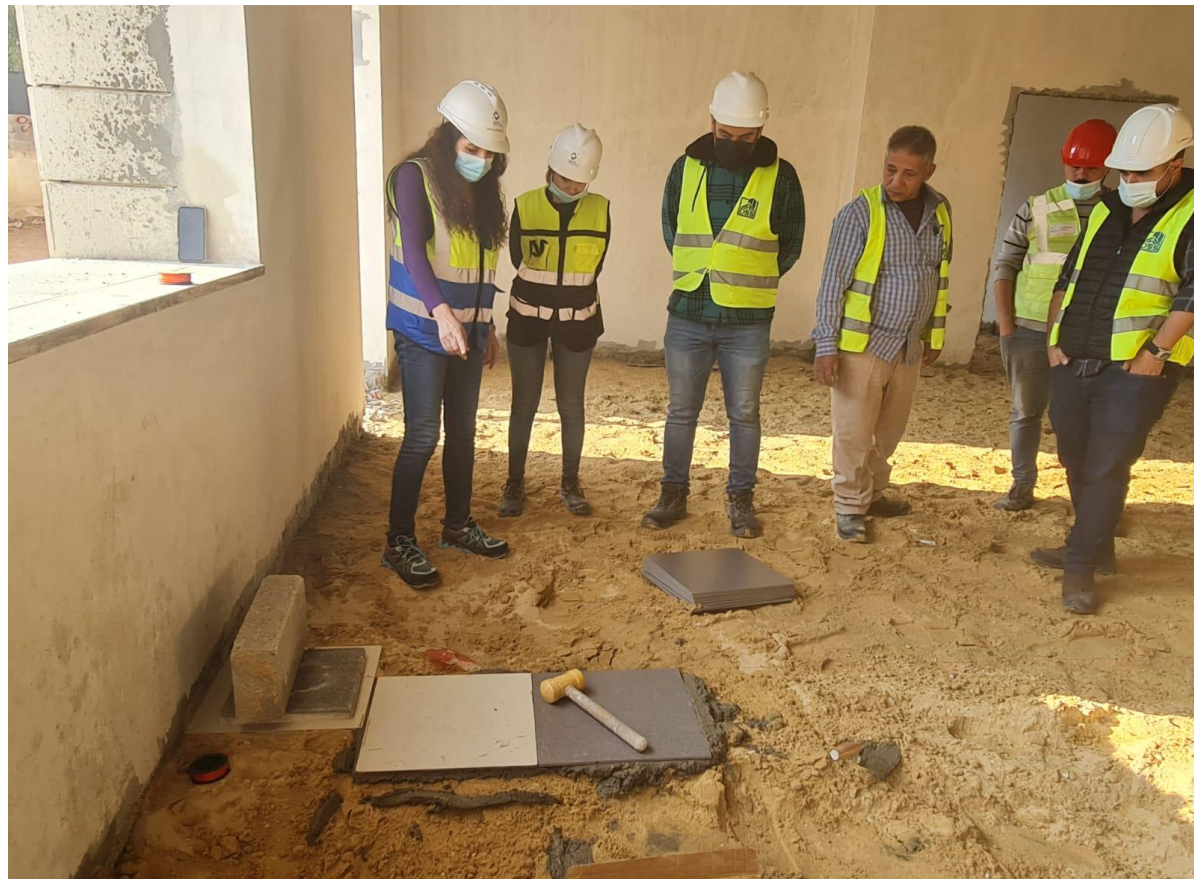
(figure:18 & 19)

| 10 | The workshop drawings for floor tiles have been reviewed by Consultant and Contractor and the process of tiling and the grouting color have been agreed on. |

The workshop drawings for floor tiles have been reviewed by Consultant and Contractor and the process of tiling and the grouting color have been agreed on

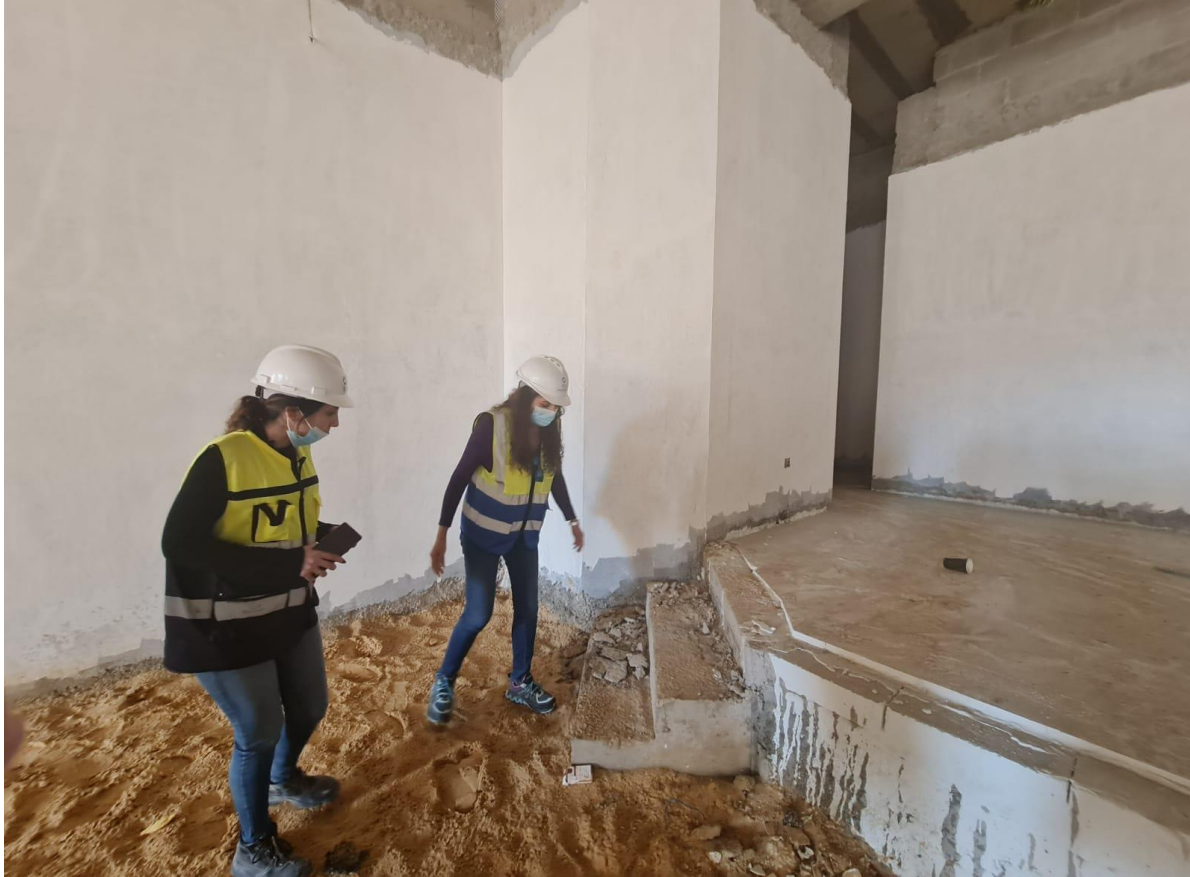
(figure:20)

| 9 | It was observed that the Contractor executed the stairs inside the multi-purpose hall as per the supervision instructions. |

It was observed that the Contractor executed the stairs inside the multi-purpose hall as per the supervision instructions

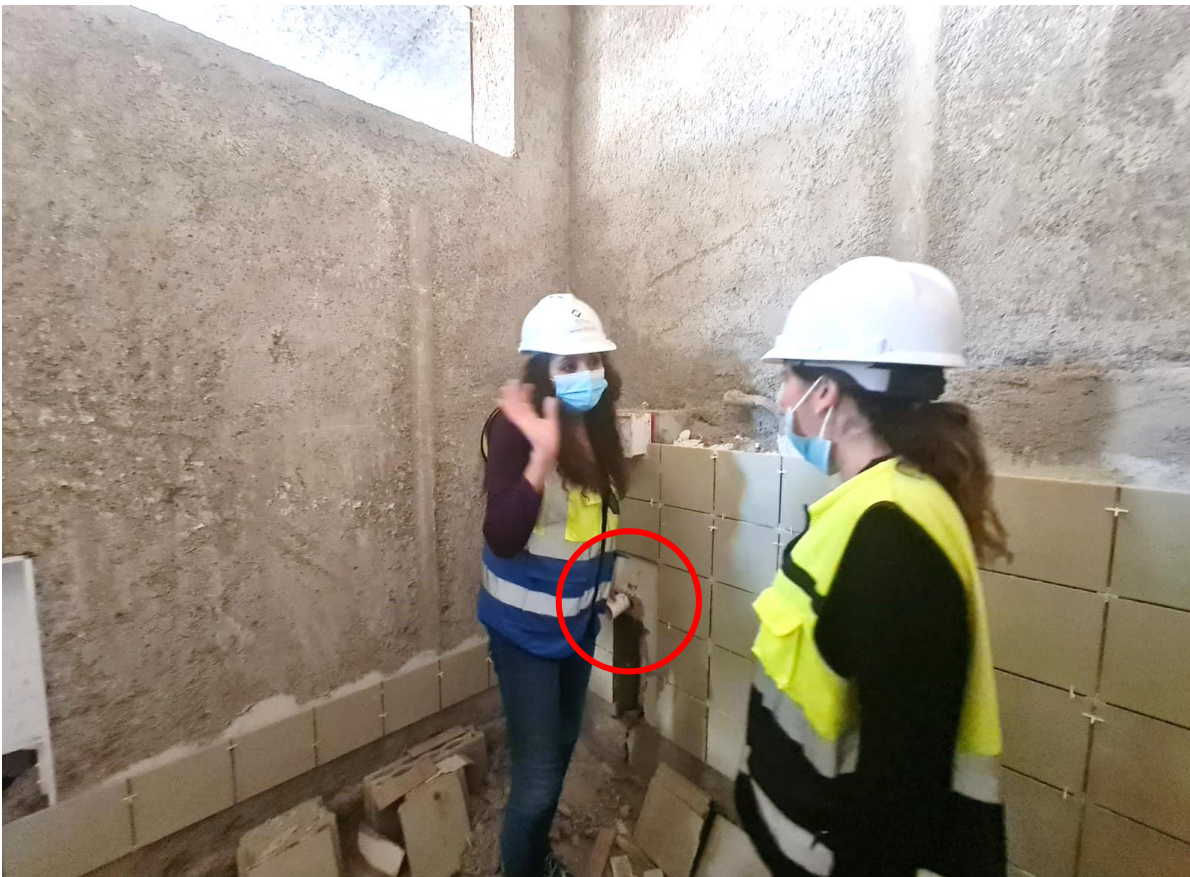
(figure:21)

| No. | Description |
|---|--|
| 2 | General inspection was conducted on the mechanical installations in the toilets. |

General inspection was conducted on the mechanical installations in the wet area
