| Consultant | Wahib Medanat Consultant Engineer | Rep No. | 11-22112021 |
| Contractor | Derar Saraireh & Sons for Engineering & Contracting | Tender No. | (11/2019/USAID/SKEP/3/S) Schools for a Knowledge Economy Project (SKEP) - Phase (3) Package (1, 2) |
| Site Name | Um Al Dananir Basic Mixed School- Al Balqa | Day/ Date | Mon. 22/11/2021 |

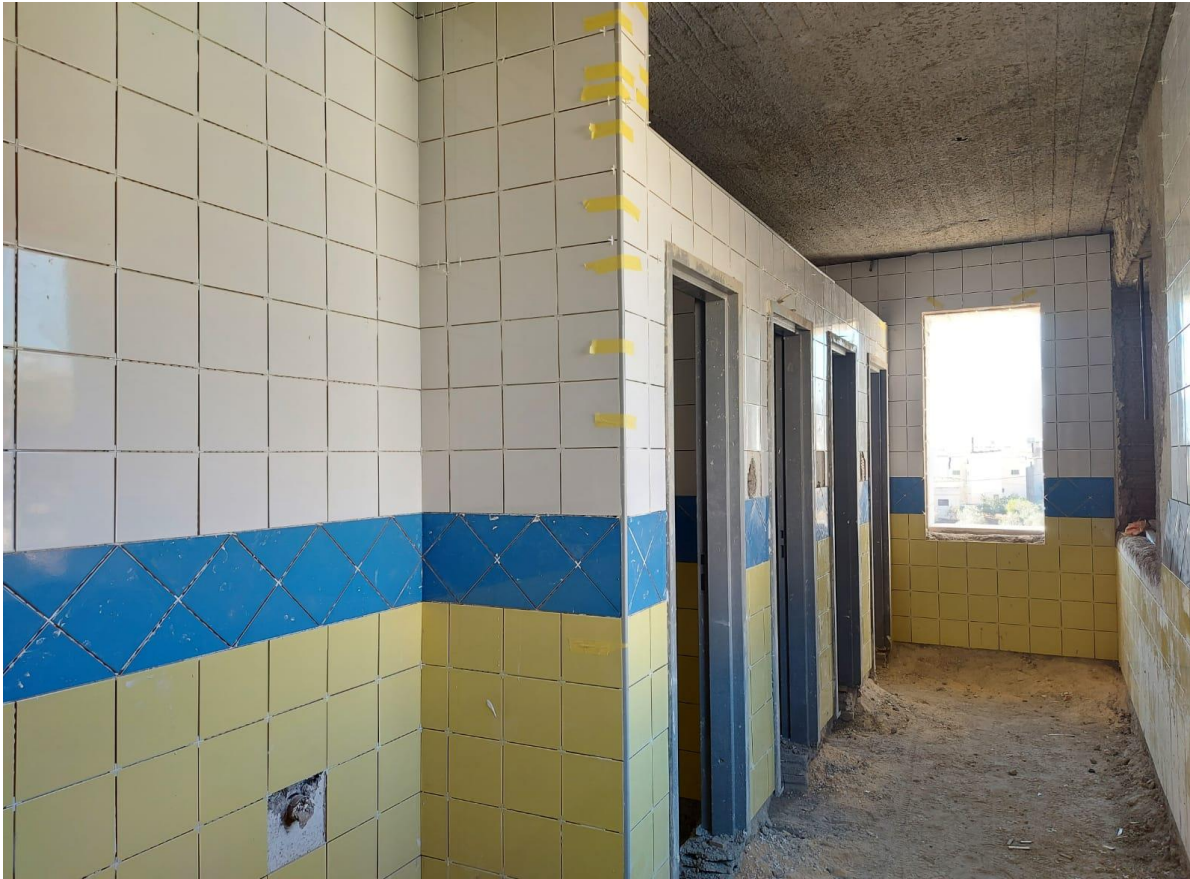
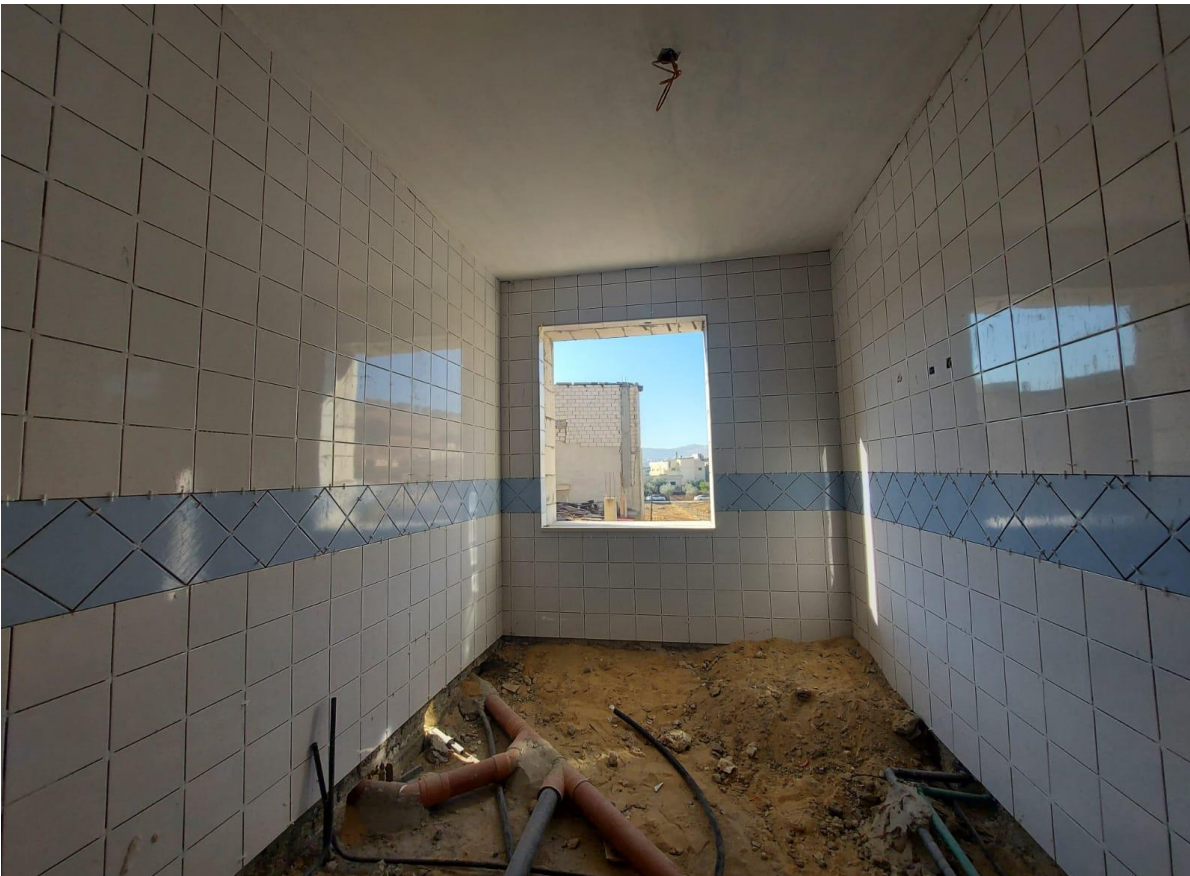
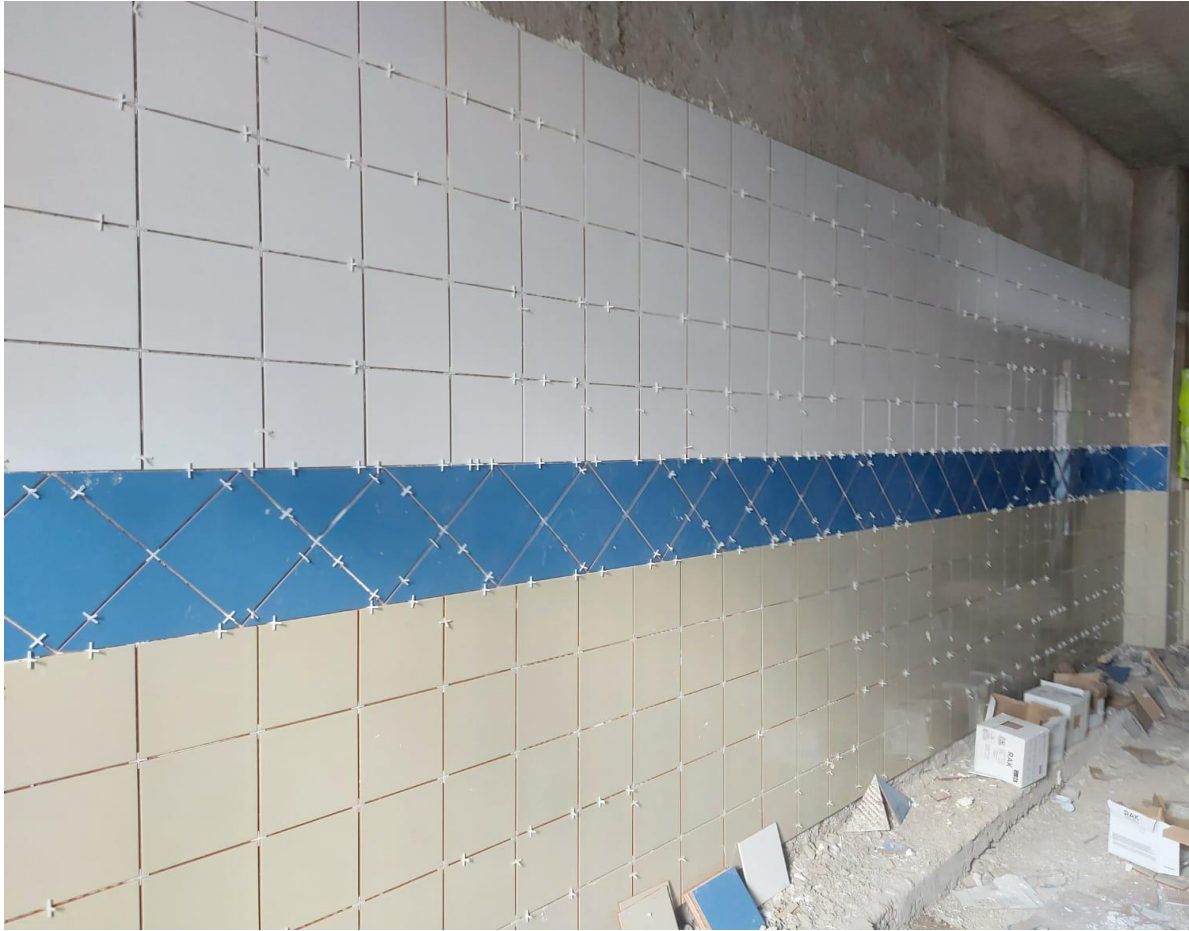
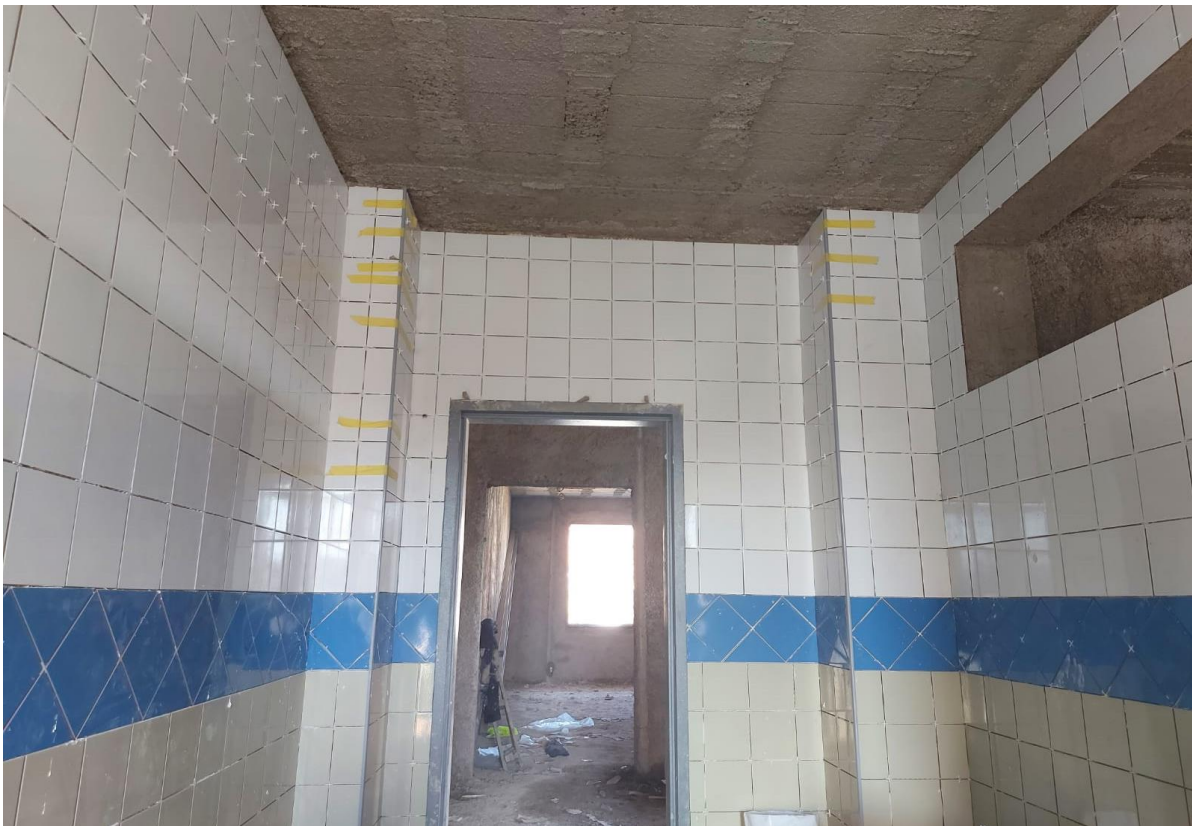
Tiling work at the wet area
(figures: 22, 23, 24 & 25)

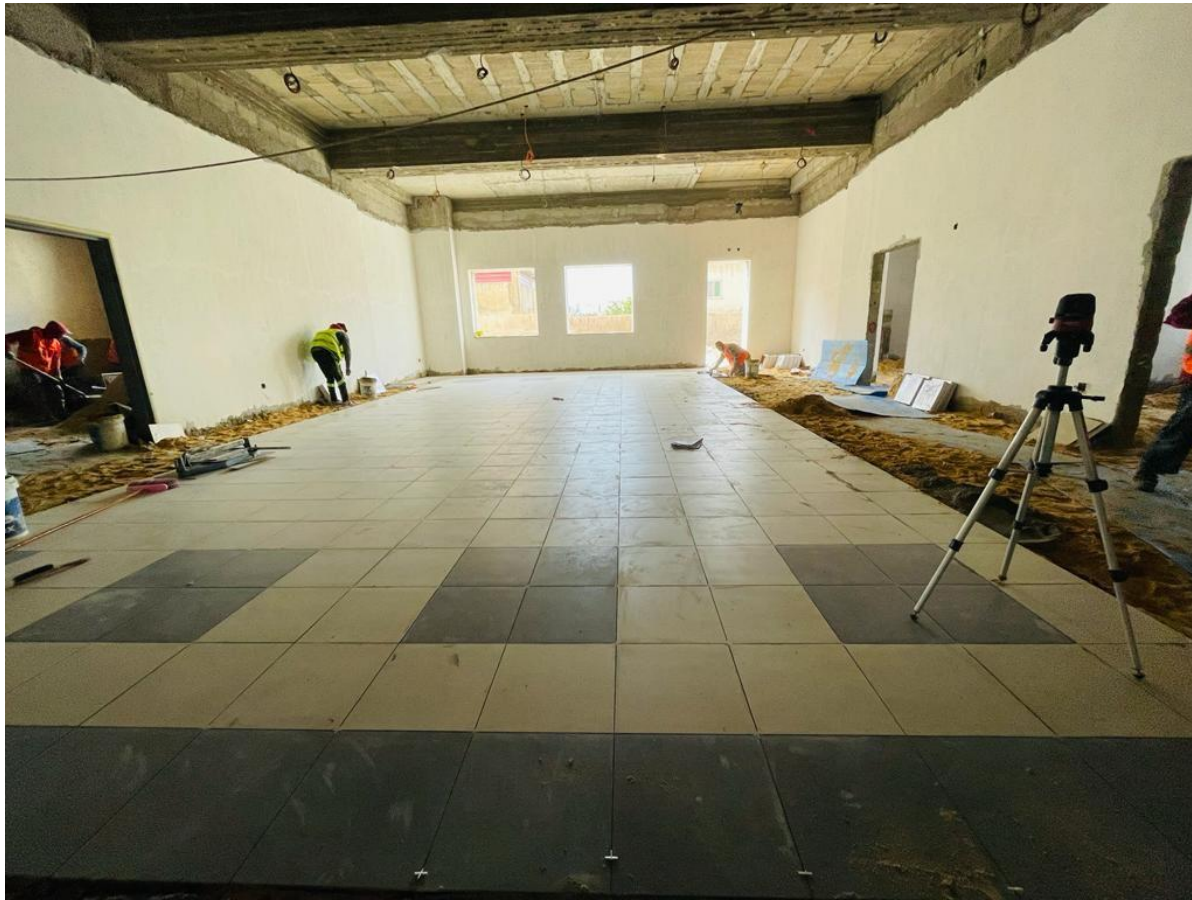
(figure:26)

Porcelain Tiles
for flooring
