# Quality Control Report

**Consultant** **Wahib Medanat** Consultant Engineers  
**Site Name** **Thahr Al Sarow Basic Boys - Jerash**  
**Package** **Package 2**  
**Contractor** **Dijlah Est. Construction Co.**  
**Tender No.** **10/2019/USAID/SKEP/3/2**

**Rep No.** **QC-22 15**  
**Date** **19 / 04 / 2022**

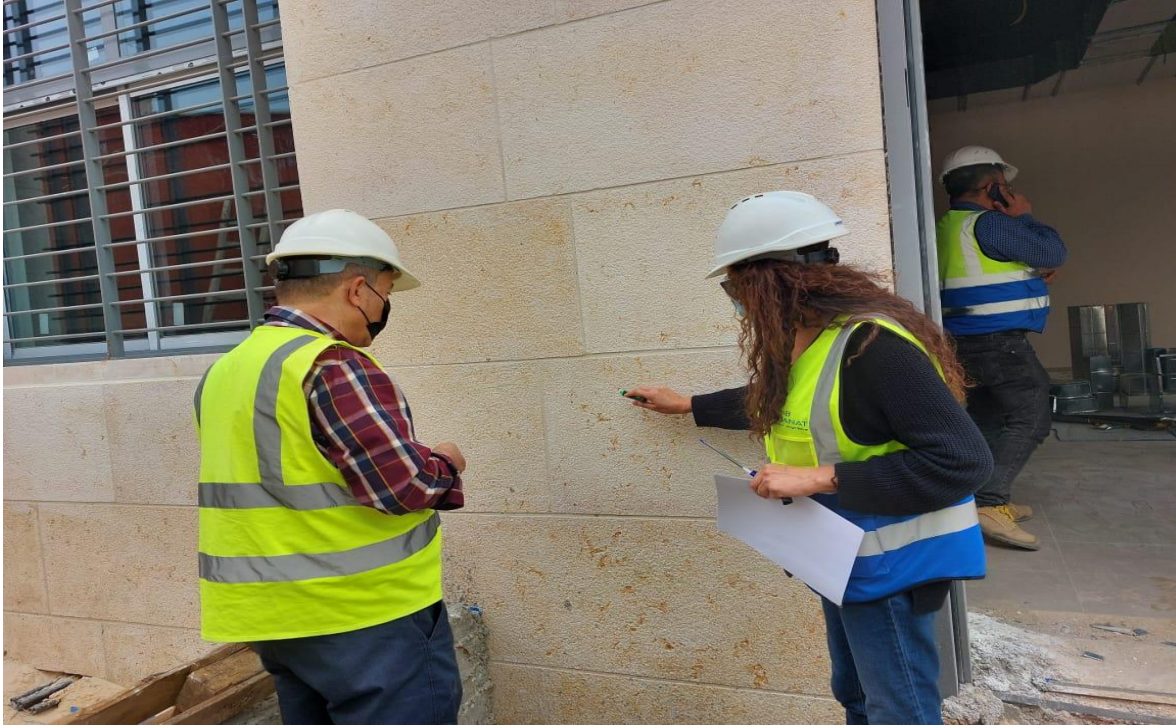
**Not removed defected stones**

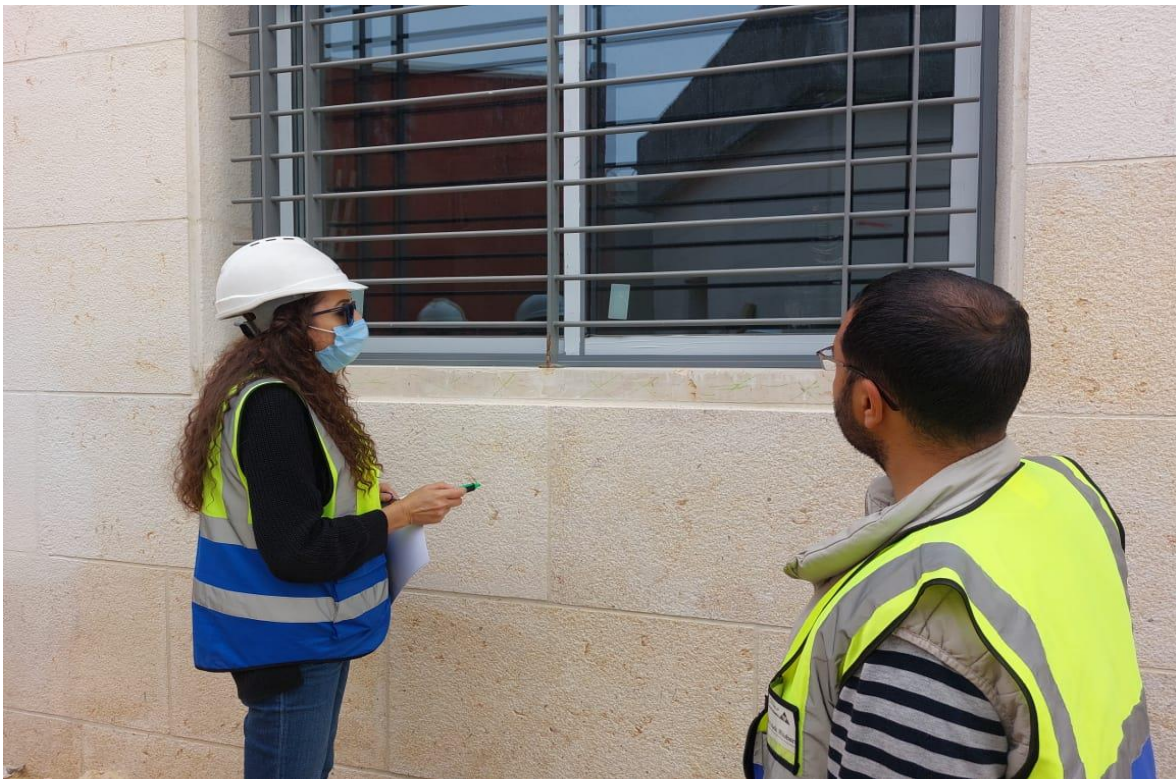
**Defects in the steel protection screen**

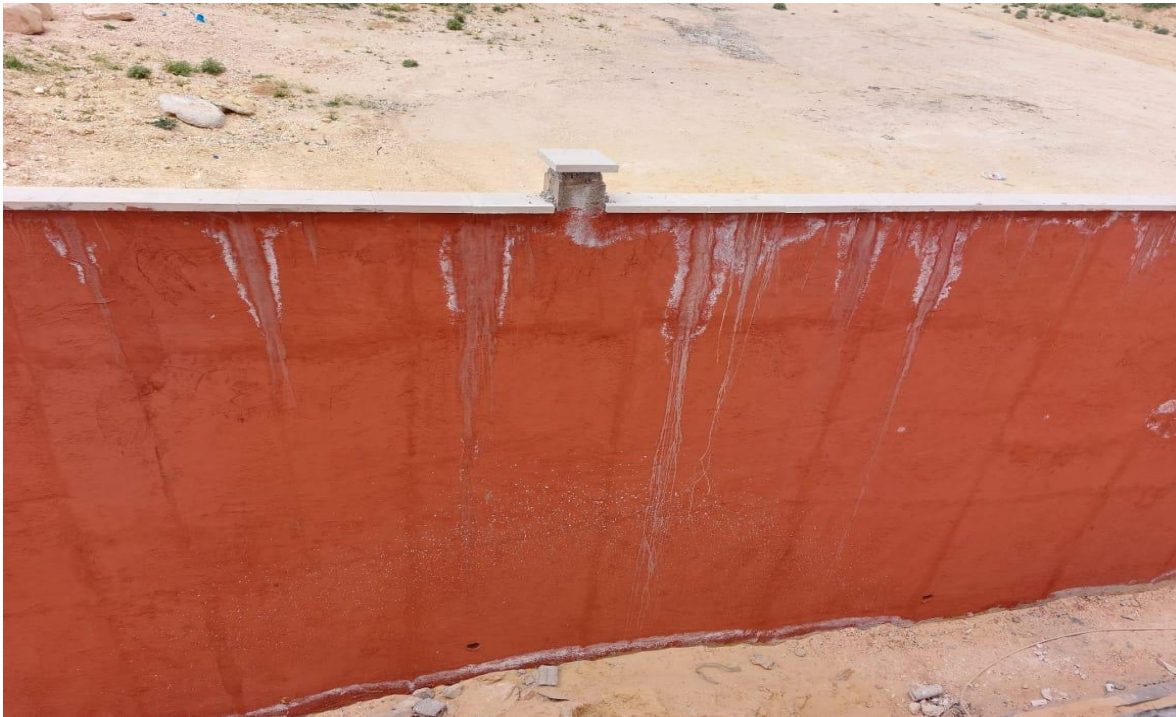
**White color appears on the external plastering**

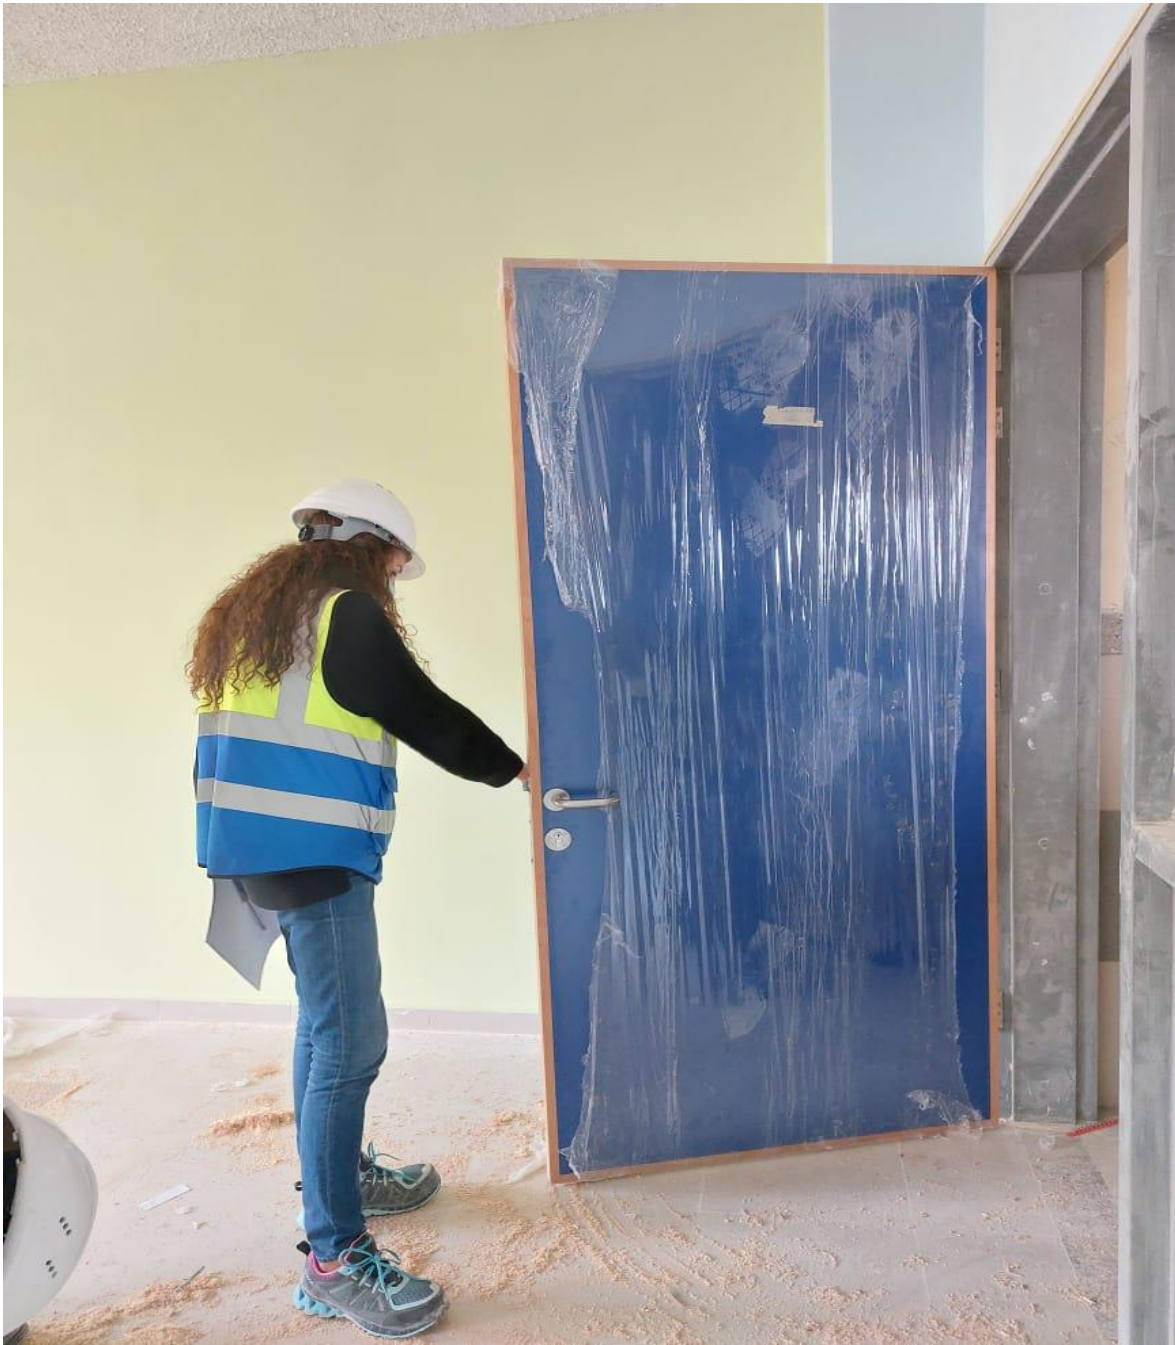
**Defected beech wood frames**

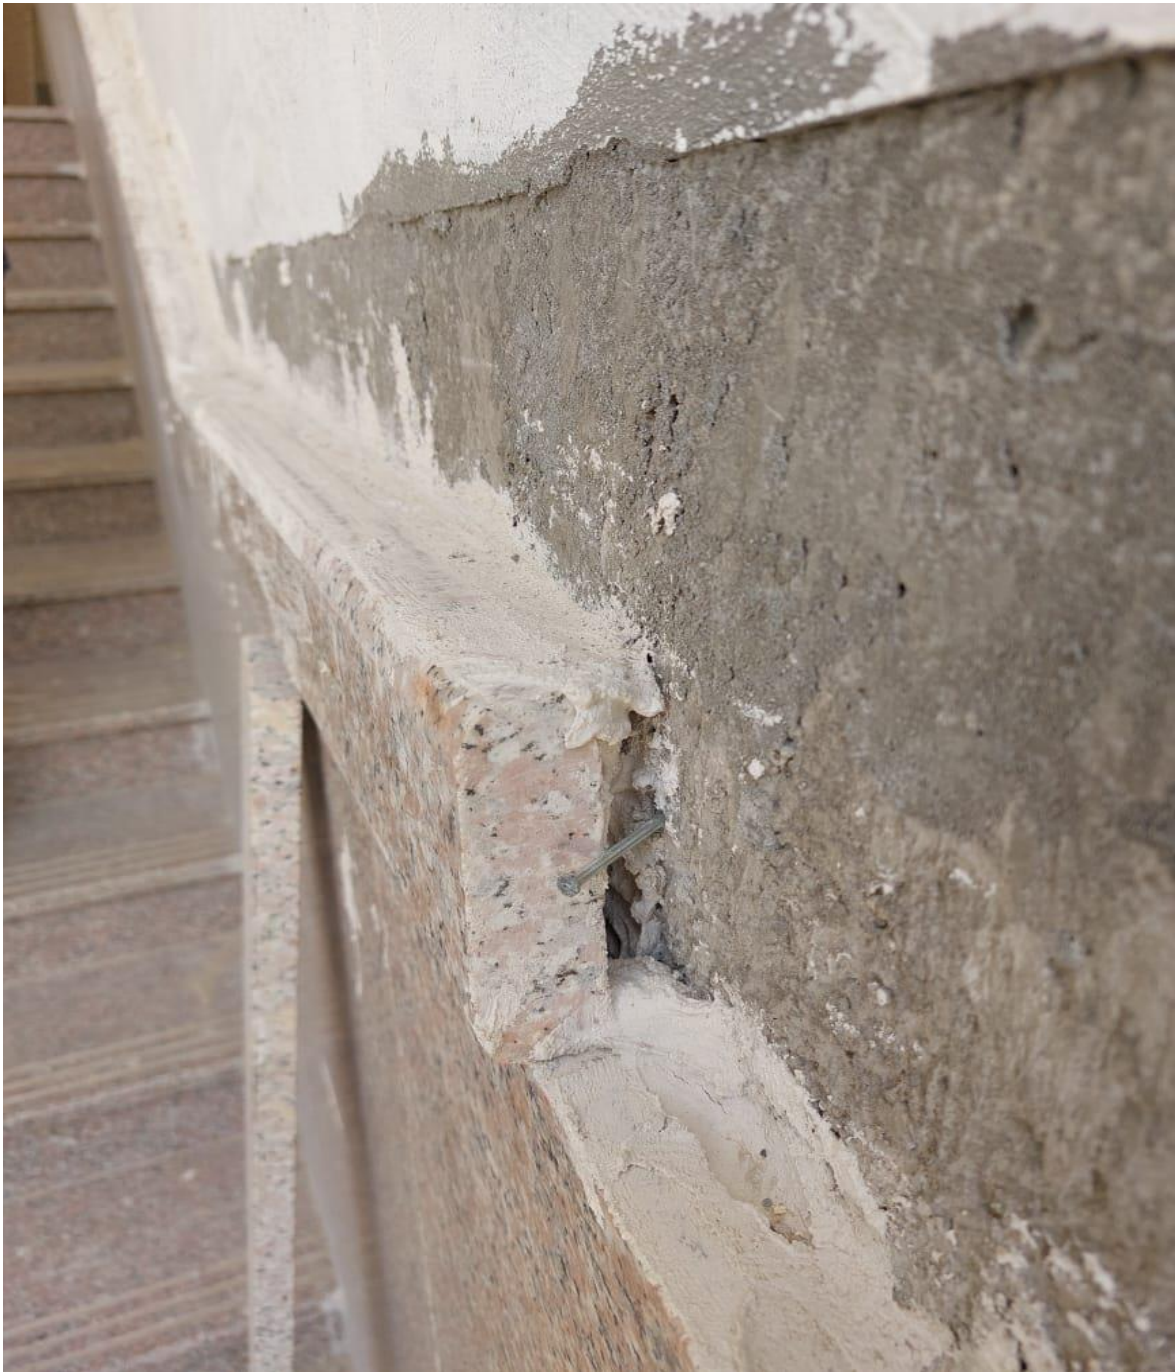
**Defects in installing the granite coping**

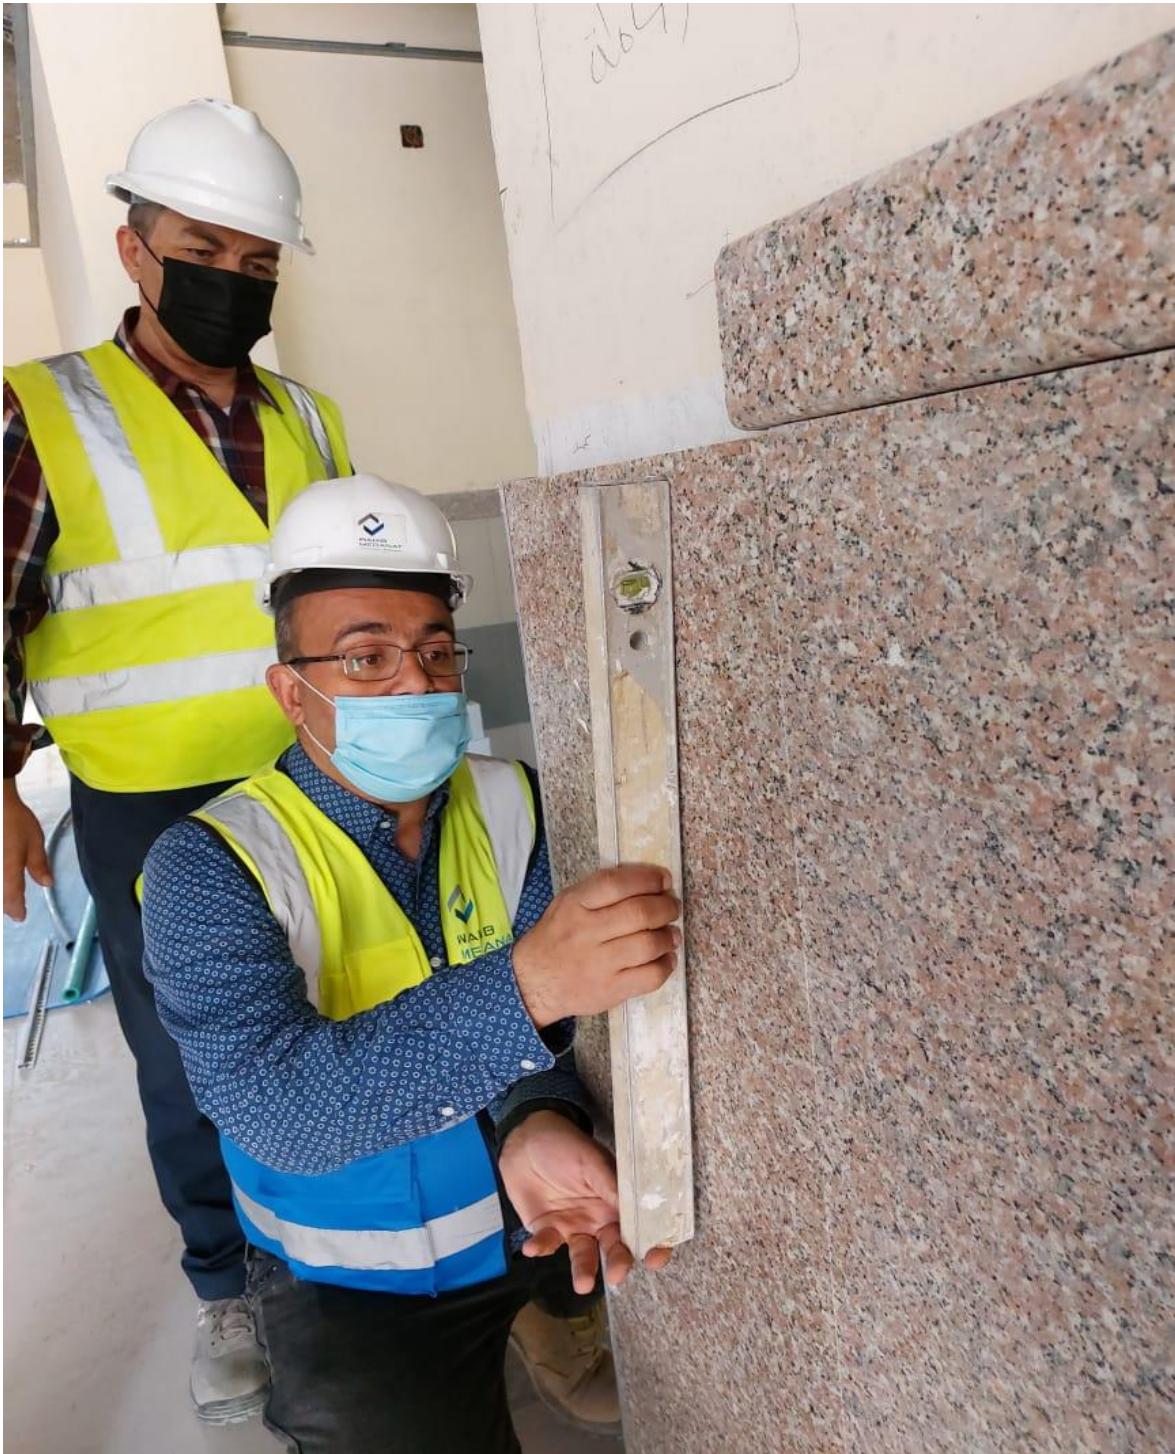
**Defects in installing the granite cladding**

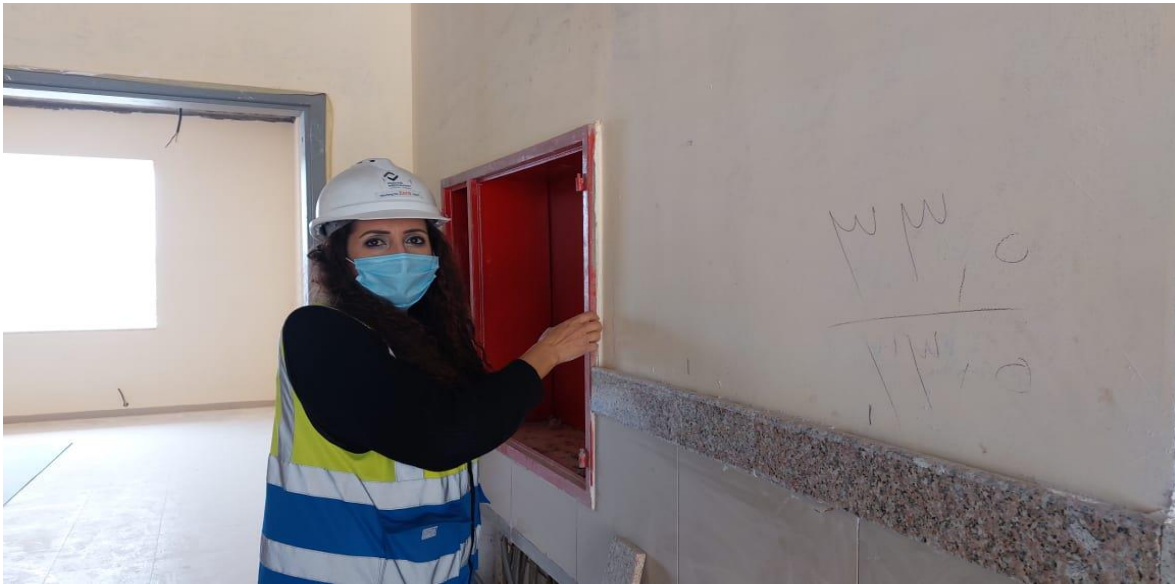
**Unacceptable filling around the cabinets**

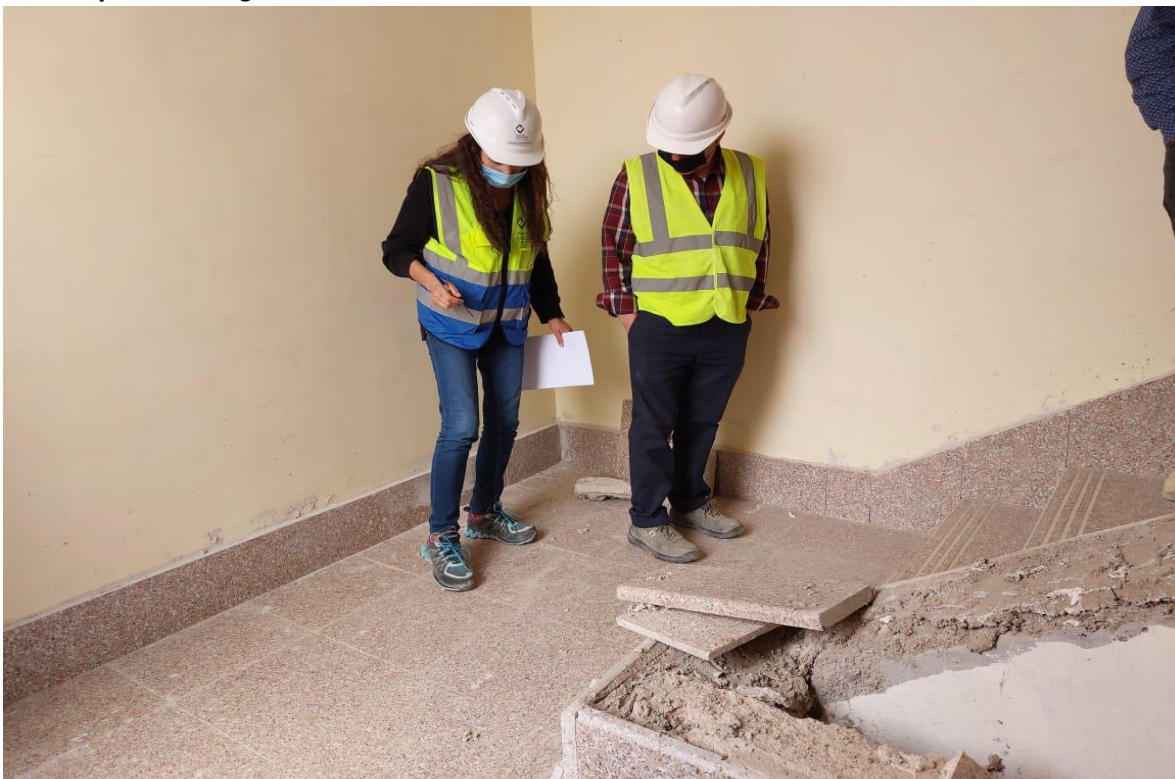
**Teething in the granite tiles at the landing**

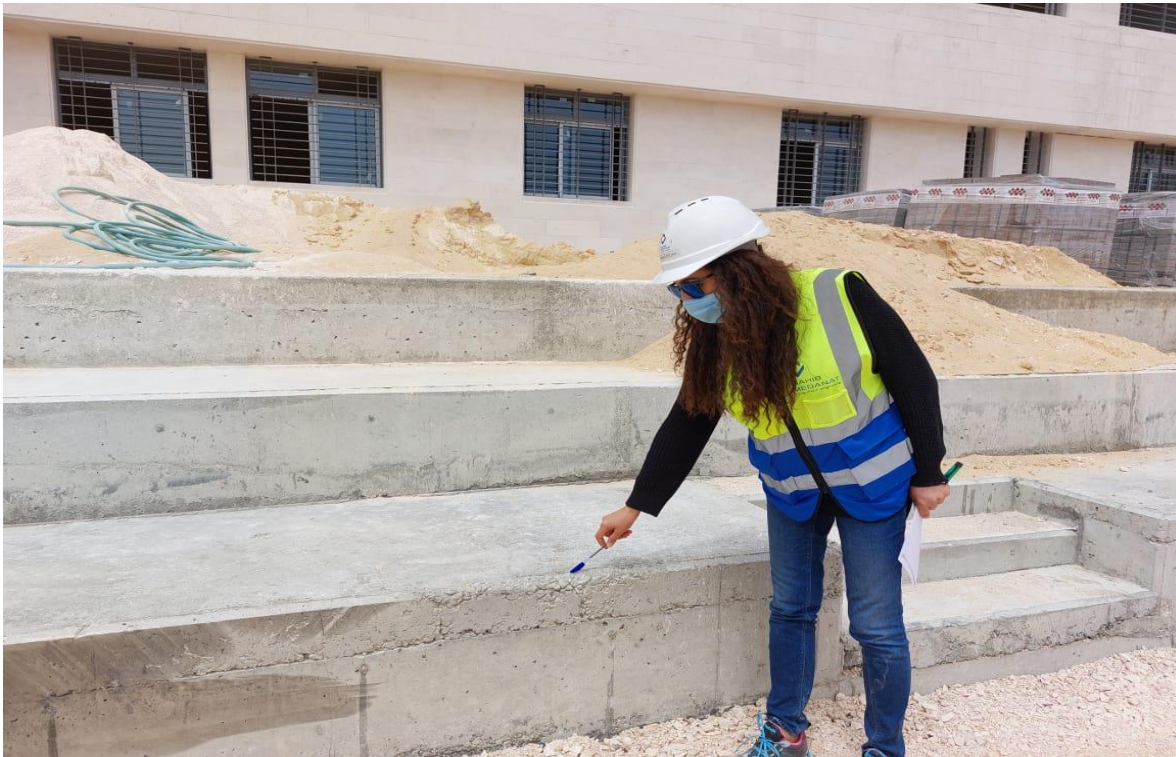
**Defects in concrete**
