Quality Control Report

Consultant **Wahib Medanat** Consultant Engineers
Site Name **Hay Al Iskan Basic mixed - Jerash**
Package **Package 2**
Contractor **Dijlah Est. Construction Co.**
Tender No. **10/2019/USAID/SKEP/3/2**

Rep No. **QC-21 03**
Date **1 / 03 / 2021**

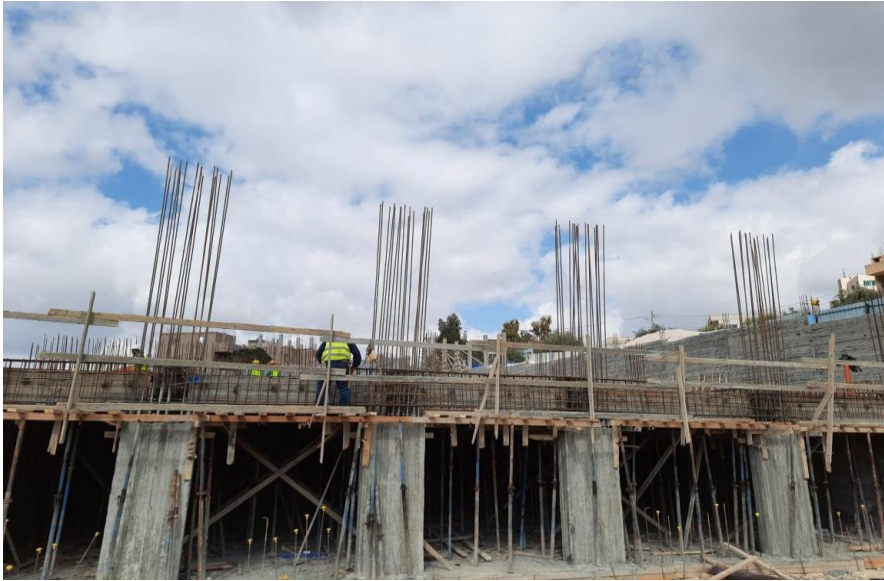
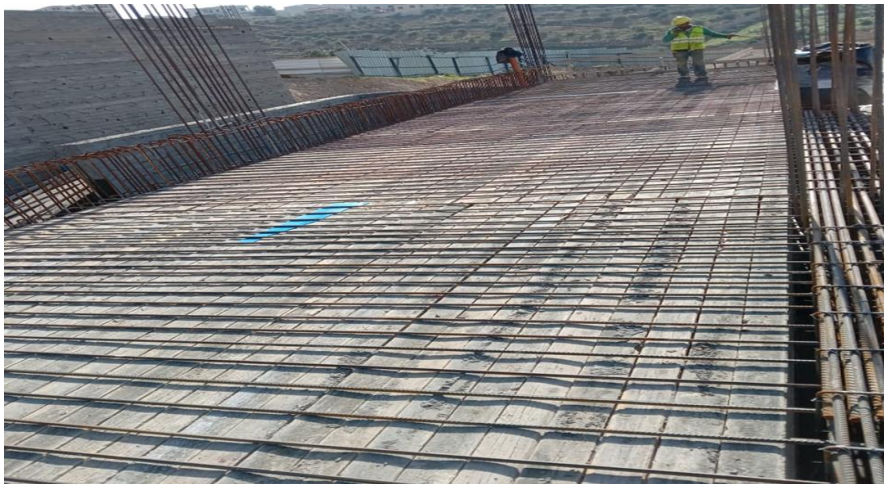
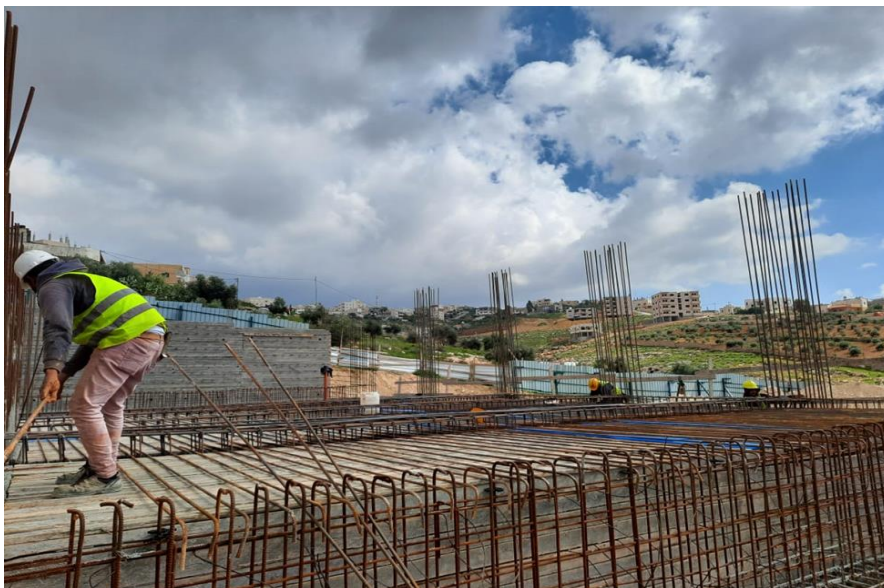
Description of Non Conformance	Corrective Action	Required by / When
<p>1- The wood used for shuttering of the solid slab of basement axis (A-D/ 7-10) is overused and defected. (Attached Photos).</p> <p>2- The Contractor did not submit a job request for the Supervision Engineer to inspect the shuttering before further work.</p>	<p>1- The defected shuttering should be removed and replaced by new wood</p> <p>2- The Contractor is required to follow the contract condition and principles of general practice and request the Supervision Engineer to inspect each stage of work.</p>	<p>Contractor to replace the shuttering as required immediately.</p> <p>Contractor to submit a job request to the Supervision Engineer to each stage of work and for the shuttering of the said slab immediately.</p>

The Contractor is expected to remove the defected shuttering and the said action will be documented as required.
