# SKEP III Home Office Support Site Visit Report

Consultant	Wahib Medanat Consultant Engineer	Rep No.	23-12022022
Contractor	Dijlah Establishment Constr. Contracting	Tender No.	(11/2019/USAID/SKEP/3/S) Schools for a Knowledge Economy Project (SKEP) - Phase (3) Package (1, 2)
Site Name	Jumana Bint Abit Taleb Basic Mixed School - Jerash	Day/ Date	Sat. 12/02/2022
Duration of Project	450 Calendar Days	Total Project Budget	8,314,983.735 JD

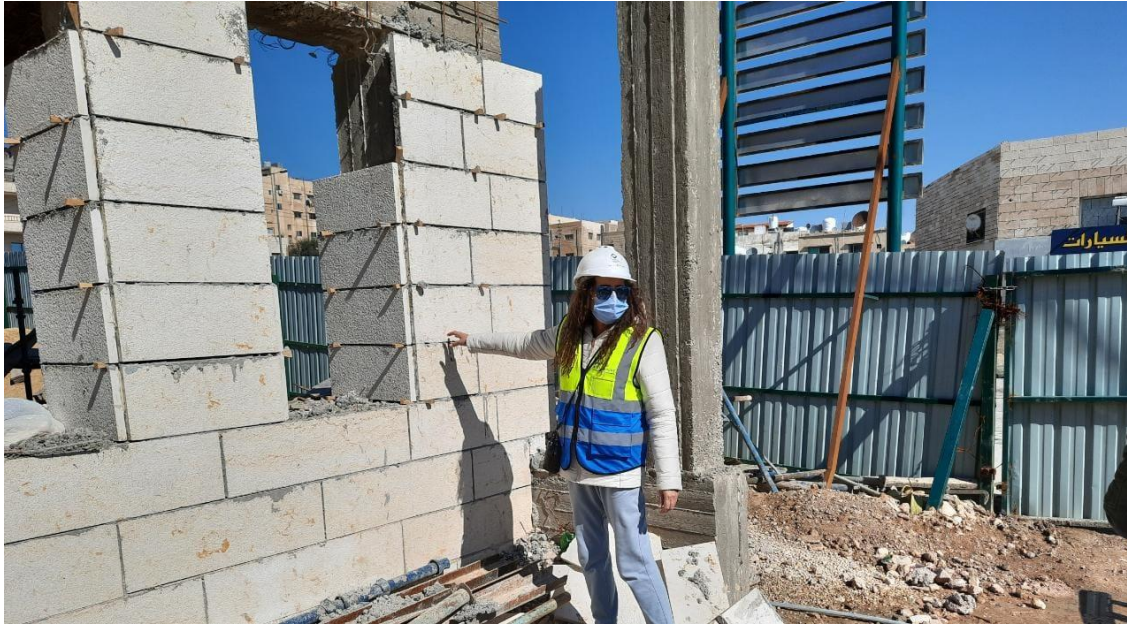
(Figure: 05)

No.	Description
1	The supervision team observed that considerable parts of the built stones for the guard room are defected and need to be replaced. Broken and not homogeneous stones were observed.
2	The team observed that the built stones at the entrance still not rectified by Contractor as required.
3	At the multipurpose hall, the team observed the following: 3.1. Teething in the floor tiles. 3.2. Remarks in the painting of the steel protection screen. 3.3. The window jambs have to be inspected and the aluminum should not be installed before final finish of the jambs. 3.4. The stairs in the hall have to be executed as required. 3.5. The team noticed water penetration from the ceiling due to the failure of the water leakage test. The Contractor was requested to rectify.

Inspecting the built stones for the guard room.

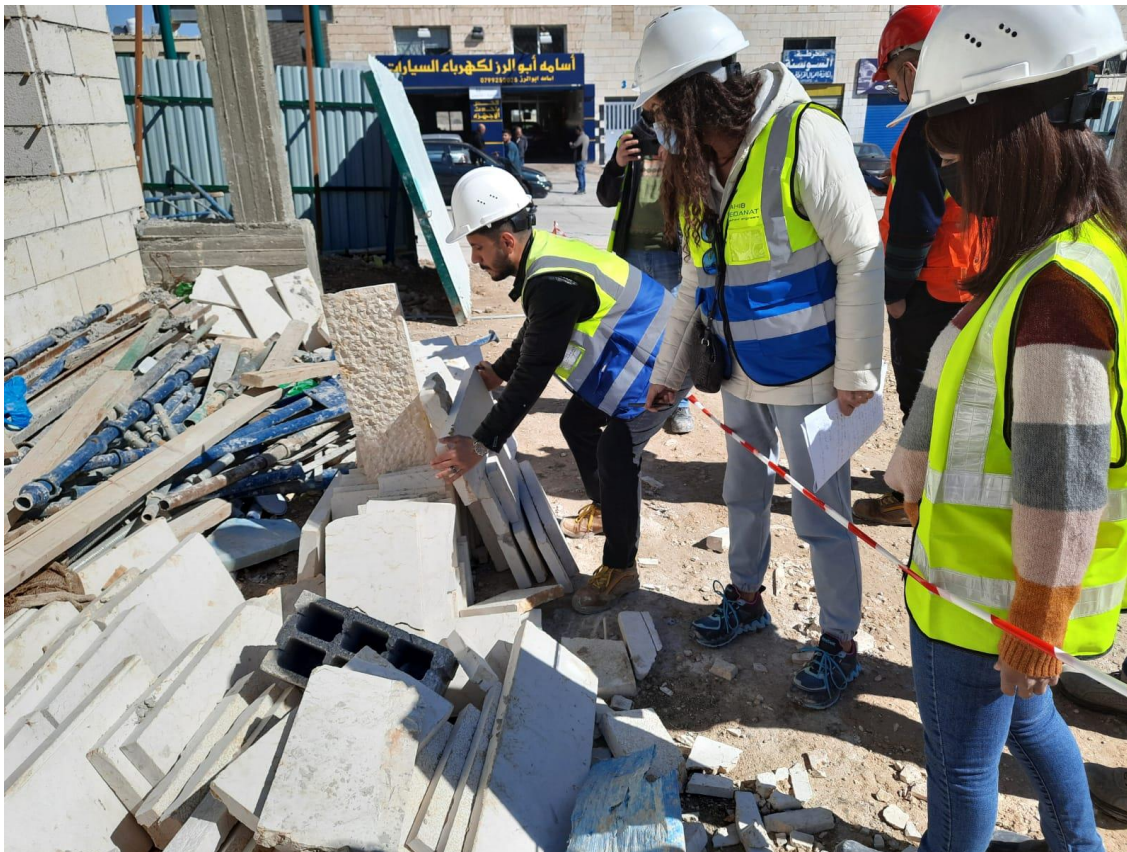
(Figure: 06)

Inspecting the sorting of the stones

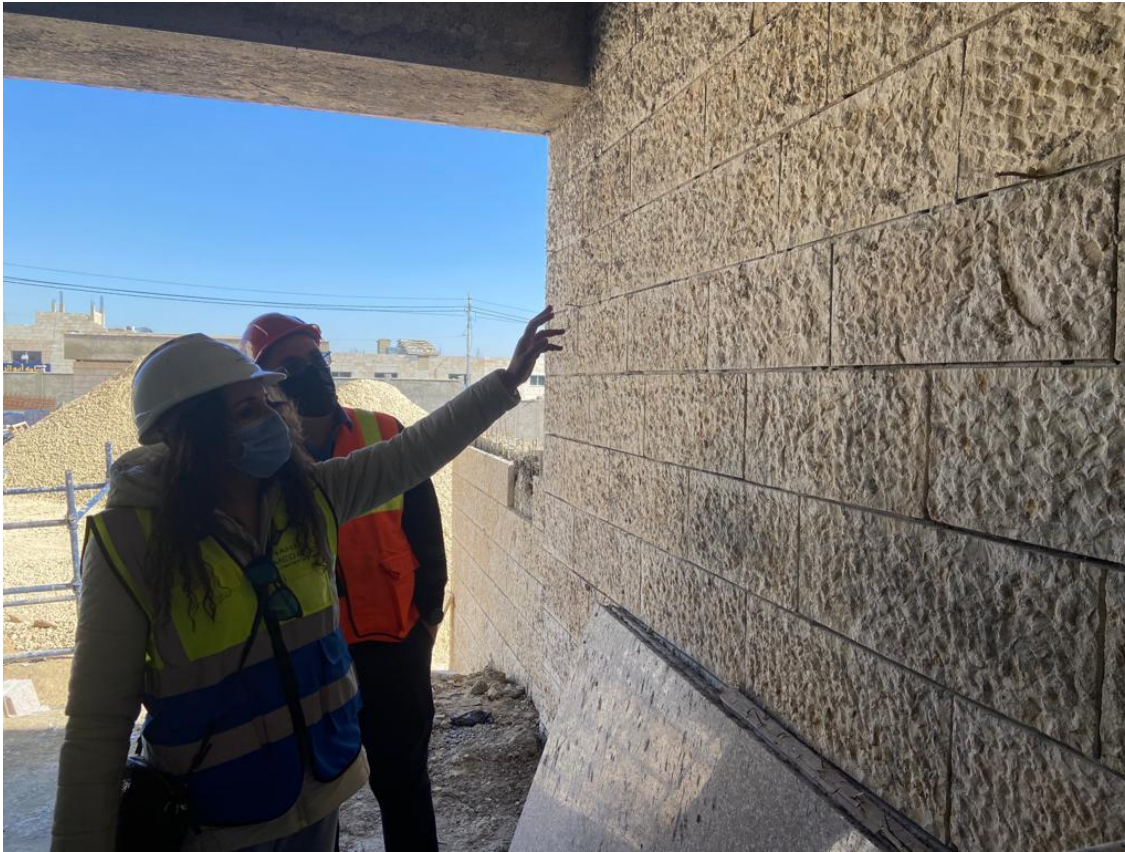
(Figure: 07)

Inspecting the built stones at the Entrance.

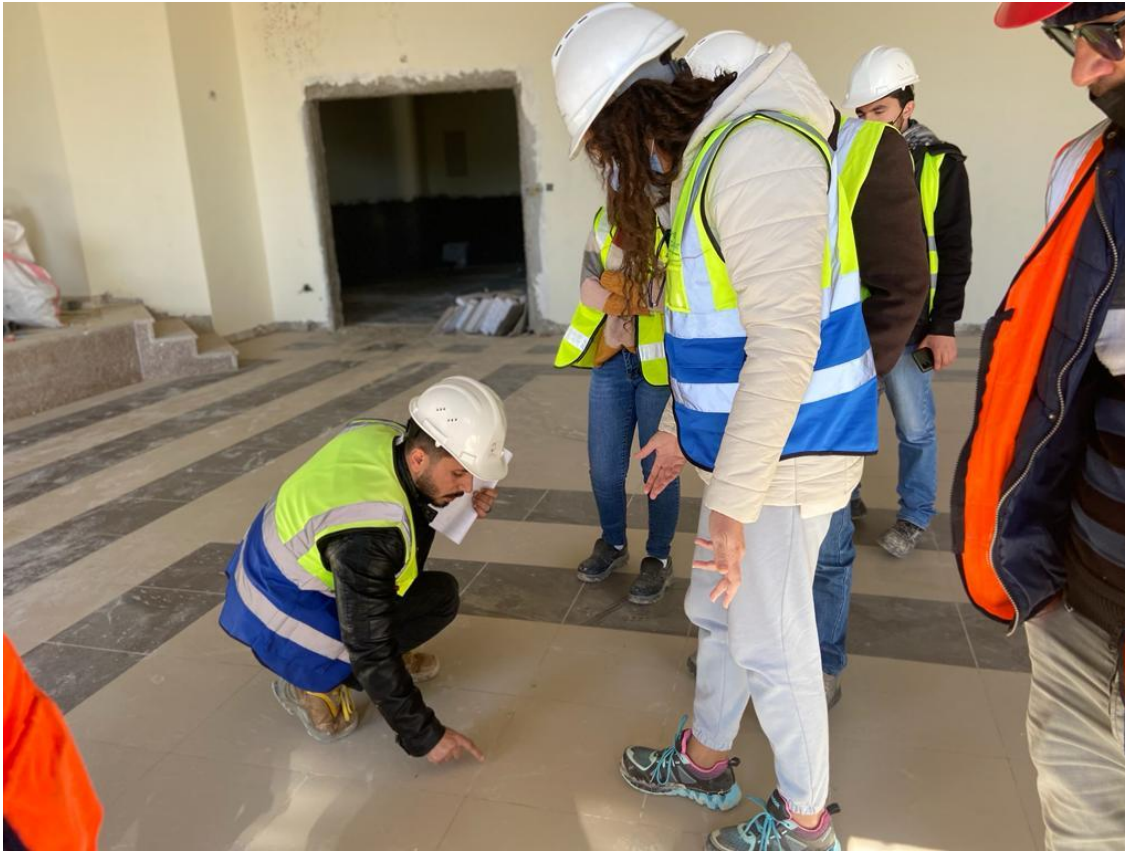
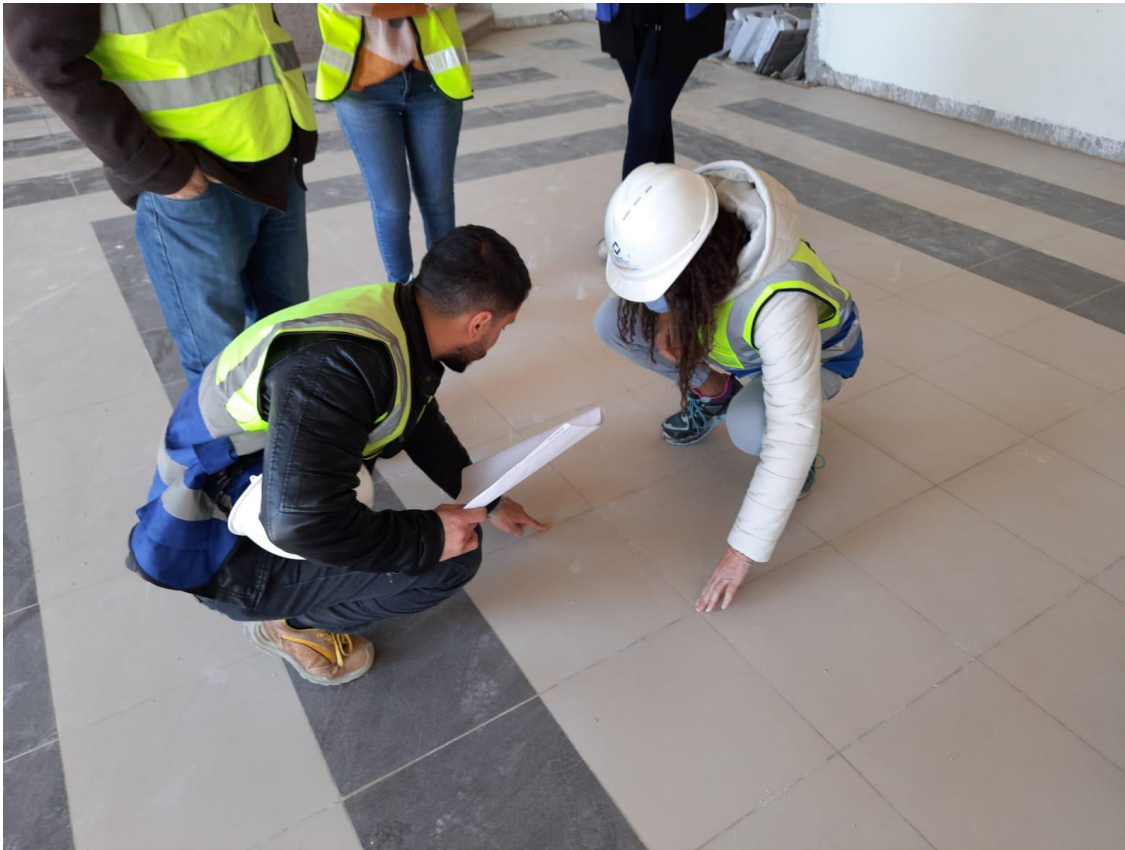
No.	Description
4	It was noticed that the fire rated door frames are not delivered to the site to this date.
5	In the ground floor corridor, the team observed defects in parts of the executed floor tiles due to the teething. The supervision requested the Contractor to replace the teethed tiles and avoid the teething to occur again by not allowing the workers to walk on the newly tiled areas before drying.
6	The team observed that number of installed aluminum sections need to be replaced to match with the exact dimensions of the openings to avoid the observed gaps considered as over tolerance.
7	The supervision team and contractor team discussed the continuation of porcelain wall tiles at the window jambs for laboratories and workshops. The supervision team approved a sample made in one window accordingly during the visit.
8	The supervision team inspected two samples for the installation of granite coping corners at the corridors the team approved the sample with rounded edge without chamfer to be made at the factory.

Inspecting the executed floor tiles.

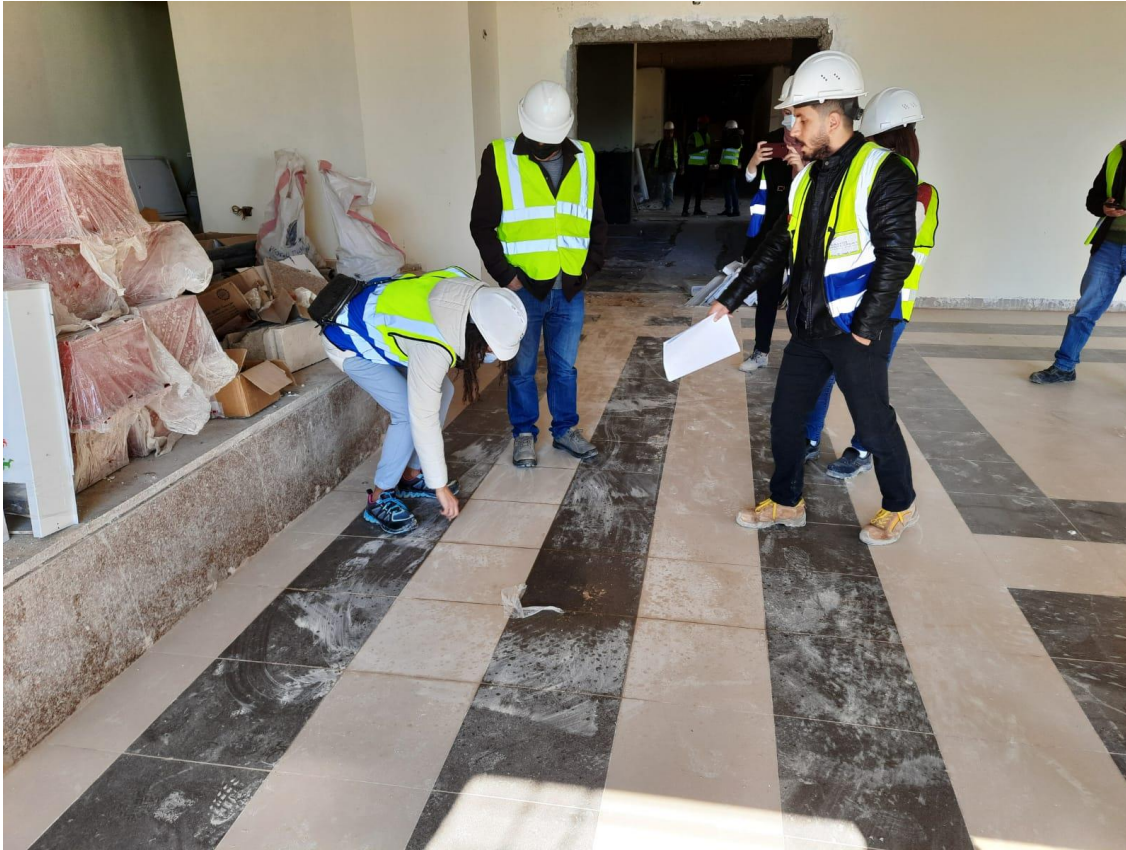
(Figure: 11)

Inspecting the porcelain floor tiles at the multi-purpose hall.

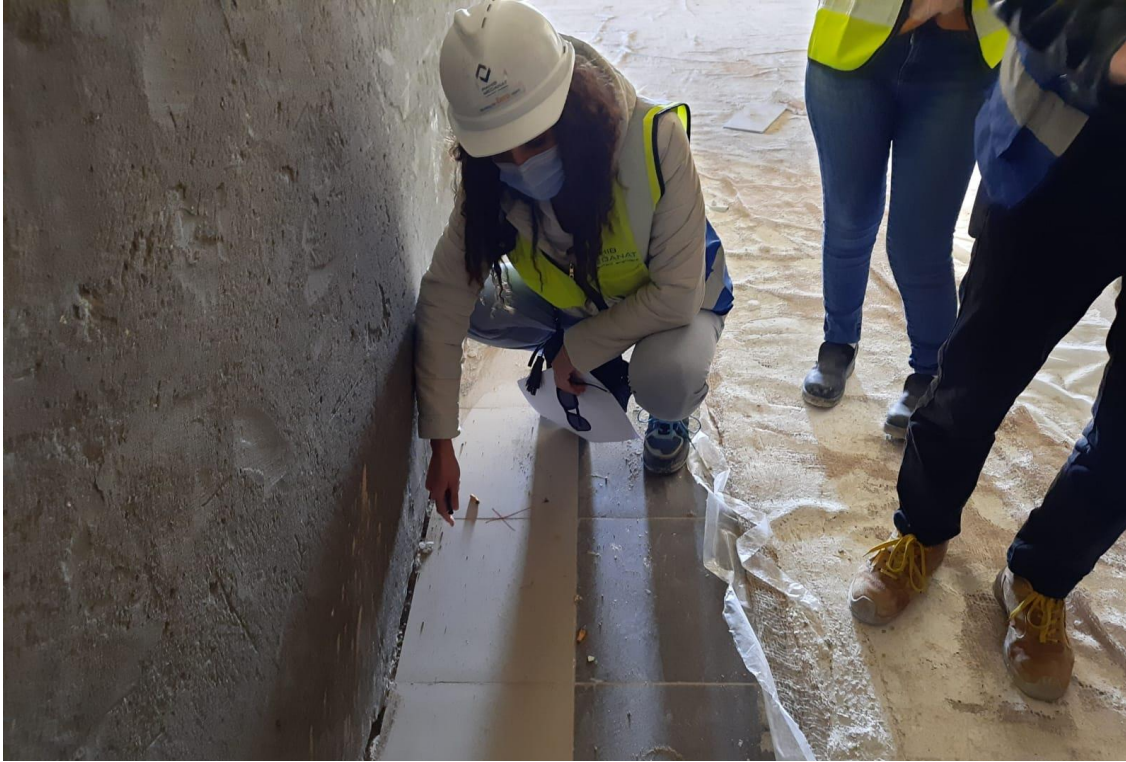
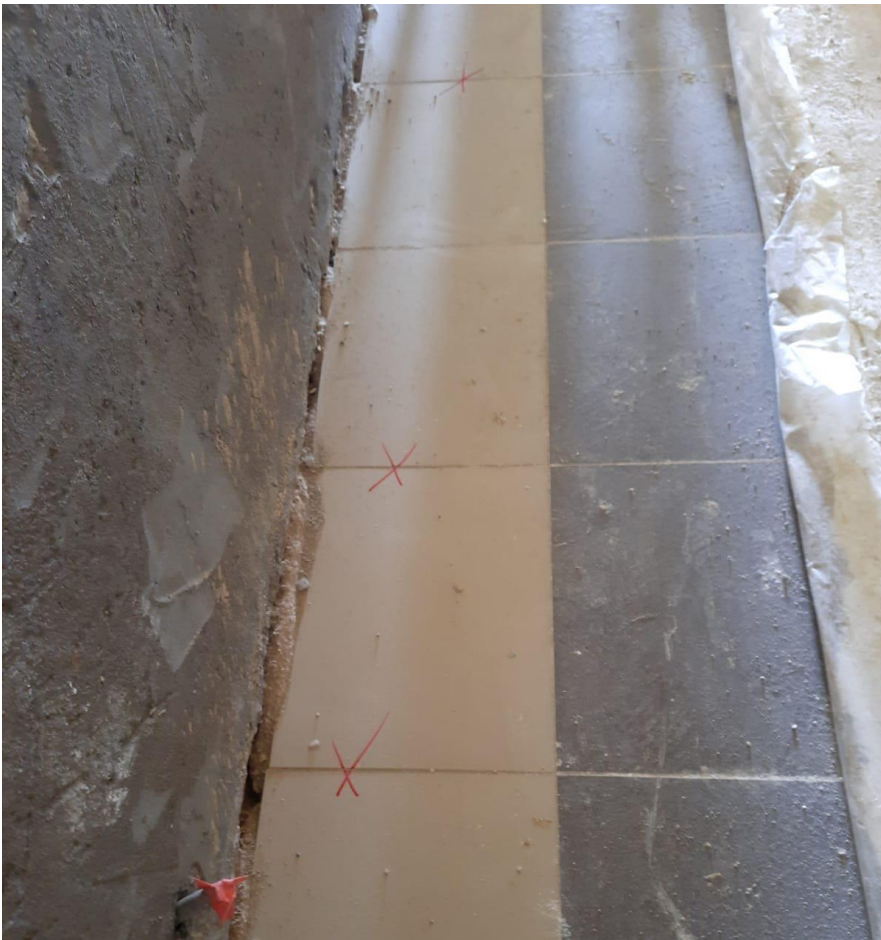
Defected floor tiles  
at the corridors

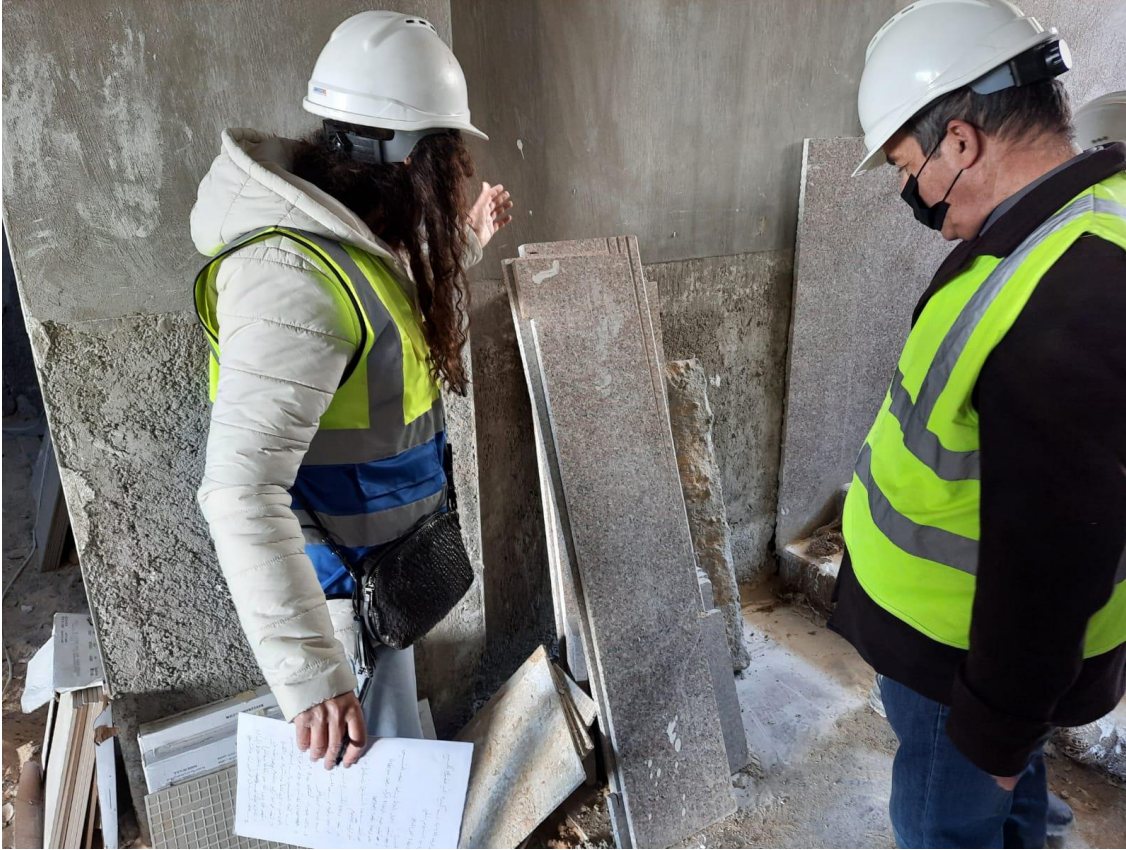
(Figure: 17)

Inspecting the newly delivered granite pieces for staircase walls. The team observed that the newly delivered quantities have the same defect

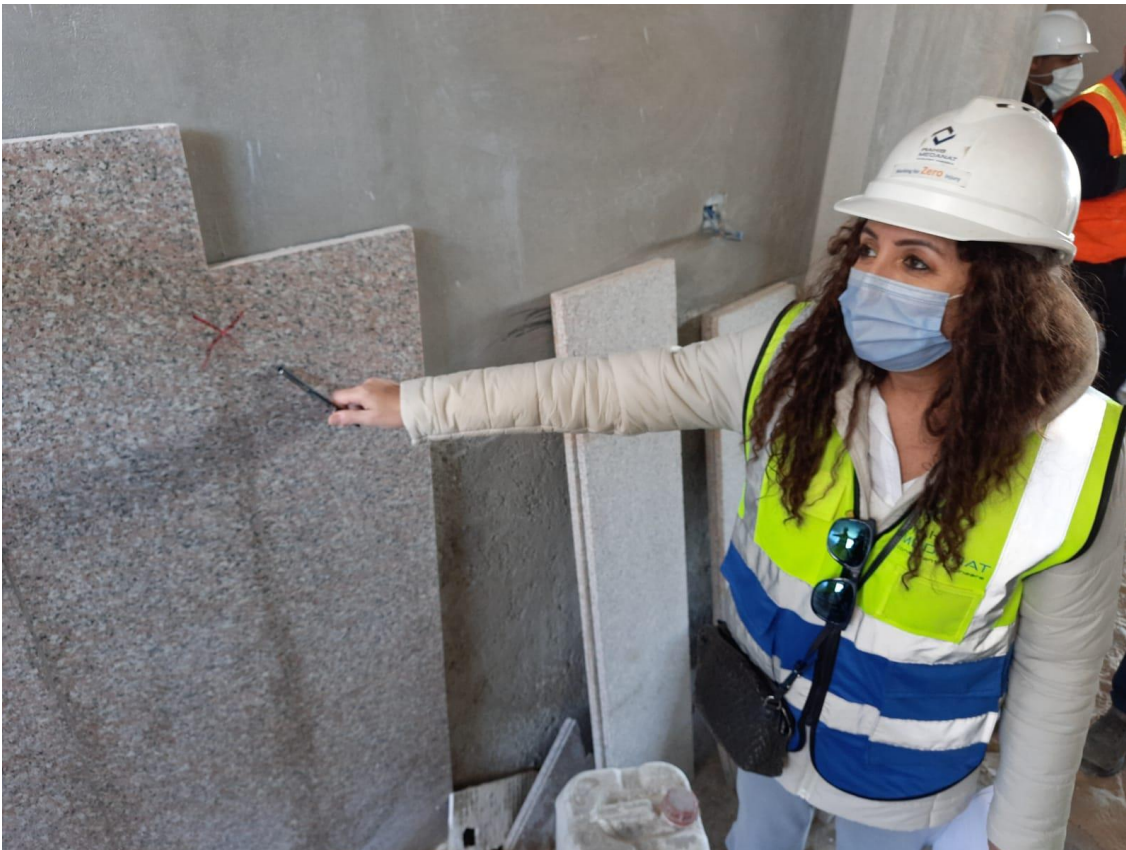
(Figure: 18)

Inspecting the defects in tiling of granite for staircase walls

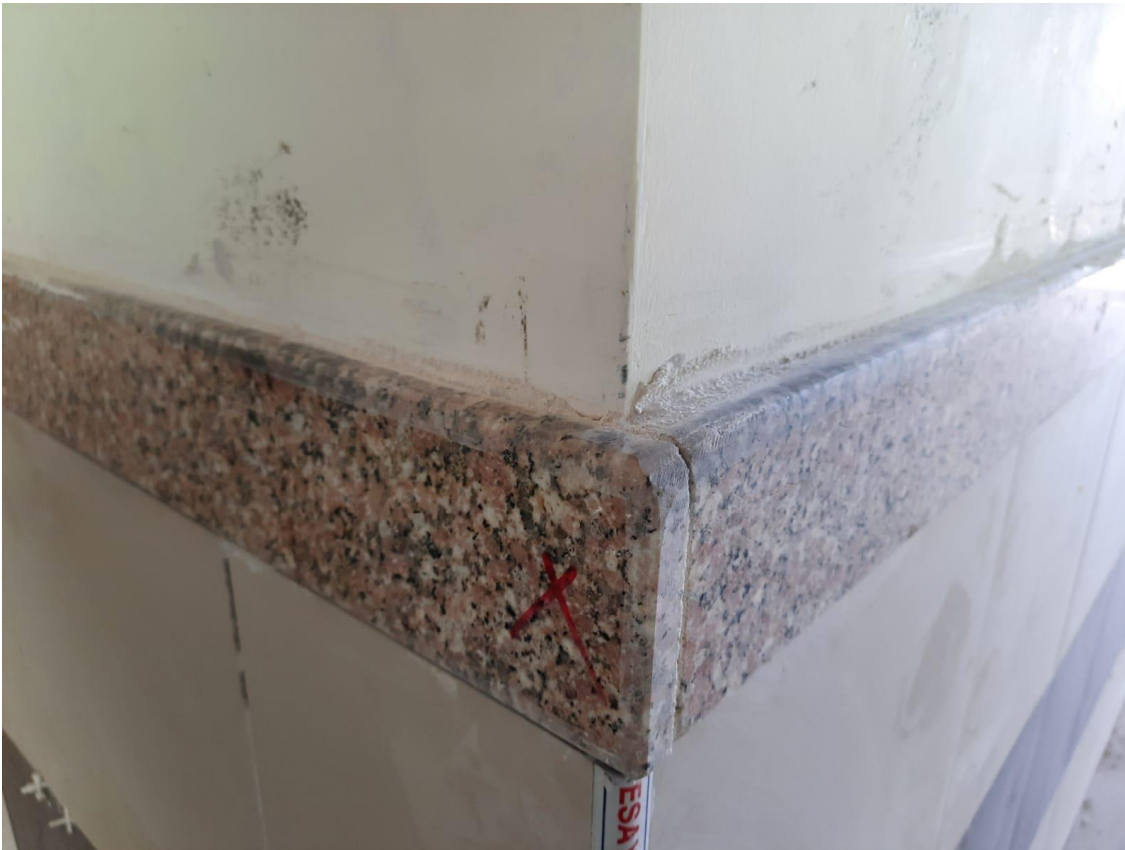
(Figure: 22)

Sample (2): rounded edge

The supervision team inspected two samples for the installation of granite coping corners at the corridors the team approved the sample with rounded edge without chamfer to be made at the factory

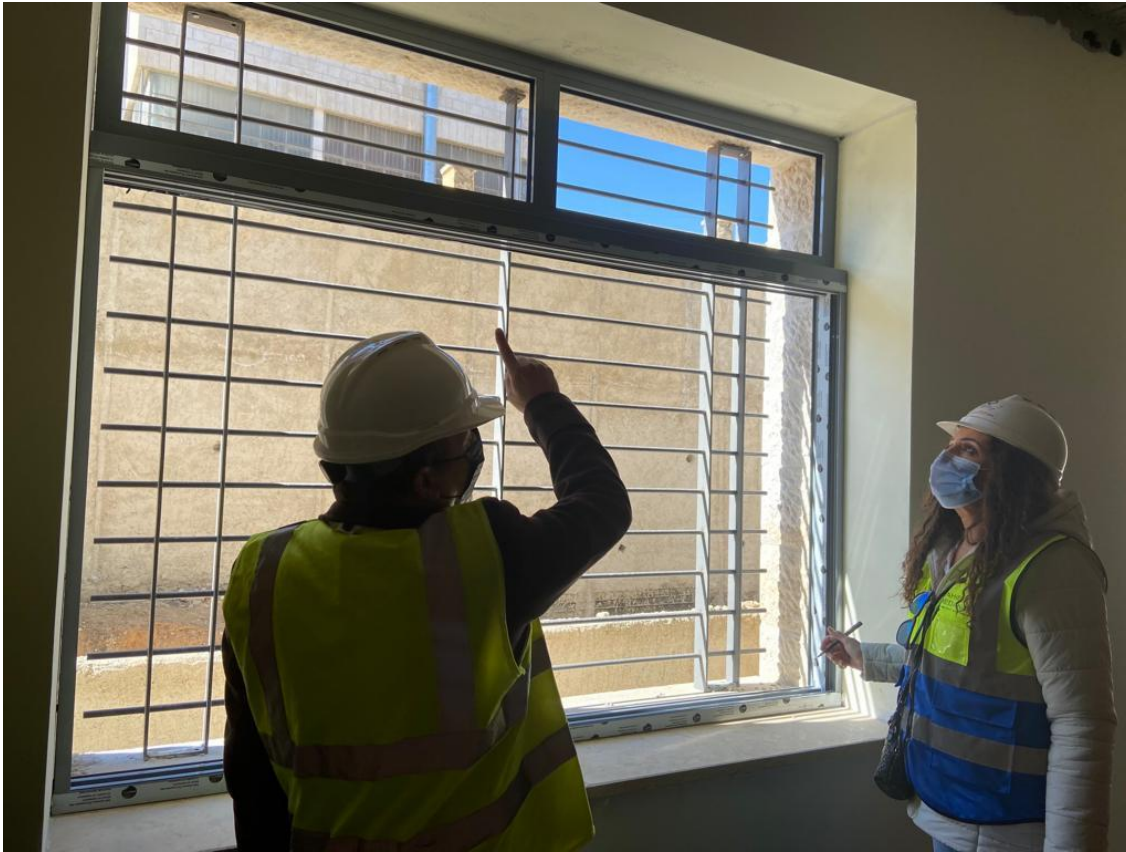
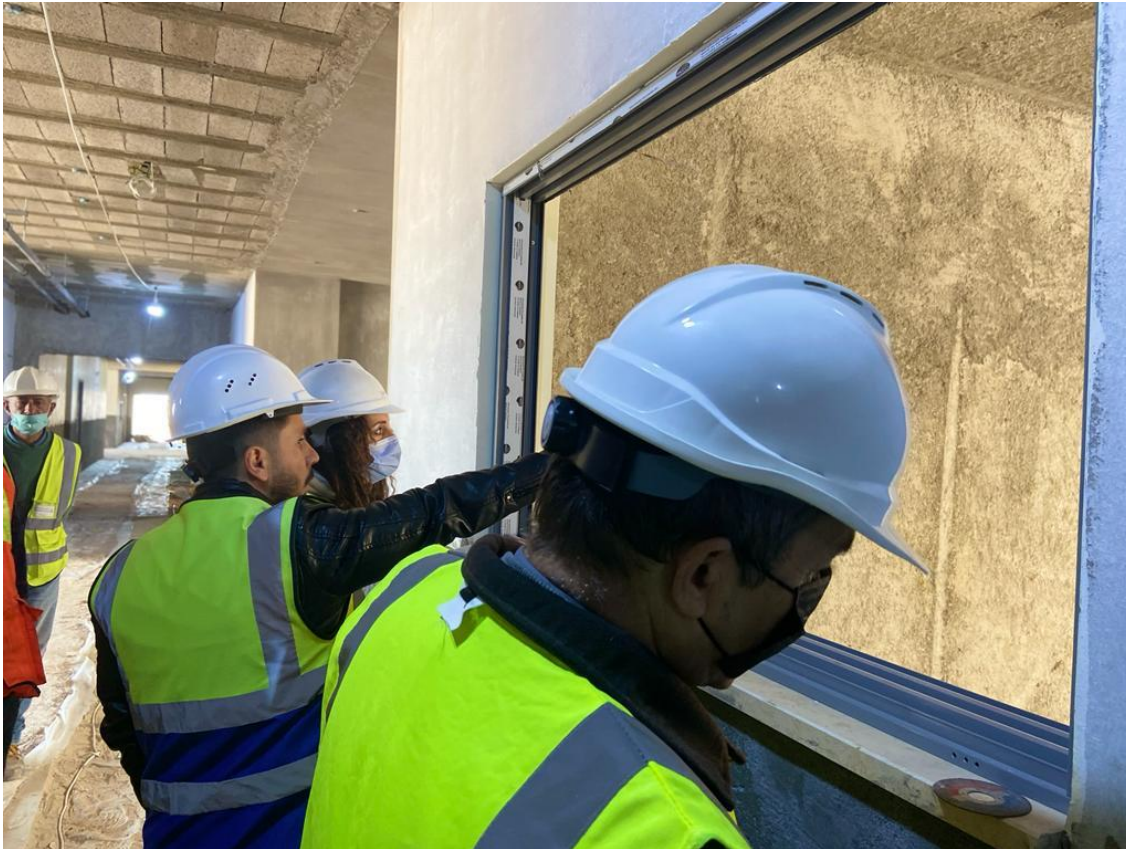
(Figure: 23 and 24)

9	The supervision team observed that in number of windows, the aluminum sections do not match the actual dimensions of the opening. Therefore, those sections should be replaced.
10	The team observed that the Contractor has executed part of the heating pipes hanged on the ceiling of the corridors as required.
11	It was observed that the Contractor has not replaced the defected granite pieces fixed at the staircase walls. The team noticed that the Contractor has just delivered new pieces and observed that the newly delivered quantities have the same defect. One of the major defects is that the cutting off is not done properly.
12	The team observed that the defected stones in stock were sorted from the acceptable ones by the Contractor upon the instructions of the supervision site engineer.
13	It was observed that the Contractor executed electromechanical manholes near the guard house without following the exact location shown in the drawings.

Inspecting the aluminum works

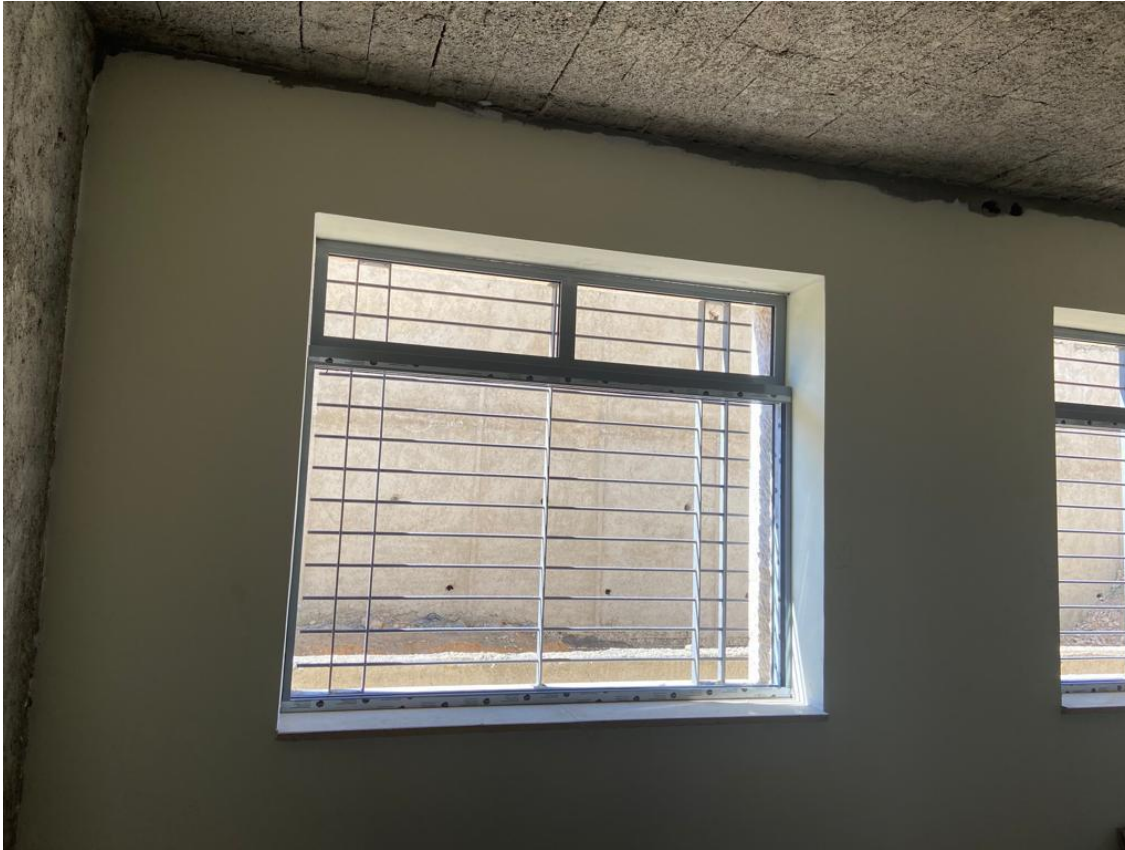
(Figure: 25)

The team observed that number of installed aluminum sections need to be replaced to match with the exact dimensions of the openings to avoid the observed gaps considered as over tolerance.

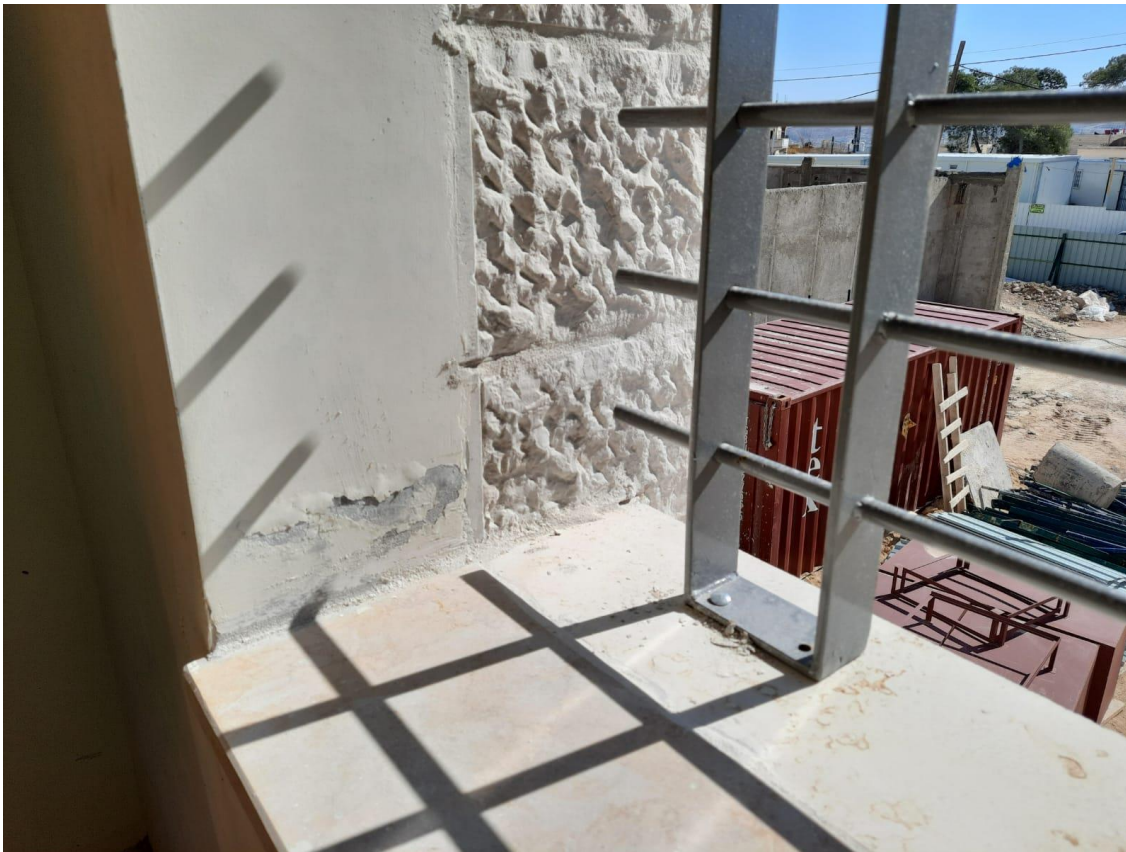
(Figure: 30)

Defects in the window jambs

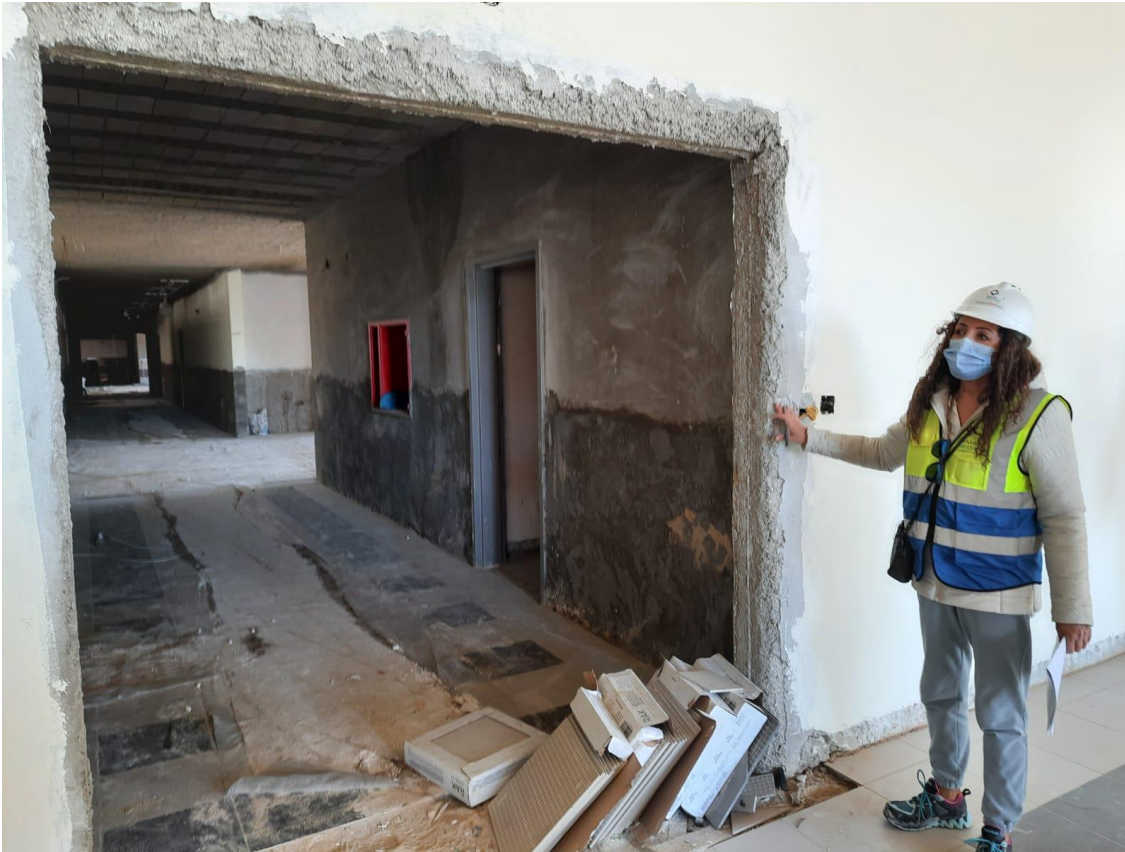
(Figure: 33)

Fire rated door frame not installed
