### **Site Visit Report Form**

FTR # 259 QR

**School Name:** Thahr Al Sarow Basic School for Boys

Date and Time of Field Trip:January 6, 2021Date of Report:January 9, 2021Weather During Visit:Clear 19°Report Submitted By:Abedalaziz Abu

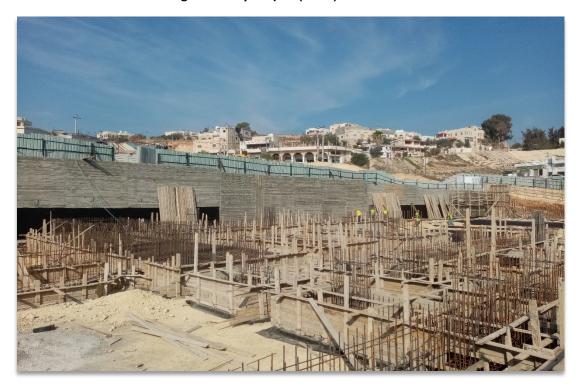
Figure 3: Reinforcement Steel Laying and Frameworks in the Southern Section

Figure 3 shows the southern section of the site which is progressing ahead of the Northern section (Figure 4) where the Construction Contractor was just applying the Third layer of Bitumen insulation to the blinding.

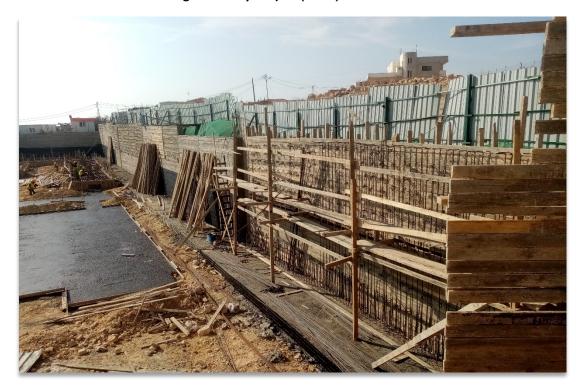
Figure 5: Retaining Wall

Retaining wall execution is ongoing, 80% of the Construction work is done and 10% has been insulated.

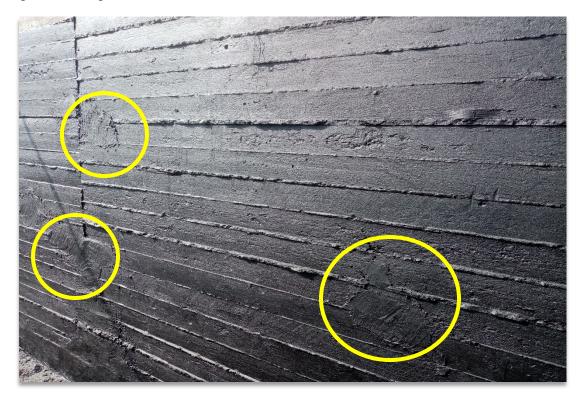
Figure 6: Concrete Segregation Treatment

Minimal Concrete Segregation areas were noticed and have been treated with approved material.

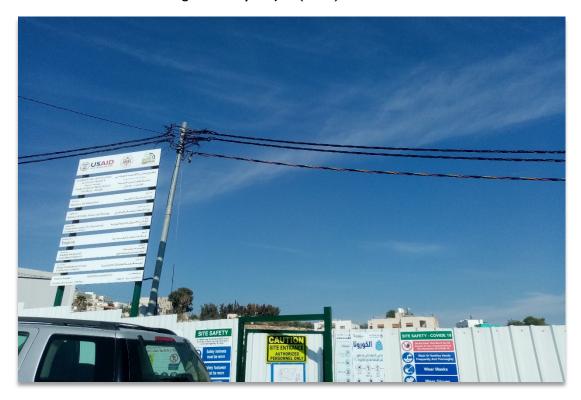
Figure 7: Electrical Pole

Electrical pole is located at the Construction site entrance and in the way of the Concrete pump trucks. It might cause a real danger if it was hit by the Concrete pump truck Boom

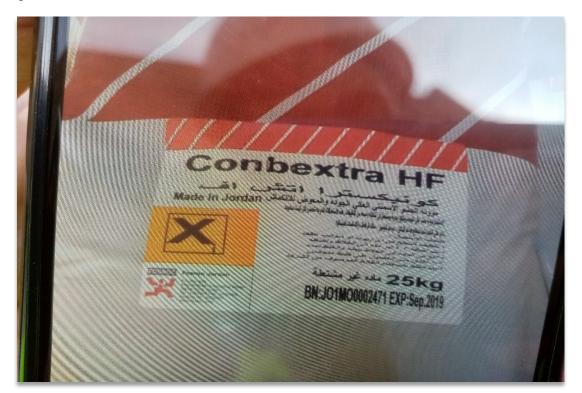
Concrete Segregation treatment Material used by the Construction Contractor.
Approved by the SE
